香港青年協會 賽馬會西貢戶外訓練營 第三期擴建工程

工程項目簡介

2010年8月

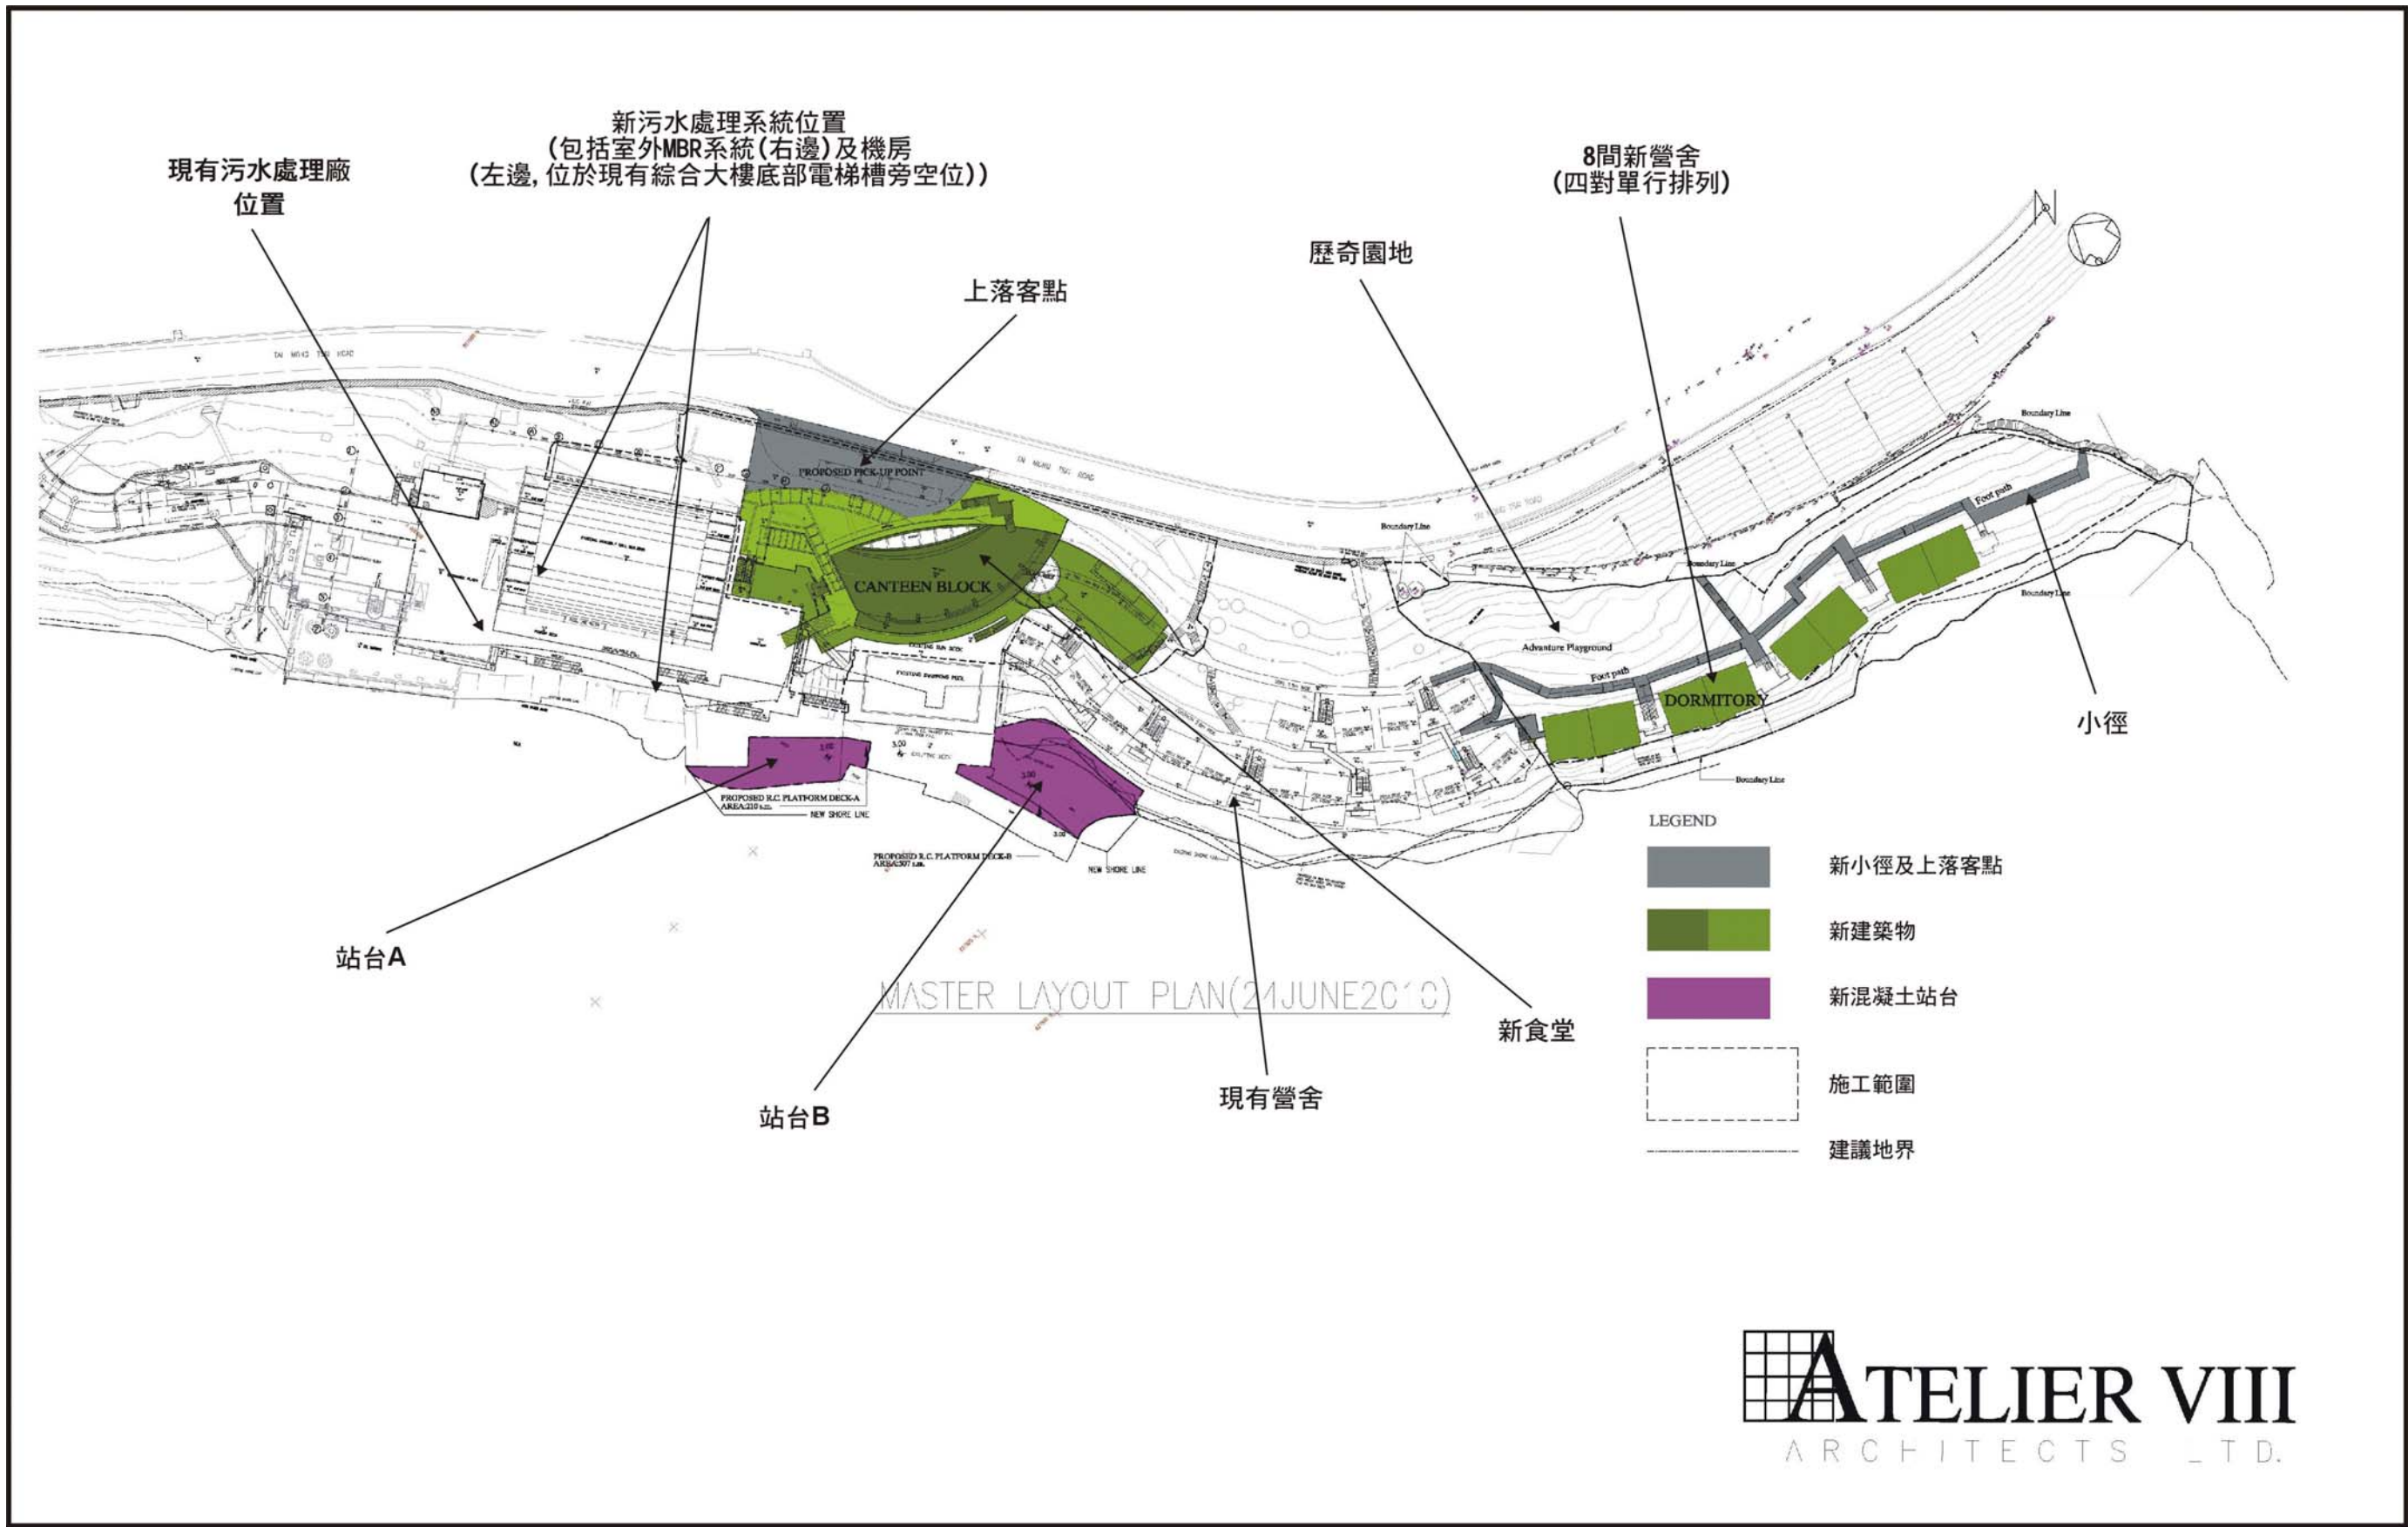
圖1.2 總網發展藍圖

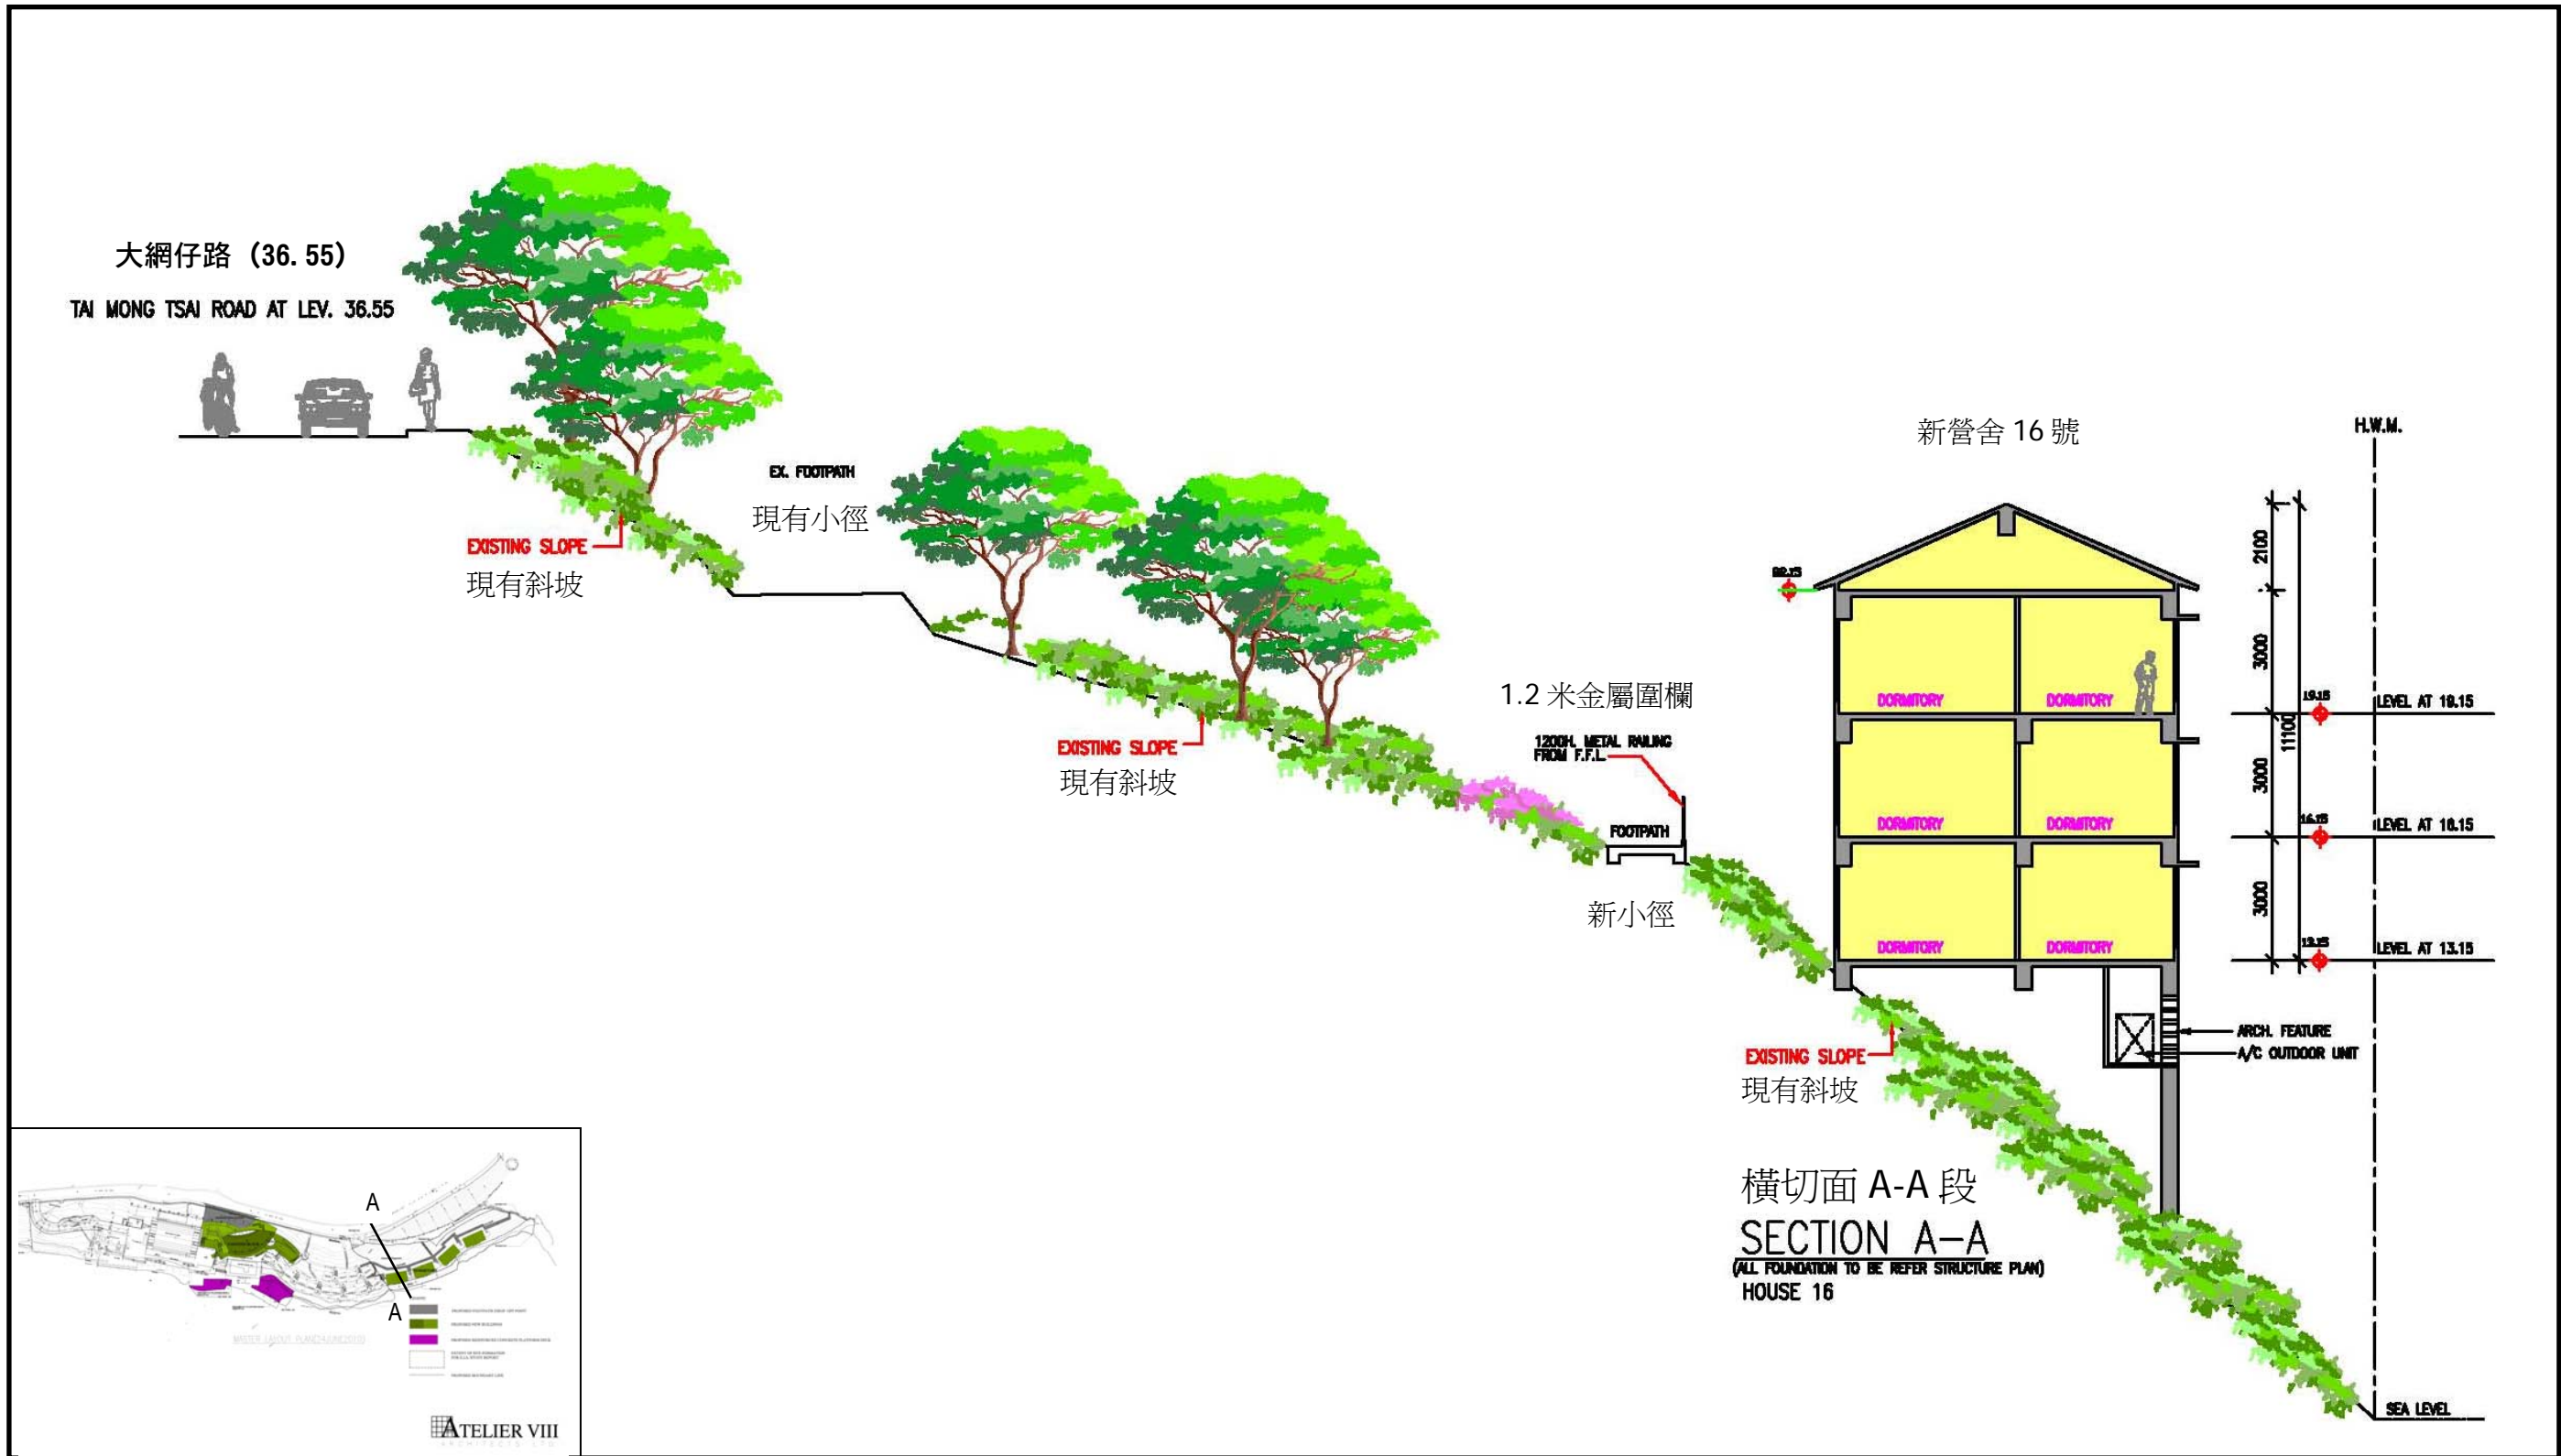
圖 1.3a 擬建營屋的橫切面圖

- 1.4.4 八座 2-3 層高的營屋樓房合共有 19 個房間，將建於現有營屋西面山坡較低的位置。八座樓房混合了兩層及三層的高度，以半獨立屋型式排列成爲一行，以融入現場環境和盡量減少建築物覆蓋範圍及對環境影響，總覆蓋面積爲 718 平方米。不同高度的新營屋能破除視覺上的單調及添加視覺上的趣味。新營屋與第二期相似，將供團體住客入住。爲減低對視覺影響，所有樓房的高度將低於大網仔路，在外觀的安排上，環保設計包括遮擋陽光功能和綠化的特色及植樹。**圖 1.3a** 顯示三層營屋橫切面。**圖 1.3b** 的營屋正面圖顯示其高度、大小及與大網仔路之間的關係。噪音方面，所有新營屋距離大網仔路最少 40 米及安裝空調，並不倚賴窗戶作通風用途。此外，因擴建而增加的交通亦很輕微且只在日間發生，所以對在夜間才使用的營屋也不構成影響。新設的廢水處理系統中噪音較大的機件（風機和滲透水泵）亦會被藏於現有大樓底部升降機井旁的新機房，機房距離新營屋多於 190 米，機房聲浪亦會被現有大樓阻隔，故此營運期間的噪音對新營屋的影響將會微不足道。

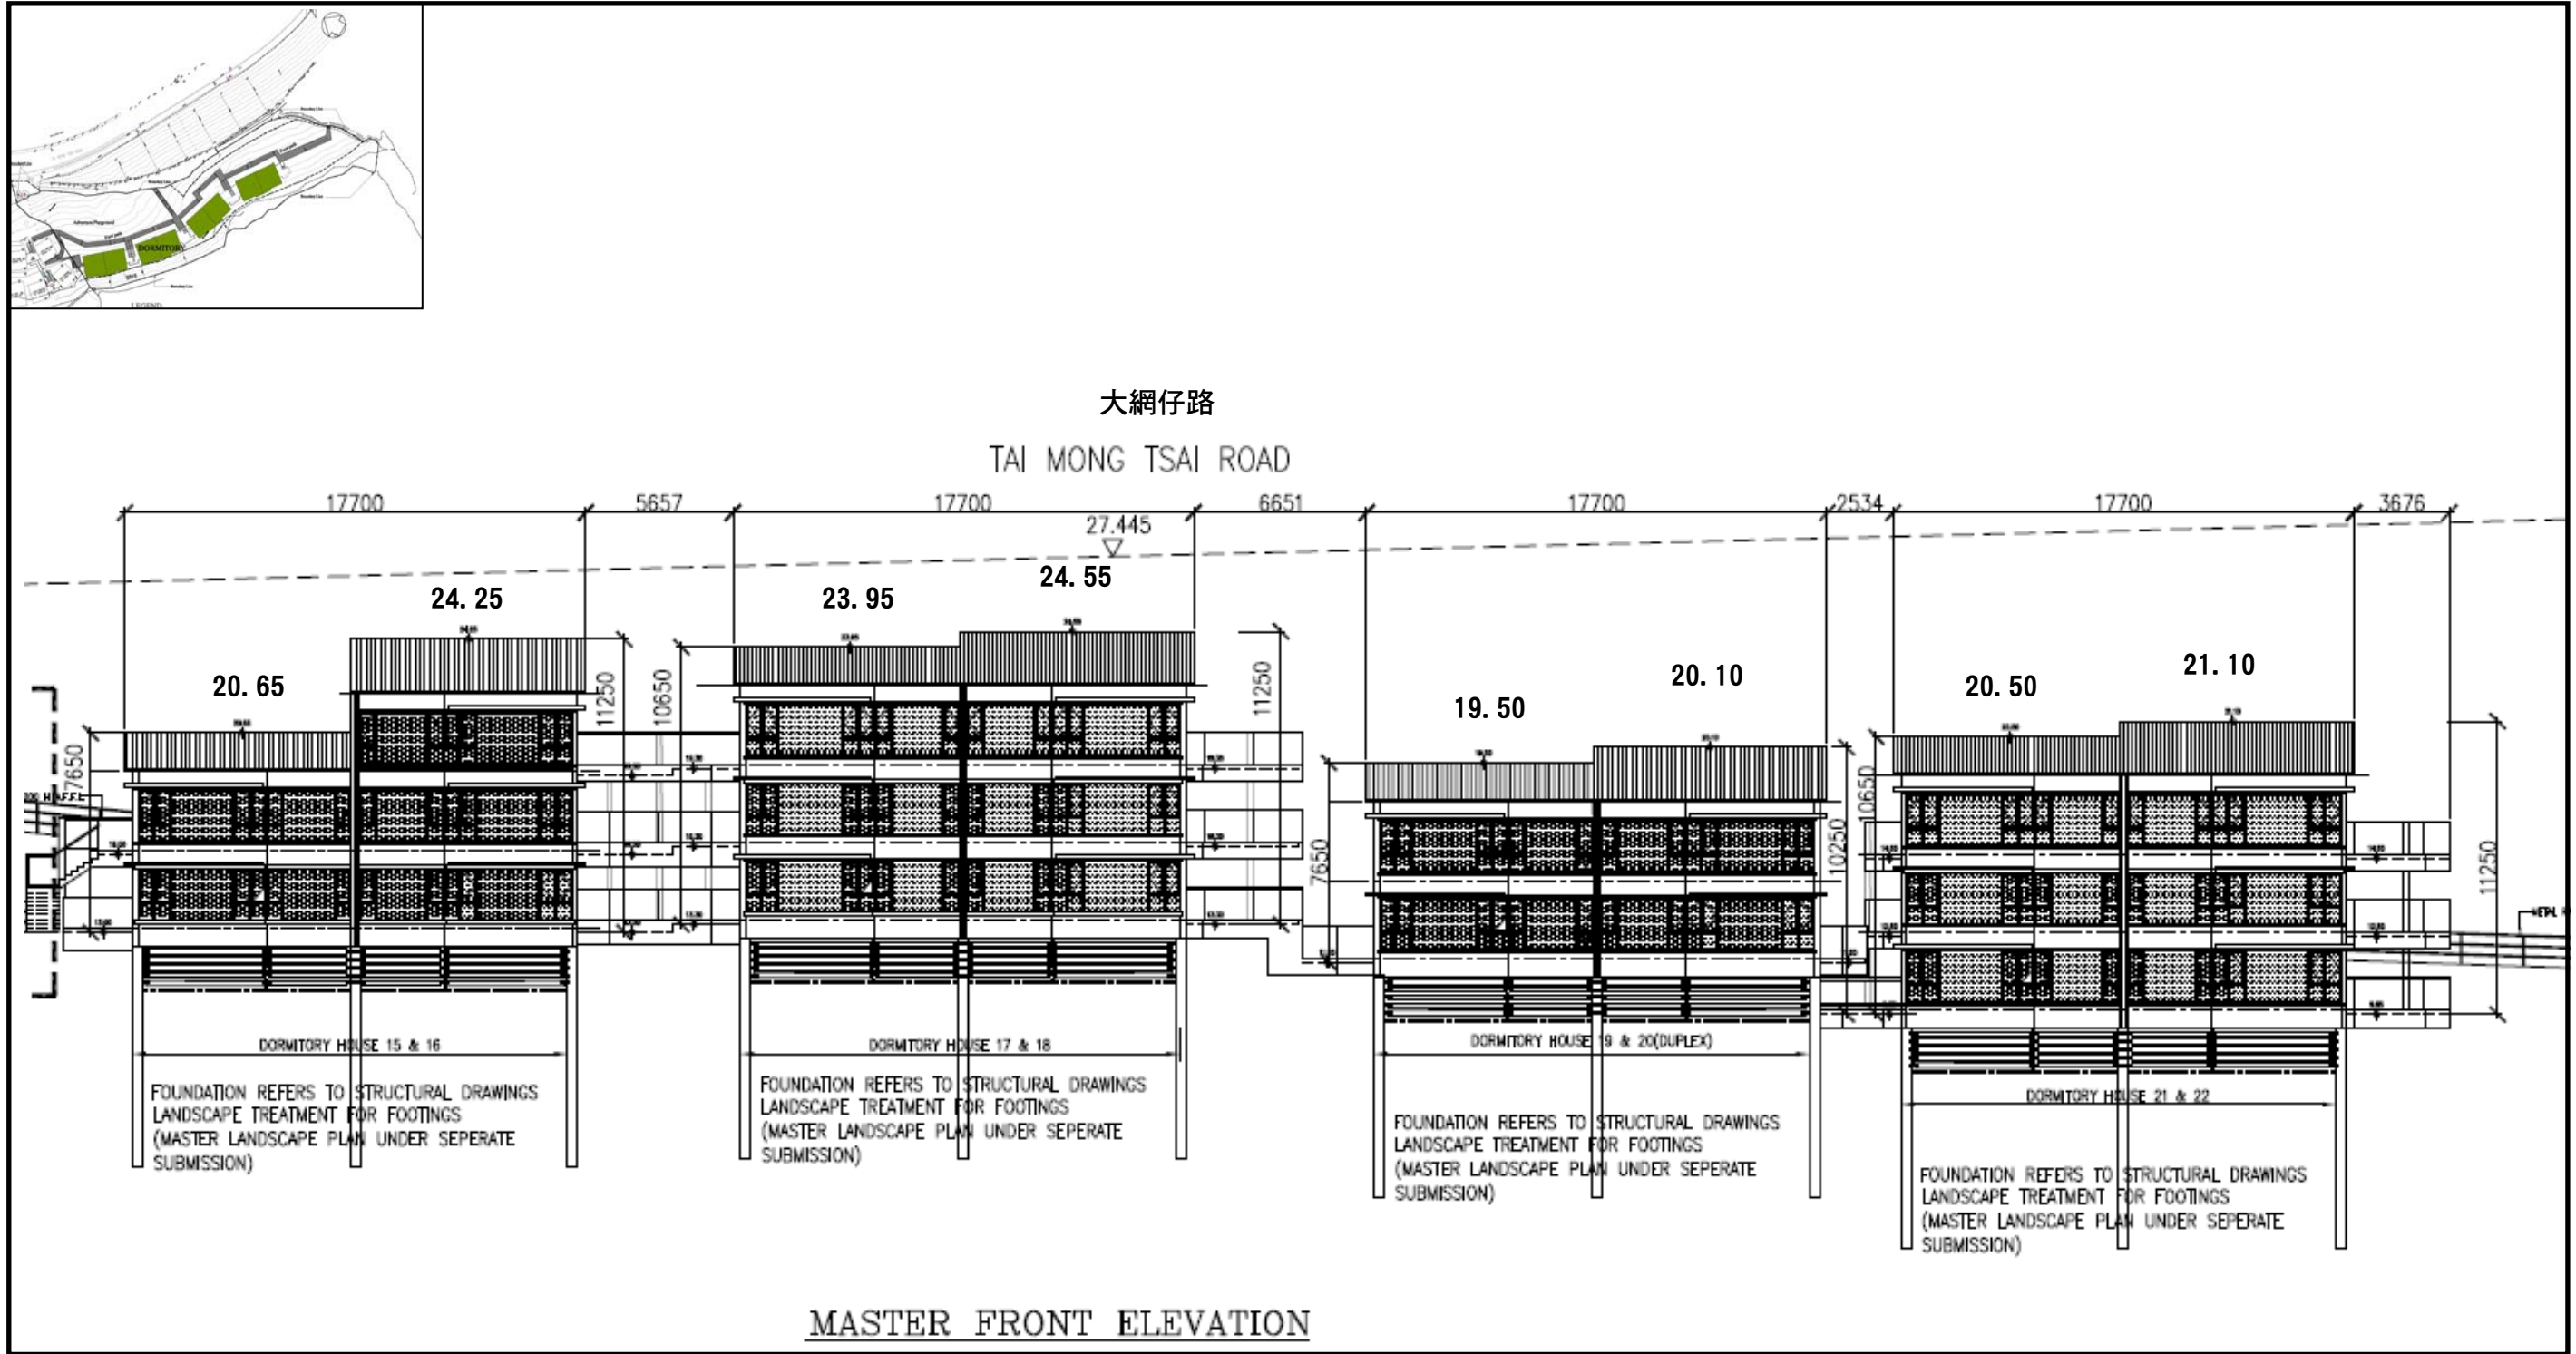
圖 1.3b 擬建營屋的正面圖，展示樓宇高度(米)，大小(毫米)及與大網仔路的關係

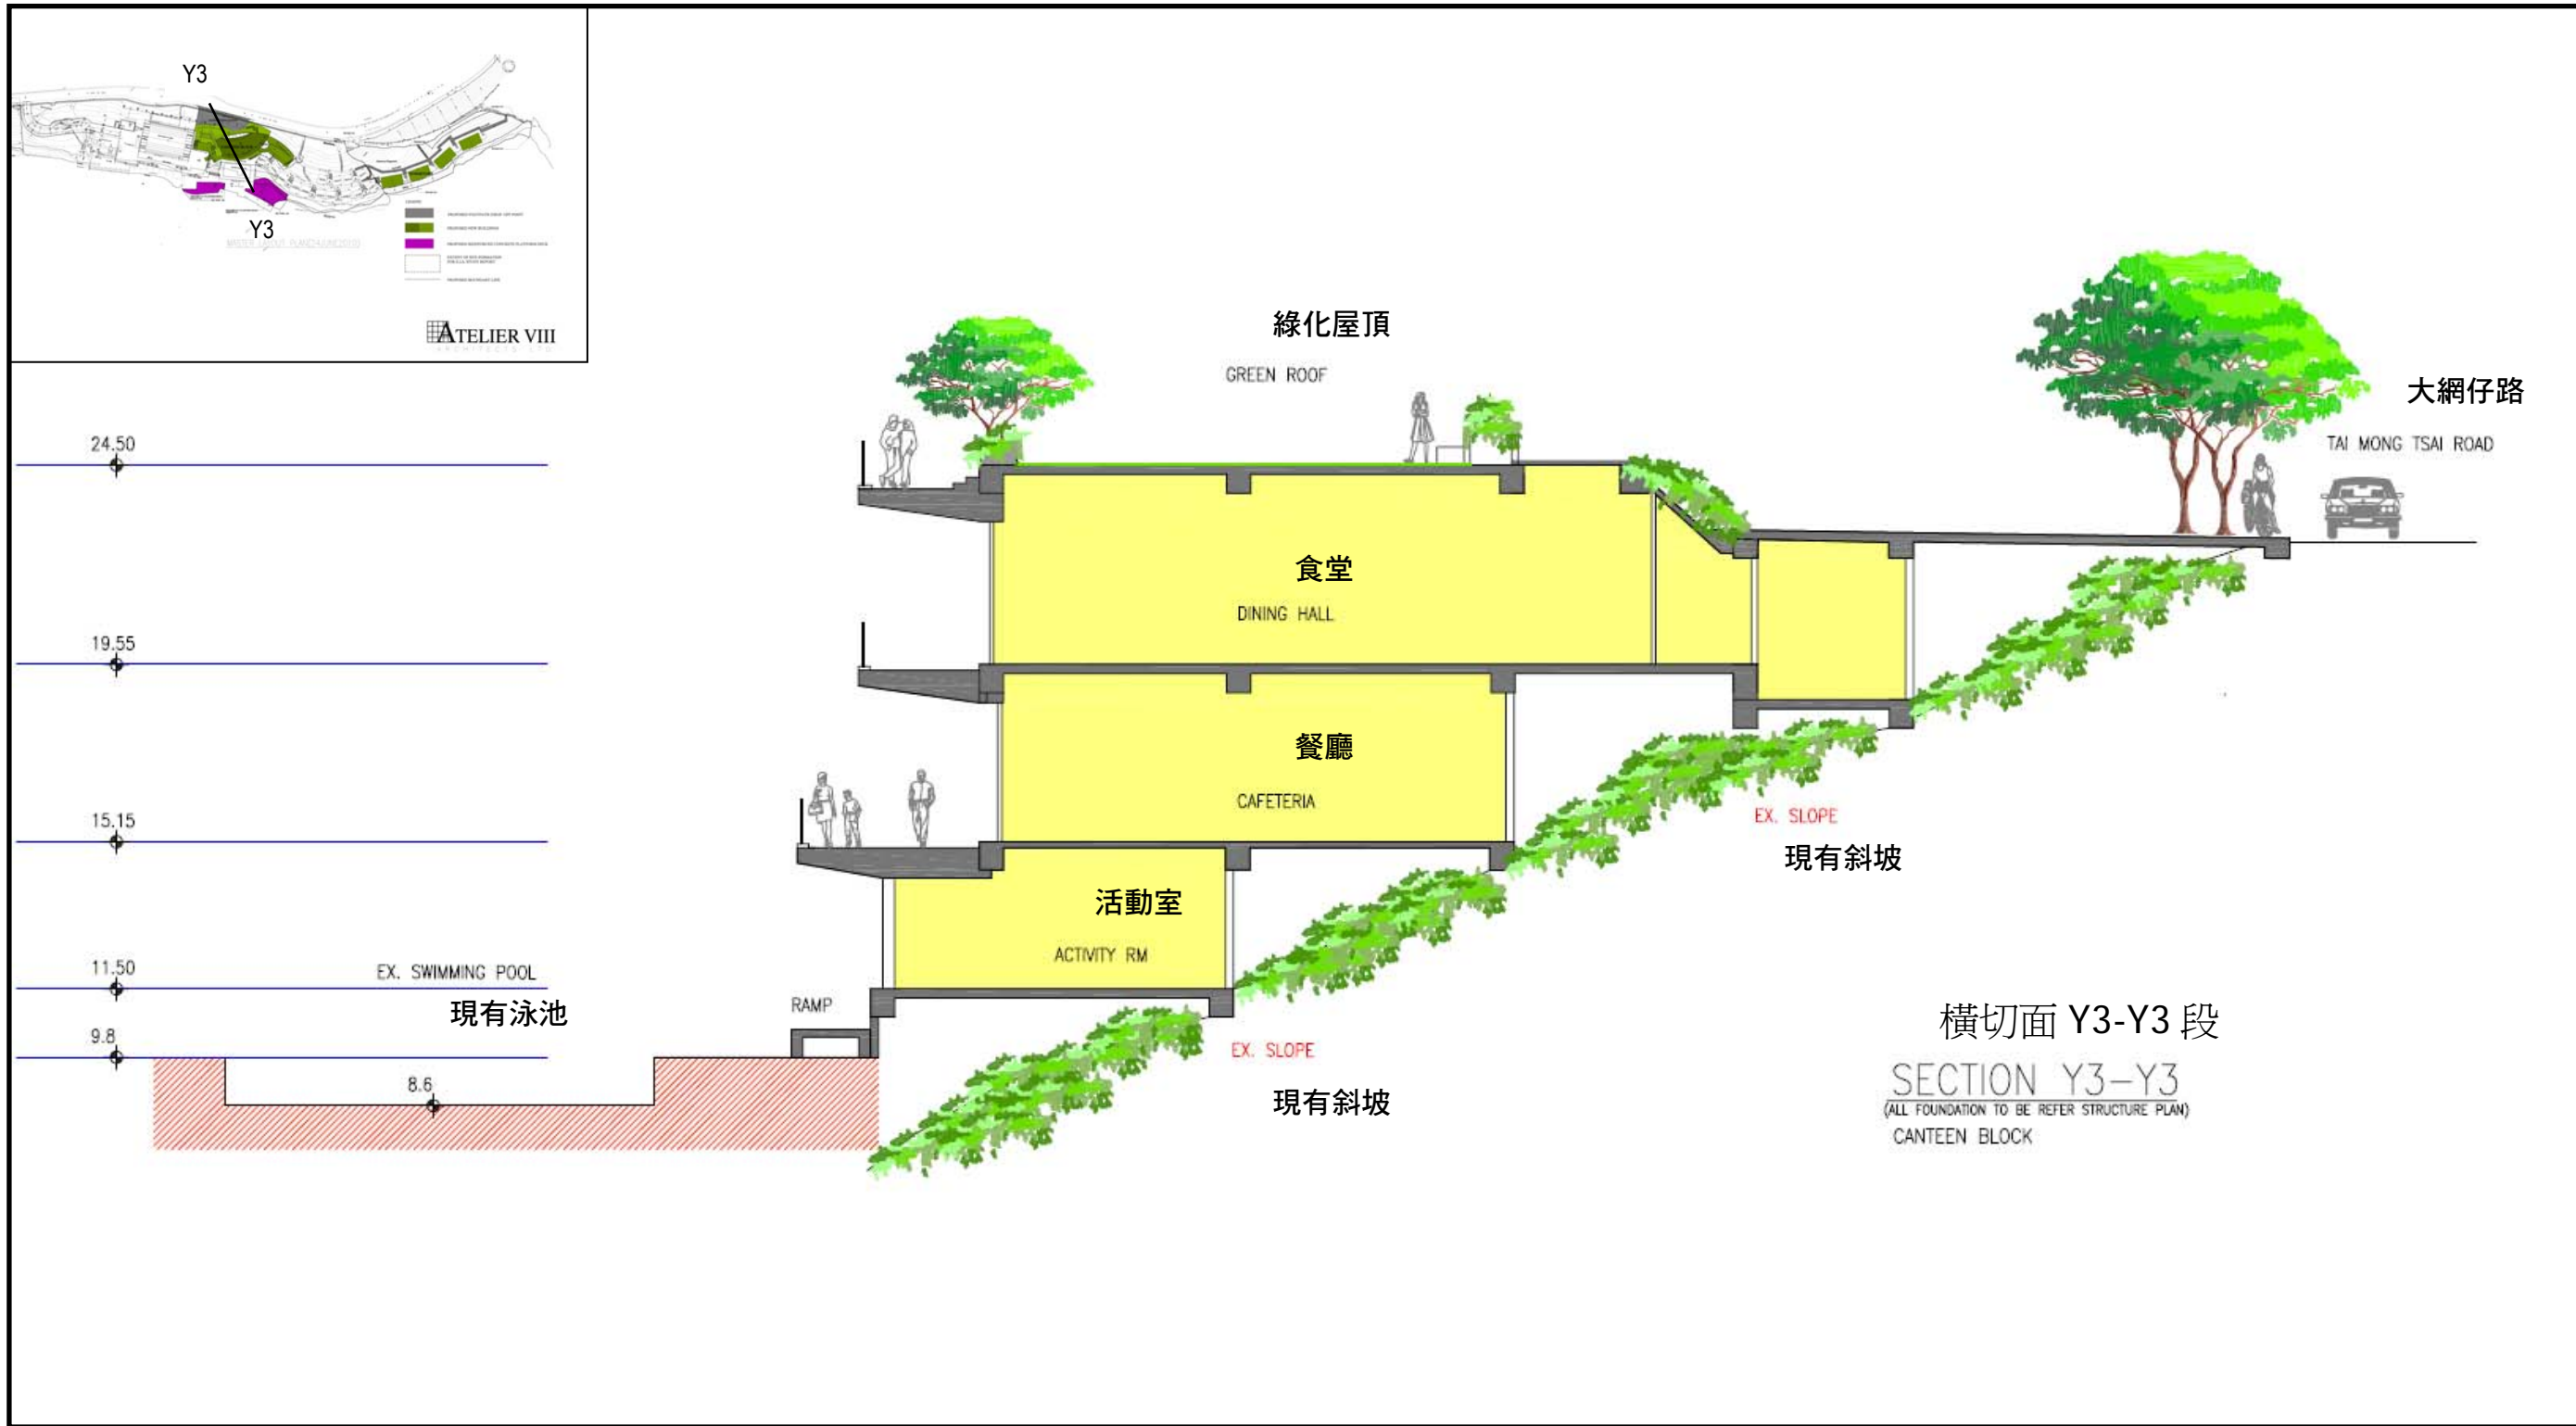
圖 1.3c 擬建食堂的橫切面圖

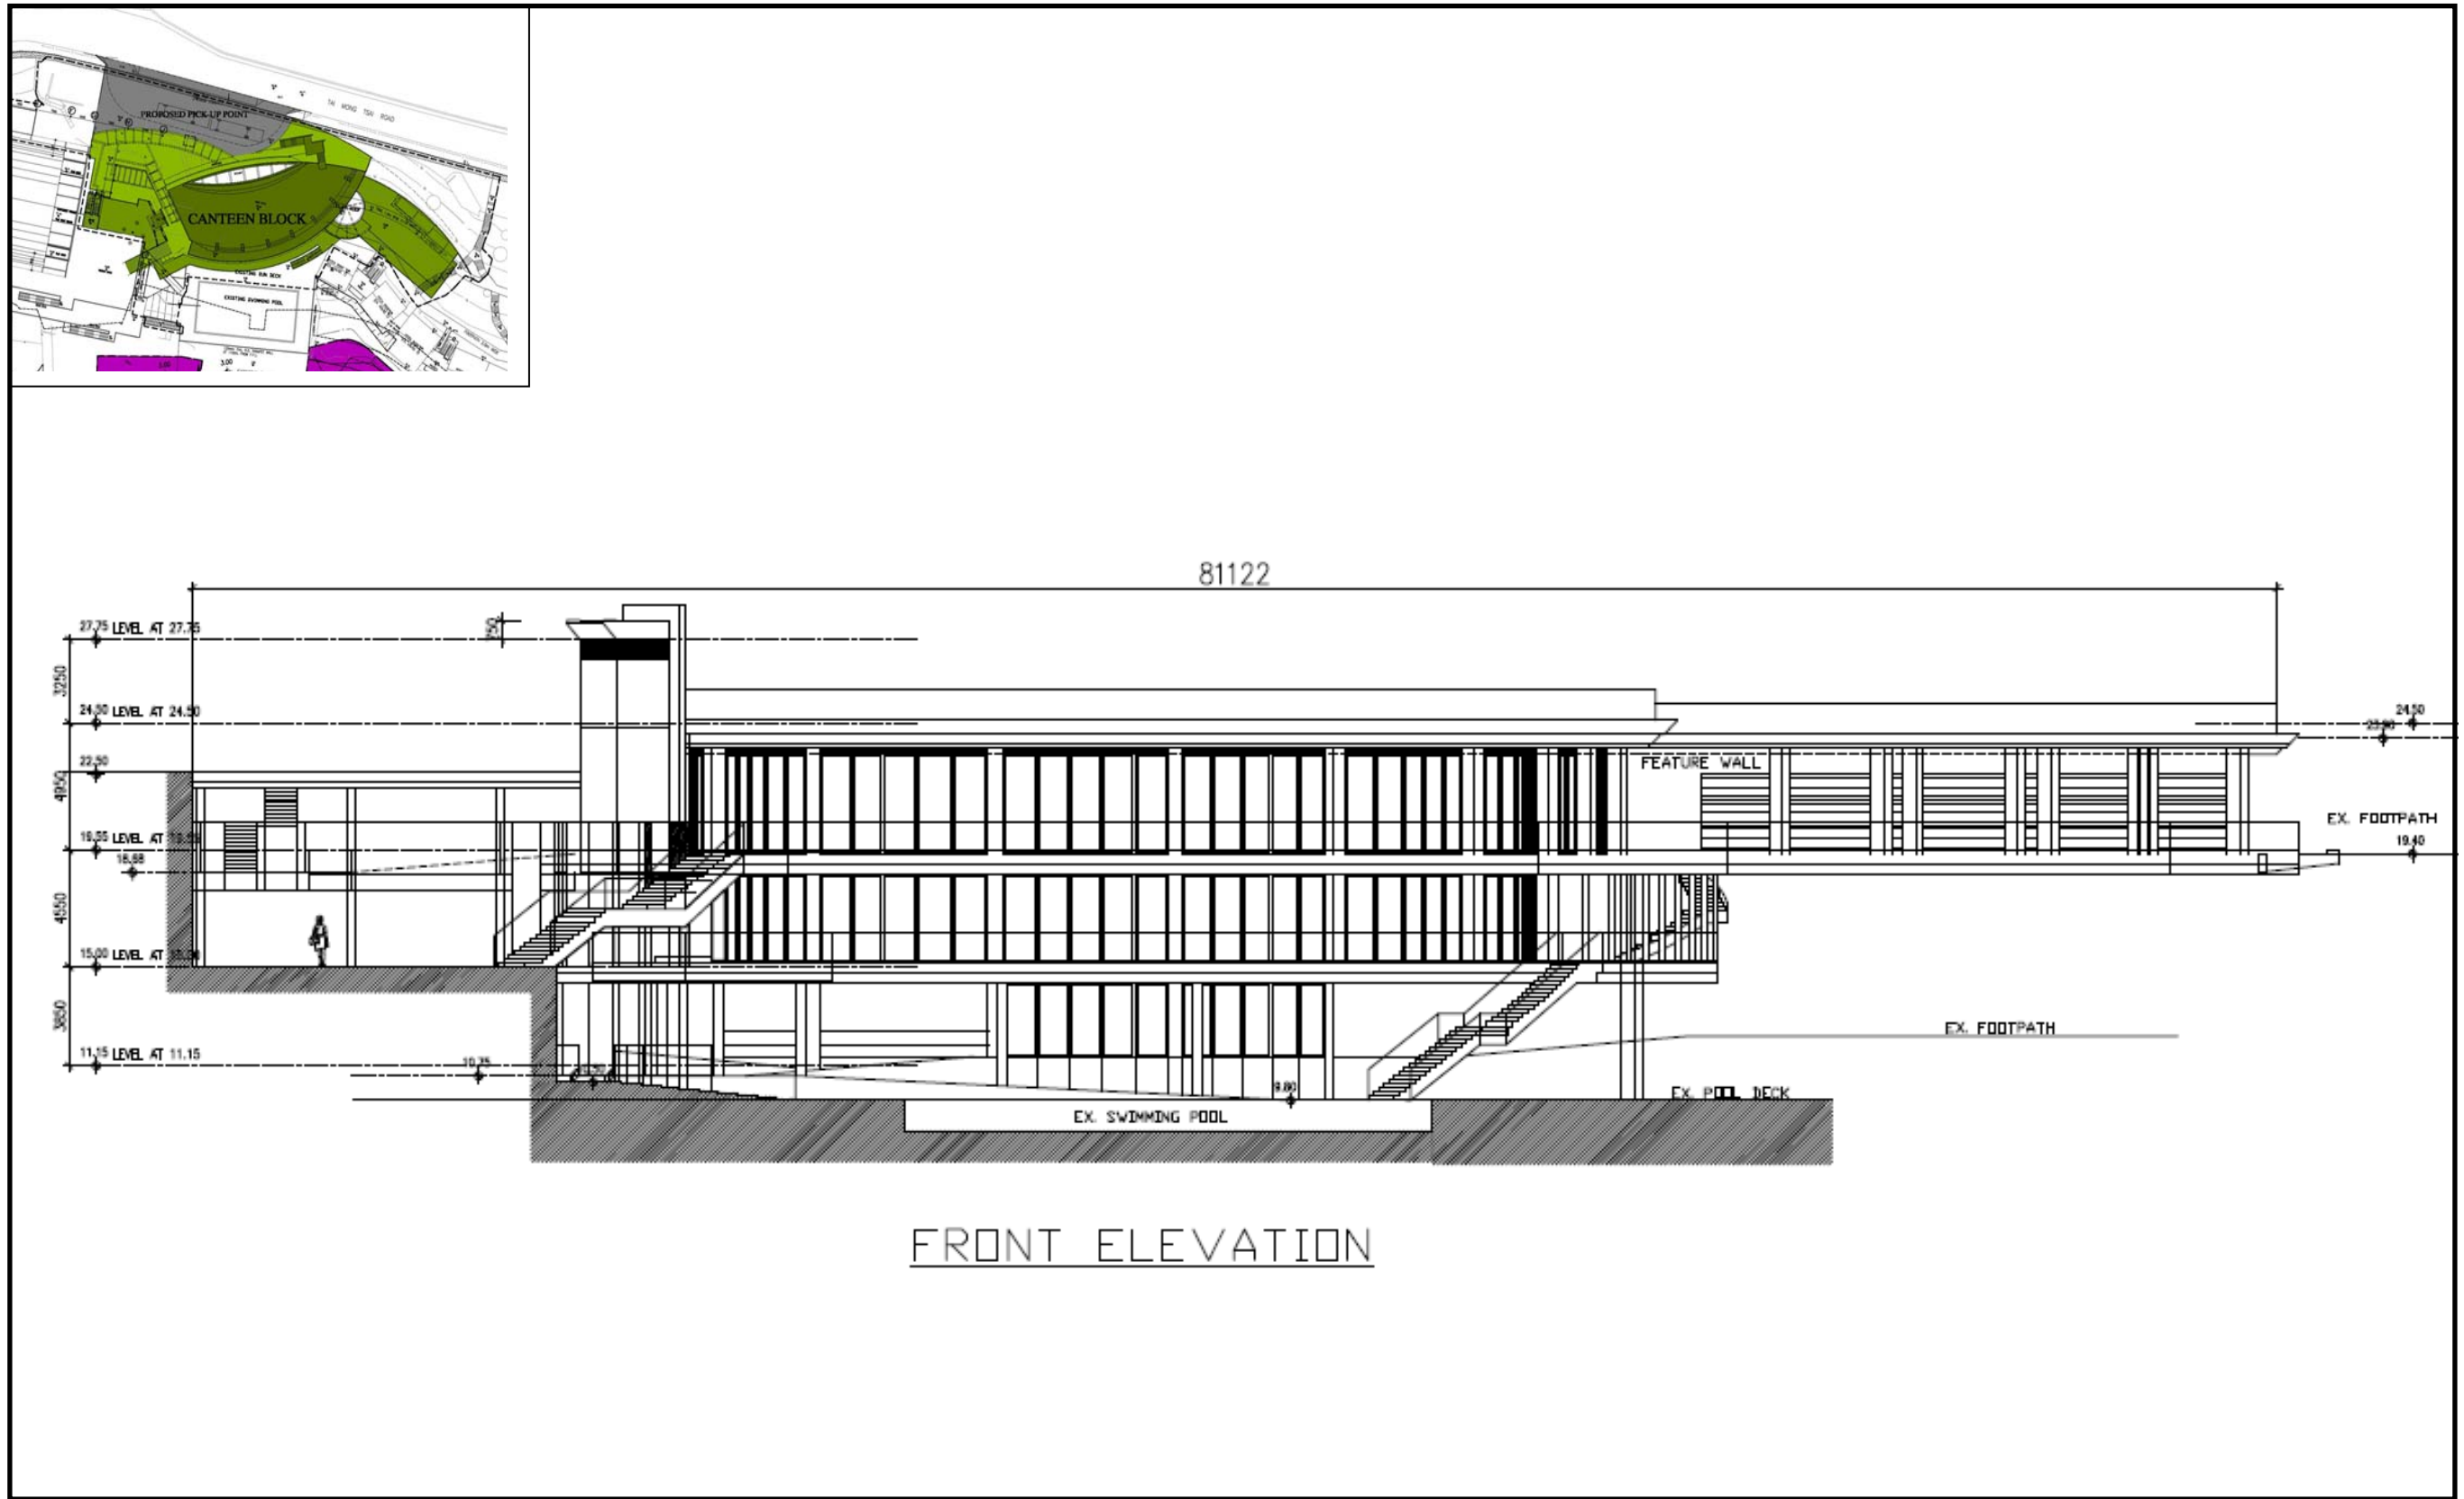
圖 1.3d 擬建食堂的正面圖，展示樓宇高度(米)，大小(毫米)及與大網仔路的關係

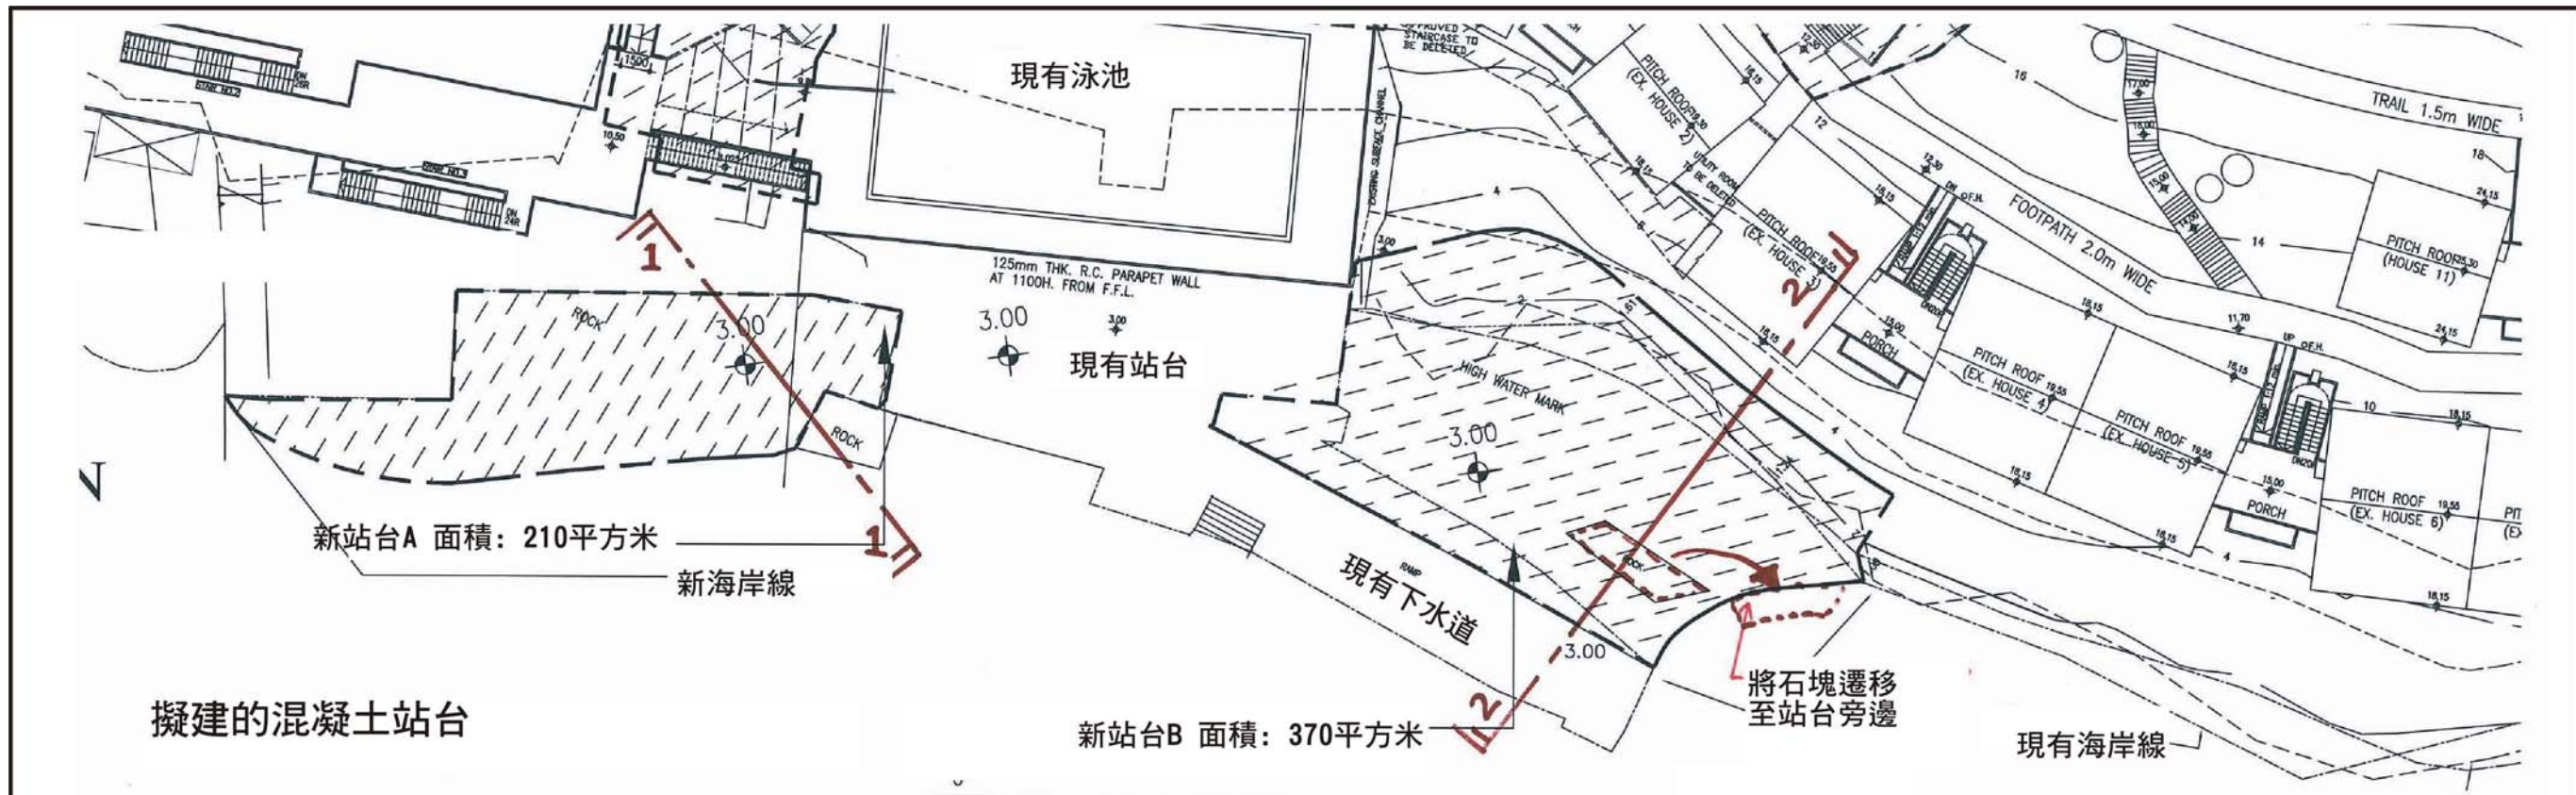
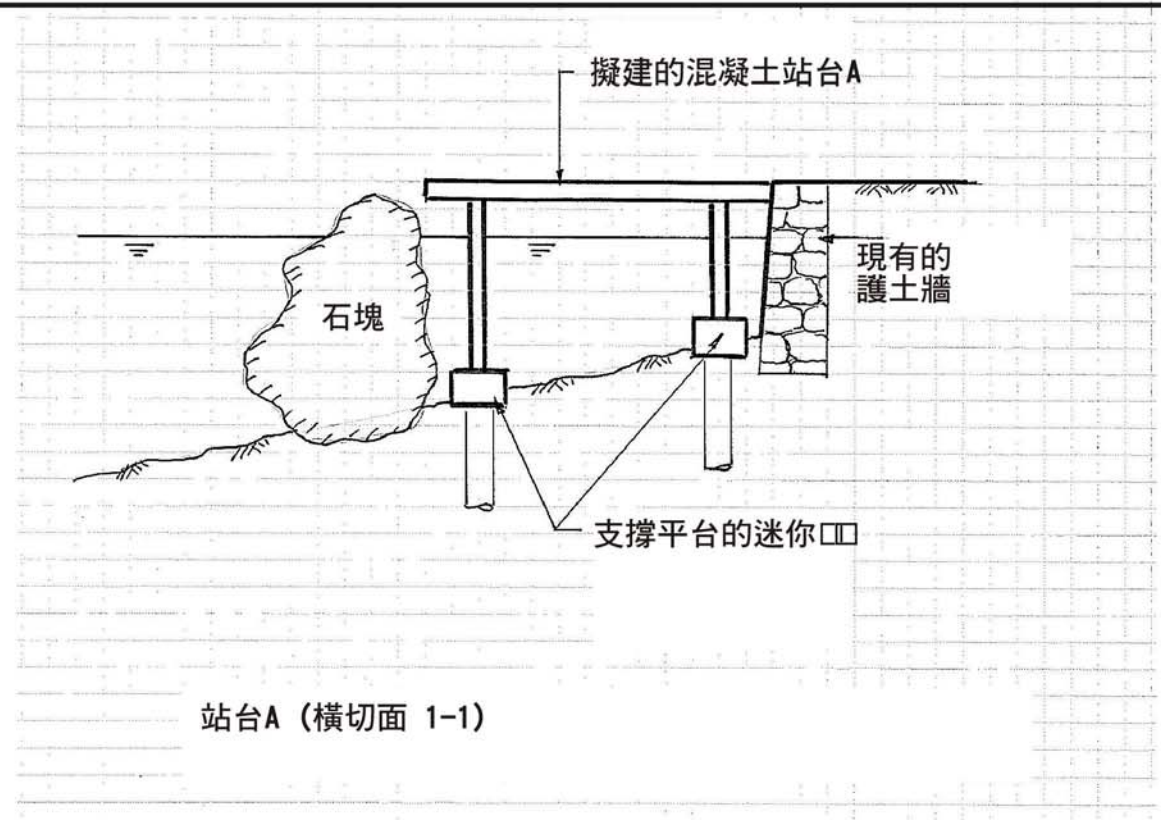
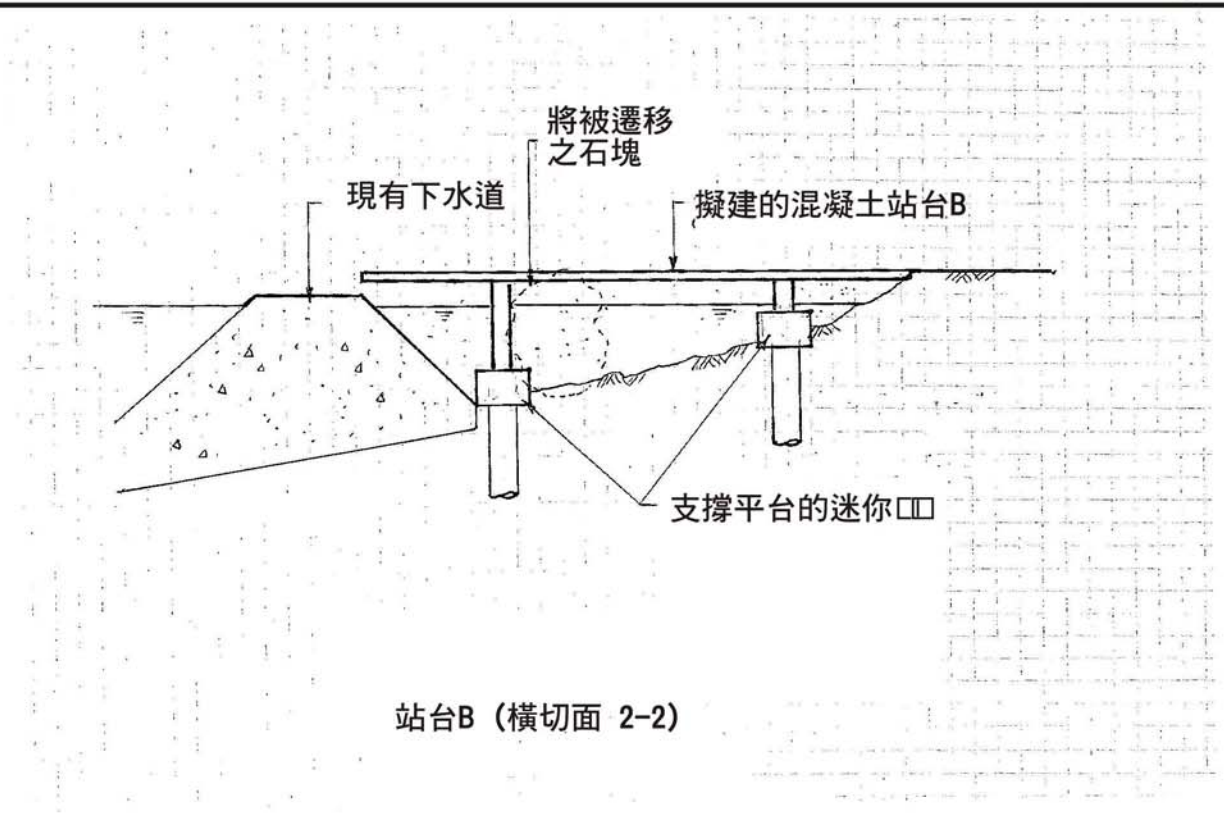
圖1.4 擬建的站台 - 放大及橫切面圖
