香港青年協會 賽馬會西貢戶外訓練營 第三期擴建工程

工程項目簡介

2010年8月

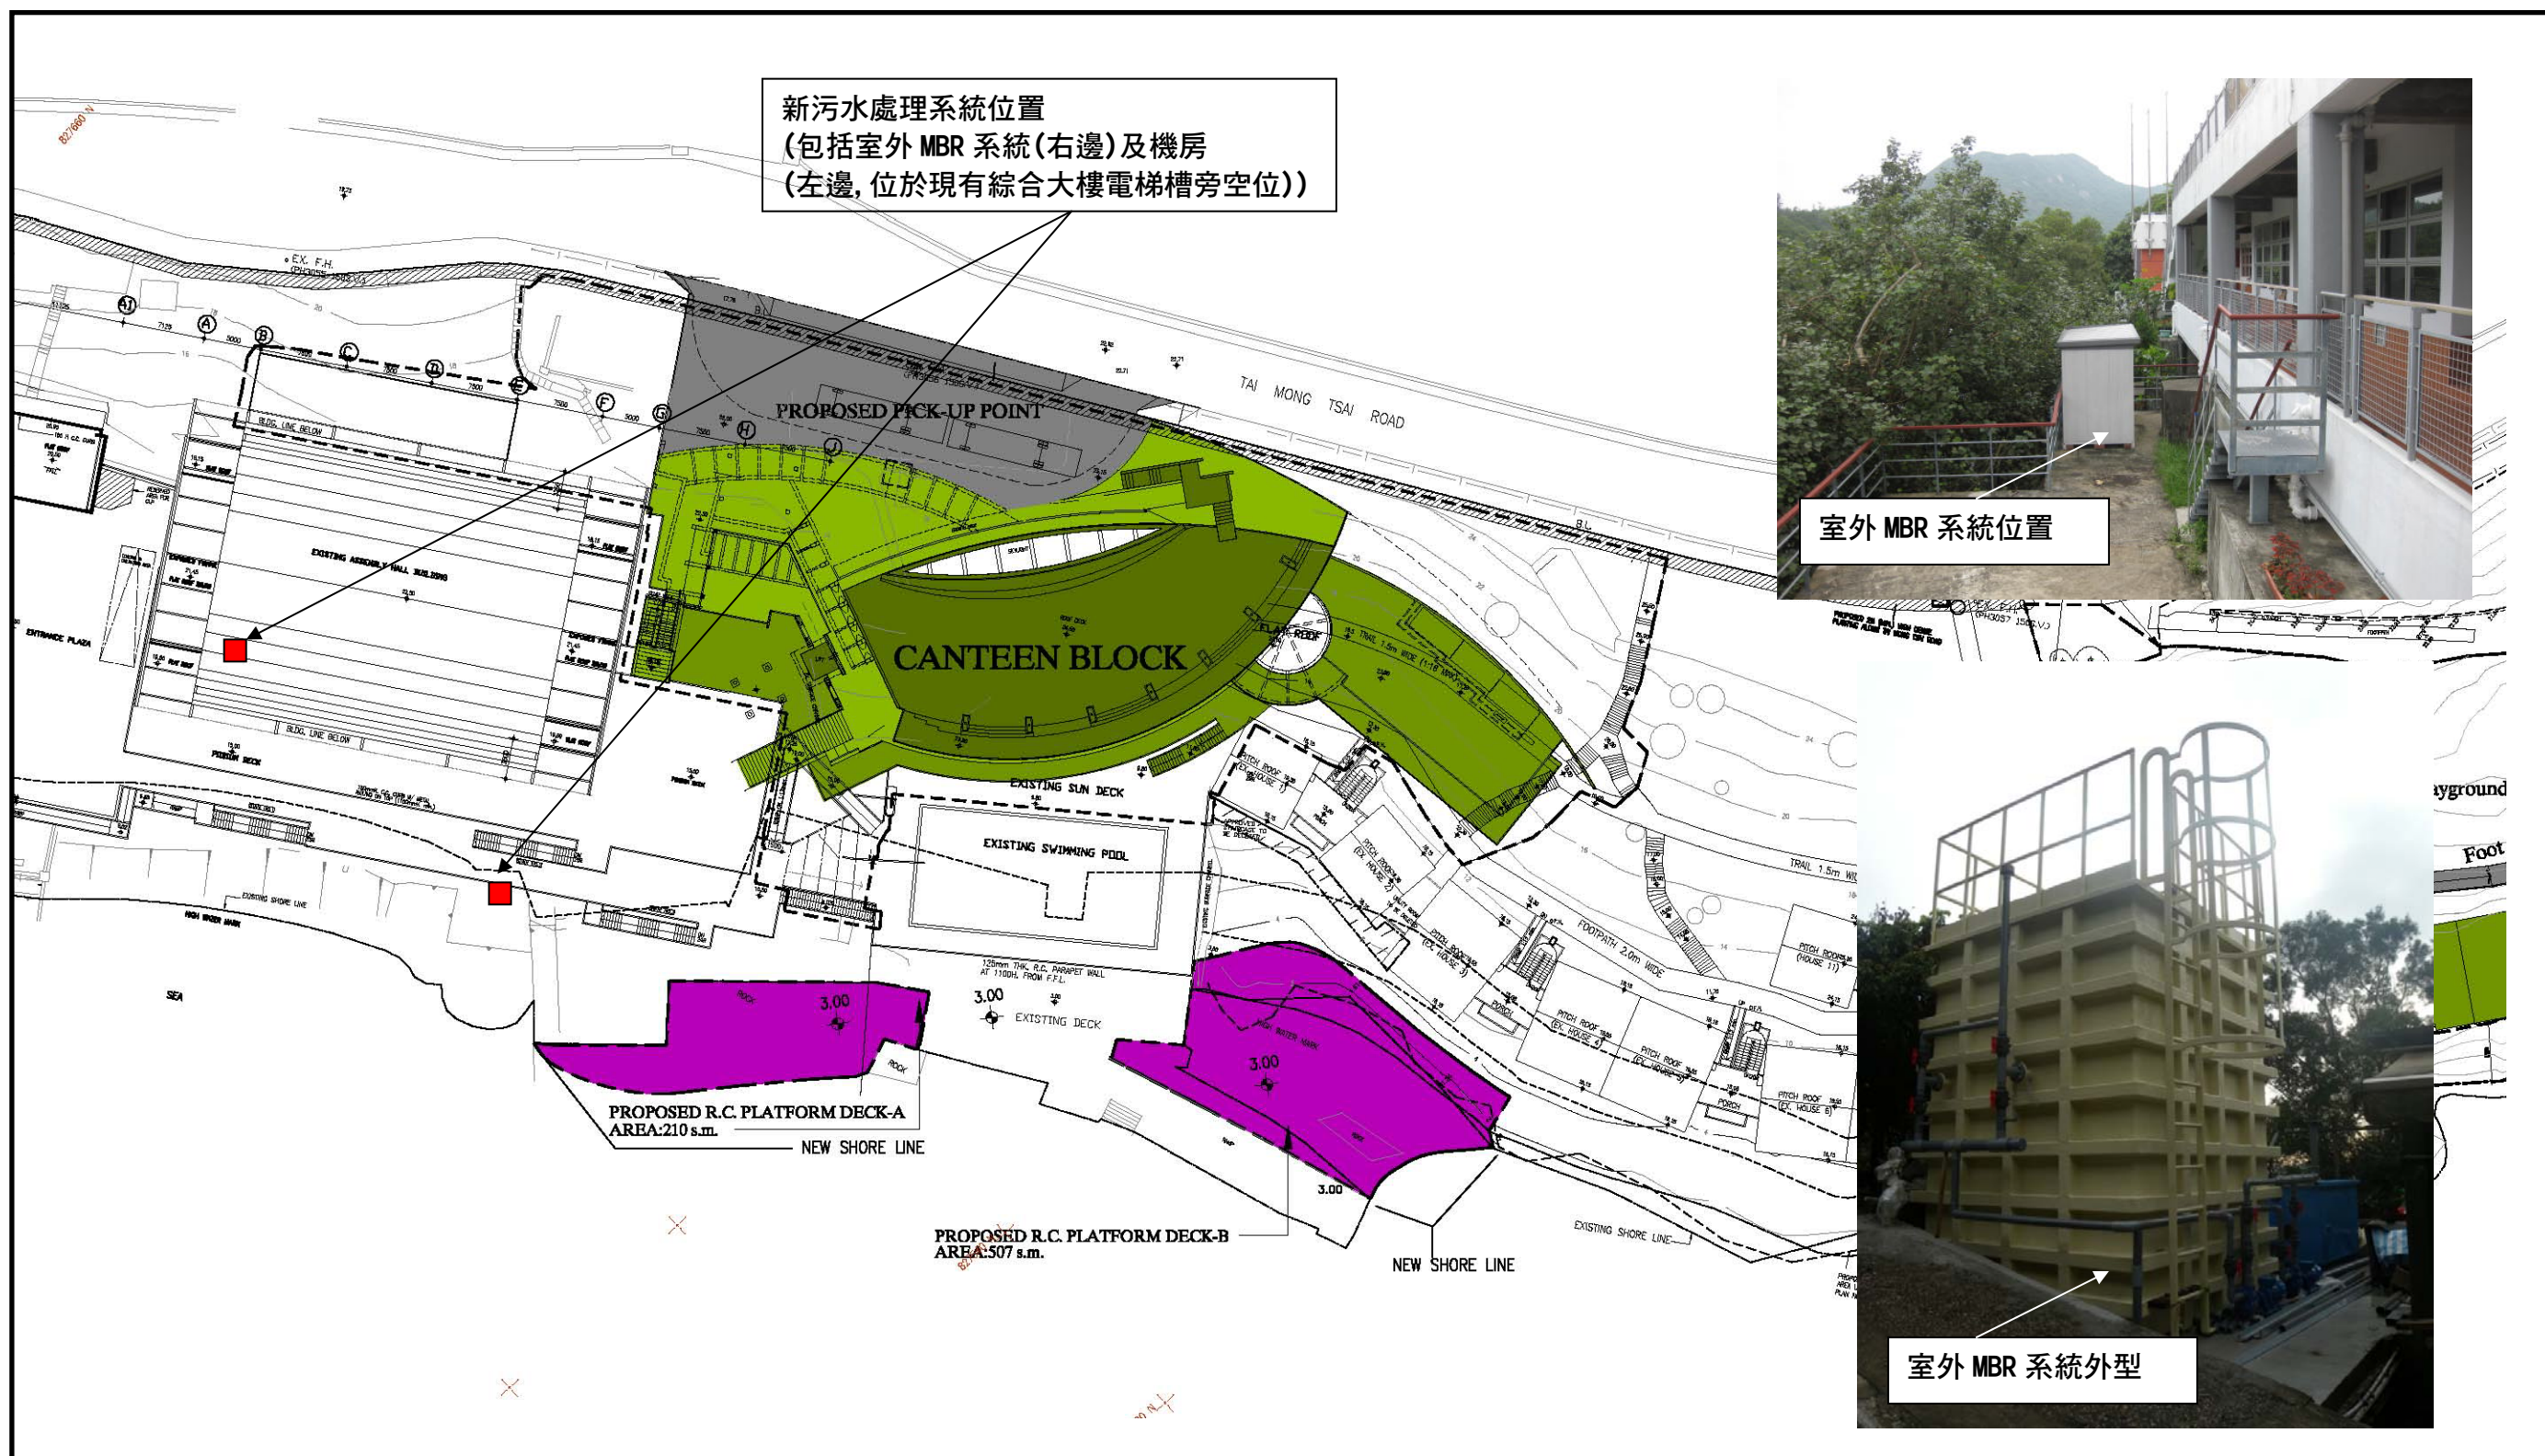
圖 1.5a 擬建廢水處理系統位置

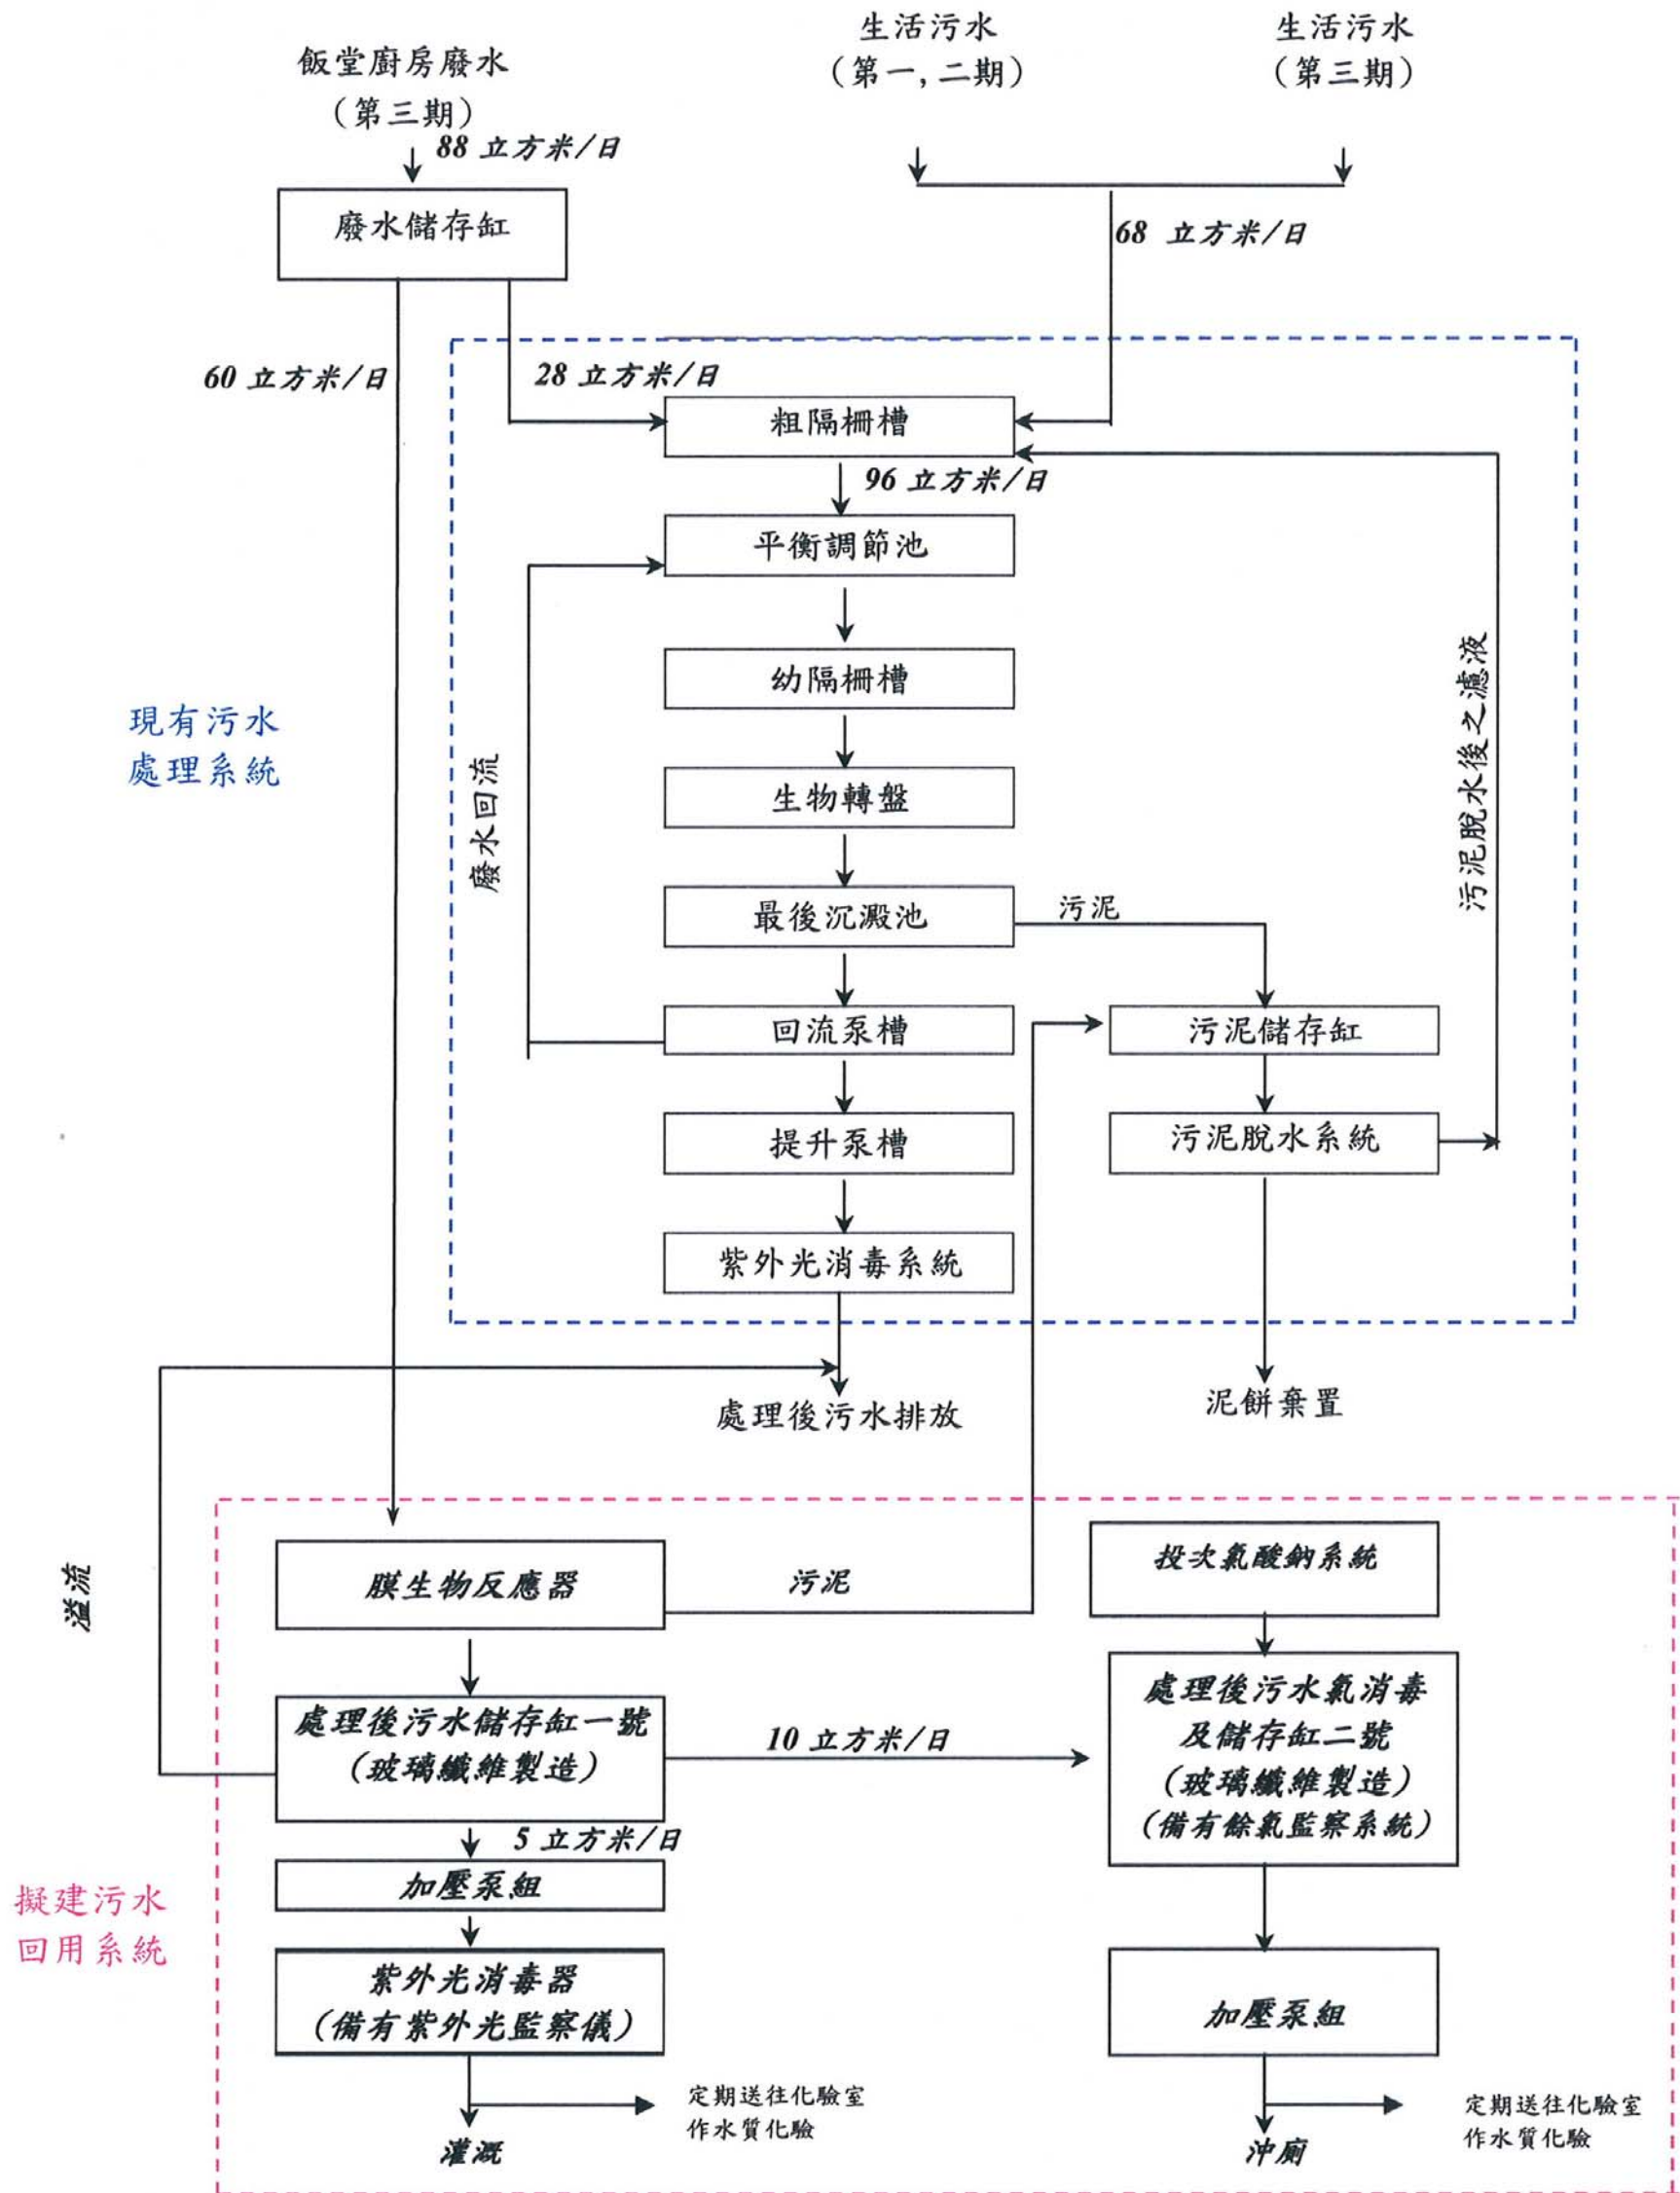
圖 1.5b 現有污水處理廠及擬建廢水處理系統的運作流程

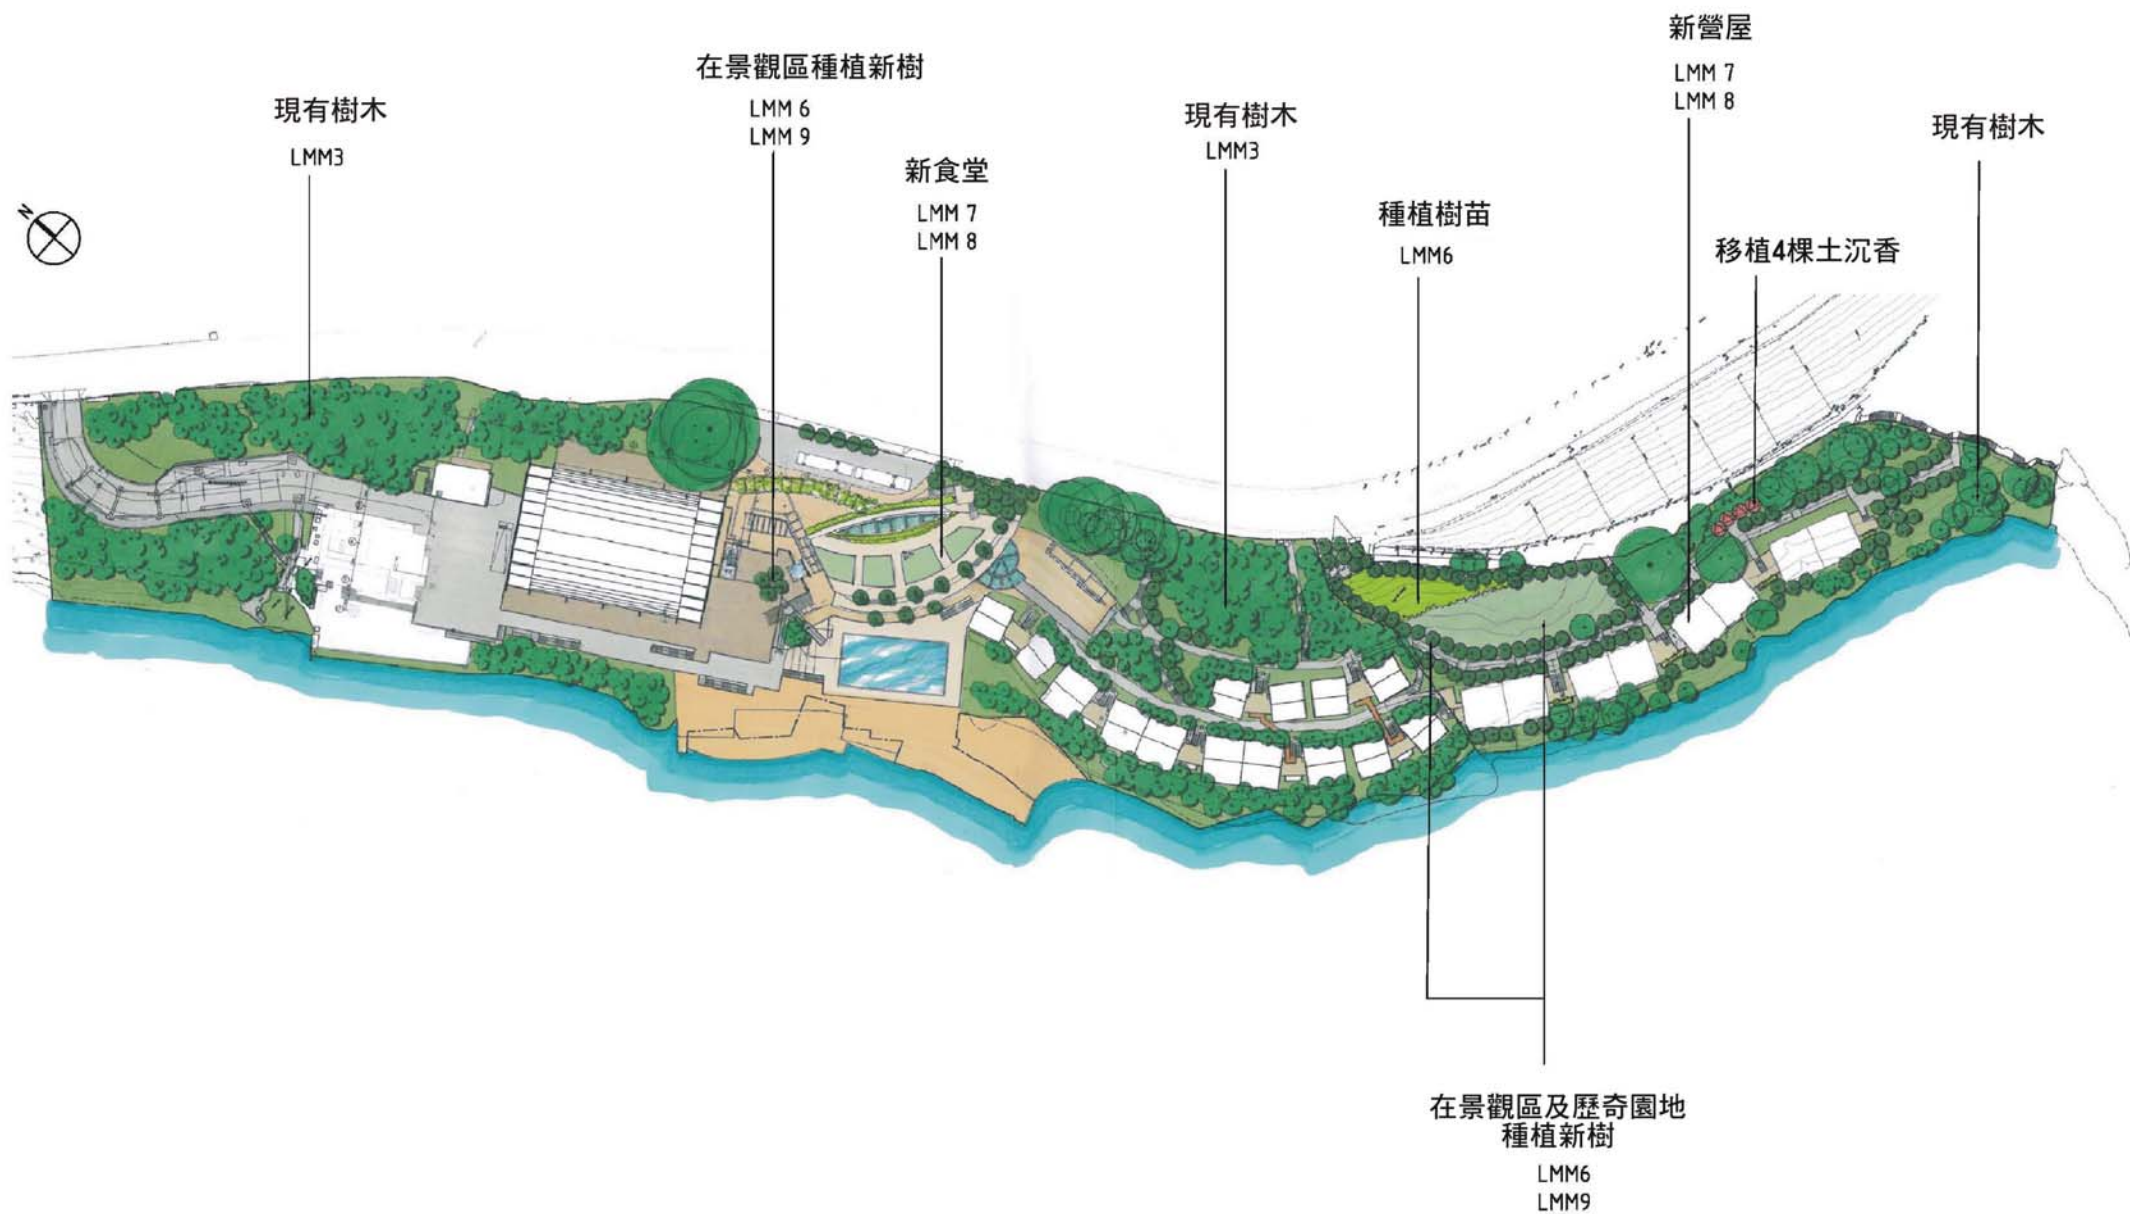
圖5.2 景觀總設計平面圖

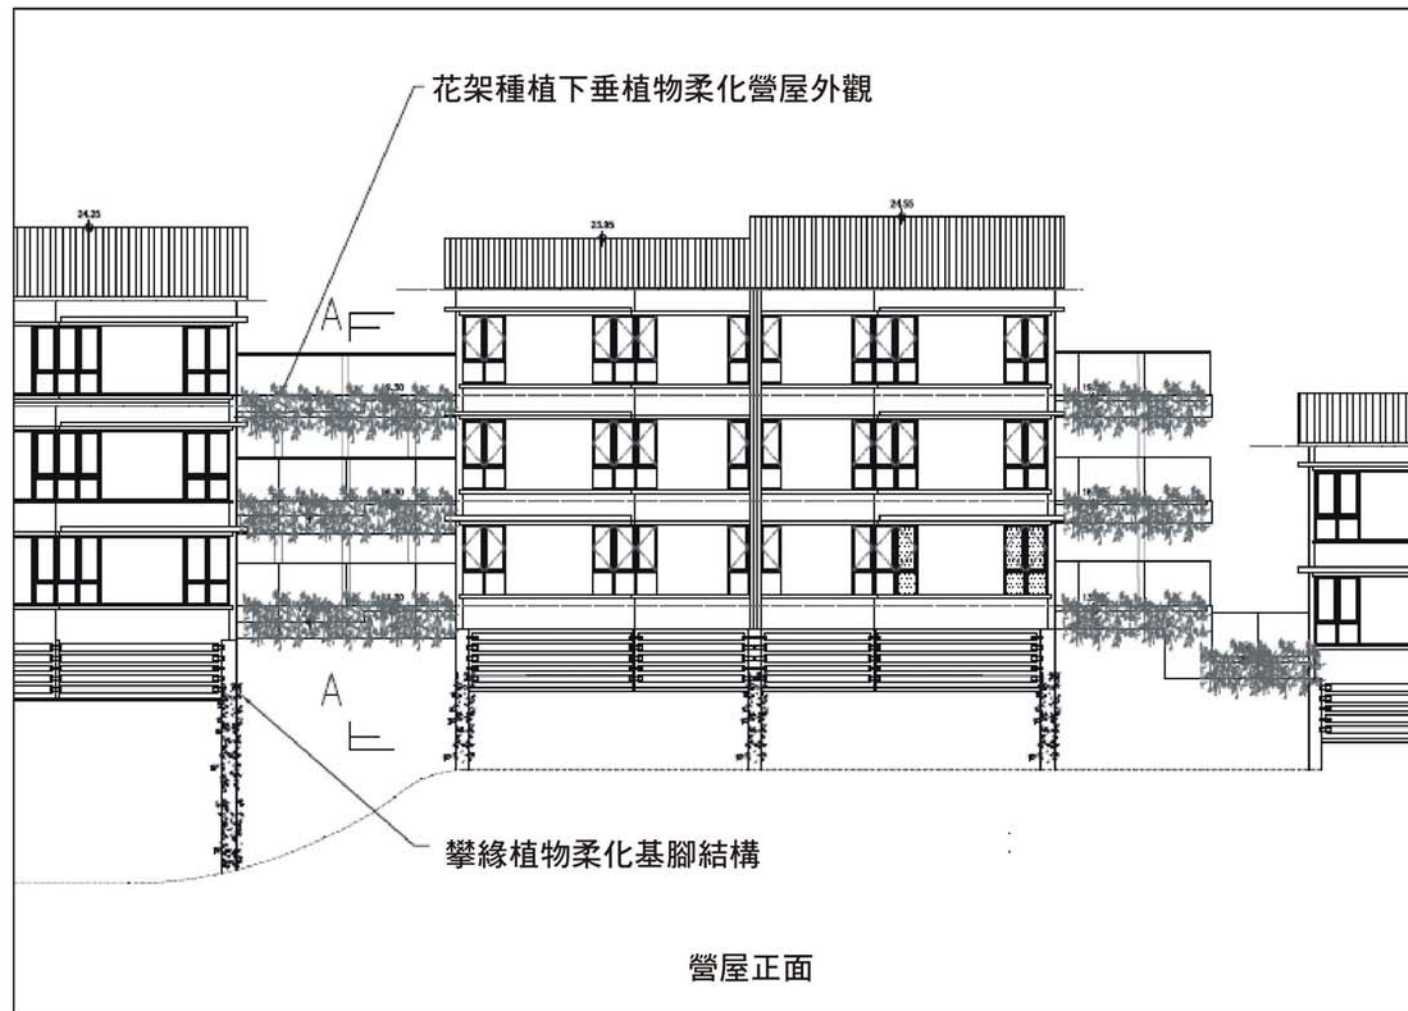
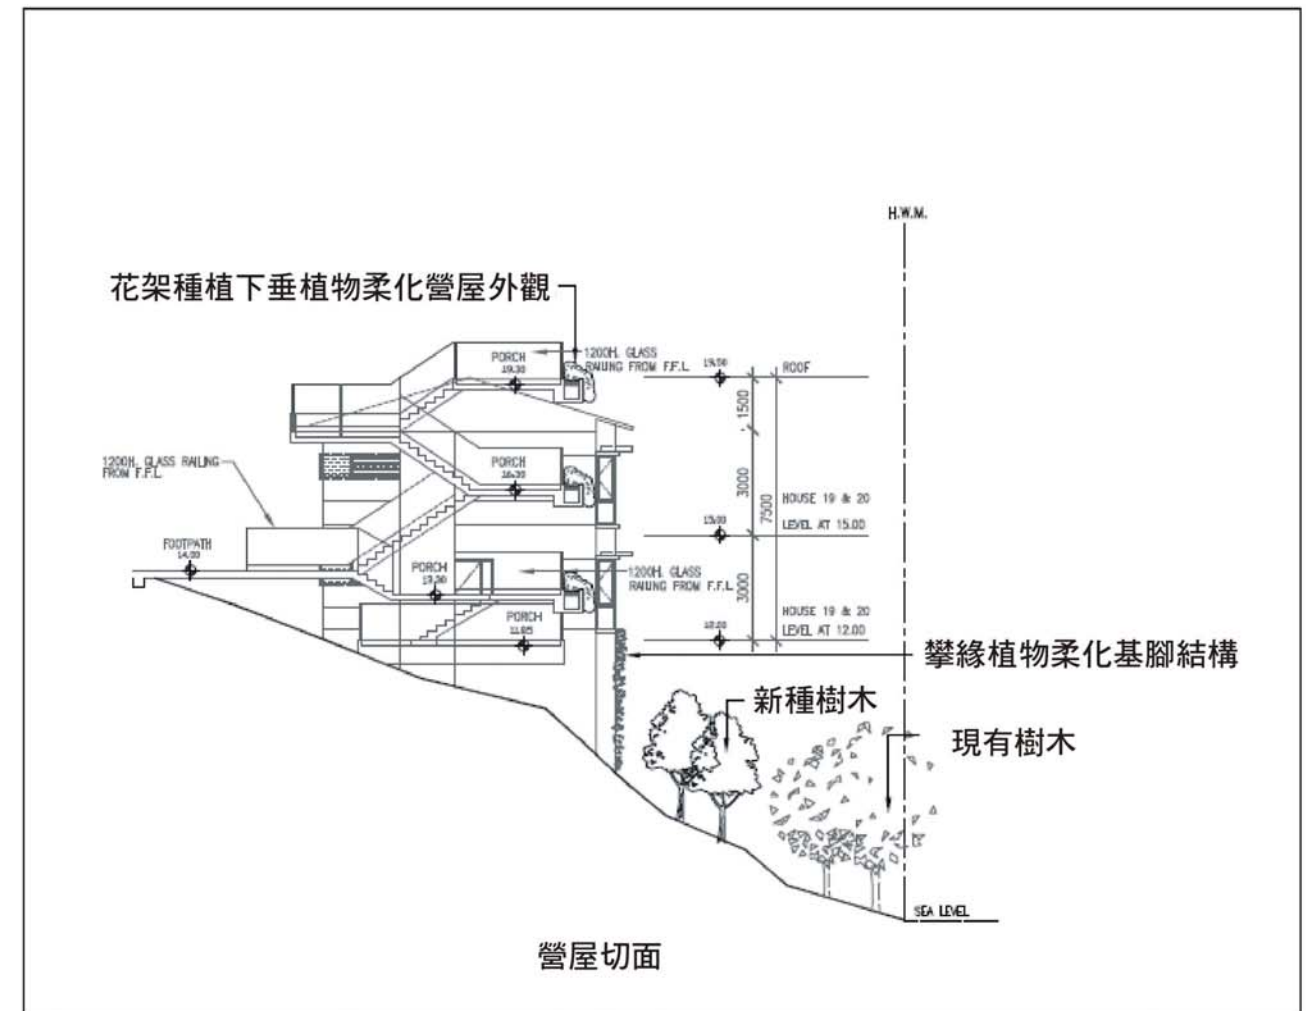
圖5.3 建議的綠化營屋設計

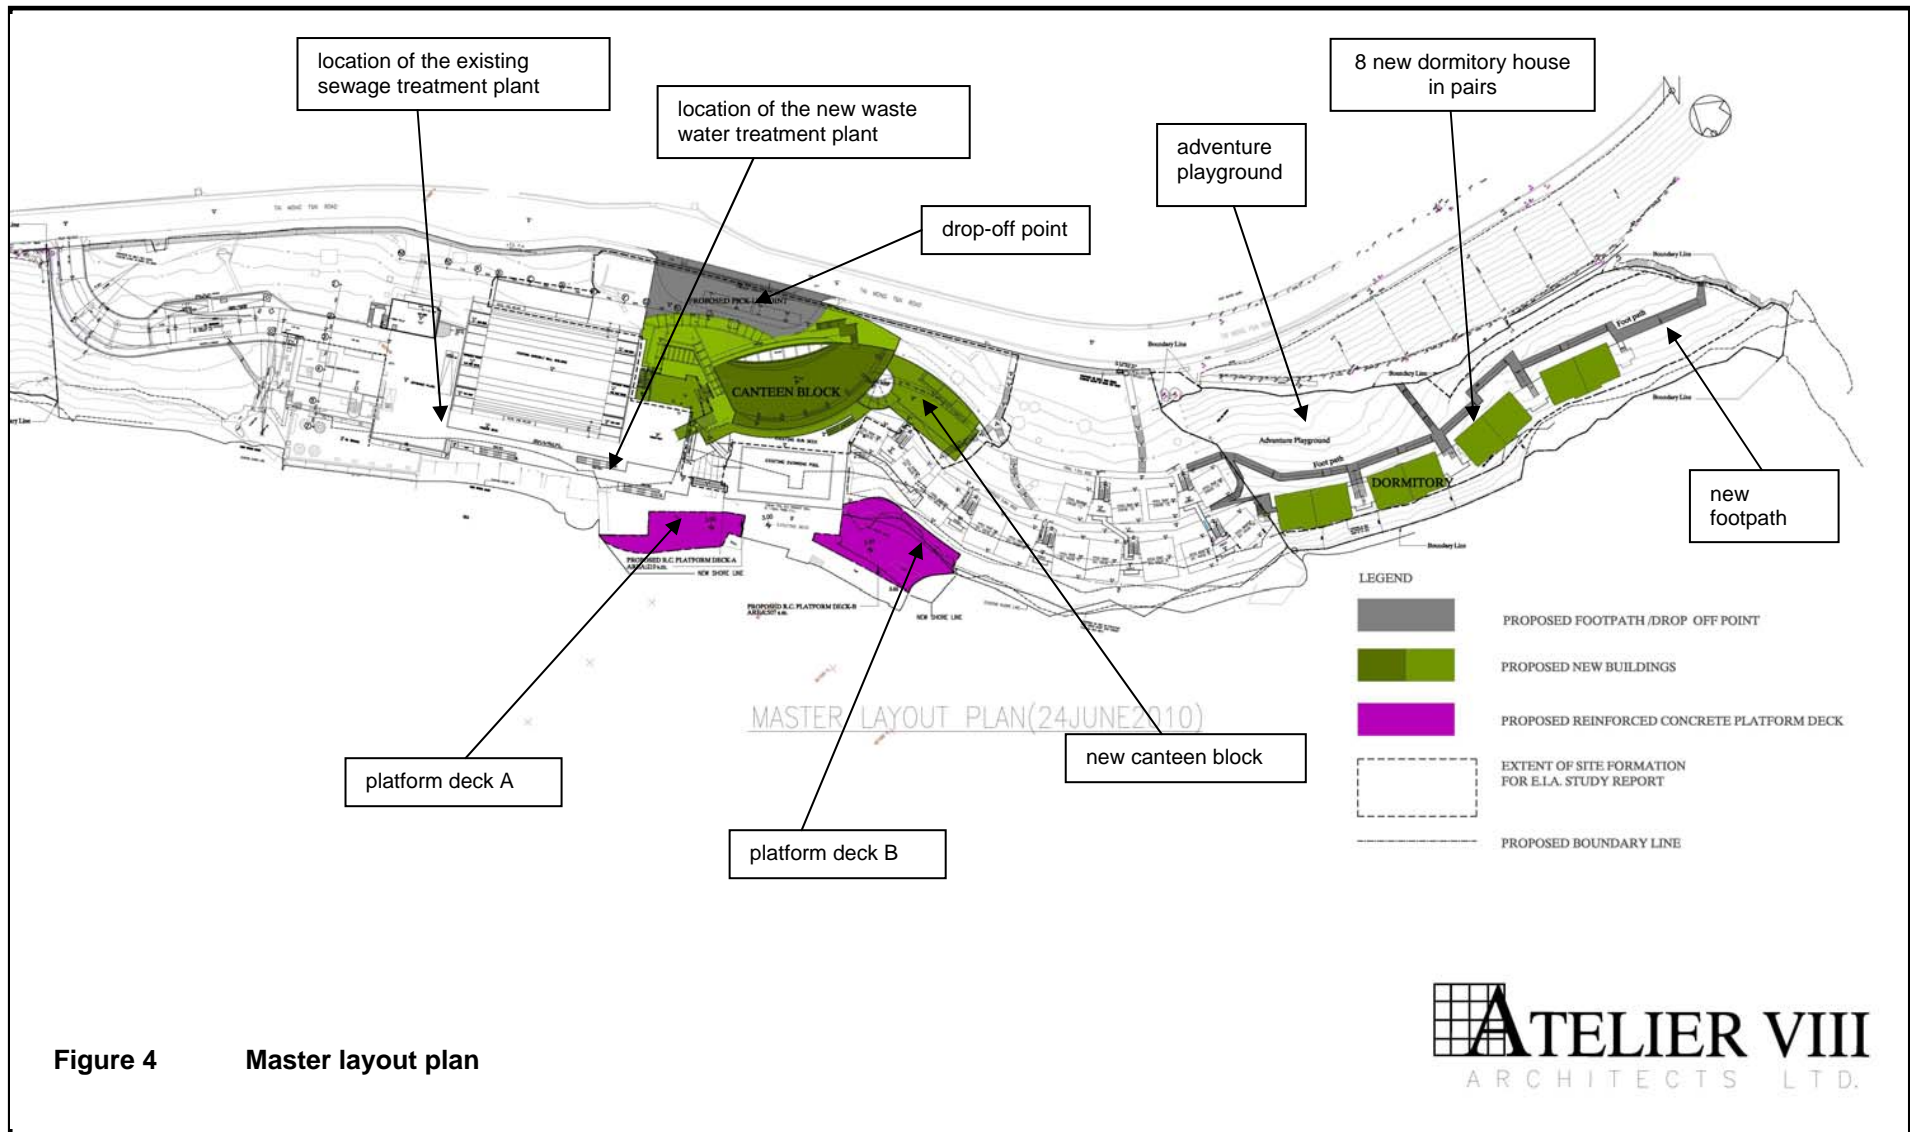
Figure 4 Master layout plan

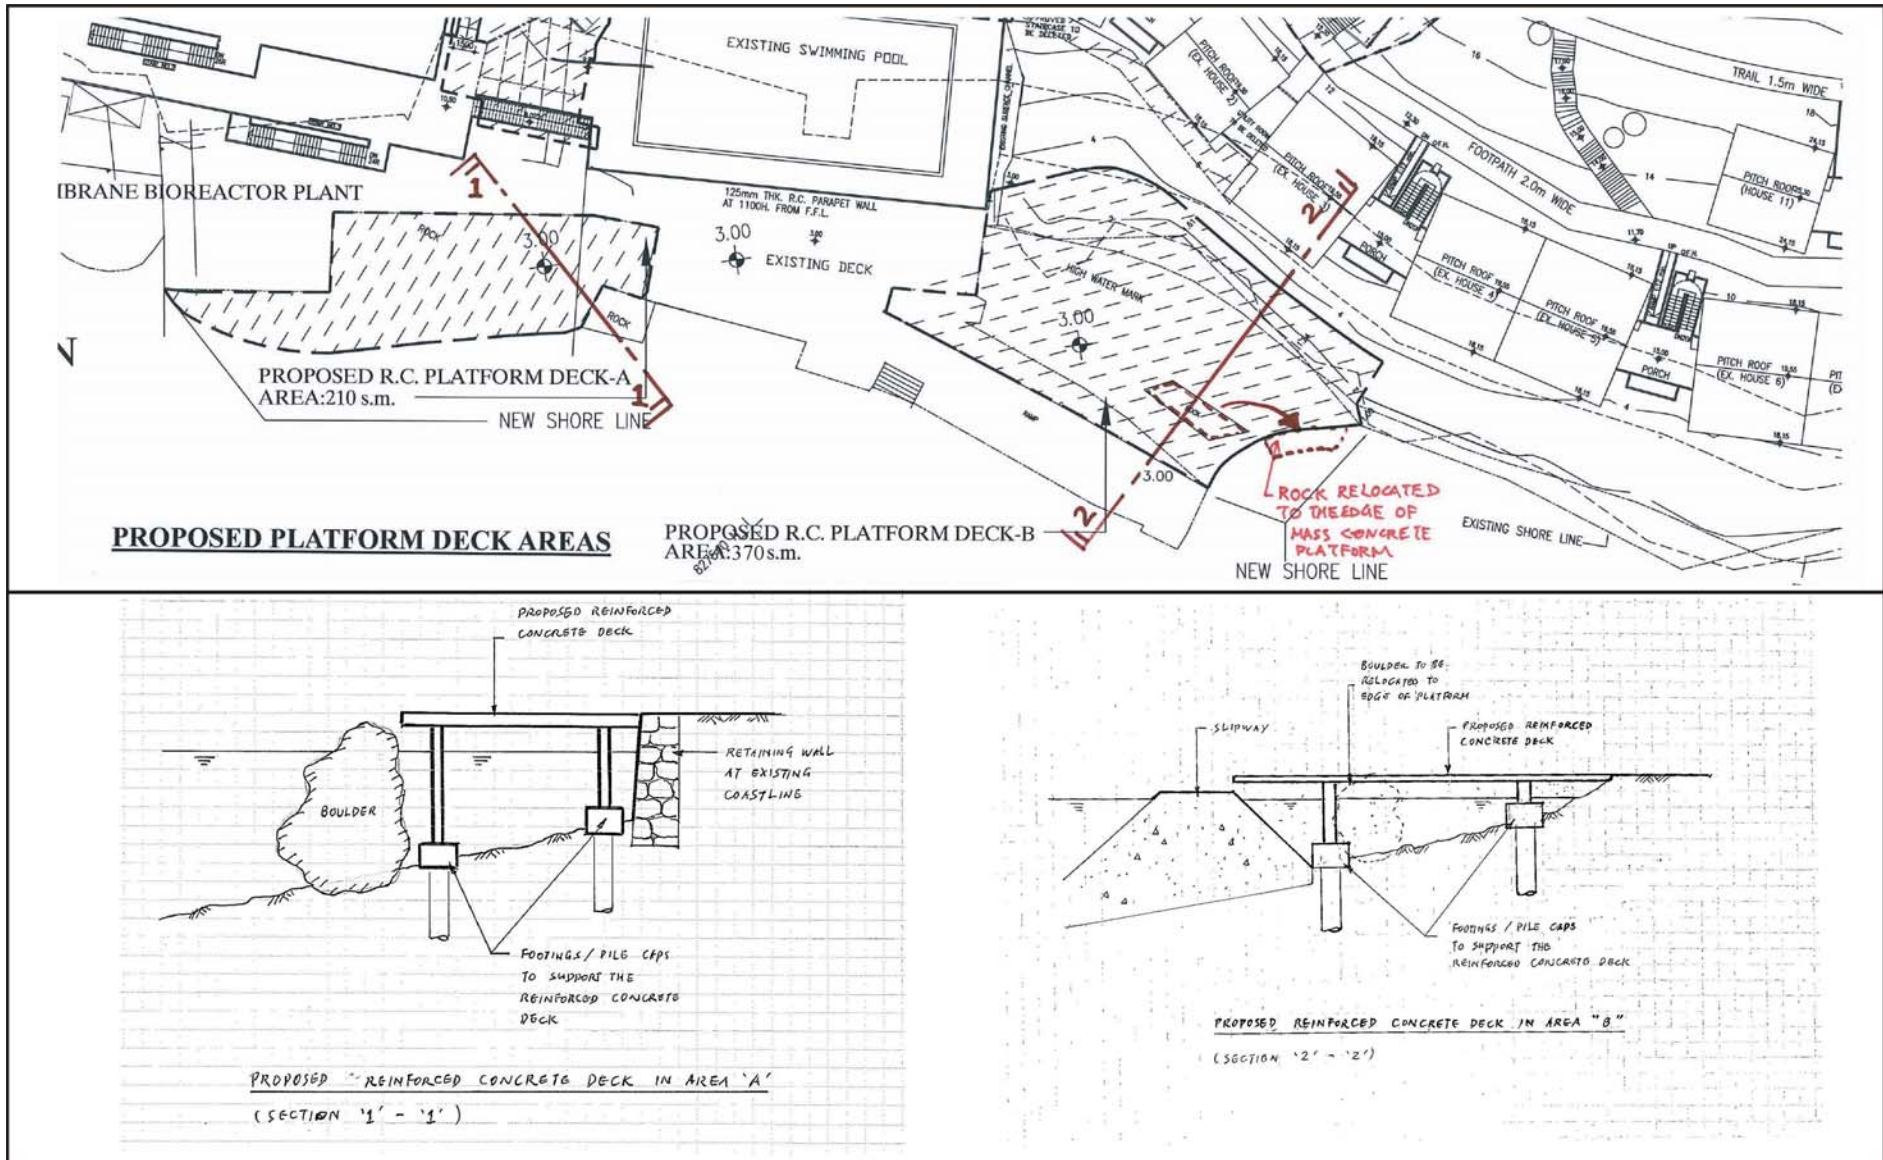
Figure 5 Close up of proposed platform decks

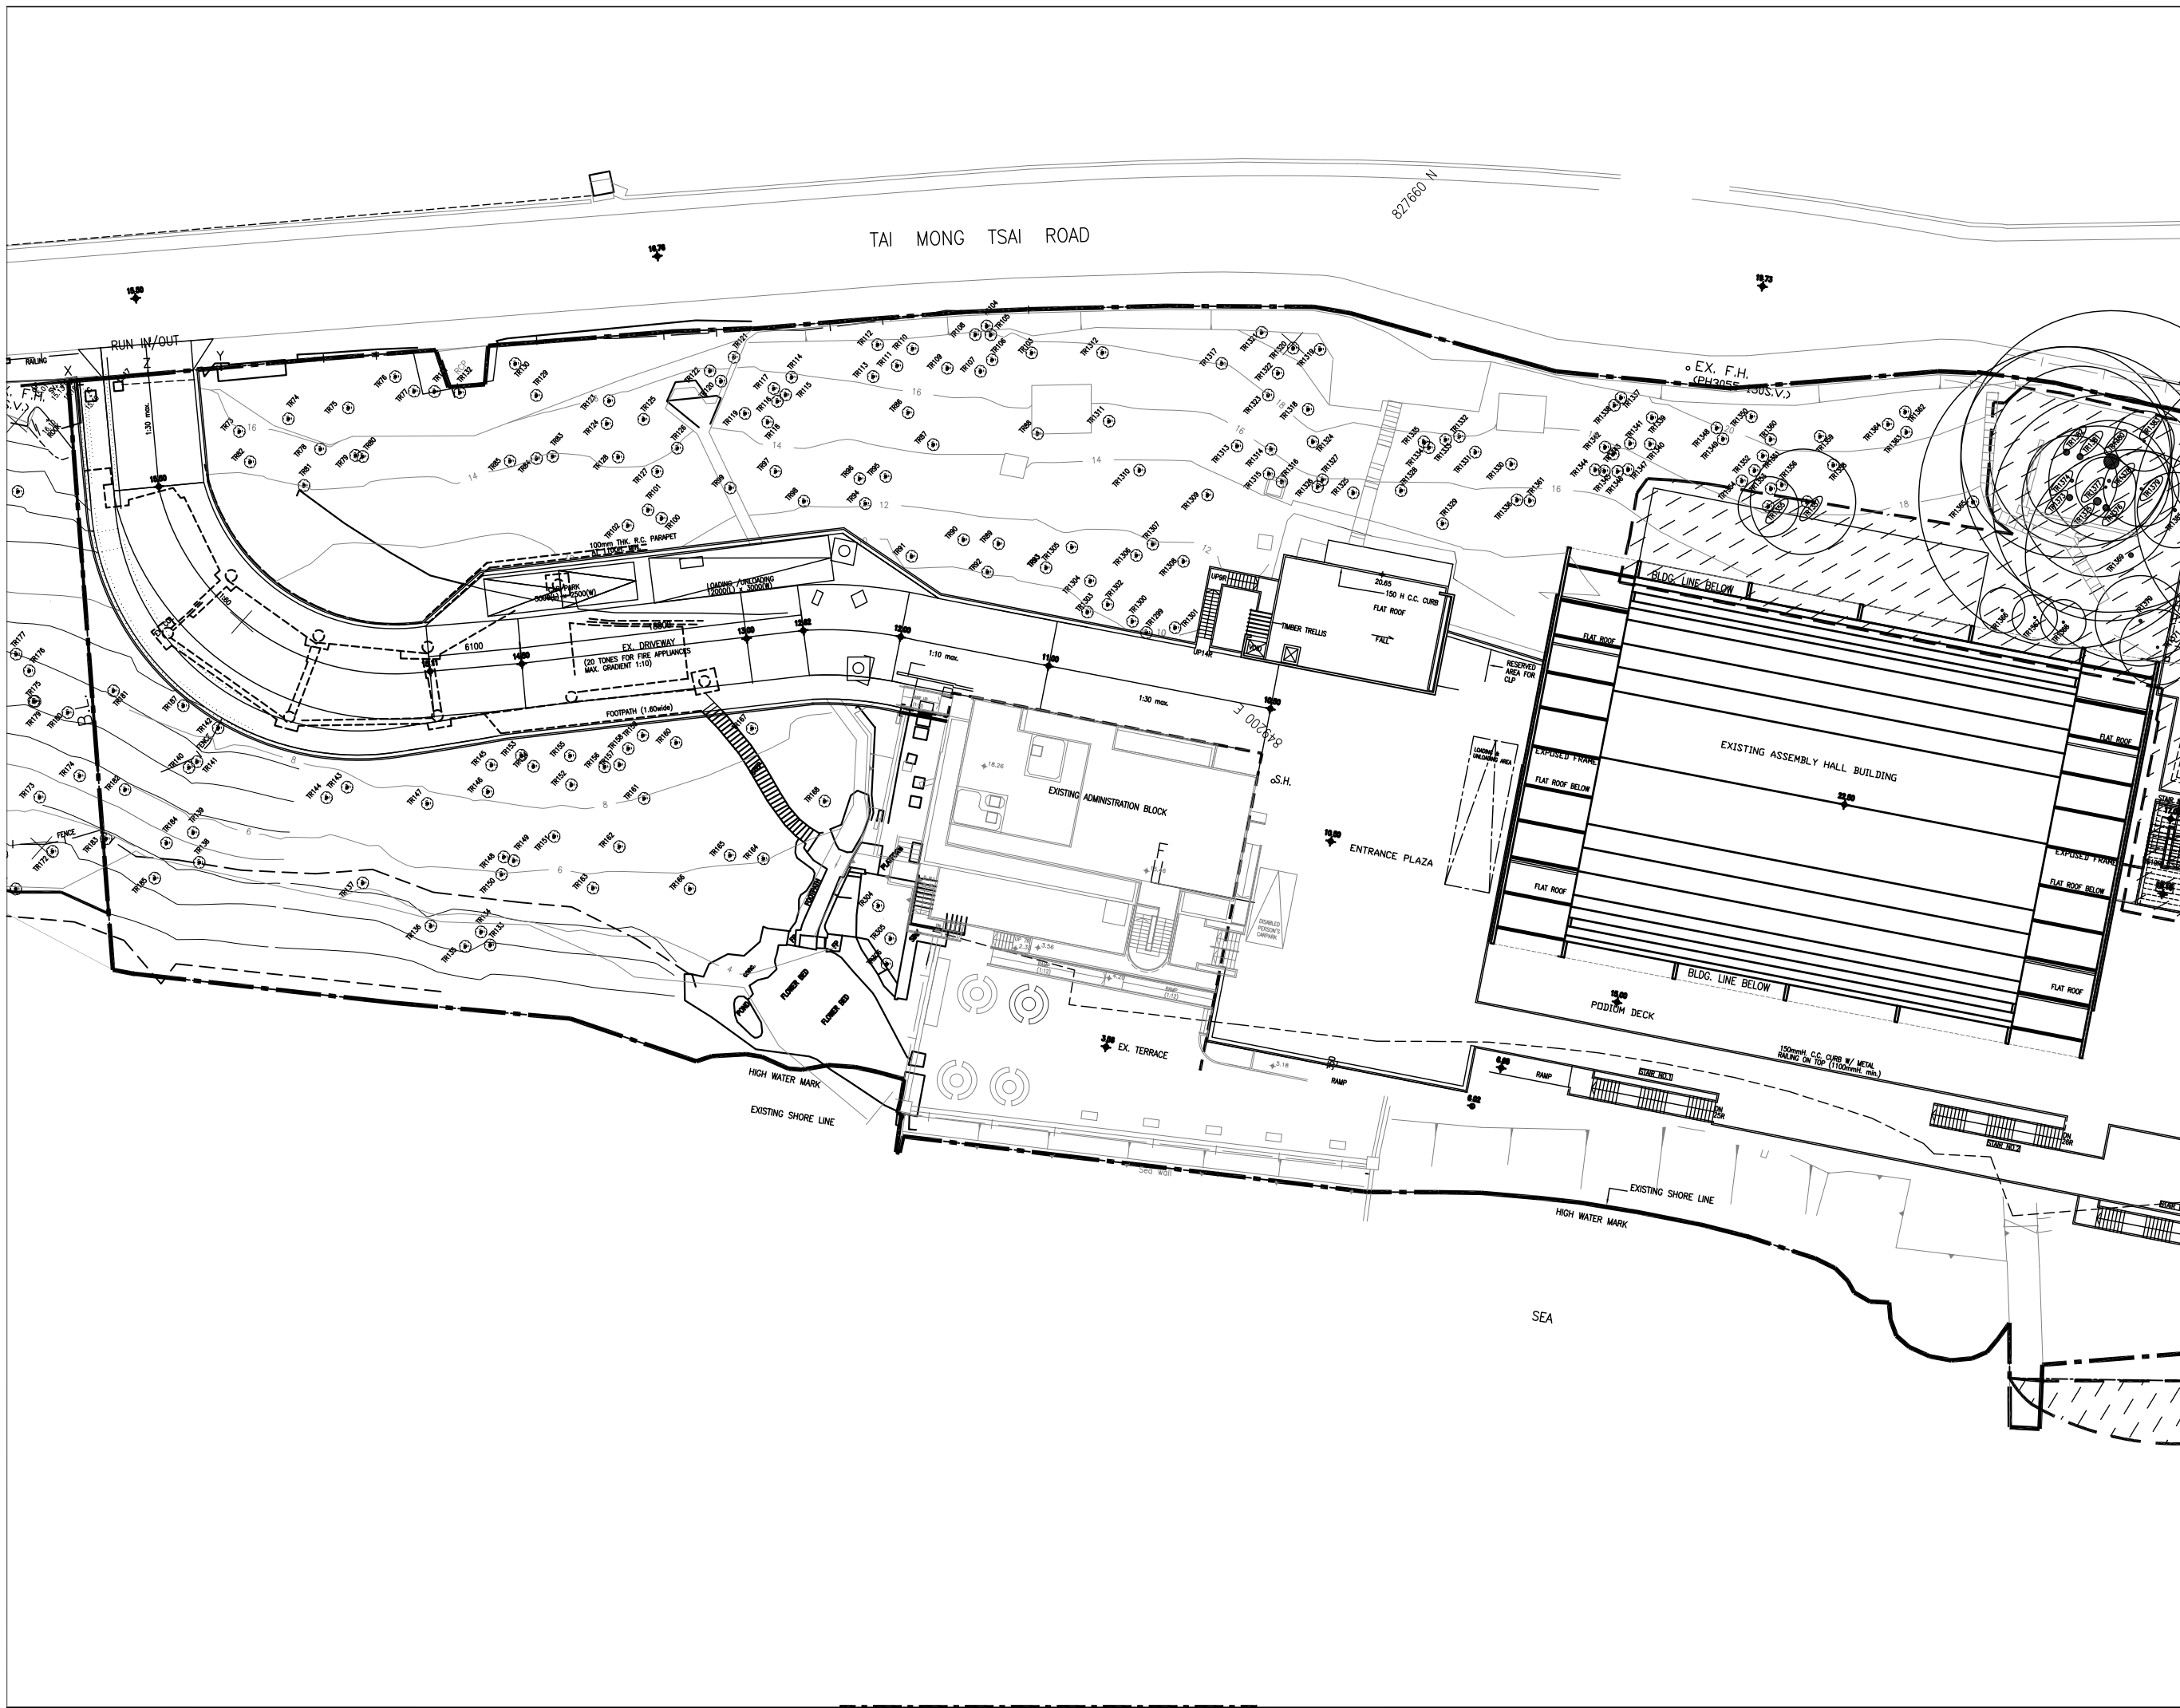
Drawing Title 標題
 TREE SURVEY PLAN
 FIGURE 6.2
