香港青年協會 賽馬會西貢戶外訓練營 第三期擴建工程

工程項目簡介

2010年8月

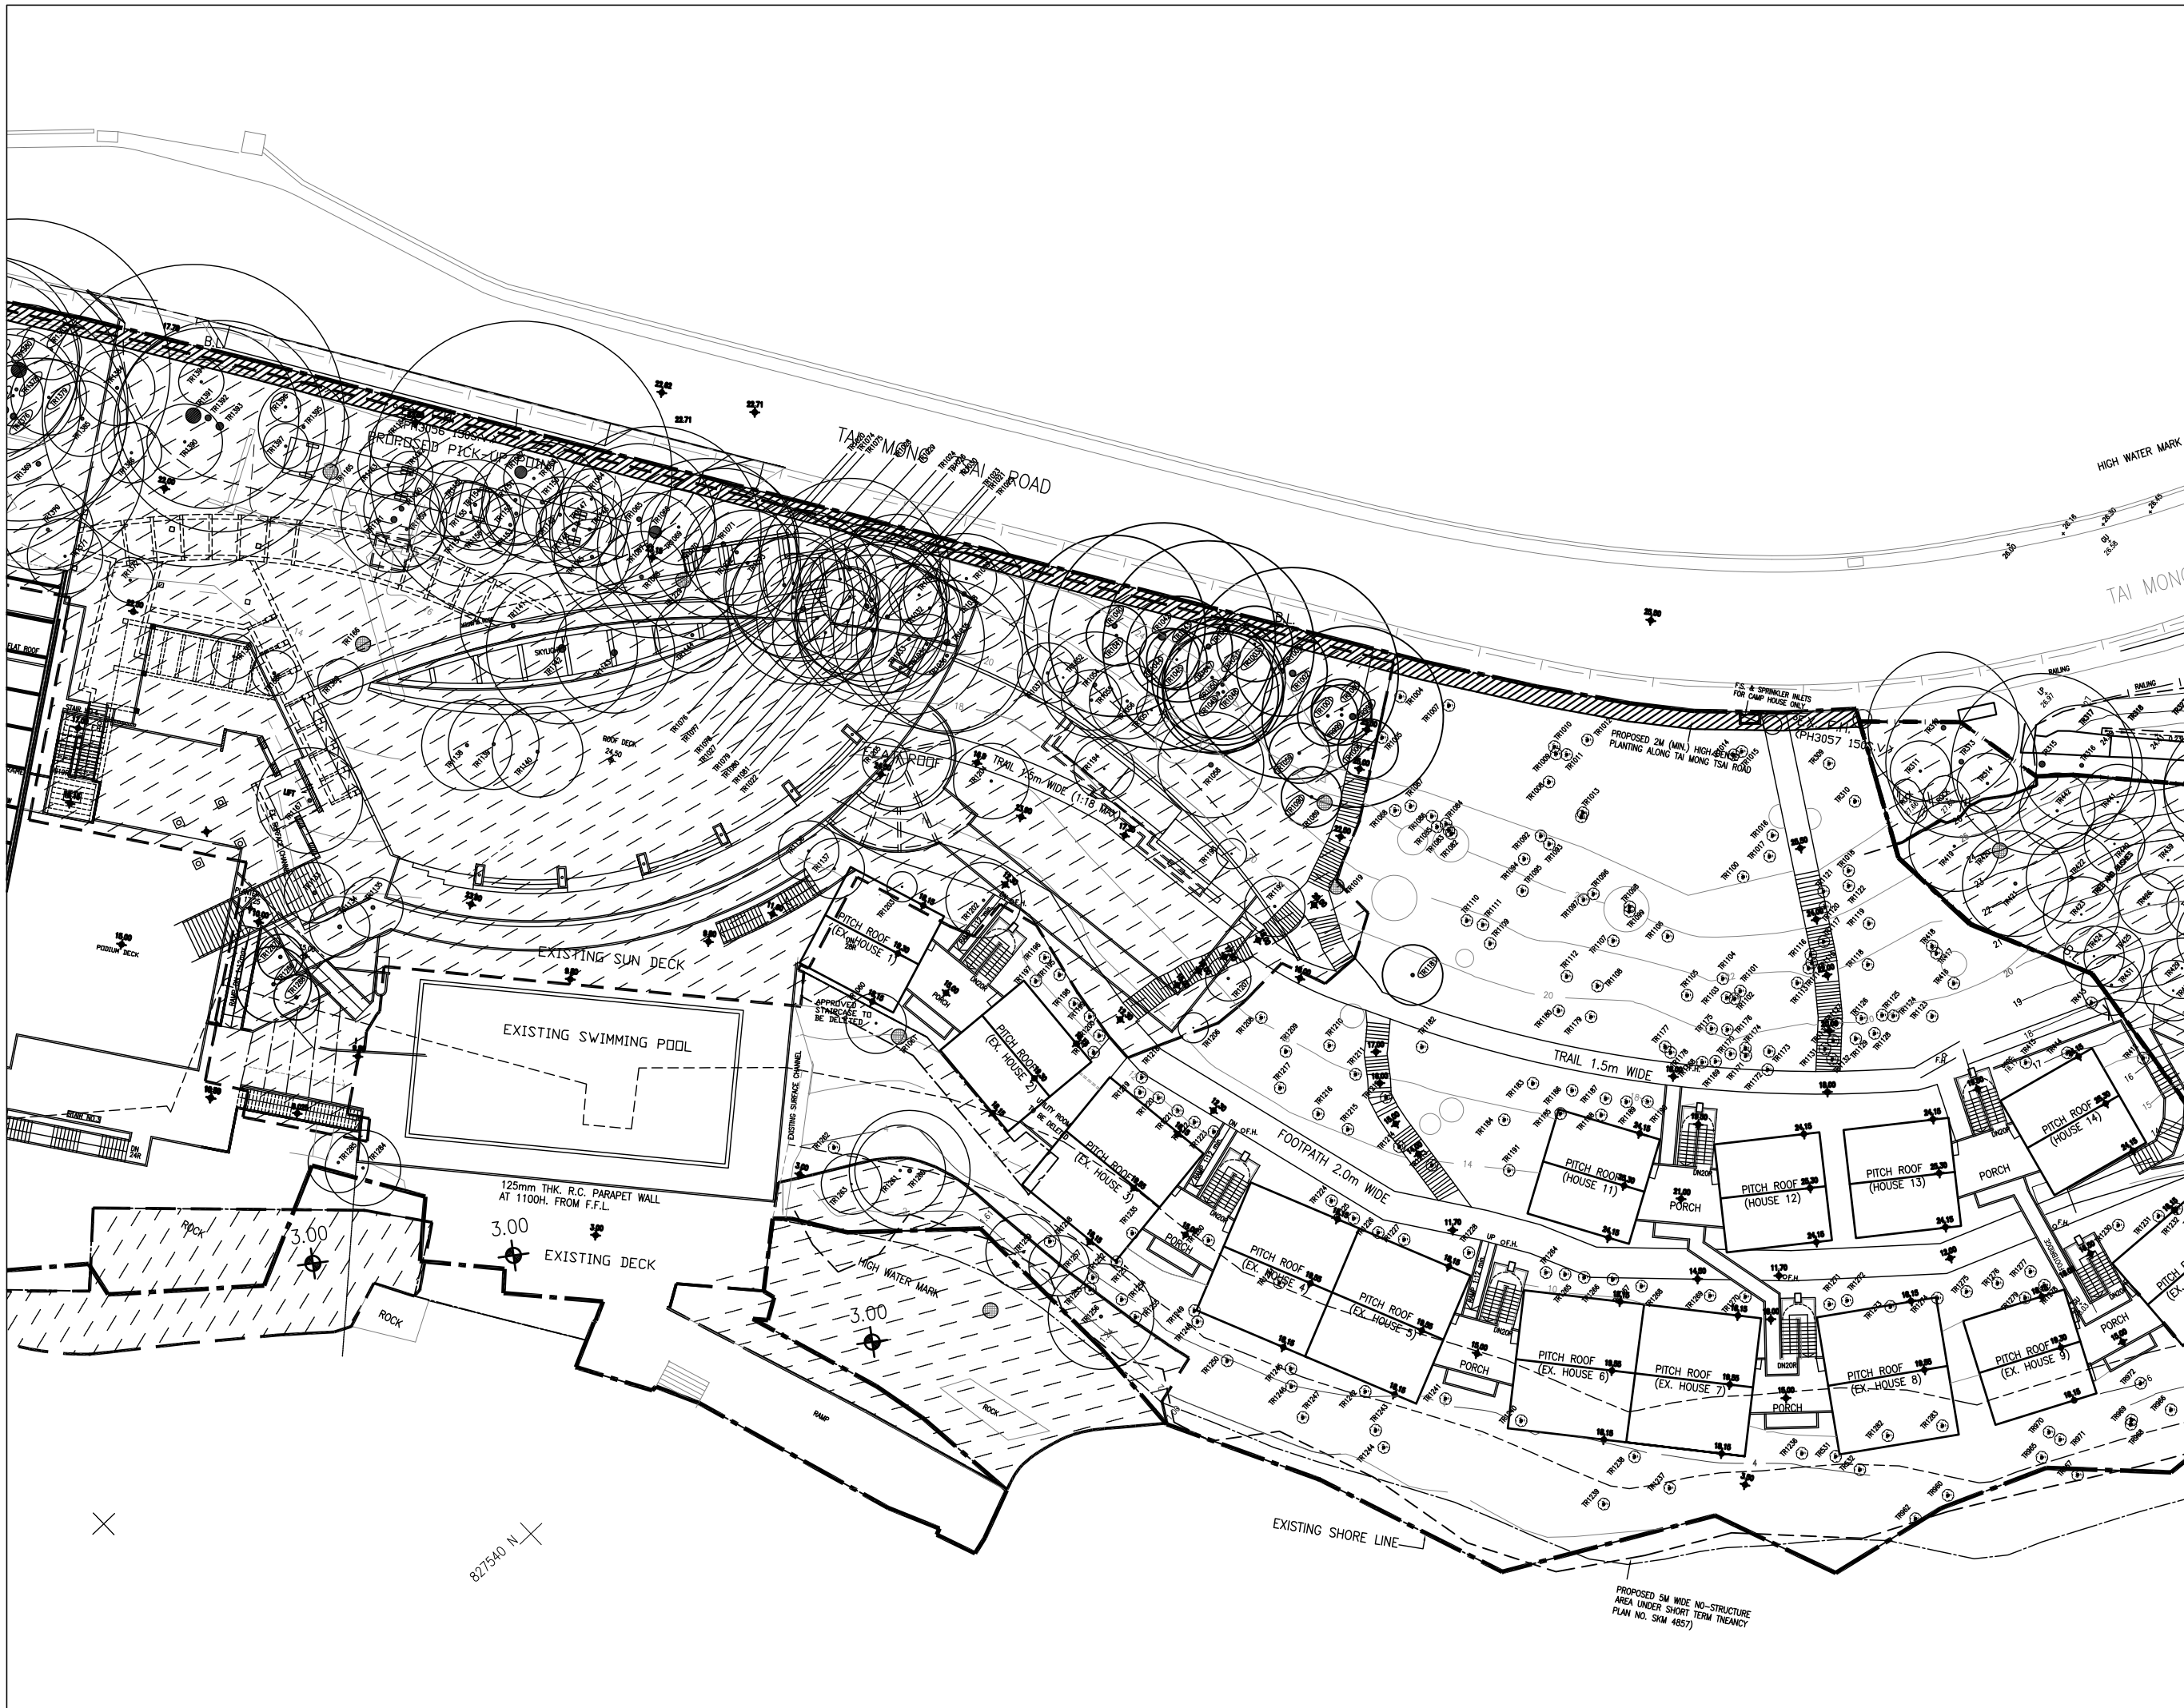
Drawing Title 標題
 TREE SURVEY PLAN
 FIGURE 6.3

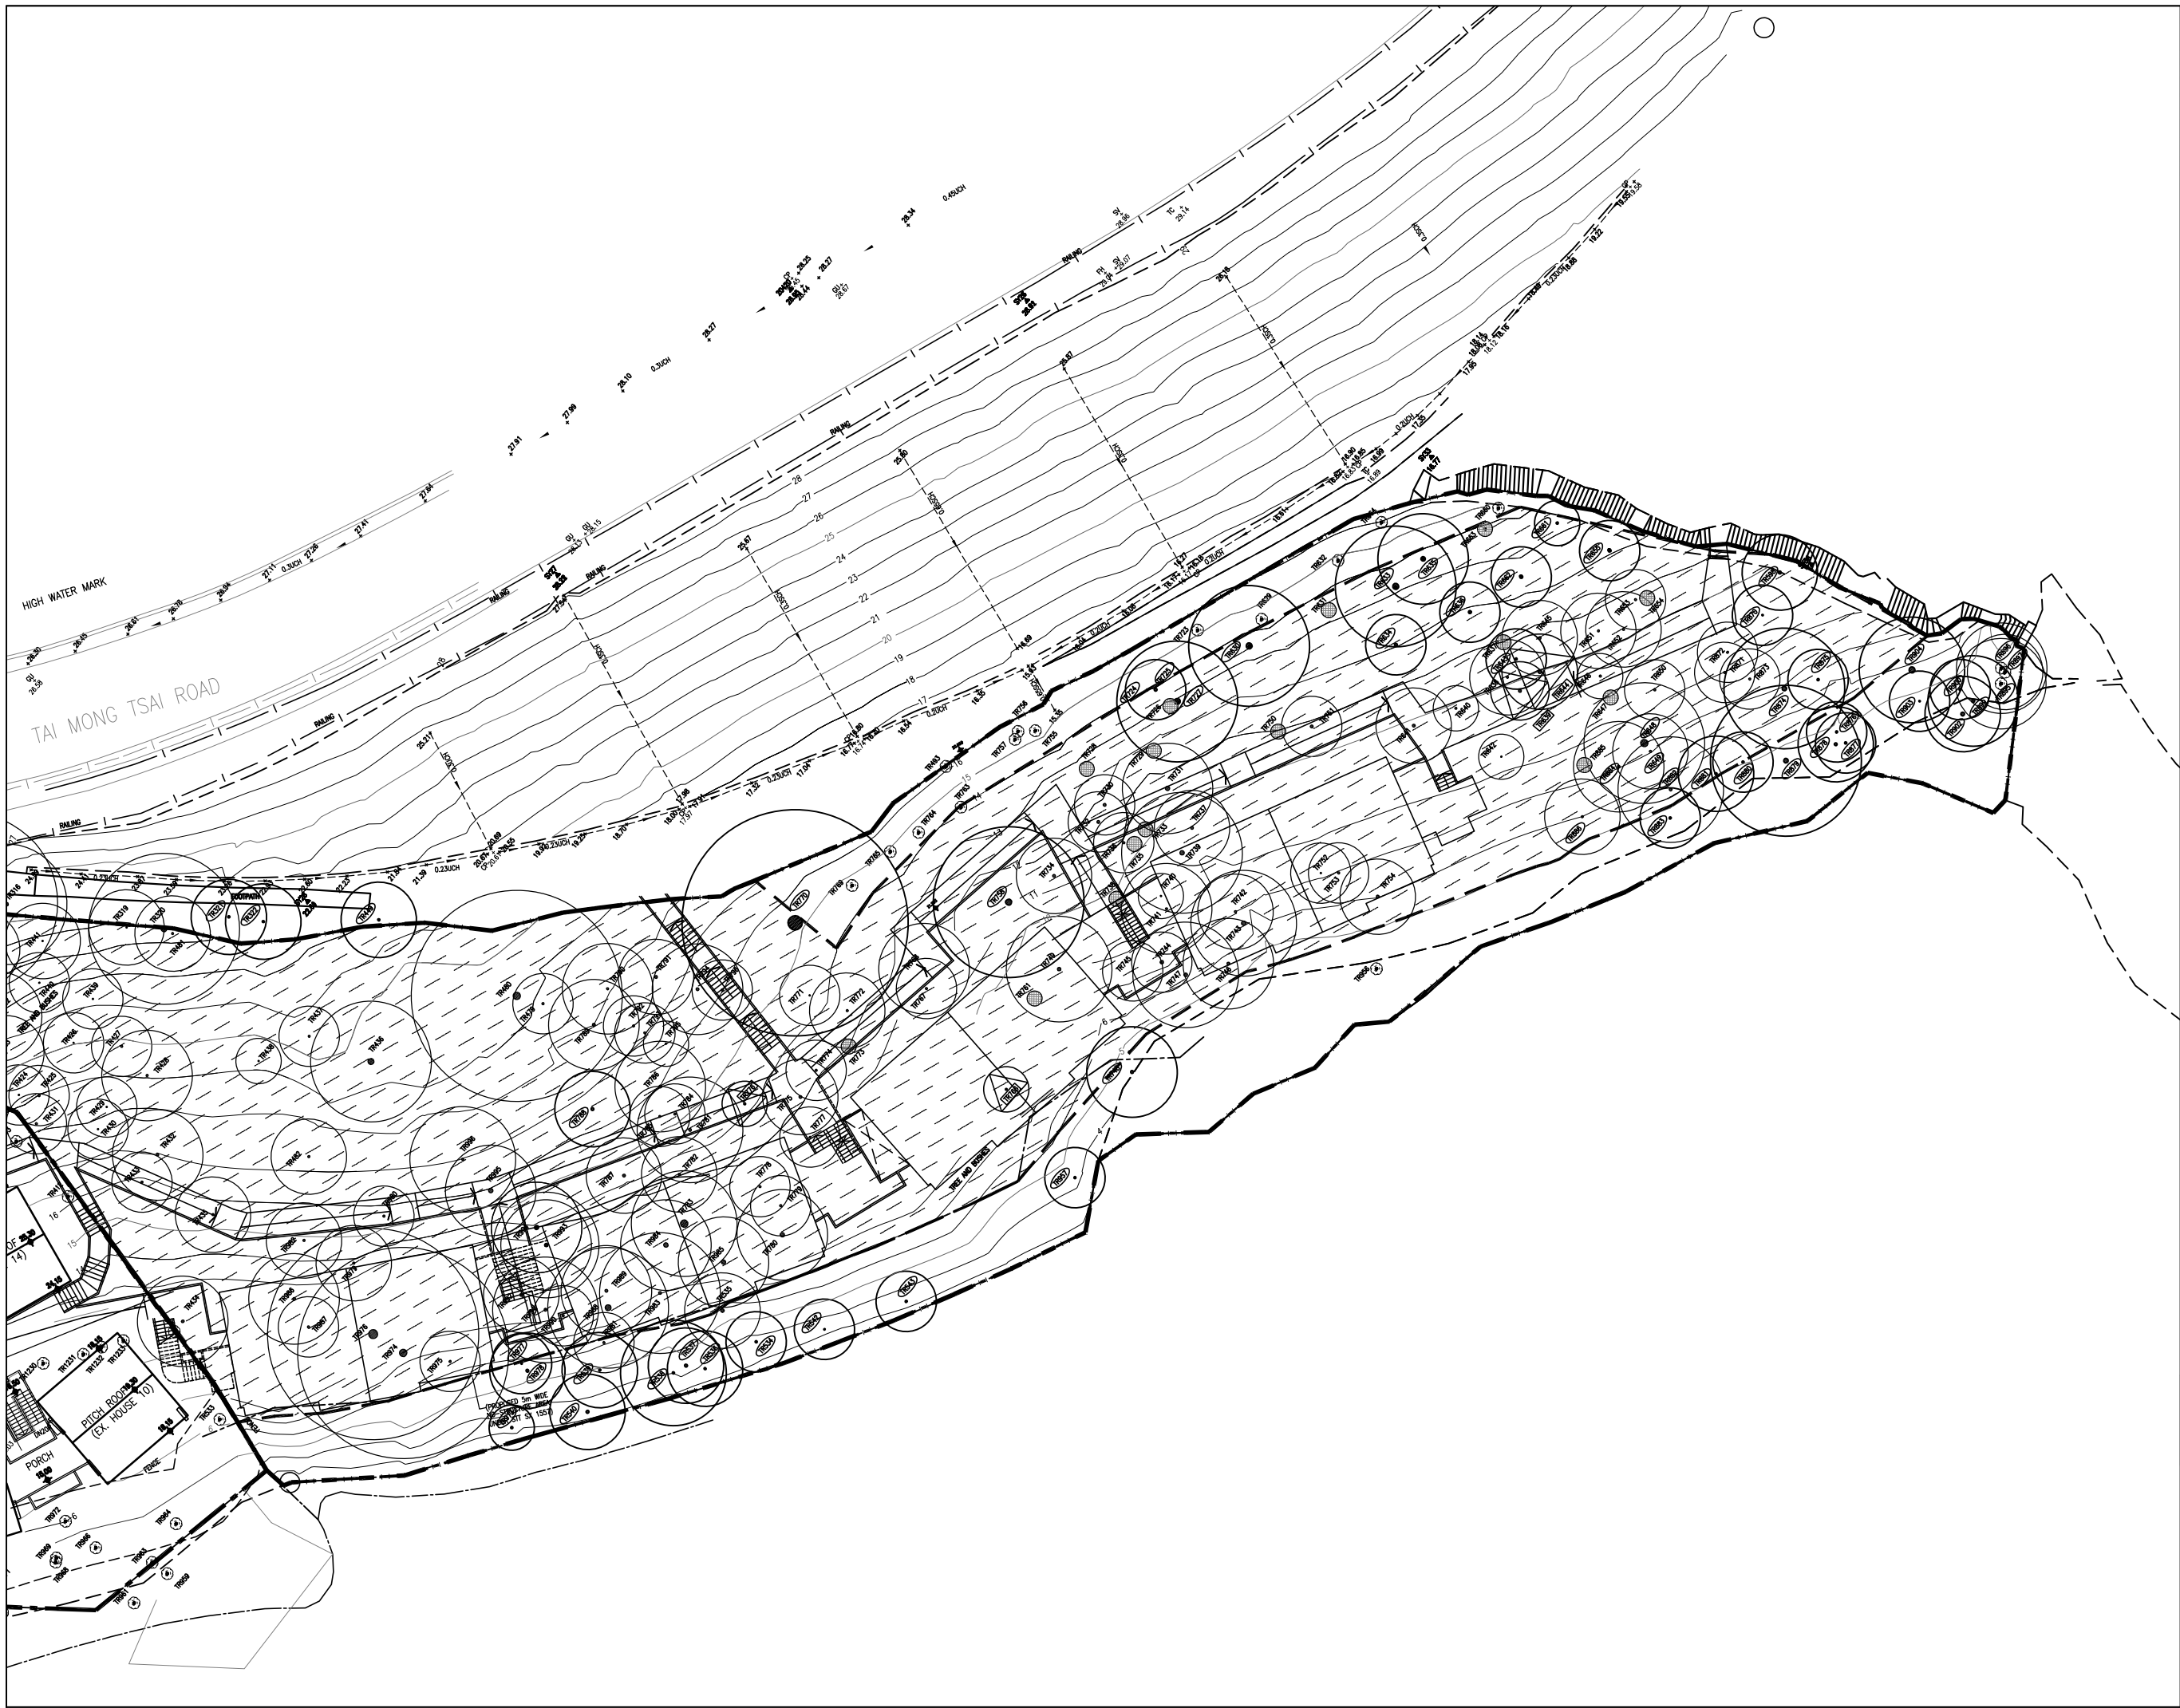
Drawing Title 標題
 TREE SURVEY PLAN
 FIGURE 6.4
