Phase III Redevelopment of The Hong Kong Federation of Youth Groups Jockey Club Sai Kung Outdoor Training Camp

Project Profile

August 2010

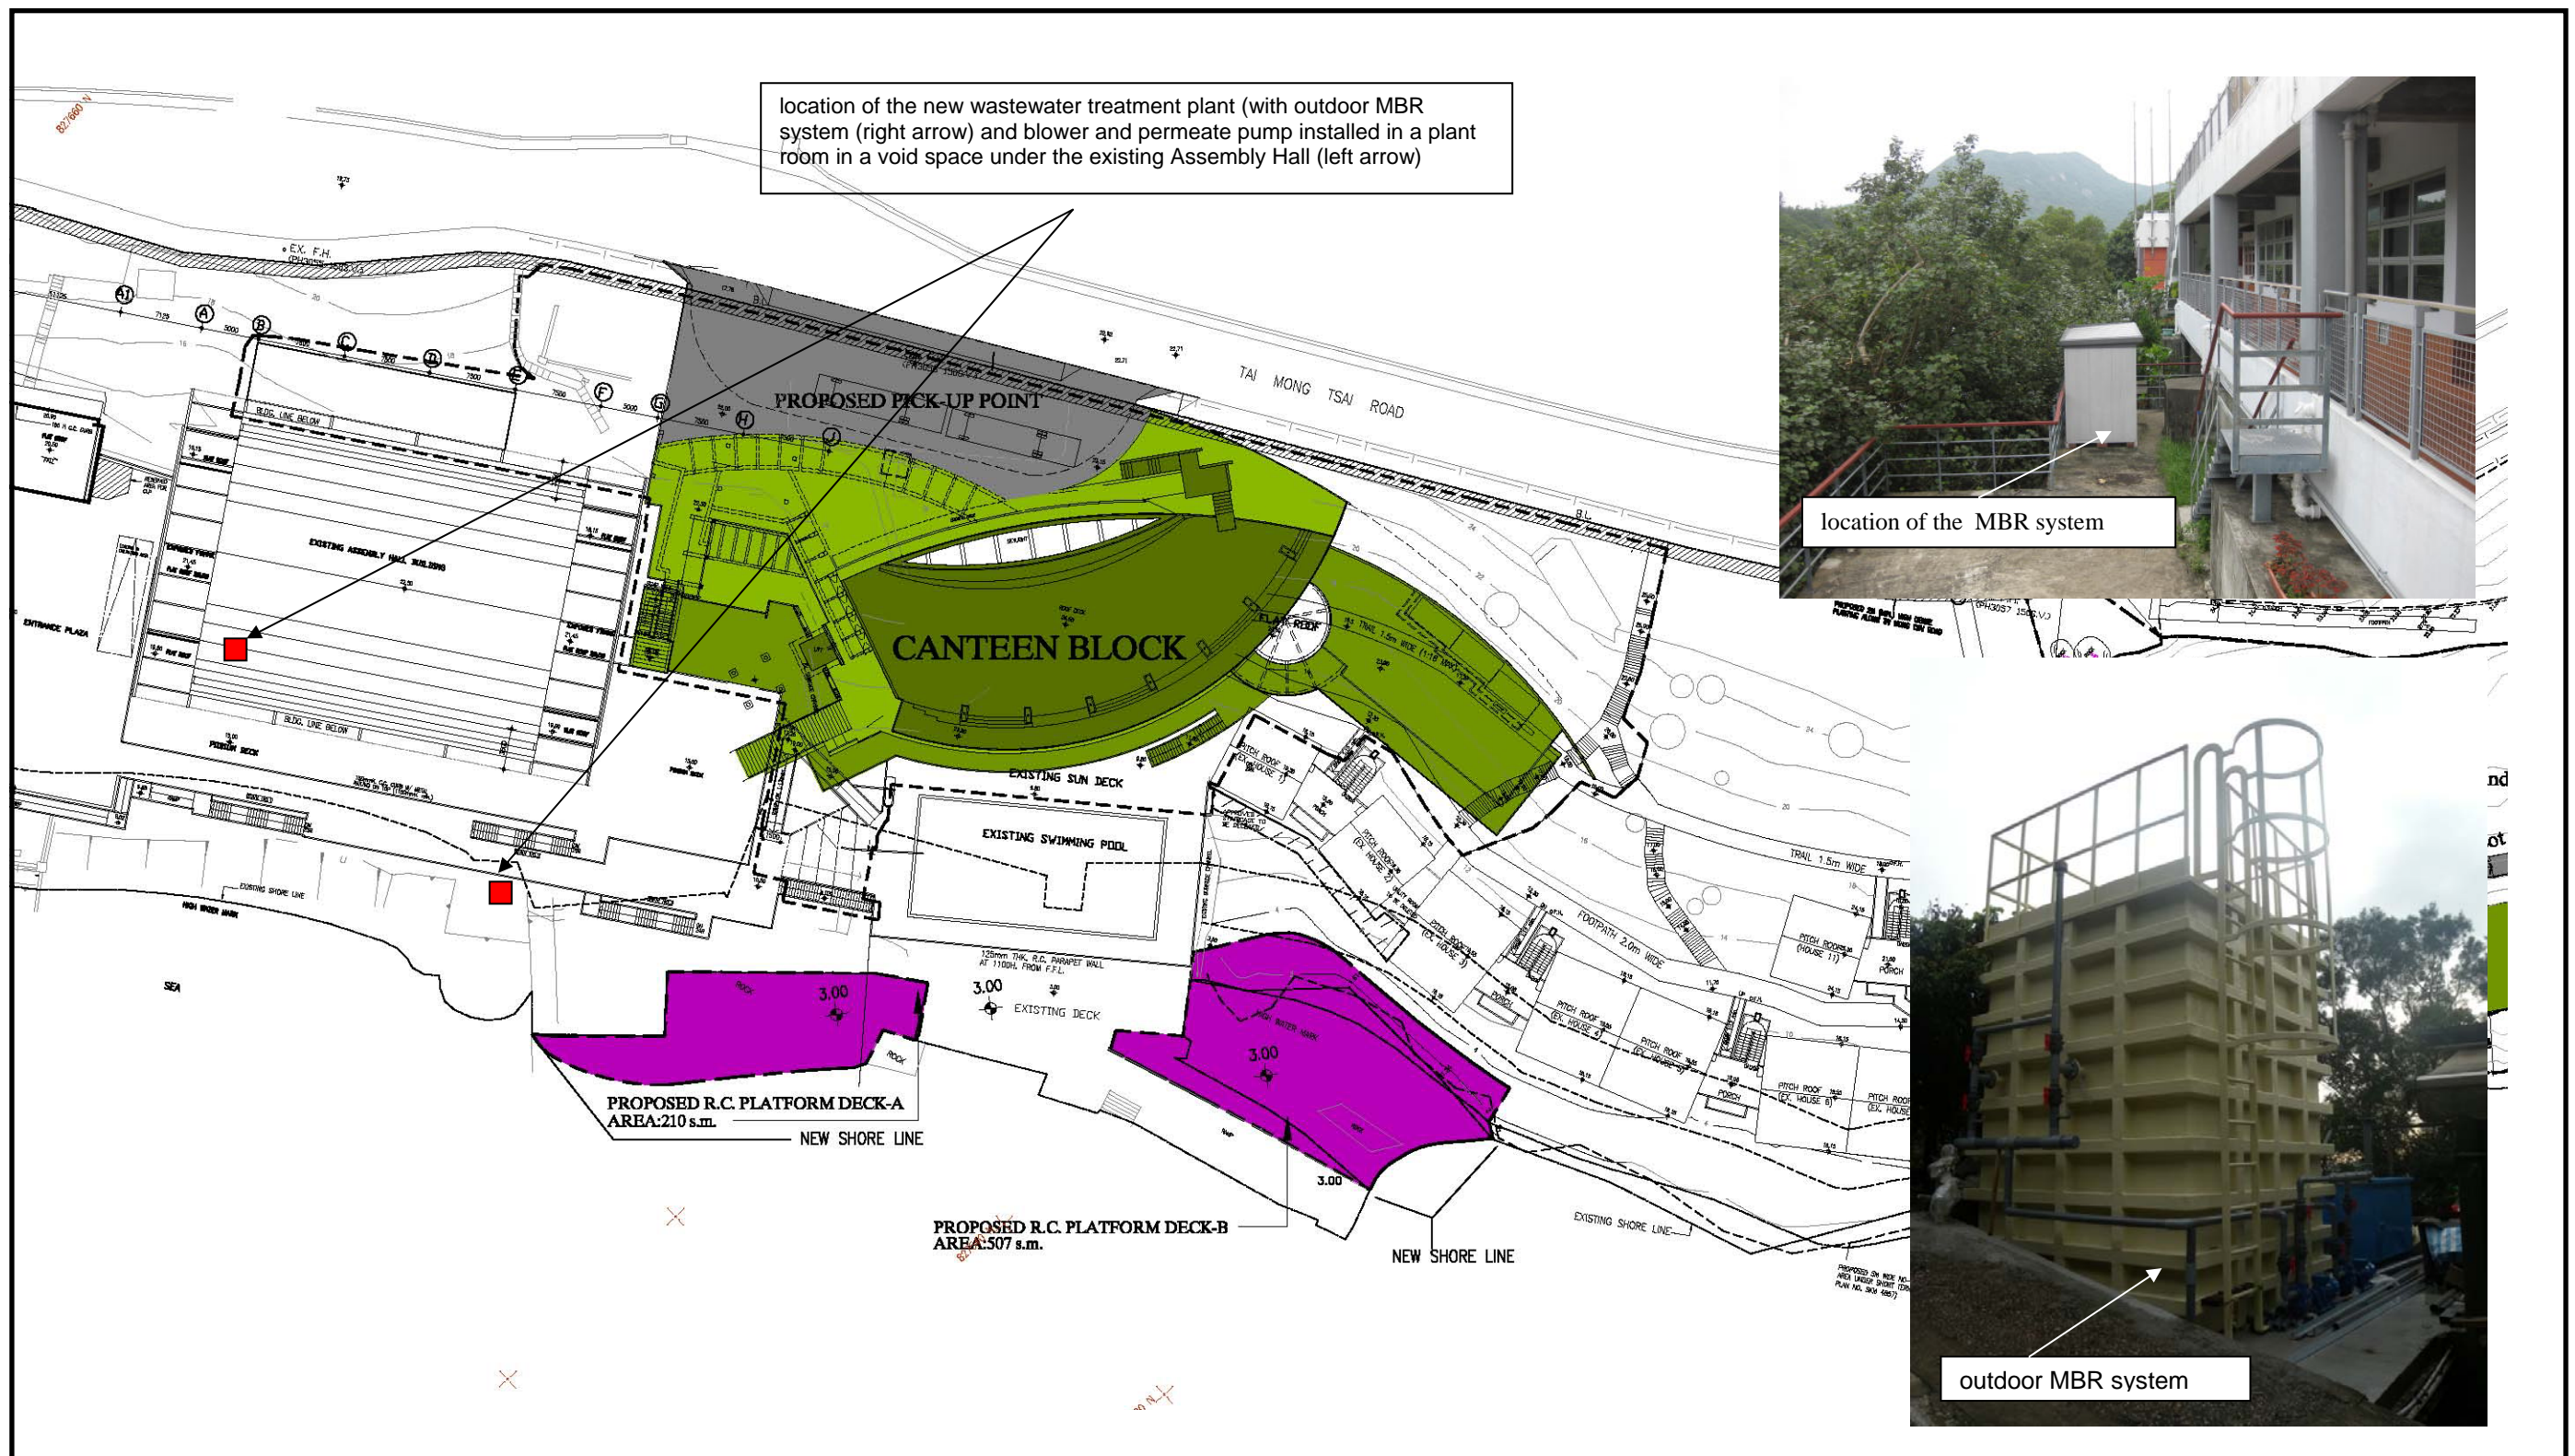
Figure 1.5a Location of the Proposed Wastewater Treatment System

Figure 1.5b Flow Diagram of the Treatment Process of the existing Sewage Treatment Plant and Proposed Wastewater Treatment Plant

- 1.4.7 Locations of the existing sewage treatment plant and new wastewater treatment plant are shown in **Figure 1.2 & 1.5a**.
- 1.4.8 The existing sewage treatment plant (STP) collects sewage from Phase I and II including backwash wastewater from swimming pool, cleaning wastewater and toilet flushing. The existing plant is using a multi-stages Rotating Biological Contactor (RBC) for organic degradation. The existing STP average discharge flow for Phase I and II is 35 m³/day while the proposed future discharge flow for Phase III is about 121 m³/day. To cater for relocation of the canteen and increased sewer generated by additional visitors and to promote water conservation, a new wastewater reuse system is proposed to treat a portion of the canteen wastewater in the site for irrigation and flushing purpose. The wastewater reuse system will share the loading of the existing STP and also to reduce the fresh water consumption within the camp site. The wastewater reuse system will operate in parallel with the STP and will employ membrane bioreactor (MBR) for the core treatment process.

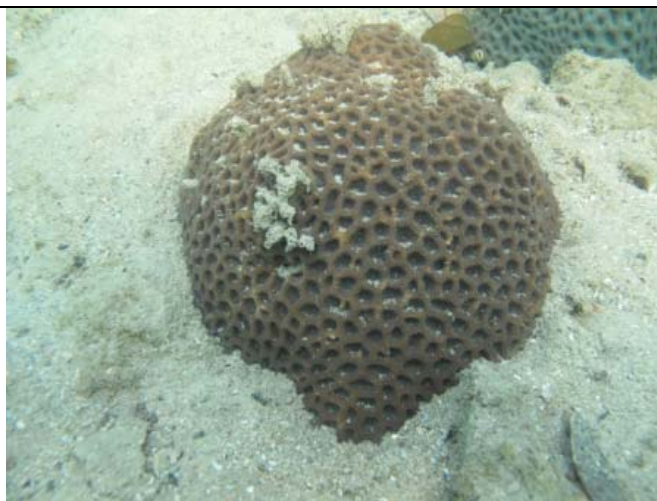
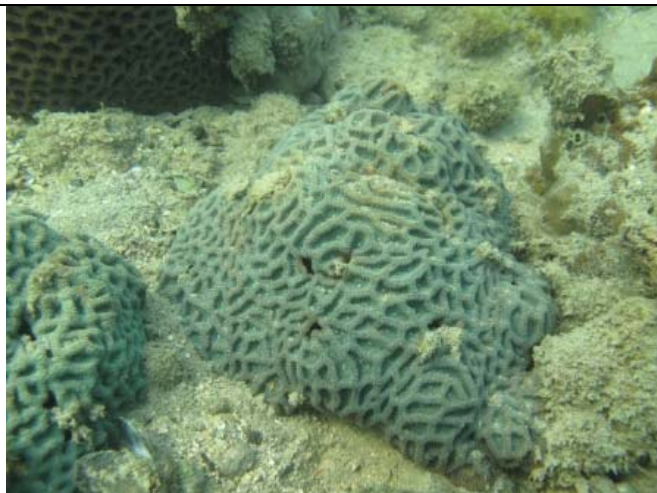
Favites flexuosa

Goniastrea favulus

Figure 3c Locations of intertidal survey and dive survey and the two uncommon coral species found

There were shallow subtidal areas outside the embayment. A one-time spot-check dive survey for corals and other hard substrate marine organisms were conducted to investigate the conditions of subtidal habitats near the embayment. The purposes of the spot-check dive survey are to qualitatively record the habitat types and ecological values of the area by SCUBA diving. The locations for spot-check dive survey are shown in **Figure 3c**. Photos of the surveyed areas and the marine organisms encountered were taken during the dive survey.

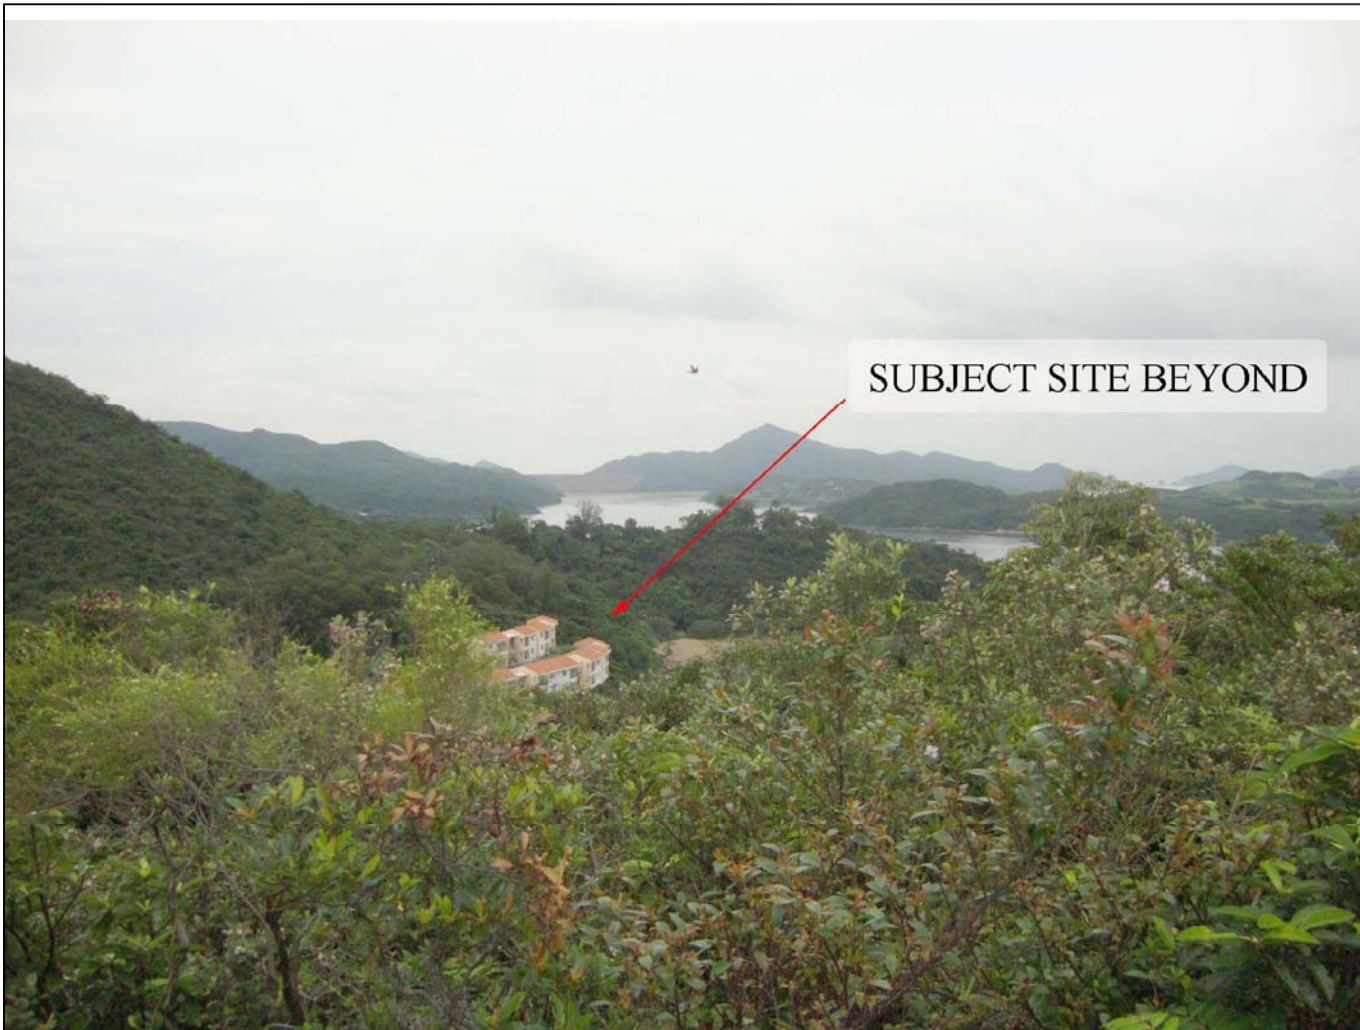
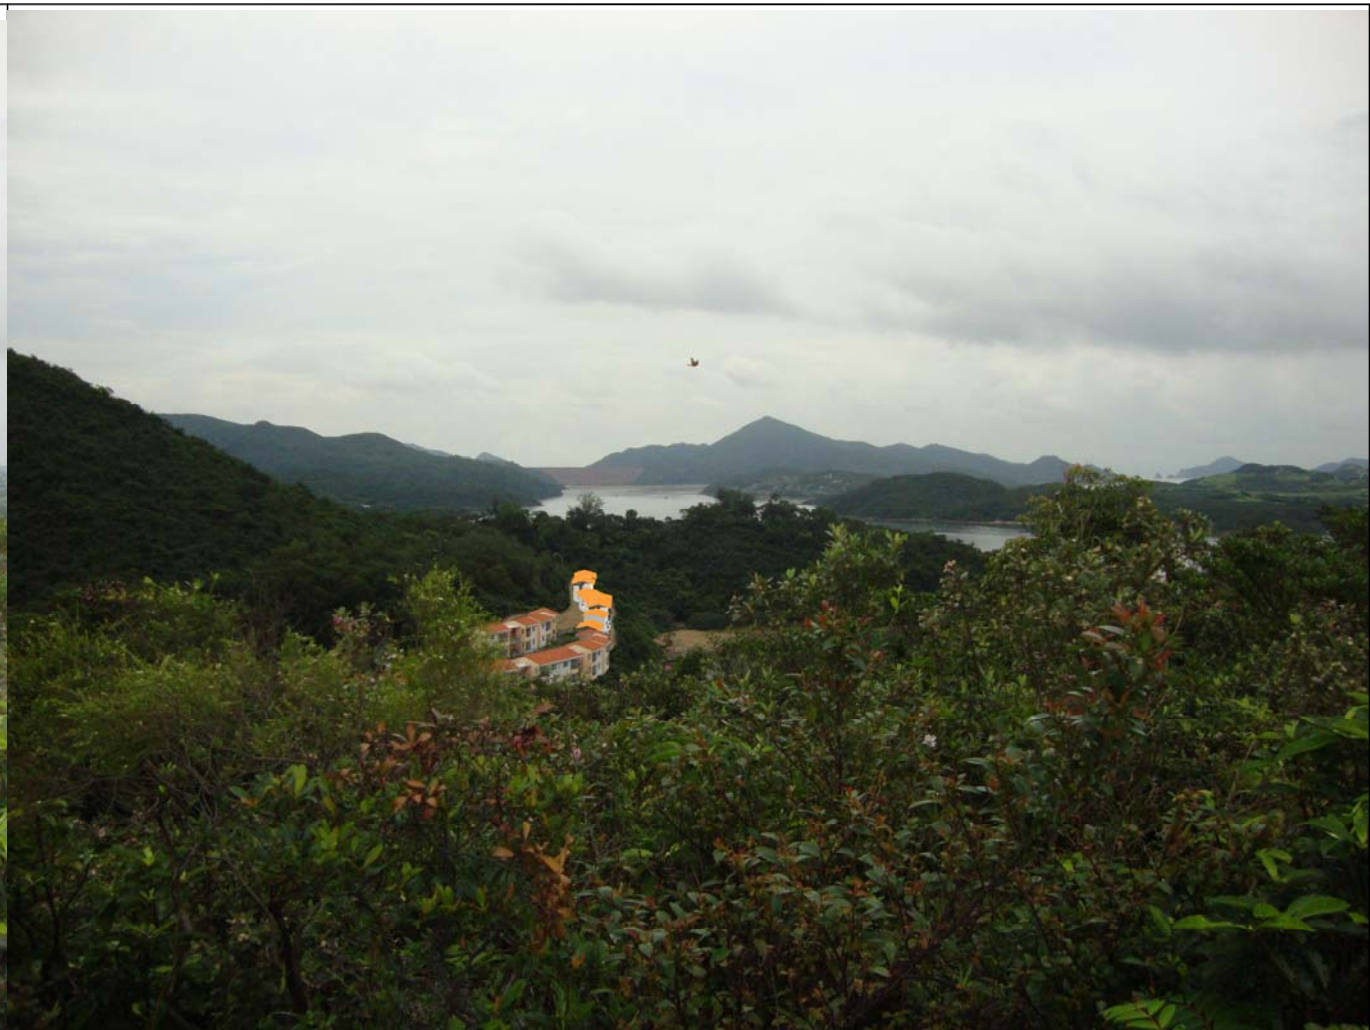
Drawing Title 標題
PHOTOMONTAGE VPT 3.3
(VIEW SOUTHEAST FROM HILLSIDE TRAIL WEST OF SITE)
FIGURE 9.3

EXISTING VIEW

DAY 1 WITHOUT MITIGATION

NEW DORMITORY
LMM7, LMM8, LMM9

DAY 1 WITH MITIGATION
