BULGE-DORSET 132kV LINE PROJECT

**CONSTRUCTION OF A 132kV POWERLINE FROM BULGE RIVER
SUBSTATION TO DORSET SUBSTATION**

SPECIALIST REPORT ECOLOGICAL ENVIRONMENT

**COMPILED BY
Flori Horticultural Services cc**

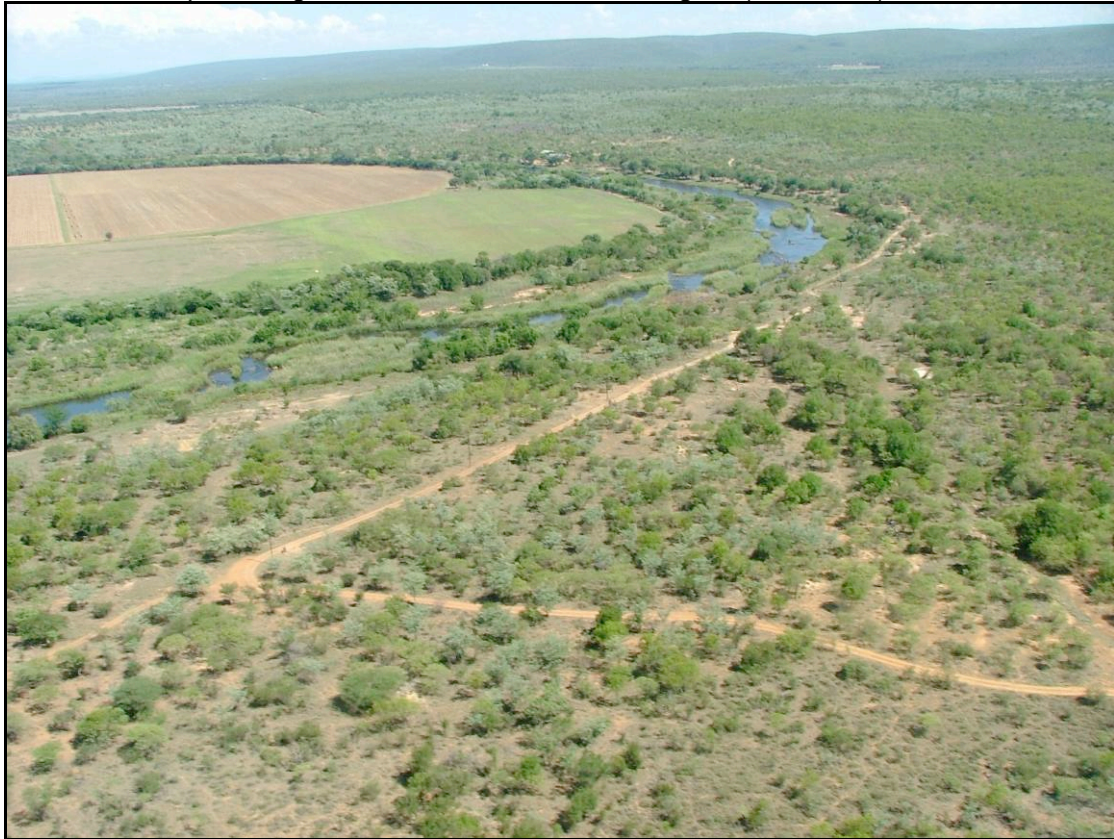
Figure 5. Mokolo River which runs through the study area. With a mix of natural bushveld and pivot-irrigated lands common in the region (Dec.2010)

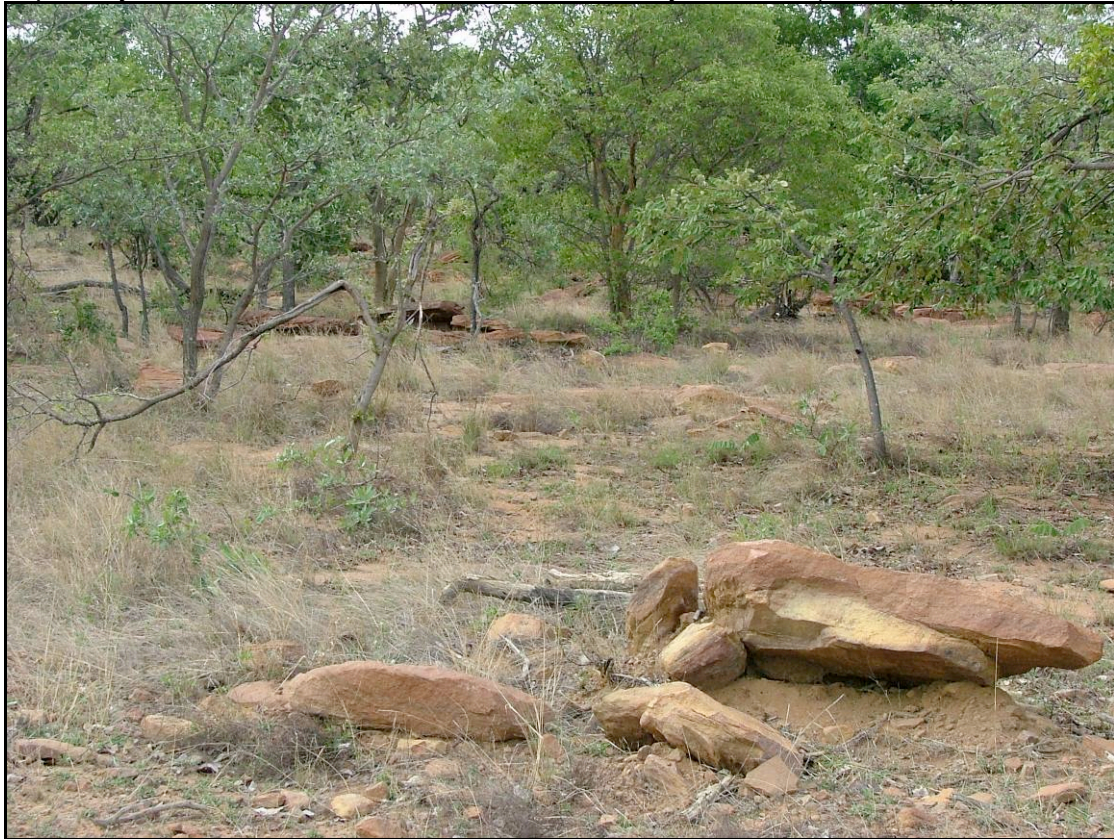
Figure 6. Rocky area east of the Mokolo River along the D1882 sand road, especially the northside. The area is viewed as fairly sensitive (Dec.2010)
