## **ESKOM TRANSMISSION**

# **EIA for the Proposed Thyspunt Transmission Lines Integration Project**

## **Biodiversity Impact Assessment (Northern Corridor)**

**Issue Date:** 8<sup>th</sup> June 2011

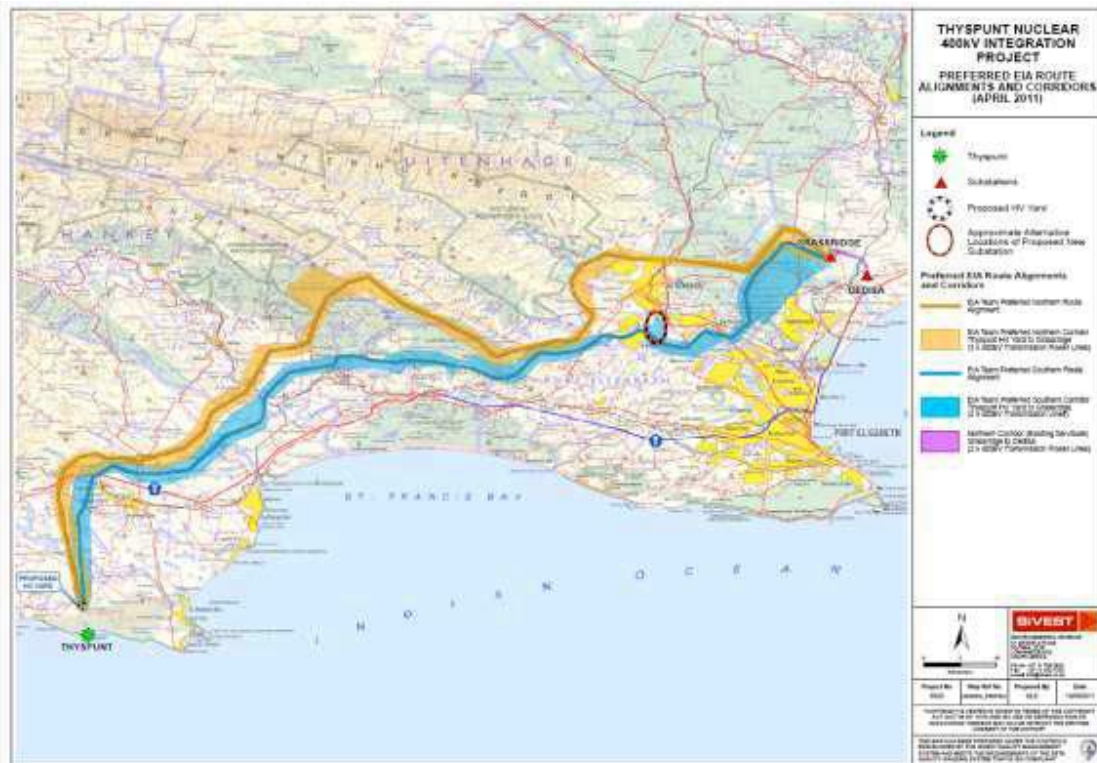
Figure 44: Preferred Routes

The preferred route for the Northern Corridor is highlighted by the yellow route in the map below. This route has been adjusted to allow for development expansion north of Humansdorp and avoids the intense agriculture around the Gamtoos River. The corridor has also been pulled out of the firebreaks slightly and into the forestry in an effort to protect the fynbos vegetation. The route has also been adjusted for development near Grassridge in the Alwynhoek area.
