PROPOSED MELKHOUT SUBSTATION BATTERY ENERGY STORAGE SYSTEM, HUMANSDORP, EASTERN CAPE VEGETATION IMPACT ASSESSMENT

Report Number 535611/4

November 2018

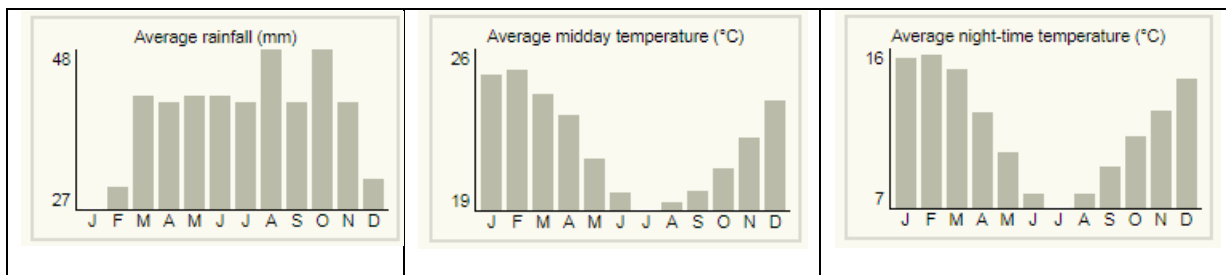
Figure 4-1: Climate conditions of the surrounding area (SA Explorer, 2000-2018)

The climate of the Humansdorp area (closest town to the site) receives on average 474 mm of rain per year. Humansdorp receives its highest rainfall during August (48 mm) and its lowest rainfall during January (27 mm). The average midday temperatures range between 18.6°C in Winter (July) to 25°C in February (Summer). The coldest time is during July when night time temperatures drop to 7.4°C on average (SA Explorer, 2000-2018). Figure 4-1 portrays the local climate conditions of the area within which the residential development is proposed.

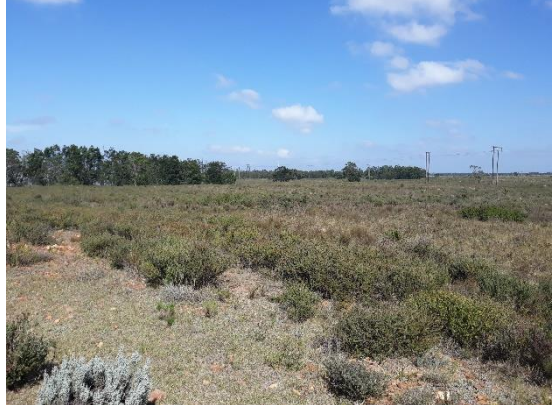
<p>Photo 1: View looking towards the southern boundary of the site from the existing substation. Note the pylons.</p>	<p>Photo 2: View looking towards the western boundary of the site from the existing substation.</p>

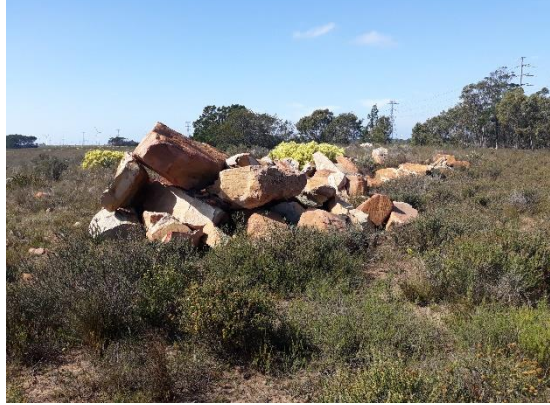
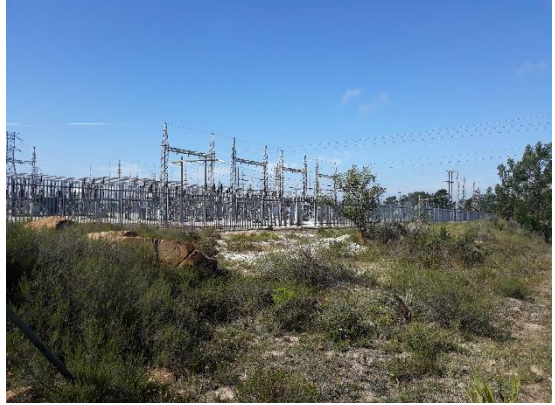
<p>Photo 3: <i>Acacia mearnsii</i> infestation adjacent to the existing substation.</p>	<p>Photo 4: View of the site vegetation looking southwards from the northern boundary</p>

The sections of the site on and directly adjacent to areas of disturbance are largely infested with *Acacia mearnsii*. Isolated clumps and individuals of *Acacia cyclops* (Rooikrans), *A. saligna* (Port Jackson Willow) and *A. melanoxylon* (Australian Blackwood) are scattered around the site. The surrounding area is also infested with large stands of *Acacia mearnsii* (most prominently within the surrounding wet areas). A list of invasive alien species observed within the site boundary and descriptions of the NEMBA Invasive Species Categories and their prescribed legal requirements are listed in Table 5-3 and Table 5-4 respectively.

<ul style="list-style-type: none"> • All invasive alien species currently surrounding the substation should be removed and disposed of as waste at a registered landfill site; • Appropriate fire-fighting equipment must be available on site at all times and serviced at regular intervals; • No smoking shall be allowed in the vicinity of flammable substances and relevant signage must be displayed; and • It is recommended that an 8 m fire break be maintained around the perimeter of the battery storage facility for the duration of the operational phase. The fire break should be maintained on a regular basis. 									
After Management	Local	Medium	Short-term	Very Low	Possible	INSIGNIFICANT	-	Medium	Medium

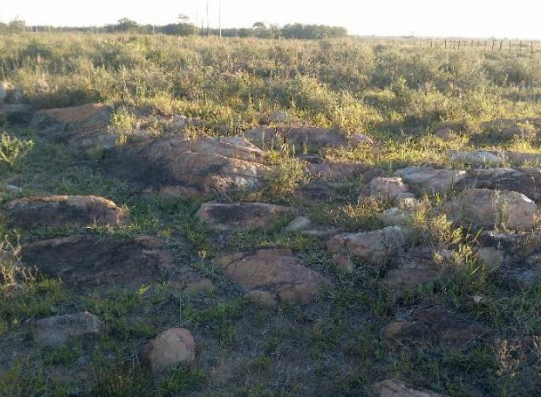
<p>Photo 5: Stockpiled rocks on site</p>	<p>Photo 6: Transformed/disturbed area adjacent to existing substation. Note dumped materials and <i>Acacia</i> infestations.</p>
