HARD TO FIND OBD II CONNECTORS

dKC – de la Torre Klausmeier Consulting, Inc
1401 Foxtail Cove, Austin, TX 78704
Phone: 512-447-3077
Fax: 512-447-3116
E-mail: delaklaus@aol.com

INTRODUCTION

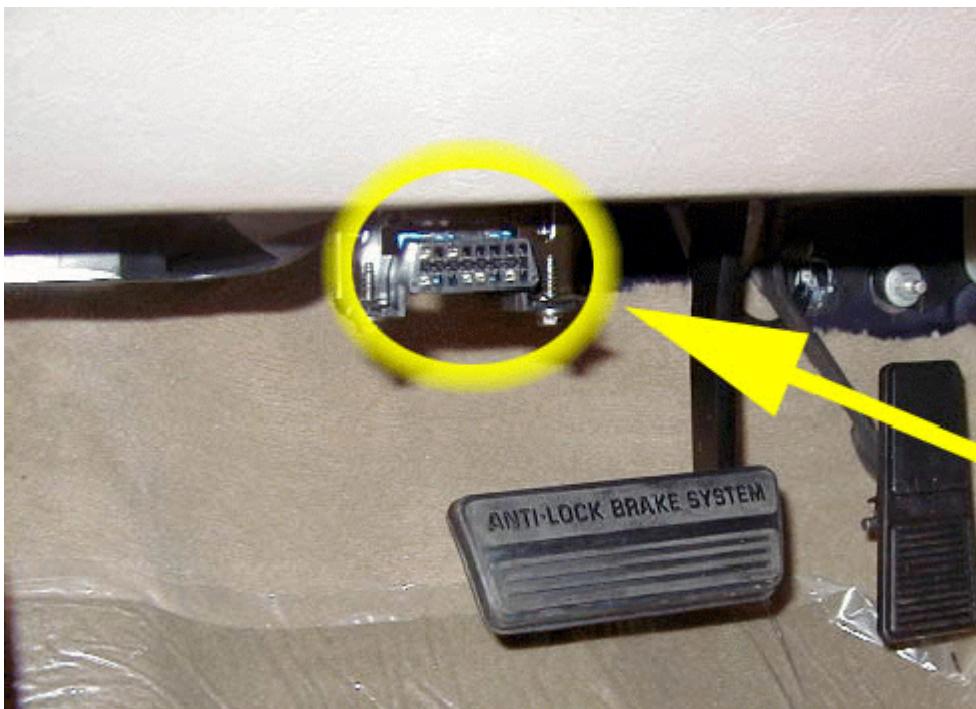
Typical DLC Location

1996 and newer light-duty vehicles are equipped with second generation onboard diagnostic (OBDII) systems. All vehicles with OBDII systems have a standardized diagnostic link connector (DLC). Technicians can connect a scan-tool to the DLC and download information from the OBDII system. On most vehicles, the DLC is below the steering column in an easy to access location.

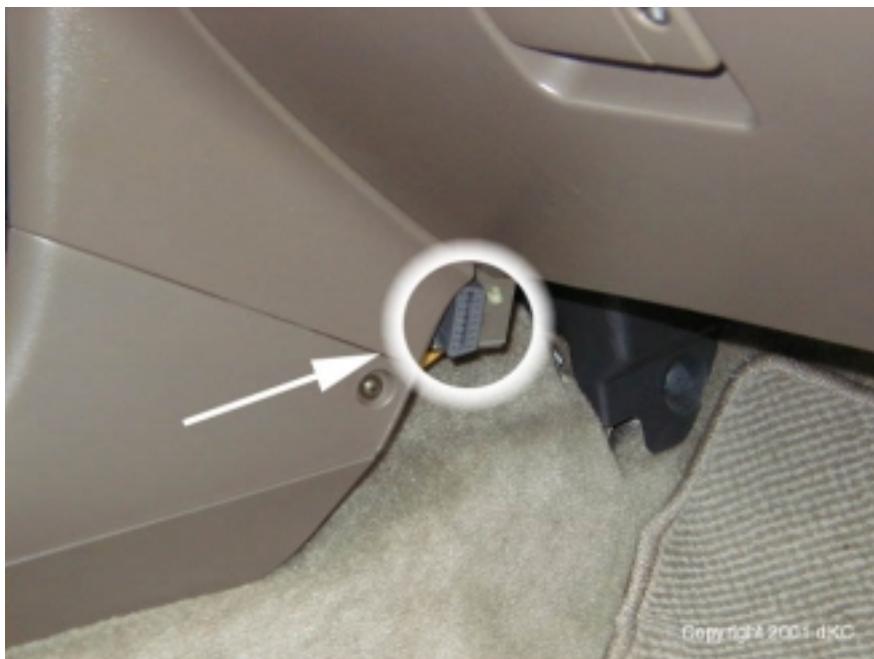
96-2000 Acura Integra – passenger's side of center console (right side of the hump, behind right side of front center console)

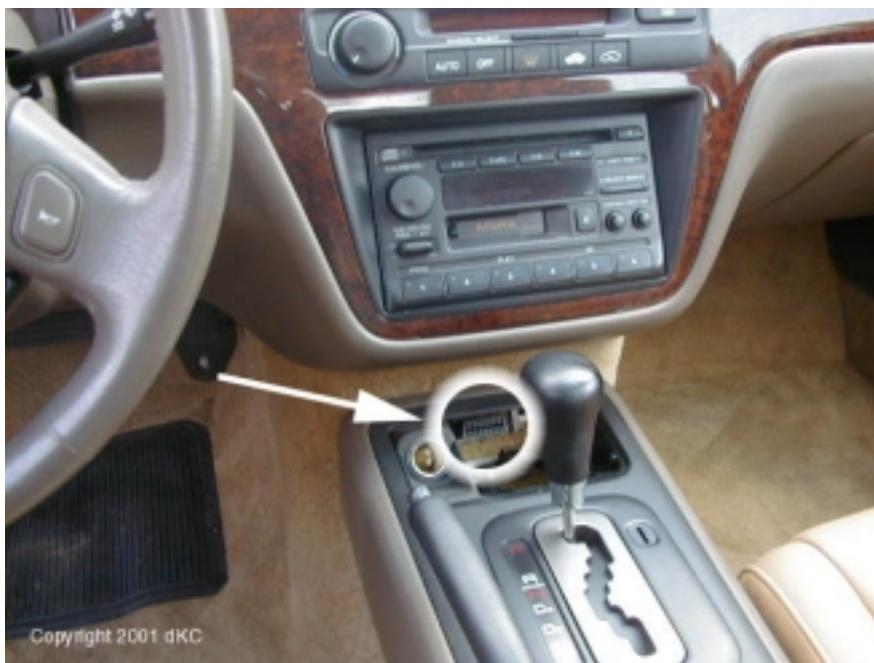
96-98 Acura TL – **DIFFICULT – BEHIND ASHTRAY**

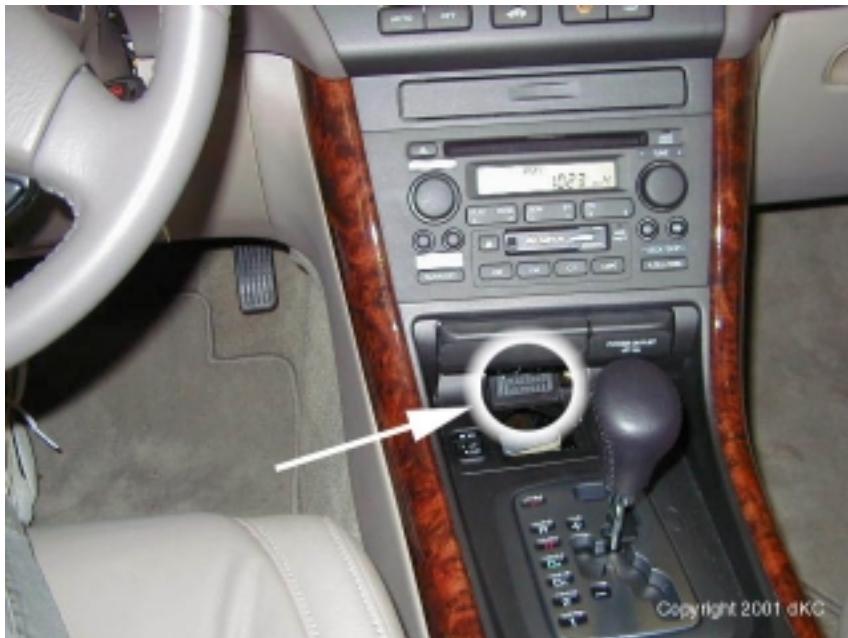
99-2001 Acura CL/TL – DIFFICULT -- BEHIND COVER on center console below radio (next to seat heater controls). **Cover is hard to remove.** Note: 2002 is below instrument panel and is uncovered.

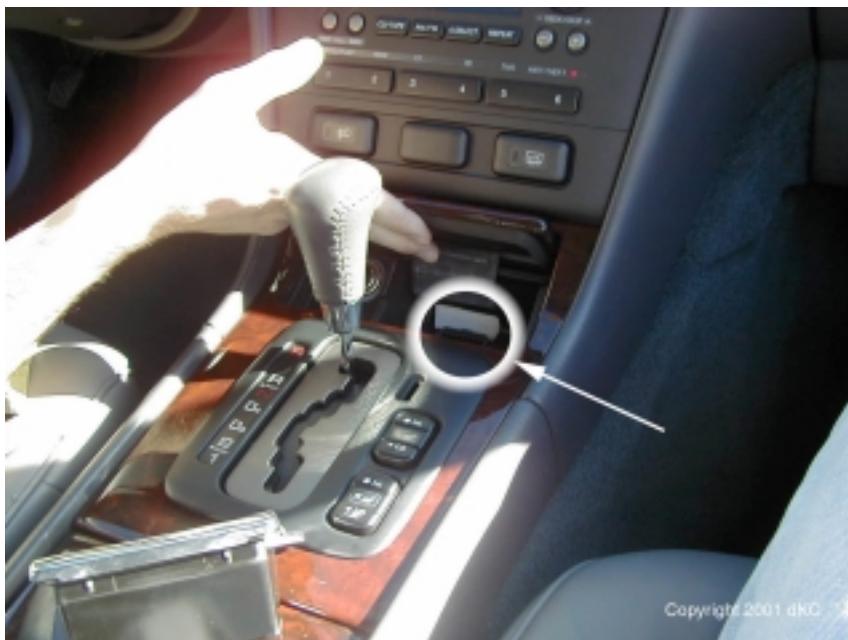
96-98 Acura RL -- DIFFICULT -- BEHIND RUBBER FLAP BEHIND ASHTRAY on center console below radio.

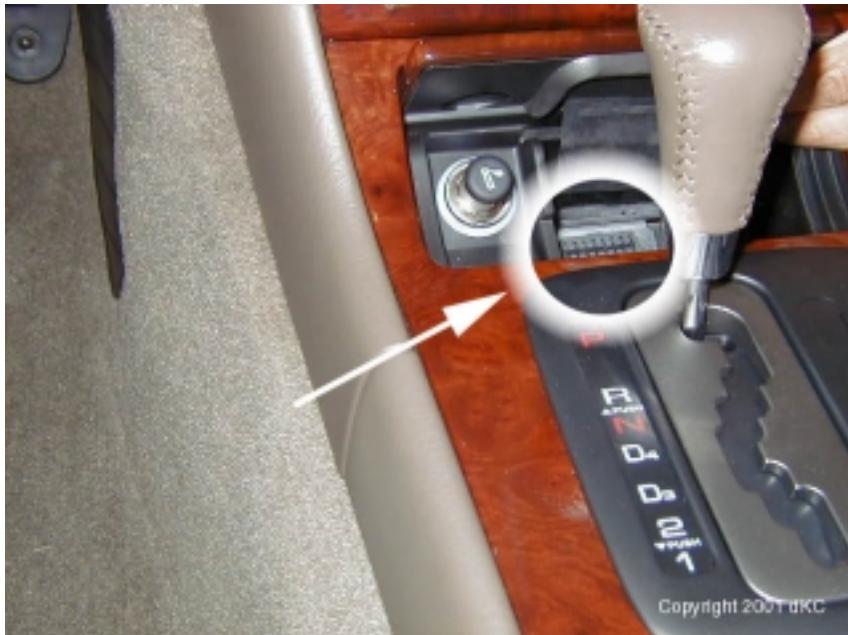
**99-2002 Acura RL – DIFFICULT -- BEHIND RUBBER FLAP
BEHIND ASHTRAY** on center console below radio.

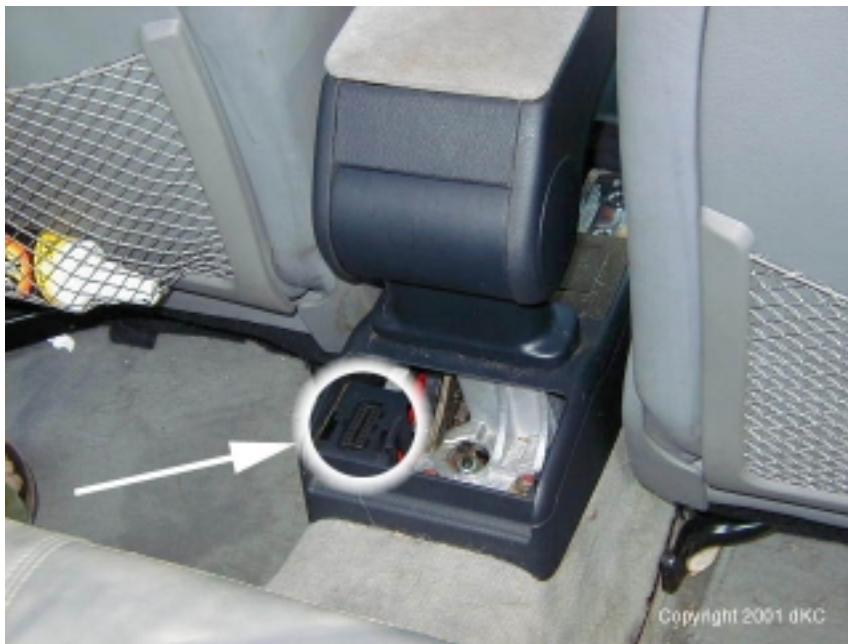
96,97 Audi A4, All 96-98 Cabriolet – DIFFICULT – access rear center console between seats through rear door; open ashtray cover, remove ashtray.

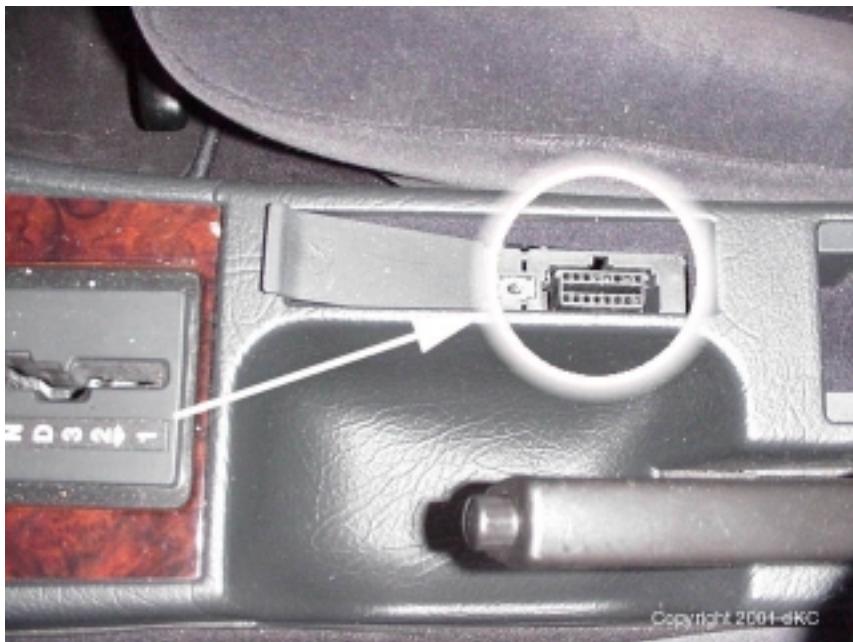
96,97 Audi A6 – DIFFICULT – on right side of center console under cover next to parking brake.

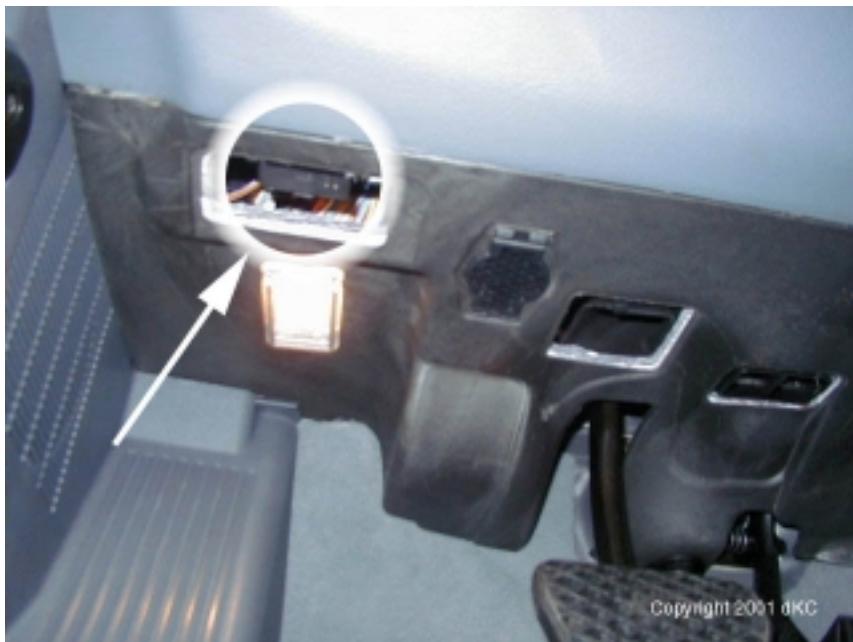
**96-98 BMW 3 Series (Including 96-99 M3) – VERY DIFFICULT,
CAN DAMAGE VEHICLE IF NOT DONE CORRECTLY –** Under left side dash under a cover marked OBDII held by slot head requiring ¼ turn.

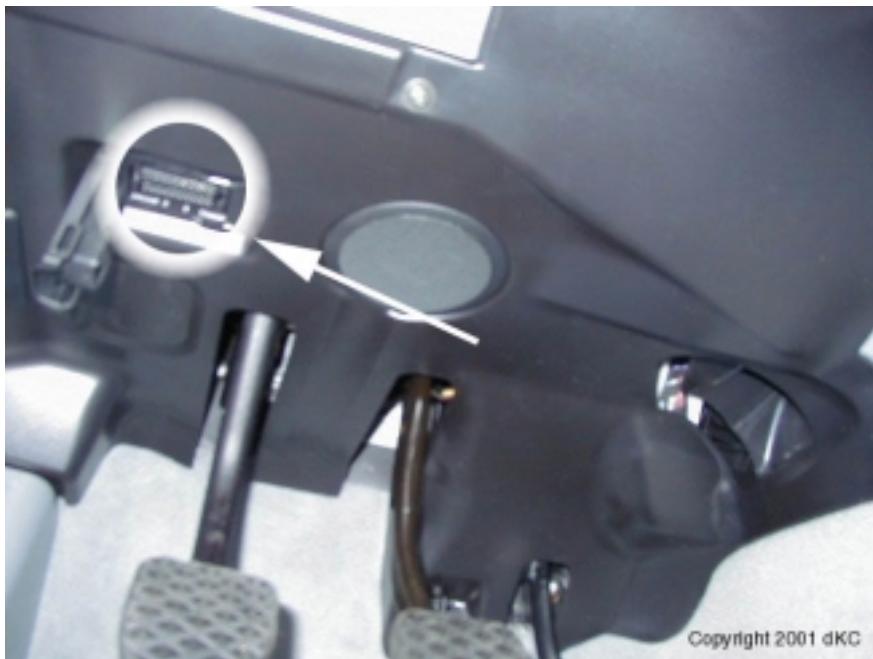
99-2002 BMW 3 Series – Under left side dash under a cover marked OBDII (**May require turning screw to release**)

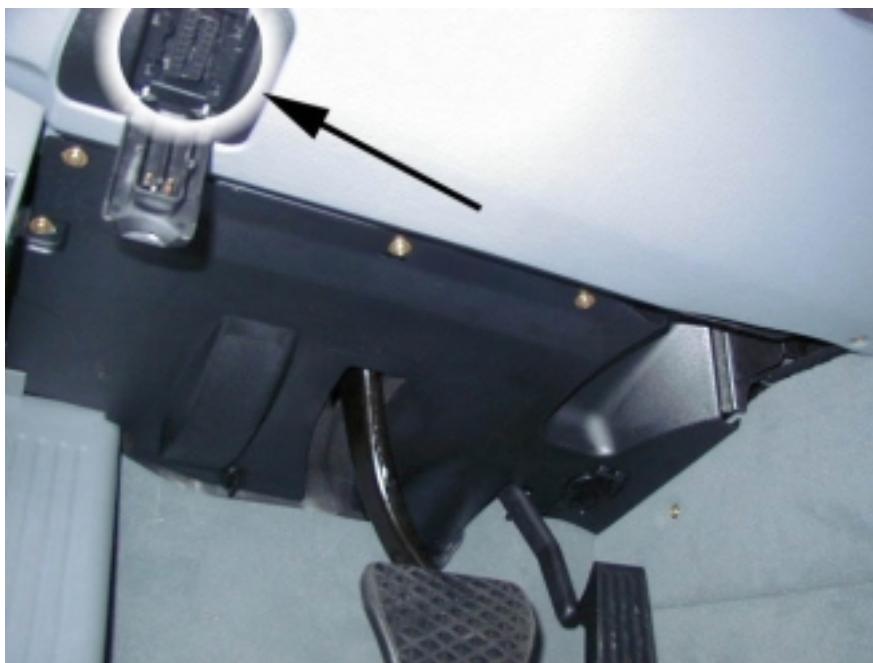
96-2002 BMW 5 Series – **VERY DIFFICULT, CAN DAMAGE VEHICLE IF NOT DONE CORRECTLY** – Under left side dash under a cover marked OBDII held by slot head requiring $\frac{1}{4}$ turn. Some vehicles have additional cover on DLC beneath dash cover.

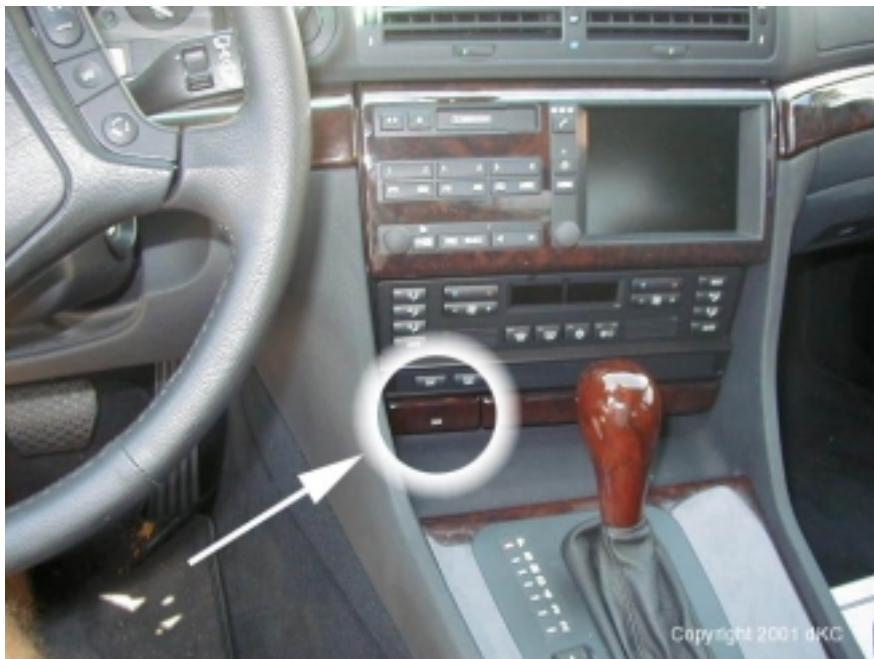
96-2001 BMW 7 Series – DIFFICULT – BEHIND HARD TO REMOVE COVER -- On dash below stereo.

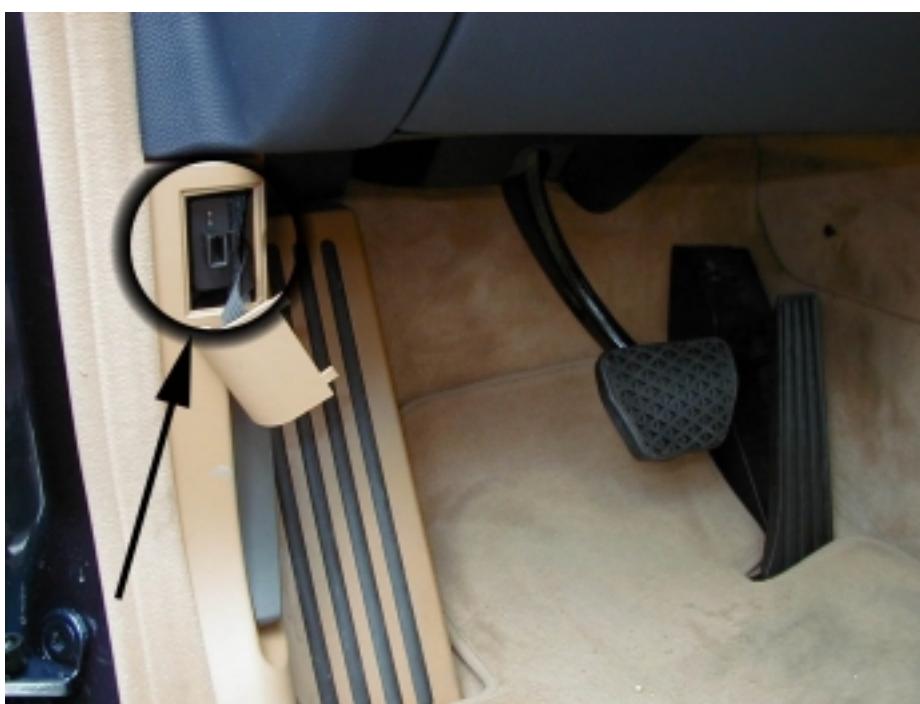
2002 BMW 7 Series – Below instrument panel on left-hand side, behind plastic cover.

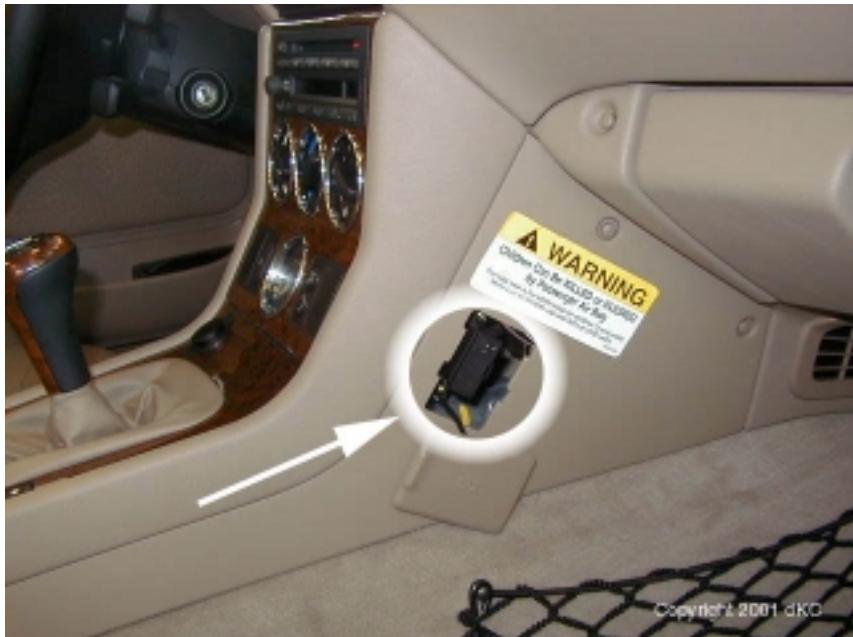
96-2002 BMW Z3/M Roadster -- BEHIND COVER on passenger's side of center console (right side of the hump, behind right side of front center console)

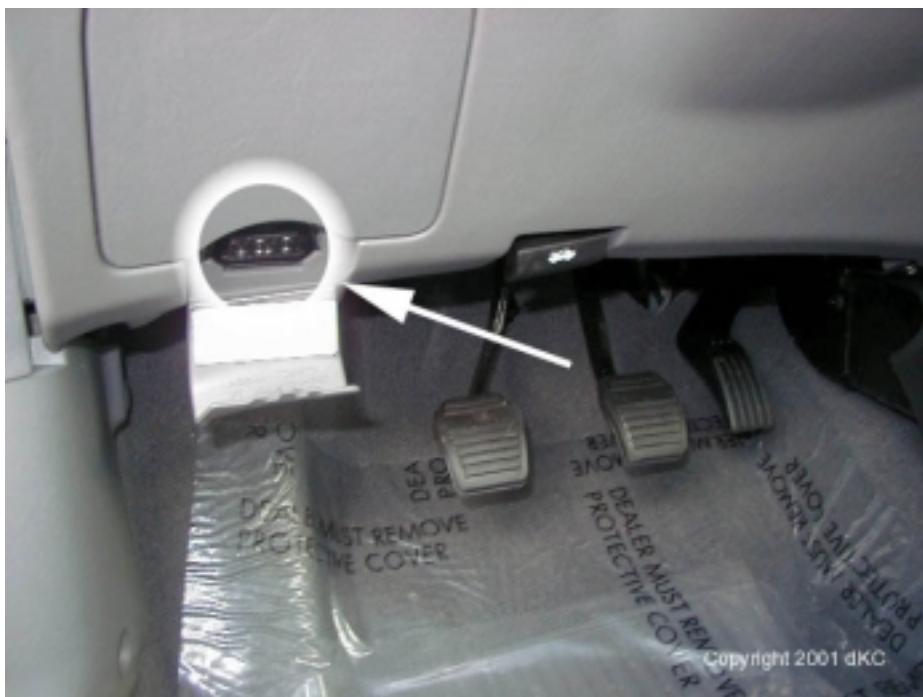
2000-2002 FORD FOCUS – Drivers side, underneath dash, covered

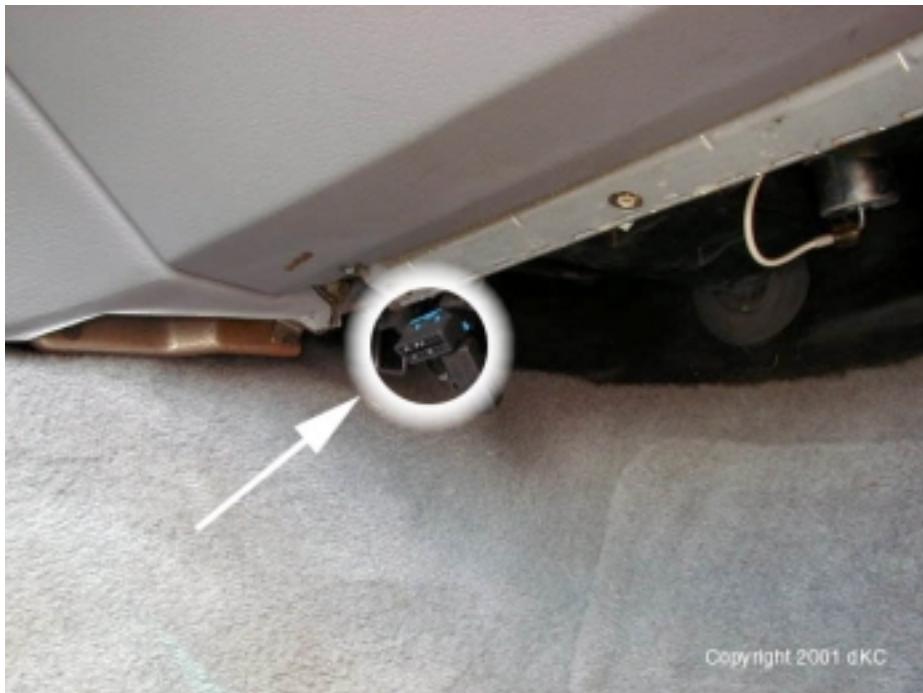
96,97 FORD Thunderbird – Passenger side , underneath dash

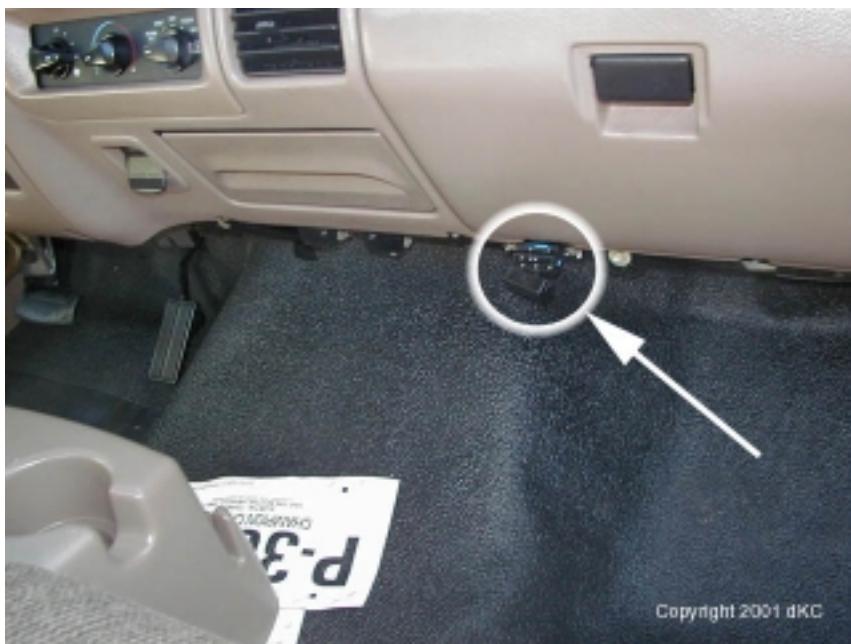
96,97 FORD TRUCKS (some) – Passenger side , underneath dash

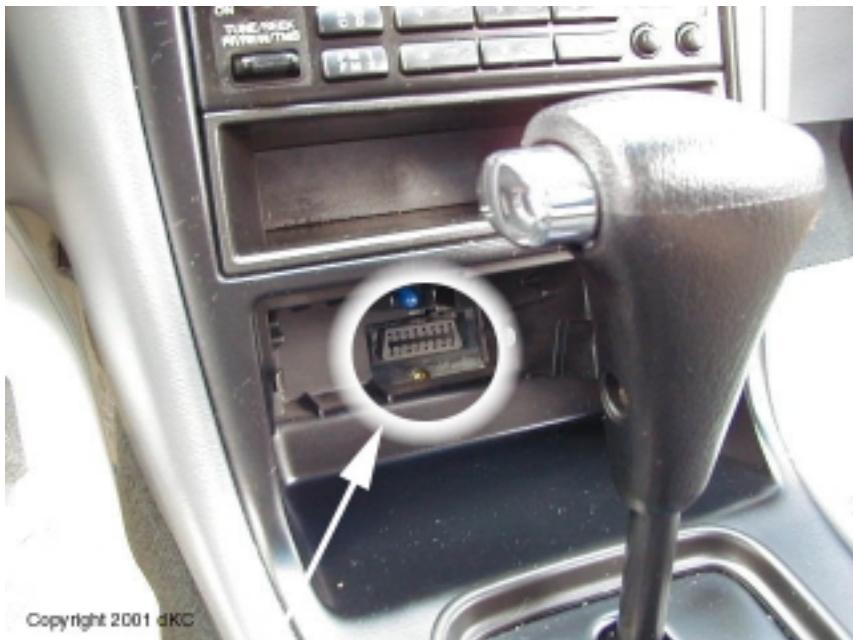
96,97 Honda Accord – **DIFFICULT – BEHIND ASHTRAY near stereo**

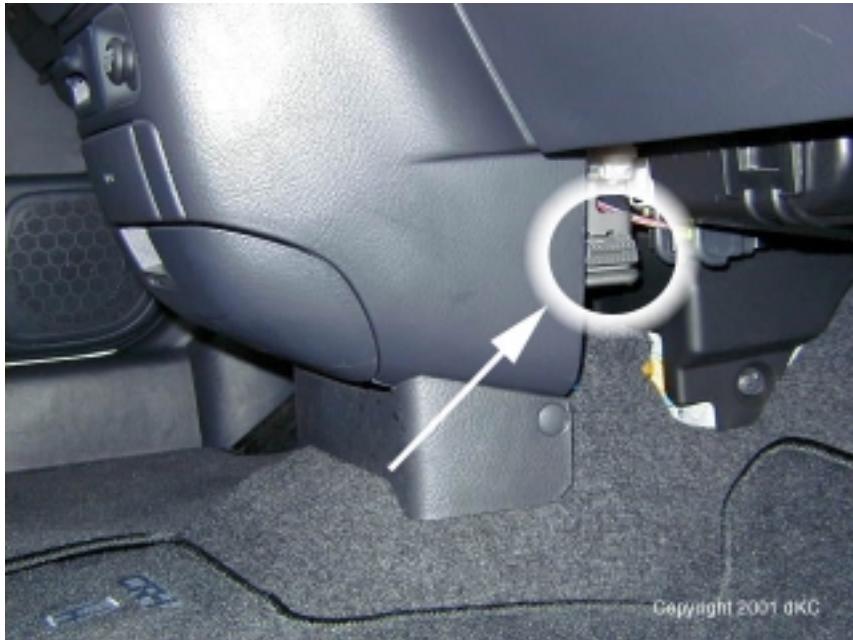
97-2002 Honda CRV – passenger's side of center console (right side of the hump, behind right side of front center console)

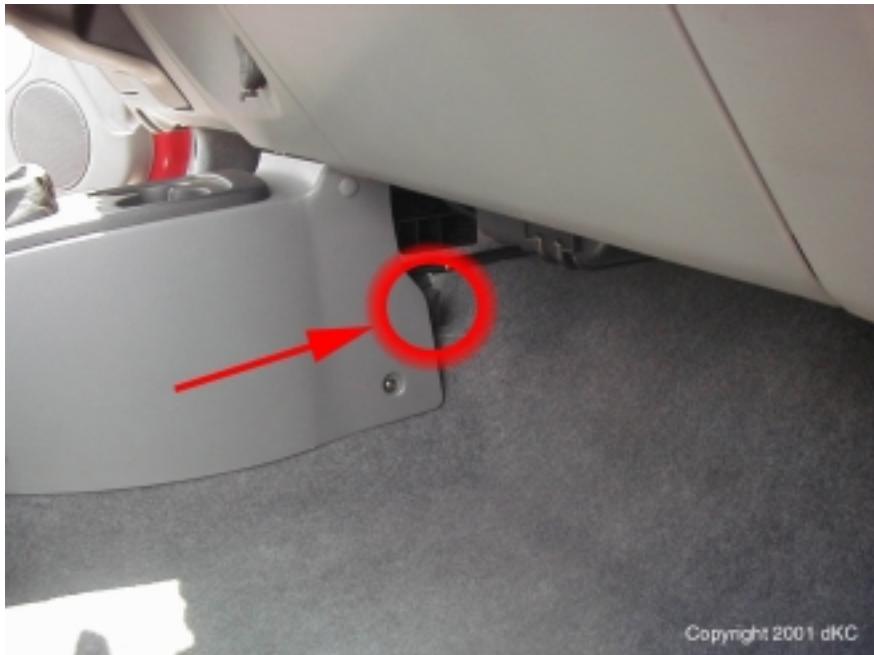
2001-2002 Honda Insight – passenger's side of center console (right side of the hump, behind right side of front center console)

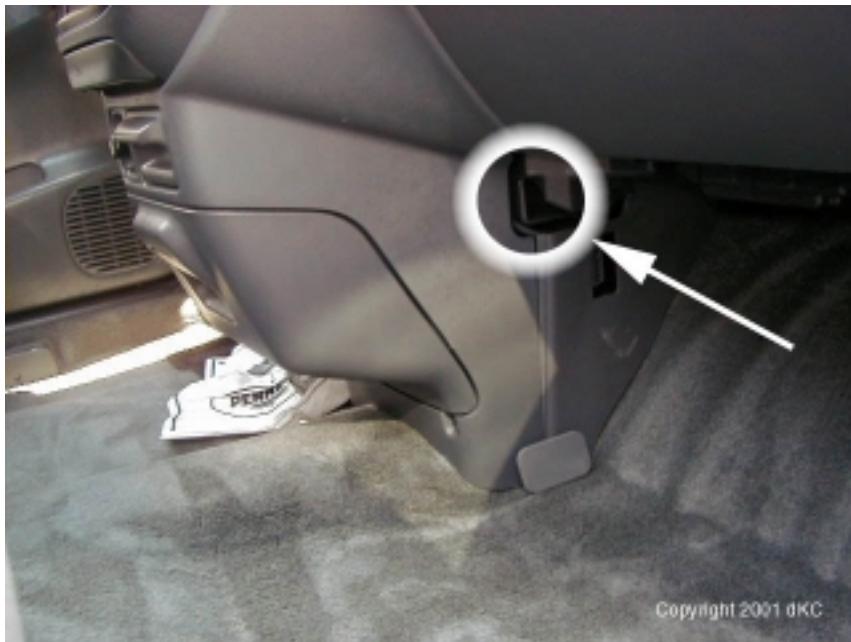
96-98 Honda Odyssey – **DIFFICULT – BEHIND COVER**,
passenger's side of center console (right side of the hump, behind
right side of front center console)

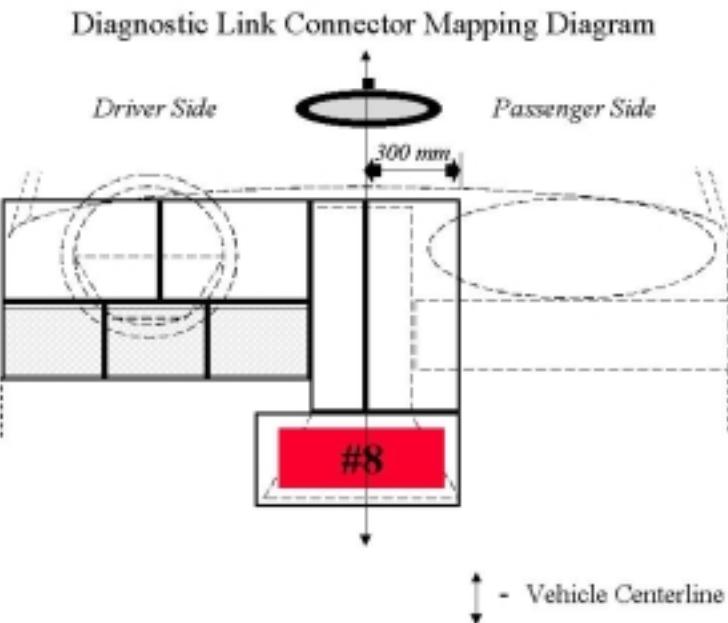
96 Honda Prelude – below center console beverage holder

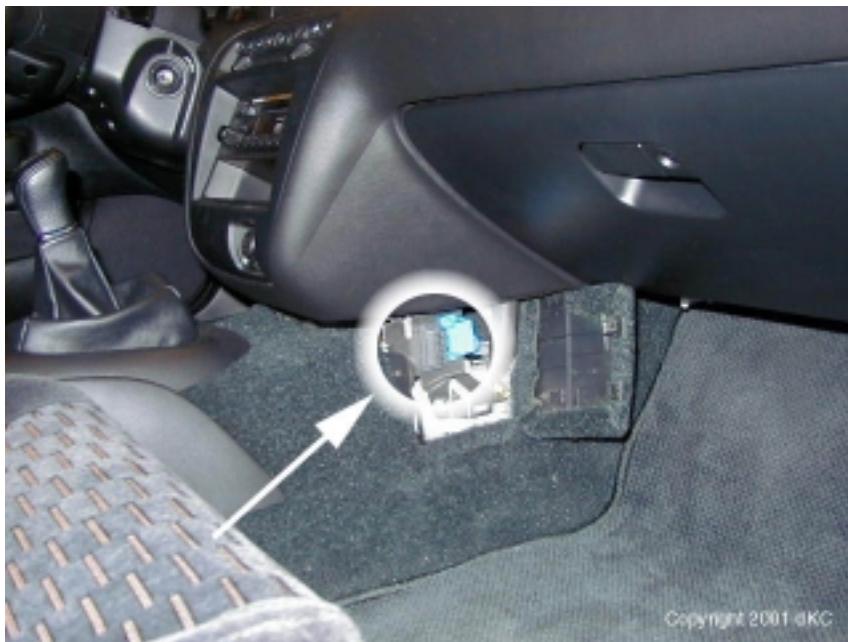
97-2001 Honda Prelude – DIFFICULT – BEHIND COVER on passenger's side of center console (right side of the hump, behind right side of front center console)

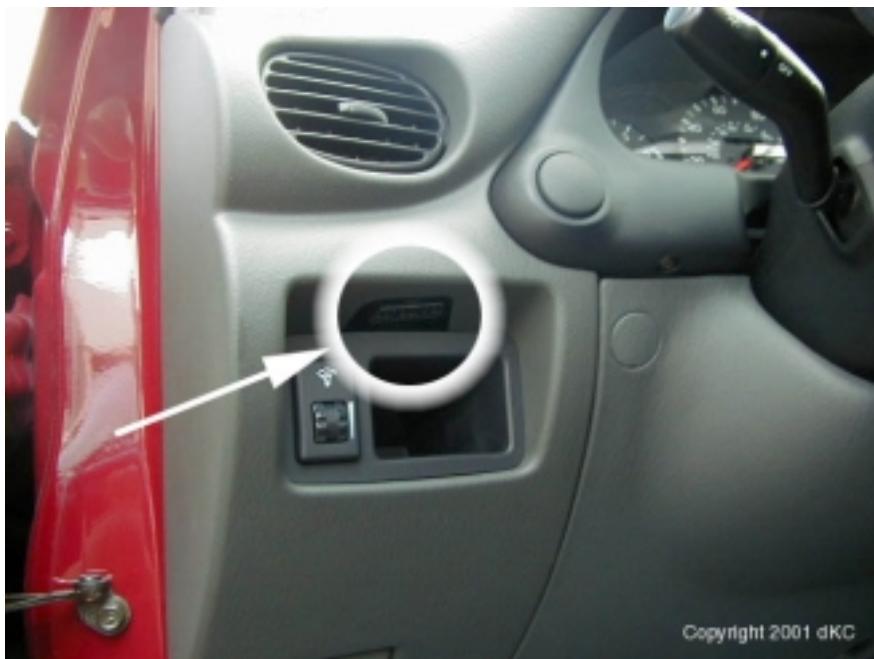
95-98 Hyundai Accent – Left side of dash in coin box

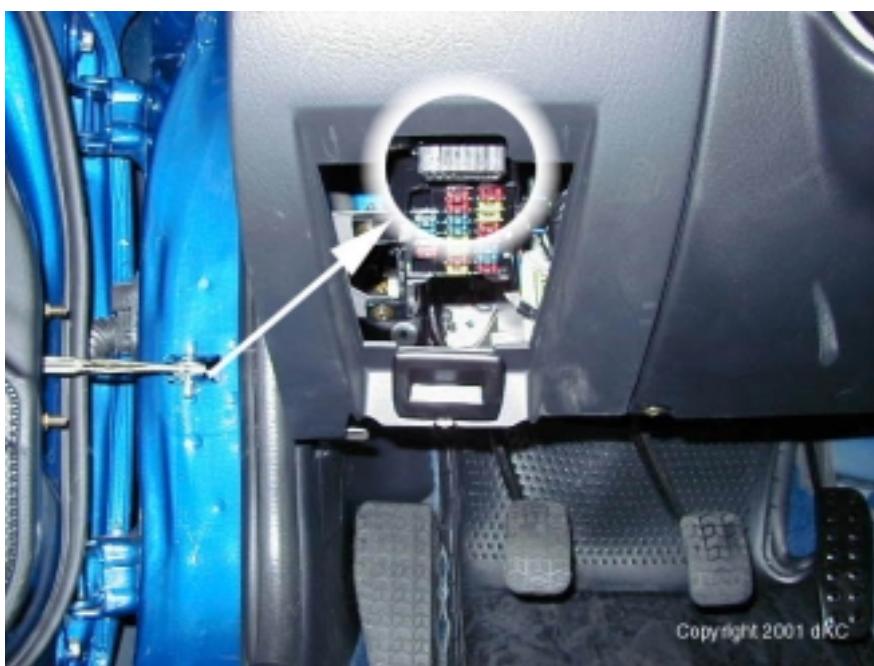
98-99 Mazda Miata -- BEHIND FUSE BOX ACCESS PANEL, left side of dash

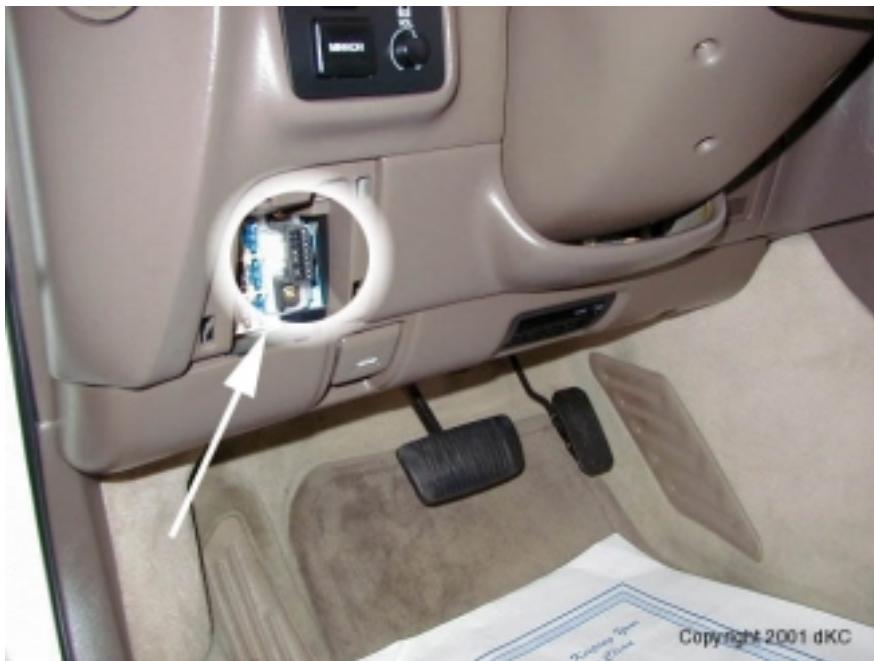
96 Lexus ES300 -- BEHIND FUSE BOX ACCESS PANEL, left side of dash, down low

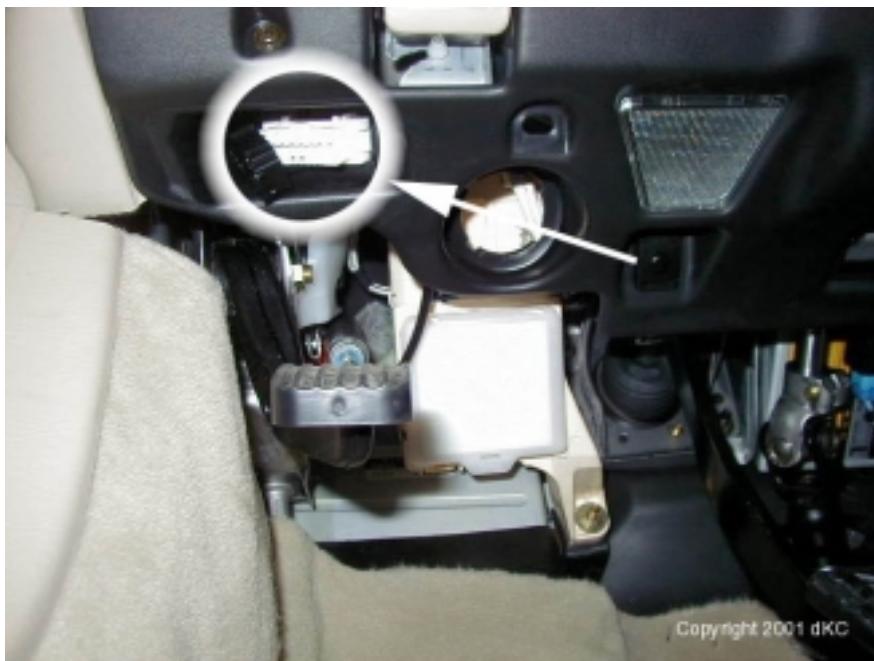
96-2000 Lexus LS400 – BEHIND COVER, above parking brake.

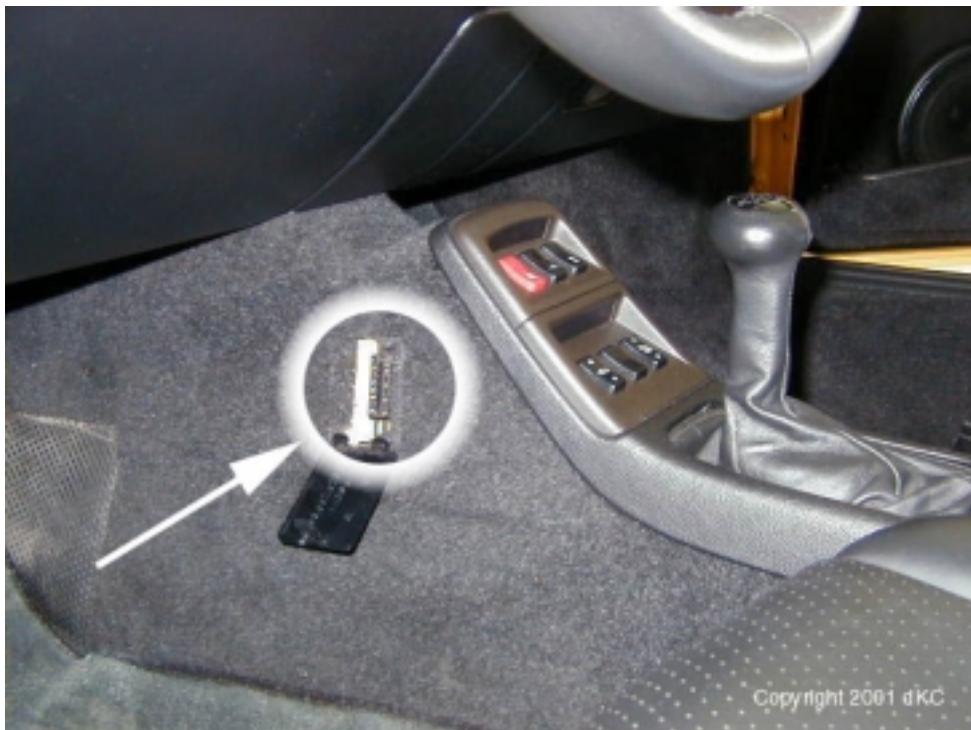
96-98 PORSCHE 911 – All models, driver's side of center console (hump), near gas pedal, behind a cover.

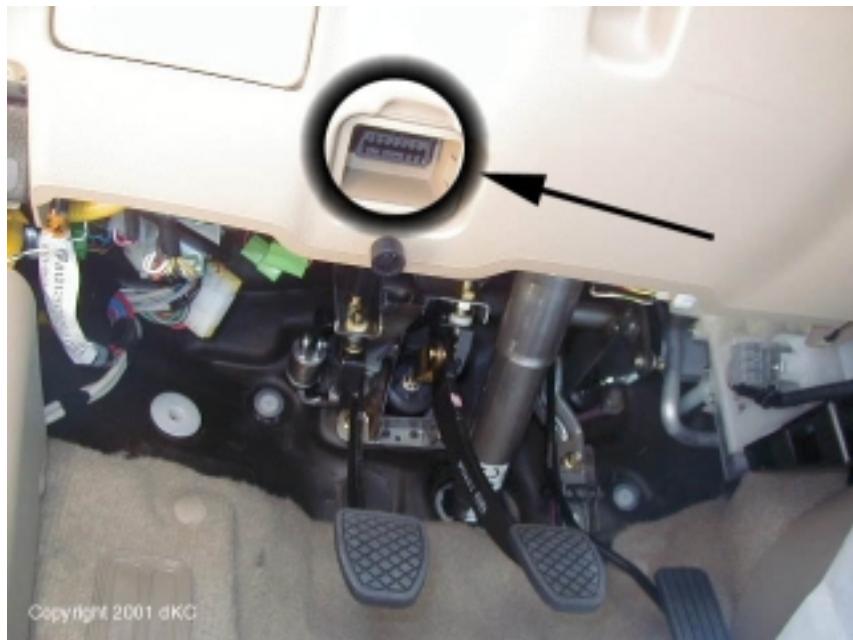
96,97 Subaru Impreza, Outback, 98-99 Forester – Left lower side of dash

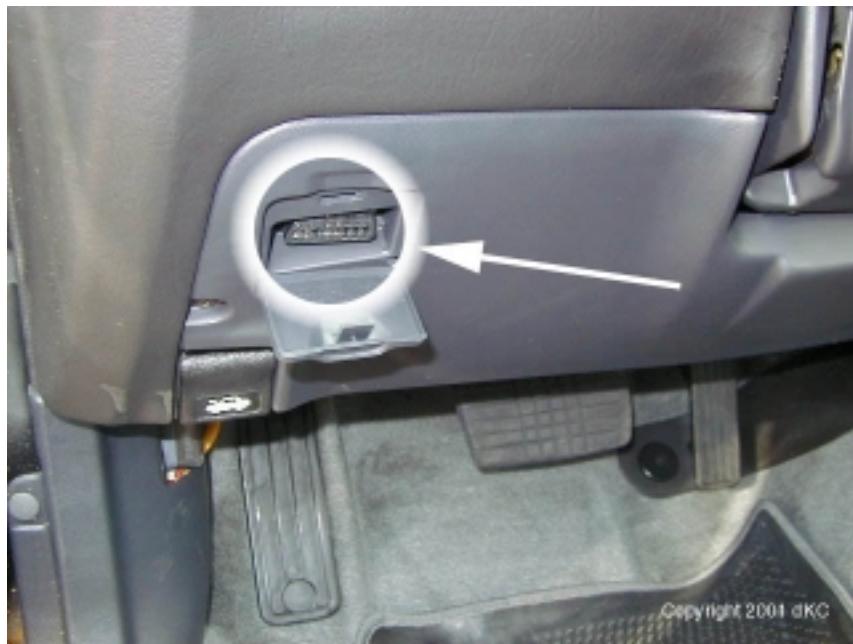
96-2000 Subaru Legacy – Left lower side of dash behind plastic hinged cover

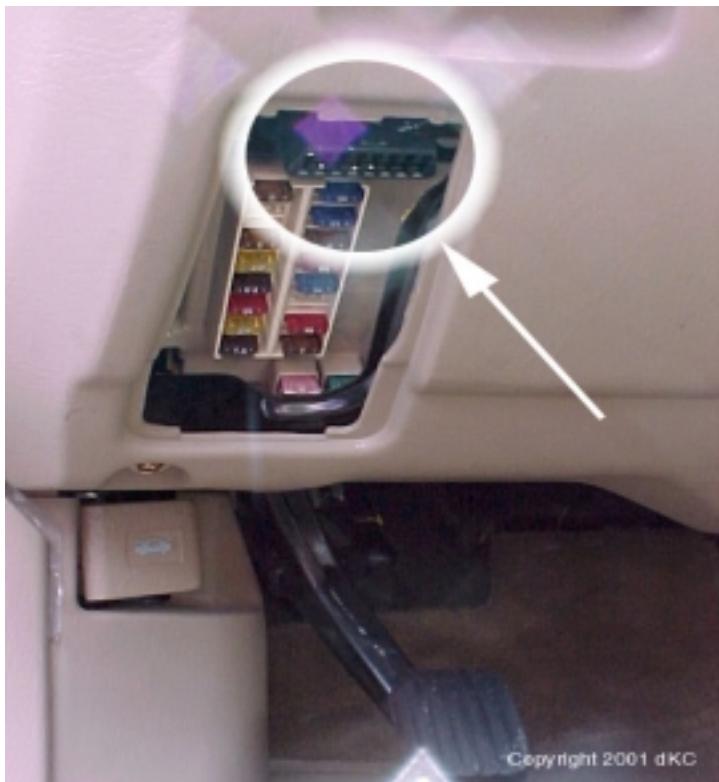
96 Toyota Avalon – BEHIND FUSE BOX ACCESS PANEL, left side of dash, down low

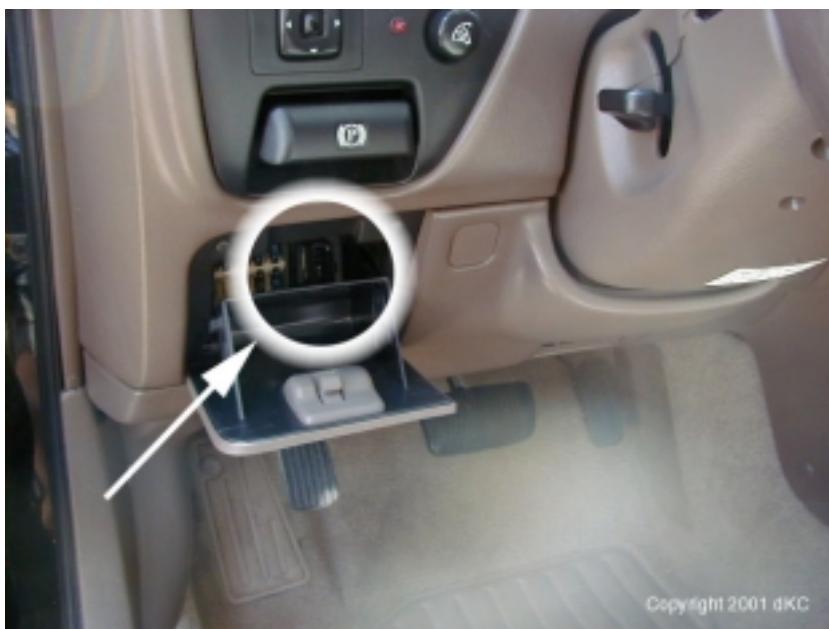
96 Toyota Camry -- BEHIND COIN BOX FLAP, lower left side of dash, down low. (Not easily visible until coin box is removed)

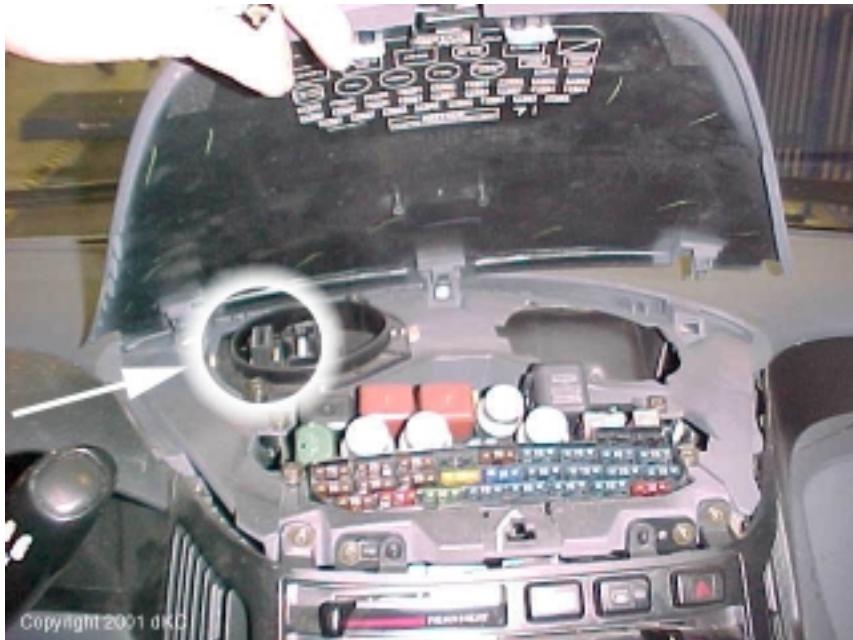
96,97 Toyota Previa – DIFFICULT – Top of dash on left-hand side
UNDER COVER PLATE (release latch center front cover under lip)

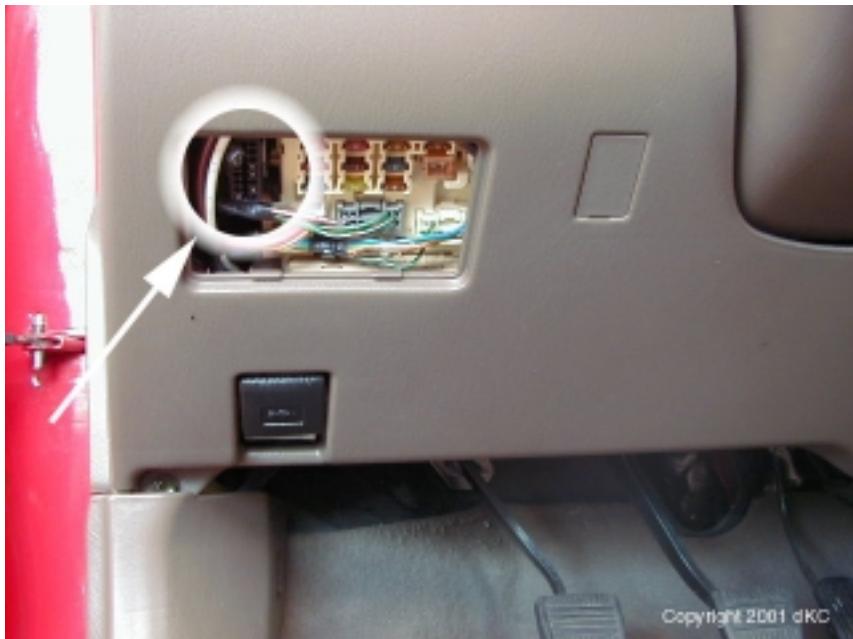
96-98 Toyota Tercel – BEHIND FUSE COVER on left side
instrument panel (far left side of fuse panel & may be partially obscured by wire)

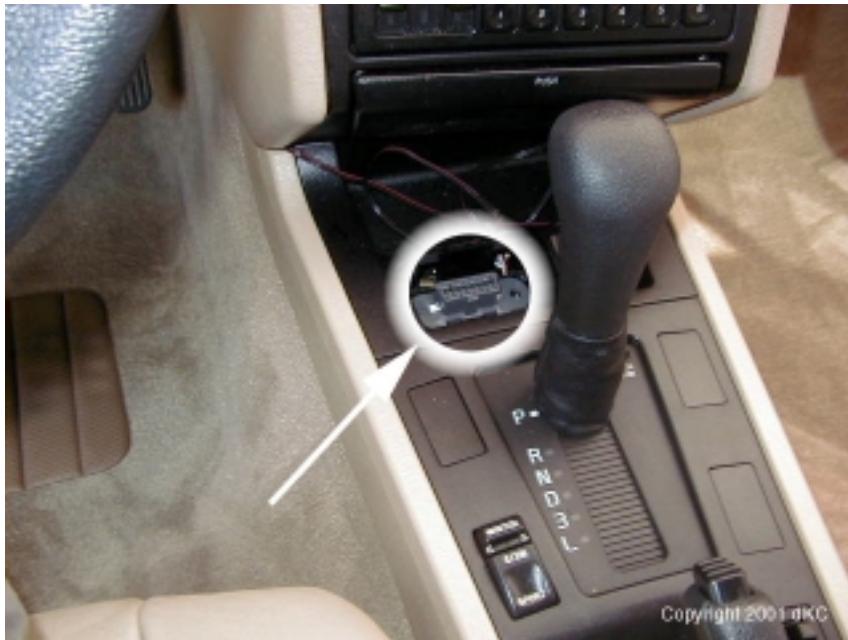
97,98 Volvo 850 – DIFFICULT – BEHIND COVER -- Center console between seats, front of shift lever, underneath coin tray marked OBDII (pull up on coin tray to remove).

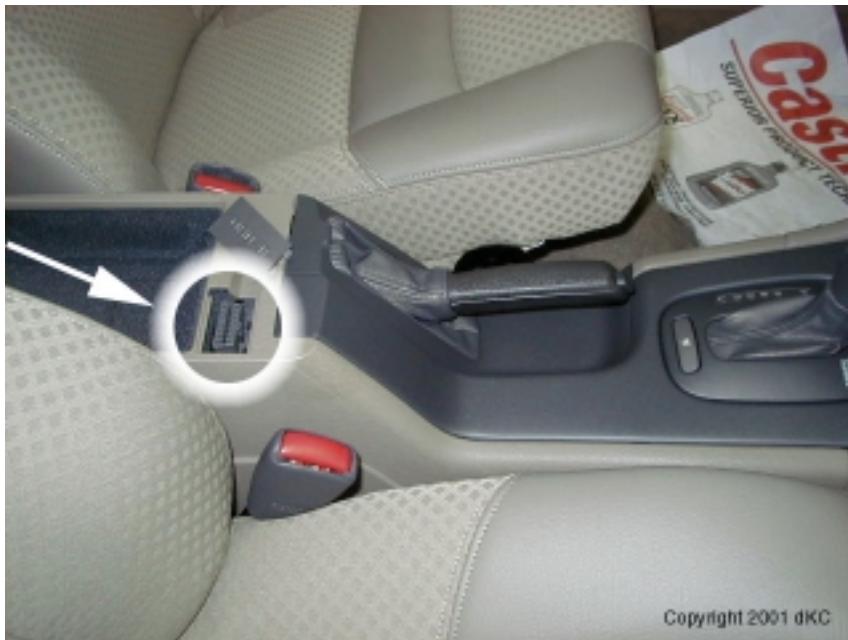
98-2000 Volvo C70 S70, 90 Series (2001/2002 C70 too) – DIFFICULT – Middle of the center console front of storage compartment to the right of the emergency brake. Remove cover or slide cover marked OBDII.

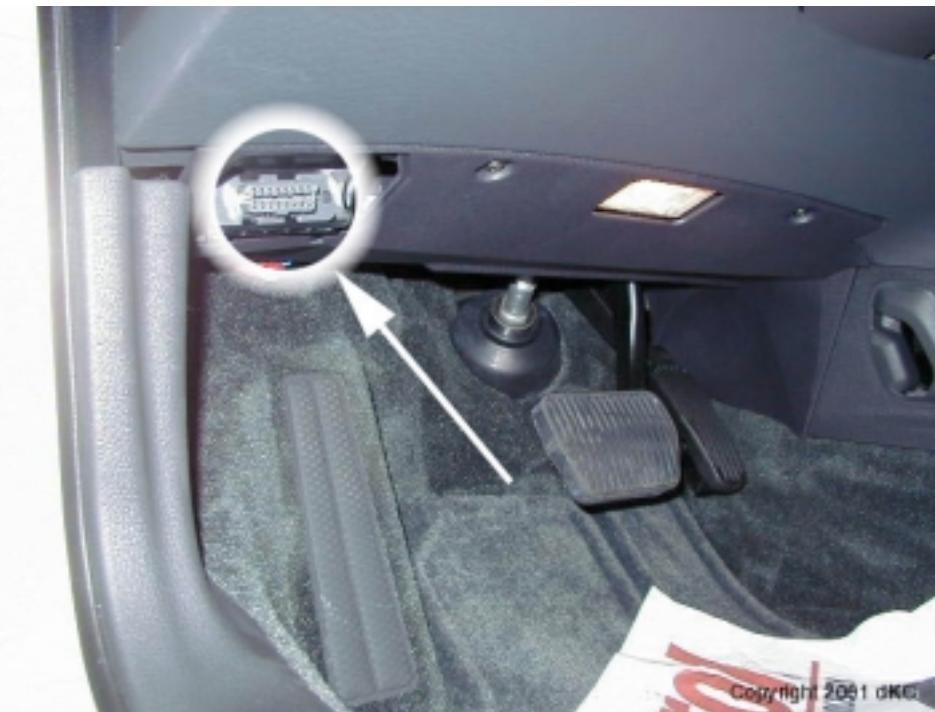
98-2000 Volvo S80 – COVERED – On left-hand side below steering column.

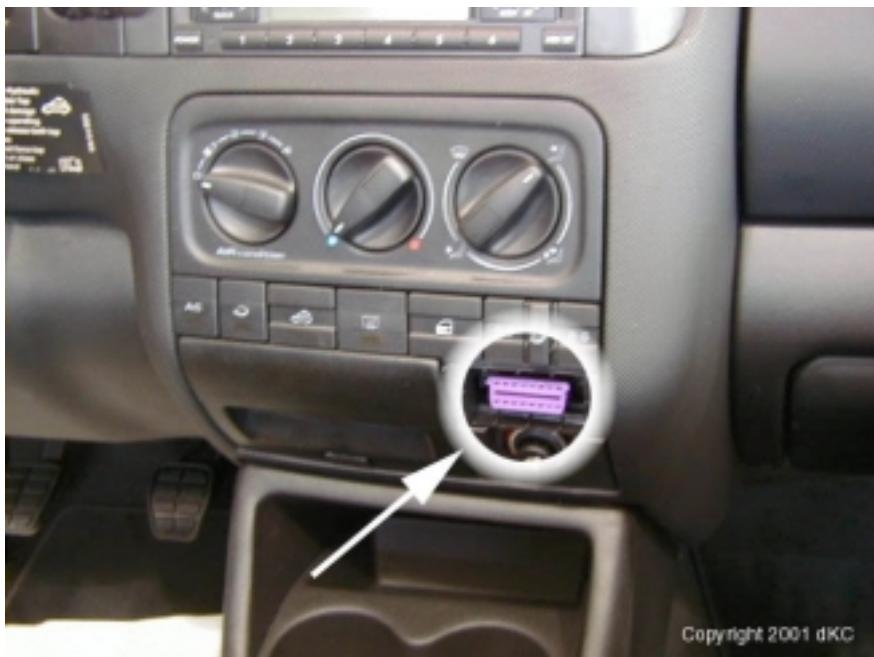
96-98 VW Jetta, Golf, Cabrio – DIFFICULT – Next to ashtray (which has to be removed) behind slide cover (which is slid over where ashtray was). Covers have a picture of an engine & a lightning bolt going through it.
