HARD TO FIND OBD II CONNECTORS

dKC – de la Torre Klausmeier Consulting, Inc
1401 Foxtail Cove, Austin, TX 78704
Phone: 512-447-3077
Fax: 512-447-3116
E-mail: delaklaus@aol.com

INTRODUCTION

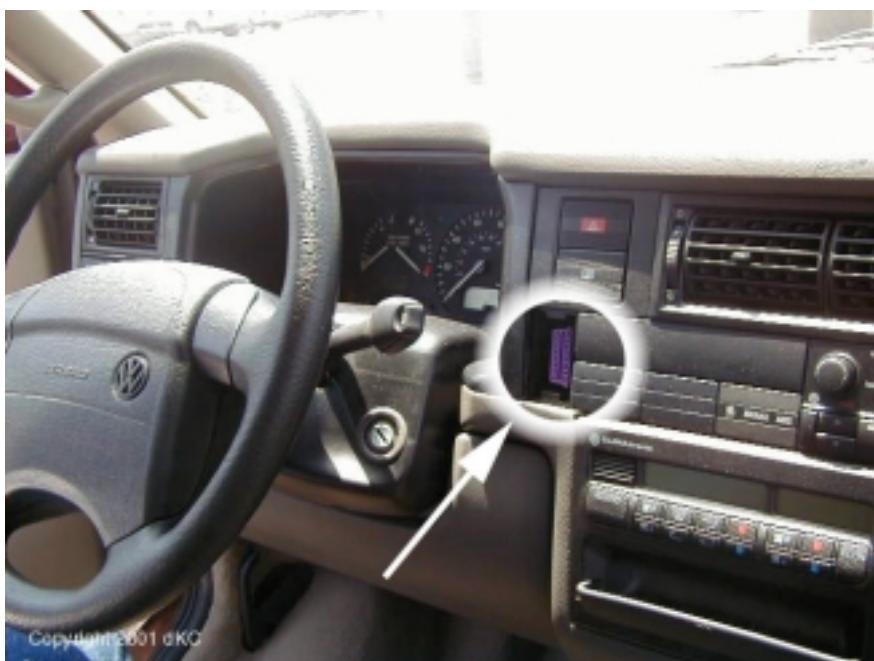
96-98 VW Eurovan – DIFFICULT – on dash, right side of steering wheel, behind wiper lever, behind large “L” shaped plastic piece of dash, edge of cluster near A/C vents.

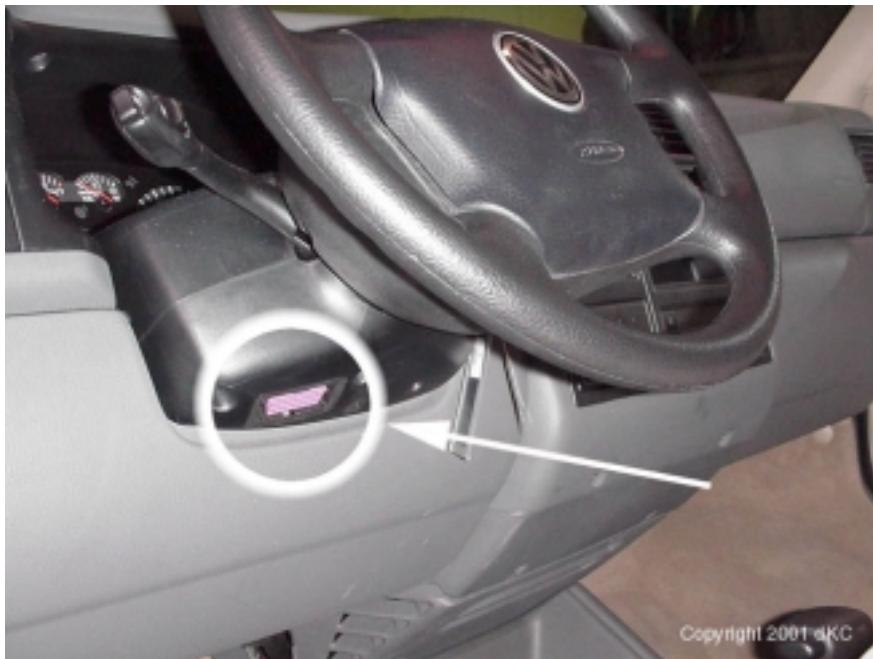
99-2002 VW Eurovan – On dash, left side of steering wheel

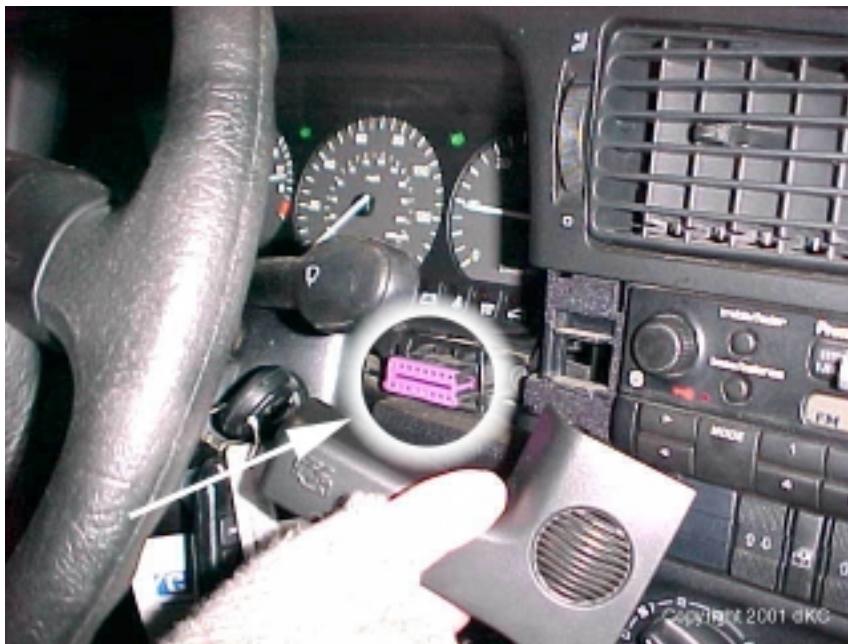
96,97VW Passat – **DIFFICULT** – on dash, right side of steering wheel, behind wiper lever, behind large “L” shaped plastic piece of dash, edge of cluster near A/C vents.

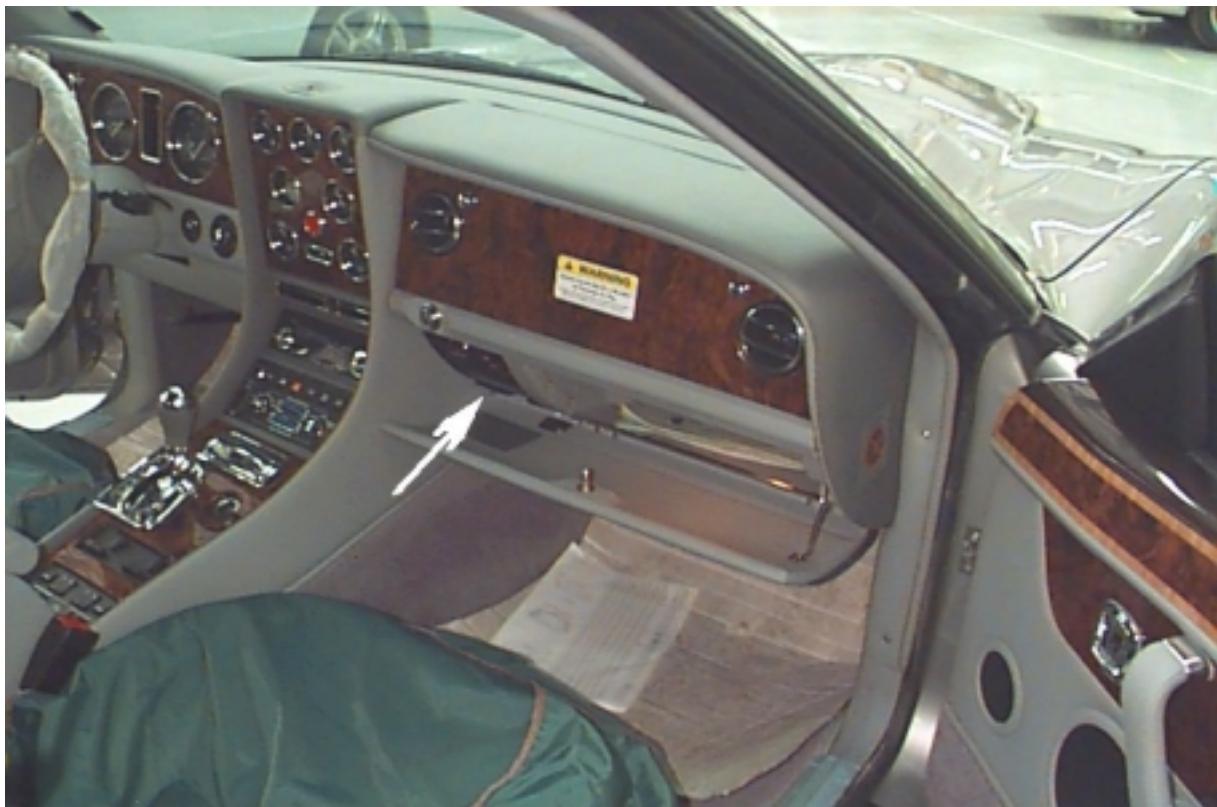
96-2000 ROLLS-ROYCE – All models , in glove box compartment
