# Old Colchester Park and Preserve

## Natural Resource Management Plan

Prepared for the  
**Fairfax County Park Authority**

**100% Submission December 15, 2011**

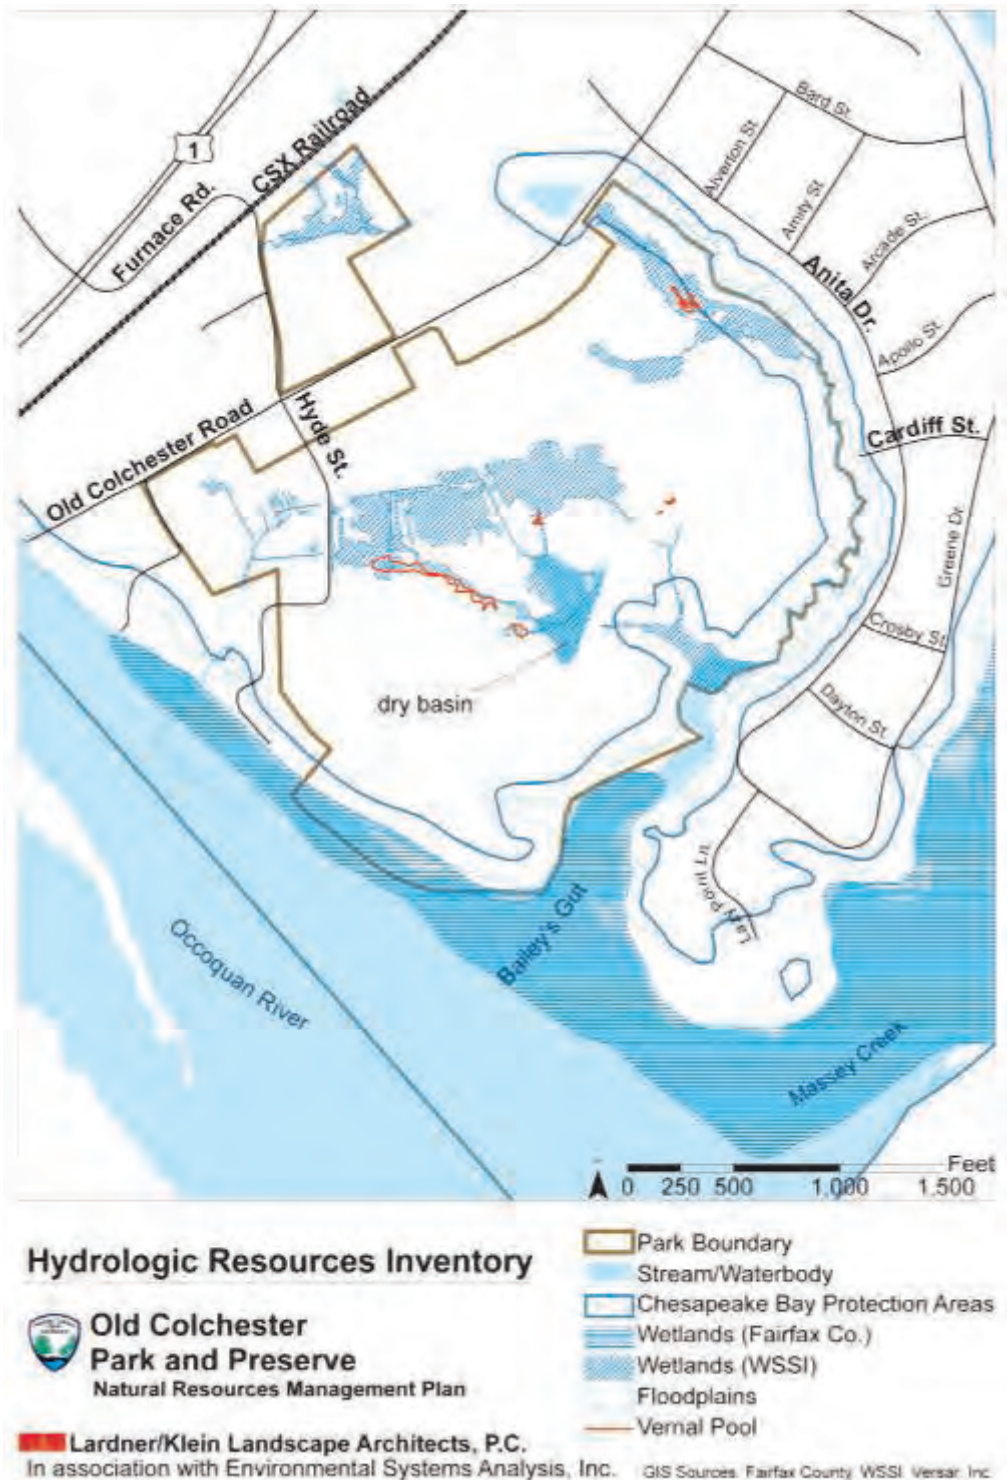
Figure 11: Hydrologic Resources map

Additional evaluation of the park's unnamed stream was performed by Versar in 2011. The stream originates on the northeastern side of the smaller of the two park tracts, northeast of Old Colchester Road. After crossing Old Colchester Road, it separates the park from the adjacent Harbor View subdivision along Anita Drive. The unnamed stream is included in the Lower

and redirect the stream away from their property by placing stone along the streambank to halt the bank erosion. The lower reach of the stream has a meandering channel with a flatter slope and an accessible floodplain, as is more typical of streams in the Coastal Plain.

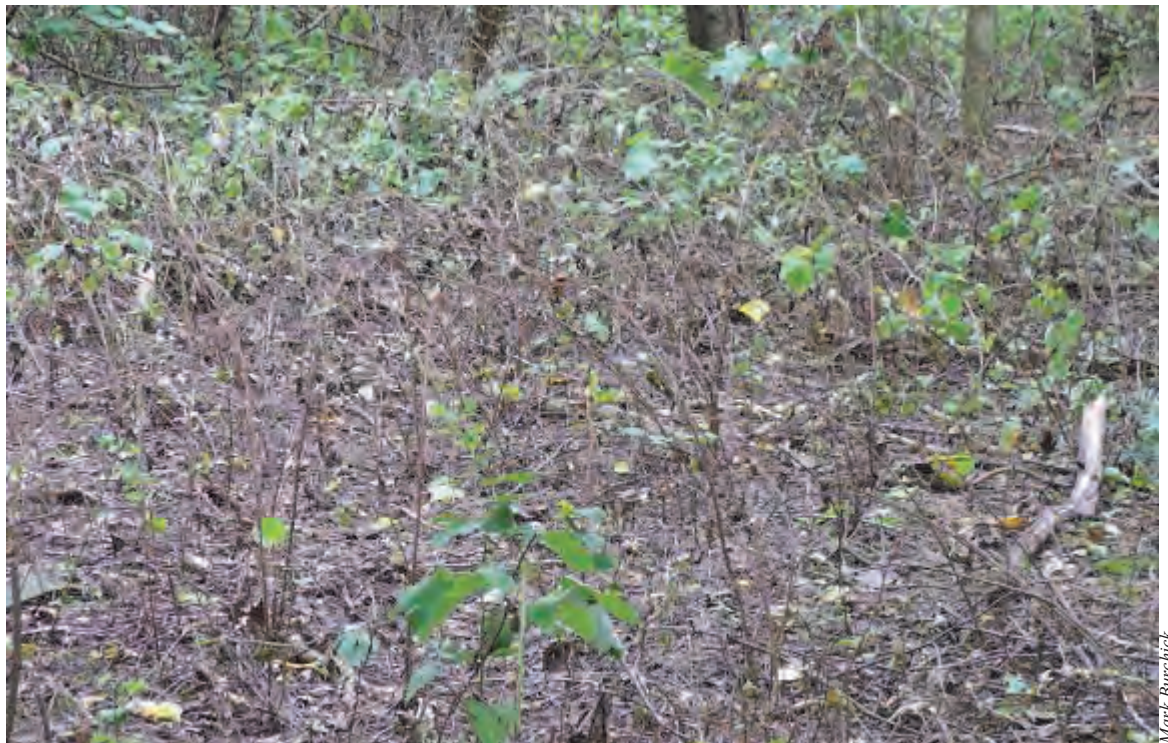
Figure 24: NNIAP Unit P treated for wineberry, a NNI

A maximum of five points can be assigned to each major category, with aggregate scores ranging from 3 to 15. An additional point may be added if the unit was treated for NNIs within the last 12 months, raising the total aggregate score to 16. The higher the aggregate score, the higher the priority to receive treatment for NNIs.

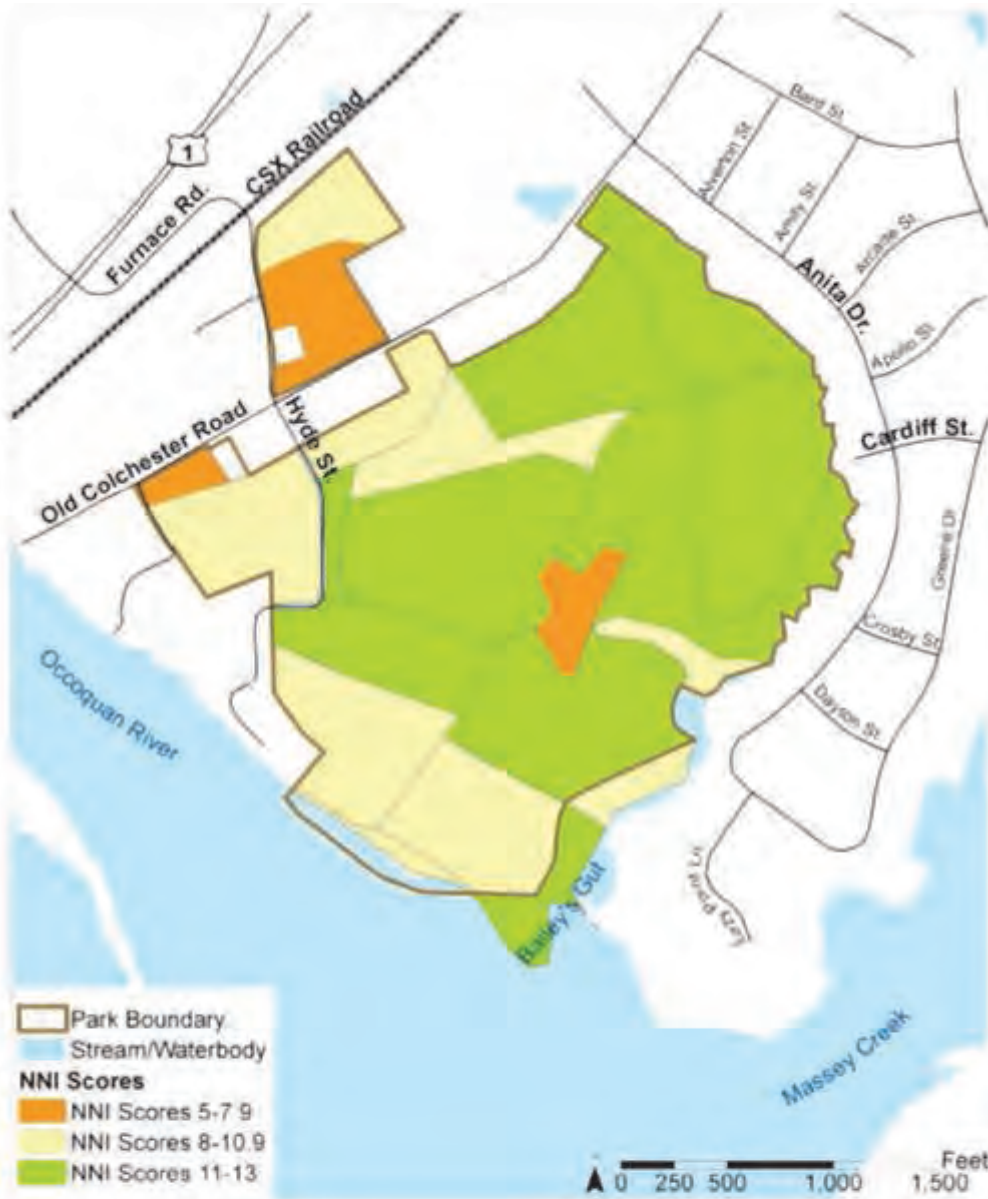
In performing an assessment of NNI species impact at the park, ESA divided the park into twenty-two geographic units. Each unit was examined by two inspectors from ESA. A species list of NNIs found on-site is included in the appendices of ESA’s *Old Colchester Park and Preserve Vegetation Assessment*, dated November 4, 2011. Appendix B of this NRMP contains a species list, but does not distinguish between NNIs and others. Examples of the NNIs found at Old Colchester Park and Preserve include Japanese stilt grass, wineberry, mile-a-minute, Asiatic bittersweet and marsh dewflower.

Using the NNIAP tool, ESA determined that the park has NNI plant site scores ranging from 5-13 (where 3 is the worst possible score and 15 is the best) with the lowest scores due to recent human disturbances. The Park Authority staff have treated wineberry, Japanese stilt-grass, mile-a-minute, multiflora rose (*Rosa multiflora*) and Japanese honeysuckle in the park but outside of the Resource Protection Area (RPA) in 2010 and 2011. Tree-of-heaven (*Ailanthus altissima*) and princess tree (*Paulownia tomentosa*) were also treated in 2011. An additional point was added to 14 of the 22 units to

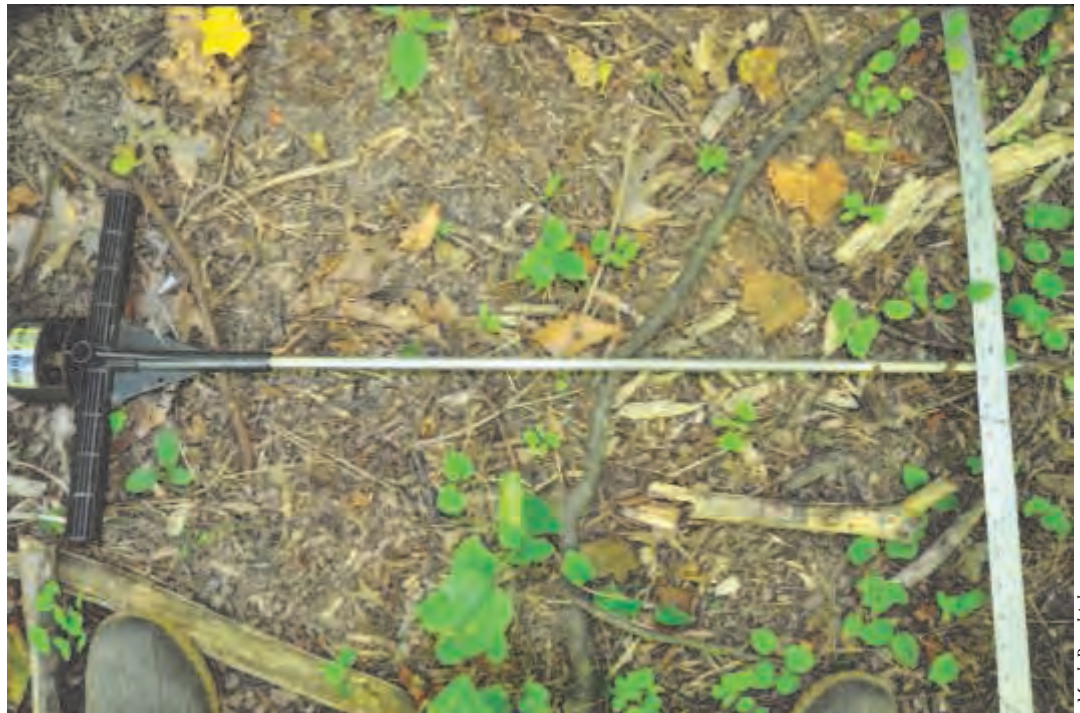
Figure 26: Trampling plot in Vegetation Plot #2 within Vegetation Community Coastal Plain Floodplain Forest

Resistance to trampling has also been shown to be a function of the erectness of plants and physiognomic types (Cole 1995b). Graminoids (grasses) are the most resistant; matted and rosette forbs (herbaceous flowering plants) and woody plants moderately resistant; and erect forbs least resistant. Resilience to trampling (ability to recover once trampling occurs) is a function of

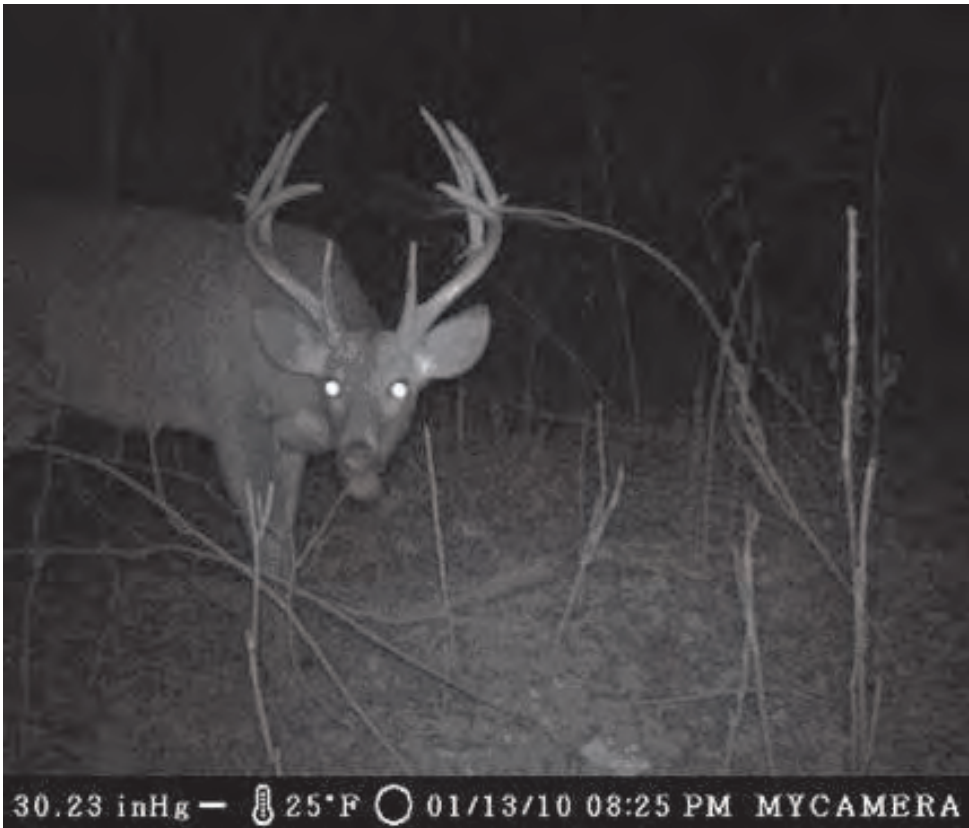
Figure 28: Image captured for the deer population survey, date on photo is incorrect and should indicate 2011

The report indicates that the number of doe occurrences is skewed in the 2011 survey, reflecting an extremely high doe-to-buck ratio recorded at one of the four cameras (Lawler, 2011). Regardless of the camera issues, the current density range of deer per square mile exceeds the measure of fifteen deer per square mile, the established ratio for a sustainable eastern forest deer population.

Deer have impacted the vegetation composition of the upland forest. The direct relationship between excessive deer densities and the prevalence of NNIs cannot be overstated. Beyond the destruction of the native understory by forage, the deer browse is leading to the introduction of NNIs through seed transport and to NNI retention as NNIs are not preferred deer food. The wetlands at the park have been somewhat spared from deer impacts. Deer feel vulnerable when walking in muddy, unstable soils and tend to avoid these areas. Because of this, native vegetation is more robust in the saturated and inundated wetlands.

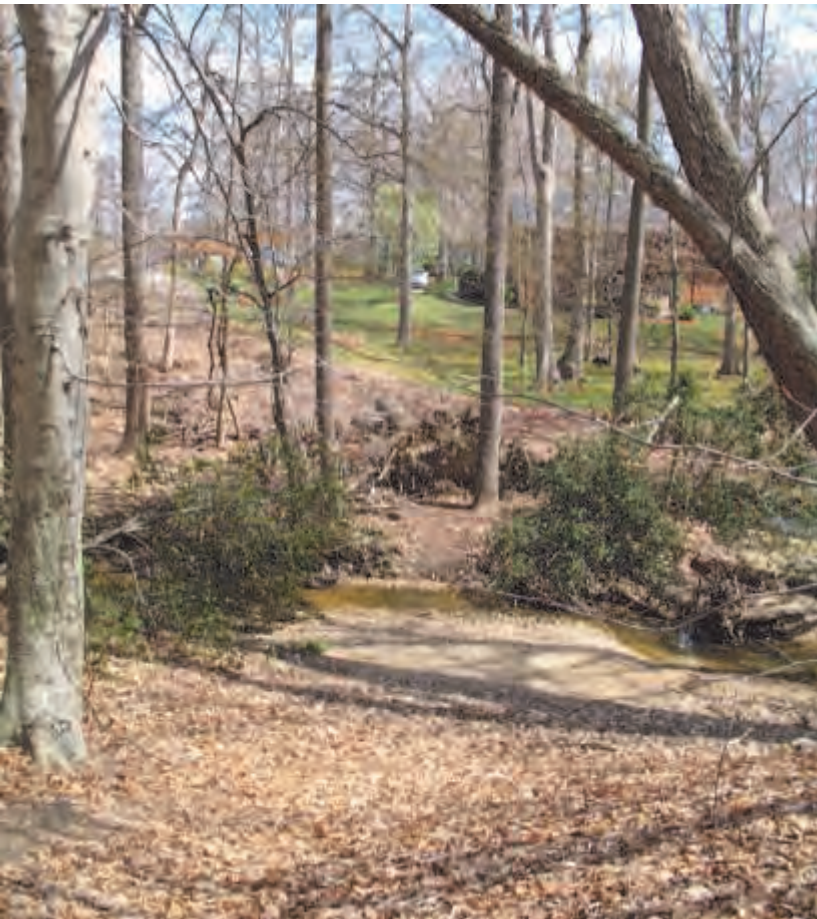
*Figure 32: Unsanctioned access point from adjacent residential neighborhood*

the ground is not de-compacted to mitigate the soil compaction attributable to foot and ATV traffic following removal of existing trails and access points.

The park also displays evidence of illegal and unsanctioned digs for artifacts, a concern given the recent archeological work being done on-site and the press attention given to their work and findings.

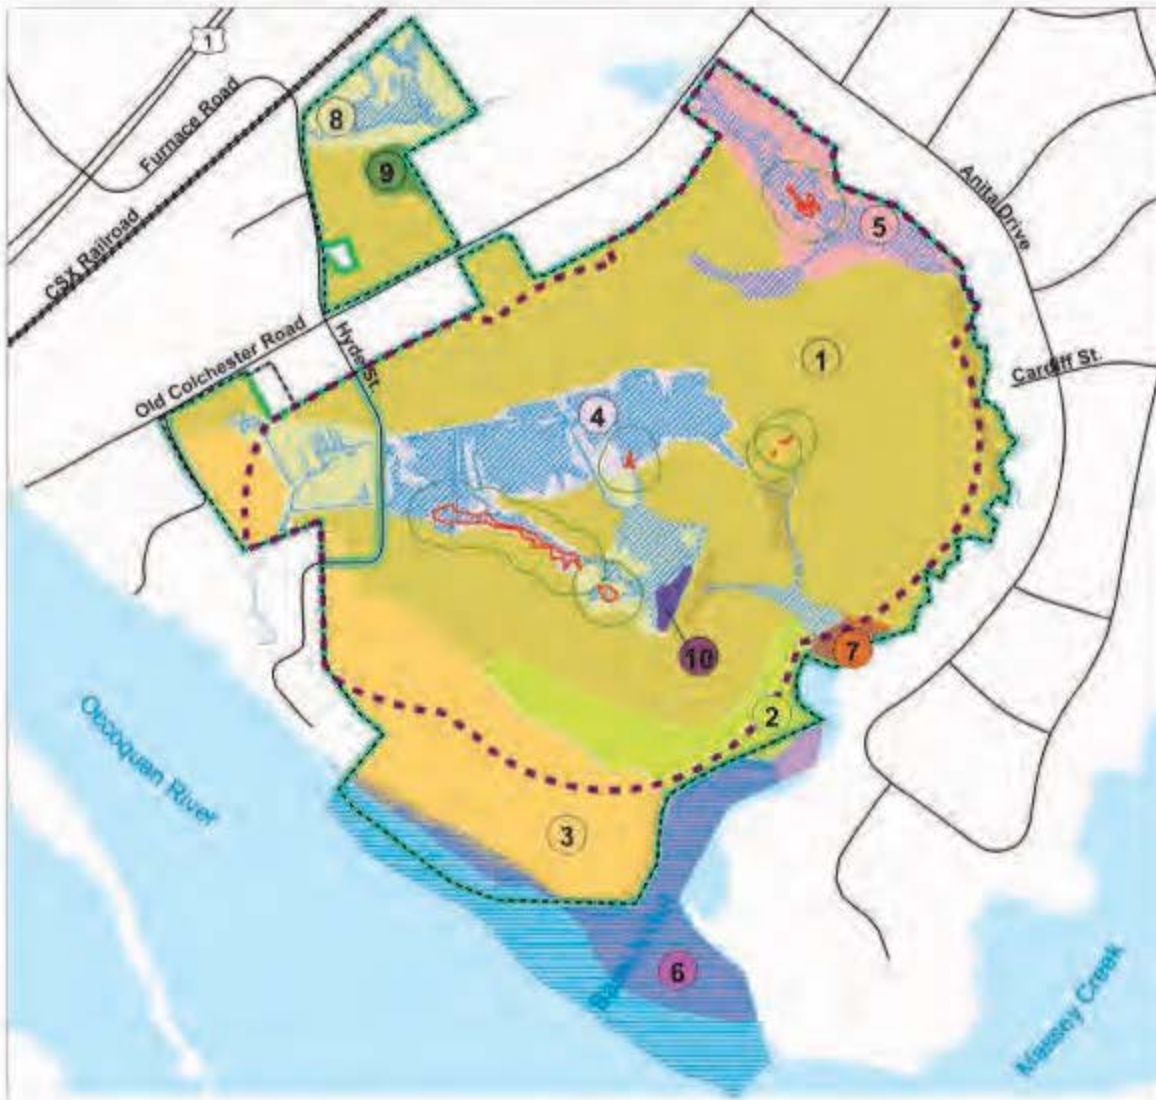
Vegetation Communities Key

Figure 35: Resource Protection Zone: Step 1
