Conservation Plan – Bremore Castle
Plean Caomhantas - Caislean Bri-mor

For
Fingal County Council
Comhairle Contae Fhine Gall

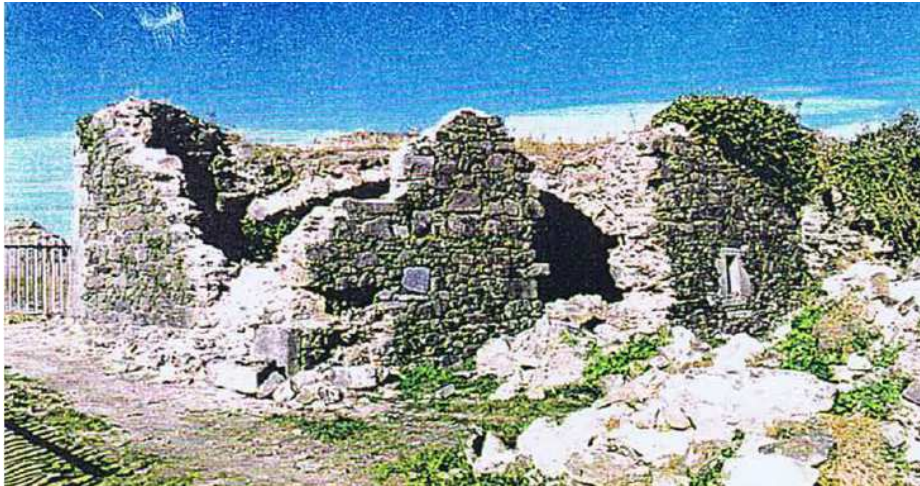
Since 1994, under support of Fingal County Council and the Balbriggan and District Historical Society, and in conjunction with a FAS training initiative, the Castle has undergone the comprehensive reconstruction of what was by the 1980's a single storey ruin within a farmyard (Plate 1). It contains significant original fabric at ground floor level that has been consolidated and repaired.

Plate 1 Bremore ruins (kitchen extension area) 1986.

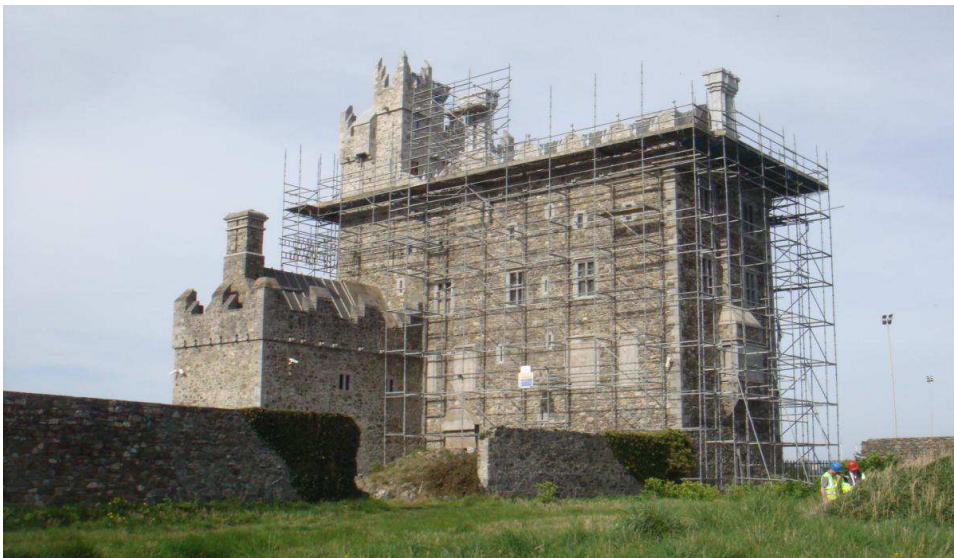
The present castle structure is primarily a late 20th century rebuild (Plate 2).

Plate 2 View towards the north east of the reconstructed Bremore Castle, from within the walled garden

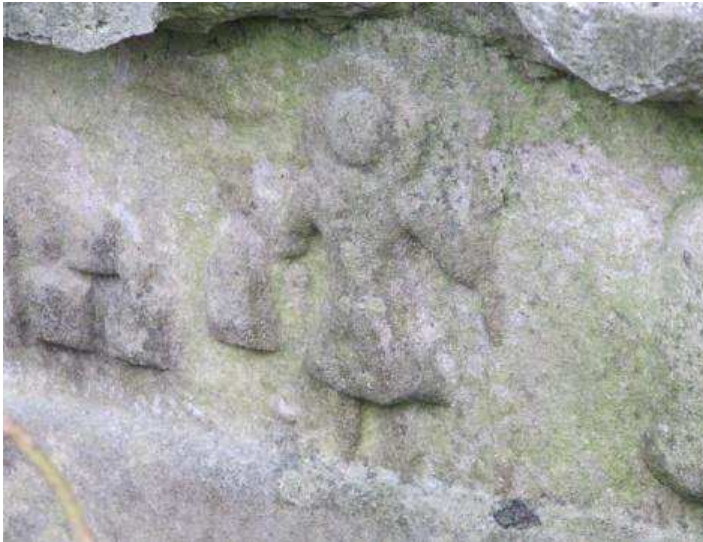
(Joyce, 1906). The association of bee keeping with Bremore survived into the later medieval period, there is a carving on a fireplace lintel of the saint holding a bee skep (Plate 3).

Plate 3 The carved door lintel in St Molaga's Church, dated 1689, amongst the highly decorated piece is a possible representation of St Molaga holding a bee skep and a long staff

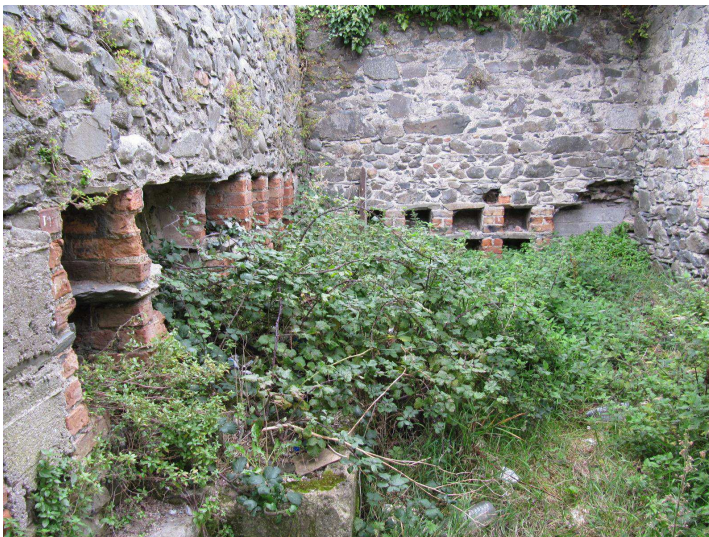
Bee keeping seems to have been carried out at the site until quite recently; there are possible bee boles in the outbuilding at the site (Plate 4). The tradition is still evident in the area, the adjacent school is dedicated to the St Molaga and a bee skep is their official logo.

Plate 4 Possible bee boles in the outbuilding

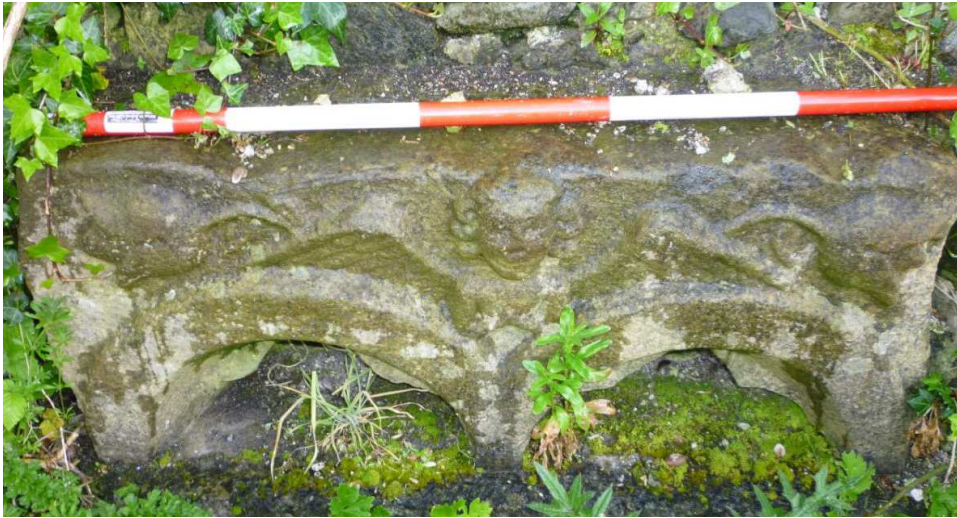
Fragments of decorated seventeenth-century stonework lying inside the church including moulded door lintels and two double-light, highly decorated window heads (Plate 6) bonded into the church wall. A plain lintel also lies on the ground adjacent to the gate piers at the entrance to the graveyard. Many graveslabs and stones are also lying within the graveyard (Plate 7).

Plate 6 Highly ornate ogee headed window with religious symbolism in Bremore Church (2011)

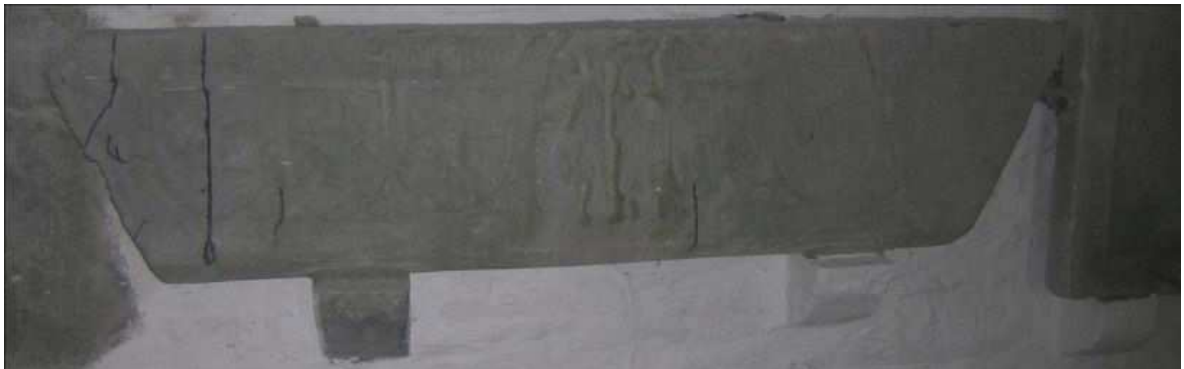
In 1832 D’Alton records a stone in front of the ‘farmhouse’ at Bremore which has ‘*the armorial bearings of the families of Buriford, Howth, and Barnewall*’. He refers to a mantel piece which celebrates the marriage of James Barnewall to Margaret St Lawrence which is now housed in Lusk Church. It comprises a sub-rectangular limestone plaque that is decorated with six-shields bearing arms, at the centre of which is an annunciation scene which commemorates the union (Plate 8). According to Newman Johnson this bridal mantel provides a mid-sixteenth century date (c. 1546) for the vaulted hall-house which is thought to be the earliest standing phase of the castle. While the mantel provides a relative date it could be argued it was inserted into an already existing castle.

Plate 8 Mantel tree piece originally from the castle at Bremore. It celebrates the marriage of James Barnewall to Margaret St Laurence of Howth in the mid 16th century c. 1546.

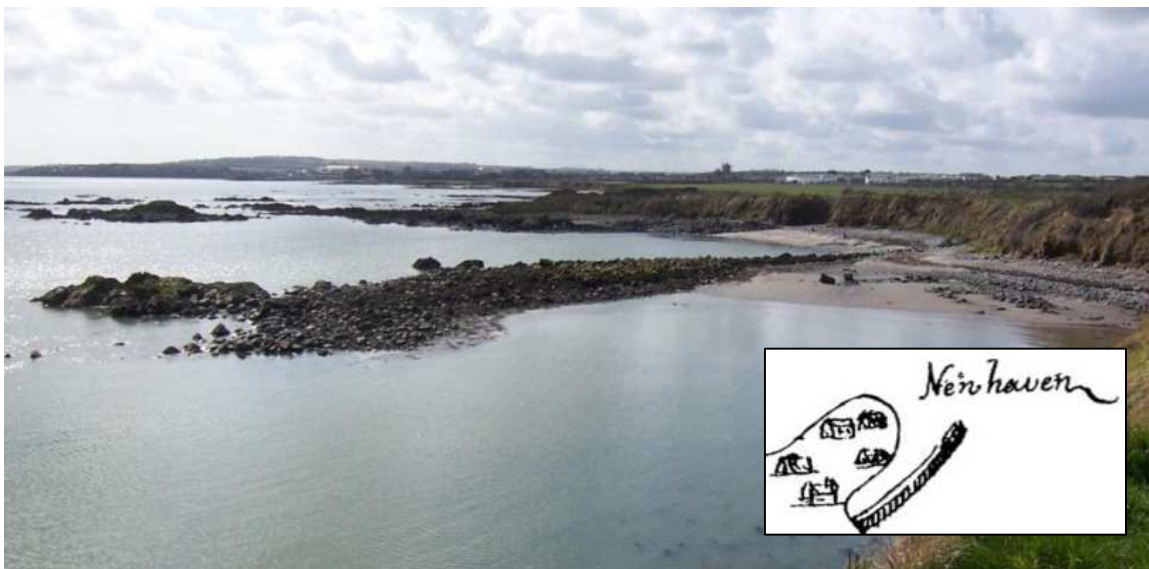
By the period of the Cromwellian wars, Bremore was held by Matthew Barnewall, who was attainted for his adherence to Roman Catholicism. In 1654, Matthew Barnewall, 'Irish Papist', was stated in the Civil Survey to hold at Bremore 'and Newhaven, a fishing towne on ye said land', 300 acres, of which 150 were arable, 140 pasture, and 10 meadow (Simington 1945). 'Breemore' was said to contain 'one burnt castle with a great barne and eight tenements, one orchard & parke with some young ash trees' while at Newhaven there were said to be ten small cottages, both of which, when combined, a jury valued at £110. It describes the settlement at Newhaven 'On the North of the Barony stands a point or North of land (extending itself into the sea) called New Haven it being by the industrie of the inhabitants of the towne which stands; near this point made a secure harbour for boates and is a considerable place for fishing' this settlement is illustrated in the Down survey. Remnants of the harbour still survive today (Plate 10).

Plate 10 View of the remnants of New Haven pier, Bremore castle can be seen in the middle distance. (Inset: Newhaven as represented in Down Survey map 1655)

Bremore is associated with the former village of New Haven; the village is indicated on Rocque’s 1760 map (Fig. 9). Newhaven Harbour¹² is located on the southern side of Bremore Head and runs in a north-northeast direction almost parallel to the headland. It comprises a rubble stone pier that survives relatively intact. It is approximately 62m in length and varies from 8- 10m in width (Brady et al 2007). It is sited in a sheltered location in an enclave of high sea cliffs and a level sandy beach which would have facilitated the unloading of cargo

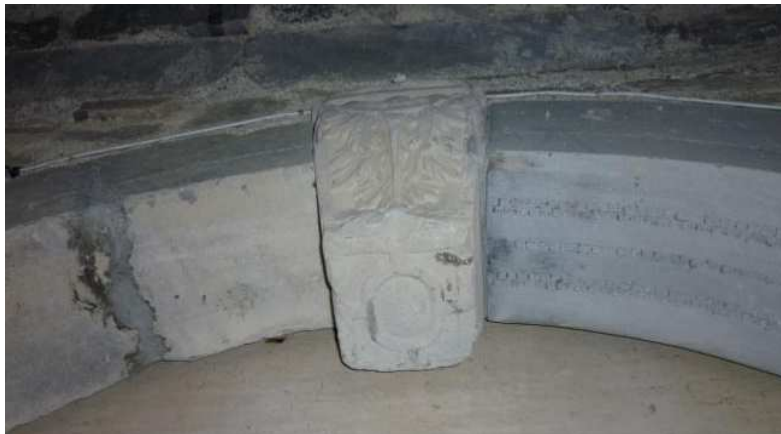
Cooper's illustration and historical evidence suggests that the kitchen extension and the erection of an alternative entrance in the western facade are likely to have been carried out in the late 16th and early 17th century. This date range is further confirmed by the discovery in 1996, of four finely carved stones belonging to an architrave found within rubble that blocked a window embrasure in eastern facade of the castle, this architrave appears to be the one that is illustrated by Cooper. The fragments comprised a carved calp limestone keystone and upper voussoir which was carved out of one stone, two moulded pilaster capitals and the inner three quarters of a capital. The decorative detail has dateable comparables to the end of the 16th century (Plate 12) (Newman Johnson 2007).

Plate 12 Architrave now inserted into the internal porch at the principal seventeenth century entrance into the monument

Based on the evidence outlined it has been suggested that this door was inserted into the castle at the same time that the original entrance at the northern end of the western facade was incorporated into the kitchen extension, that is somewhere between the late 16th or early 17th century (Newman Johnson 2007). The pieces have been incorporated into the inner porch of the castle to preserve them from being exposed to the elements. The discovery of this architecturally significant fragment is well reported on, however, there are many other reused fragments within the reconstructed structure for which there is no written record of its find spot or their new location e.g. the many door and window jambs are reused in the reconstruction.

During the recent works an Elizabethan doorway was uncovered hidden behind facing stonework on the east façade, this has been discussed previously, it been reinstated in the west wall of the castle under the guidance of Newman-Johnston (image shown previously, Plate 12).

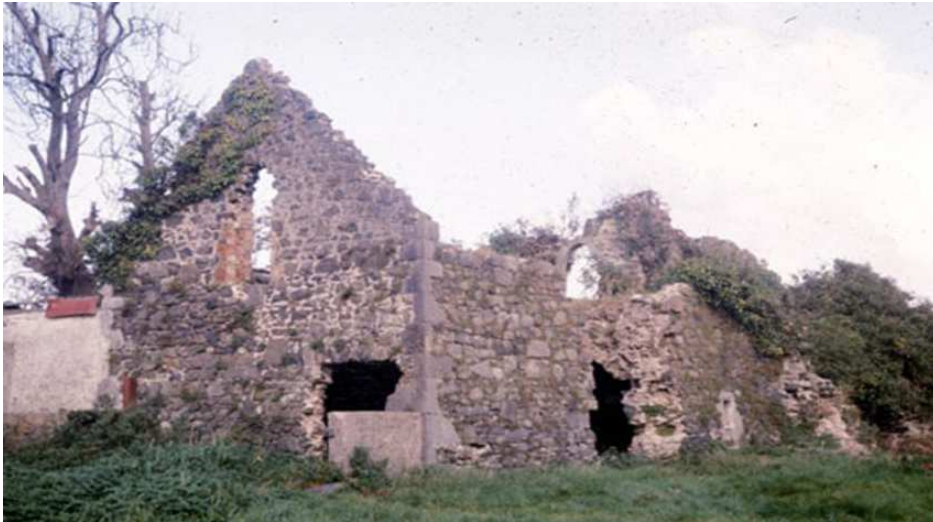
Plate 13 The kitchen extension in 1985 (after Healy) showing a complete gable end with a narrow opening in it with brick repair. There is a pointed Gothic doorway on the first floor of this extension which would have lead to the head of the stairs in the main hall-house structure, for which there was evidence of a stairwell.

castle has undergone the comprehensive reconstruction of what was by the 1980's a single storey ruin (Plates 13 and 14).

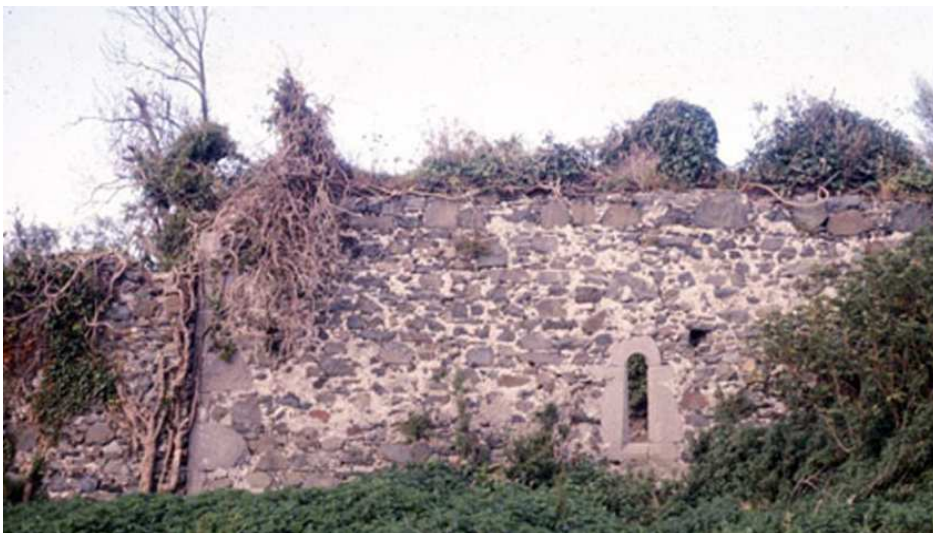
Plate 14 The south-western wall of the hall-house, centrally placed is a round headed loop with a tapering external chamfer and inward splay, this is typical sixteenth century type (after Healy 1985)

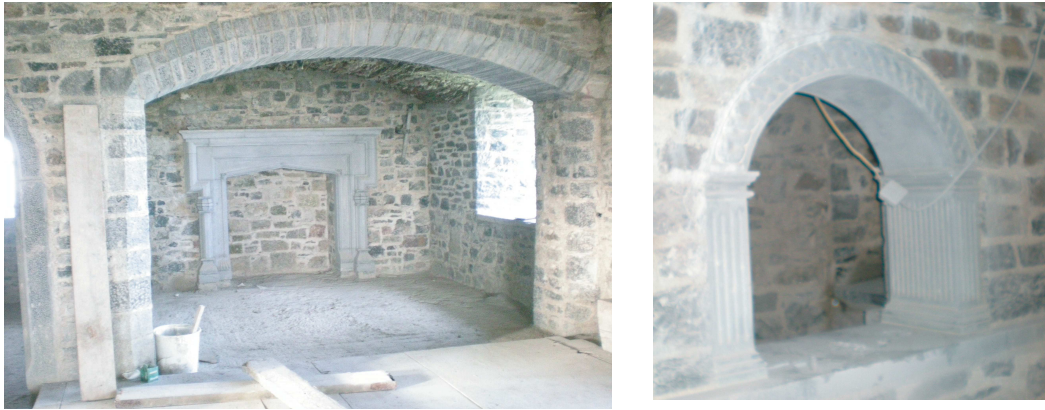
FAS training initiative, overseen by Frank Whelan and stonemasons Richard Perry and Per Steppe, who designed and made some of the fireplaces in the castle ¹¹ (Plate 15).

Plate 15 New fireplace and example of new decorated architectural detailing

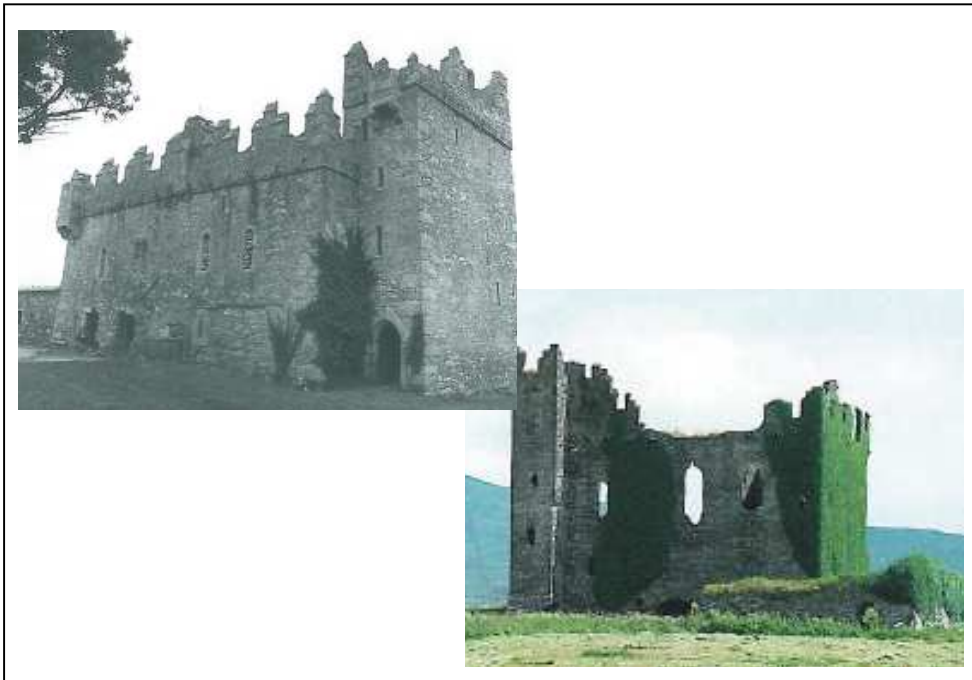
Plate 19 Hall houses in Coolhull, Co Wexford and Ballaycarbery, Co Kerry (After Sweetman.)

Present knowledge would indicate that the hall-house in Ireland originated in the west but developed towards the tower house tradition and form in the east which are later examples, having vaults over the ground floor, angle towers and machicolations in common with tower houses (Sweetman 1999 89-104; Mc Neill 1997, 148-54). They were essentially a domestic residence, which also had strong military capabilities. Their defining characteristics can be summarized as a two-storied rectangular plan, with a hall or living area at first floor level, with larger windows. They generally had a first floor entrance which was accessed via a wooden external stair or super structure, but there are exceptions to this where the entrance was via the ground floor. The ground floor was defensive having narrow slit-opes, a base batter and large wicker centered vaults to carry the hall above (Plate 19).

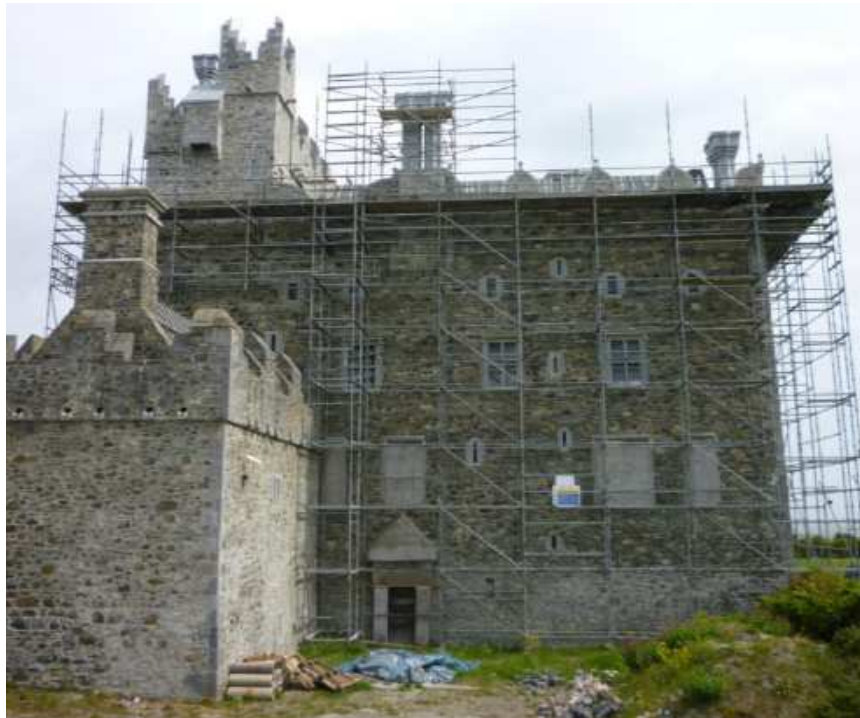
Plate 20 Bremore Castle as reconstructed

Cooper's sketch has been used as an aide in the reconstruction of the castle (Plate 20), albeit with embellishments. The reconstruction is not completely faithful to this drawing as many additional details have been inserted such as the battlemented roof on the kitchen wing and the gable chimney to the kitchen. The height of the eaves appears higher than in the sketch

Bremore has been rebuilt to an idealised version of a fortified house based mainly on the sketch of the western view of the castle made by Austin Cooper in 1783 (Fig. 5).

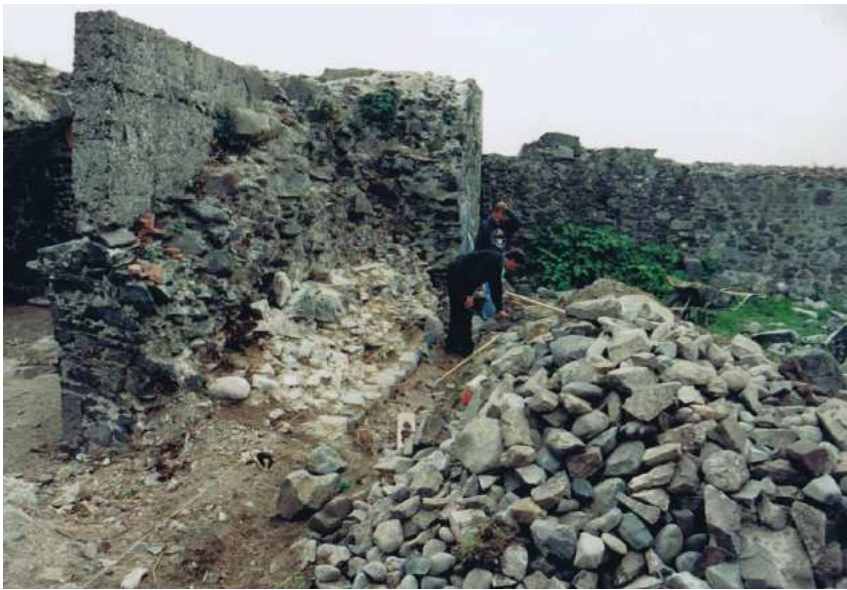
Plate 21 View looking south along the southwestern wall, indicating what little had survived of this elevation. At this location the wall had been broken through in antiquity, a new doorway and porch has been constructed and a new stone spiral stair well

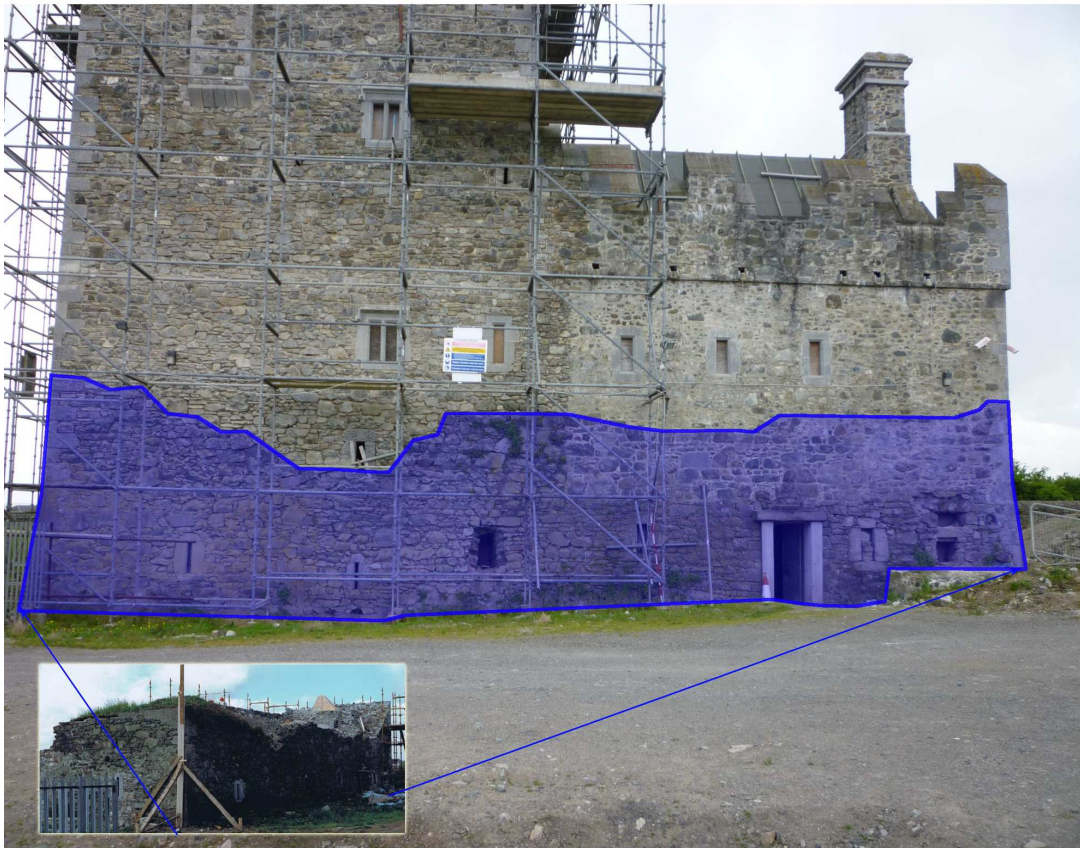
Plate 22 The northern elevation

Using early site photographs from a variety of angles, and a visual archaeological inspection of the site it was possible to identify those sections of the castle that belonged to the original ruin, these are illustrated in Plates 22 to 25 (highlighted in blue) with the original working shots of both the castle in ruin and under construction (Plates 22–25).

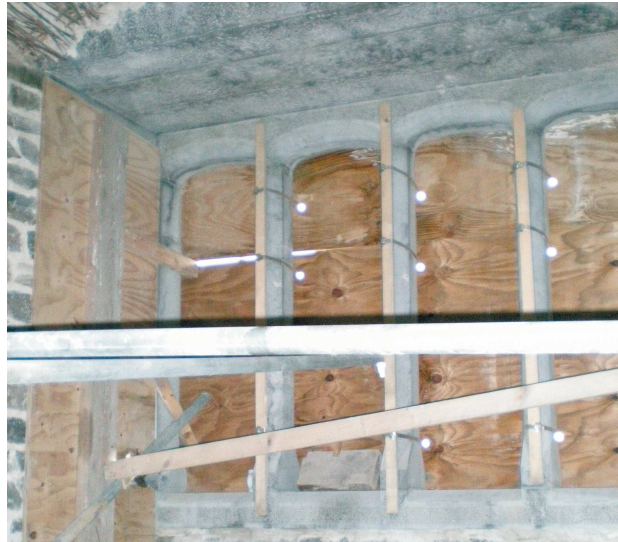
Plate 26 Third Floor view of oriel window in the south gable

There is an oriel projection at first floor on the south façade and two oriel projections (Plate 26) at third floor on the east facade.

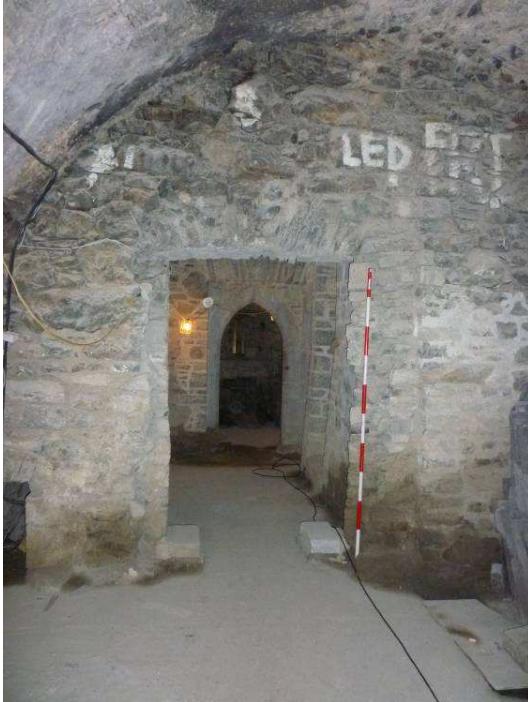
Plate 27 View from the Kitchen Wing through to the vestibule and into the vaulted chamber, as reconstructed

Accommodation is on four floors plus a small 5th floor over the north end of the tower, the lowest floor being a stone-vaulted basement of which a substantial part is original fabric (Fig. 27 and 28). Above that is the hall, the principal room of the building as denoted by the large oriel projection on the south elevation.

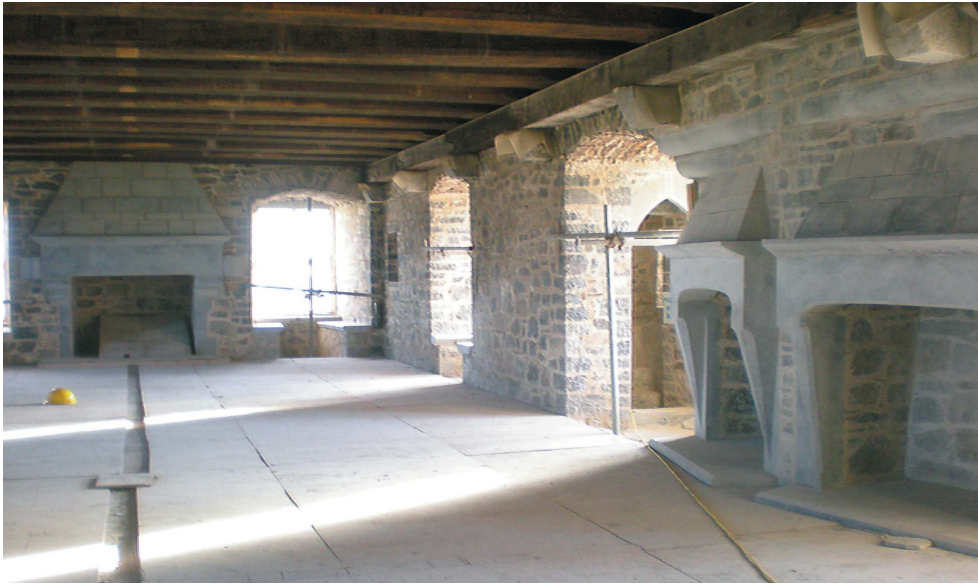
Plate 29 The second floor, main area as reconstructed, view to south, note three fireplaces

Above the hall are two further floors of living/sleeping accommodation. At the north end of the tower there are two stone-vaulted chambers and a stone spiral stair and these are repeated on all floors (except on the fourth floor where the two chambers are joined to form one larger chamber) while the stone spiral stairs at the nodal point where the kitchen block is connected to the main block continues through to provide access to the wall-walk at roof level. On the east wall a new mural stairs has been included in the reconstruction for the purpose of providing a second means of access/egress.

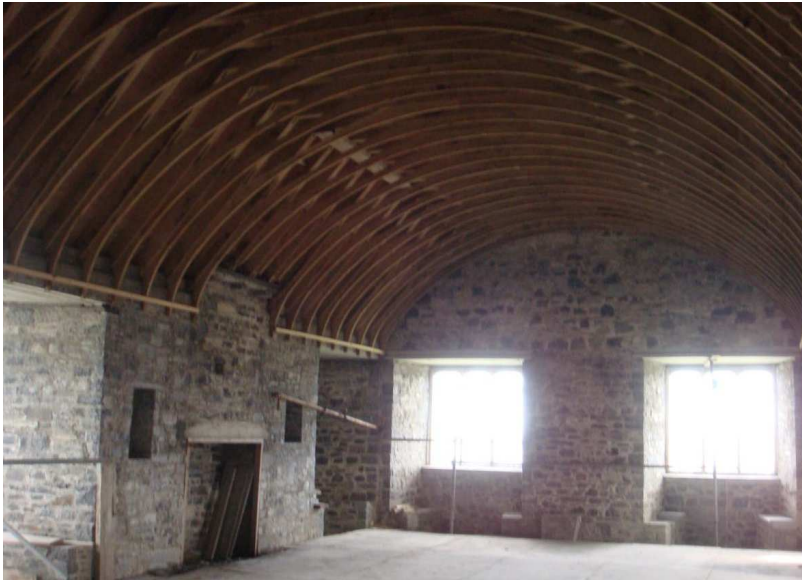
Plate 30 Third floor as reconstructed, note the curved roof

The new timber floors as reconstructed are based on examples seen at Clara in Co Offaly while the roof structure to the top floor is a curved form. New doors have been incorporated in the works using boarded construction with large iron decorative strap hinges.

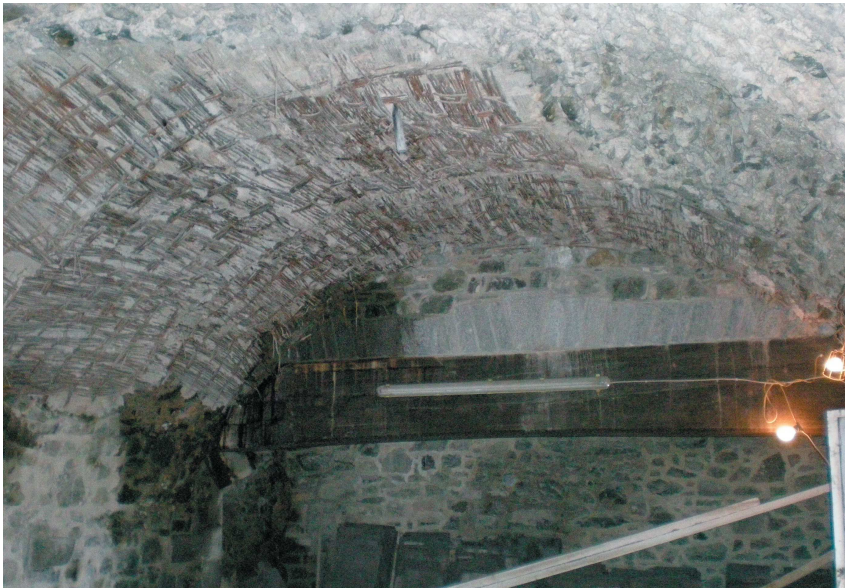
Plate 31 View of reconstructed stone vaulted ground floor with wicker centring and timber lintel to open range fireplace in background

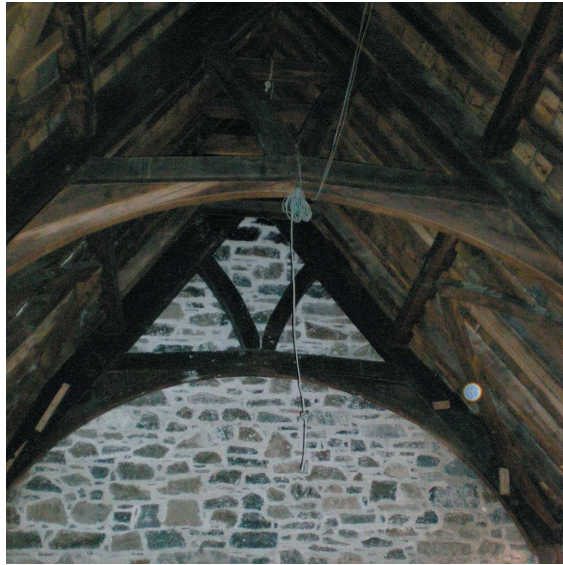
Plate 32 View of reconstructed timber roof to kitchen wing extension

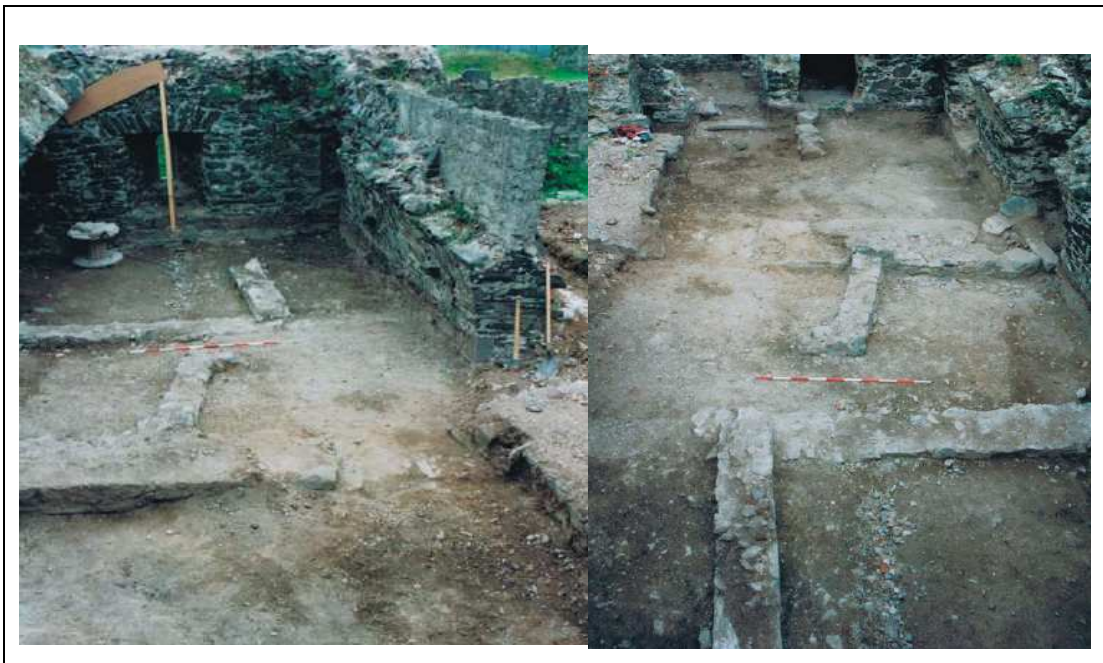
Plate 33 Mid excavation photographs showing Main Hall viewed towards the southeast end, showing its later subdivision. The remnants of the curving stone vaulted roof can be seen and a mid-excavation of the Main Hall viewed towards the northwest end showing its later subdivision (site photographs Swan, mid-1990's, precise date unknown)

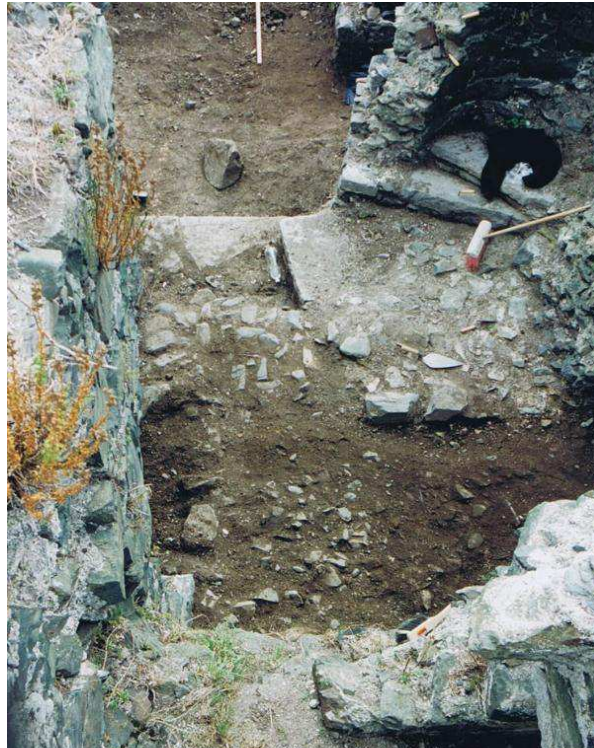
Plate 34 Swan excavation photo, (mid-1990's, precise date unknown), showing view to the Vestibule on ground floor and the first two steps of newel stairs

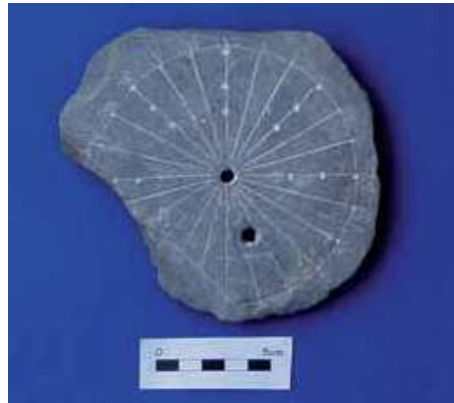
Plate 35 The mass dial discovered during excavations to the north of Fingal (O'Carroll, 2009)

heap associated with the earthmoving works for the development of the site. A horizontal sundial (mass dial), a rare find, was recovered from one of the cisterns, its date is uncertain and could range anywhere between the 15th and 17th centuries (Plate 35). It is thought to have come from the manorial chapel (O' Carroll, 2009) i.e. St Molaga's Church.

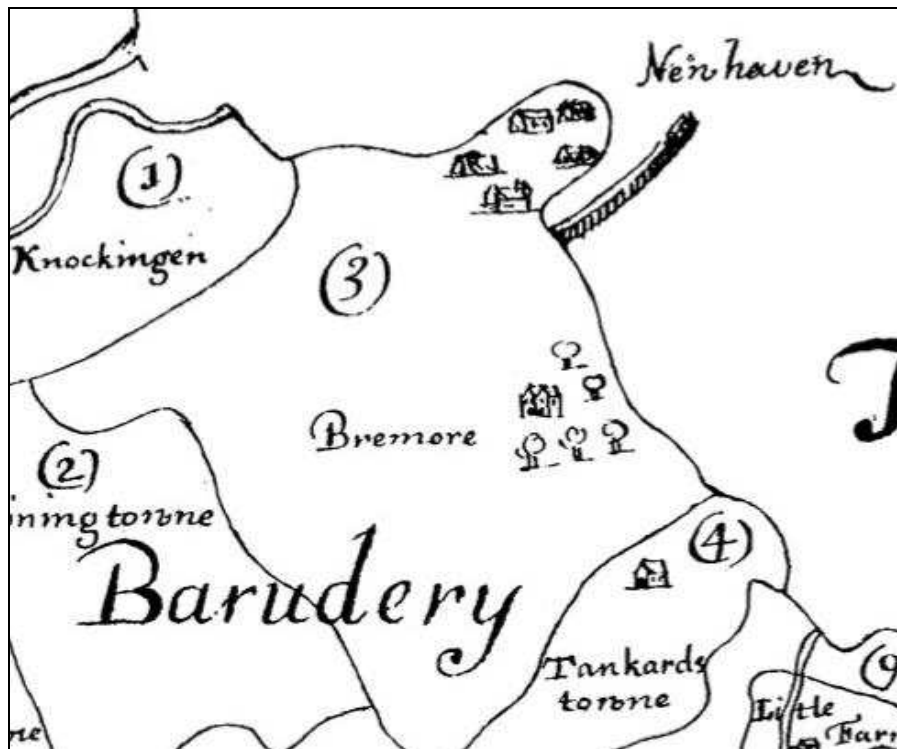
Figure 8 Down Survey Map of 1655

The earliest historical map showing Bremore Castle is the Down Survey Map of 1655 (Fig. 8). Although there is a lack of reliable detail it portrays the castle as an imposing edifice with high gables surrounded by trees. During this period it is described in the Civil Survey (1654-6) as a burnt castle with a great barn, eight tenements, one orchard and a park. The survey also shows Newhaven with five structures on Bremore Head and a large pier, this settlement is referred to in the Civil Survey as a fishing settlement. No upstanding features of the village survive today, however remnants of its long pier still endure.

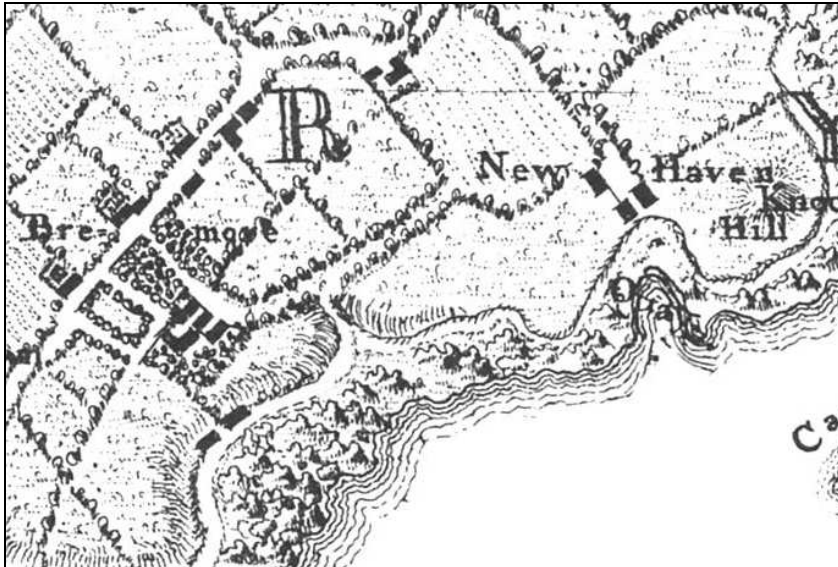
Figure 9 John Rocque, An Actual Survey of the County of Dublin, 1760

Rocque's Map of 1760 (Fig. 9), is the earliest map that shows field divisions and property plots. There appears to be three access roads from the Drogheda Road into Bremore Castle lands. One road runs to the north of the castle and continues to the village at Newhaven, the central road leads into the main complex and the most southern one runs to the southeast

corner of the complex. The central road is in a similar alignment and location as the newly constructed entrance off the Drogheda Road. A 'Quay' is indicated at New Haven at an inlet.

It is difficult to identify which of the structures depicted is the castle, there is an L-shaped structure but its return is at the southern end of the structure rather than at the northern end which is to be expected. The chapel is not indicated. It shows the site with no apparent enclosed garden or visible walling. The site at this time is segmented and trees and scrub shown occupying the area of ground that roughly corresponds with the site of the castle bawn/walled garden area and St. Molaga's Grave Yard.

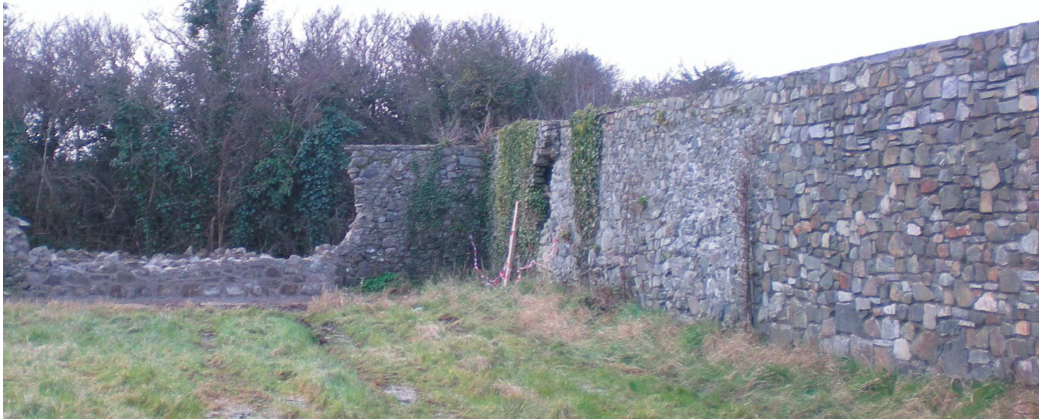
Plate 36 The Garden walls have been partially reconstructed

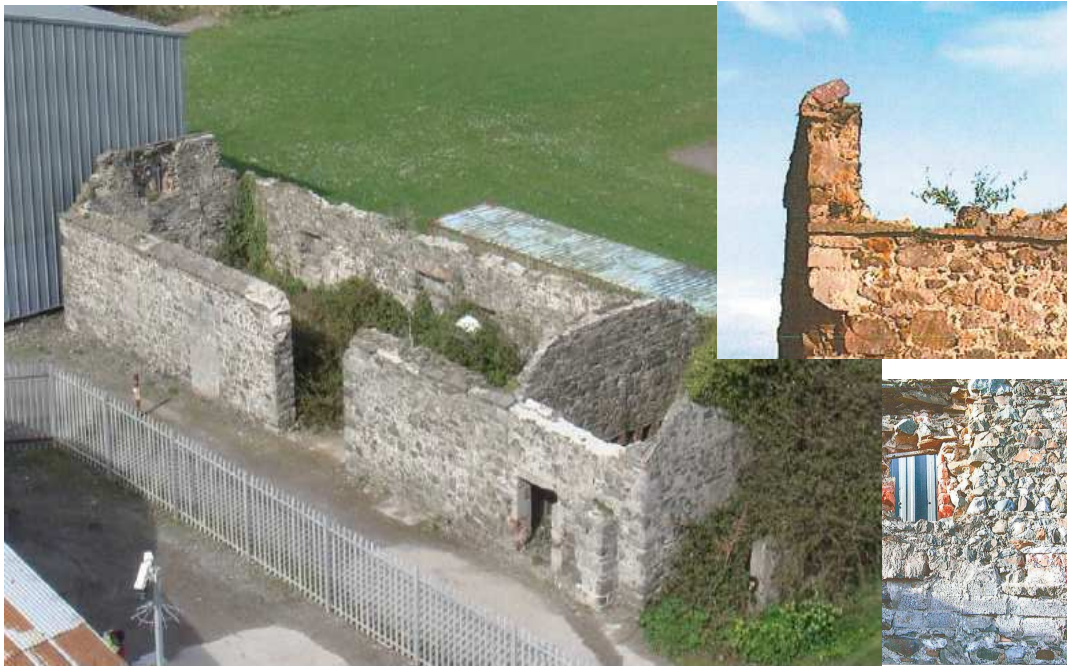
Plate 37 Aerial view of the outbuilding, view of the the northern gable and damaged window ope

The outbuilding: The condition to the outbuilding is of major concern at present, it is a health and safety hazard, there is a danger of collapse remedial work is urgently required.

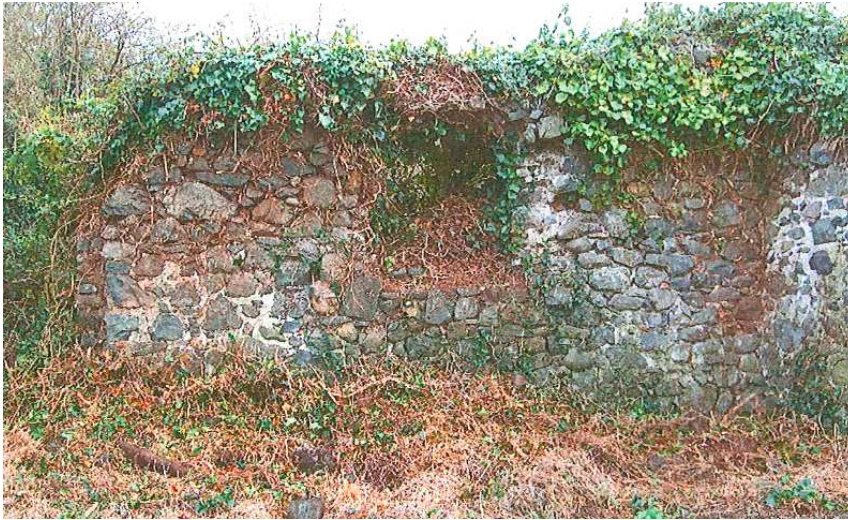
Plate 38 St Molaga's Church - masonry has been engulfed and eroded by vegetation

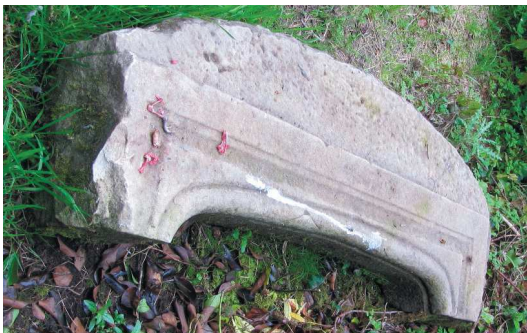
Plate 40 Decorated lintel, lying outside the church walls

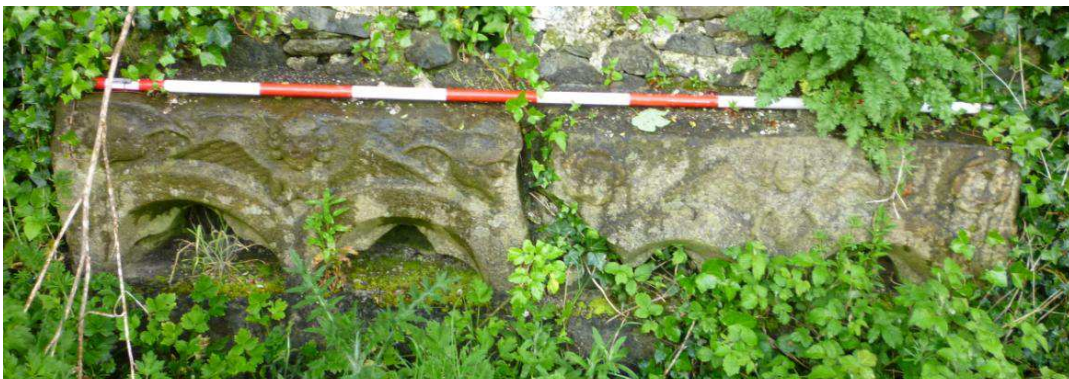
Plate 41 Carved fragment, two ogee headed windows in the graveyard, bonded to the wall

- The remaining superstructure of St Molaga's Church containing parts of walls, stone arches, openings and built-in carved stone fragments and outlying fragments that are covered in vegetation.
- The carved stone door lintel dating 1689 and other stone fragments built into the church walls.
- Carved lintel on the ground outside the entrance to the graveyard (Plate 40)
- Two ogee headed windows (Plate 41)
- The graveyard and headstones.
- Potential subsurface archaeological remains and burials.

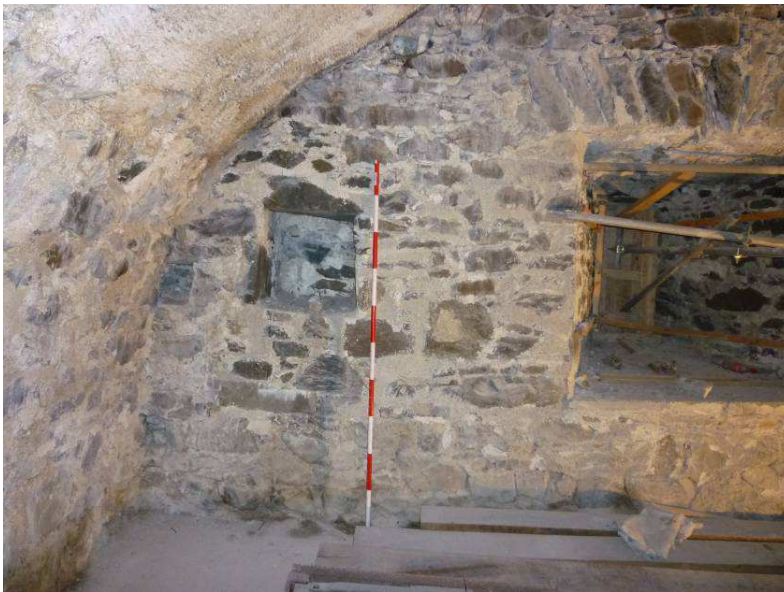
Plate 42 Ambry and deep embrasure in the Main Hall

- The original fabric of the castle on the ground floor. The plan form of a hall-house, the remnants of original wall fabric e.g. corner quoins with punched dressing, deep embrasures, ambries, remnants of the original stone vaulted floor, and the medieval loops remain (Plates 42 and 43)
- The stone vaults on ground floor.
- The fireplace in the kitchen.
- The stone door-case fragments now incorporated in the new door-case on the west façade.
- The stone fragments of window framing built into the castle walls.
- The stone boundary walls to the west of the castle.
- The walled garden.

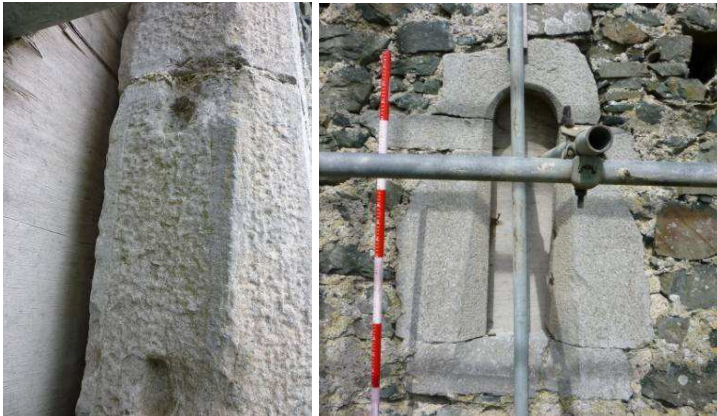
Plate 43 Original window detail. The original round headed loop window (at the southern elevation) has splayed jambs flared toward the base. Some of the new openings replicate this style. To the upper right of the loop is a possible putlog hole.

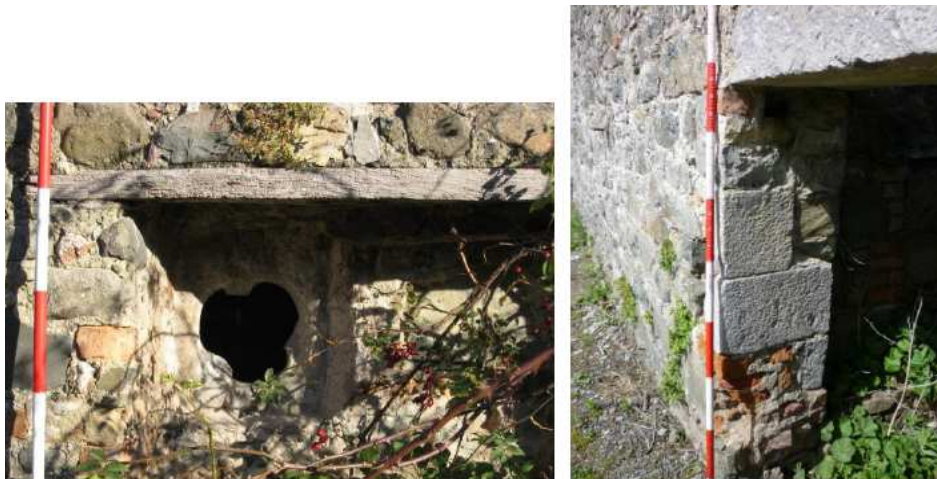
Plate 44 Trefoil and dressed limestone reused in the outbuilding

- The sandstone trefoil window inserted into the wall of the outbuilding (Plate 44)
- The nesting boxes or bee boles built into the outbuilding walls (Plate 4 above).

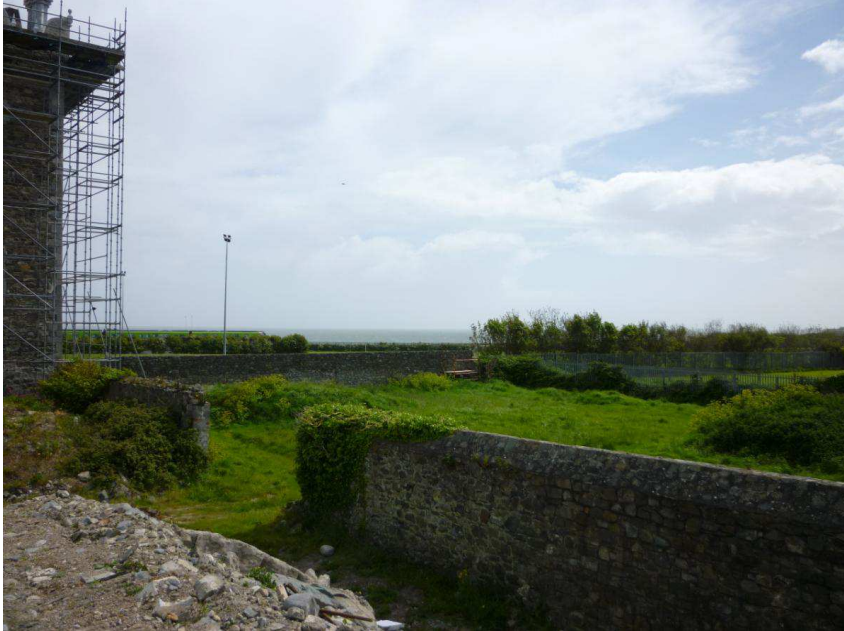
Plate 48 entrance into the walled garden or 'bawn' from the castle court yard

The gap leading directly from the castle court yard into the walled garden is a wide gateway of suitable width for horse drawn carts.

This entrance in recent decades has been considerably altered and widened to facilitate farming activities in the walled garden. Closer investigation of this entrance and wall after removal of vegetation may reveal evidence of an elliptical archway.

The walled garden or 'bawn' of Bremore (Plate 48), when compared to other castle sites, is similar in its close proximity to the dwelling, its siting to the south of the castle which protects it and its orientation on a north-west by south-east axis as the most favoured position for shelter. Its size and scale is also comparable to other bawn sites.

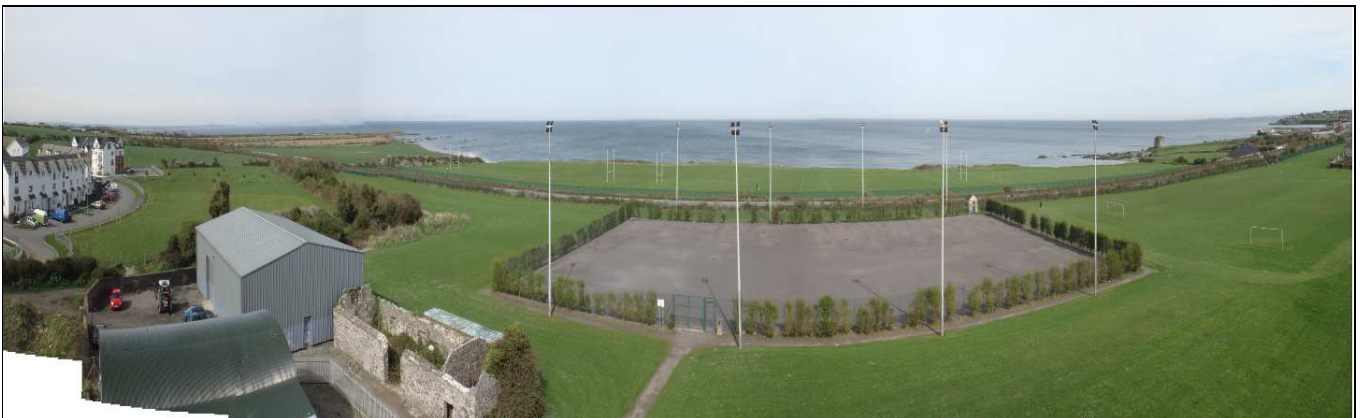
Plate 49 Panoramic view towards the coast from the top of the Castle. From right to left it shows Bremore Head, Cardy Rocks Development, the outbuildings and modern sheds within the complex, the railway line, playing pitches, the Martello Tower and Balbriggan Harbour to Isaac's Bower

Bremore Castle enjoys the most impressive views over the north Fingal coastline up to County Meath and south to Balbriggan Harbour (Plate 49). The existing modern agricultural buildings within the site detract from the setting (though this is easily remedied once work is completed).
