Conservation Plan – Bremore Castle
Plean Caomhantas - Caislean Bri-mor

For
Fingal County Council
Comhairle Contae Fhine Gall

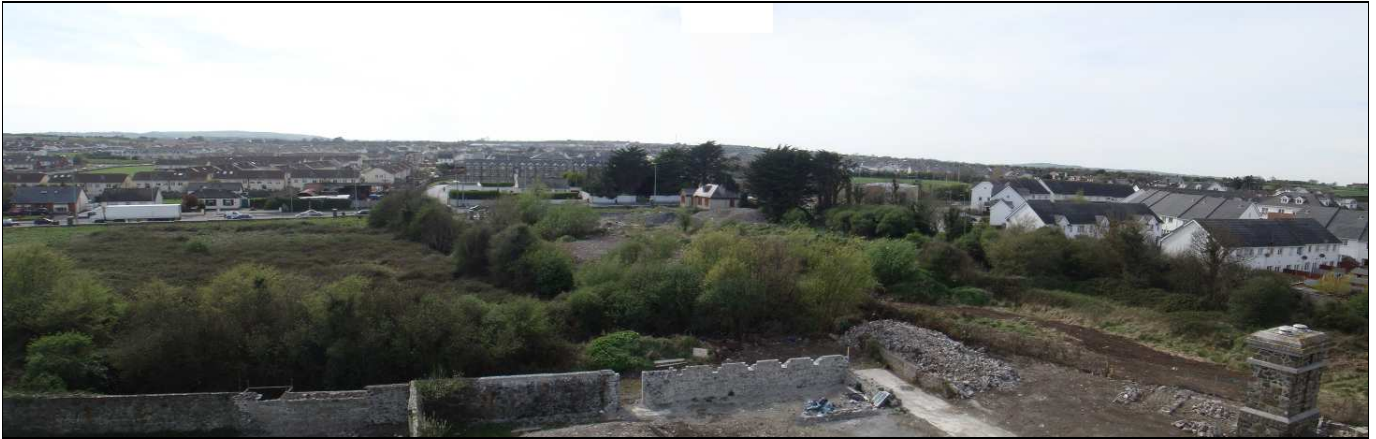
Plate 50 Panoramic views towards the Drogheda Road from the top of the Castle. From right to left it shows the fields to the west of the castle, mature tree lined boundaries. 'Bell House' at the northern entrance, the northern laneway is defined by a linear row of trees adjacent to the modern Cardy Rocks development. In the foreground are the western boundary walls of the castle/walled garden.

The castle is visible from the Drogheda Road as an impressive and imposing edifice however the wild nature of the fields in the background and rubble mounds detract from this view (Plate 50). The mature tree lined boundaries contribute to the setting.

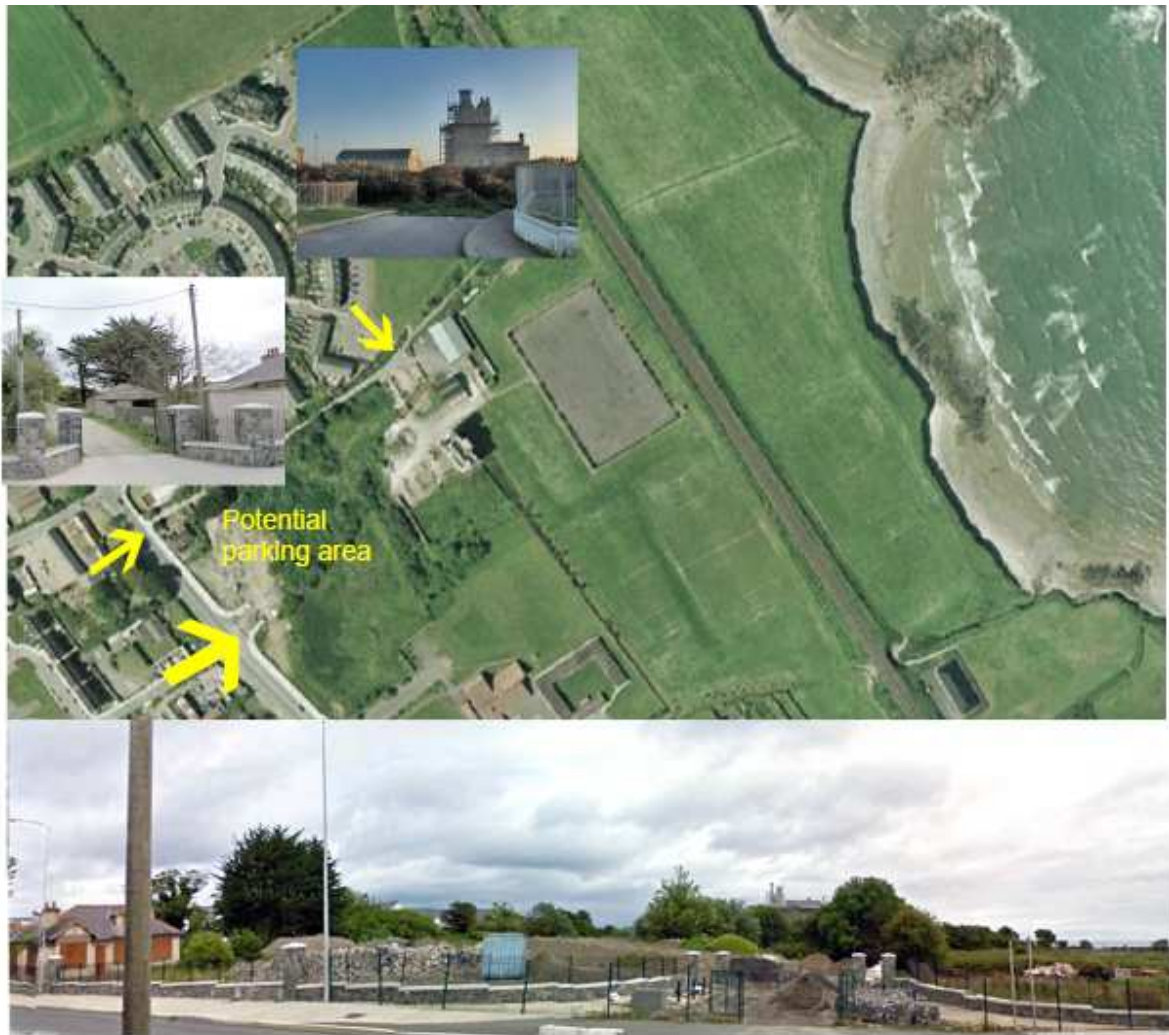
Plate 51 Current entry points to Bremore Castle. The two eastern fields provide considerable opportunity for parking and ancillary uses. Inserts: the entrance provision at Cardy Rocks (top right) this is not an opening provided by the Co Council, existing entrance off the Drogheda Road (centre right), panoramic view of the the new vehicular entrance from the Drogheda Road (foreground) including the derelict Bells Cottage (far right).

Access to Bremore is currently via a narrow single carriage laneway to the north of the site from the Drogheda Road (Plate 51). An ample vehicular gateway has been constructed off the Drogheda road; this forms an excellent main entrance to Bremore. This approach is in a similar position as an original entrance shown on Rocque's 1760 map and its location frames the approach to the castle. Using these access points a number of circulation routes can be designed in association with the development of the regional park. They can also control access into the park for events. The provision of a road entrance to the castle has also been made within the Cardy Rocks development, this is currently blocked by a hedgerow, however this is not associated with the Bremore Castle site or its development.
