TWENTIETH-CENTURY
BUILDING MATERIALS
HISTORY AND CONSERVATION

EDITED WITH A NEW PREFACE BY THOMAS C. JESTER

GETTY CONSERVATION INSTITUTE, LOS ANGELES

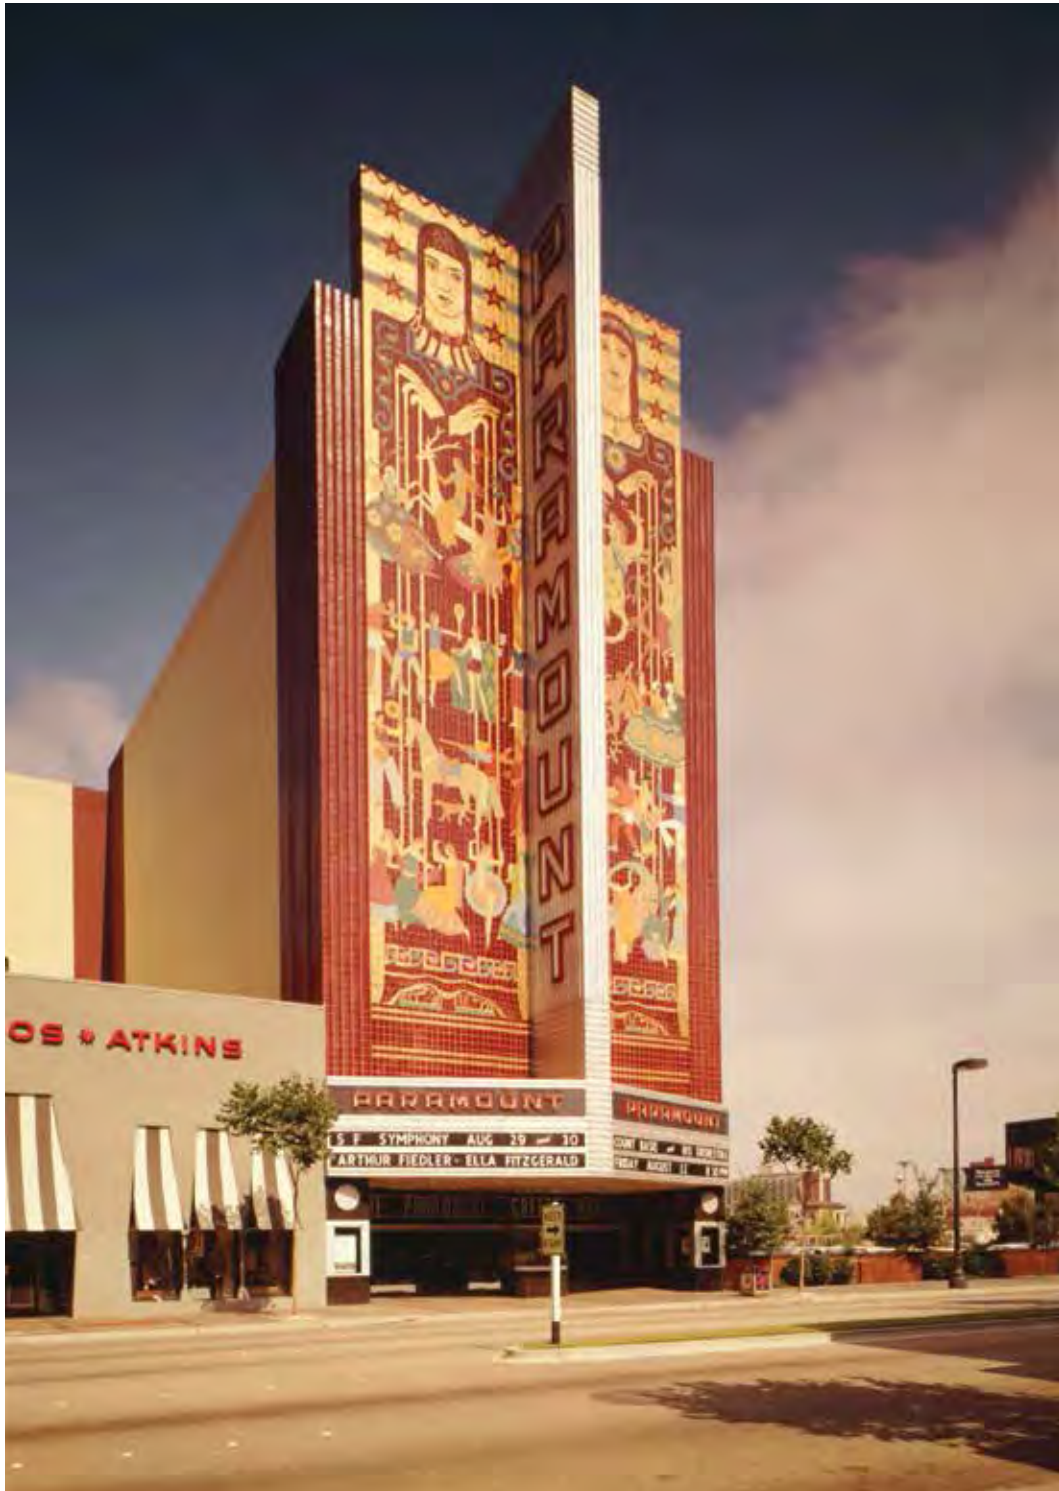
Plate 2. The Paramount Theater (1931, Timothy Pflueger and James Miller), Oakland, Calif., was a billboard itself. The two 20-by-120-foot murals of the god and goddess of cinema, separated by an aluminum sign, were executed in glazed mosaic terra cotta tiles.

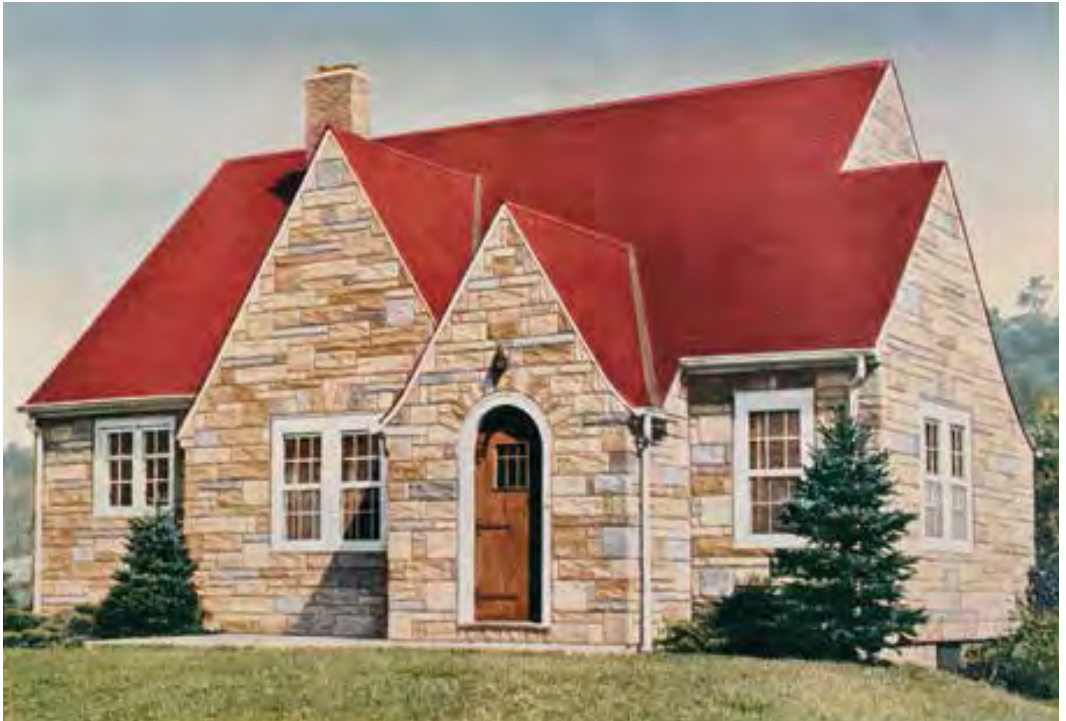
Plate 3. Perma-Stone's resemblance to quarried stone lent ordinary houses an aura of permanence (above). Perma-Stone was sold and applied by licensed dealers nationwide in a range of colors created with mineral pigments.

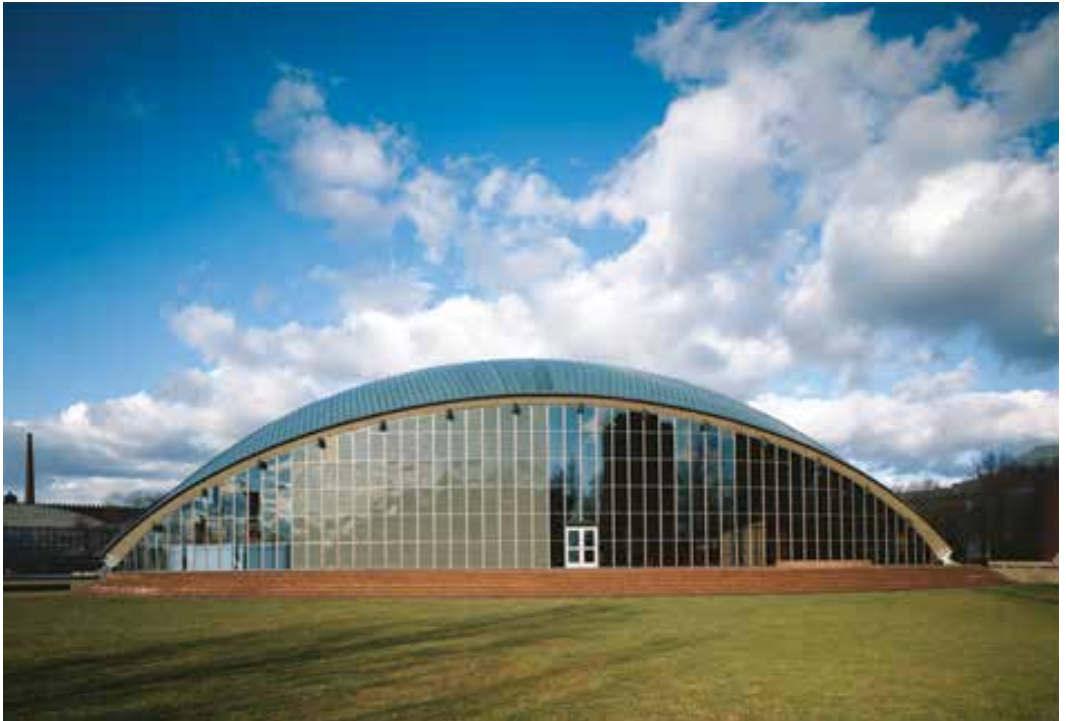
Plate 8. Eero Saarinen's inventive use of modern materials—a thin reinforced concrete shell and aluminum-framed glass panels—contributes to the dramatic form of the Kresge Auditorium (1955) at the Massachusetts Institute of Technology, Cambridge, Mass.

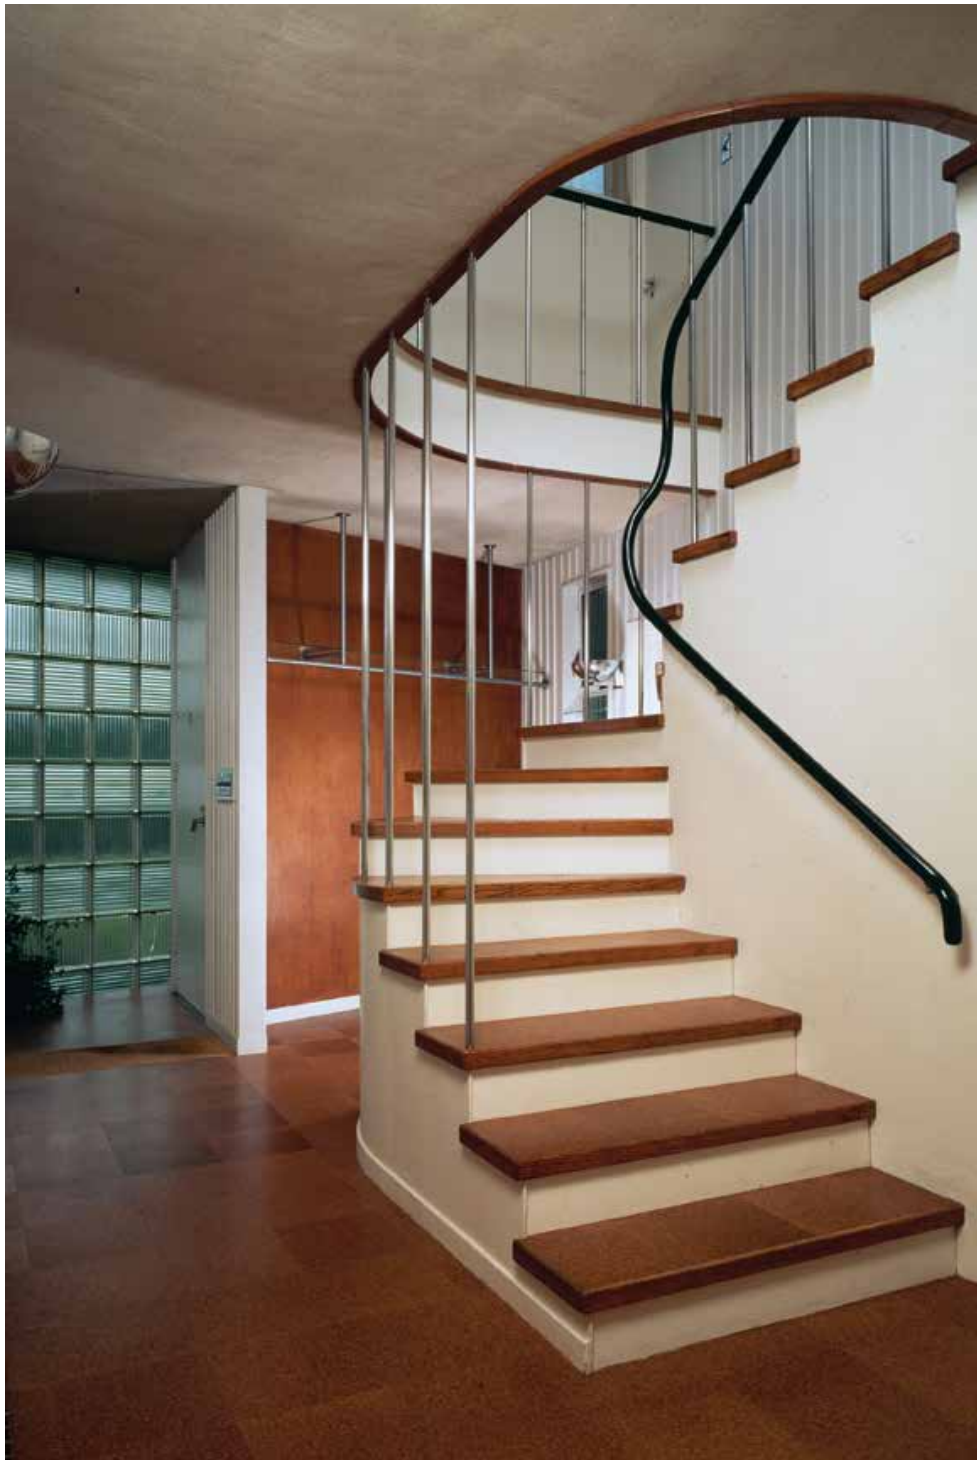
Plate 10. Walter Gropius selected mass-produced materials, including cork tile, glass block, and steel windows, when he designed his Lincoln, Mass., house (1938, with Marcel Breuer). When the house was restored in 1986, the deteriorated cork tile floor was replaced with new tile that matched the original.

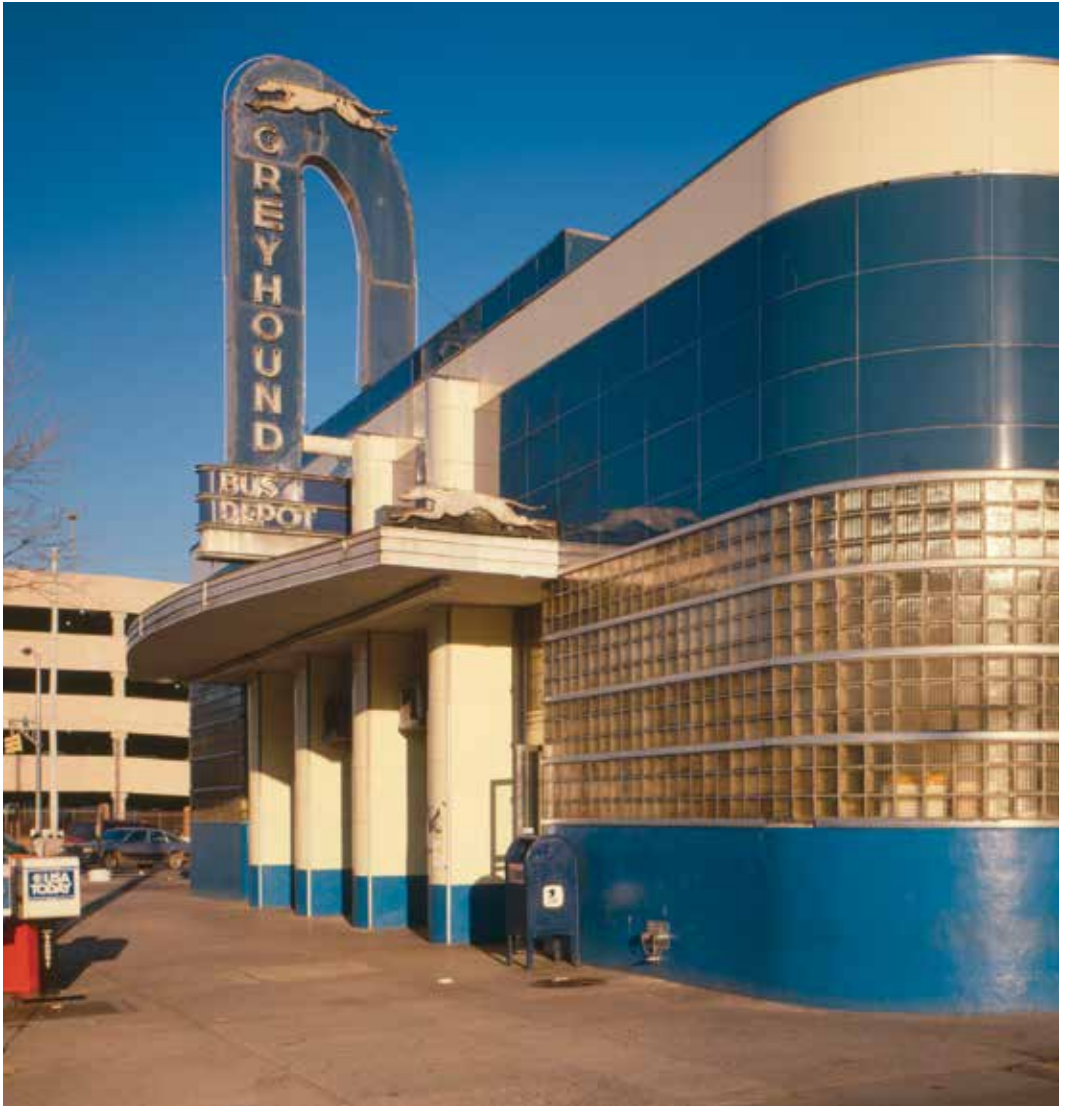
Plate 20. The Greyhound Bus Depot (1939, George D. Brown), Columbia, S.C., is a tour-de-force of twentieth-century building materials. On top of the reinforced concrete foundation, bands of glass block alternate with stainless steel. The mirrored blue and ivory Vitrolite structural glass color scheme above the aluminum marquee was developed for Greyhound by the industrial designer Raymond Loewy.

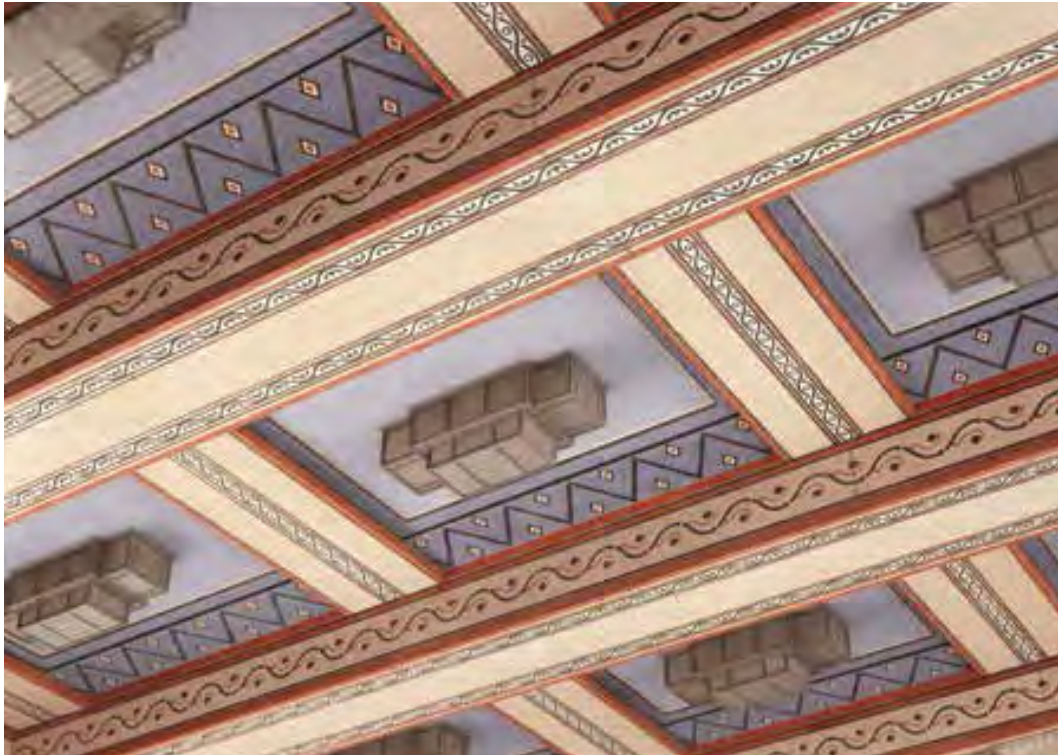
Plate 21 The polychromatic lobby ceiling (1934, John J. Earley) of the Department of Justice building, Washington, D.C., features a series of thin architectural precast concrete panels (above).

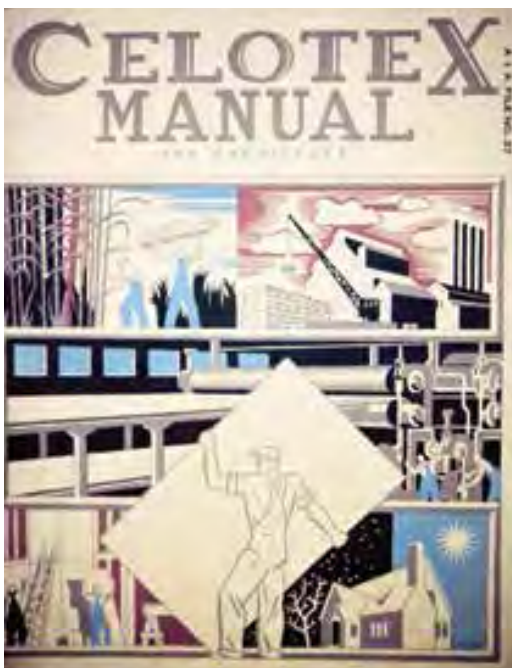
Plate 22. Celotex fiberboard products, made from bagasse (sugarcane fibers), included sheathing, wallboard, hardboard, insulating lath for plaster, and acoustical tile (left). *Celotex Manual for Architects*, The Celotex Corporation, 1937.

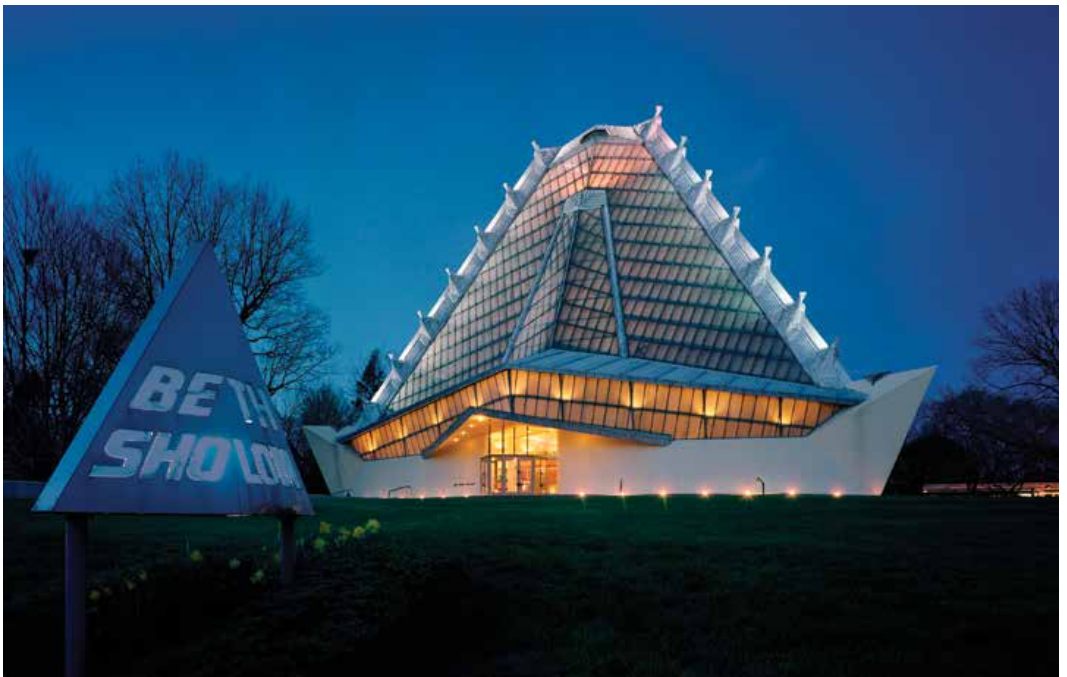
Plate 24. In his design for the Beth Shalom Synagogue (1954), Elkins Park, Pa., Frank Lloyd Wright explored the translucent qualities of plastic and glass (bottom). Free of internal supports, the main sanctuary has a tripod frame covered by a double layer of translucent wire glass outside and corrugated, fiber-reinforced plastic inside.

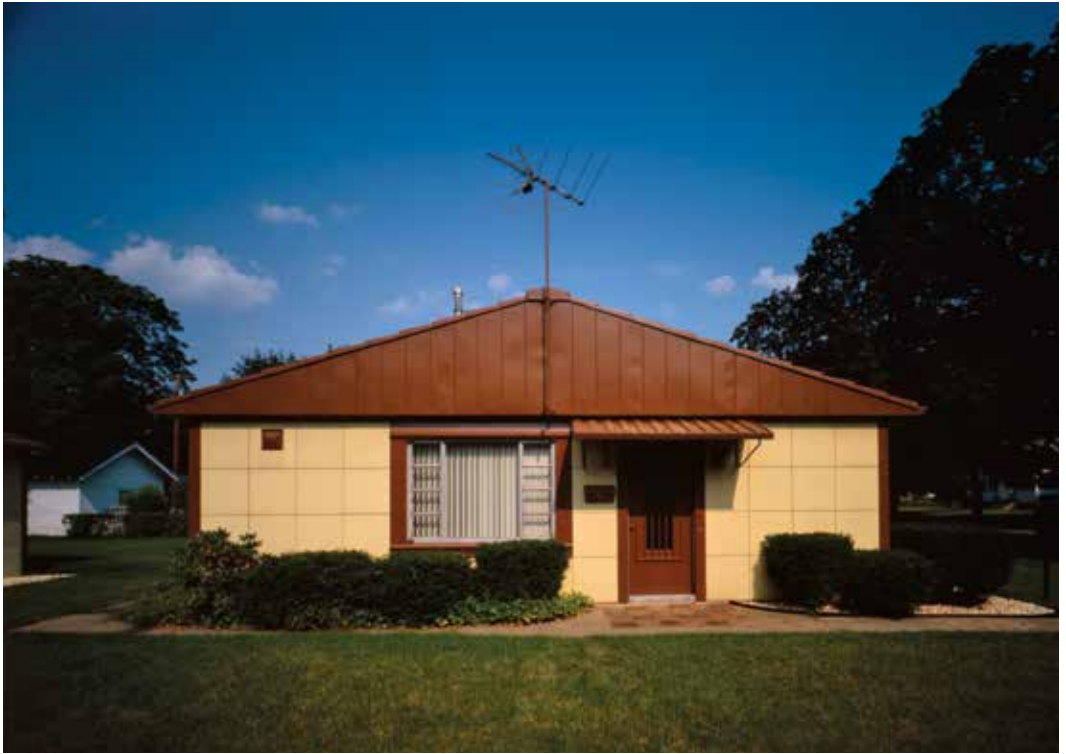
Plate 26. The design for this prefabricated Lustron house (1950, Morris Beckman), Chesterton, Ind.—number 2,329 off the production line—featured 2-foot-square porcelain enamel panels screwed to wall studs (above). All the components needed to construct a Lustron house were delivered on one tractor trailer.

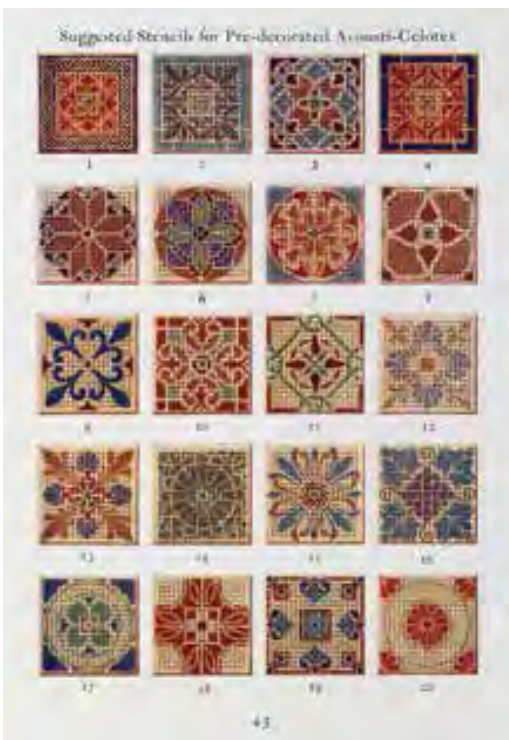
Plate 27. Painted and stenciled Acousti-Celotex tiles, offered by the Celotex Corporation in the late 1920s, afforded greater light reflection than unpainted acoustical tile without decreasing sound absorption (left). *Acousti-Celotex*, The Celotex Corporation, 1927.

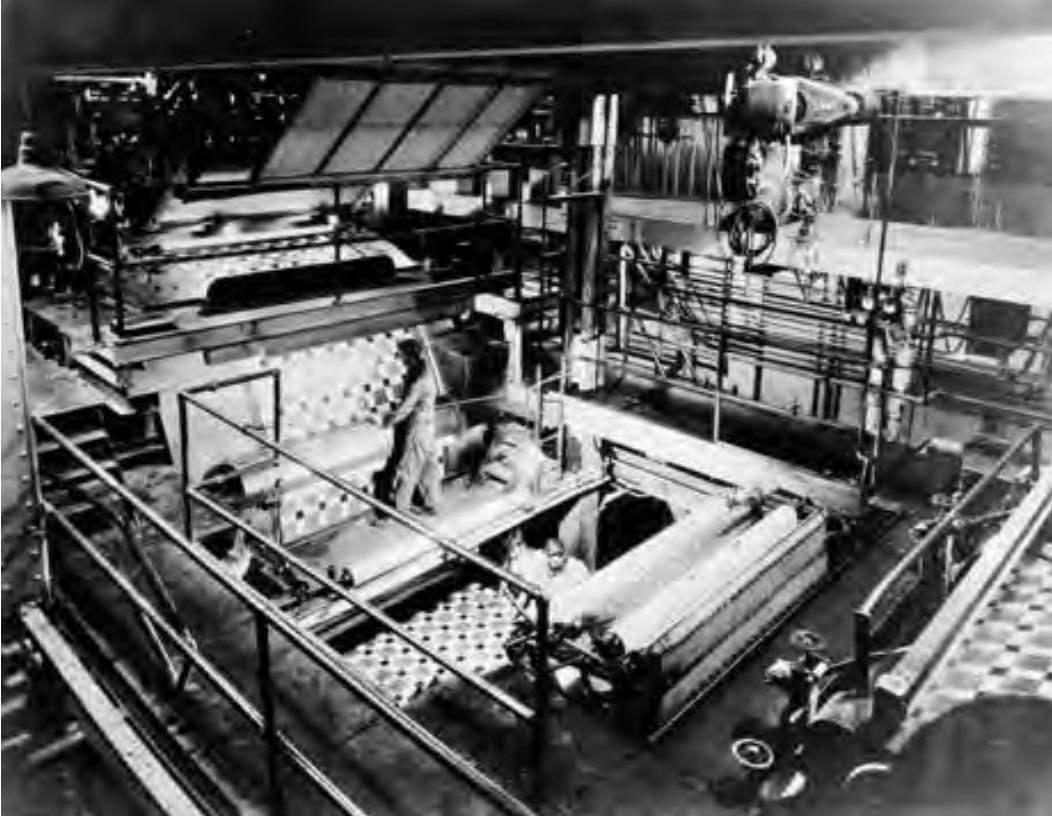
Figure 1.2. To keep ahead of competitors, the Armstrong Cork Company designed and installed a new rotary machine to manufacture straight-line linoleum in 1920. Machinery used to produce building materials became increasingly mechanized in the early twentieth century, lowering the cost of many.

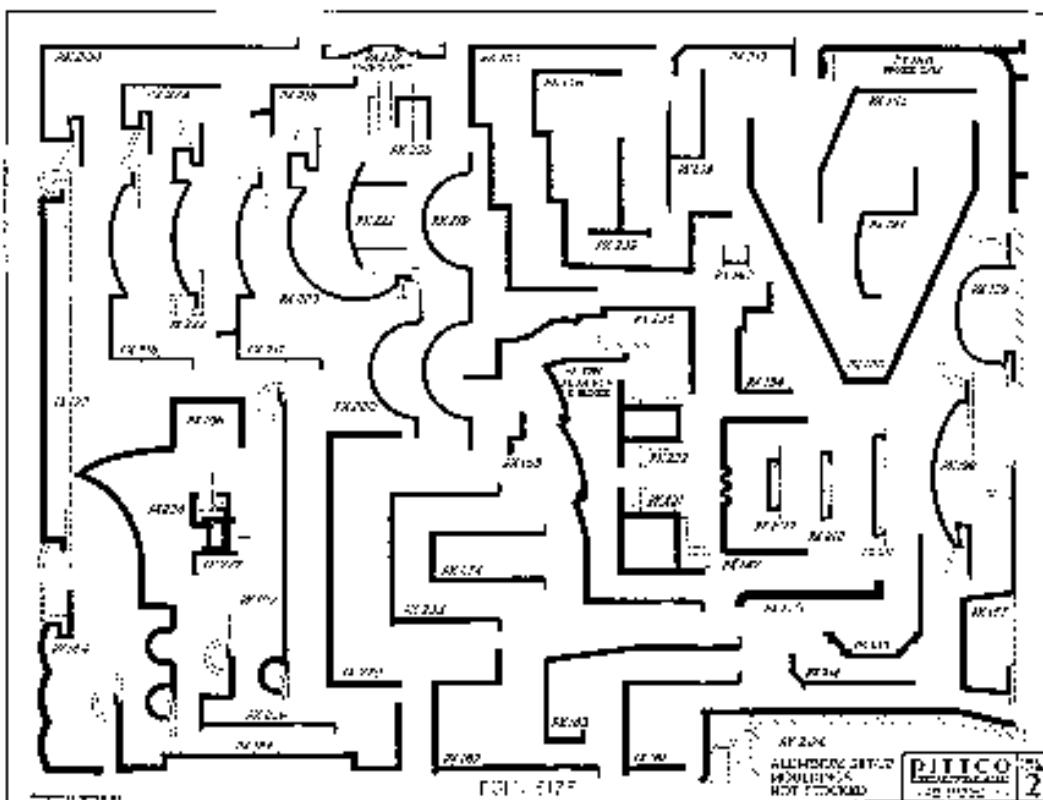
Figure I.5. The Pittsburgh Plate Glass Company offered industrially produced aluminite and architectural bronze moldings for storefronts under the trade name Pittco. Architects and builders could choose from a nearly endless array of shapes from a catalogue to create “modern” storefronts.

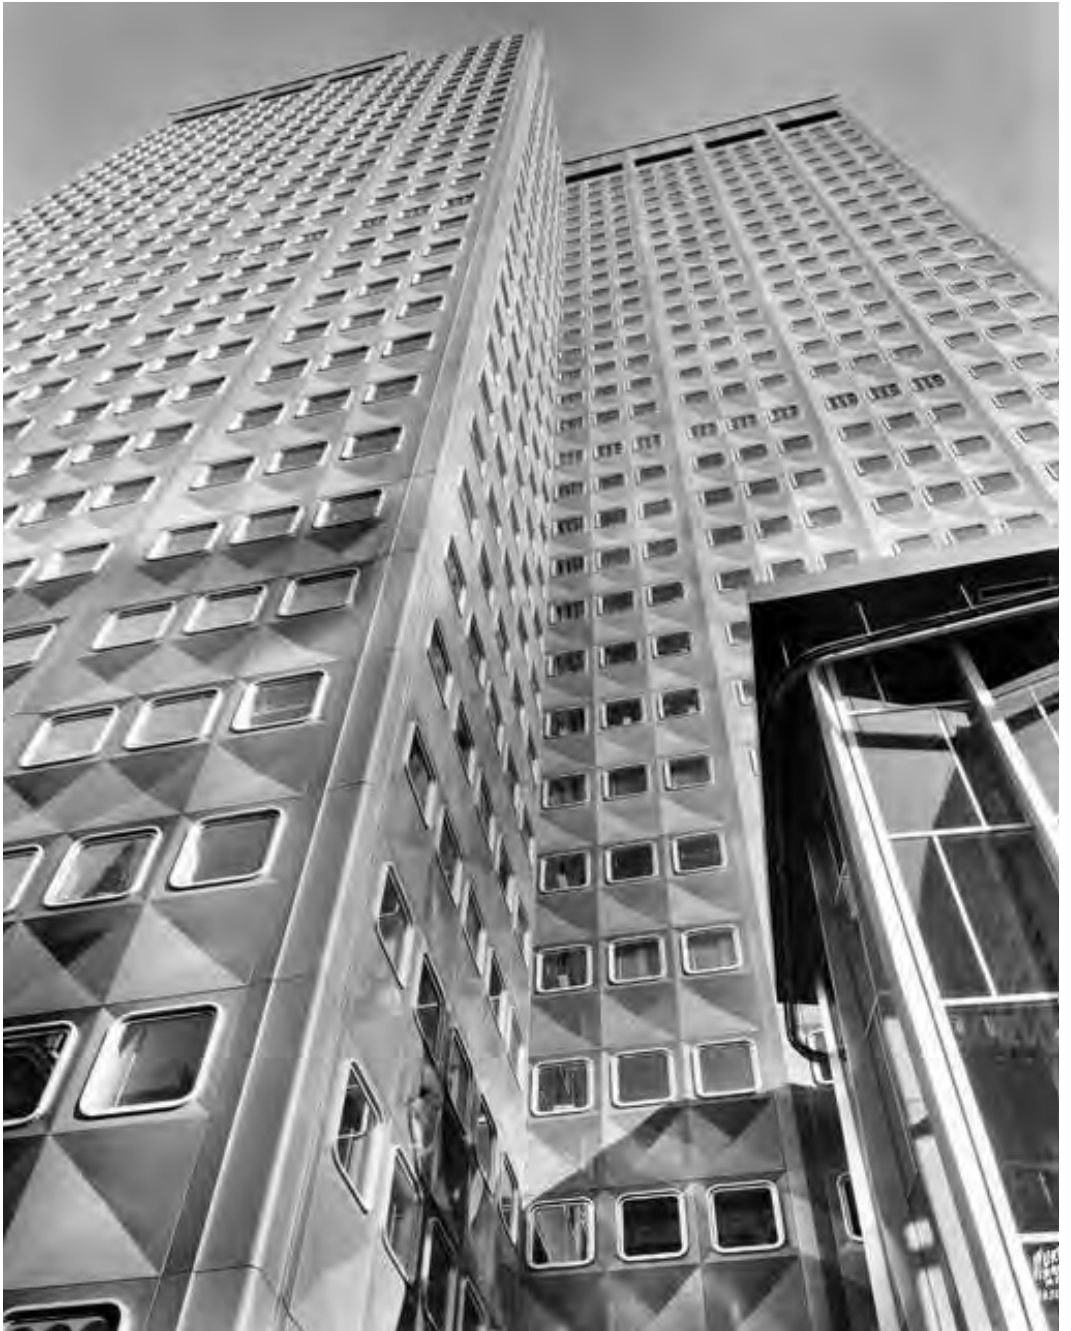
Figure 1.3. The Alcoa Building (1953, Harrison and Abramovitz), Pittsburgh, was one of the first to use prefabricated curtain wall panels.

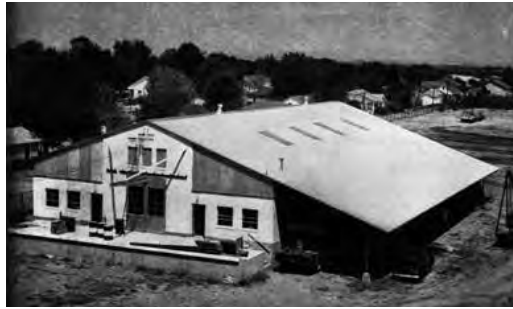
Figure 1.4. Industrial aluminum roofing and siding for structures like this Tulsa, Okla., warehouse (top) were marketed by companies such as Kaiser Aluminum. Selling points included the material's low maintenance, light weight, and strength.

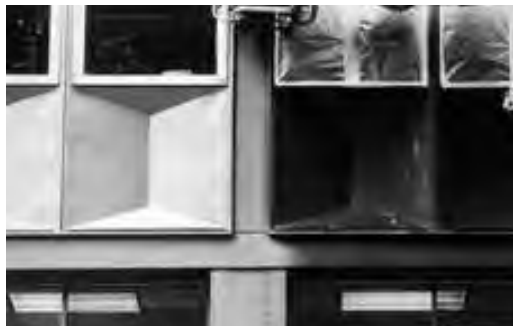
Figure 1.5. Aluminum curtain wall panels can be cleaned by hand, primed, and recoated with a custom metallic product to match the original appearance. The right panel shows deterioration; the left, the appearance after cleaning and recoating (bottom).

Corrosive agents that break down the natural oxide film include hydrochloric acid, chlorides, sulfates, dirt, and high humidity.³² Aluminum is also subject to corrosion when wet and in contact with certain alkalines, such as concrete, mortar, and plaster. Some forms of wood, wall-board, flooring, and insulation materials may also attack aluminum.³³ Most soils in direct contact with aluminum will cause corrosion. Acid-based chemicals used to clean facades and masonry surfaces should not be allowed to come into contact with aluminum.³⁴

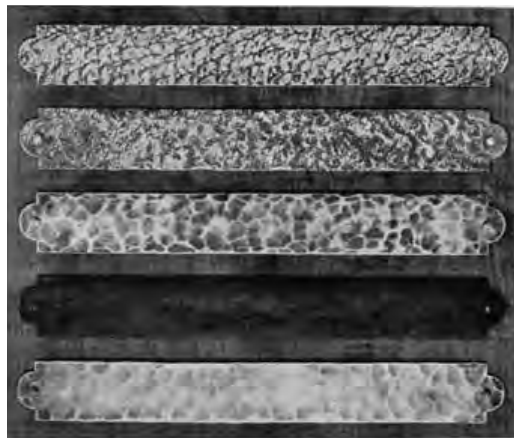
Figure 2.3. Because Monel could not be extruded, decorative elements had to be built up from rolled stock, as was this ornament on the T. Eaton Department Store (1930, Ross and Macdonald, Sproat and Rolph), Toronto (bottom left).

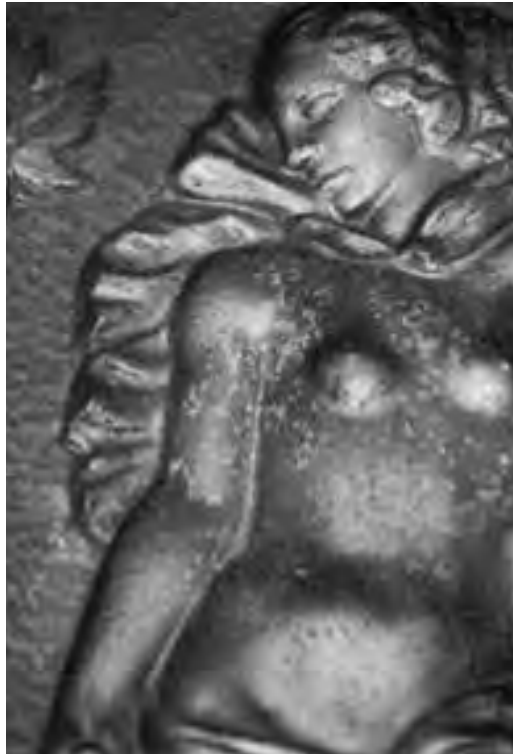
Figure 2.5. This door of the United Nations General Assembly Building (1953, Ernest Cormier), New York City, has developed a patina from its semimarine environment.

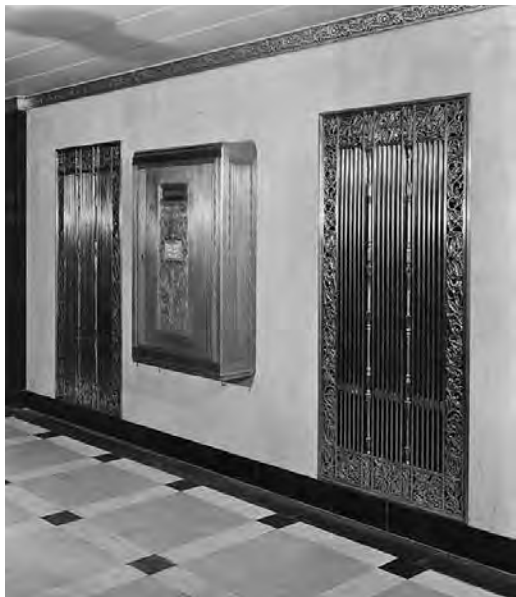
Figure 3.2. A popular white metal for Art Deco designs, polished nickel silver was used extensively for the elevators, stair railings, directory cases, and radiator grilles in the Chicago Daily News Building (1929, Holabird and Root).

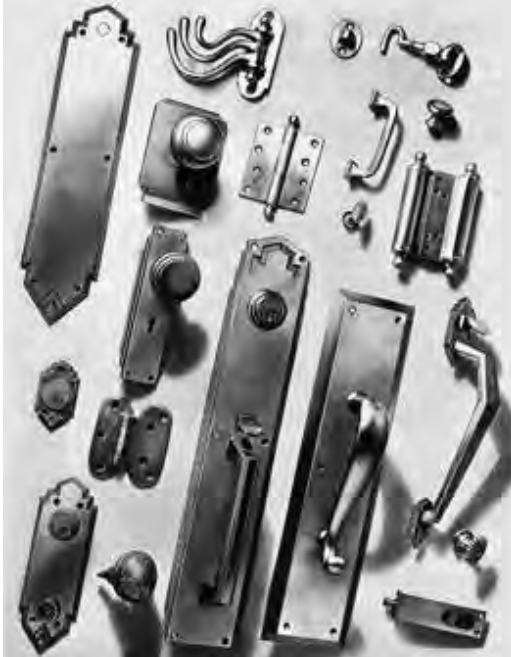
Figure 3.4. Abrasion resistance, workability, and bright surface finish made cast, drawn, and wrought forms of nickel silver suitable for plumbing and hardware in large buildings such as hotels, particularly during the 1930s.

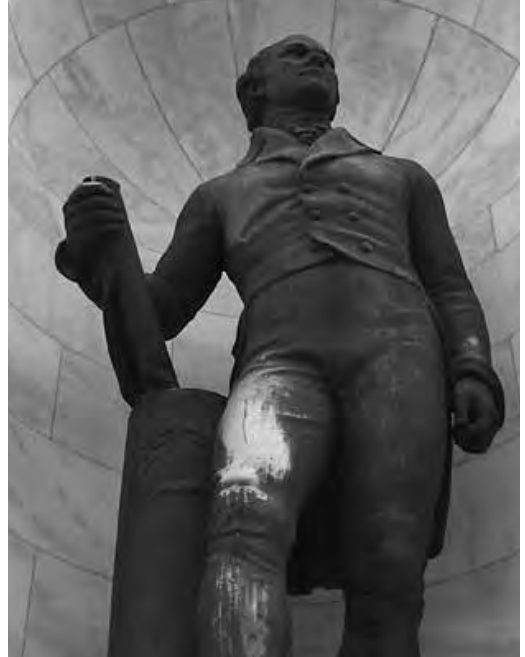
Figure 3.5. The nickel silver statue of Alexander Hamilton (1940, Adolph A. Weinman) at the Museum of the City of New York has tarnished to a slate gray color, similar in tone to many bronze patinas, and is showing signs of deterioration.

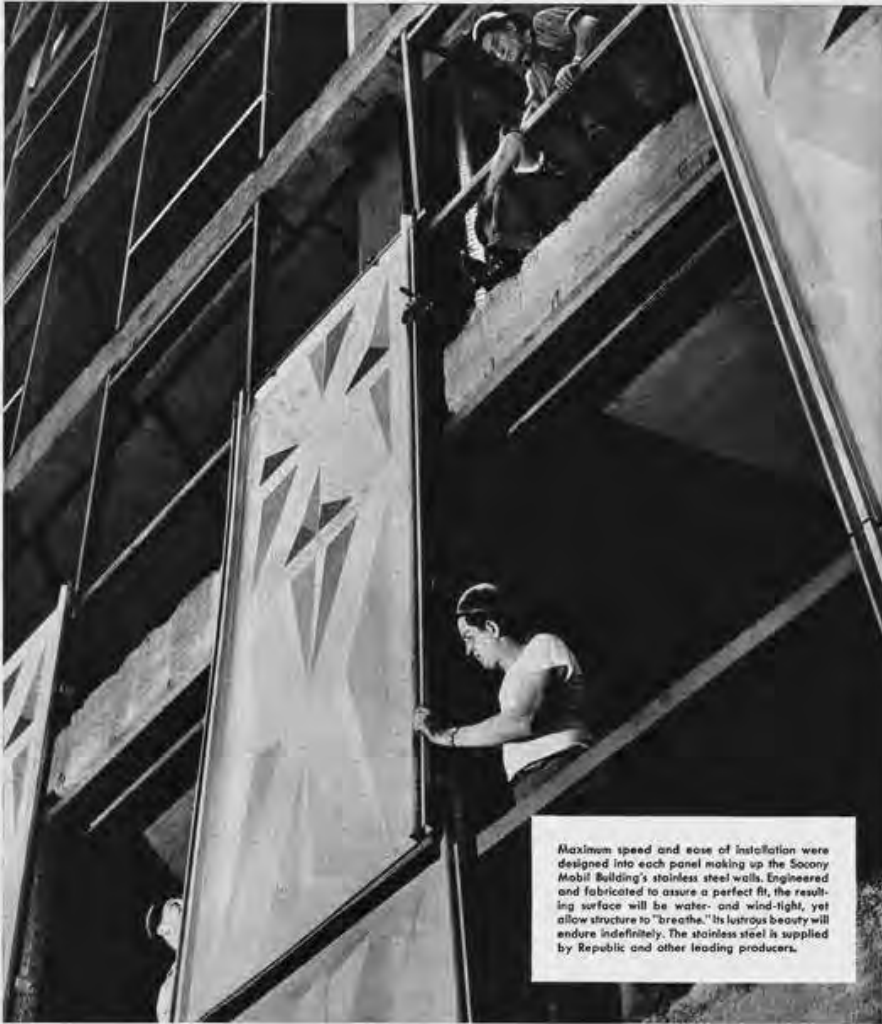
Maximum speed and ease of installation were designed into each panel making up the Soony Mobil Building's stainless steel walls. Engineered and fabricated to assure a perfect fit, the resulting surface will be water- and wind-tight, yet allow structure to "breathe." Its lustrous beauty will endure indefinitely. The stainless steel is supplied by Republic and other leading producers.

Figure 4.1. The ease with which stainless steel curtain wall panels could be installed made them a popular cladding material beginning in the 1950s. *Architectural Forum*, 1955.

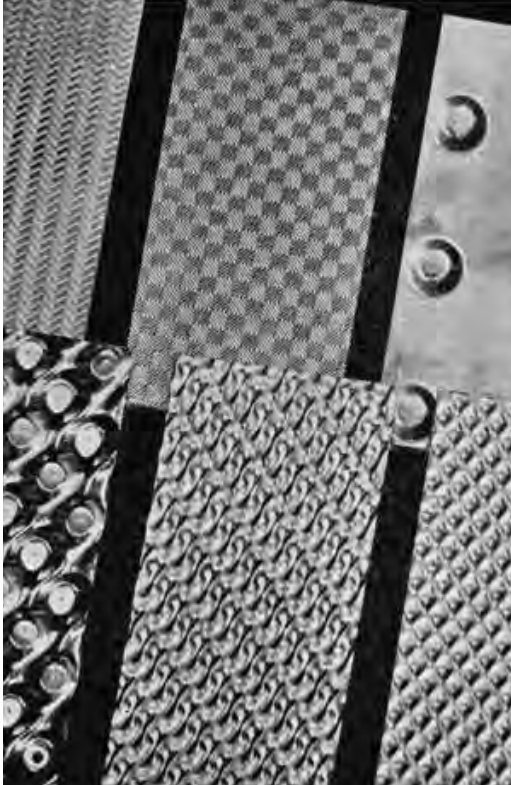
Figure 4.2. Used for storefronts, Rigid-Text patterned sheets of embossed and rolled finishes for stainless steel were produced by the Rigidized Metals Corporation.

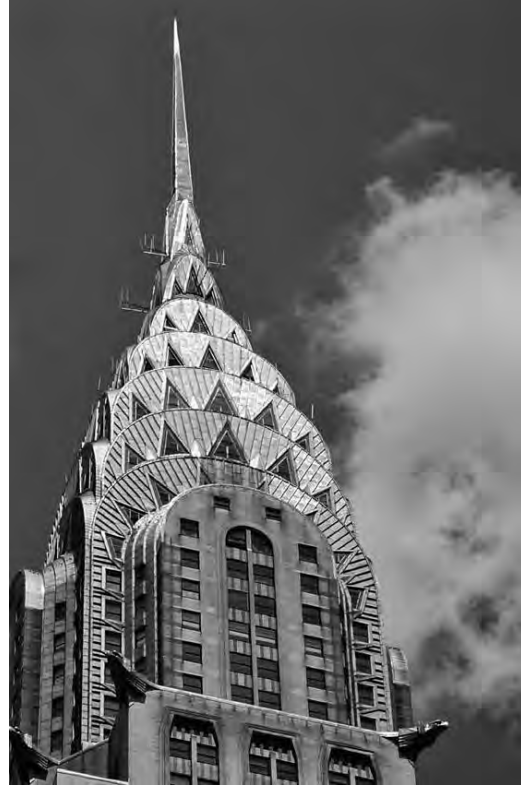
Figure 4.3. Stainless steel sheets were manufactured for the dome (the top nine floors) of the Chrysler Building (1930, William Van Alen), New York City.

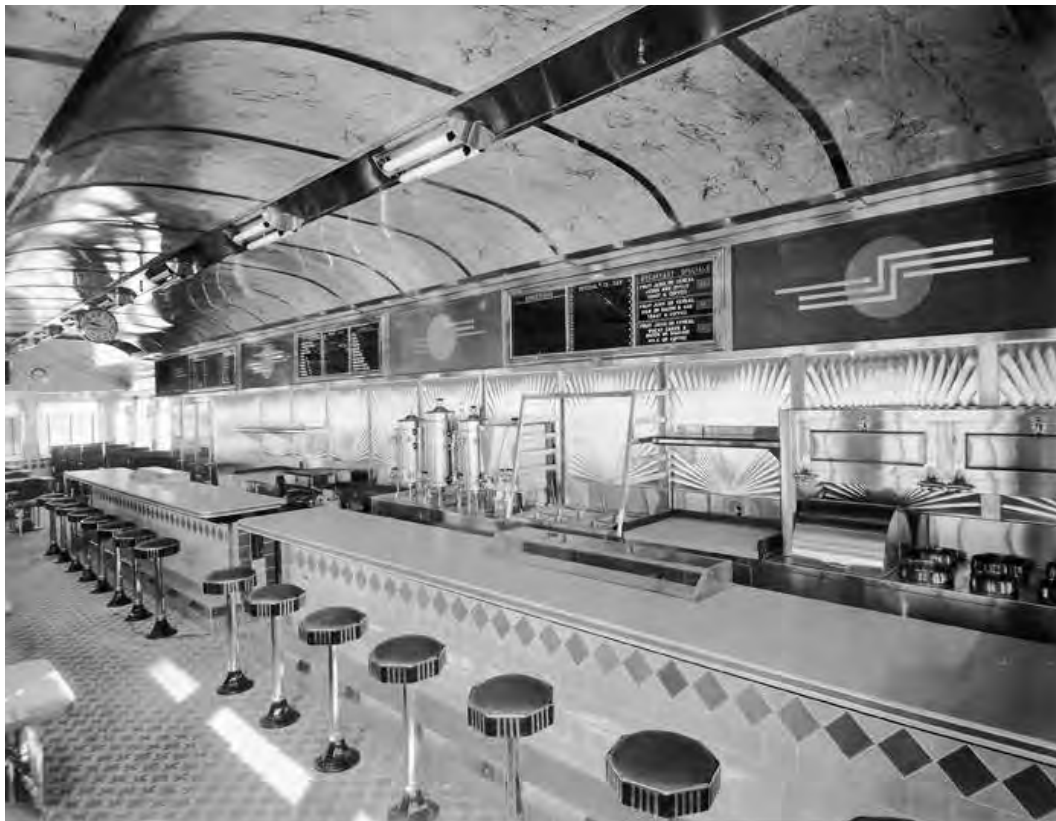
Figure 4.4. Throughout the 1940s and 1950s stamped stainless steel was ubiquitous in diners, where it was used for wall panels, food preparation surfaces, decorative trim, and other features. This diner was manufactured in 1939 by the Paramount Diners of Haledon, N.J.

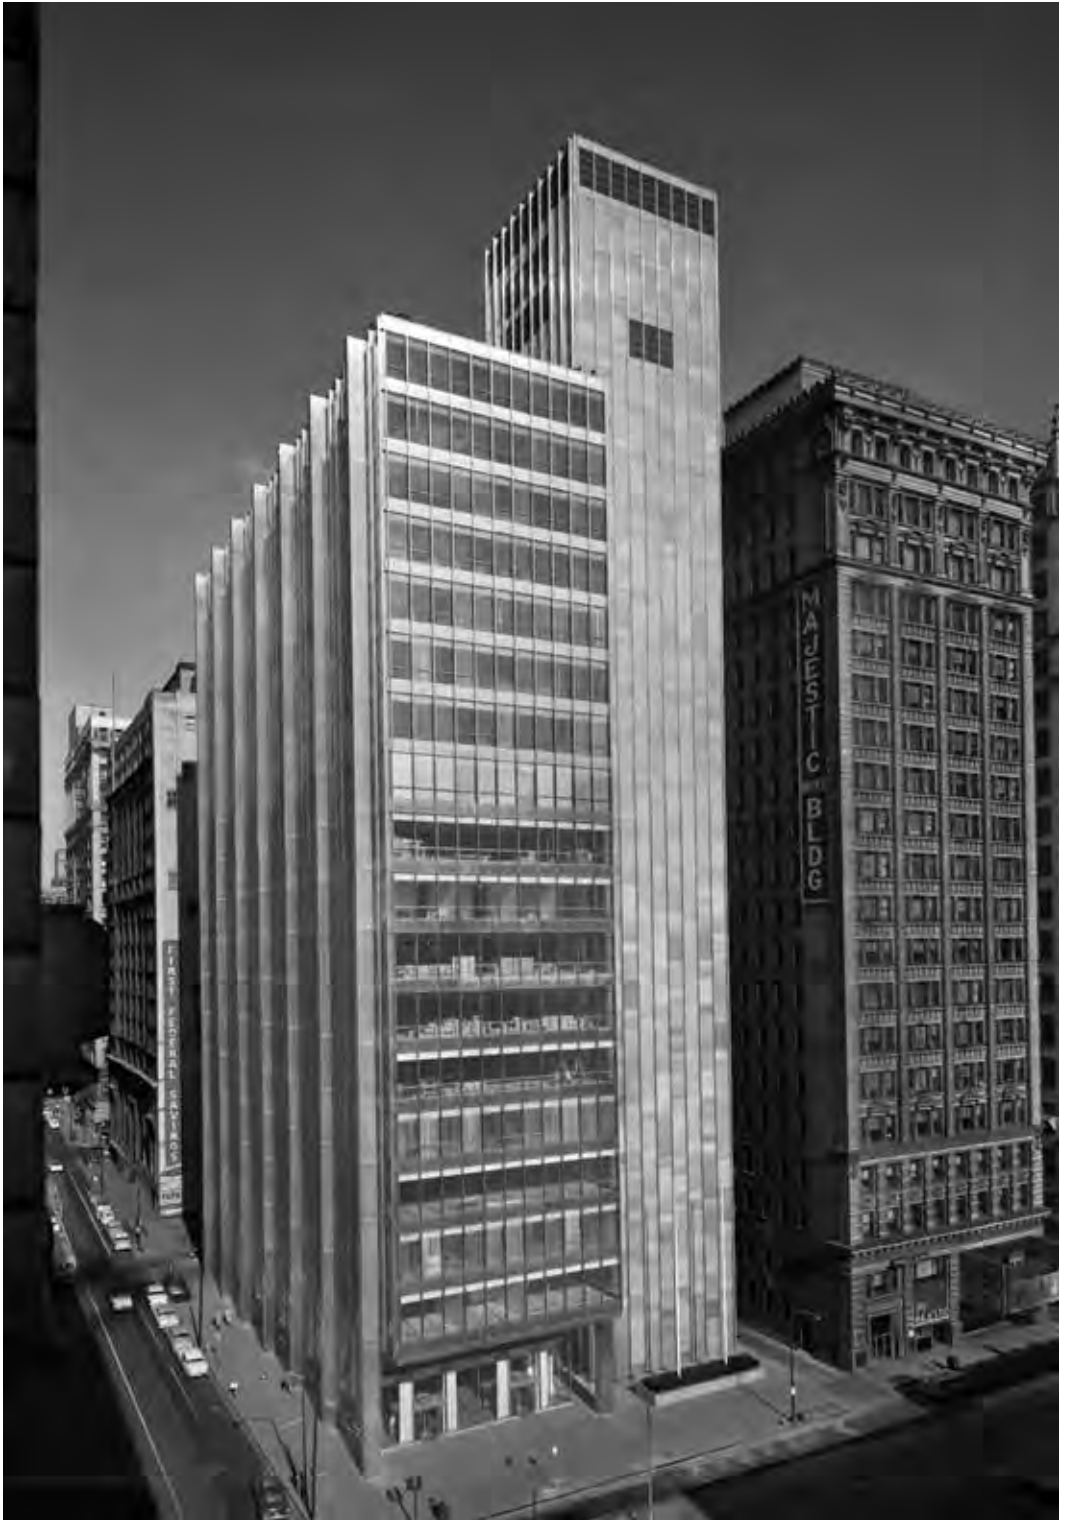
Figure 4.5. The Inland Steel Building (1957, Skidmore, Owings and Merrill), Chicago, an early application of stainless steel in modern architecture, juxtaposes polished stainless steel mullions and spandrel panels with tinted green glass.

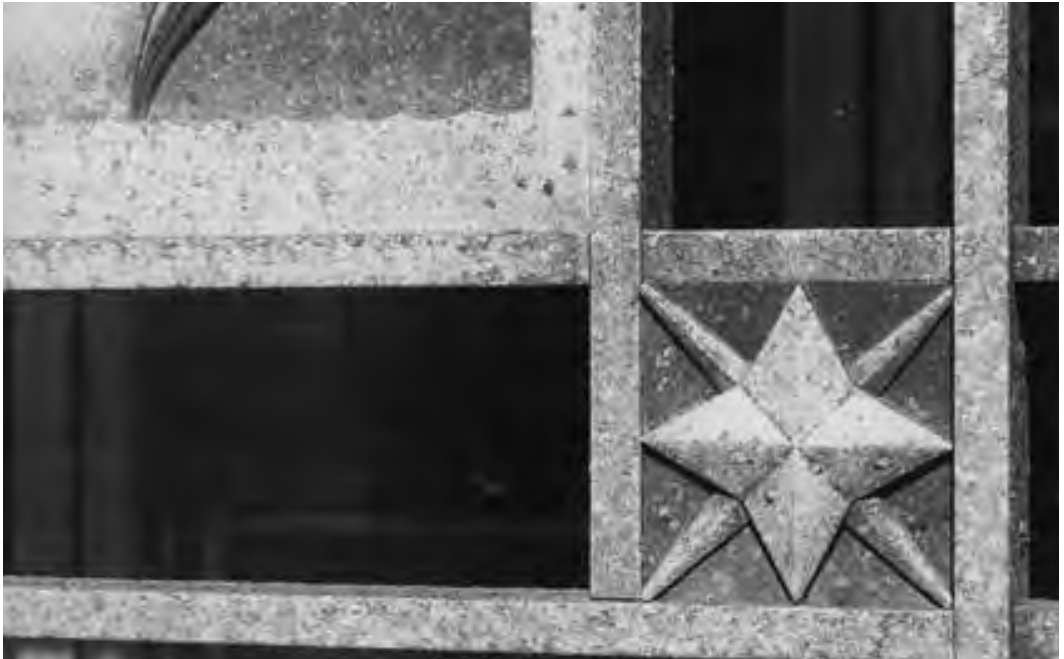
Figure 4.7. When exposed to a highly polluted atmosphere, stainless steels will corrode and are then often mistaken for aluminum. The gates at the Federal Trade Commission (1937, Bennett, Parsons, and Frost), Washington, D.C., have pitted because dirt on the surface has trapped moisture and created local electrolytic cells. Stainless steel should be cleaned periodically with water and a mild detergent.

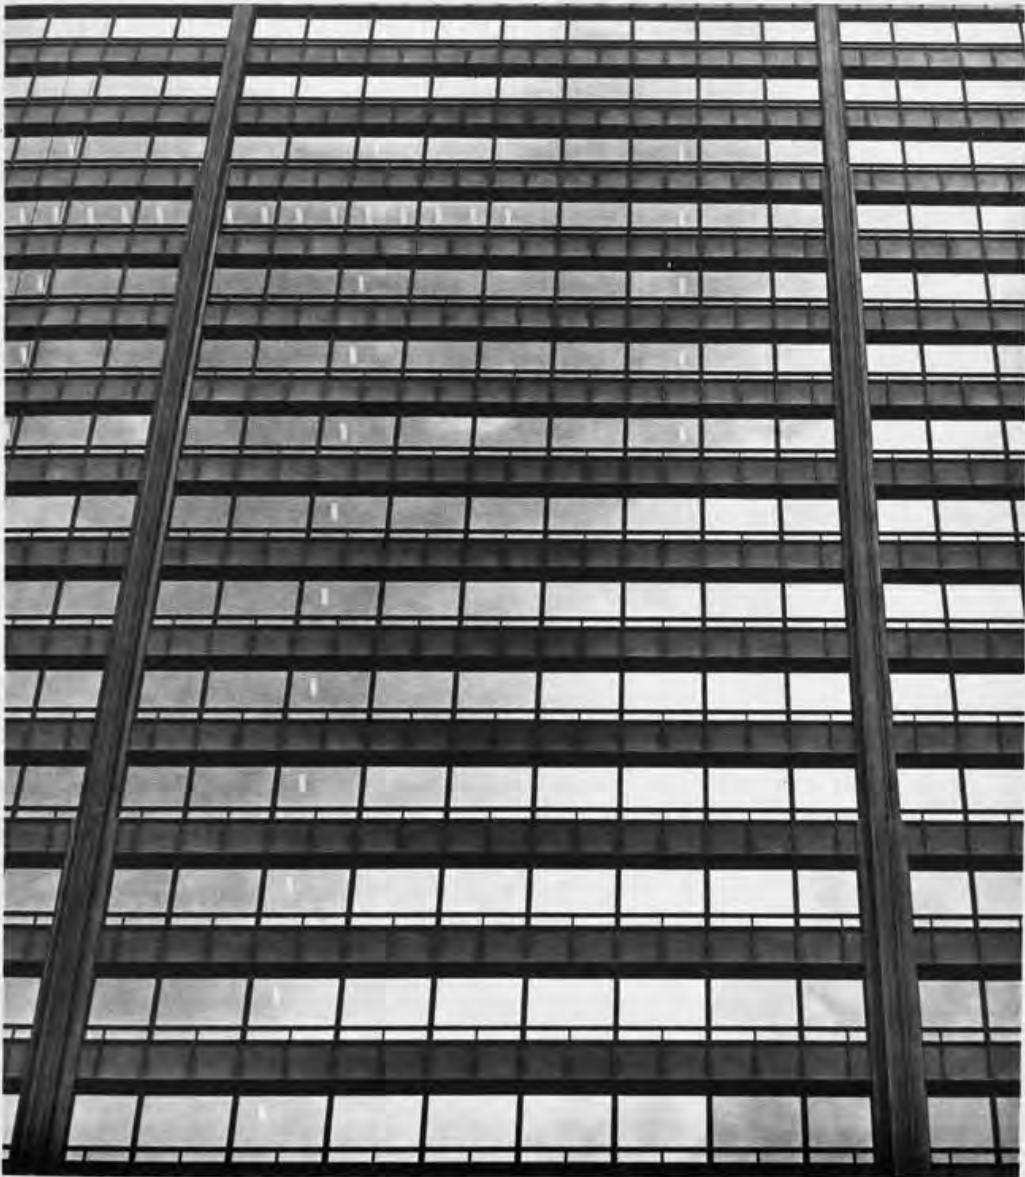
Figure 5.1. Weathering steel's texture and color, which can range from light to dark to earth browns, appealed to some designers in the 1960s and 1970s. The Civic Center Building (1965, C. F. Murphy Associates) in Chicago was an early architectural application. Weathering steel catalogue, Bethlehem Steel, March 1978.

Eero Saarinen and Associates' Deere Company Administrative Center (1958) in Moline, Illinois, was apparently the first architectural use in the United States of unpainted weathering steel.⁶ The first high-rise building using unpainted weathering steel and located in an urban central business district was Chicago's Civic Center Building (1965, C. F. Murphy Associates).⁷ U.S. Steel's Pittsburgh headquarters (1971, Harrison and Abramovitz) is a tour de force in the use of weathering steel.

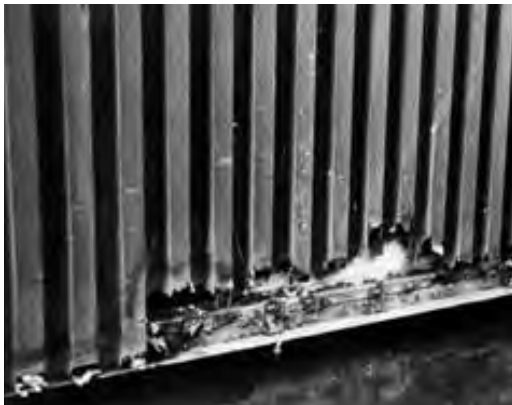
Figure 5.3. Corrosion of weathering steel is accelerated when water pools on surfaces, joints, and crevices.

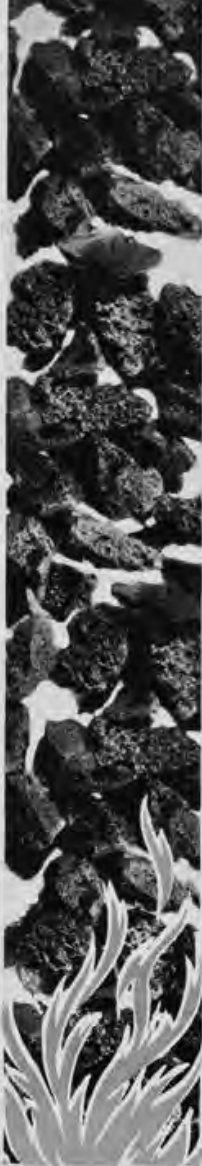
HAYDITE AGGREGATE
is clay or shale
expansively burned at
over 2000° Fahrenheit
— light weight, uniform,
completely cellular
and chemically inert.
(actual micro-photograph)
