TWENTIETH-CENTURY
BUILDING MATERIALS
HISTORY AND CONSERVATION

EDITED WITH A NEW PREFACE BY THOMAS C. JESTER

GETTY CONSERVATION INSTITUTE, LOS ANGELES

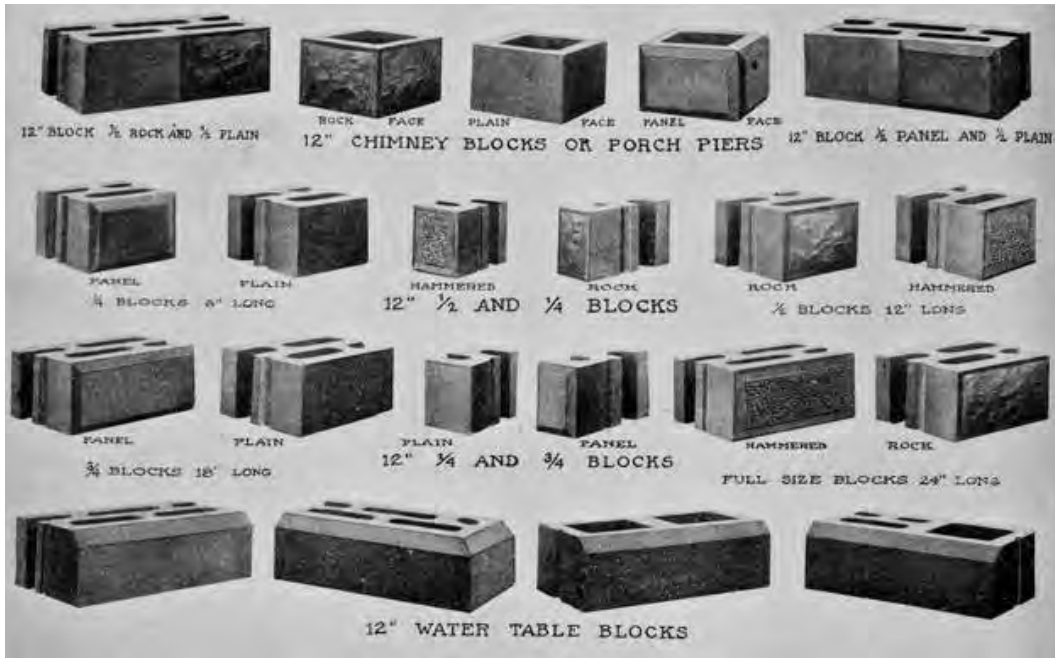
Figure 6.2. Frost- and moisture-proof because of their staggered air cavities, Miracle Blocks, patented in 1903 by the Miracle Pressed Stone Company of Minneapolis, were used for chimney flues, porch piers, and exterior walls.

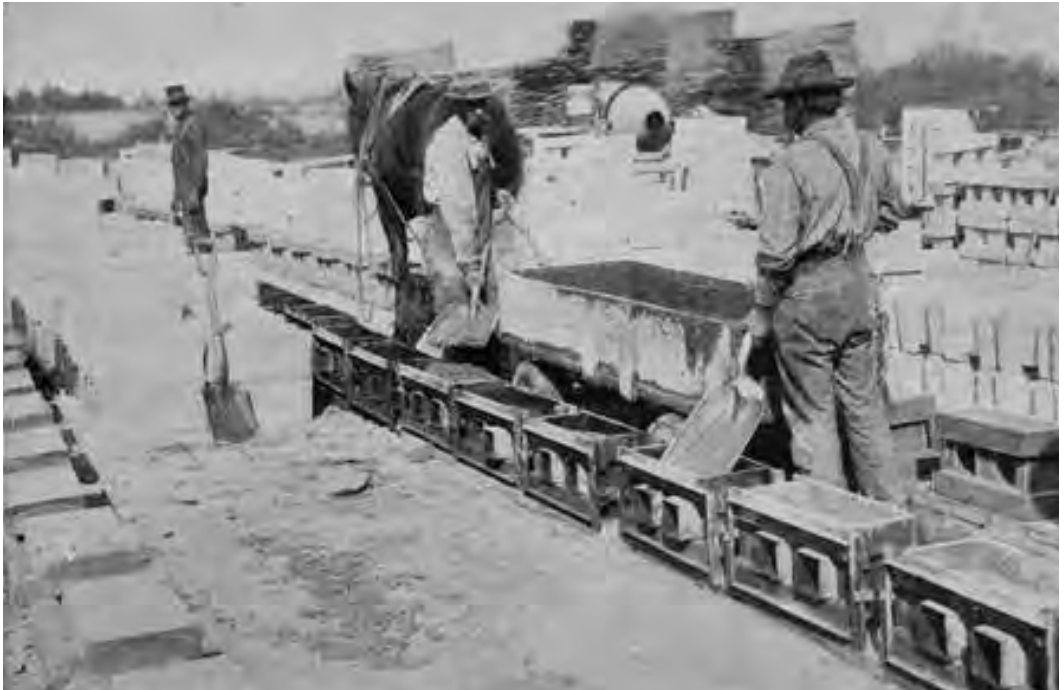
Figure 6.3. In the early 1900s concrete blocks were manufactured in molds filled by hand (above).

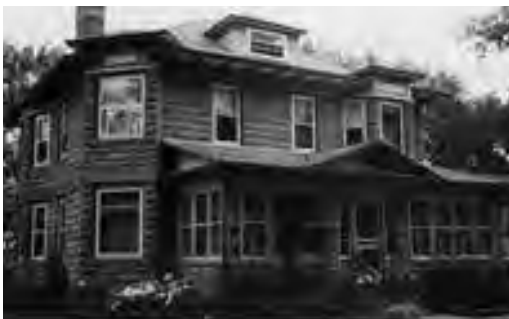
Figure 6.4. Concrete blocks were occasionally produced in colors. Rose-colored blocks were used for this foursquare house (1906) in Devil's Lake, N.D. (left).

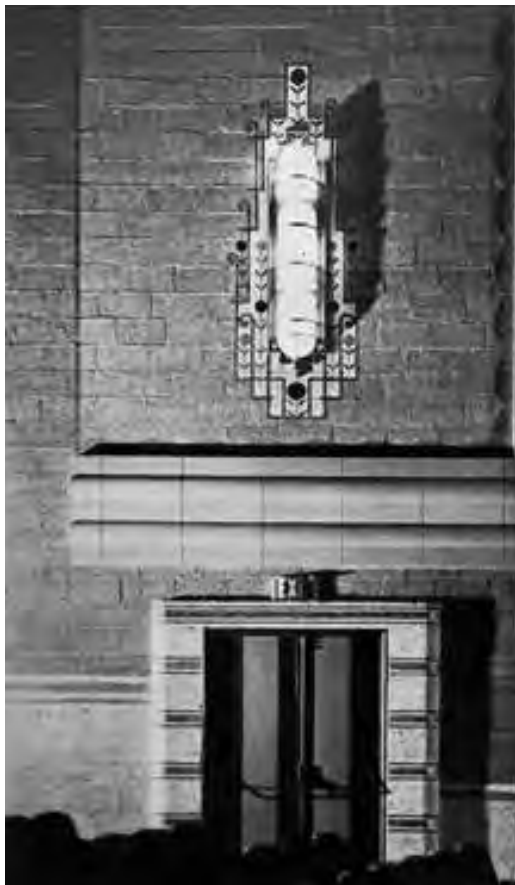
Figure 6.5. Often relegated to foundation and backup use, concrete blocks could also be decorative. The concrete ashlar walls of Chicago's Will Rogers Theater (1935, Z. Erroll Smith) were elaborately painted.

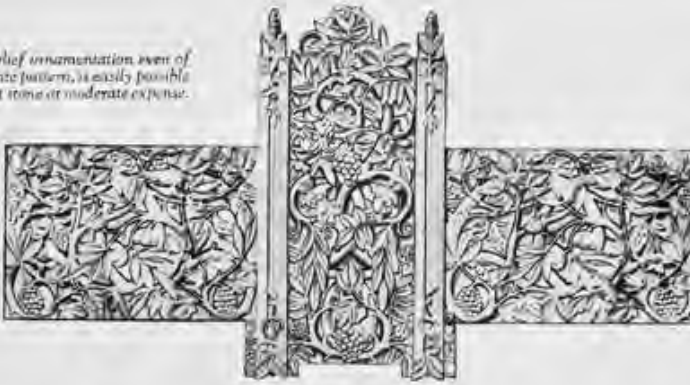
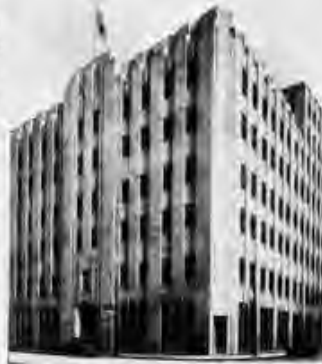
Bas-relief ornamentation even of intricate pattern, is easily possible in cast stone at moderate expense.

CAST STONE—concrete moulded in sections to definite architectural designs—opens new possibilities of beauty in modern commercial buildings.

Figure 7.1. Intricate ornamentation could be achieved with cast stone. This Portland Cement Association advertisement highlights the New York Telephone Company Building (1928, Vorhees, Gmelin and Walker), Syracuse, N.Y. *Architectural Forum*, April 1929.

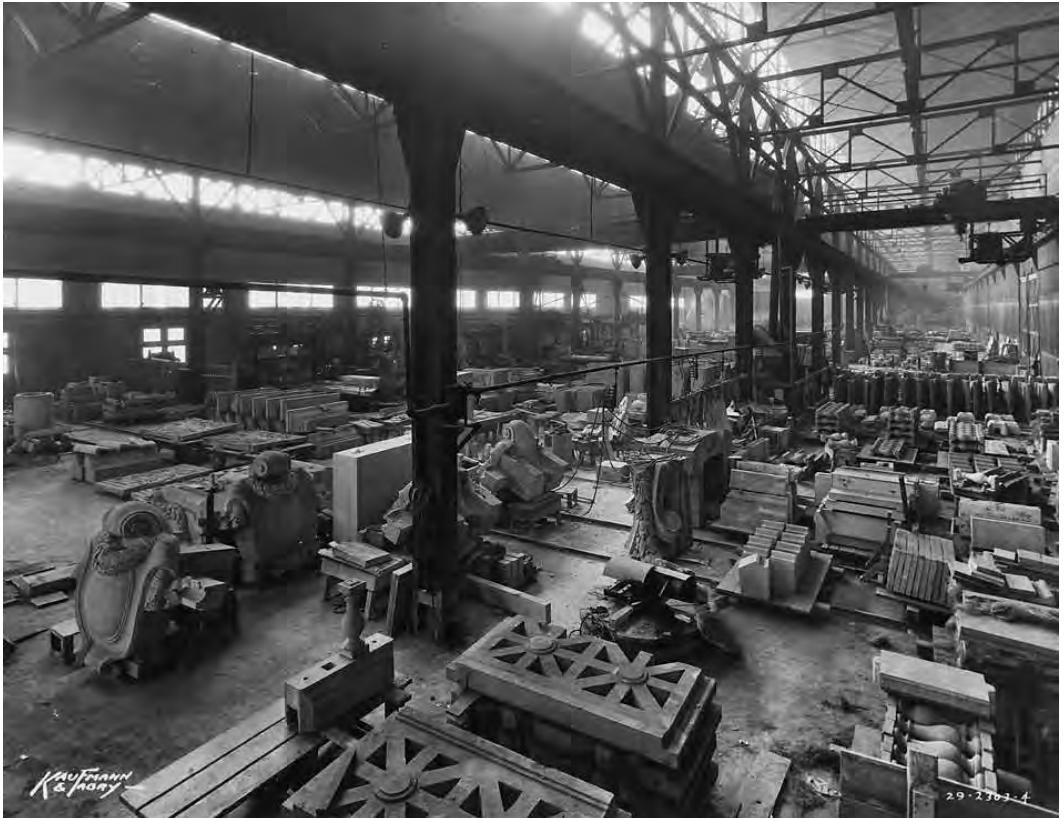
Figure 7.3. Large cast stone operations employed modelers and carvers for elaborate details. At the Benedict Stone Company's plant in Chicago, ornamental components are in various stages of production.

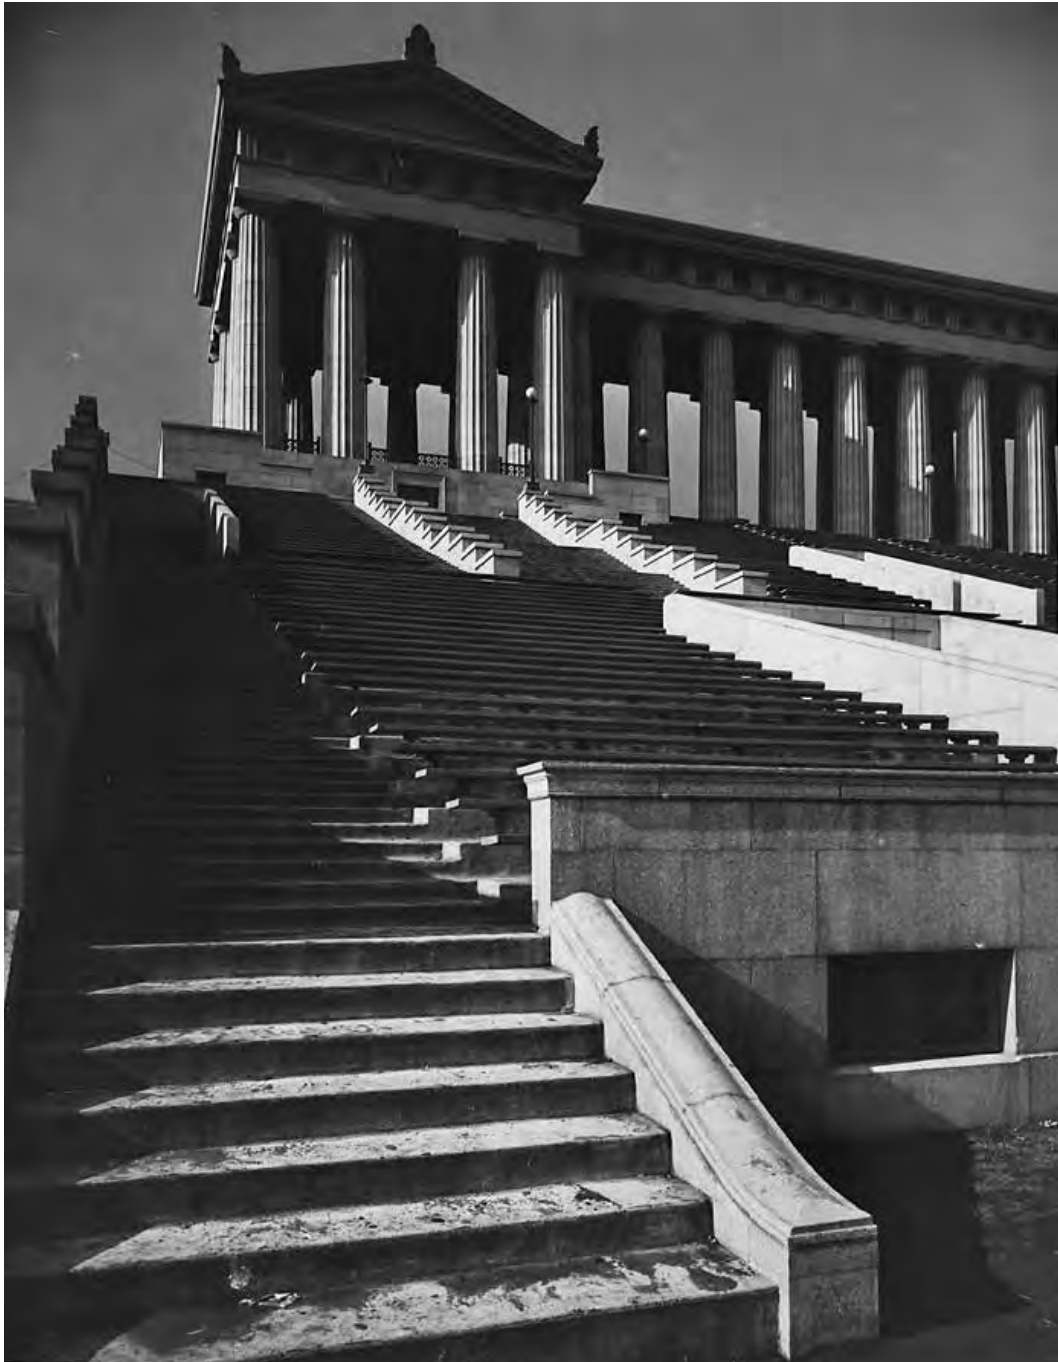
Figure 7.4. Benedict Stone was used for Soldier Field (1924, Holabird and Roche), Chicago. The textured finish is visible in the steps.

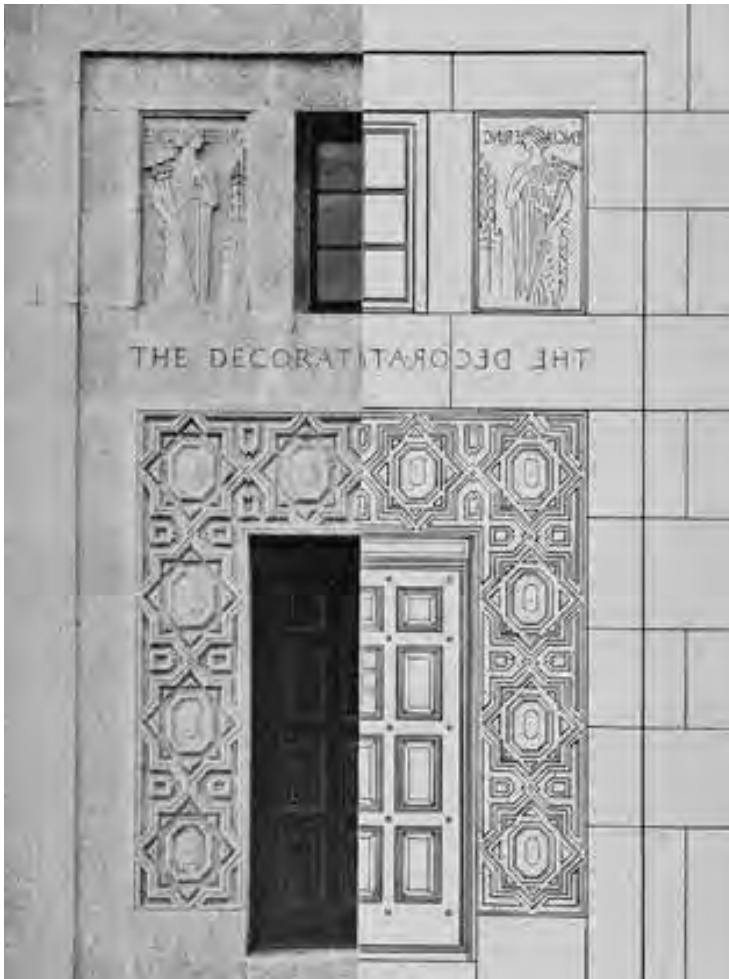
Figure 7.6. Clarence B. McKay's design for a building entrance (1920s) typifies cast stone's ornamental possibilities.

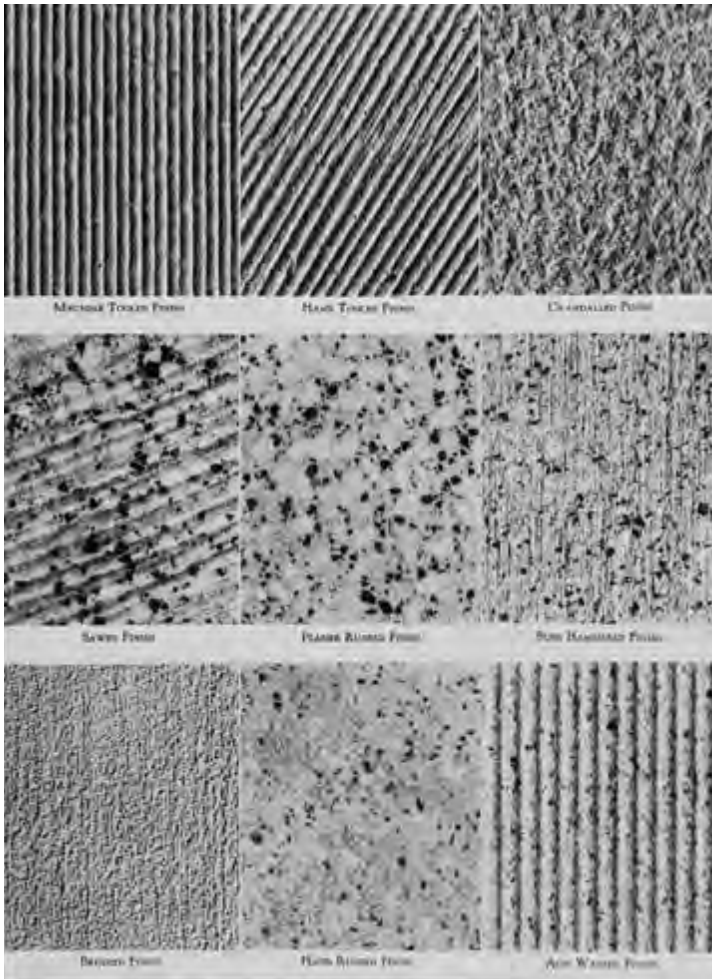
Figure 7.7. For decorative finishes, cast stone was mechanically tooled or chemically etched.

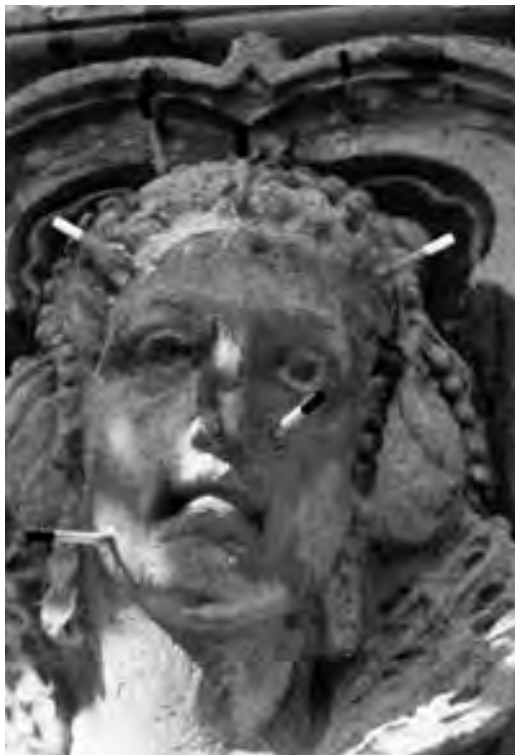
Figure 7.8. A delaminated ornamental layer of cast stone on the Orpheum Theater (1925, B. Marcus Priteca), San Francisco, was reattached with epoxy.

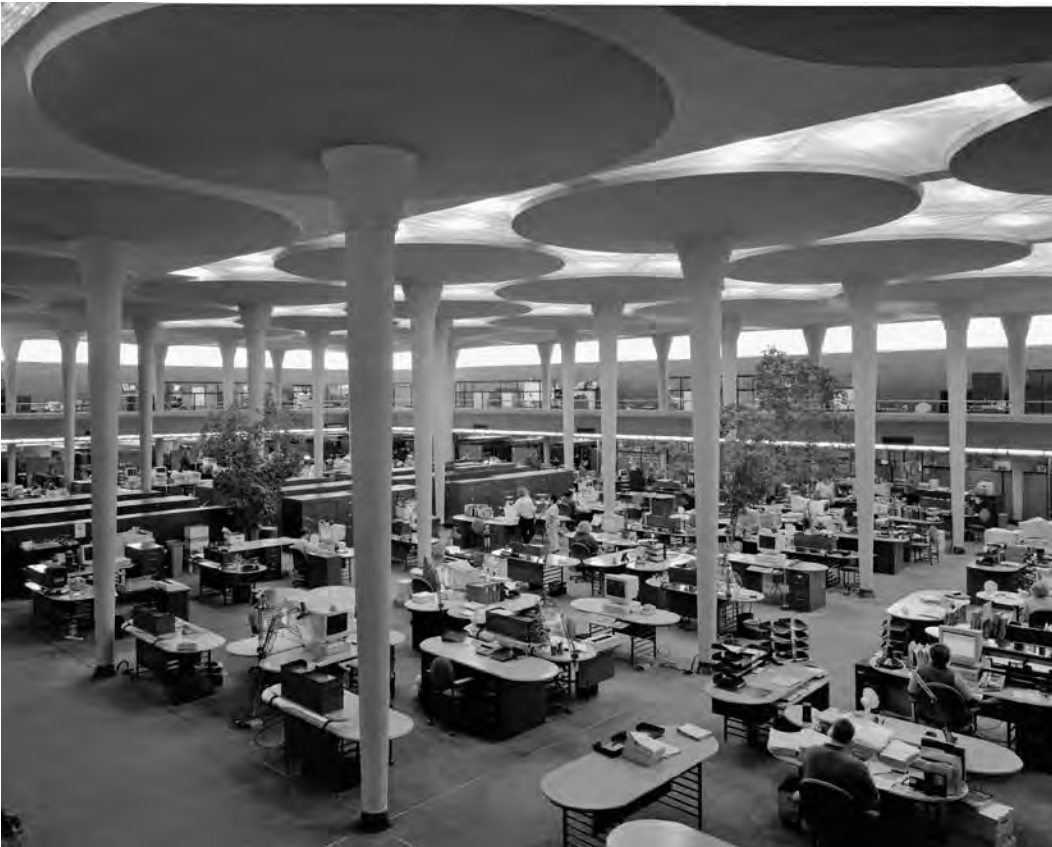
Figure 8.4. In the Johnson Wax Administration Building (1939), Racine, Wisc., Frank Lloyd Wright experimented with unusual mushroom-shaped, reinforced concrete columns. Before construction began these were loaded with sandbags to test their structural capacity.

Dramatic rib-and-arch designs of reinforced concrete began to appear in the 1930s, and in the Johnson Wax Administration Building (1939) Frank Lloyd Wright elevated the cantilevered slab-and-mushroom column to an aesthetic form.⁹ For much of the first half of the century, frank expression of concrete technologies appeared only in the most utilitarian buildings. In all others, concrete elements were heavily disguised; the Ingalls Building, for example, featured marble, terra cotta, and brick cladding. But by the late 1950s, when the functionalist aesthetic gained favor among architects, the concrete frame asserted itself. Load-bearing reinforced concrete screen walls, of delicate vertical members joined to horizontal members at floor level, clearly revealed their material

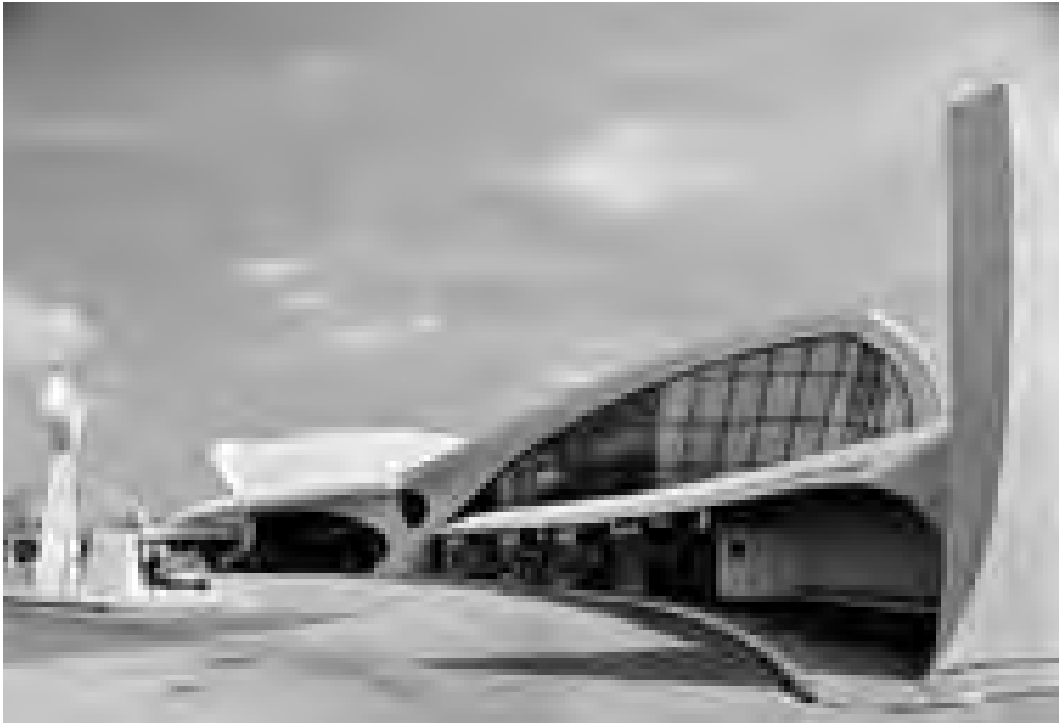
Figure 8.5. For the TWA Terminal (1962), New York City, Eero Saarinen used a more expressive form of reinforced concrete as well as thin-shell construction techniques. Saarinen's goal was "to design a building in which architecture itself would express the drama and . . . excitement of travel."

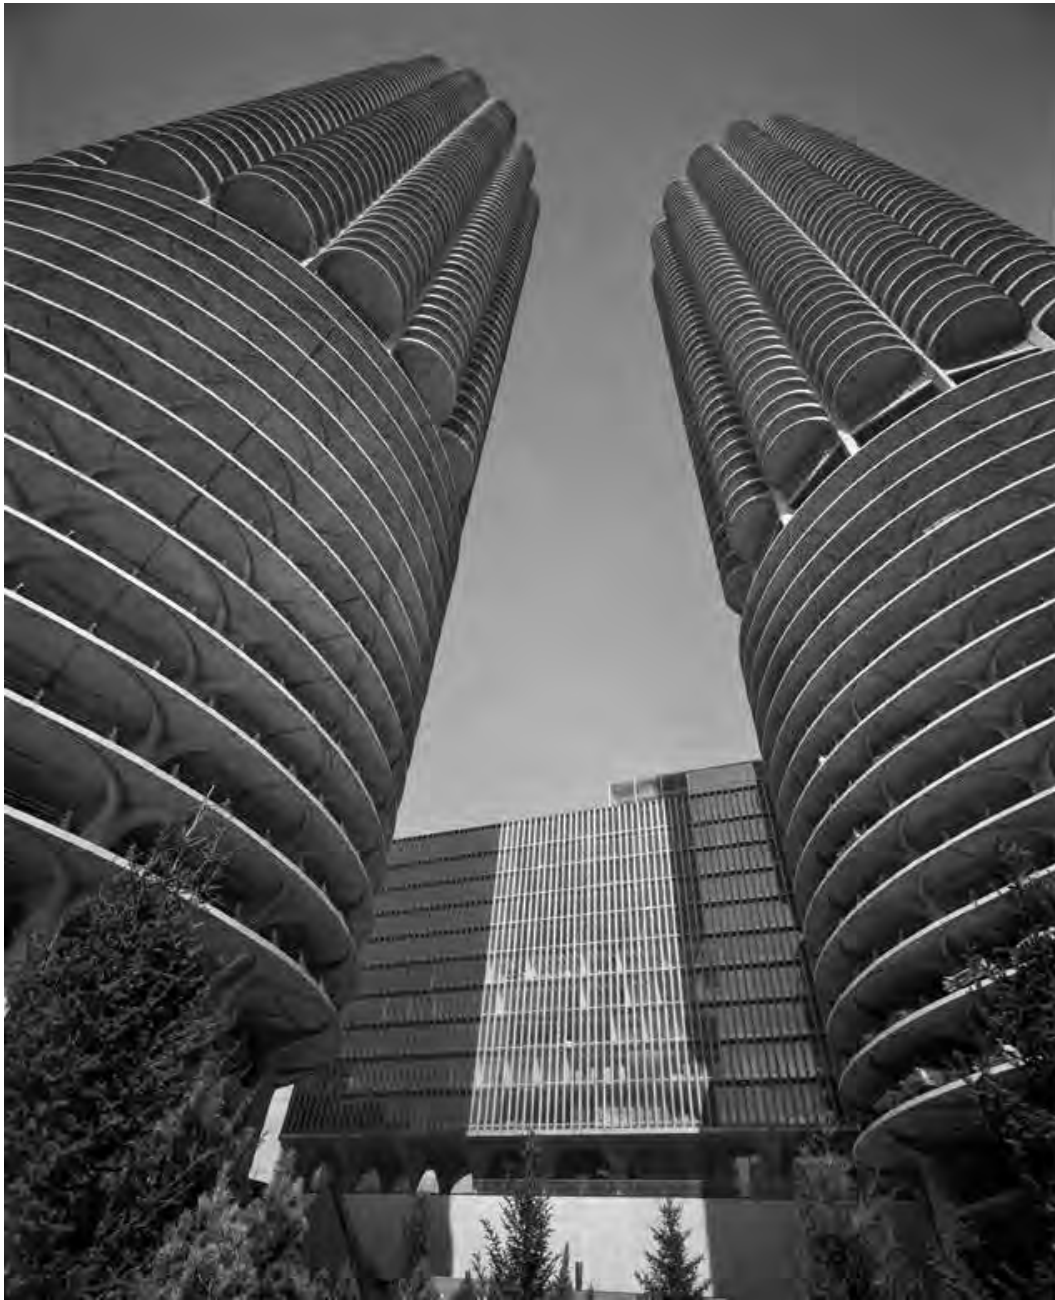
Figure 8.6. Curved, petal-like balconies of reinforced concrete project from the twin towers of Marina City (1963, Bertrand Goldberg), Chicago.

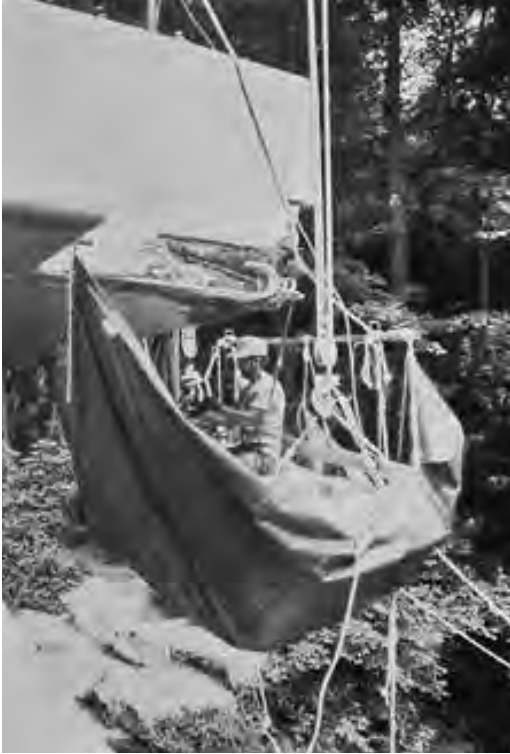
Figure 8.7. At Fallingwater (1937, Frank Lloyd Wright), Mill Run, Pa., conservators in suspended scaffolding assess deterioration of reinforced concrete.

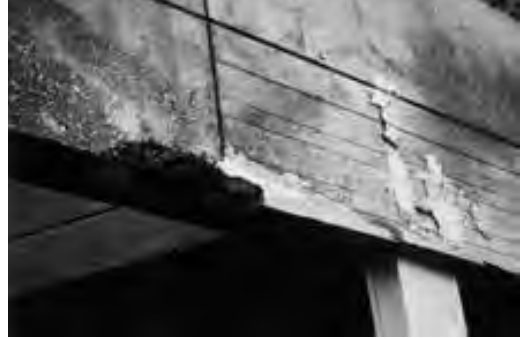
Figure 8.8. Cracking (top) can be caused by freeze-thaw cycles.

Damage due to cyclic freezing action results when concrete that is saturated with water freezes. This type of damage appears as surface degradation, including severe scaling and cracking, that extends into the concrete. It was accidentally discovered that portland cement concretes that incorporate microscopic air bubbles were resistant to damage from cyclic freezing and thawing. This air-entrainment provides "relief valves" that protect the concrete. Air-entraining agents are now usually added to mortar or concrete used in exposed applications in areas of the United States subject to subfreezing temperatures.

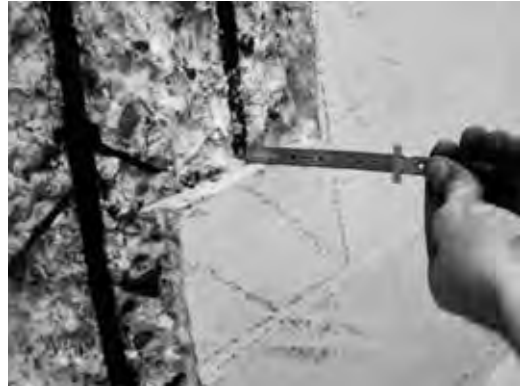
Figure 8.9. A worker measures the depth of concrete cover over reinforcement (bottom).

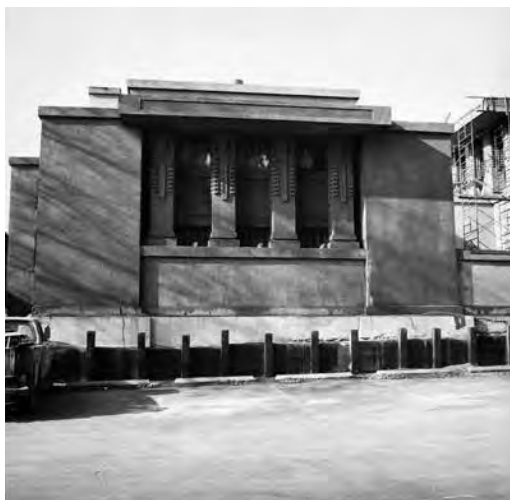
Figure 9.5. Unity Temple (1904, Frank Lloyd Wright), Oak Park, Ill., built of exposed aggregate reinforced concrete, was repaired with shotcrete in the 1970s.

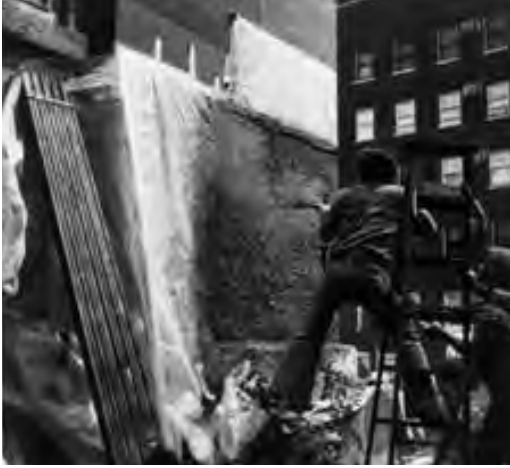
Figure 9.6. Wet-mix shotcrete, using pea-gravel aggregate from the original source, was applied to Unity Temple to match the original cast-in-place finish.

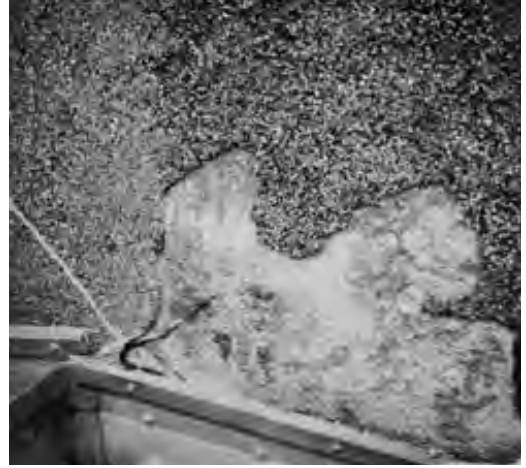
Figure 9.7. Expansion cracking caused the shotcrete surfaces to delaminate. Conservation of the deteriorated shotcrete is being planned.

Cracking and debonding (delamination) are the primary forms of shotcrete failure. A number of factors affect its long-term durability, including poor initial surface preparation, improper application, insufficient detailing, substrate flaws, and water infiltration. Thorough surface preparation is essential for achieving a secure coating, and a clean, stable substrate is necessary to assure proper bonding. In addition, shotcrete must be applied by a qualified applicator with proper equipment.

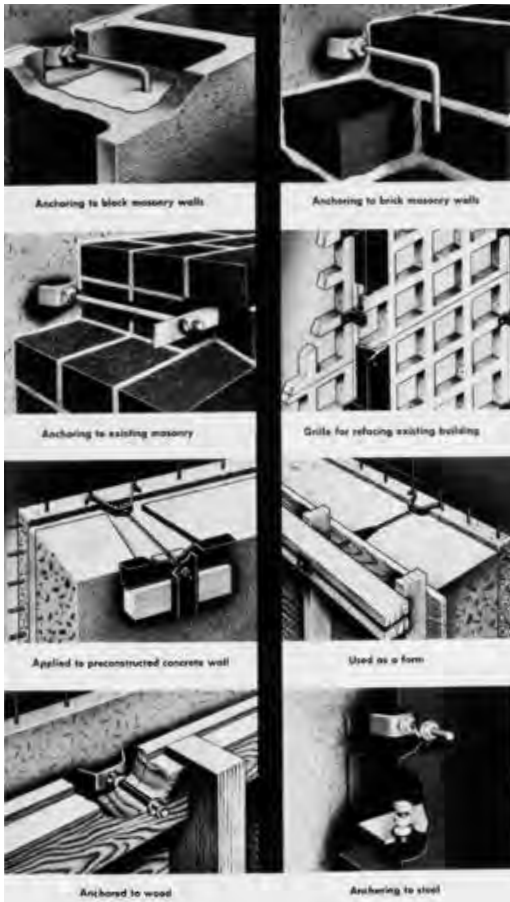
Figure 10.2. Mo-Sai anchoring systems fit various types of walls.

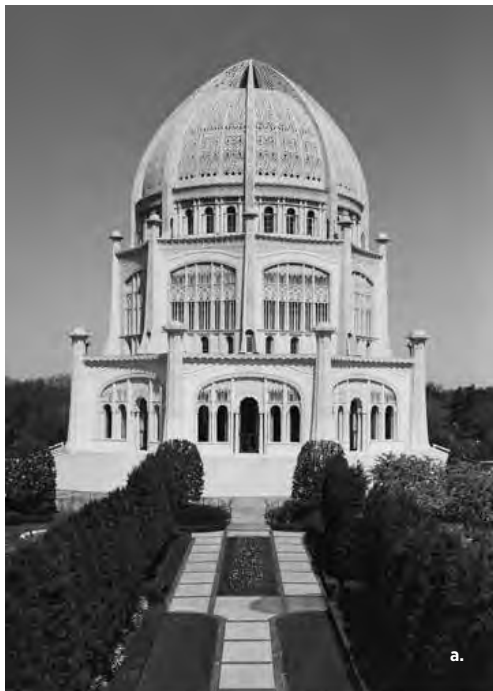
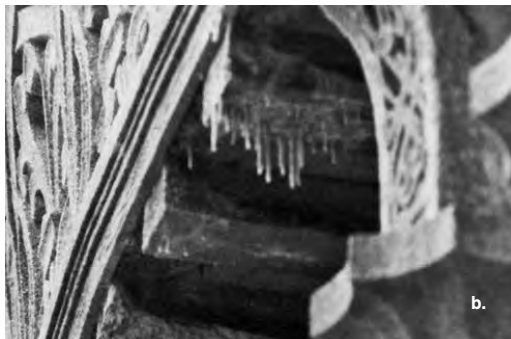
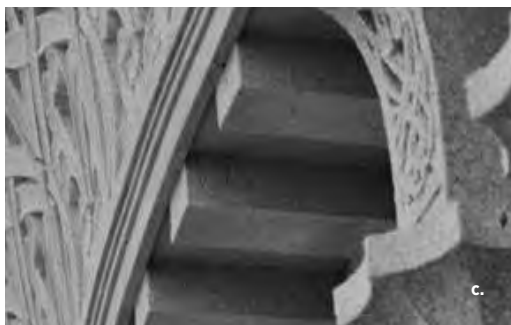
Figure 10.3a-c. a. At the Baha'i House of Worship (1920–53, Louis Bourgeois), Wilmette, Ill., water infiltration led to (b) efflorescence and stalactite formation. c. Components were patched in place.

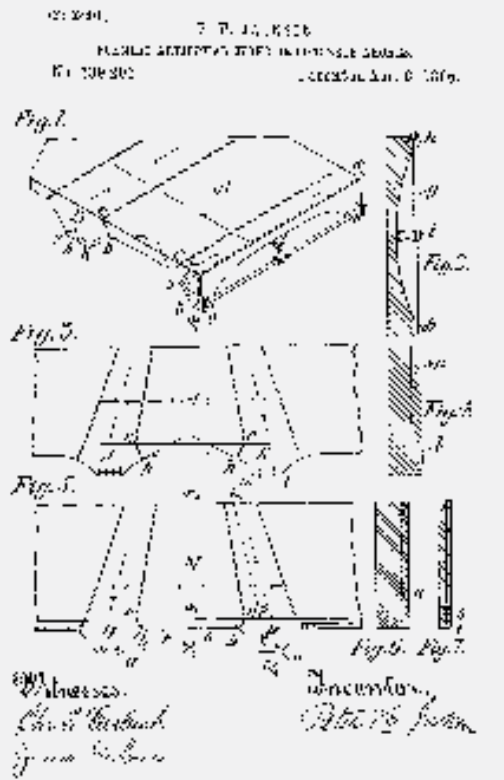
Figure 11.2. Early attempts to improve the durability of concrete by prestressing it, including P. H. Jackson’s patented arch system, failed.

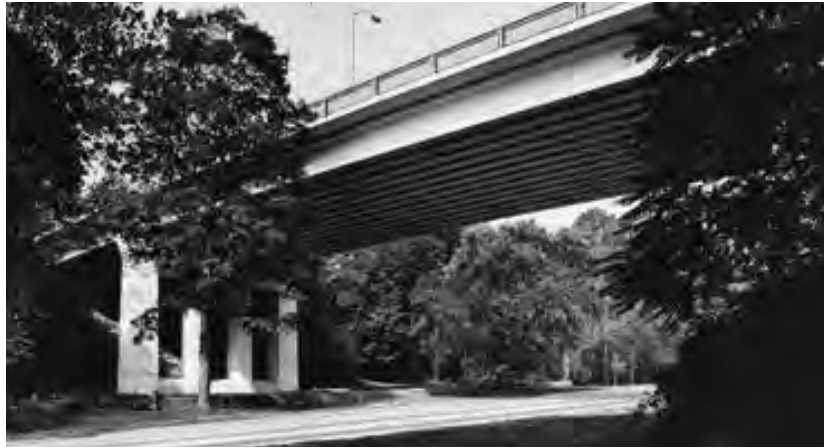
Figure 11.3. The Walnut Lane Bridge (1950, Gustave Magnel et al.), Philadelphia, was the first linear prestressed concrete structure in the United States (top). Before construction a 160-foot girder identical to the type used in the bridge was tested to failure.

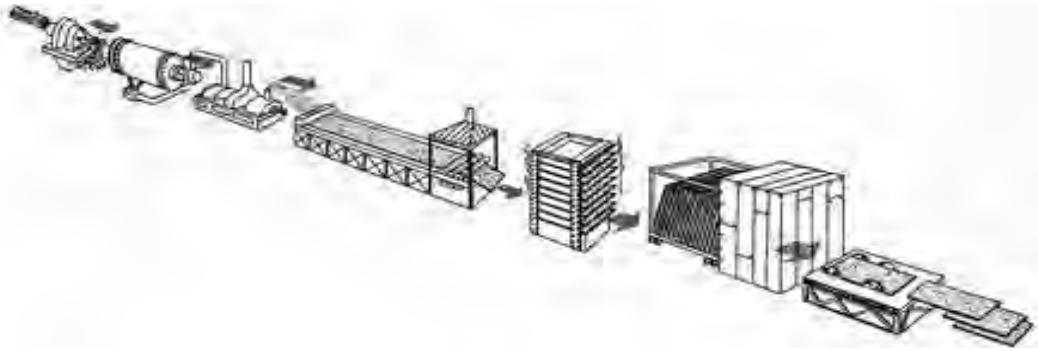
Figure 12.2. Steps in the manufacture of hardboard include (from left to right) chipping logs, defibering chips, refining fibers, compressing interlocking fibers into a continuous mat, treating with heat and hydraulic pressure to produce board sheets, adding moisture, and trimming for shipment.

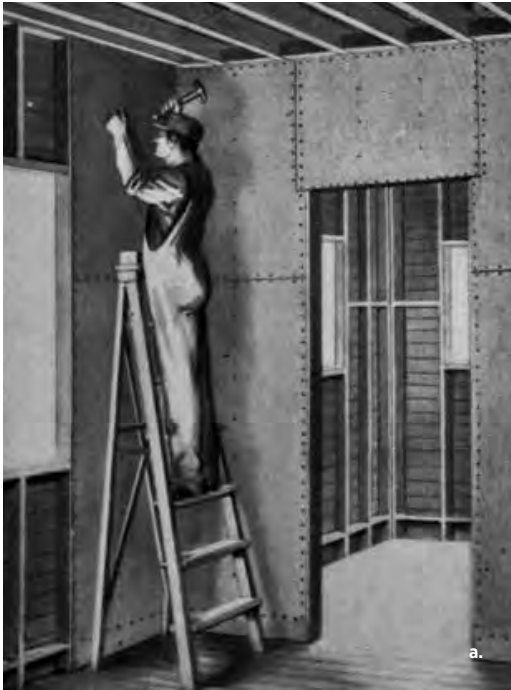
Figure 12.3a–b. **a.** The 1912 Beaver Companies catalogue showed how a carpenter could nail boards to wall studs and floor joists in any desired panel arrangement. **b.** Stained panel strips or battens used to cover nails created a paneled effect.

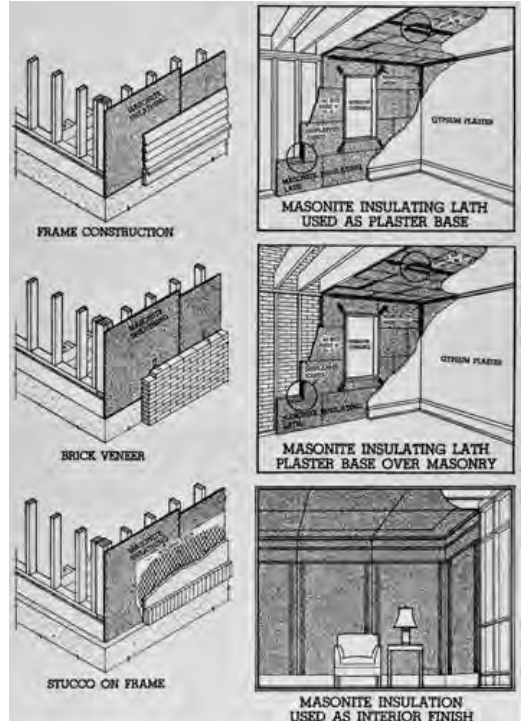
Figure 12.4. Masonite products could be used for both exterior sheathing (left) and as a plaster base for interior finish (right).

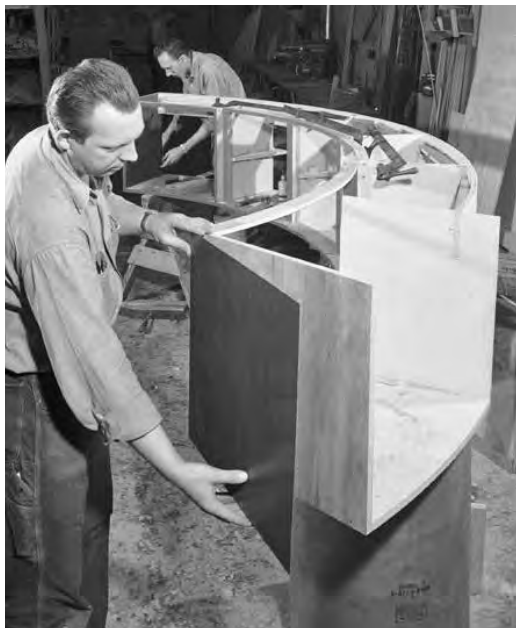
Figure 13.2. Decorative plastic laminates are installed and trimmed to fit the backing material. A worker applies a laminate with an adhesive to a wood substrate on the panel of a curved counter.

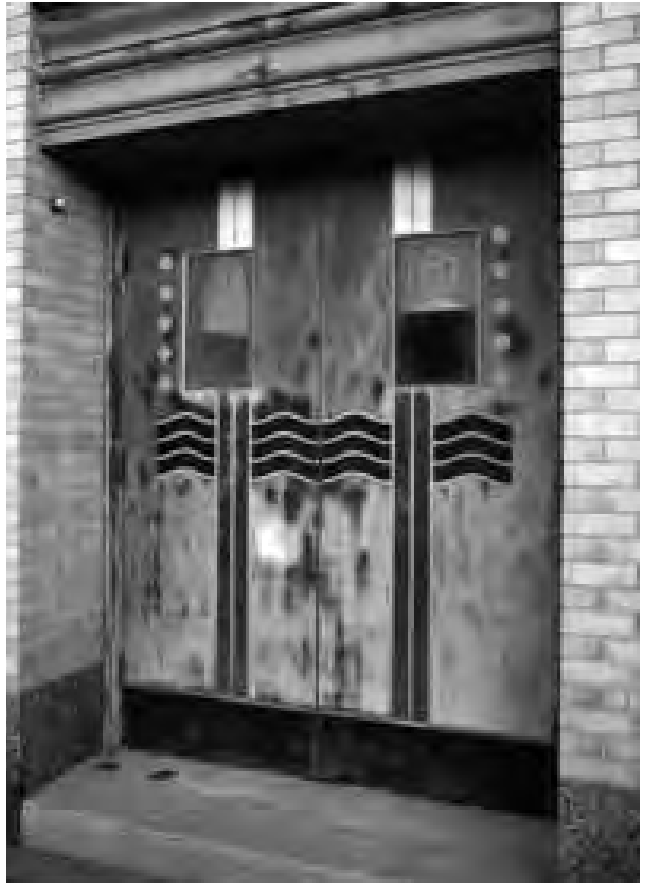
Figure 13.4. Decorative plastic laminates on the doors of the old Schine's Theater (1935, John Eberson), Auburn, N.Y., have faded from exposure to sunlight and have abraded from use.

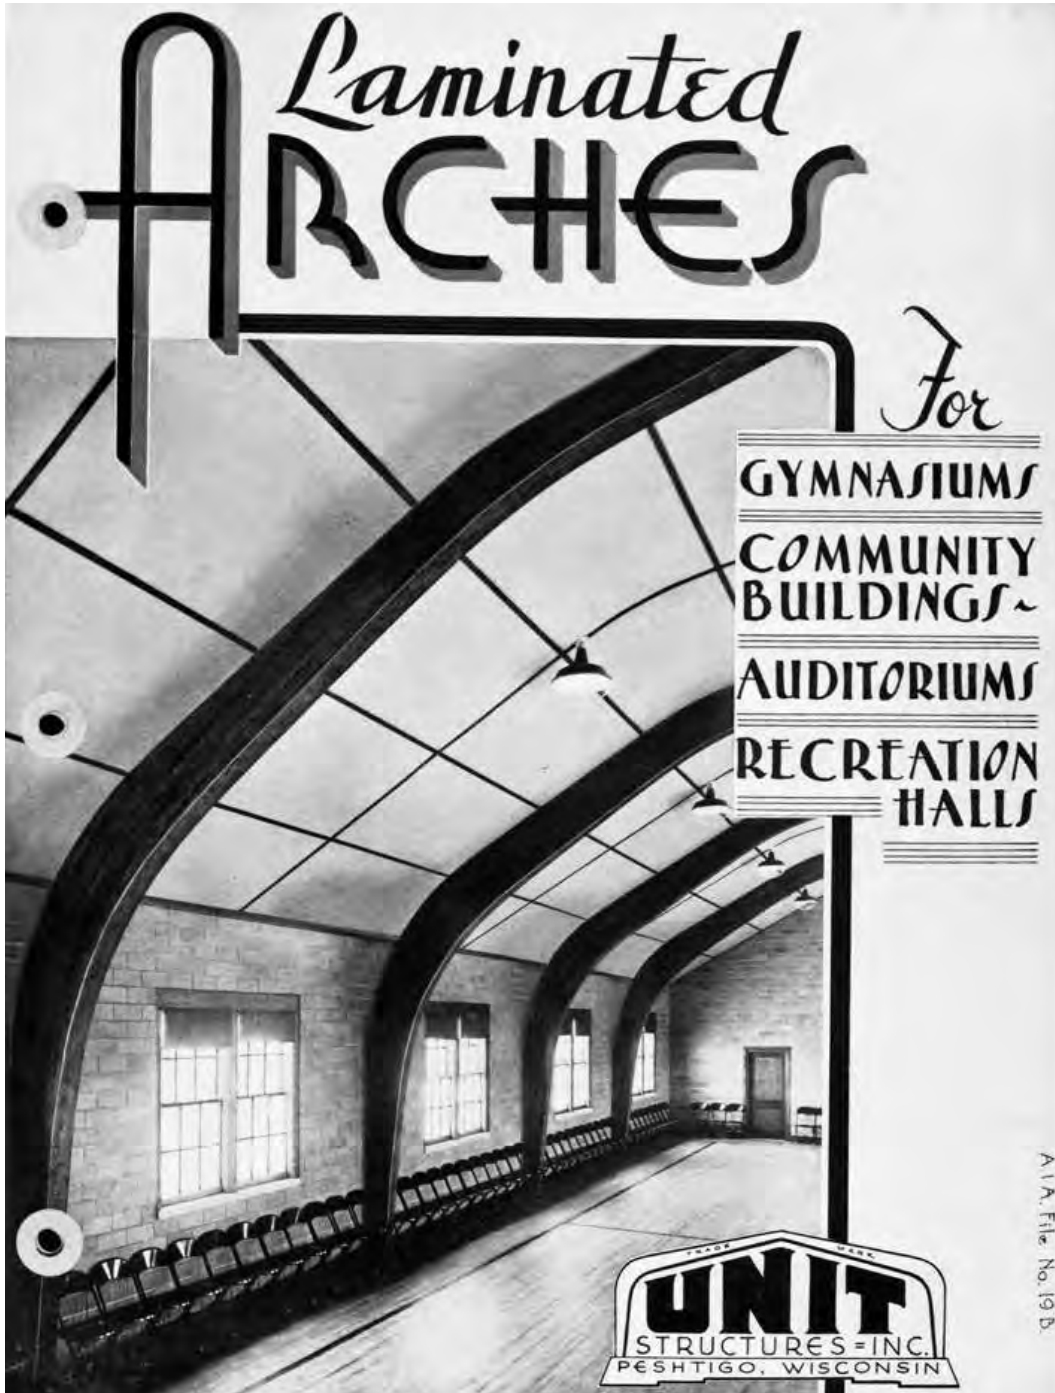
Figure 15.1. Unit Structures, the first U.S. company to manufacture glued laminated timber, marketed laminated arches for gymnasiums, auditoriums, and recreation halls. Laminated Arches catalogue, Unit Structures, Peshtigo, Wisc., 1939.

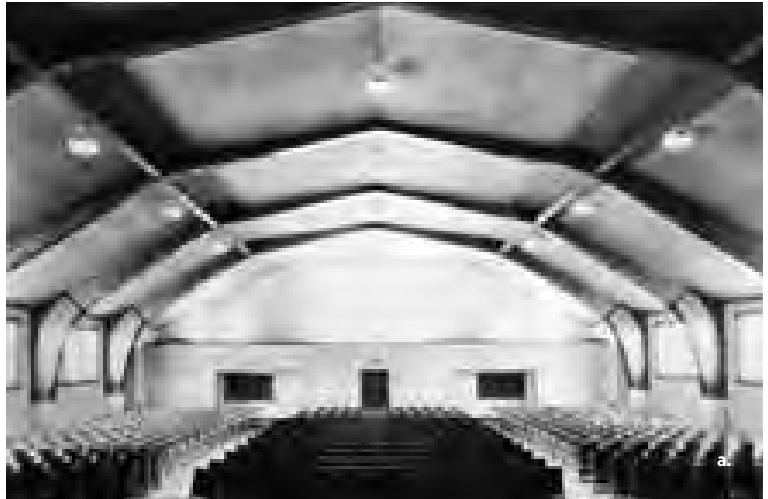
Figure 15.3a–b. The Peshtigo High School gymnasium (1934, Max C. Hanisch, Sr.), Peshtigo, Wisc., the first glued laminated building in the United States (a), used one of the typical arch shapes available in the 1930s, such as these manufactured by Unit Structures (b).

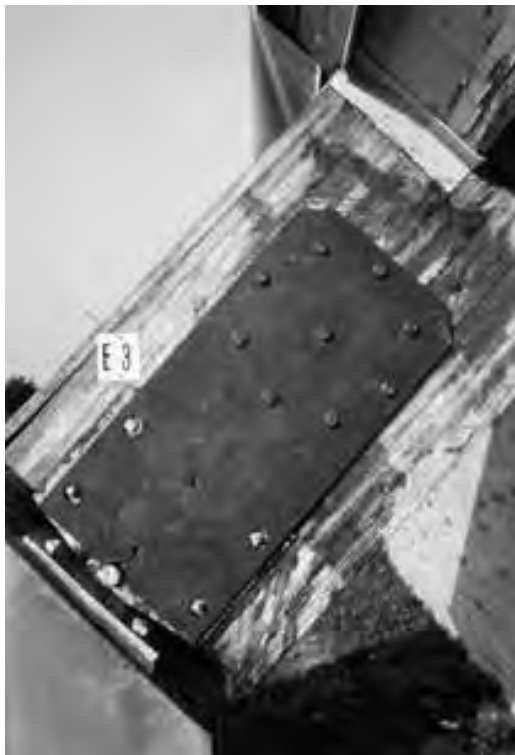
Figure 15.4. Shear plates were installed during repair of the Cary High School gymnasium, Cary, N.C.

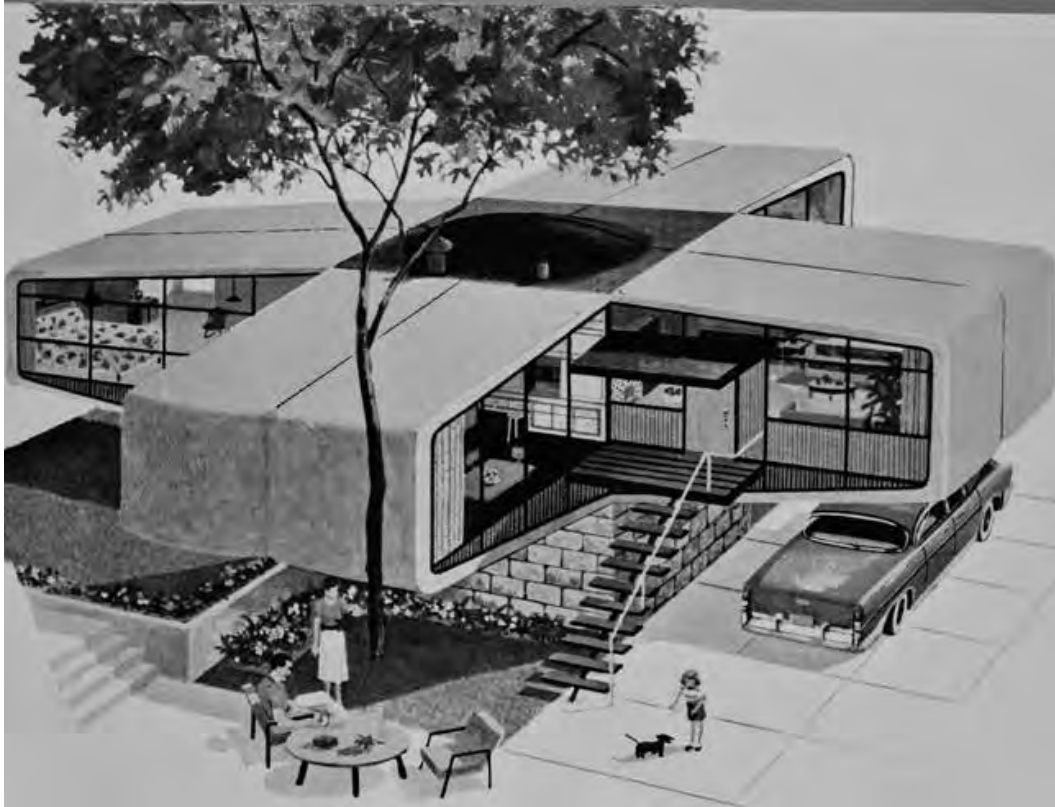
Figure 16.1. Probably the most celebrated plastic house ever built, the Monsanto House of the Future (1957, Albert G. H. Dietz, Hamilton and Goody), constructed at Disneyland, Anaheim, Calif., had modular fiber reinforced plastic walls filled with foam insulation. *Popular Science*, April 1956.

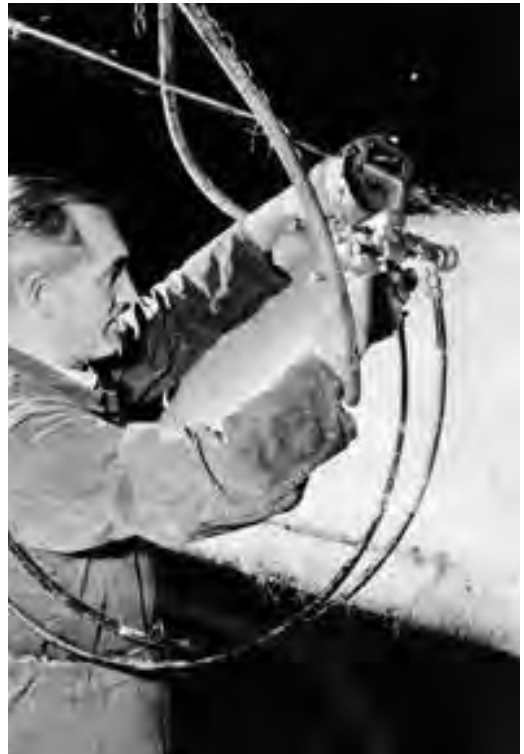
Figure 16.2. When the spray lay-up technique is used to fabricate components with fiber reinforced plastic, the resin and reinforcing materials are sprayed onto the mold simultaneously.

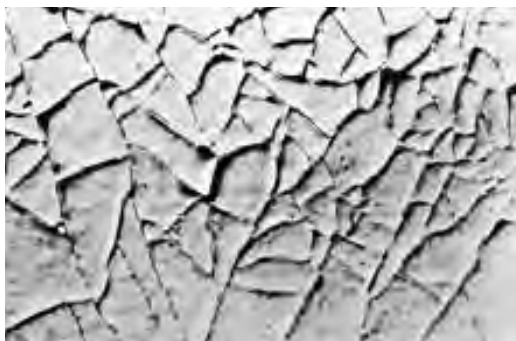
Figure 16.5. Unsuitable gel coats or resin formulations of fiber reinforced plastic components can cause crazing, or fine surface cracks (top).

Weathering erodes the resin, exposing fibers on surface components. Water subsequently penetrates the laminate by capillary action (wicking) along the glass fibers and causes a bloom or whitening by attacking the resin-fiber interface.⁴¹ Gel coats can prevent or limit such deterioration. However, additives used in the gel coat to

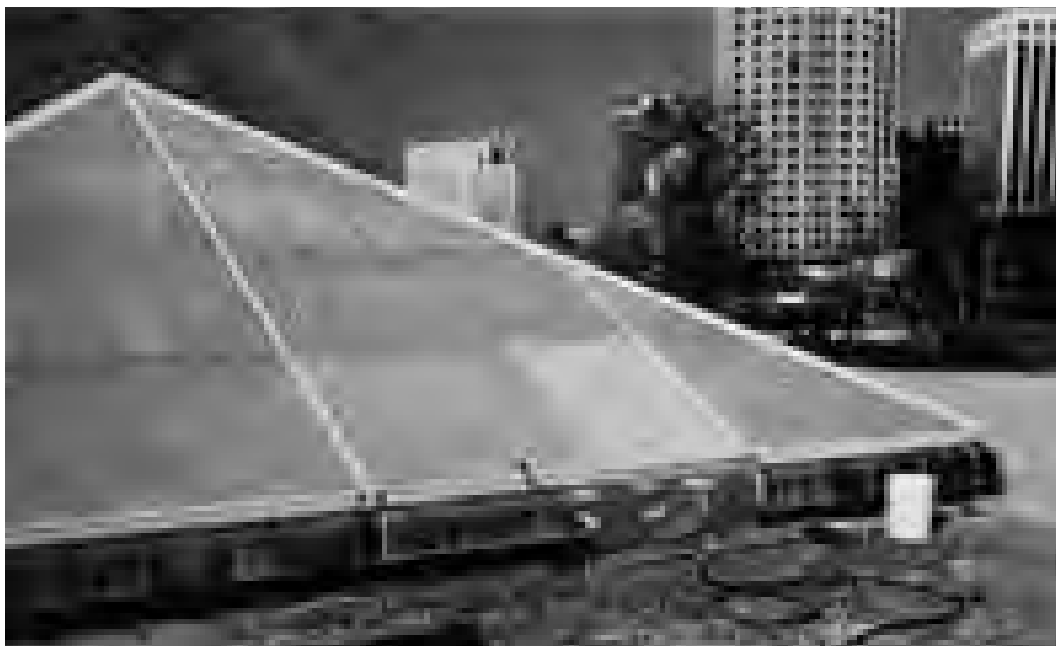
Figure 16.6. Unlike some plastics, fiber reinforced plastic can be repaired. Techniques range from resurfacing to cutting out and replacing the defective material. Translucent Kalwall panels that were damaged in a skylight installation have been resurfaced (bottom).

Unlike many plastics, FRP can be repaired. However, it is often difficult to match the surface appearance of opaque materials or achieve a similar degree of transparency for translucent FRP.

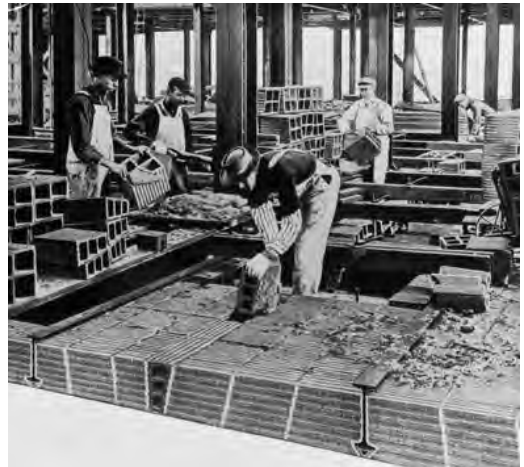
Figure 17.2. The blocks forming this combination floor arch were covered with concrete to stiffen the floor and distribute the load.

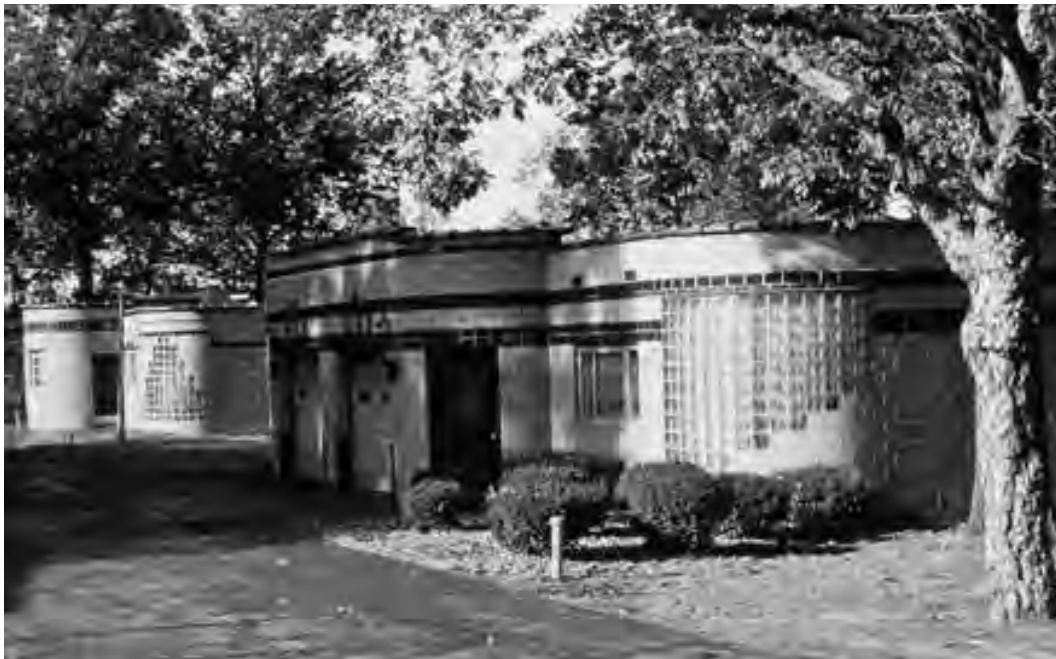
Figure 17.3. Expanses of glazed structural clay tiles, applied over concrete masonry, and glass block give the Coral Court Motel (1941, Adolph L. Struebig), near St. Louis, Mo., its distinctive streamlined appearance.
