TWENTIETH-CENTURY
BUILDING MATERIALS
HISTORY AND CONSERVATION

EDITED WITH A NEW PREFACE BY THOMAS C. JESTER

GETTY CONSERVATION INSTITUTE, LOS ANGELES

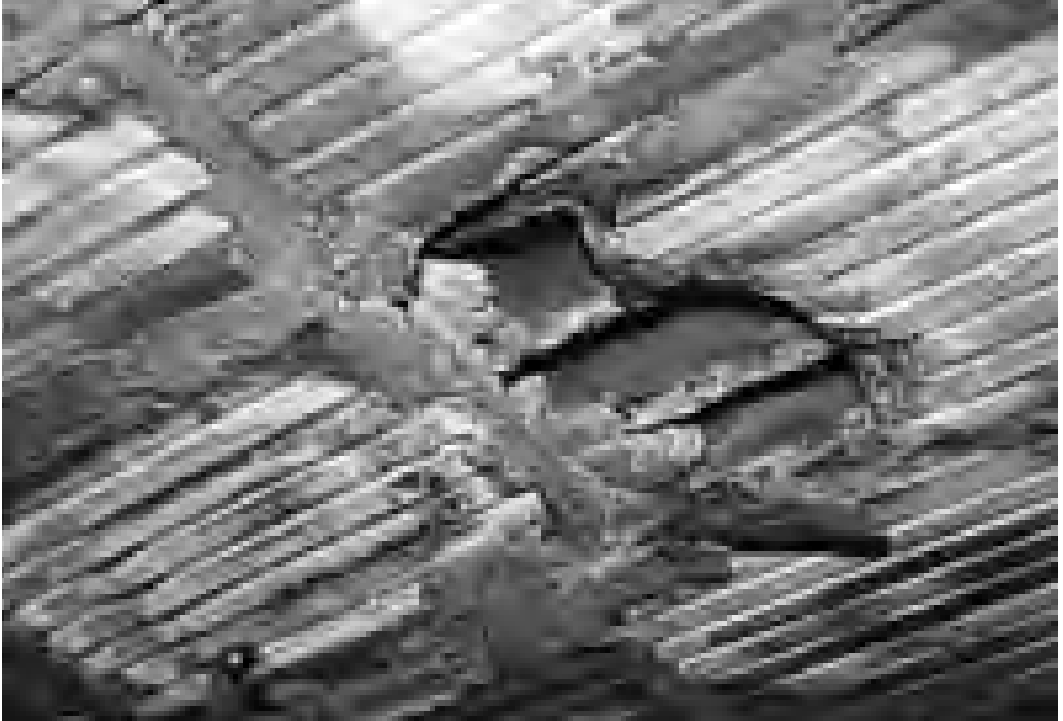
Figure 17.5. The soffit of this structural clay tile flat roof arch is severely deteriorated. Excessive moisture in the arch has caused efflorescence, and the tiles are spalling. A thorough structural assessment is required for tiles in this condition to determine whether replacement is necessary.

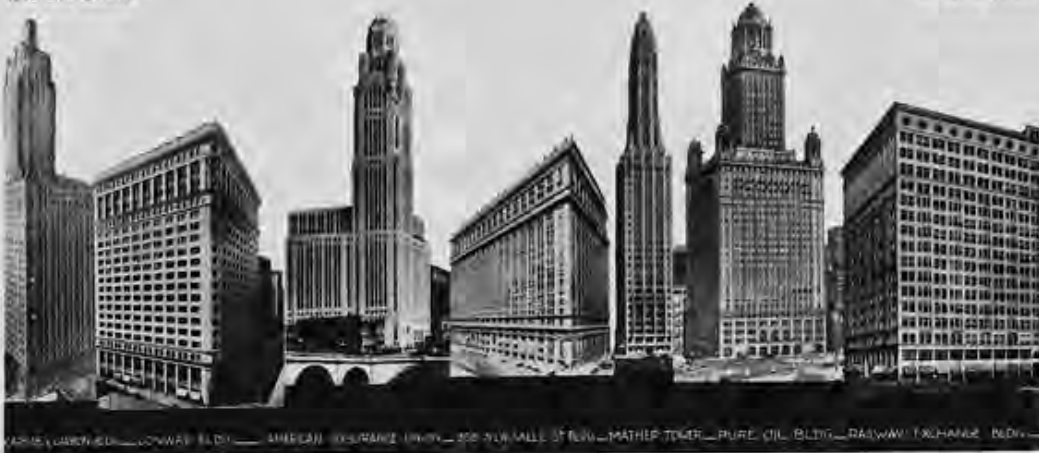
Figure 18.1. The Northwestern Terra Cotta Company offered stock and custom terra cotta elements with plain or mottled glazes to suit a variety of architectural applications. In the 1930s shallow relief patterns gained popularity for features such as spandrels. *Sweet's Architectural Catalogues, 1932.*

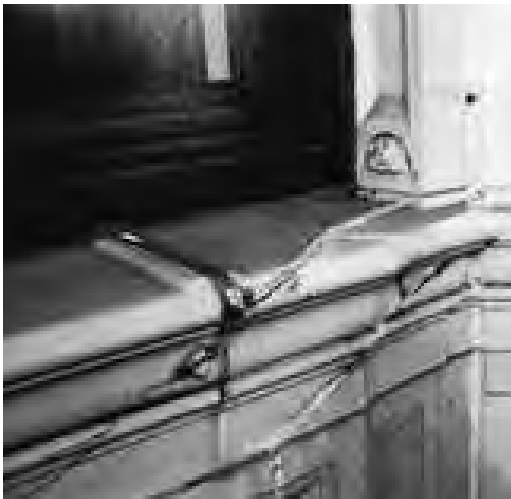
Figure 18.5. Terra cotta distress is often related to expansion corrosion of embedded metal anchorage elements.

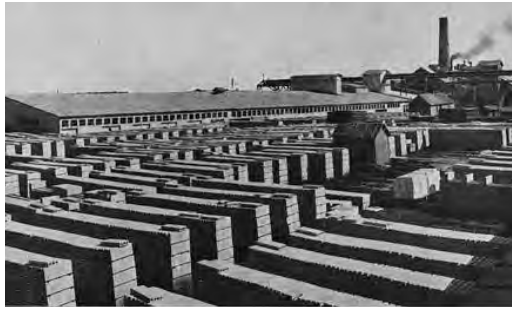
Figure 19.2. Once cast in molds, tiles were dried in the open, in kilns, or in drying sheds, which were heated with air, steam coils, or direct furnace heat. Stacks of gypsum blocks and tiles await shipment to distributors around 1917 (top).

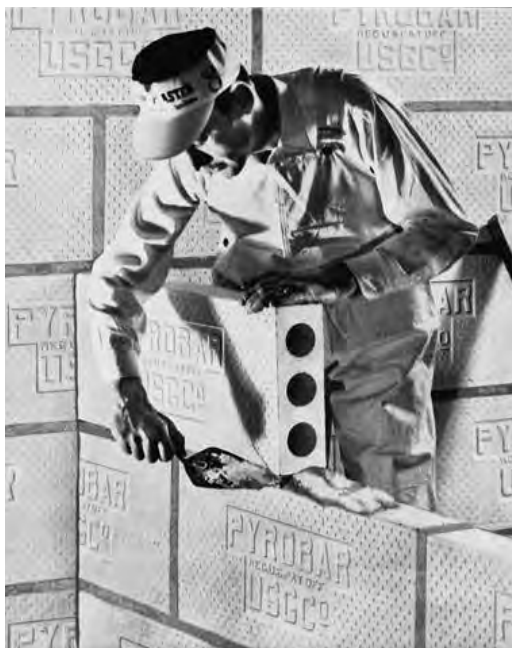
Figure 19.3. Quick-setting cement mortar was used to lay up United States Gypsum's Pyrobar tiles to create partitions (bottom). Tiles could easily be cut to fit various types of wall constructions and fireproof beams and girders, thus speeding construction and lowering costs.

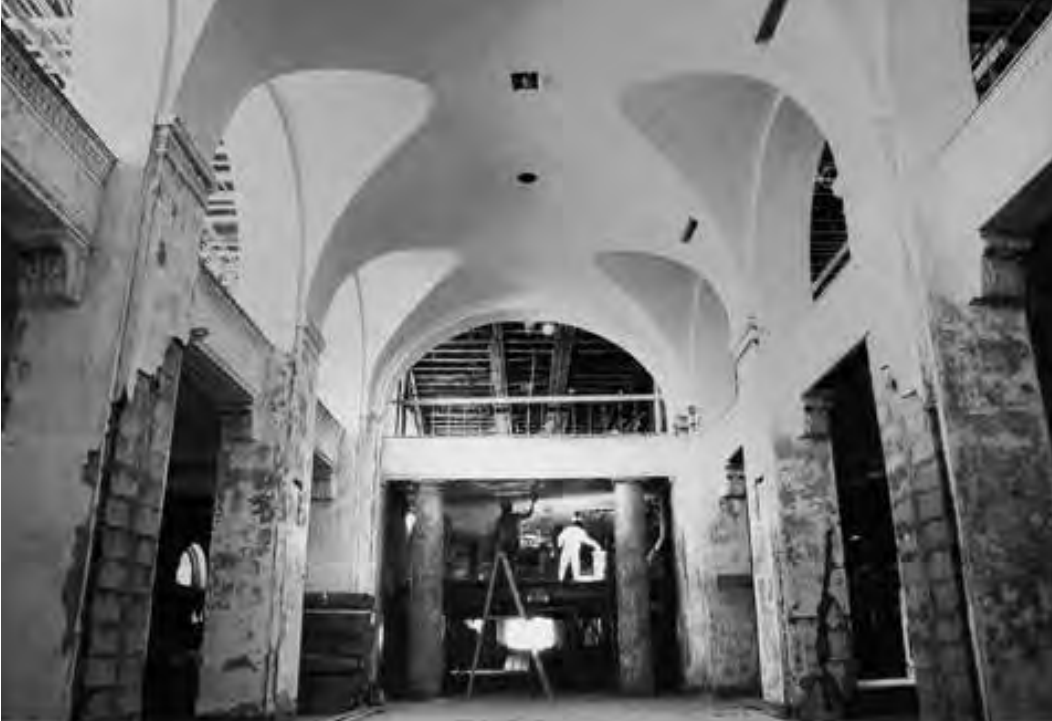
Figure 19.6 During restoration of the Vinoy Park Hotel (1925, Henry L. Taylor), St. Petersburg, Fla., deteriorated gypsum furring tiles in the lobby were replaced with concrete blocks, visible in the columns.

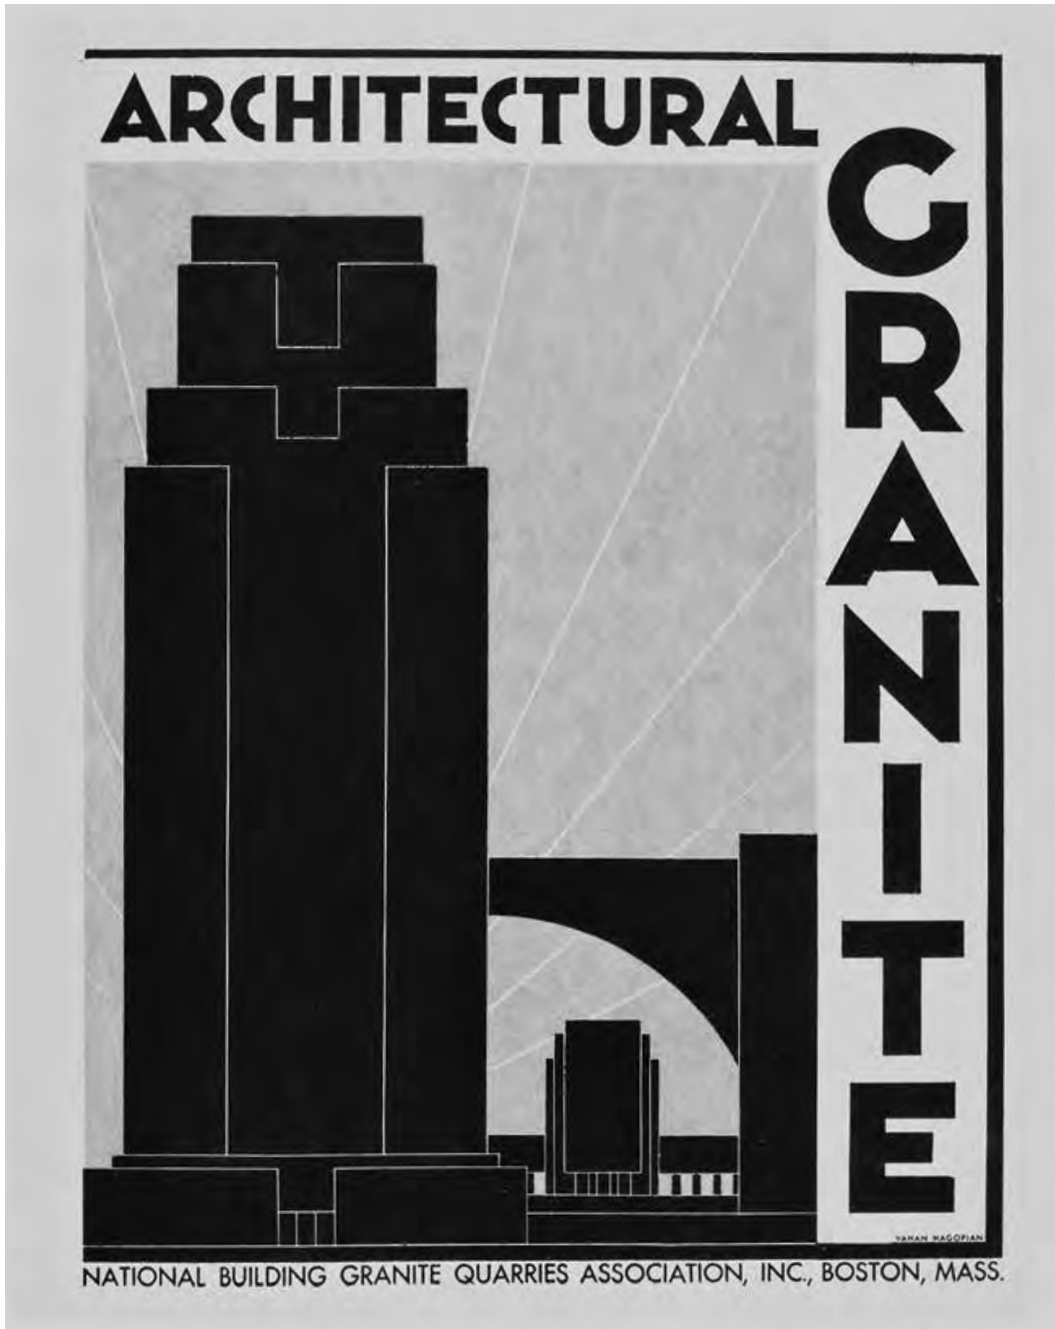
Figure 20.1. A design guide by the National Building Granite Quarries Association included details about anchoring “modern granite veneer,” stone less than 4 inches thick. *Sweet’s Architectural Catalogues*, 1932.

Veneer panels were typically laid up on mortar beds, and joints were finished with mortar in a manner similar to traditional masonry construction. Interior panels were tied to the backup material, brick or block, by wire anchors set in holes drilled into the panels and discrete mortar spots. Lateral anchoring of exterior panels

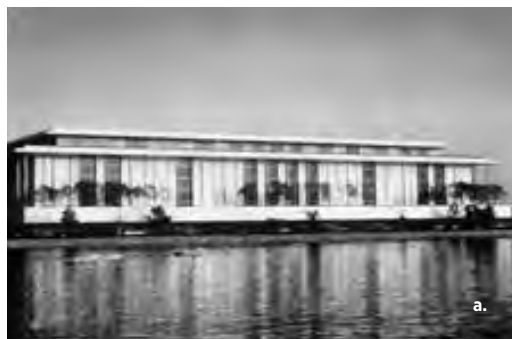
Figure 20.4a–c. The John F. Kennedy Center for the Performing Arts (1964, Edward Durell Stone), Washington, D.C. **a.** This was one of the first prominent buildings to be clad in thin stone veneer. **b.** Spalls, such as this one in a travertine panel, often occur at concealed metal anchors. **c.** Torque testing of a remedial expansion anchor installed in a precast concrete backup ensures that the panel is properly attached.

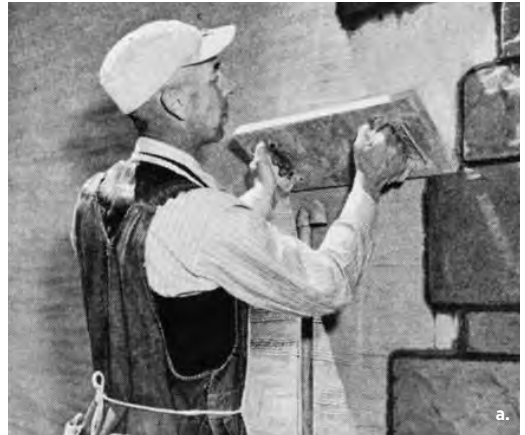
Figure 21.3a-b. a. A worker hand-presses a final Perma-Stone coat to a wall surface. b. Perma-Stone could be applied to many new and existing substrates.

To install Perma-Stone, metal or wood lath is secured to the building to provide a base for attachment. The application process is a three-part procedure. A first coat, referred to as a brown coat, is applied over the lath. Before it sets, it is grooved to provide additional surface area for the next coat. Once dry, the second coat (the scratch coat) is applied. While the second coat is still wet, the finish coat is applied through the use of pressure molds designed to imitate the look of natural stone.¹⁴ Minor hand finishing and application of a final membrane coating to serve as a water repellent complete the job.

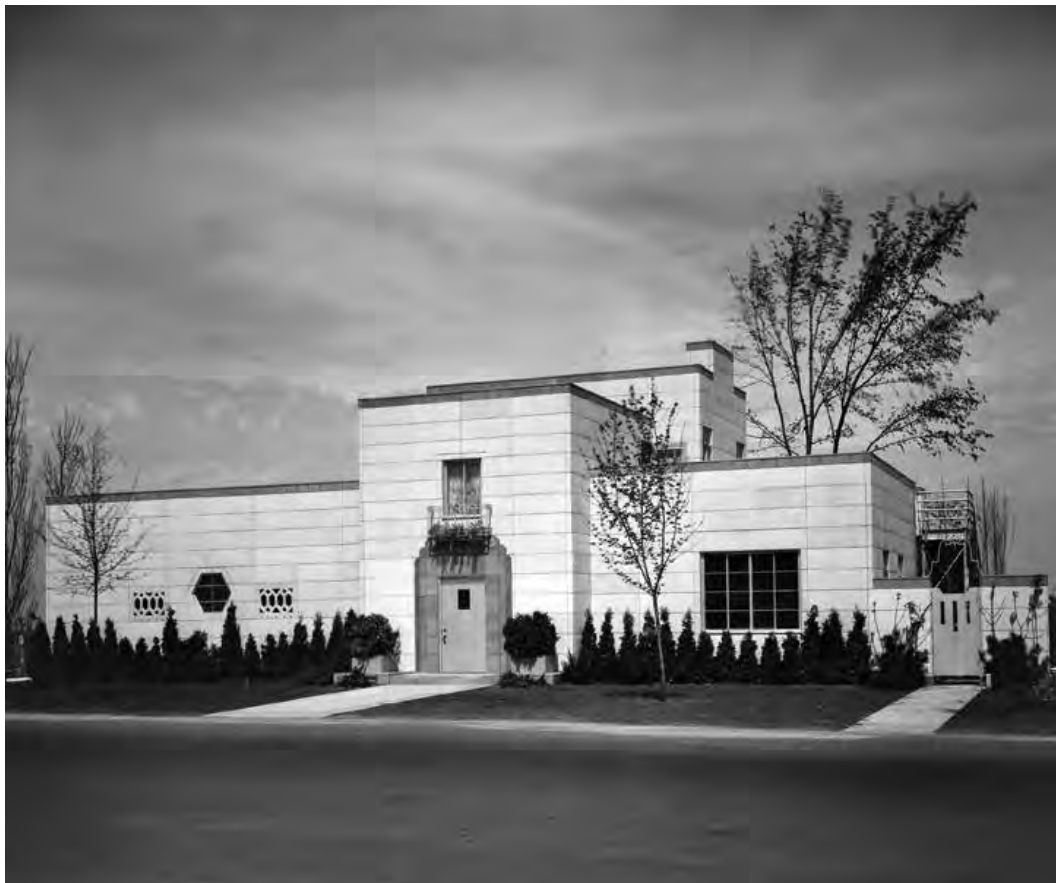
Figure 21.4. The Wieboldt-Rostone House (1933, Walter Scholer), Beverly Shores, Ind., used Rostone, a precast form of simulated masonry.

Rostone panels were produced as standardized 16-by-24-inch sheets either 1 inch or 1¼ inches thick; custom sizes and shapes were available at an additional cost. The panels could be finished in three surface textures: honed, a polished surface; natural, a slightly rough finish that mimicked natural stone; and shot blast, a moderately rough surface. Rostone could be made in any color, but earth tones were most popular. Greens, pinks, and reds were used as accent colors in carved designs and to convey a multidimensional look.¹¹

In modernization and remodeling projects, Rostone panels were applied directly over the existing wall surface. When Rostone was used in new construction, the panels were attached to a steel frame with specially designed clips. The joints were filled with a mastic, thus providing an easily maintained system.¹²

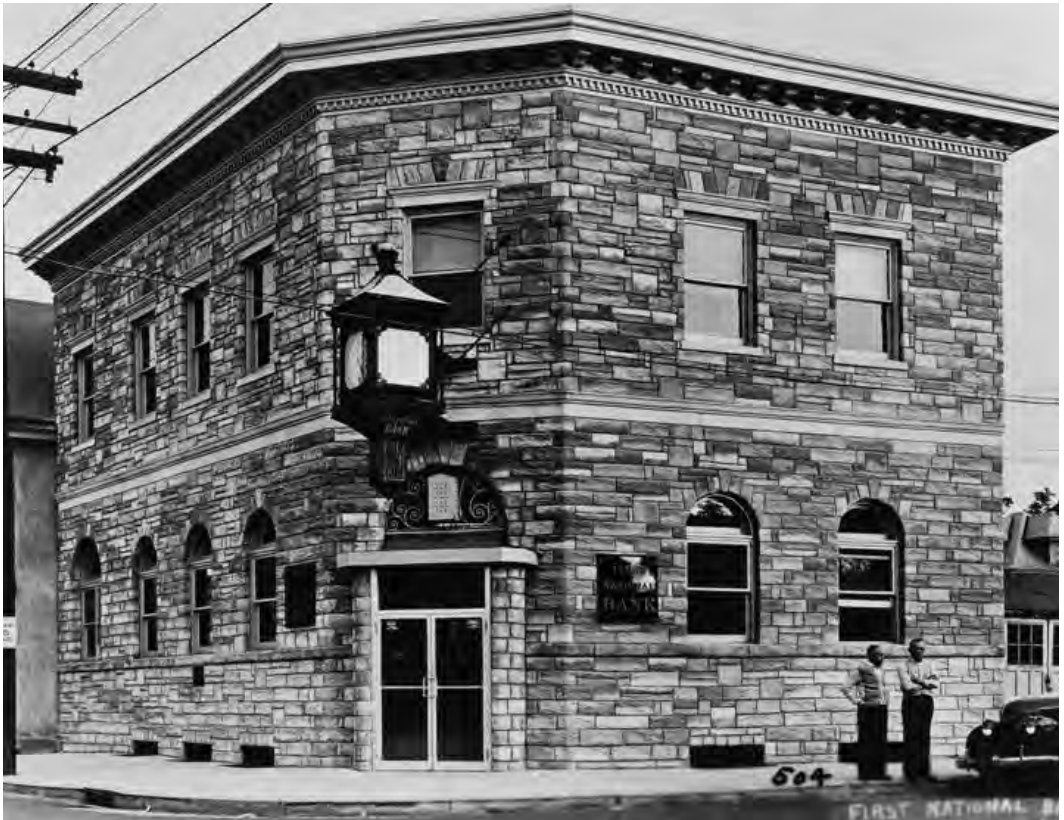
Figure 21.5. Across America in the 1940s and 1950s buildings like this bank were remodeled with Perma-Stone.

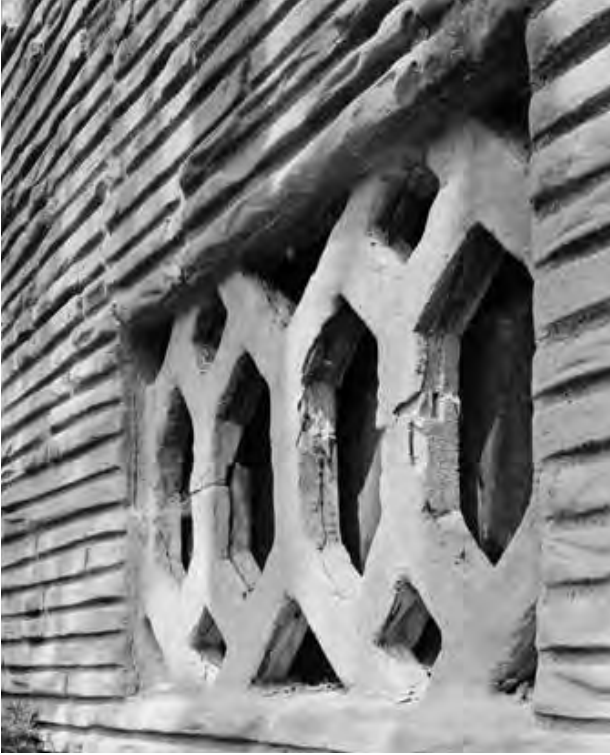
Figure 21.6. In 1950 the Wieboldt-Rostone House was covered with Perma-Stone, shown in poor condition.

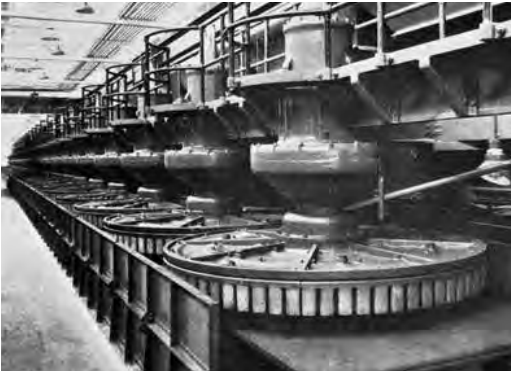
Figure 22.2. In the continuous grinding process perfected at the Ford Motor Company, Detroit, the annealed glass moved on railcars under the grinders, fed with progressively finer sands (top). Plates were then inverted, and the process was repeated.

Following World War I the automobile industry created a new market for plate glass. In 1918 the Ford Motor Company conceived the idea of manufacturing plate glass for automobiles by continuous methods.¹⁸ The continuous process, introduced in 1923, automated the entire manufacturing process.¹⁹ Molten glass in large tanks flowed

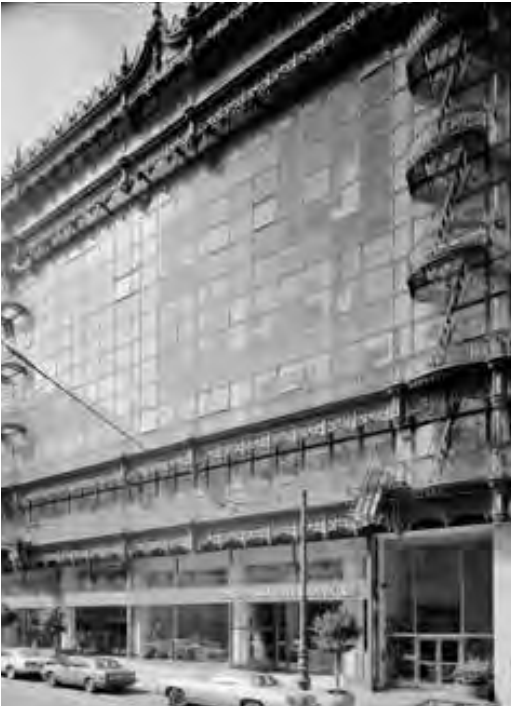
Figure 22.3. The Hallidie Building (1918, Willis Polk), San Francisco, one of the earliest buildings with a glass facade, had large, operable window sashes placed several feet in front of the end of the floor beams and window sills only 3 inches thick (bottom).

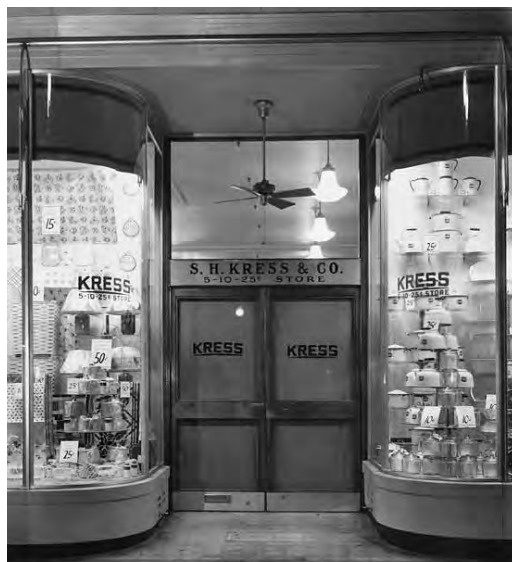
Figure 22.4. Plate glass was the material of choice for shop windows, where the highest quality glazing was a necessity for displays. This simple Kress Company store with curved plate glass is a typical example.

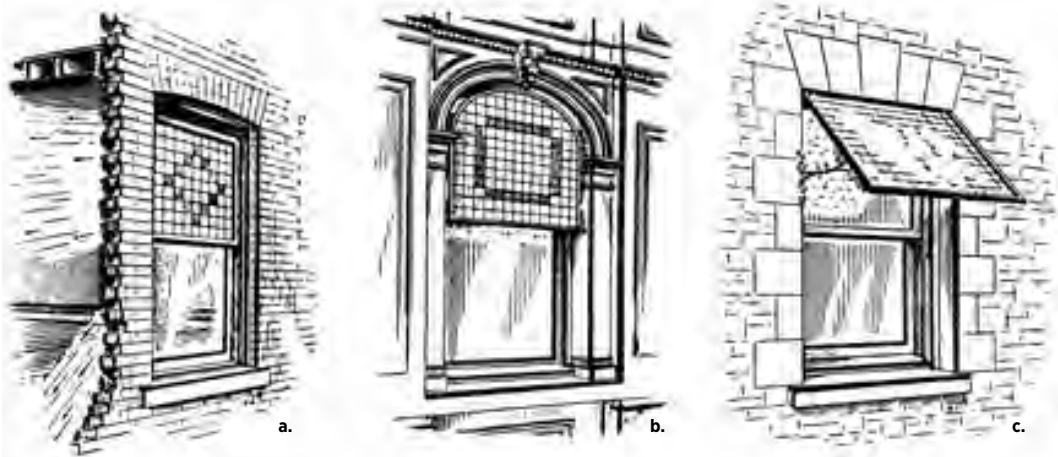
Figure 23.4a-c. Common types of prismatic glass installations included (a.) window sash filled with prismatic glass; (b.) separate screens set in front of window glass; and (c.) protruding canopies, often used for buildings on narrow streets or where tall buildings blocked natural light.

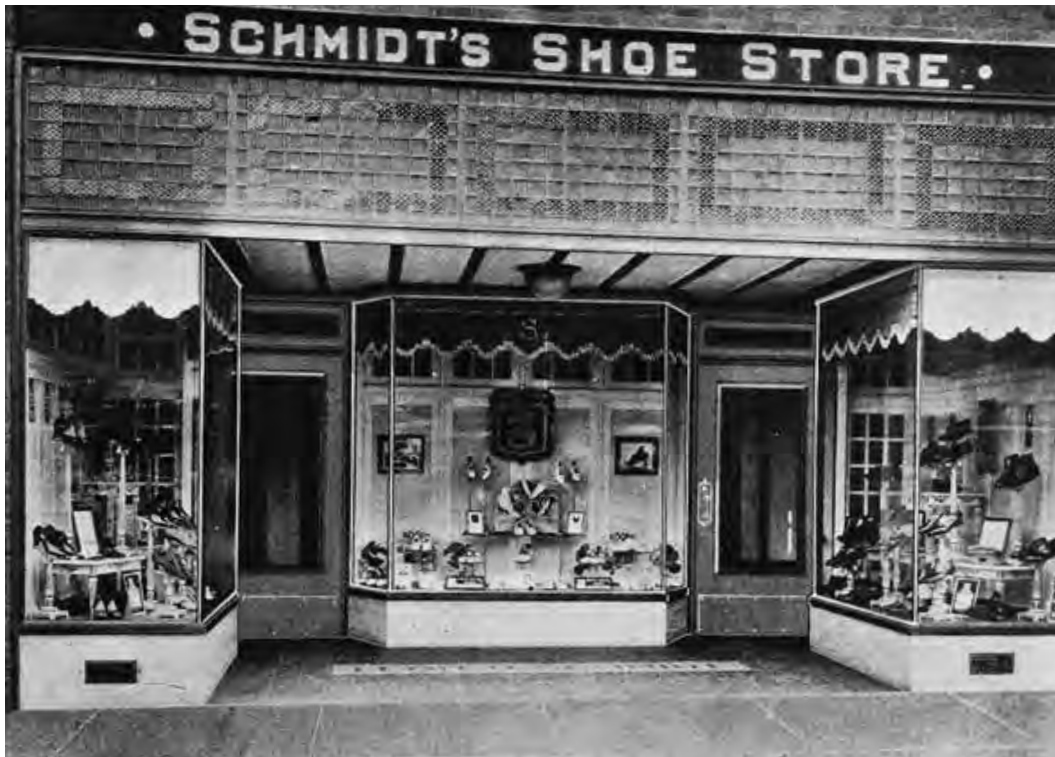
Figure 23.5. The widespread use of prismatic glass panels in storefronts, usually incorporated as a horizontal band in the upper third of the storefront, changed the appearance as well as the design of stores. The 2- to 4-foot-high panels were generally fixed in steel frames with copper, zinc, or lead.

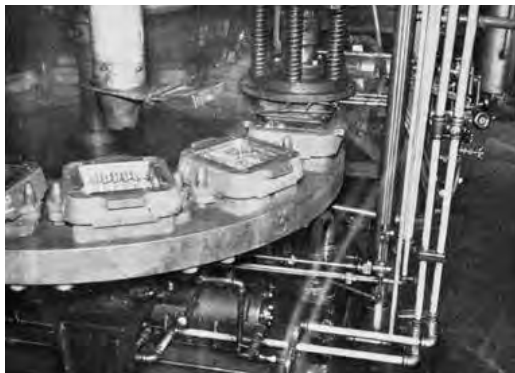
Figure 24.2. By pressing molten glass into molds, manufacturers were able to produce blocks with walls of uniform thickness and strength (top). The plunger creates the pattern on the interior face.

Several American glass producers experimented in the early 1930s with solid and partially evacuated blocks.¹⁰ In 1929 the Structural Glass Corporation introduced several sealed hollow glass blocks, and the Owens-Illinois Glass Company introduced the first pressed glass block in 1932.

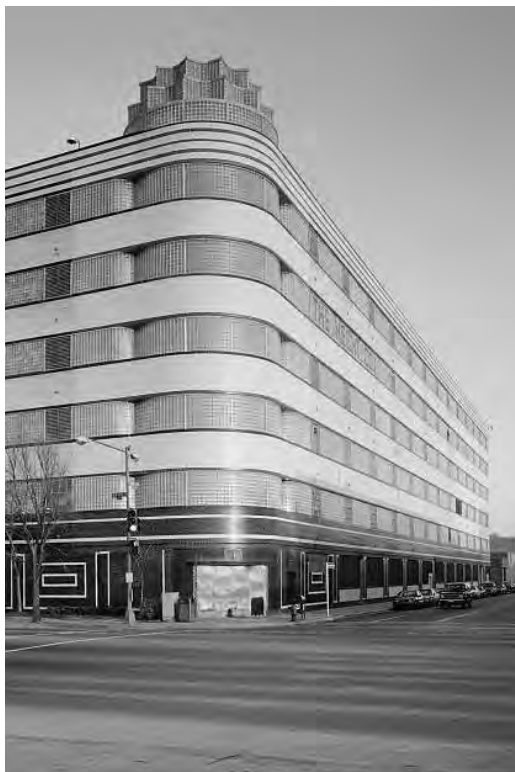
Figure 24.3. The Hecht Company Warehouse (1937, Abbott, Merkt), Washington, D.C., represented one of the earliest large-scale architectural applications of glass block (bottom). The sleekness of glass block made it a perfectly compatible material for Art Deco designs.

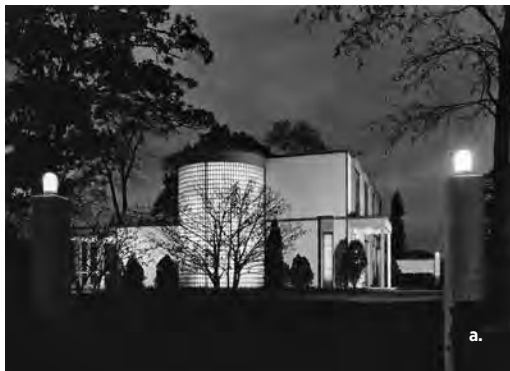
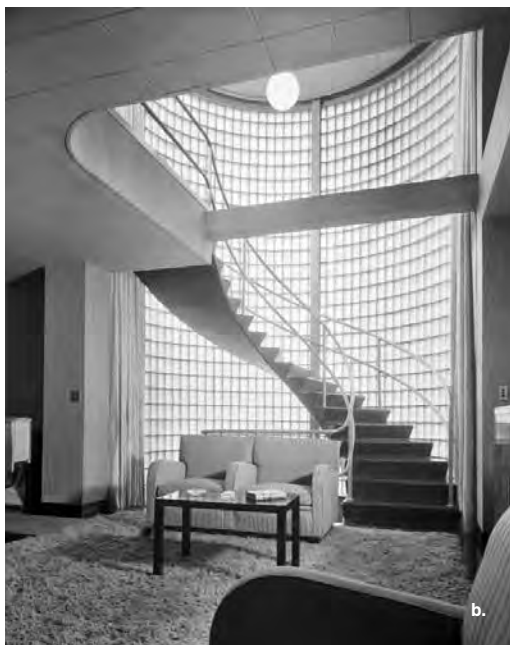
Figure 24.4a–b. The dramatic plan of the Bruning Residence (1936, George Fred Keck), Wilmette, Ill., included a two-story staircase enclosure of glass block. Residential applications of glass block were numerous, ranging from sweeping curved walls to interior partitions to replacement for standard sash. The luminous quality of glass block, when lighted from behind, was both a selling point and an indication of the material's consummate modernity: it permitted light to enter but did not sacrifice privacy.

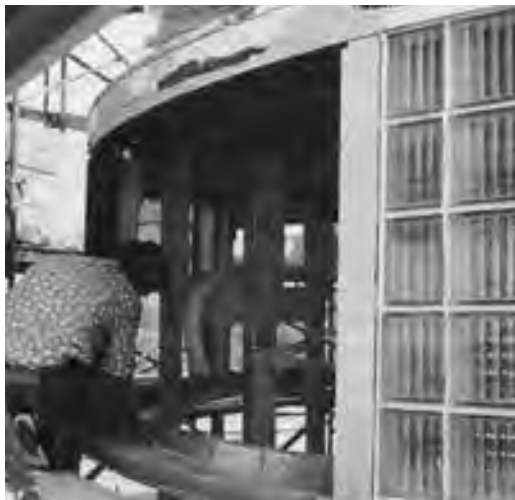
Figure 24.5. Replacement glass blocks may be difficult to find. Restoration of the Hecht Company Warehouse required 10,000 custom manufactured blocks.

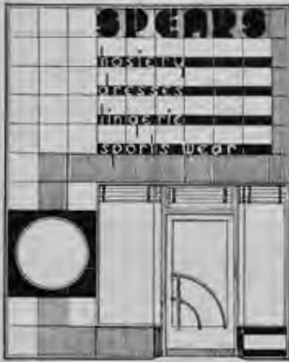
VITROLITE SHOP FRONT
REMODELED WITH COLORED VITROLITE AND
INLAID LETTERS. SCALE 1/4"=1'-0"

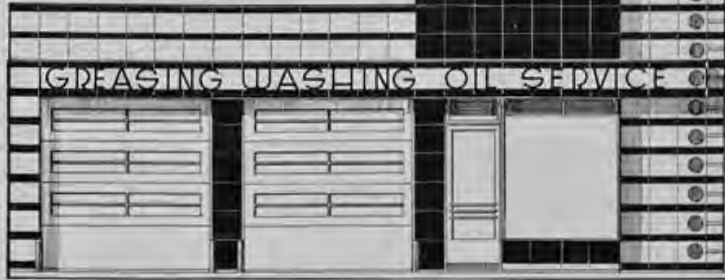
GAS AND SERVICE STATION
SHOWING EFFECTIVE APPLICATION OF VITROLITE CEMENTED
TO MASONRY WALL. SCALE 1/4"=1'-0"

Structural glass's versatility was due partly to its tolerance of various substrates. It could be readily applied to most flat surfaces, including plaster on metal lath, concrete, or masonry (wood substrates, however, were discouraged because of their absorptive nature and potential to warp). The backing surface was prepared and sealed with a bonding coat supplied or approved by the glass manufacturer, and mechanical fasteners (nonferrous metal brackets, angles, or channels) were secured to the substrate. The panels were prefabricated to specifications and attached with an asphaltic mastic.

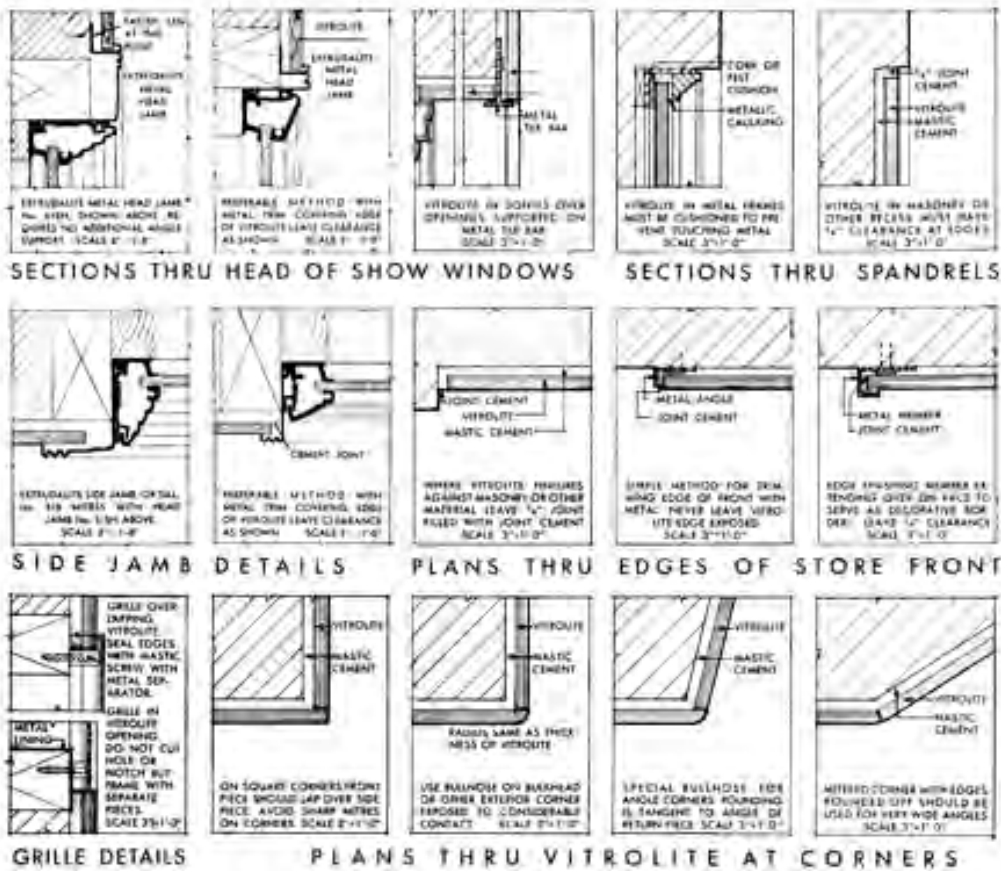
Figure 25.2. A brittle material, structural glass had to be properly installed to prevent breakage. These cross sections show typical late-1930s installation of such storefront details as window heads and jambs, spandrels, and corners. Edges were always separated by joint cement, cork tape, felt, or caulking.

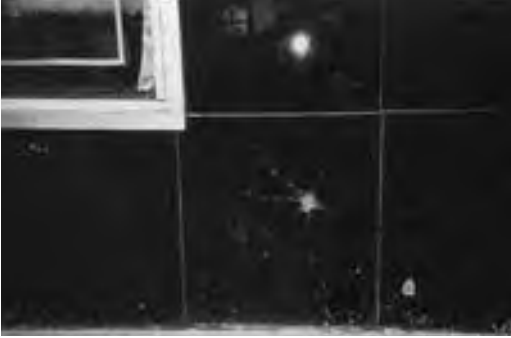
Figure 25.5. The most common causes of structural glass breakage include accidental impact and vandalism. This street-level panel requires replacement.

Another common form of deterioration is hardening of the mastic adhesive. When the mastic becomes brittle over time, movement can occur between the glass and substrate and can compromise the assembly's structural integrity.²⁶ Because of the narrow joints, such movement can cause stresses in adjacent panels and breakage if the slab detaches and falls. Water infiltration also damages the mastic, accelerating the hardening process.

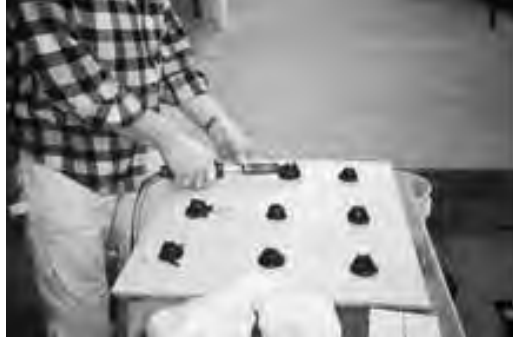
Figure 25.6. In reinstalling or replacing structural glass, asphaltic mastic is daubed on the back of the panels, which are eased into position against the substrate.

Mastic was applied to the back of the glass in 3-inch daubs covering 50 percent of the back of the panel. The

glass was set in position by rocking the panel until the flattened mastic was forced into the backup surface, providing a keying action. When the cement was set, the joints were pointed with a pointing cement, which, like the mastic, was provided by the glass manufacturer. Panel edges could be protected with cork tape $\frac{1}{16}$ inch thick, which was set back $\frac{1}{8}$ inch from the front of the glass.²⁴ In locations where high moisture was expected, such as tub surrounds, and the backup substrate was masonry, the panels were sometimes attached with cement rather than mastic. For ceiling applications, small screws with felt washers were used in addition to the larger daubs of mastic.²⁵

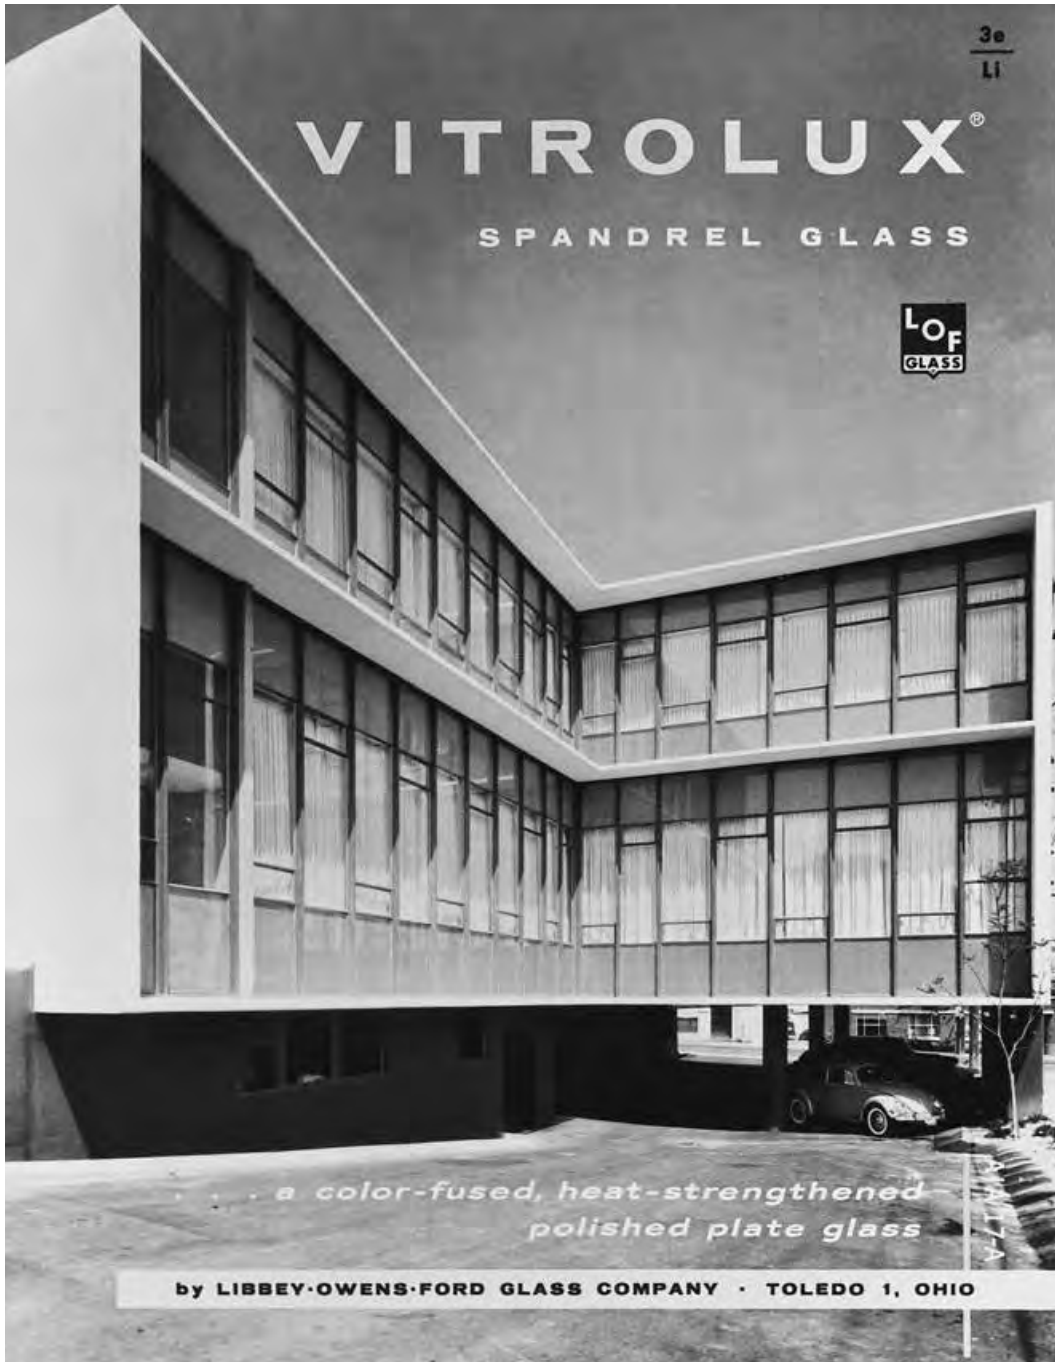
Figure 26.1. Vitrolux spandrel glass, Libbey-Owens-Ford's color-fused tempered plate glass, became popular for curtain wall construction in the late 1950s. It was used in the AAA Building (1960, John Graham and Company), Seattle, Wash. Vitrolux catalogue, Libbey-Owens-Ford Company, 1960.

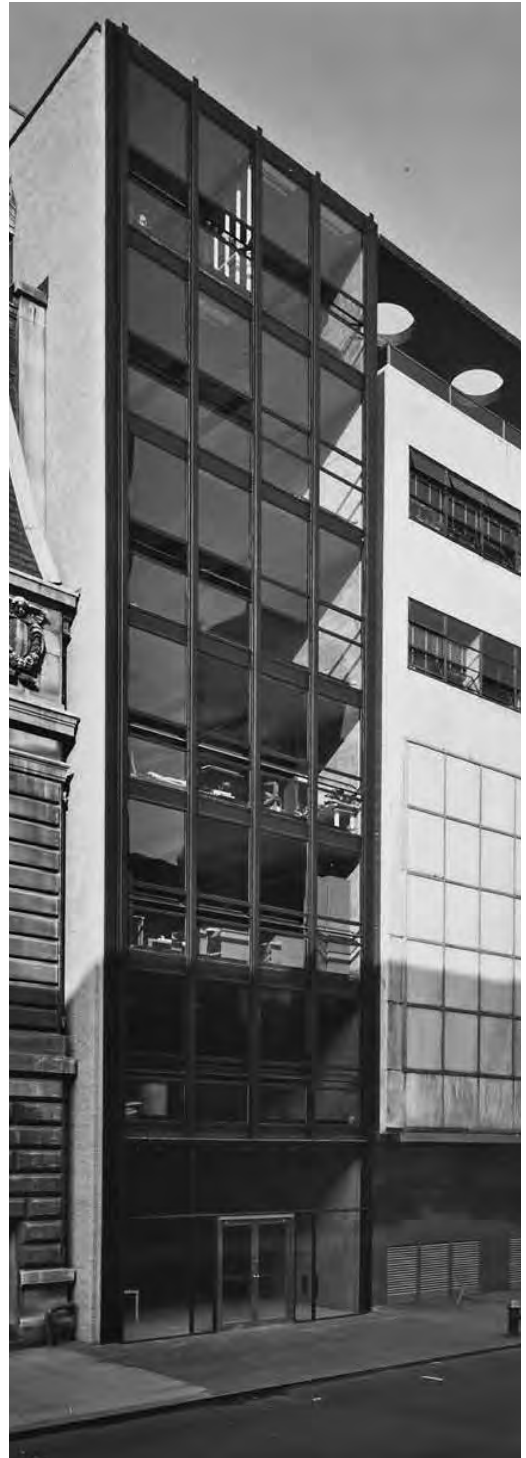
Figure 26.3. For the Rainey Rogers Building (1951, Philip Johnson), an annex to the Museum of Modern Art, New York City, the Pittsburgh Plate Glass Company developed an opaque, ceramic-coated spandrel glass that led to the commercial production of Spandrelite.

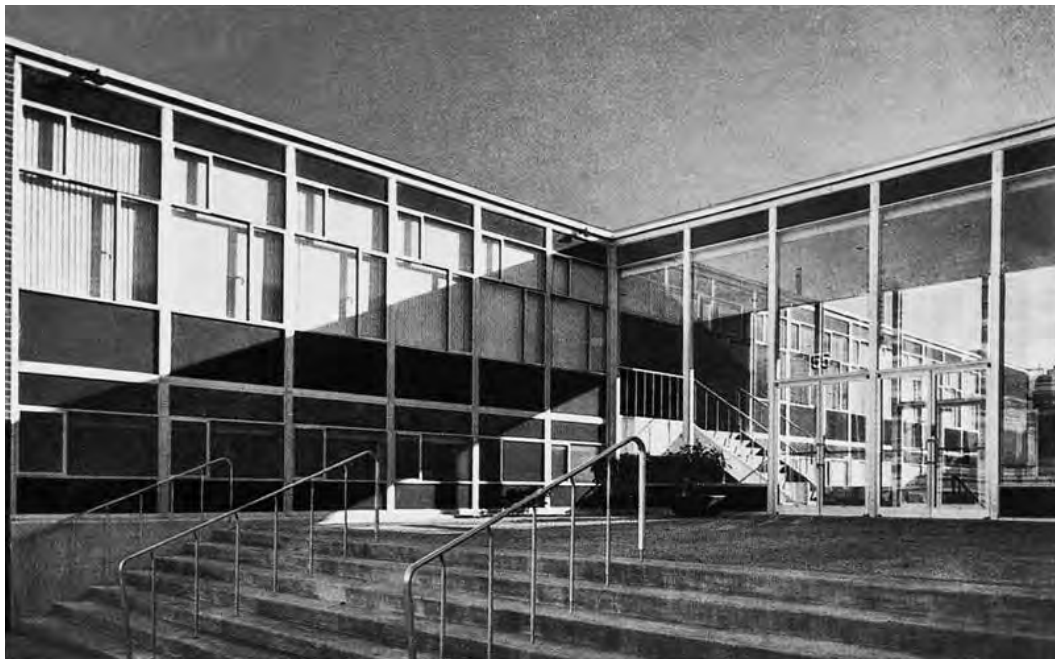
Figure 26.4. A two-color scheme, featuring red and charcoal spandrel glass, was used for the curtain wall of the Electricians Union Building (1956, Joseph McCarthy), San Francisco. The spandrel glass for this modern office building was Spandrelite, produced by the Pittsburgh Plate Glass Company.

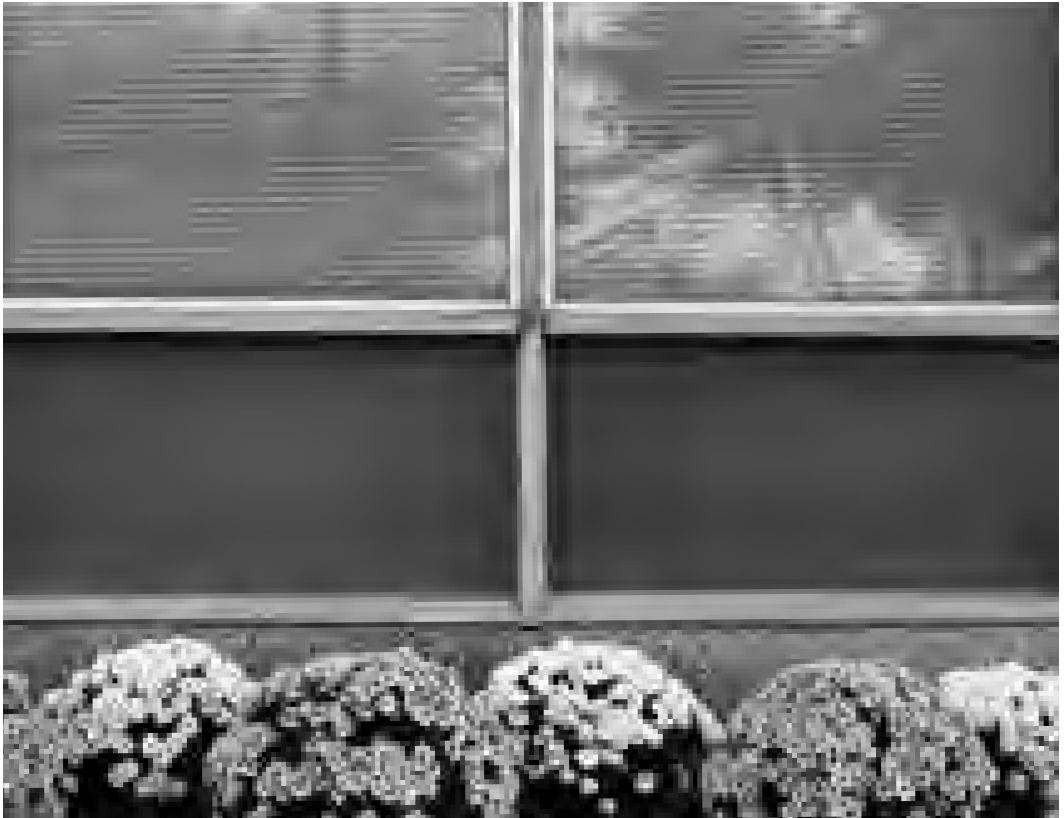
Figure 26.5. Finding spandrel glass to match historic colors is difficult. When an inappropriate replacement is installed (as in the left lower panel), the visual flaws are immediately apparent and compromise the building's character.

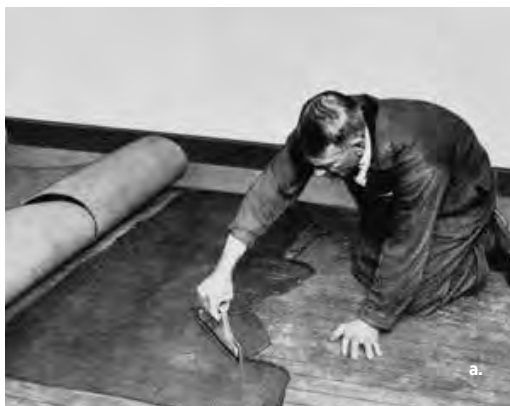
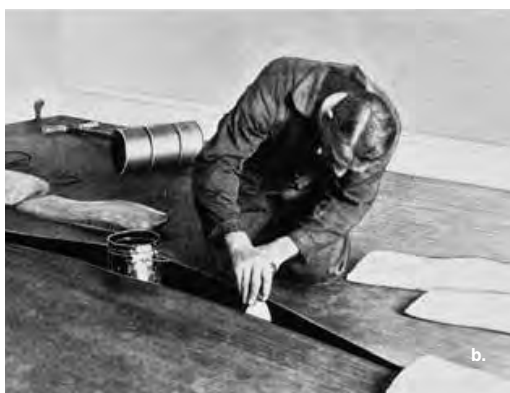
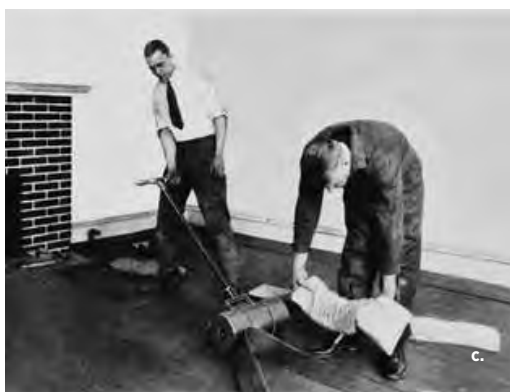
Figure 27.3a-c. a. Applying felt under linoleum with paste was a common installation practice by the late 1920s. b. When the linoleum was installed, edges of the adjoining linoleum overlapped and seams were subsequently cut with a special tool. c. Unpasted areas near the seams were sealed with waterproof cement and the linoleum was then rolled and seams were weighted with sandbags until the floor was dry.

Linoleum was originally installed directly over subflooring. However, because of seasonal contracting and expanding of wood subfloors, buckling and cracking were common problems. The solution was to glue a felted product to the floorboards before installing the linoleum.²¹ For the thinner gauges, even the felt did not always keep irregularities in the subflooring from showing through. The manufacturers recommended starting by smoothing the floor as much as possible.

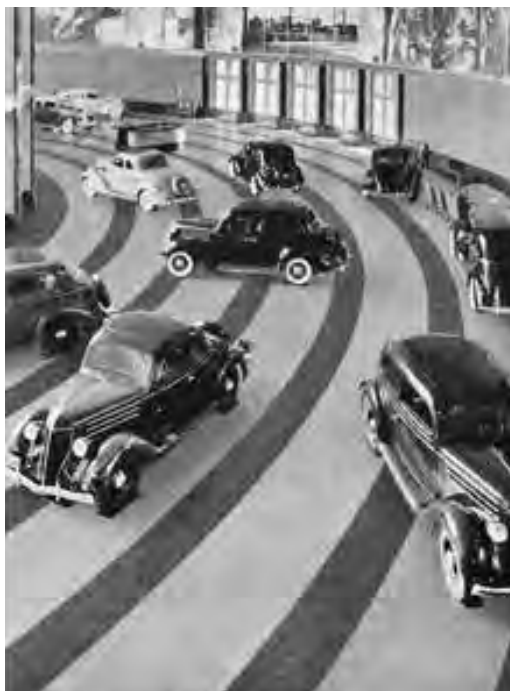
Figure 27.5. Linotile, a ¼-inch-thick linoleum tile, was produced in "Ford" blue for the Ford Rotunda (1935, Albert Kahn), Dearborn, Mich.

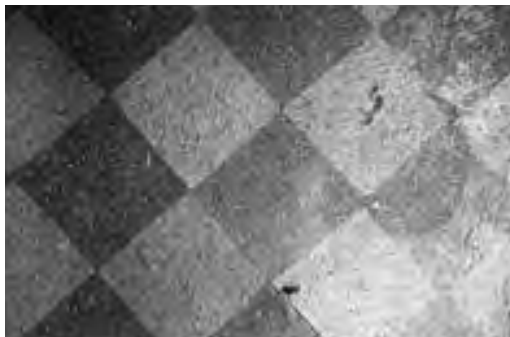
Figure 27.8. This worn linoleum shows the effects of abrasion and indentations. Some edges are beginning to lift up, usually a sign of water damage.

The deterioration of linoleum has three primary causes: wear, water, and chemical changes within the product itself. Wear results largely from abrasion from dirt and grit in high-traffic areas. Heavy furniture and high-heeled shoes cause indentations that can also seriously damage the surface. Where worn areas are severe and have ex-

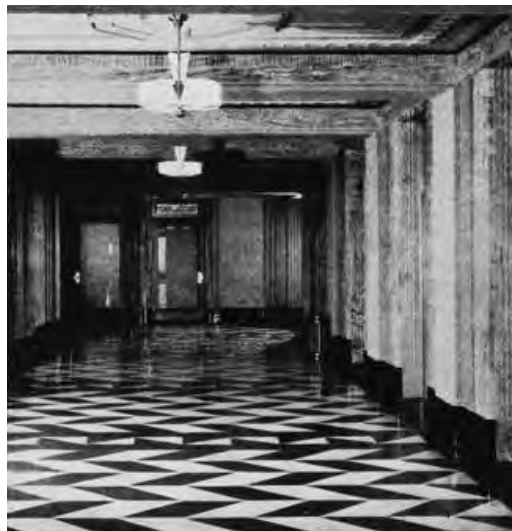
Figure 28.3. More than 31,000 square feet of Goodyear rubber tiles were installed in the Richfield Oil Building (1929, Morgan, Walls and Clements), Los Angeles.

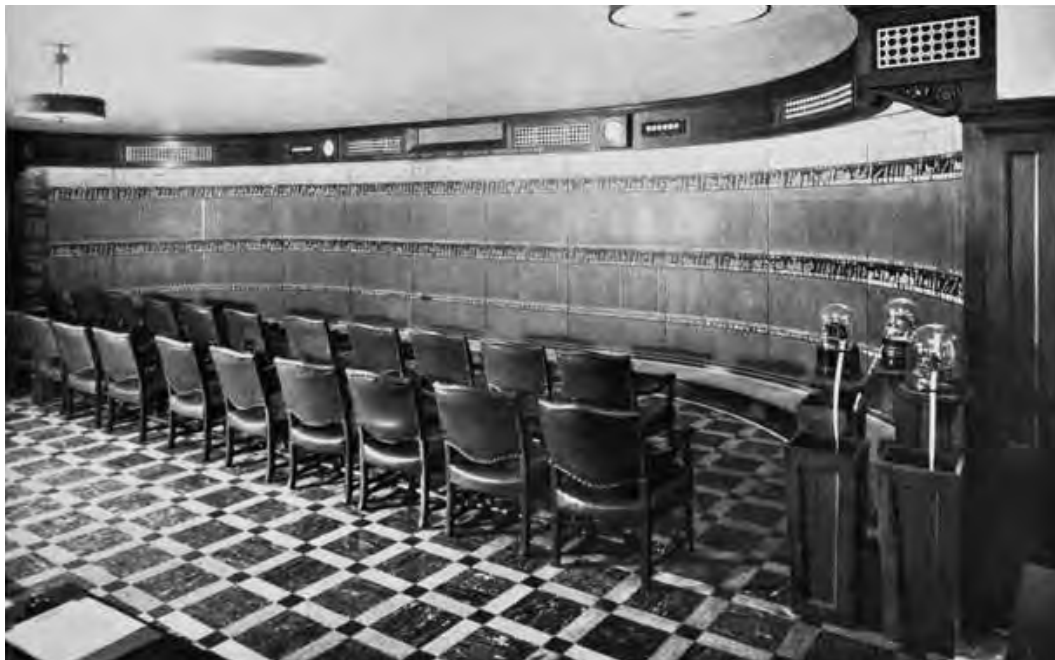
Figure 28.4. For the telegraph room of this Los Angeles, Calif., office building (late 1920s), rubber tiles in varying shapes, colors, and geometric patterns were used.

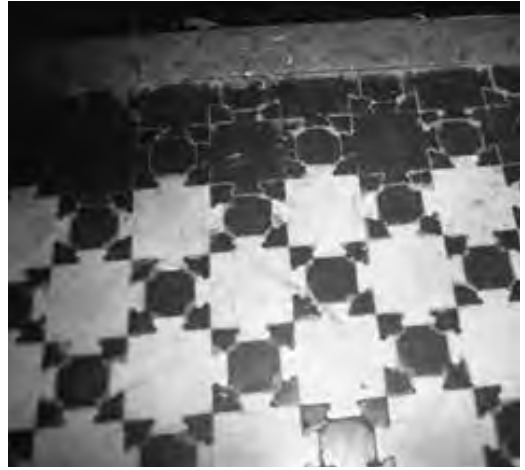
Figure 28.5. Interlocking rubber tiles at the Anderson House (1905, Arthur Little and Herbert W. C. Browne), Washington, D.C., show drying and chalking. Natural, vulcanized interlocking rubber tiles are particularly prone to long-term aging and drying, which causes them to become brittle.

Oxidation, which is caused by oxygen and can be catalyzed by light, heat, and metals, is manifested by increasing brittleness and surface crazing, conditions known as shelf aging. Rubber surfaces may appear dull from exposure of inorganic fillers as the rubber deteriorates,

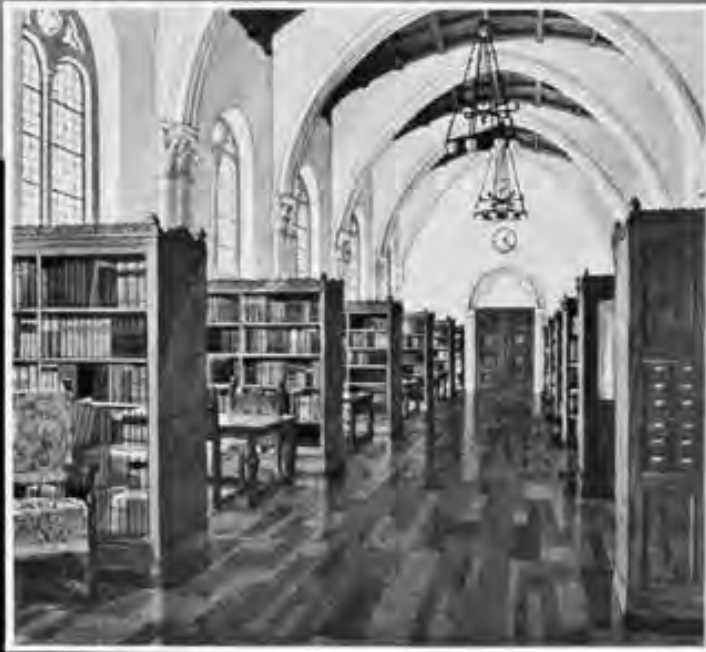
Figure 29.1. Cork tile was marketed specifically for its sound-deadening properties, which made it suitable for buildings such as libraries and churches. Ease of maintenance also made square- and beveled-edged cork tile an attractive choice as a floor covering. Cork tile catalogue, Armstrong Cork Company, 1936.

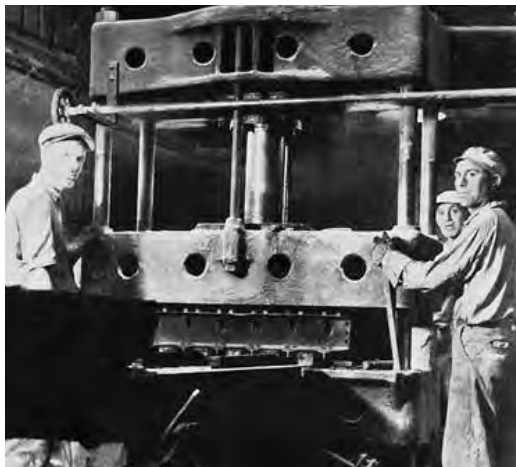
Figure 29.2. In cork tile manufacture, molds loaded with cork shavings were placed under enormous hydraulic presses. The level of compression, which determines the tiles' density, was maintained by inserting steel rods in slots in the mold. Molds were typically baked from 7 to 10 hours (top).

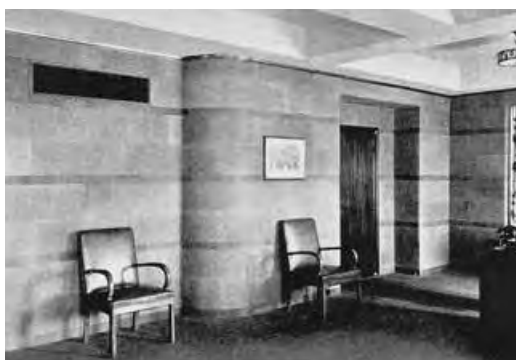
Figure 29.3. Cork tile could be used to line interior walls as well as floors. Bands of cork tile in varying shades gave this office a modern appearance (bottom).
