TWENTIETH-CENTURY
BUILDING MATERIALS
HISTORY AND CONSERVATION

EDITED WITH A NEW PREFACE BY THOMAS C. JESTER

GETTY CONSERVATION INSTITUTE, LOS ANGELES

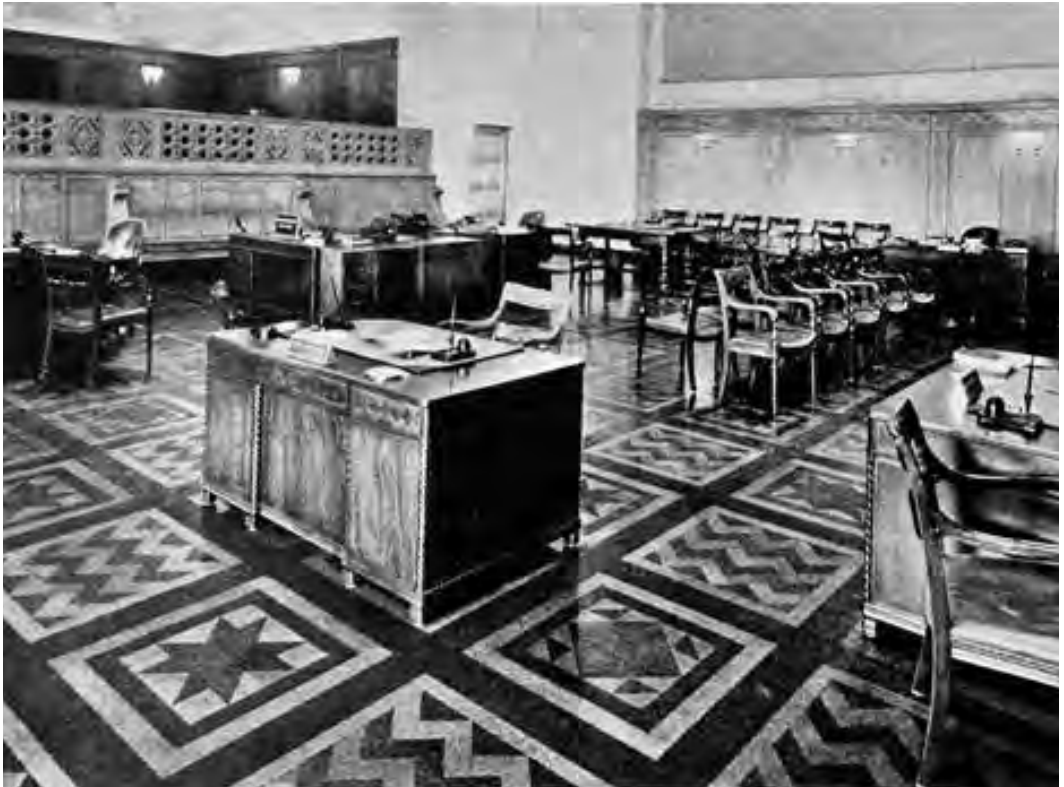
Figure 29.4. The warm colors of the elaborate hand-laid cork design installed in the Bowery Savings Bank (1893, McKim, Mead and White), New York City, “lent dignity” to the room, according to the Armstrong Cork Company.

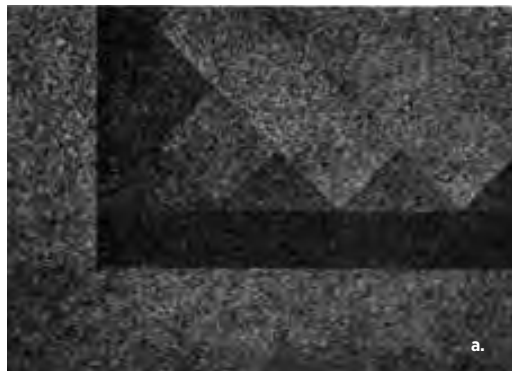
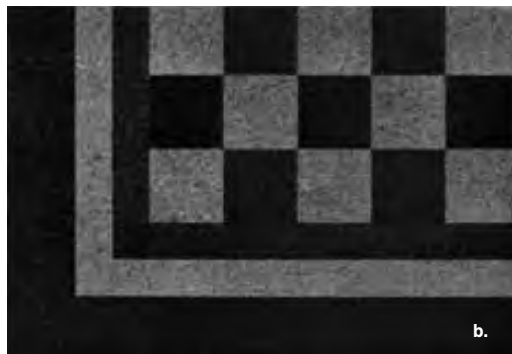
Figure 29.5a–c. Armstrong's suggested cork tile designs (a. no. 700, b. no. 720, and c. no. 740) could be created using dark, medium, and light shades of cork. Precision molding created tiles with uniform densities and smooth surfaces, and the unique cellular structure of compressed cork contributed to its "restful resilience" and "rich beauty," according to the company.

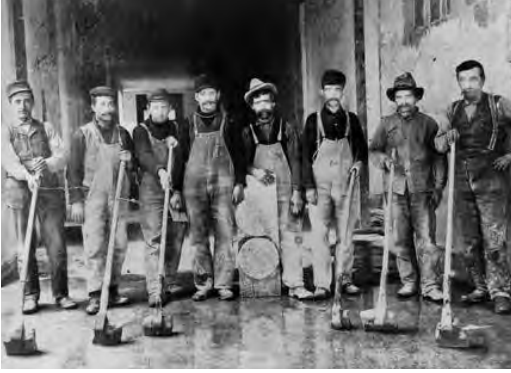
Figure 30.2. Before electricity terrazzo installers used galleras (long-handled tools) to polish floors.

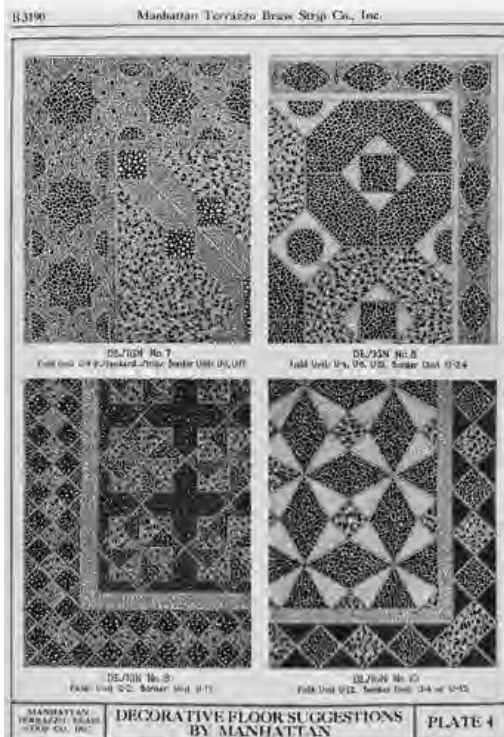
Figure 30.4. The Manhattan Terrazzo Brass Strip Company's 1931 floor designs featured various combinations of field and border units.

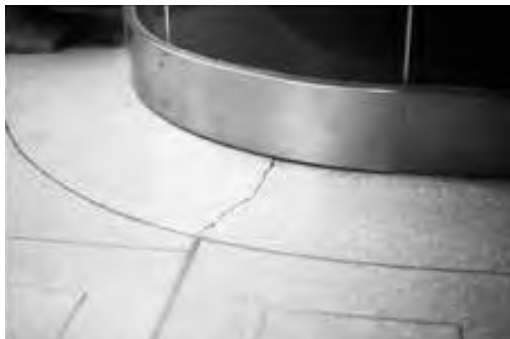
Figure 30.5. Differential settlement in the entrance of this Washington, D.C., apartment building has caused the terrazzo to crack. The durability of most terrazzo installations is largely a function of the structural stability of the system supporting the terrazzo.

Cracking, the most common form of failure, is the result of movement and differential settlement or expansion and contraction of the structural system supporting the terrazzo topping. Cracking can occur regardless of the installation method. Once cracks appear, the terrazzo topping can spall along a crack, particularly next to control joints.²⁶

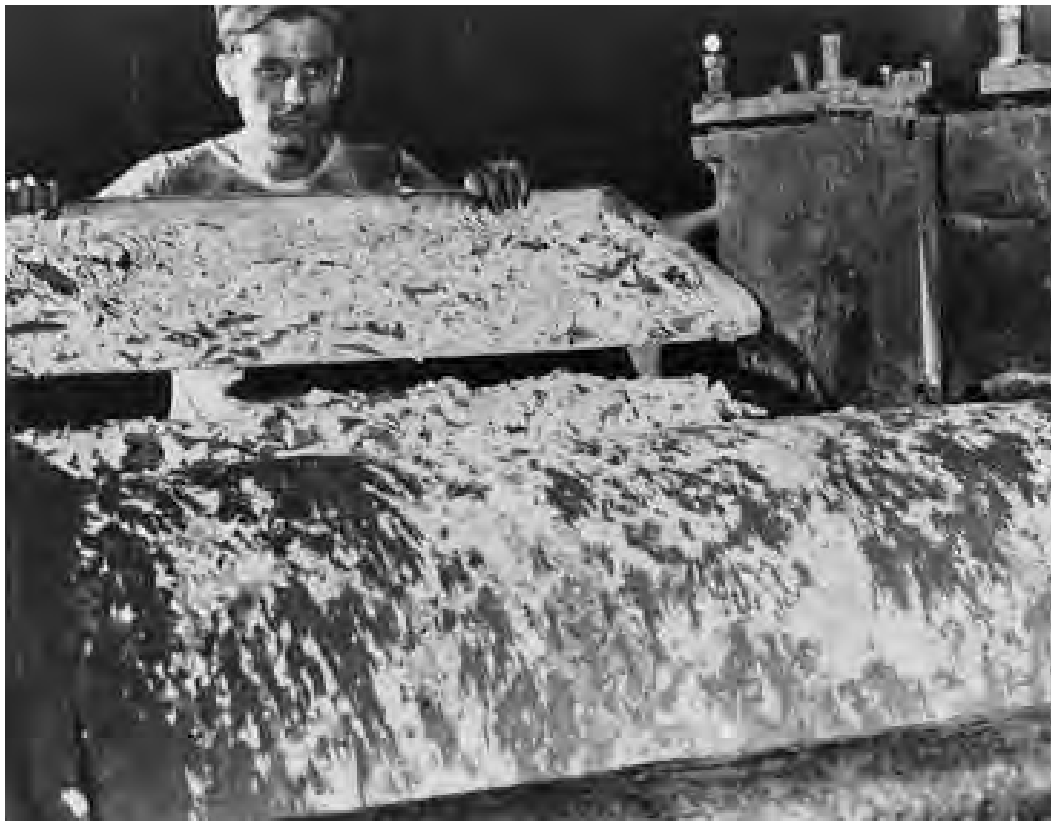
Figure 31.2. Materials are mixed under heat and pressure, and the resulting dough passes through a series of calenders to attain the proper gauge.

The squares are cut out of the hot material either with a square knife and ejector plate or by punching the tiles with a male and female punch. The process of punching tiles produces a large quantity of waste; however, since the material is thermoplastic, waste can be reheated and used again.

On cooling, the tiles harden into their finished form and require no curing. Thermoplastic resin-bonded tiles

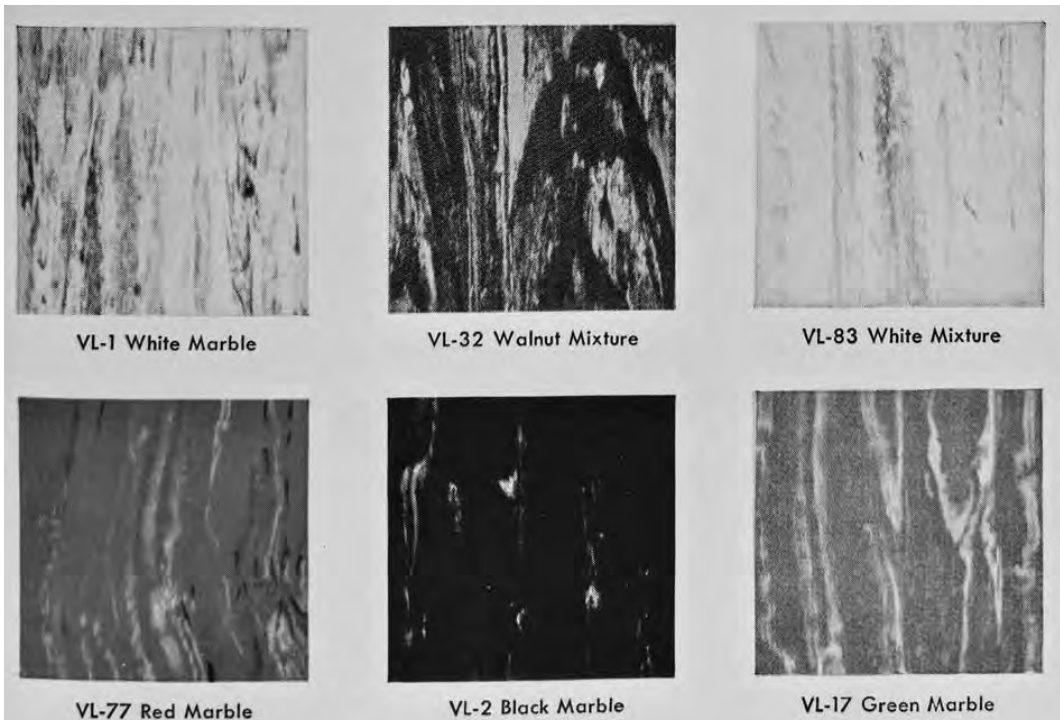
Figure 31.3. Pigments added in the mixing stage are used to create colors and patterns, such as marbleizing.

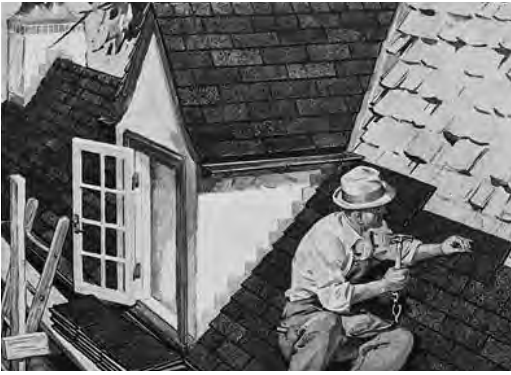
Figure 32.4. Properly installed asphalt shingles are applied over roofing felt, but shingles were sometimes installed directly over existing roofing systems (top).

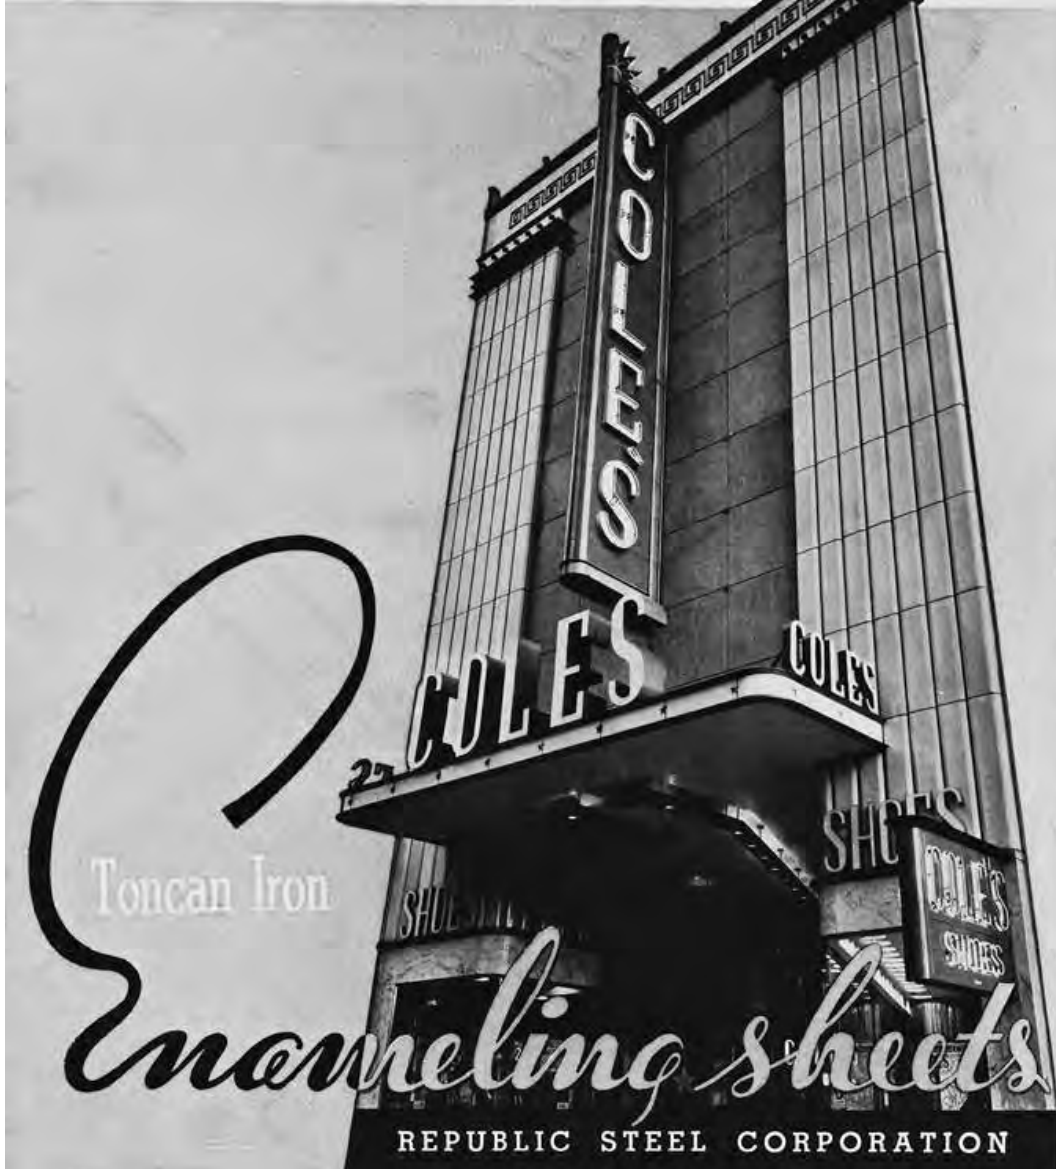
Figure 33.1. Republic Steel was one of several companies that manufactured and supplied iron specifically engineered for enameling. In addition to being flat and free of waves, enameling iron maximized enamel adherence. *Architectural Porcelain Enamel*, 1938.

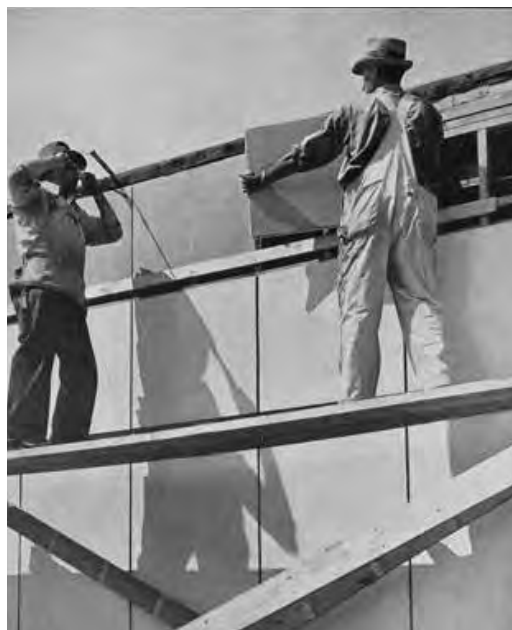
Figure 33.3. Porcelain enamel panels are installed sequentially to a wood-framed structure in the late 1930s. The panels were fastened by hand.

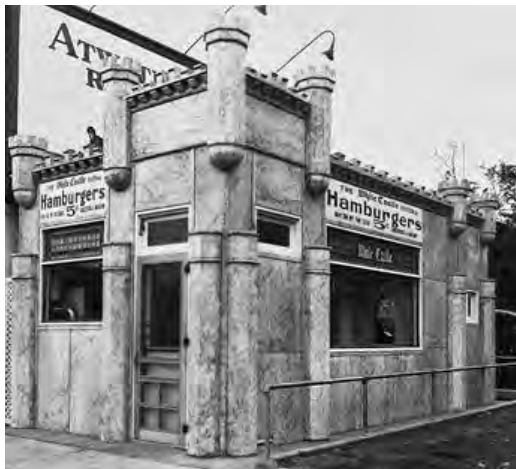
Figure 33.4. White Castle's Wichita, Kans., store, which opened in 1929, probably exemplified the first use of flanged porcelain enamel panels (above).

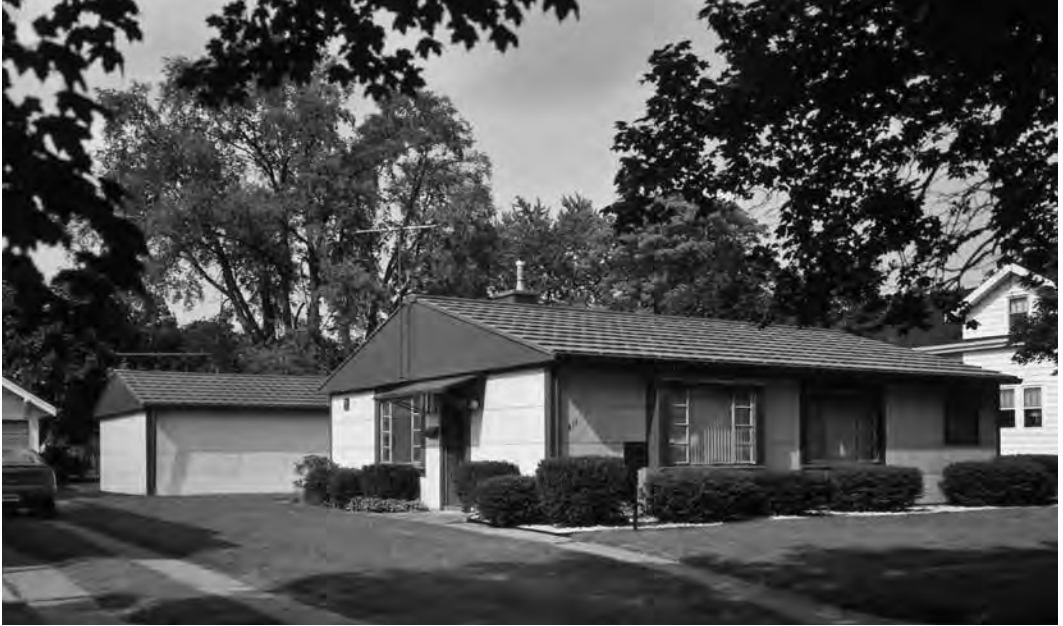
Figure 33.7. In this Lustron house and garage (1950), Chesterton, Ind., the only elements not made of porcelain enamel were the windows and structural frame.

New markets also emerged. Before the war porcelain enamel in houses had been limited to bathroom tiles, sinks, and appliances.³⁸ Between 1947 and 1950 the Lustron Corporation, a short-lived but notable housing venture, developed and sold approximately 2,500 prefabricated houses made almost entirely of porcelain enamel components.³⁹ Panels measuring 2 by 2 feet were used for exterior walls, and panels 2 by 8 feet were used for interior walls.

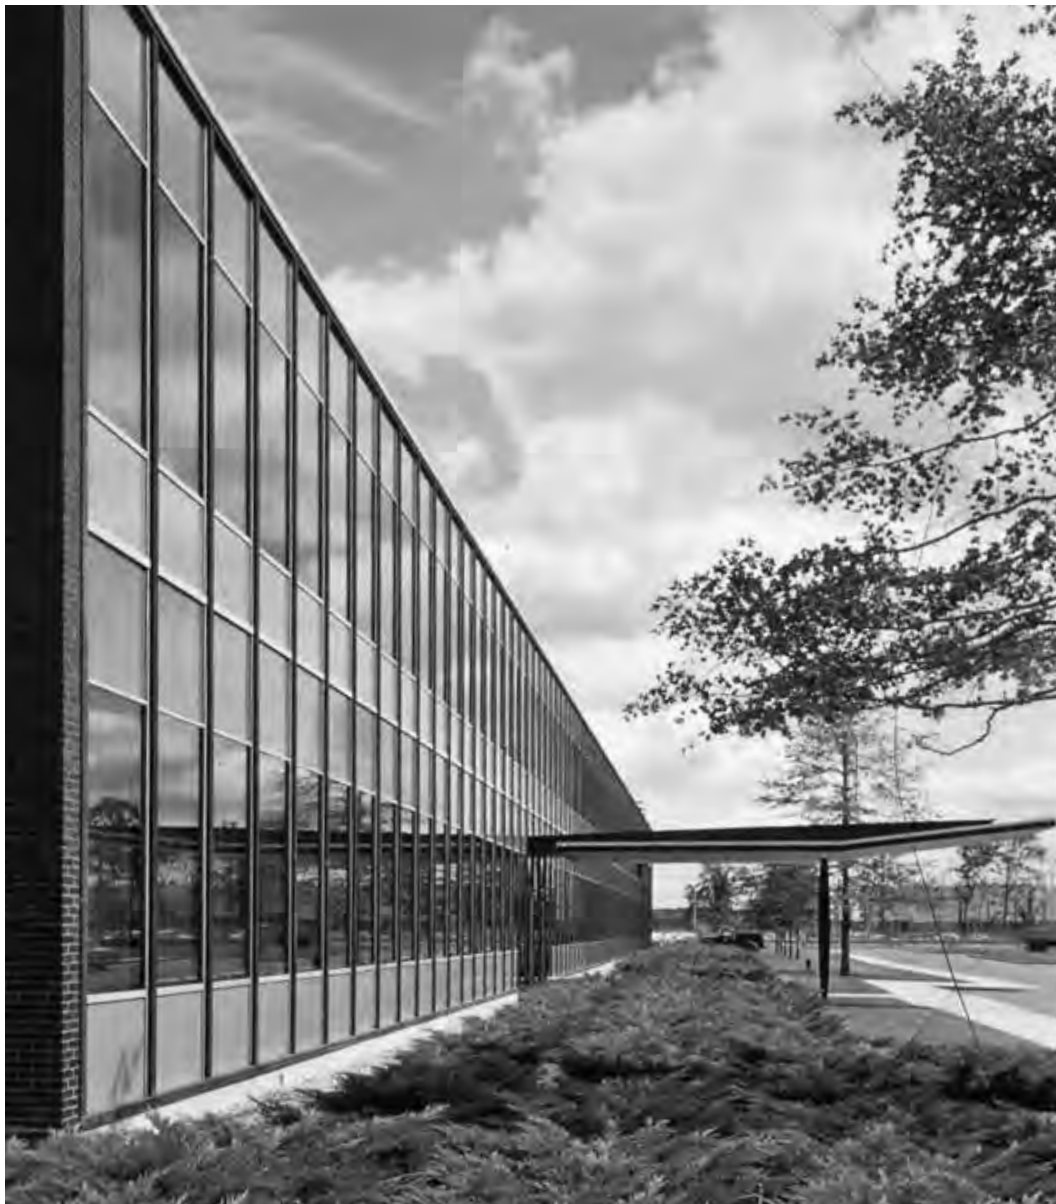
Figure 33.8. Eero Saarinen and the Wolverine Porcelain Enameling Company developed a porcelain enamel curtain wall panel with a honeycomb core for the General Motors Technical Center (1950), Warren, Mich.

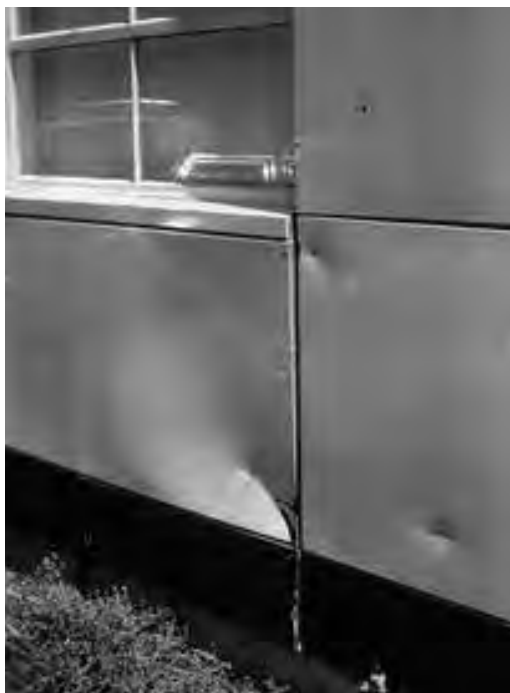
Figure 33.9. Dented and chipped panels on a former Texaco gas station in Austin, Tex., reveal (top) that direct impact has fractured the bond between the enamel coating and metal substrate. When chipping occurs, the exposed metal substrate corrodes.

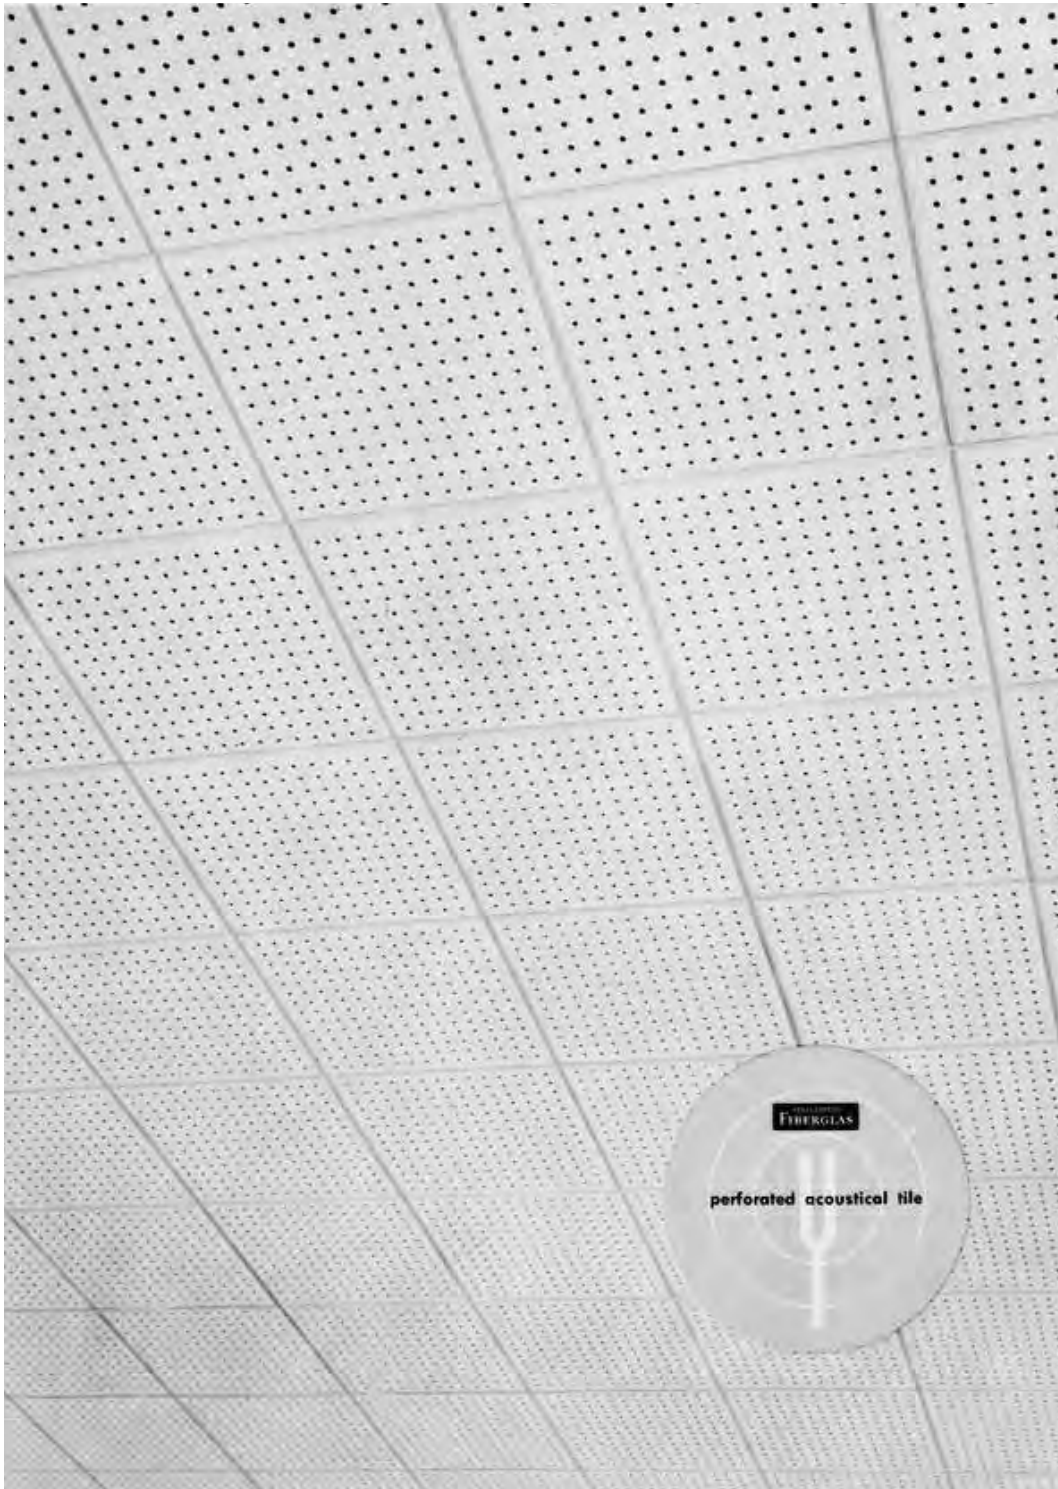
Figure 34.1. The perforations in acoustical tiles absorbed unwanted noise, making them suitable for schools, offices, and restaurants. Tile thicknesses, ranging from $\frac{1}{2}$ inch to 1 inch, determined the sound-absorption coefficient. Catalogue, Owens-Corning Company, 1954.

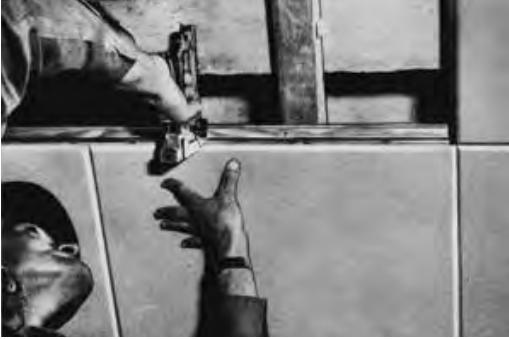
Figure 34.2. Acoustical tiles are stapled to furring strips with aluminum splines that support the tile in the kerfed edges. Tiles could also be attached with adhesives, nails, screws, or suspended T-bar systems.

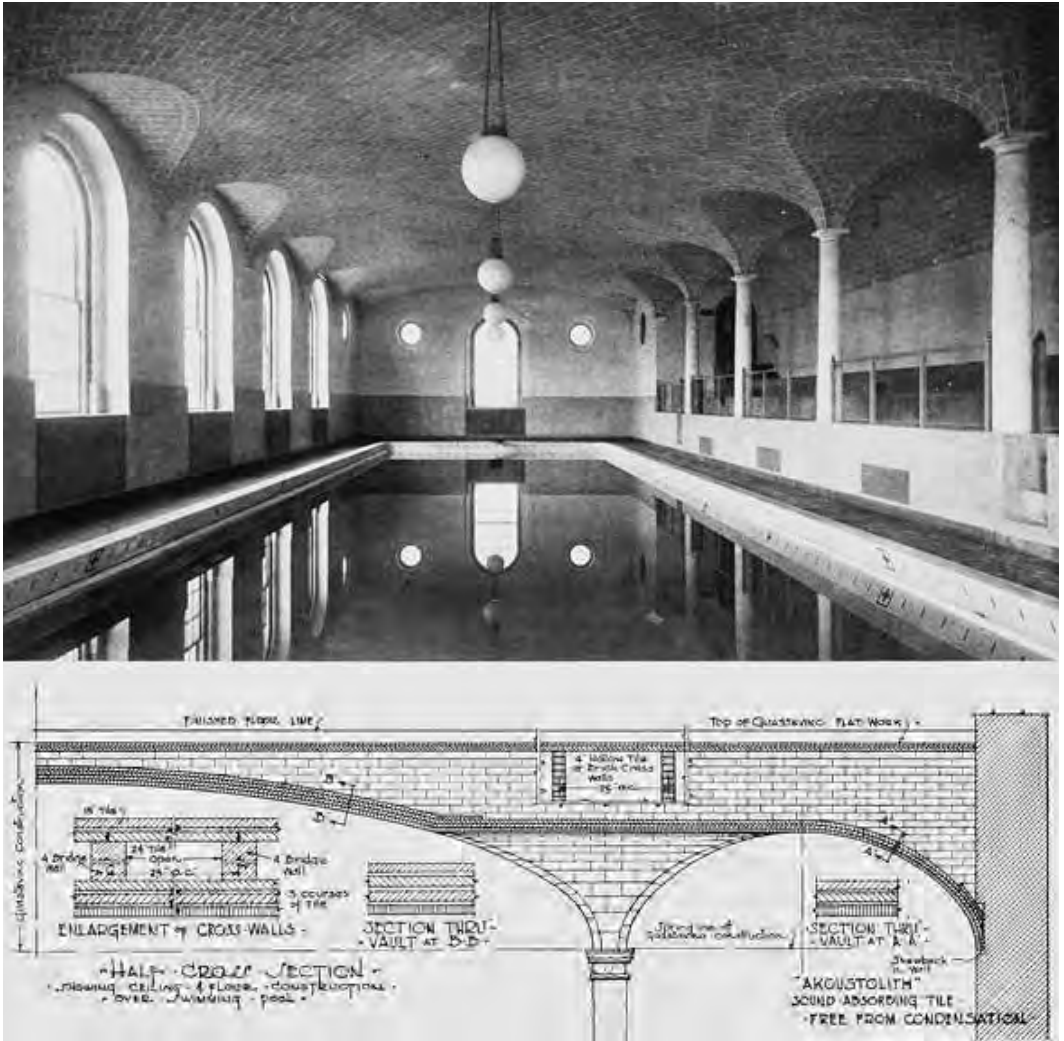
Figure 34.3. Akoustolith sound-absorbing tile, produced by the R. Guastavino Company, formed the vaulted ceiling of the swimming pool at Smith College (J. W. Ames and E. S. Dodge), Northampton, Mass.

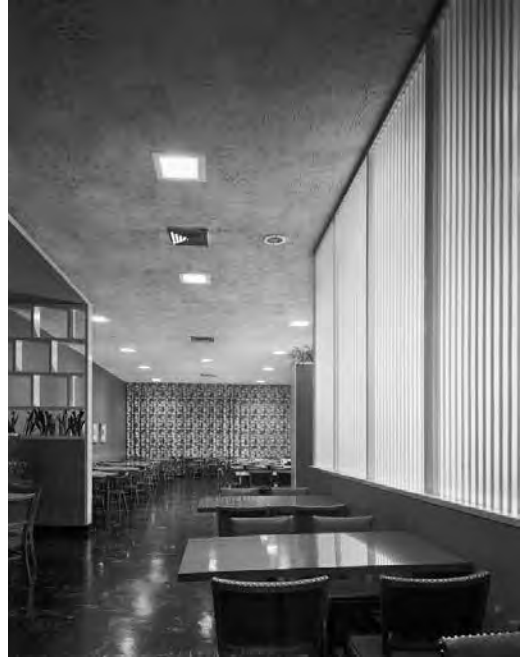
Figure 34.4. Acoustone tile was specified for the ceiling of the remodeled employee dining room (1949) of the Northern Trust Company (1905, Frost and Granger), Chicago. The striated tiles were applied flush to one another, creating the effect of a flat plane (top).

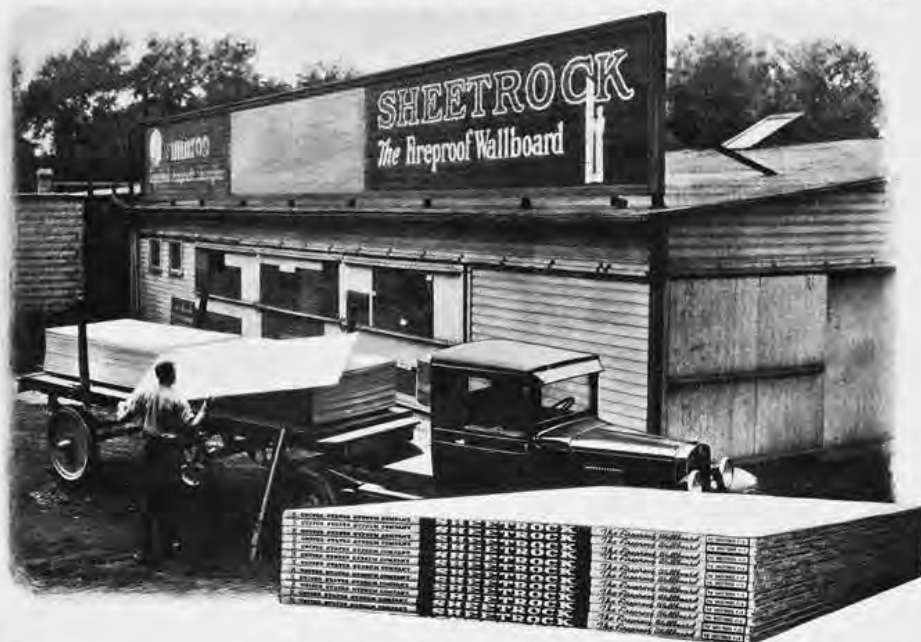
Figure 35.1. By the mid-1930s gypsum board was becoming a staple building material available in lumber yards. Sheetrock, the United States Gypsum Company's fireproof wallboard, was even sold in "zip-cord" packages for easy transportation to and use on the job site. Catalogue, United States Gypsum Company, 1937.

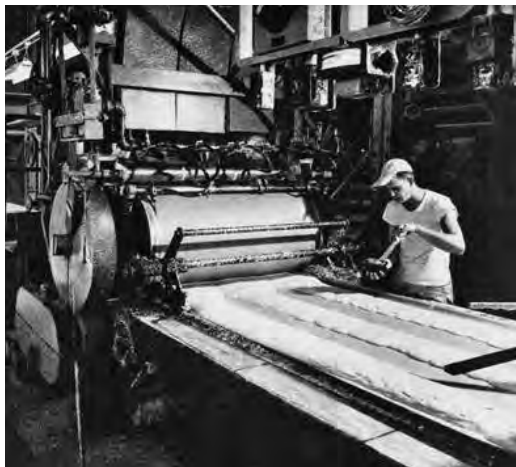
Figure 35.2. In the forming end of gypsum board machinery, foam and gypsum were spread between the paper layers (top). The introduction of foam filler into gypsum boards created lighter products.

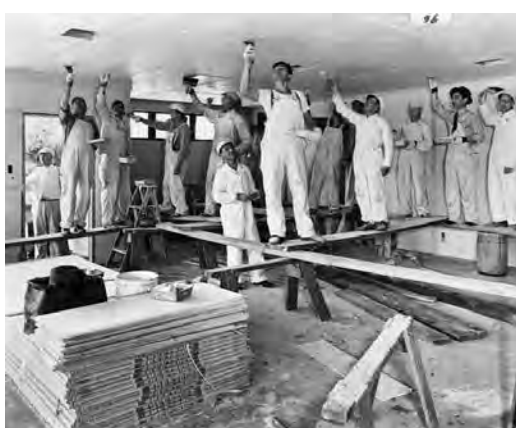
Figure 35.3. Workers install gypsum board in 1946 (bottom). Joint cement was applied over the joint and nail heads, a perforated metal strip was centered over the joints, and a finish coat of cement was applied.

Installation methods have changed over the years to create smoother, more even wall surfaces. In the early 1900s the boards were produced with a round, folded edge to provide a reinforced nailing edge. This was replaced by the square, folded edge, which allowed the boards to fit together snugly; later, tongue-and-groove edges were introduced to eliminate ridging. In 1937 a process was developed to produce wallboards with recessed edges. This created a valley at the joint where two boards were fitted together, allowing for a flat, smooth joint treatment. In the 1950s a wallboard with a tapered edge was introduced and is still used today.

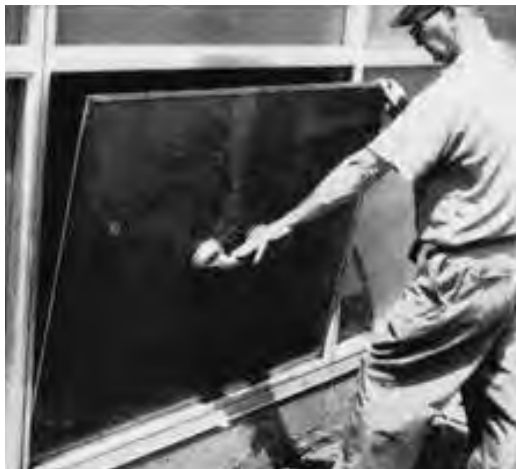
Figure 36.2. These curtain wall lights were sealed with pre-formed butyl rubber gaskets in the late 1950s. Such gaskets could be installed easily, provided good resistance to heat, and were weathertight.

Butyl sealants are manufactured from gaseous hydrocarbons (butyl rubber, a synthetic rubber, also contains a small percentage of isoprene). They became available to the construction industry in the mid-1950s, although butyl rubber was being manufactured earlier for other uses.¹⁰ Butyl rubber was developed to replace natural rubber, which was in great demand just before and during World War II. Butyl rubber-based sealants are one-component sealants that may include talc powder, calcium carbonate filler, polybutene, mineral spirits, and adhesion promoters.

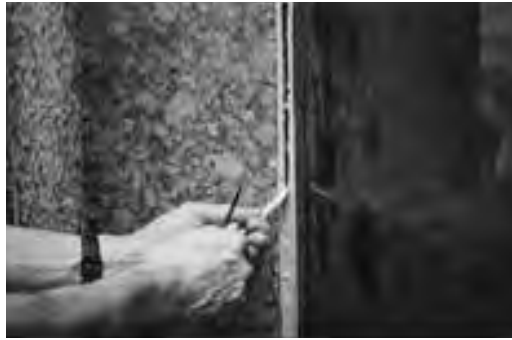
Figure 36.3. In-place field adhesion pull tests provide information about a sealant's adhesive, cohesive, and elastic properties.
