GGAT 112: Second World War Military Airfields of South Wales

Year 1-Airfield Core and Technical Buildings

A report for Cadw
by Paul W Huckfield BA

GGAT report no. 2012/032
Project no. GGAT 112

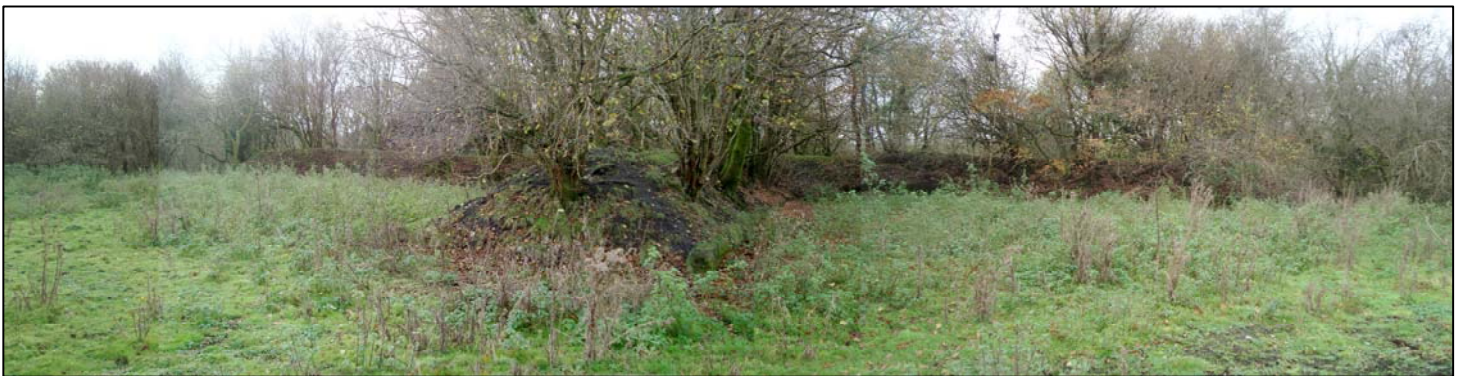
Condition rating	Poor
Period	Modern
Group Value	Yes
Form	Earthwork
Associated PRN sites	06828w, 06829w, 06830w, 06831w, 06832w, 06833w, 06834w, 06835w, 06836w, 06837w, 06838w, 06839w, 06840w
Linked to airfield function?	Yes
Of technical/Structural interest?	Yes
Historical association?	No

Plate 1: Fighter Pen 4. View to the southwest

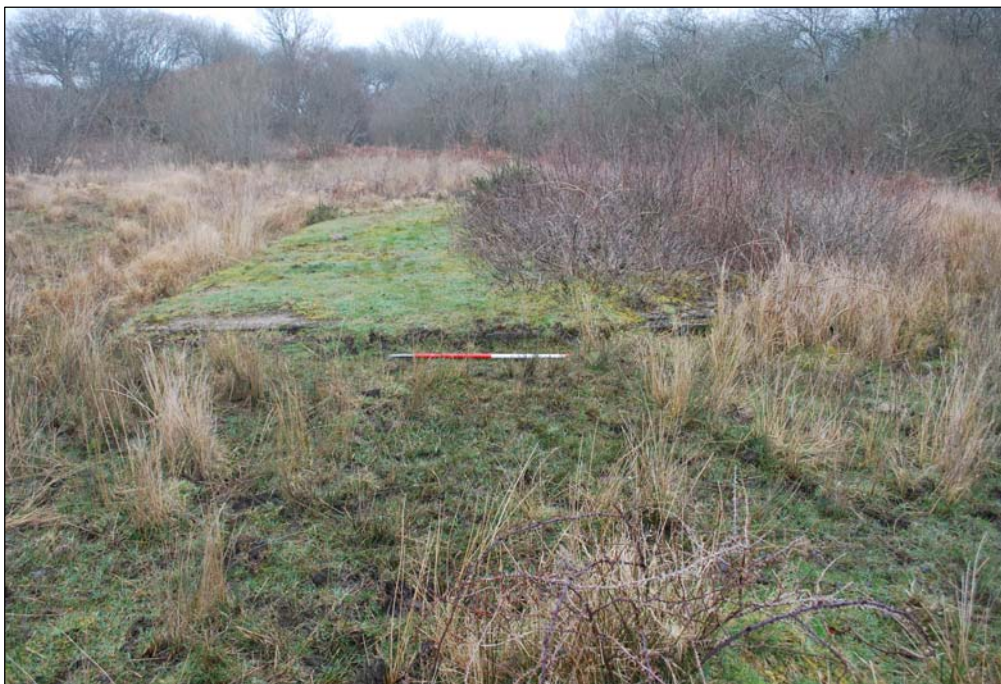
ID No	FC7
PRN	06833w
Name	S S A STORE
NGR	SS5688990705
On Air Ministry Plan?	Yes
MoD Building No	38
In Use	No
Description	A two tier linear concrete pad 8ft (2.4m) x 14ft (4.2m) is all that survives of the store. This structure (drawing No. 16076/40) would originally have been a single Nissen structure.
Condition	Near Destroyed
Condition rating	Destroyed
Period	Modern
Group Value	Yes
Form	Other structure
Associated PRN sites	06827w, 06828w, 06829w, 06830w, 06831w, 06832w, 06834w, 06835w, 06836w, 06837w, 06838w, 06839w, 06840w
Linked to airfield function?	No
Of technical/Structural interest?	No
Historical association?	No

Plate 4: The concrete base is all that remains of S S A Store

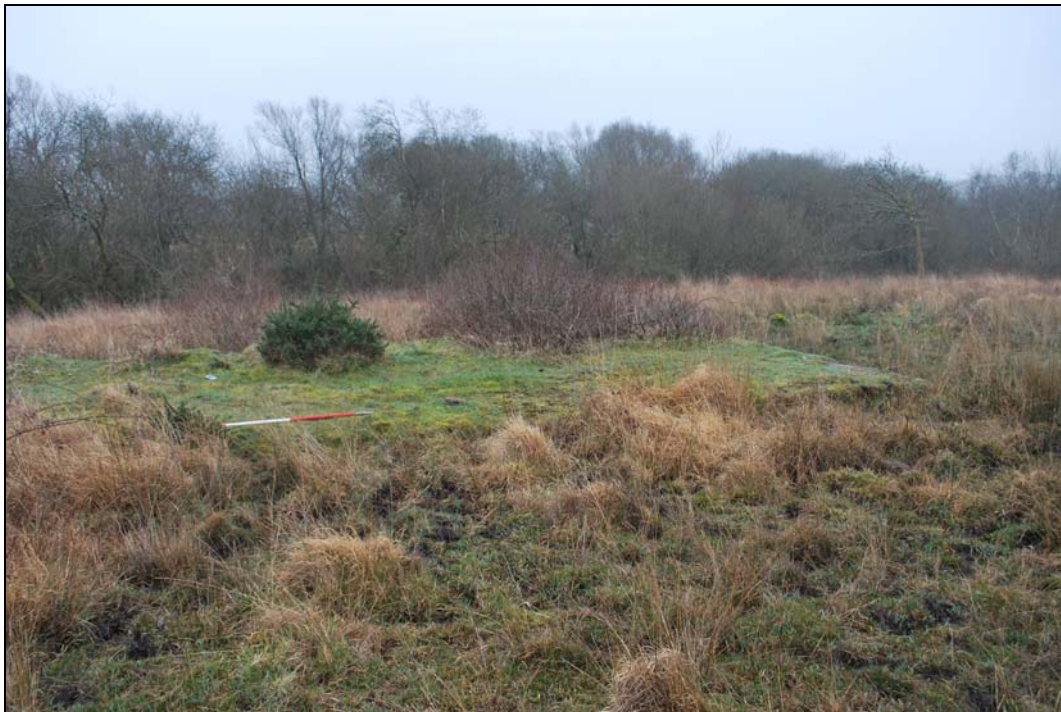
ID No	FC8
PRN	06834w
Name	UNKNOWN STRUCTURE
NGR	SS5688590684
On Air Ministry Plan?	Yes
MoD Building No	-
In Use	No
Description	A two tier linear concrete base is all that survives of this building.
Condition	Near Destroyed
Condition rating	Destroyed
Period	Modern
Group Value	Yes
Form	Other structure
Associated PRN sites	06827w, 06828w, 06829w, 06830w, 06831w, 06832w, 06833w, 06835w, 06836w, 06837w, 06838w, 06839w, 06840w
Linked to airfield function?	No
Of technical/Structural interest?	No
Historical association?	No

Plate 5: Remains of unknown structure. View to the southwest

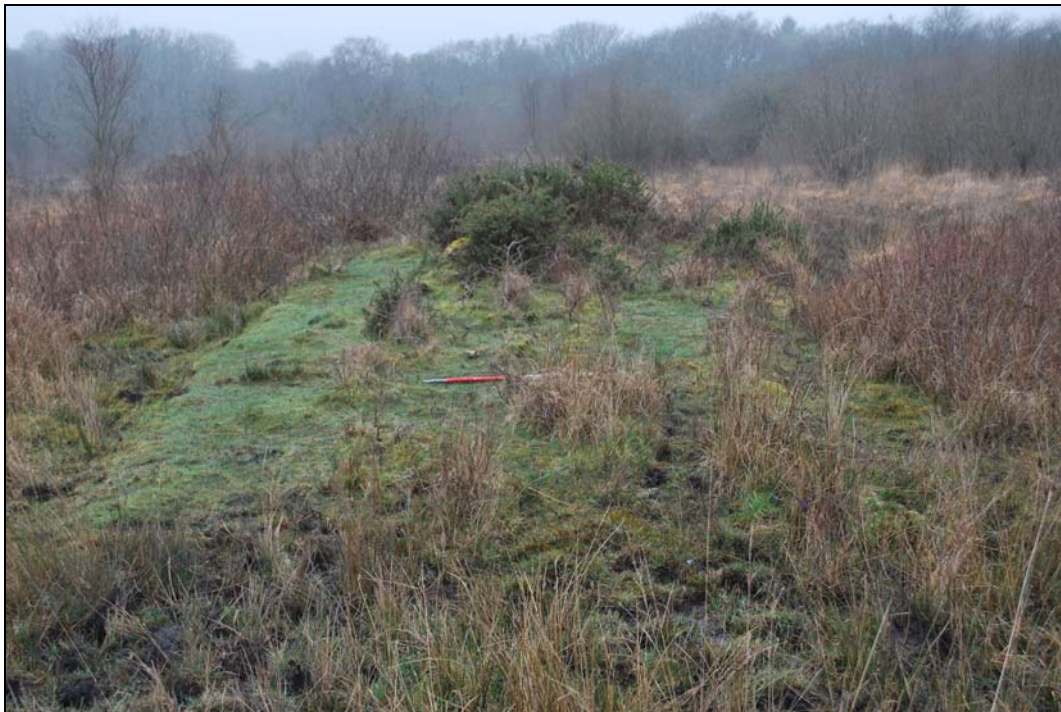
ID No	FC9
PRN	06835w
Name	S A A STORE
NGR	SS5688990705
On Air Ministry Plan?	Yes
MoD Building No	38A
In Use	No
Description	A two tier linear concrete base is all that survives of the store building.
Condition	Near Destroyed
Condition rating	Destroyed
Period	Modern
Group Value	Yes
Form	Other structure
Associated PRN sites	06827w, 06828w, 06829w, 06830w, 06831w, 06832w, 06833w, 06834w, 06836w, 06837w, 06838w, 06839w, 06840w
Linked to airfield function?	No
Of technical/Structural interest?	No
Historical association?	No

Plate 6: Remains of S A A Store. View to the northwest

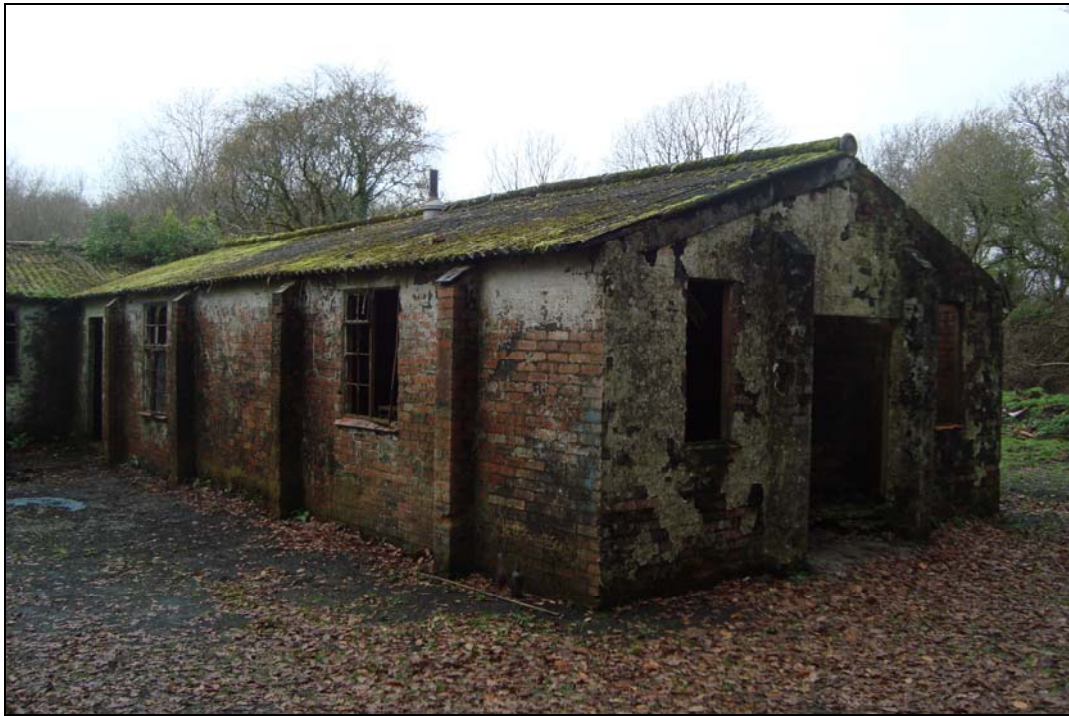
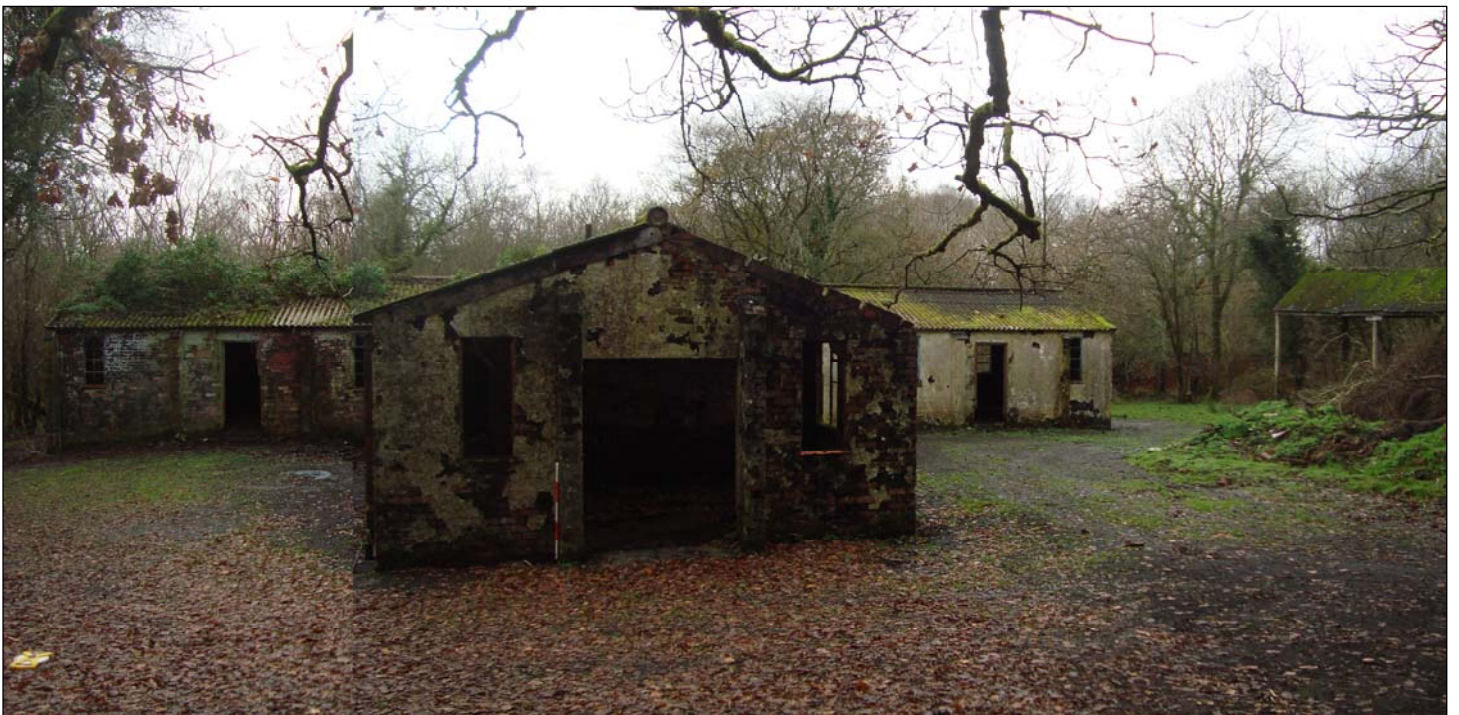
Condition	Damaged
Condition rating	Fair
Period	Modern
Group Value	Yes
Form	Building
Associated PRN sites	06827w, 06828w, 06829w, 06830w, 06831w, 06832w, 06833w, 06834w, 06835w, 06837w, 06838w, 06839w, 06840w
Linked to airfield function?	Yes
Of technical/Structural interest?	No
Historical association?	No

Plate 7: Flight Office. View to the west.

Plate 8: Flight Office complex (southwest elevation)

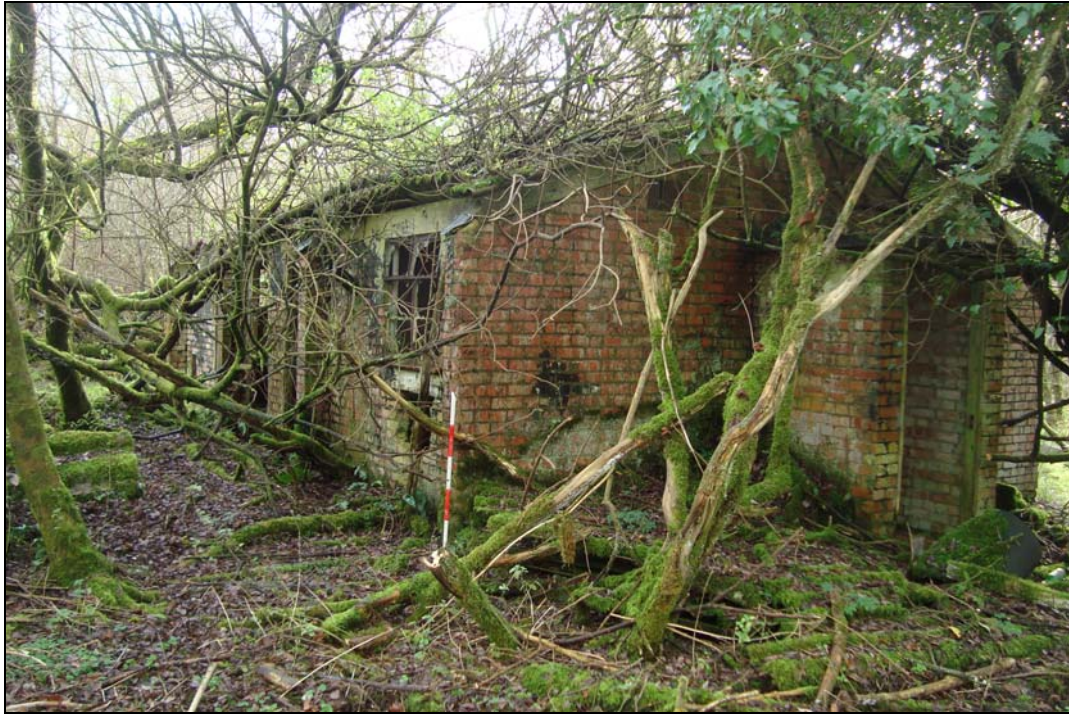
ID No	FC11
PRN	06837w
Name	DRYING ROOM & LATRINE
NGR	SS5650990791
On Air Ministry Plan?	Yes
MoD Building No	253
In Use	Yes
Description	Remains of drying room and latrine block (drawing No. 14052/40). This building is in a poor condition and has undergone some alterations to convert it to use for livestock. Feeding troughs have been added to the western suite of rooms and holes have been made within the external walls to ease filling the troughs. The latrine block is small brick structure with a concrete slab roof added to the north western gable end of the building. This feature still maintains its wooden doorframe and wooden Elsan toilet lid and surround, which remain <i>in situ</i> . The site is heavily overgrown with scrub woodland that is starting to cause major damage to the structure.
Condition	Converted
Condition rating	Poor
Period	Modern
Group Value	Yes
Form	Building
Associated PRN sites	06827w, 06828w, 06829w, 06830w, 06831w, 06832w, 06833w, 06834w, 06835w, 06836w, 06838w, 06839w, 06840w

Plate 9: Drying room and latrine block. View to the south

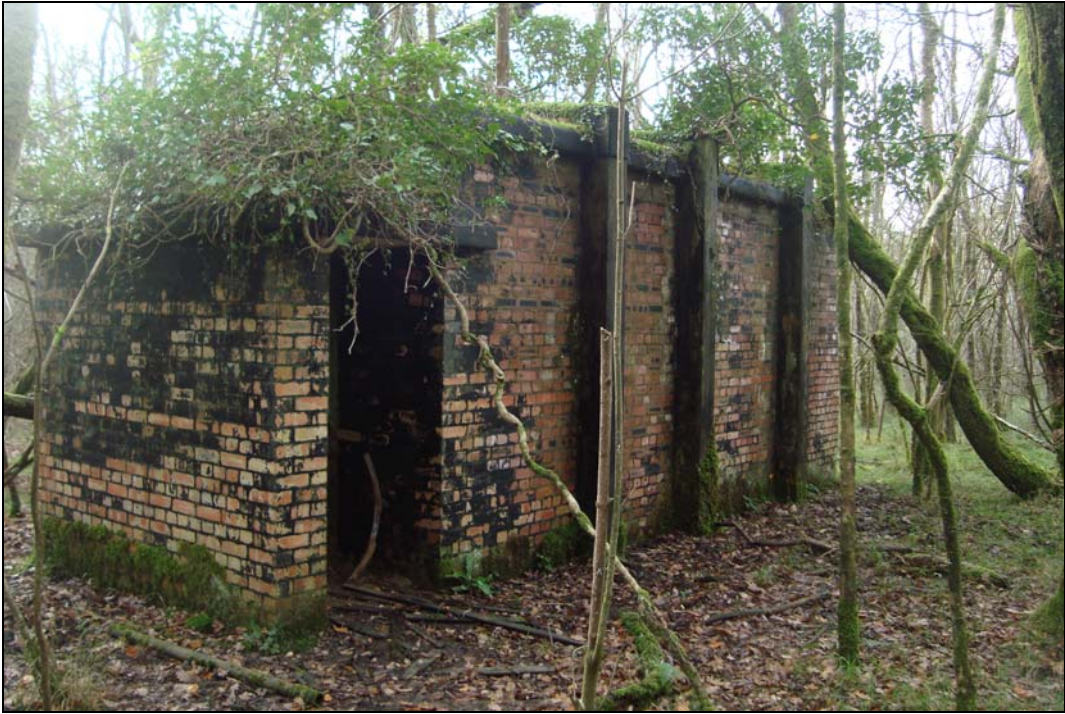
Condition	Damaged
Condition rating	Good
Period	Modern
Group Value	Yes
Form	Building
Associated PRN sites	06827w, 06828w, 06829w, 06830w, 06831w, 06832w, 06833w, 06834w, 06835w, 06836w, 06837w, 06839w, 06840w
Linked to airfield function?	Yes
Of technical/Structural interest?	No
Historical association?	No

Plate 12: Hardened Sleeping Shelter. Note the reinforced bands and blast porch

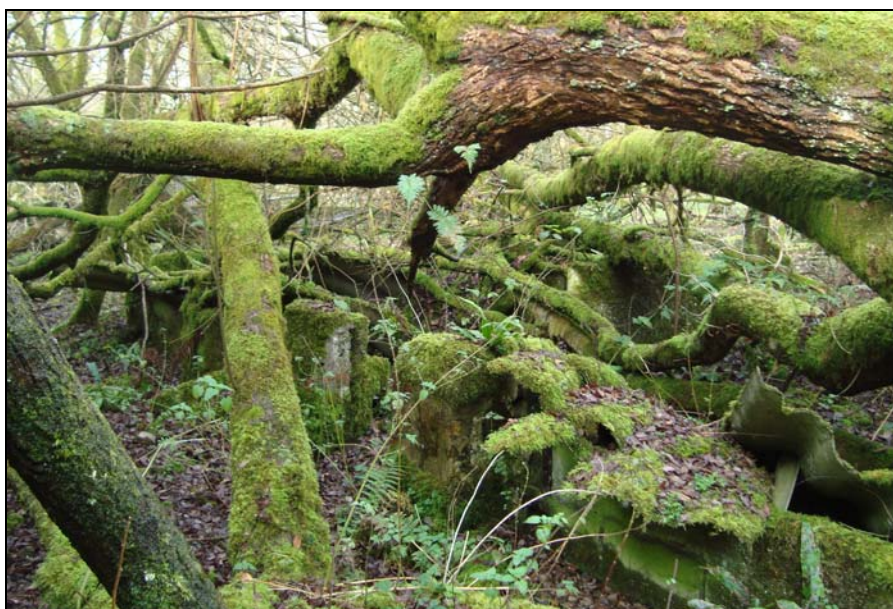
ID No	FC14
PRN	06840w
Name	UNKNOWN BUILDING
NGR	SS5651490791
On Air Ministry Plan?	No
MoD Building No	-
In Use	No
Description	Remains of an unknown brick building. Linear structure sub-divided into three separate bays with a doorway in the southwest facing elevation. These remains resemble the floor plan of a latrine block (drawing No. 9026/41). The building has been almost completely destroyed by a falling Beech tree, which lies across the remains.
Condition	Near Destroyed
Condition rating	Destroyed
Period	Modern
Group Value	Yes
Form	Other structure
Associated PRN sites	06827w, 06828w, 06829w, 06830w, 06831w, 06832w, 06833w, 06834w, 06835w, 06836w, 06837w, 06838w, 06839w
Linked to airfield function?	Yes
Of technical/Structural interest?	No
Historical association?	No

Plate 16: Remains of an unknown building

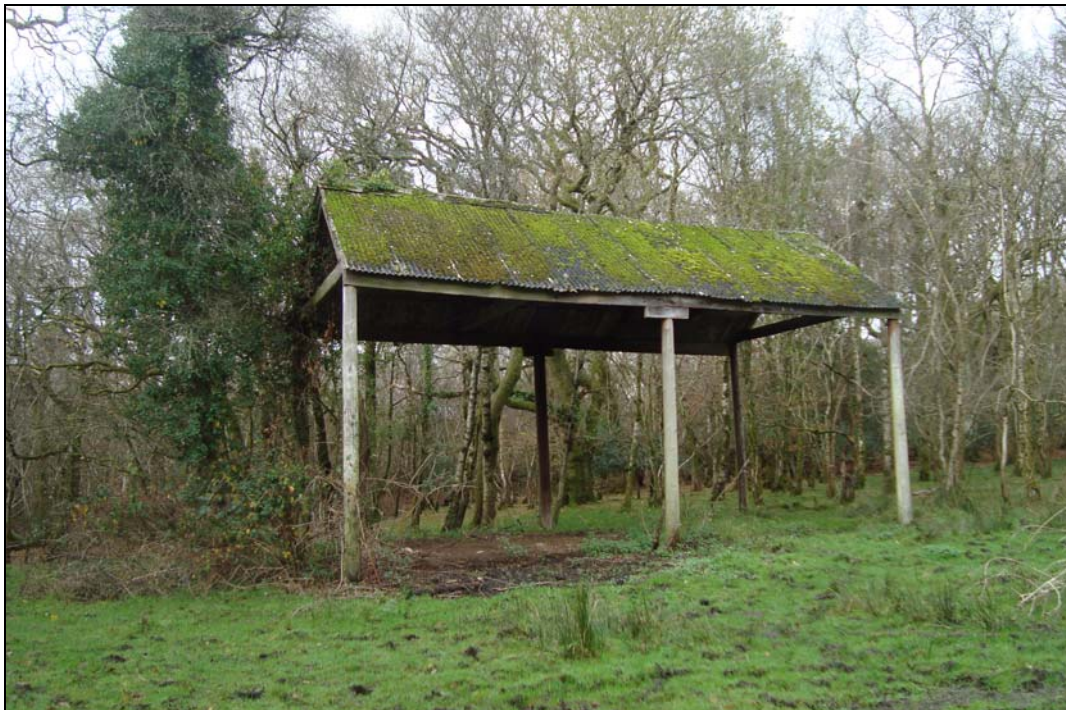
ID No	FC15
PRN	06840w
Name	MECHANICAL TRANSPORT SHED
NGR	SS5650290820
On Air Ministry Plan?	No
MoD Building No	-
In Use	No
Description	Temporary and rudimentary wood and asbestos constructed Mechanical transport shed.
Condition	Damaged
Condition rating	Good
Period	Modern
Group Value	Yes
Form	Other structure
Associated PRN sites	06827w, 06828w, 06829w, 06830w, 06831w, 06832w, 06833w, 06834w, 06835w, 06836w, 06837w, 06838w, 06839w
Linked to airfield function?	No
Of technical/Structural interest?	No
Historical association?	No

Plate 17: Remains of the Mechanical Transport Shed

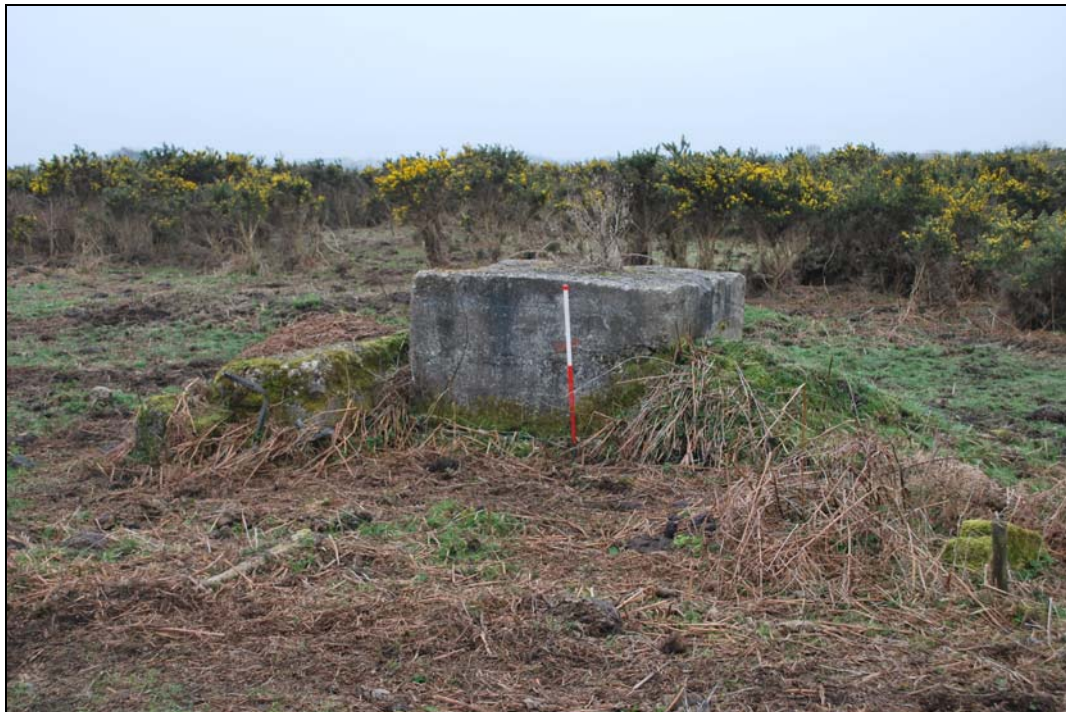
ID No	FC16
PRN	06842w
Name	CONCRETE BLOCK
NGR	SS5634791082
On Air Ministry Plan?	No
MoD Building No	-
In Use	No
Description	A large concrete block of unknown use. The block is located at end of runway 23/05 and is flanked by concrete rubble.
Condition	Near Destroyed
Condition rating	Poor
Period	Modern
Group Value	Yes
Form	Other structure
Associated PRN sites	-
Linked to airfield function?	No
Of technical/Structural interest?	No
Historical association?	No

Plate 18: Concrete block surrounded by assorted concrete rubble

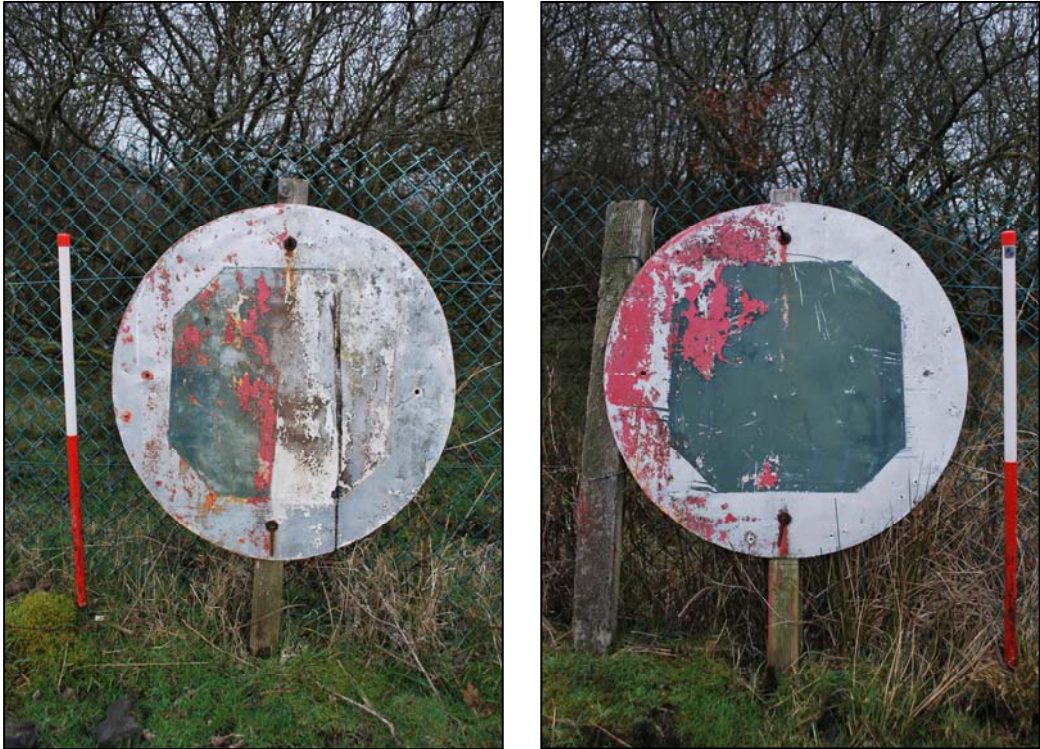
ID No	FC17
PRN	06843w
Name	RUNWAY MARKERS
NGR	SS5618391205
On Air Ministry Plan?	No
MoD Building No	-
In Use	No
Description	Two circular aluminium markers located against a boundary fence at the western end of the Second World War runway 11/29 (which stood at 41,000ft) the runway was reduced post-war to 3,407ft and a new set of markers introduced further to the east.
Condition	Damaged
Condition rating	Good
Period	Modern
Group Value	No
Form	Other structure
Associated PRN sites	-
Linked to airfield function?	Yes
Of technical/Structural interest?	No

Plate 19: The two runway markers

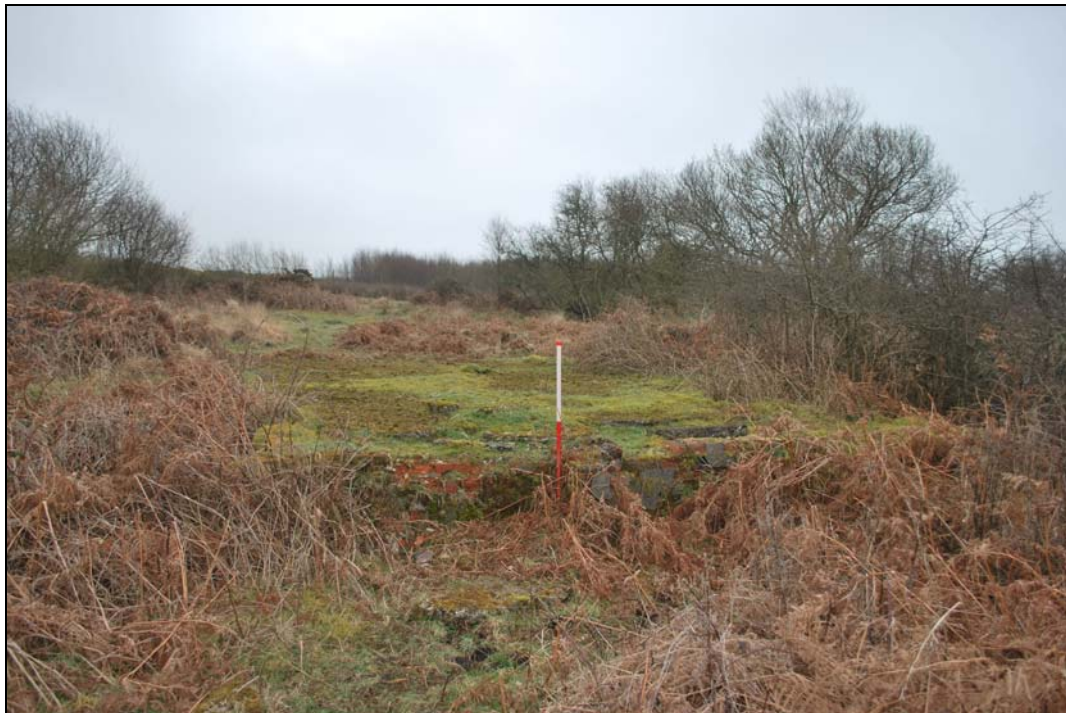
ID No	FC18
PRN	06844w
Name	BATTERY CHARGING ROOM (TYPE B)
NGR	SS5625591418
On Air Ministry Plan?	Yes
MoD Building No	60
In Use	No
Description	A linear concrete platform with the remains of external brick piers to front and rear. The concrete pad stands upon three courses of brickwork. The site is heavily overgrown with vegetation and almost completely covered.
Condition	Near Destroyed
Condition rating	Destroyed
Period	Modern
Group Value	Yes
Form	Other structure
Associated PRN sites	06845w, 06846w, 06847w
Linked to airfield function?	No
Of technical/Structural interest?	No
Historical association?	No

Plate 20: Linear concrete and brick platform. View to the northwest

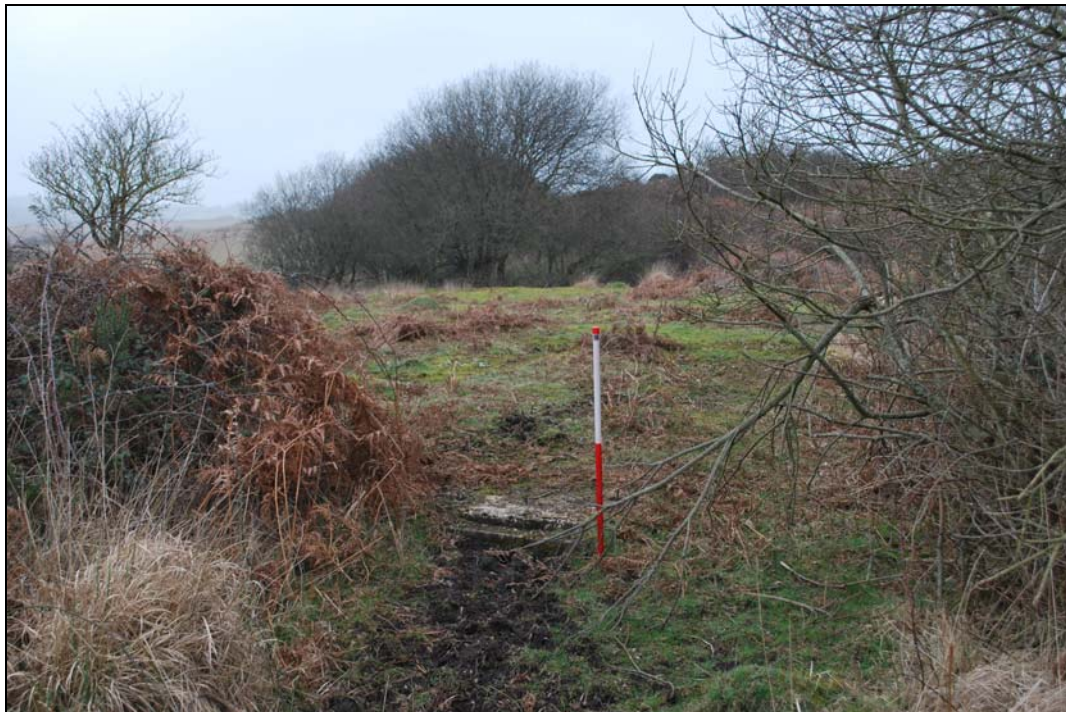
ID No	FC19
PRN	06845w
Name	FLIGHT OFFICES, REST ROOM AND WORKSHOP COMPLEX
NGR	SS5627791425
On Air Ministry Plan?	Yes
MoD Building No	49
In Use	No
Description	Two tier linear concrete platform. Only the south western corner of the structure is exposed, the rest is covered by vegetation.
Condition	Near destroyed
Condition rating	Destroyed
Period	Modern
Group Value	Yes
Form	Other structure
Associated PRN sites	06844w, 06846w, 06847w
Linked to airfield function?	Yes
Of technical/Structural interest?	No
Historical association?	No

Plate 21: Edge of the two tier building platform

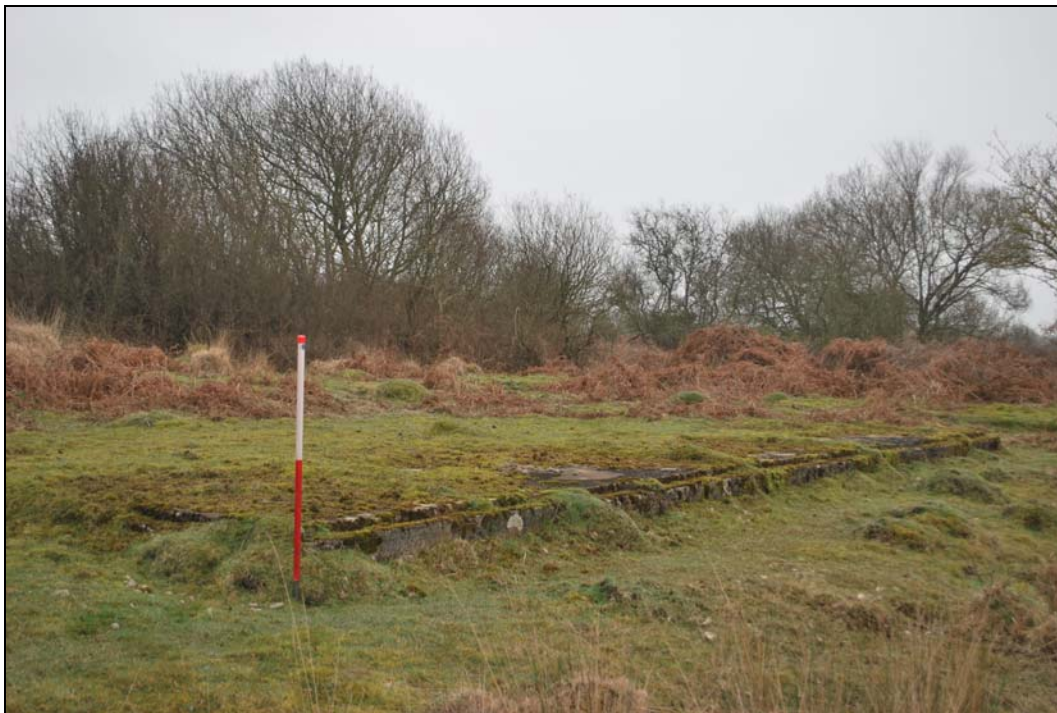
ID No FC20
PRN 06846w
Name FLIGHT OFFICES, REST ROOM AND WORKSHOP COMPLEX
NGR SS5626891441
On Air Ministry Plan? Yes
MoD Building No 49
In Use No
Description Two tier linear concrete platform.
Condition Near destroyed
Condition rating Destroyed
Period Modern
Group Value No
Form Other structure
Associated PRN sites 06844w, 06845w, 06847w
Linked to airfield function? Yes
Of technical/Structural interest? No
Historical association? No

Plate 22: Concrete platform. View to the southeast

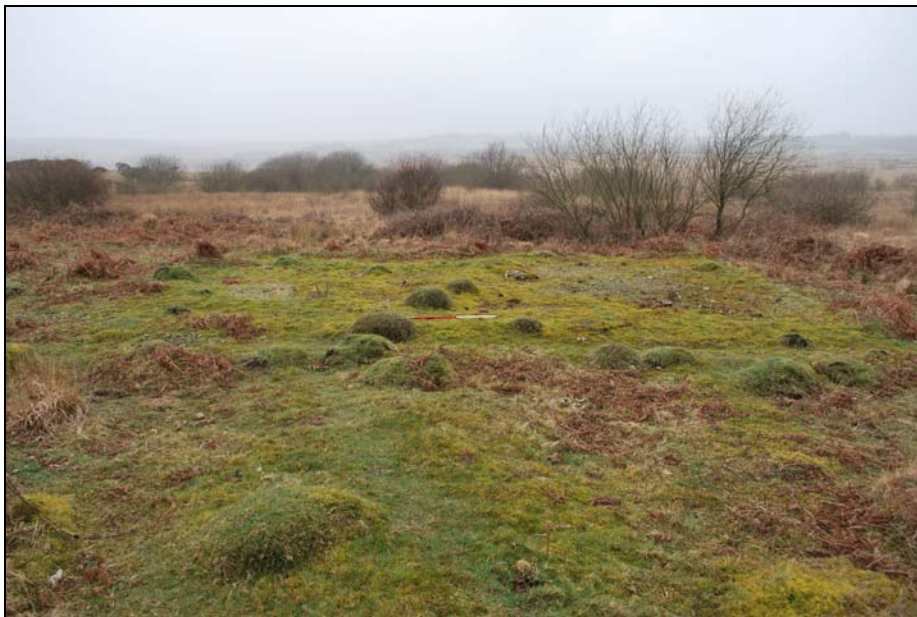
ID No	FC21
PRN	06847w
Name	LATRINE AND DRYING ROOM
NGR	SS5625591436
On Air Ministry Plan?	Yes
MoD Building No	40
In Use	No
Description	A concrete building platform. The platform is heavily overgrown and almost completely hidden by vegetation.
Condition	Near destroyed
Condition rating	Poor
Period	Modern
Group Value	Yes
Form	Other structure
Associated PRN sites	06844w, 06845w, 06846w
Linked to airfield function?	No
Of technical/Structural interest?	No
Historical association?	No

Plate 24: Concrete building platform

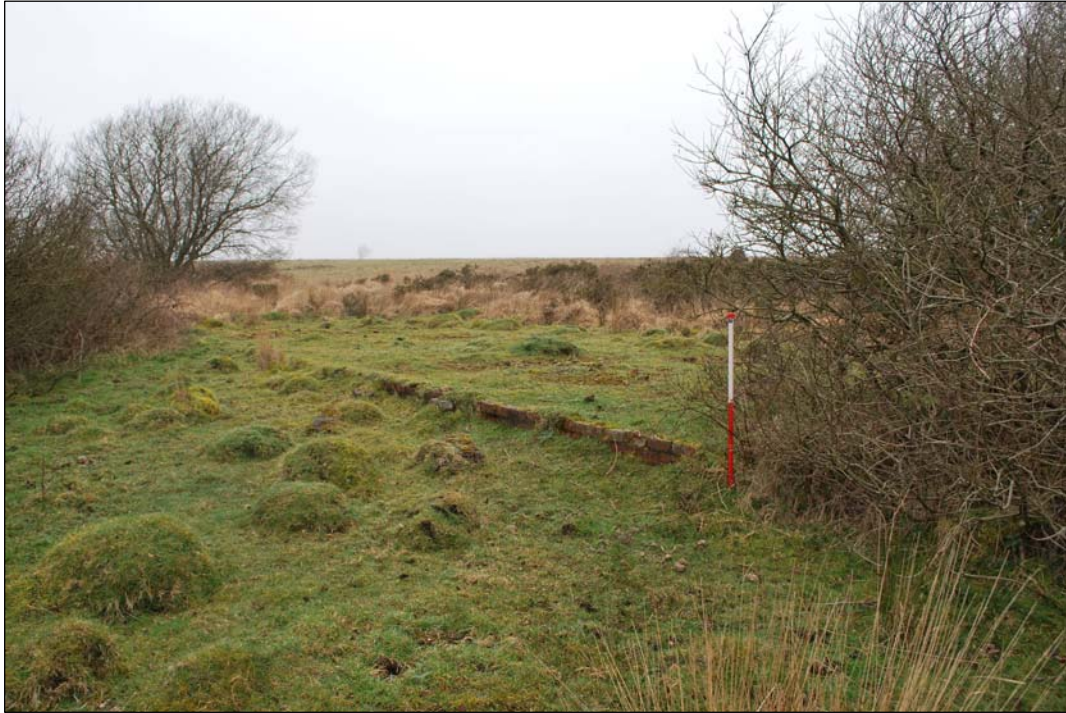
ID No	FC22
PRN	06848w
Name	TECHNICAL WORKSHOP
NGR	SS5680791933
On Air Ministry Plan?	Yes
MoD Building No	246
In Use	No
Description	A linear concrete platform with the remnants of external brick piers. The concrete pad stands upon a single course of brickwork. The site is heavily overgrown with vegetation and almost completely covered.
Condition	Near destroyed
Condition rating	Destroyed
Period	Modern
Group Value	Yes
Form	Other structure
Associated PRN sites	06849w, 06850w, 06851w, 06852w
Linked to airfield function?	No
Of technical/Structural interest?	No

Plate 25: Remains of a building platform. View to the west

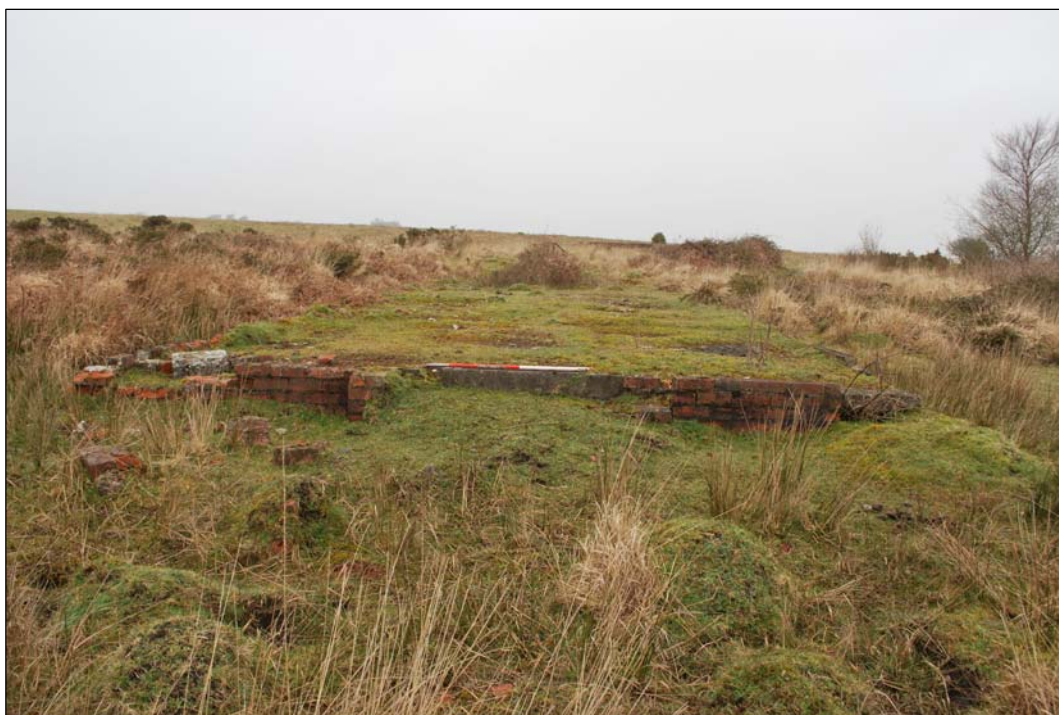
ID No	FC23
PRN	06849w
Name	TECHNICAL WORKSHOP
NGR	SS5676091930
On Air Ministry Plan?	Yes
MoD Building No	247
In Use	No
Description	Large brick built platform with the remains of a single concrete stair to the east facing elevation. The platform is raised three courses of brickwork above the ground level. In the centre of the platform is a series of features that relate to internal features within the interior of the building.
Condition	Near destroyed
Condition rating	Poor
Period	Modern
Group Value	Yes
Form	Other structure
Associated PRN sites	06848w, 06850w, 06851w, 06852w
Linked to airfield function?	No
Of technical/Structural interest?	No
Historical association?	No

Plate 26: Brick platform with the remains of a concrete step at the front of the building

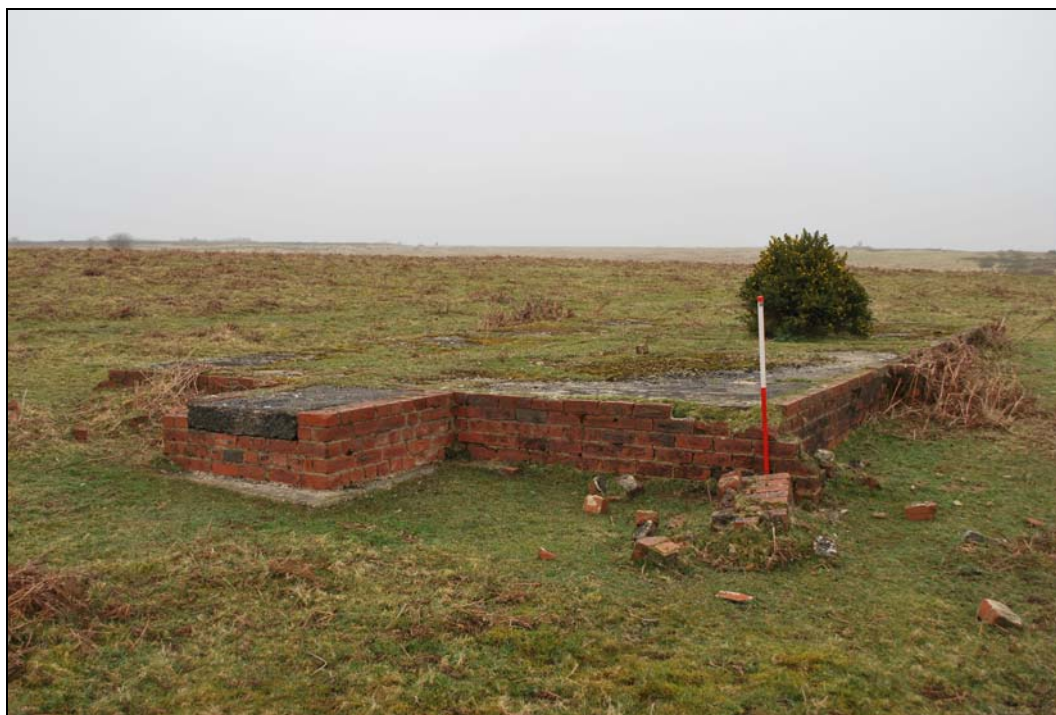
ID No	FC24
PRN	06850w
Name	36' x 16' FOUNDATION AND CONCRETE BASE
NGR	SS5678691987
On Air Ministry Plan?	Yes
MoD Building No	323
In Use	No
Description	Linear brick base with square extension to the western end, three piers sub-divide either flank. The foundations stand five courses high above the current ground level and have a reinforced concrete floor. The bricks used in the construction of the structure are stamped 'Clyne' having come from the nearby brickworks'.
Condition	Near destroyed
Condition rating	Poor
Period	Modern
Group Value	No
Form	Other structure
Associated PRN sites	06848w, 06849w, 06851w, 06852w
Linked to airfield function?	No
Of technical/Structural interest?	No
Historical association?	No

Plate 28: Brick building. View to the northeast

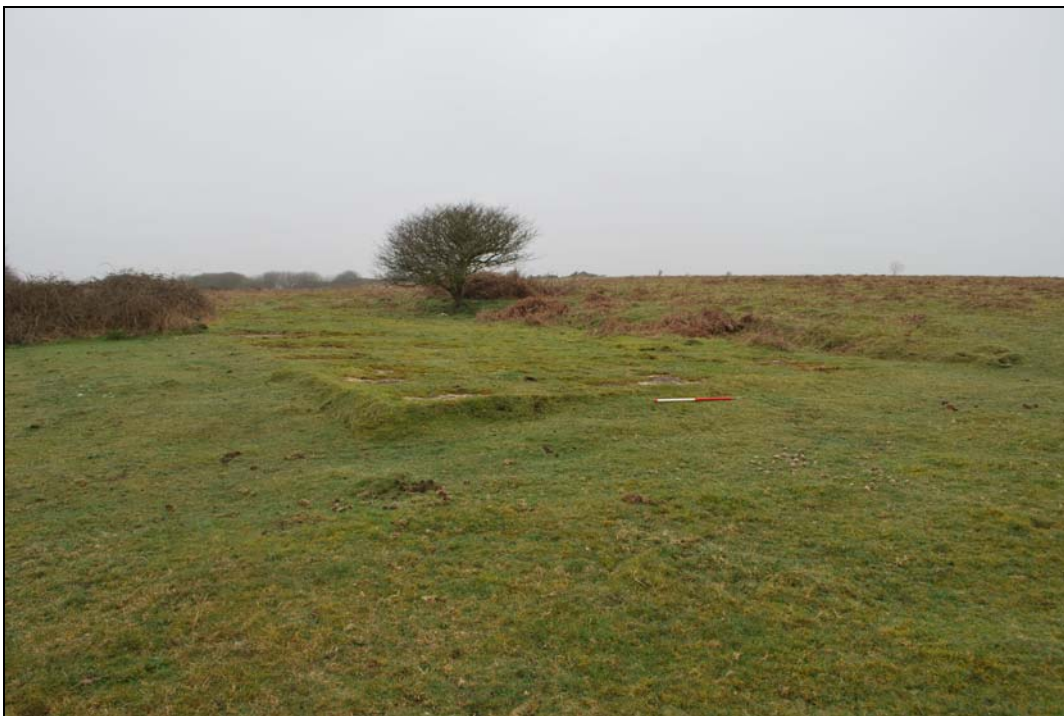
ID No FC25
PRN 06851w
Name FLIGHT OFFICE AND REST ROOM
NGR SS5685291999
On Air Ministry Plan? Yes
MoD Building No 245
In Use No
Description A concrete platform only just visible beneath the vegetation.
Condition Near destroyed
Condition rating Destroyed
Period Modern
Group Value No
Form Other structure
Associated PRN sites 06848w, 06849w, 06850w, 06852w
Linked to airfield function? Yes
Of technical/Structural interest? No
Historical association? No

Plate 29: Remains of the building platform

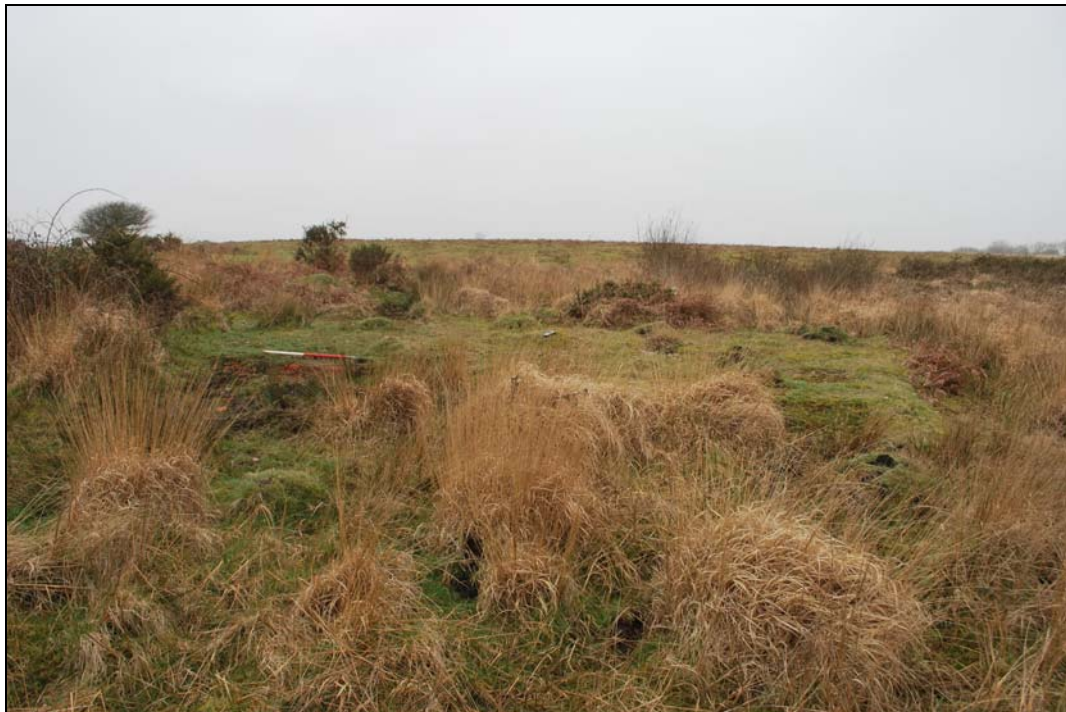
ID No	FC26
PRN	06852w
Name	LATERINE AND DRYING ROOM
NGR	SS568899206
On Air Ministry Plan?	Yes
MoD Building No	244
In Use	No
Description	Very little remains of this structure except a section of brickwork at the plinths north western corner. The majority of this site is covered in vegetation.
Condition	Near destroyed
Condition rating	Destroyed
Period	Modern
Group Value	No
Form	Other structure
Associated PRN sites	06848w, 06849w, 06850w, 06851w
Linked to airfield function?	No
Of technical/Structural interest?	No
Historical association?	No

Plate 30: Remains of building PRN 06852w

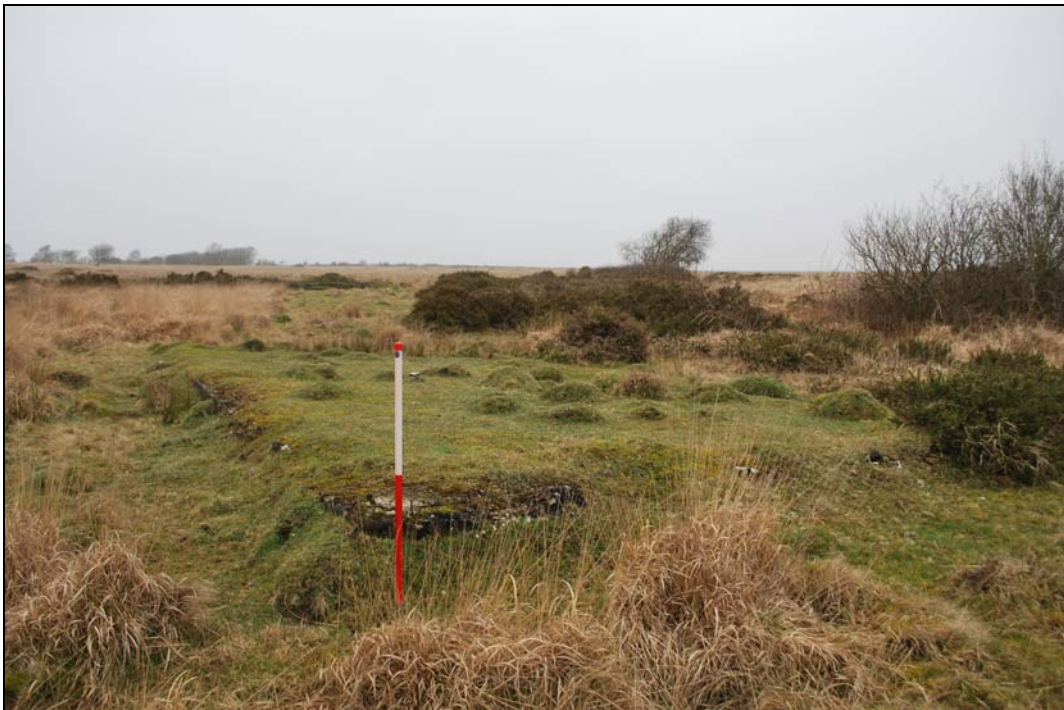
ID No	FC28
PRN	06854w
Name	R P STORES
NGR	SS5695792096
On Air Ministry Plan?	No
MoD Building No	240A
In Use	No
Description	Very little remains of this structure; a corner of the platform is exposed and the concrete has started to break down. The majority of this site is lost beneath the vegetation leaving just an outline of the buildings platform base.
Condition	Near destroyed
Condition rating	Destroyed
Period	Modern
Group Value	No
Form	Other structure
Associated PRN sites	06853w, 06855w, 06856w
Linked to airfield function?	No
Of technical/Structural interest?	No
Historical association?	No

Plate 32: Very little remains of building PRN 6854w

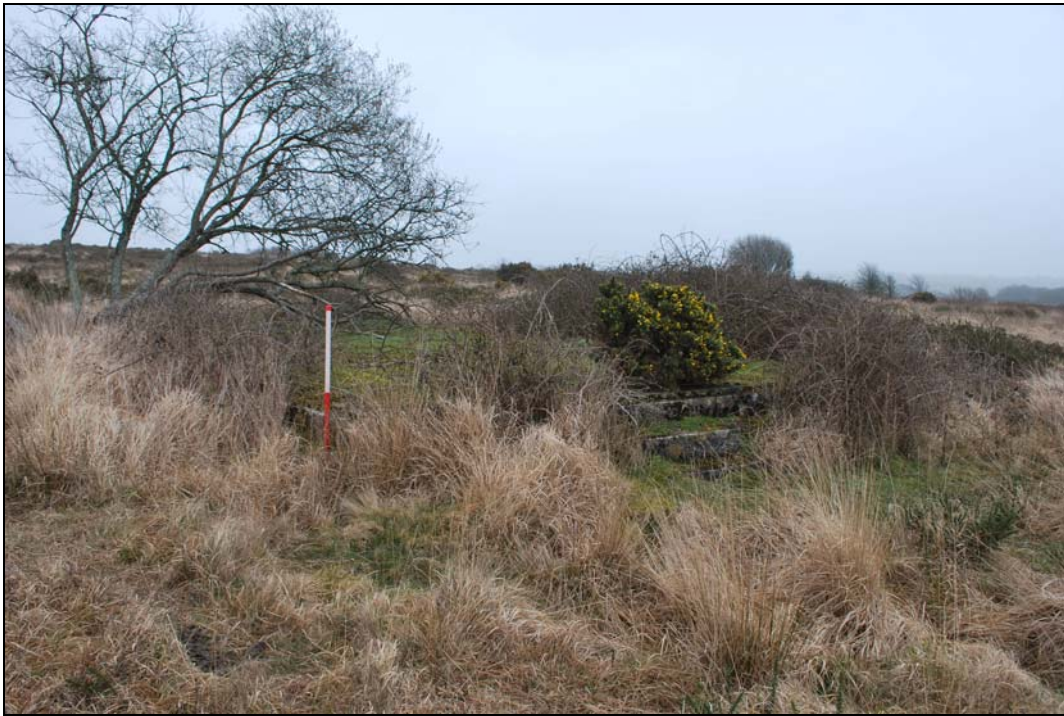
ID No FC29
PRN 06855w
Name WATCH OFFICE
NGR SS5698192114
On Air Ministry Plan? No
MoD Building No -
In Use No
Description Rudimentary Fighter Watch Office used as a shelter for the duty pilot or officer on watch on an airfield. The building is in a poor state of preservation having lost all of its upstanding structure, so all that remains is a reinforced concrete base accessed by a flight of three concrete steps. Mature trees and shrubs have all taken root on top and surrounding the base and are causing the base to be undermined towards the rear north facing corner.
Condition Near destroyed
Condition rating Very bad
Period Modern
Group Value No
Form Other structure
Associated PRN sites 06854w, 06856w, 06857w
Linked to airfield function? No
Of technical/Structural interest? No
Historical association? No

Plate 33: Remains of the Watch Office. View to the east

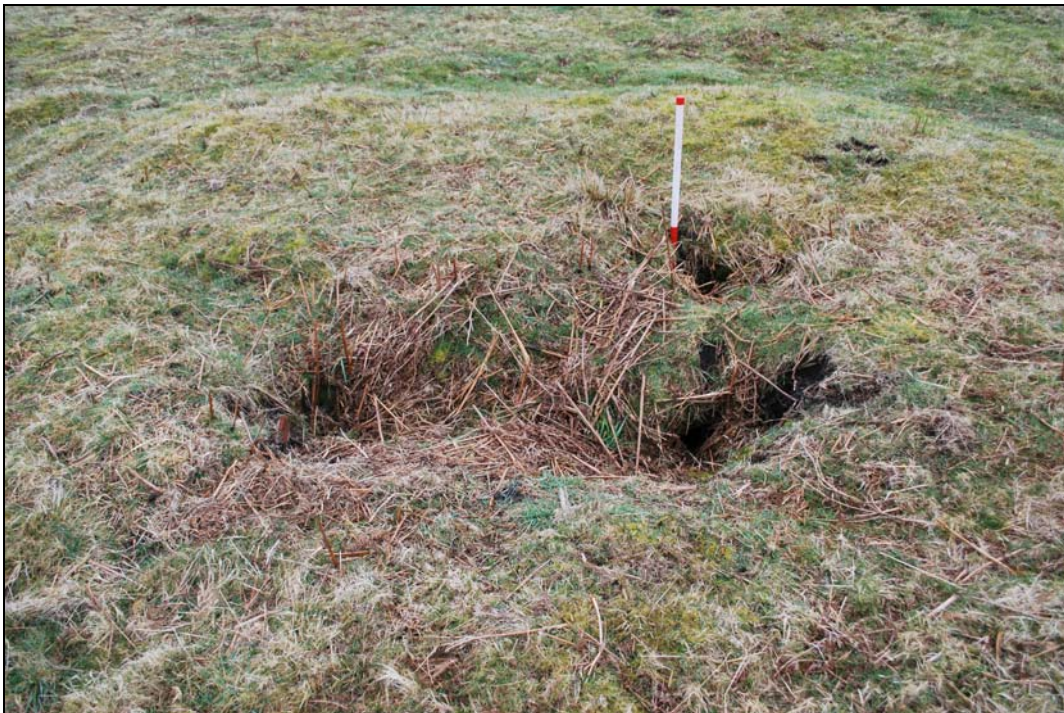
ID No	FC30
PRN	06856w
Name	INFANTRY TRENCHES
NGR	SS5633291737
On Air Ministry Plan?	No
MoD Building No	-
In Use	No
Description	Running in a zigzag pattern across the open moorland at the northern end of runway 33/15 are at least seven submerged brick and concrete lined gunpits or infantry trenches, that formed part of the airfields perimeter defences. The plan-form is a loose 'V' shape providing the operative inside with a broad field of fire. All the features are now in filled to a lesser or greater degree. Trench FC30 is unusual from the rest, located to the east of the runway on a northeast facing slope it varies from the rest as it is enclosed within a slight earthen mound. This earthwork may have been added to provide the occupant with a greater amount of protection.
Condition	Damaged
Condition rating	Poor
Period	Modern
Group Value	Yes
Form	Other structure

Plate 36: Infantry trench FC 30 (PRN 06856w). Note the loose 'V' shaped plan

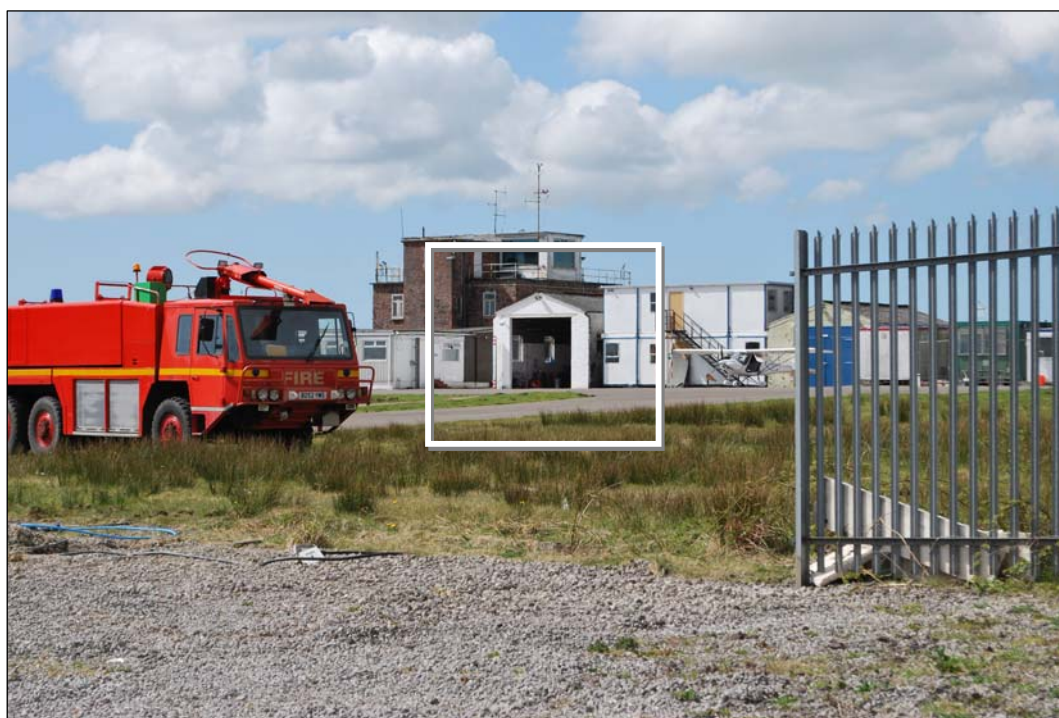
ID No	FC38
PRN	06864w
Name	FIRE TENDER SHELTER
NGR	SS5690491384
On Air Ministry Plan?	Yes
MoD Building No	2
In Use	Yes
Description	The Fire Tender Shed (drawing No. 12584/40) is still in use for its original purpose at Fairwood and houses the Airport Fire and Rescue Services six-wheeled Scammell FIRE 1 vehicle. Unable to obtain access to the airport during the course of this project, therefore the condition of the structures is not recorded.
Condition	Not Known
Condition rating	Not Recorded
Period	Modern
Group Value	Yes
Form	Other structure
Associated PRN sites	06863w, 06865w, 06866w, 06867w
Linked to airfield function?	No
Of technical/Structural interest?	No
Historical association?	No

Plate 39: Fire Tender Shelter (at the centre of the picture). View to the west.
