GGAT 112: Second World War Military Airfields of South Wales

Year 1-Airfield Core and Technical Buildings

A report for Cadw
by Paul W Huckfield BA

GGAT report no. 2012/032
Project no. GGAT 112

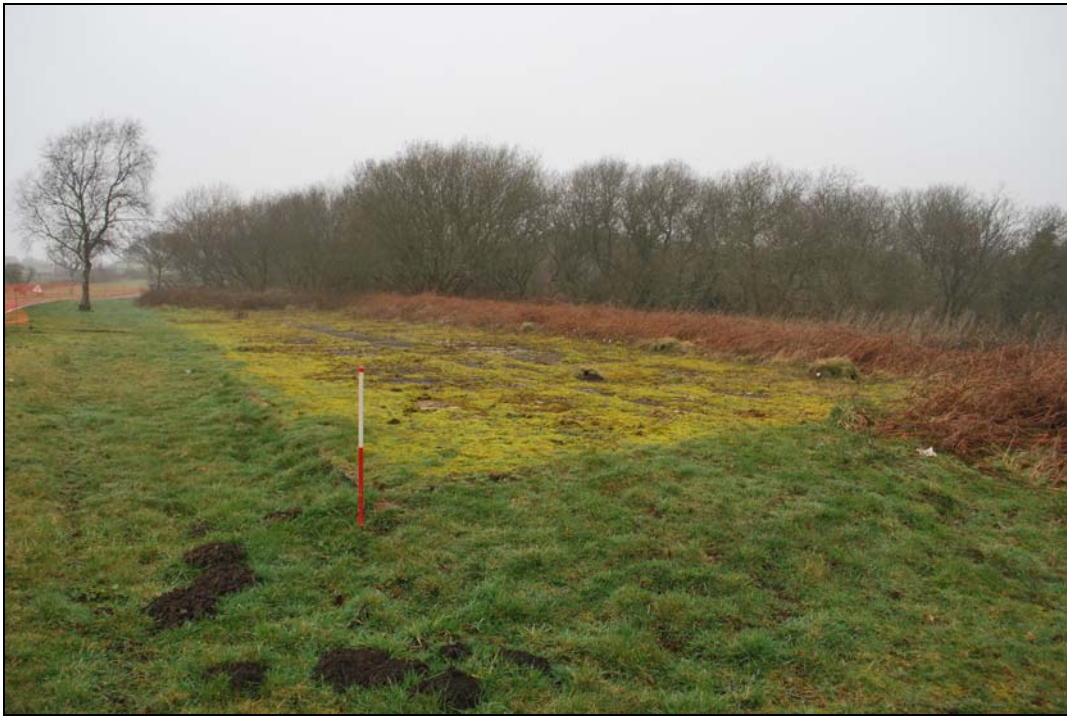
ID No FC40
PRN 06866w
Name STATION HEADQUARTERS
NGR SS5727791279
On Air Ministry Plan? Yes
MoD Building No 23
In Use Yes
Description Remains of the Station Headquarters. All that survives is a linear concrete pad. The original building would have been a long temporary brick hut rendered with concrete with external piers at ten feet centres to form five bays. Steel trusses covered with corrugated asbestos sheets would have supported the roof. These building were used for administrative purposes housing offices; lecture rooms and in some cases a library and a meteorological office.
Condition Near Destroyed
Condition rating Destroyed
Period Modern
Group Value Yes
Form Other structure
Associated PRN sites 06863w, 06864w, 06865w, 06867w
Linked to airfield function? No
Of technical/Structural interest? No
Historical association? No

Plate 40: Little remains of the Station Headquarters except the concrete pad

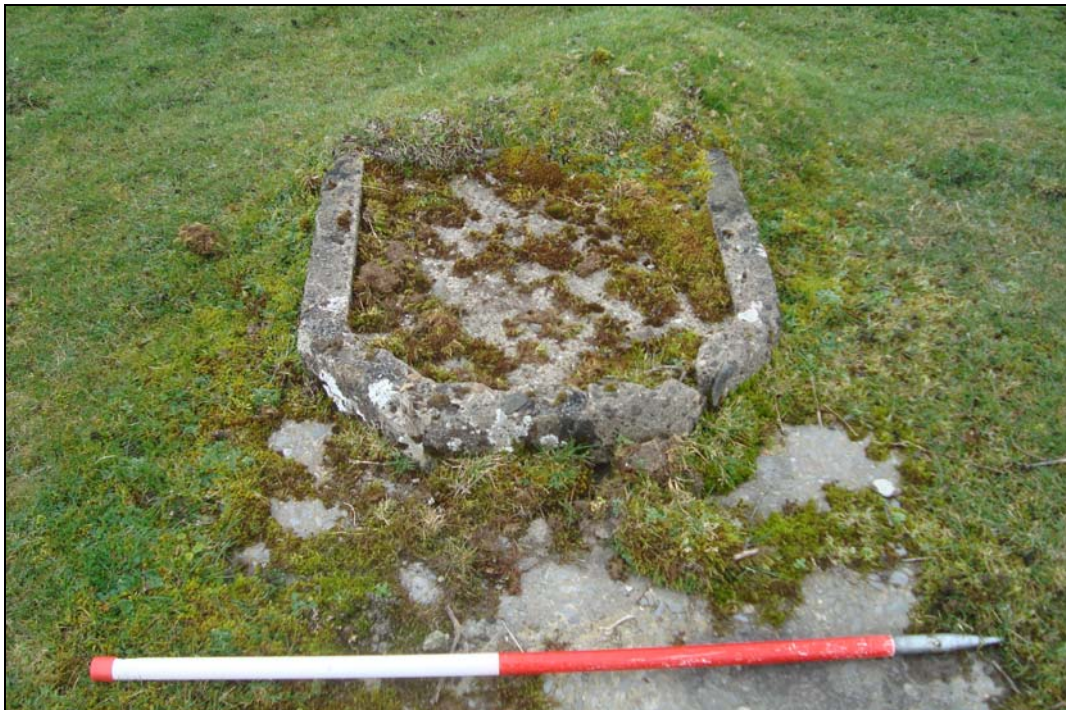
Plate 41: Remains of the grate at the north eastern end of the guard house

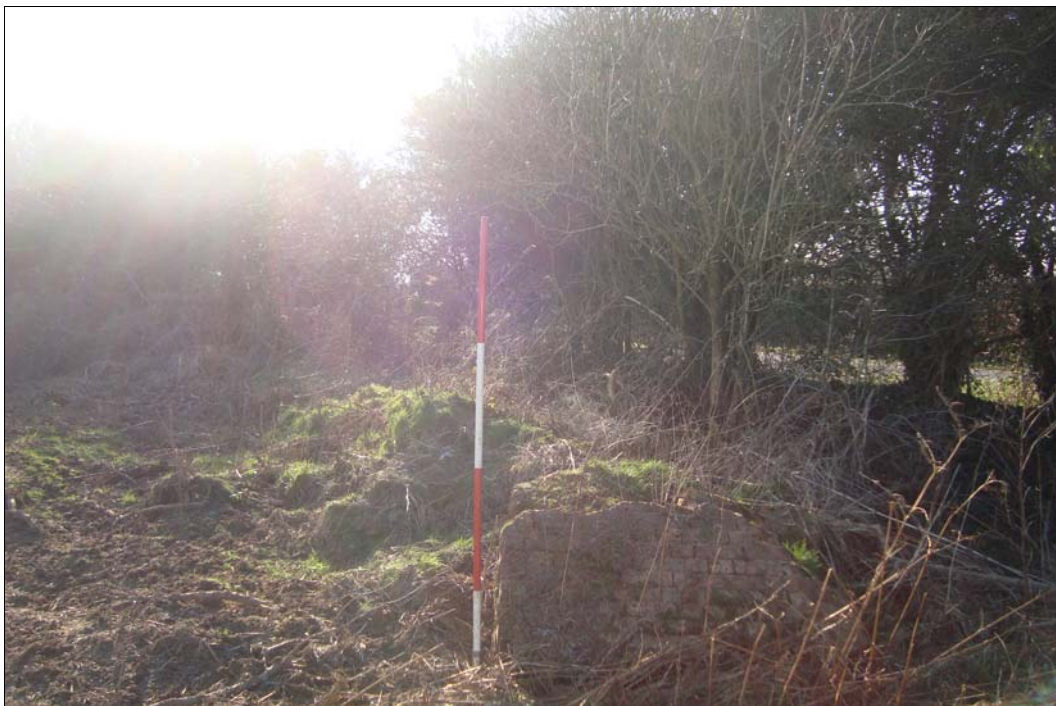
ID No	SD2
PRN	06332
Name	WAAF ACCOMODATION BLOCK
NGR	SS8453280313
On Air Ministry Plan?	Yes
MoD Building No	-
In Use	No
Description	This building has been total destroyed and is now a heap of demolition material
Condition	Destroyed
Condition rating	Destroyed
Period	Modern
Group Value	No
Form	Earthwork
Associated PRN sites	06330m, 06331m, 06333m 06334m, 06335m, 06336m, 06337m, 06338m, 06339m
Linked to airfield function?	No
Of technical/Structural interest?	No
Historical association?	No

Plate 44: All that physically remains of one of the WAAF accommodation blocks.

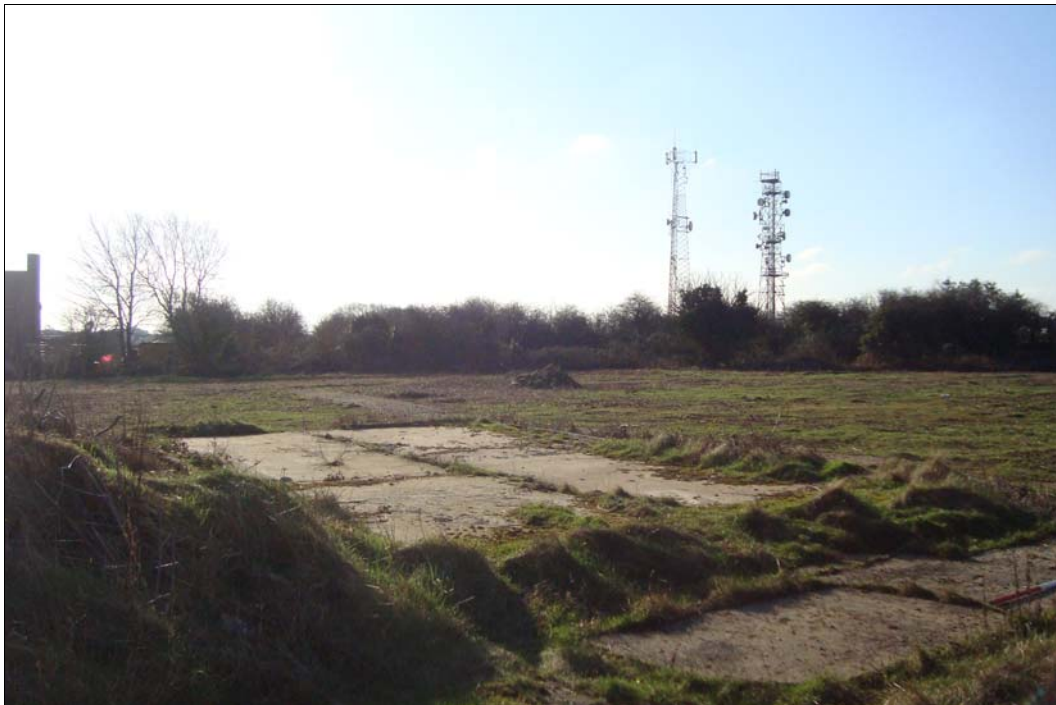
ID No	SD3
PRN	06333m
Name	WAAF BARRACK HUT (REMAINS)
NGR	SS846028034
On Air Ministry Plan?	Yes
MoD Building No	1
In Use	No
Description	Linear concrete pad represents the footings of a wooden WAAF accommodation hut. These wooden huts once covered a large percentage of the site.
Condition	Near Destroyed
Condition rating	Destroyed
Period	Modern
Group Value	No
Form	Other structure
Associated PRN sites	06330m, 06331m, 06332m, 06334m, 06335m, 06336m, 06337m, 06338m, 06339m
Linked to airfield function?	No
Of technical/Structural interest?	No
Historical association?	No

Plate 45: Visible remains of one of the WAAF wooden accommodation hut

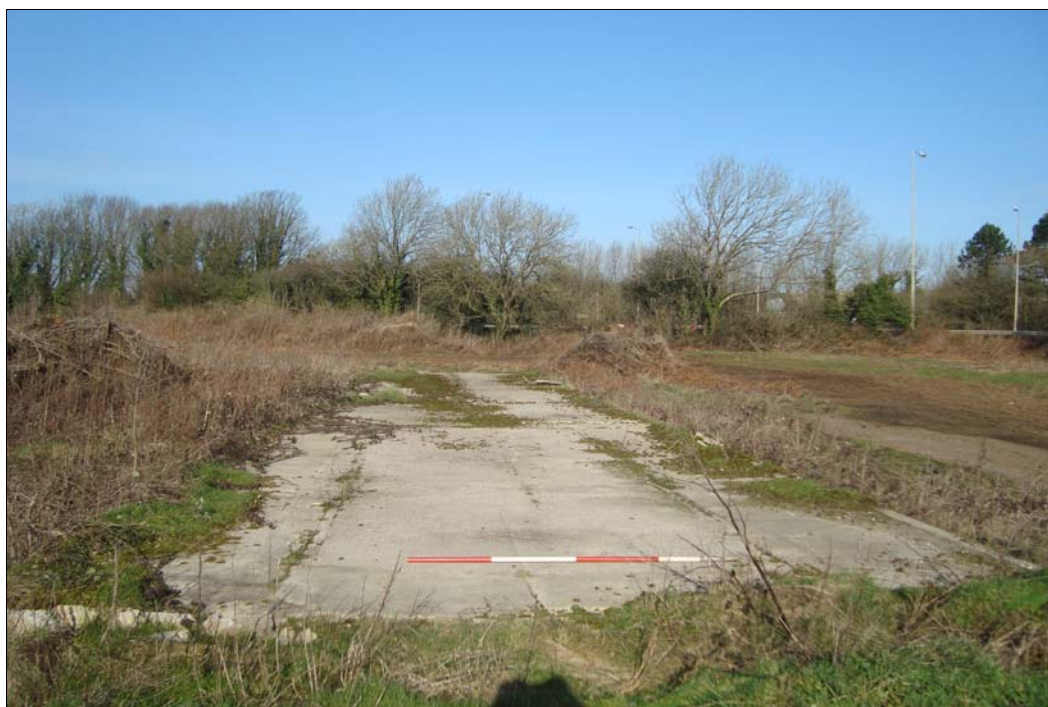
ID No	SD4
PRN	06334m
Name	WAAF COMBINED DINING ROOM & INSTITUTE (REMAINS)
NGR	SS8458980373
On Air Ministry Plan?	Yes
MoD Building No	-
In Use	No
Description	A linear concrete pad with ducting recesses is all that remains of the WAAF combined dining room and institute, building type 1441/41. This building would have been a curved corrugated type structure with small bay type windows along either flank.
Condition	Near Destroyed
Condition rating	Destroyed
Period	Modern
Group Value	No
Form	Other structure
Associated PRN sites	06330m, 06331m, 06332m, 06333m, 06335m, 06336m, 06337m, 06338m, 06339m
Linked to airfield function?	No
Of technical/Structural interest?	No
Historical association?	No

Plate 46: The remains of the WAAF combined dining room and institute

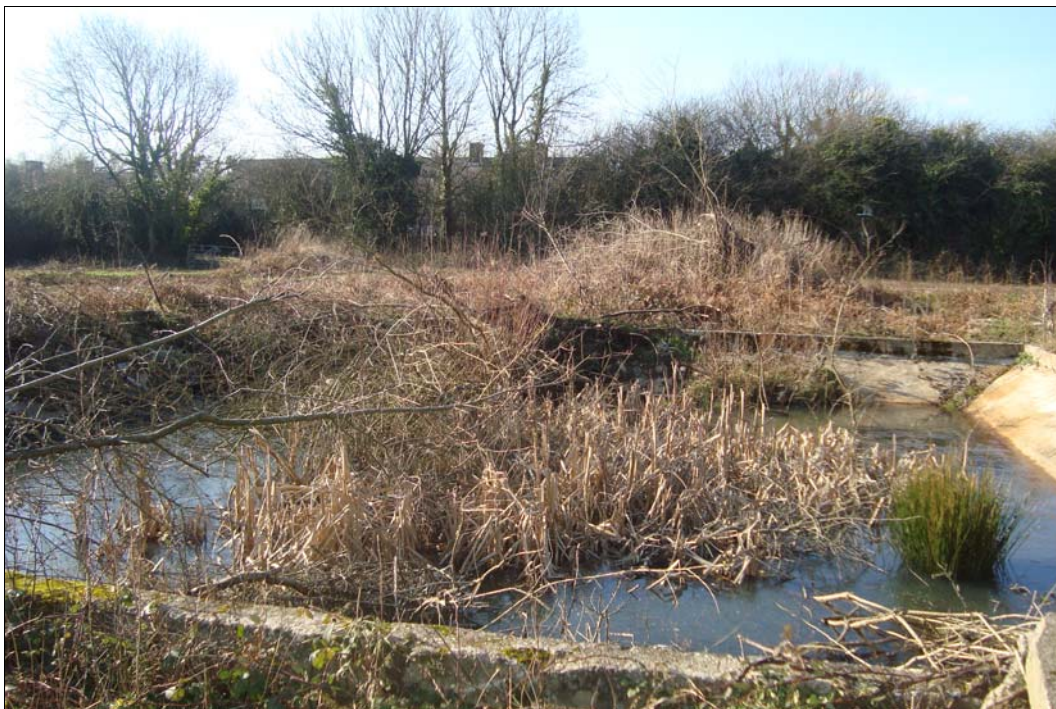
ID No	SD5
PRN	06335m
Name	STATIC WATER TANK
NGR	SS8453480421
On Air Ministry Plan?	Yes
MoD Building No	-
In Use	No
Description	Concrete banked static water tank. Constructed to hold 20,000 gallons of water. This feature is now heavy overgrown with vegetation, but still holds a small amount of water.
Condition	Damaged
Condition rating	Poor
Period	Modern
Group Value	No
Form	Other structure
Associated PRN sites	06330m, 06331m, 06332m, 06333m, 06334m, 06336m, 06337m, 06338m, 06339m
Linked to airfield function?	No
Of technical/Structural interest?	No
Historical association?	No

Plate 47: Static water tank, able to hold 20,000 gallons of water

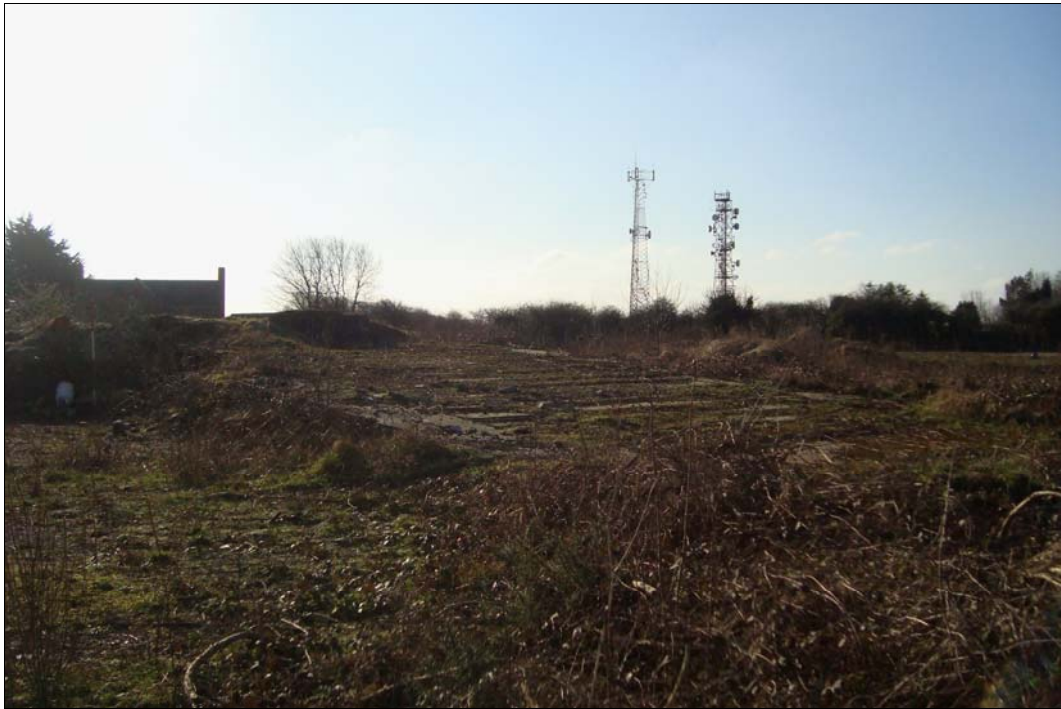
ID No SD6
PRN 06336m
Name GYMNASIUM AND CINEMA
NGR SS8462580360
On Air Ministry Plan? Yes
MoD Building No 32
In Use No
Description A standard 'temporary style' gymnasium and cinema structure. The external structure has been destroyed leaving just the internal features, a sloping ridged incline, which once held the rows of seating, and the rear stepped extension that housed the projection equipment. Demolition material surrounding the remaining features suggest that the original building was of brick and concrete with a steel 'A' framed trussed roof.
Condition Near Destroyed
Condition rating Destroyed
Period Modern
Group Value Yes
Form Building
Associated PRN sites 06330m, 06331m, 06332m, 06333m, 06334m, 06335m, 06337m, 06338m, 06339m
Linked to airfield function? No
Of technical/Structural interest? No
Historical association? No

Plate 48: Internal terracing that once housed the cinema seating

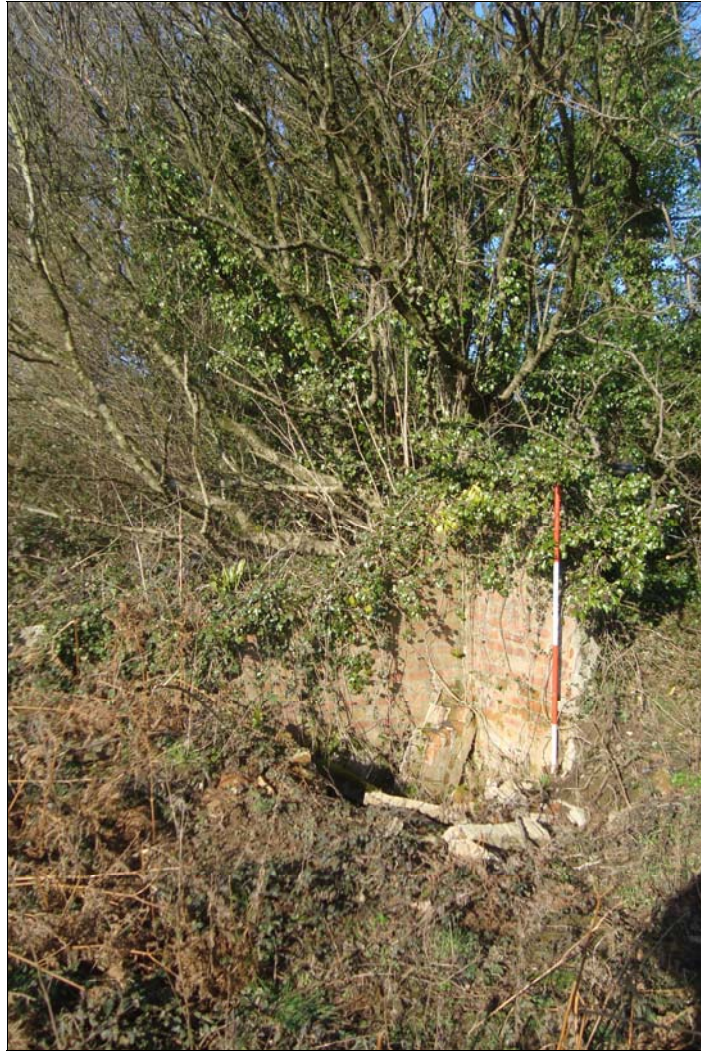
ID No SD7
PRN 06337m
Name UNKNOWN STRUCTURE
NGR SS8452880335
On Air Ministry Plan? Yes
MoD Building No 4
In Use No
Description Brick remains at the periphery of the site. These possibly represent the remains of a destroyed air raid shelter.
Condition Destroyed
Condition rating Destroyed
Period Modern
Group Value No
Form Other structure
Associated PRN sites 06330m, 06331m, 06332m, 06333m, 06334m, 06335m, 06336m, 06338m, 06339m
Linked to airfield function? No
Of technical/Structural interest? No
Historical association? No

Plate 52: Unknown brick structure, possibly an exposed air raid shelter

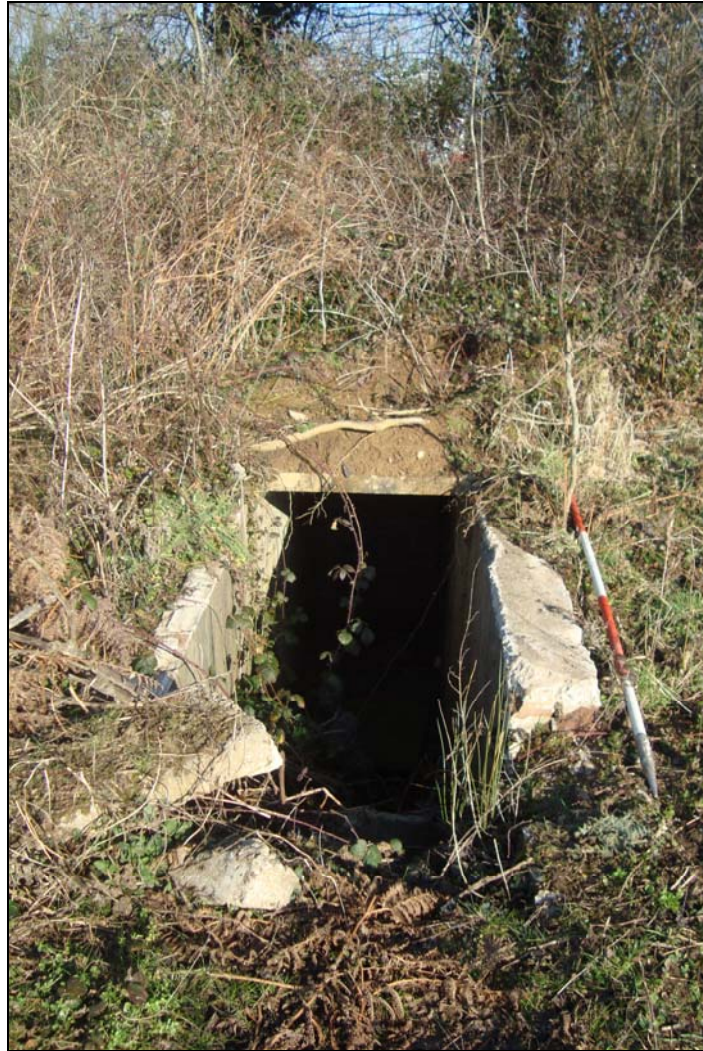
ID No SD8
PRN 06338m
Name AIR RAID SHELTER
NGR SS8458980428
On Air Ministry Plan? Yes
MoD Building No -
In Use No
Description The walls of the entrance to the underground shelter are made from pre cast concrete. Access to the interior of this site was not possible and therefore the condition is unknown.
Condition Not known
Condition rating Nor Recorded
Period Modern
Group Value No
Form Other structure
Associated PRN sites 06330m, 06331m, 06332m, 06333m, 06334m, 06335m, 06336m, 06337m, 06339m
Linked to airfield function? No
Of technical/Structural interest? No
Historical association? No

Plate 53: Access steps to air raid shelter

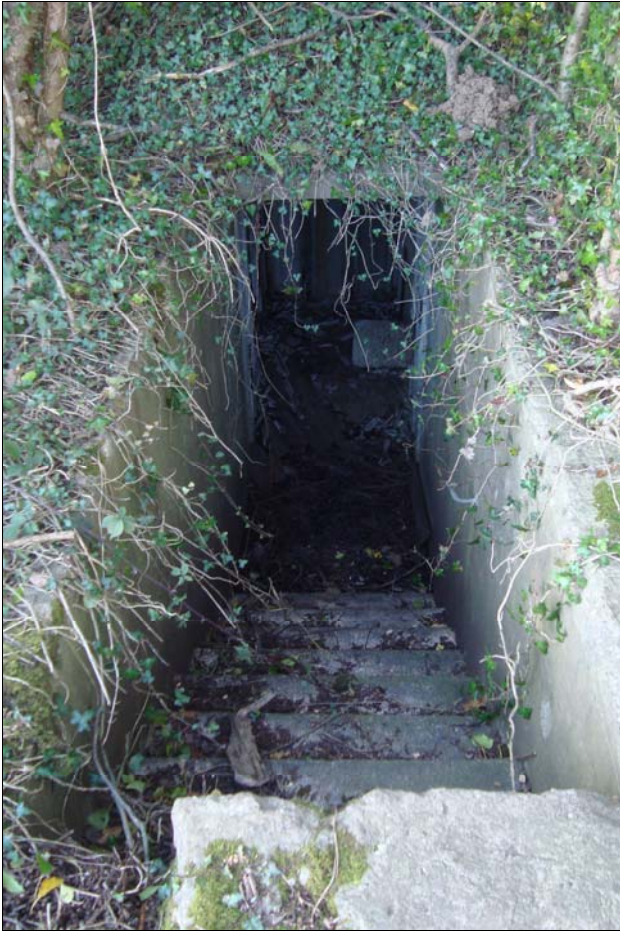
ID No SD9
PRN 06339m
Name BISON AIR RAID SHELTER
NGR SS8447780432
On Air Ministry Plan? Yes
MoD Building No -
In Use No
Description Large communal air raid shelter constructed from precast concrete panelling. Some of the original features, handrail fixings, and entrance floor grill and exit ladder still survive. This type of air raid shelter were produced by *Concrete Limited*, who also produced the Bison mobile pillbox, and were constructed from sheets of square interlocking preformed concrete pieces.
Condition Damaged
Condition rating Fair
Period Modern
Group Value No
Form Other structure
Associated PRN sites 06330m, 06331m, 06332m, 06333m, 06334m, 06335m, 06336m, 06337m, 06338m
Linked to airfield function? No
Of technical/Structural interest? Yes
Historical association? No

Plate 54: entrance to the shelter

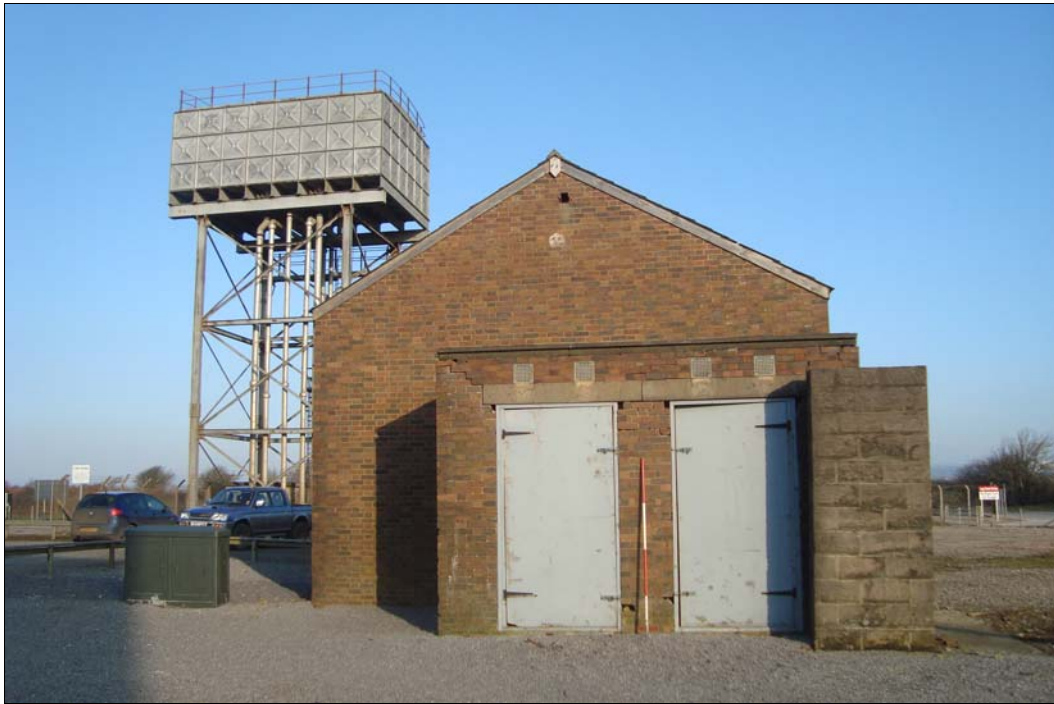
ID No	SD10
PRN	06340m
Name	INLET SUB-STATION/ TRANSFORMER HOUSE
NGR	SS8413380129
On Air Ministry Plan?	Yes
MoD Building No	29
In Use	Yes
Description	Electrical sub-station similar to civil varieties. The building has undergone a number of alterations and extensions and is now used mainly as a storeroom. Future plans for this building include the possibility of transforming it into a museum.
Condition	Damaged/Converted
Condition rating	Poor
Period	Modern
Group Value	No
Form	Building
Associated PRN sites	06330m, 06341m, 06342m, 06343m
Linked to airfield function?	No
Of technical/Structural interest?	No
Historical association?	No

Plate 54: Front of the sub-station PRN 06340m (north facing elevation)

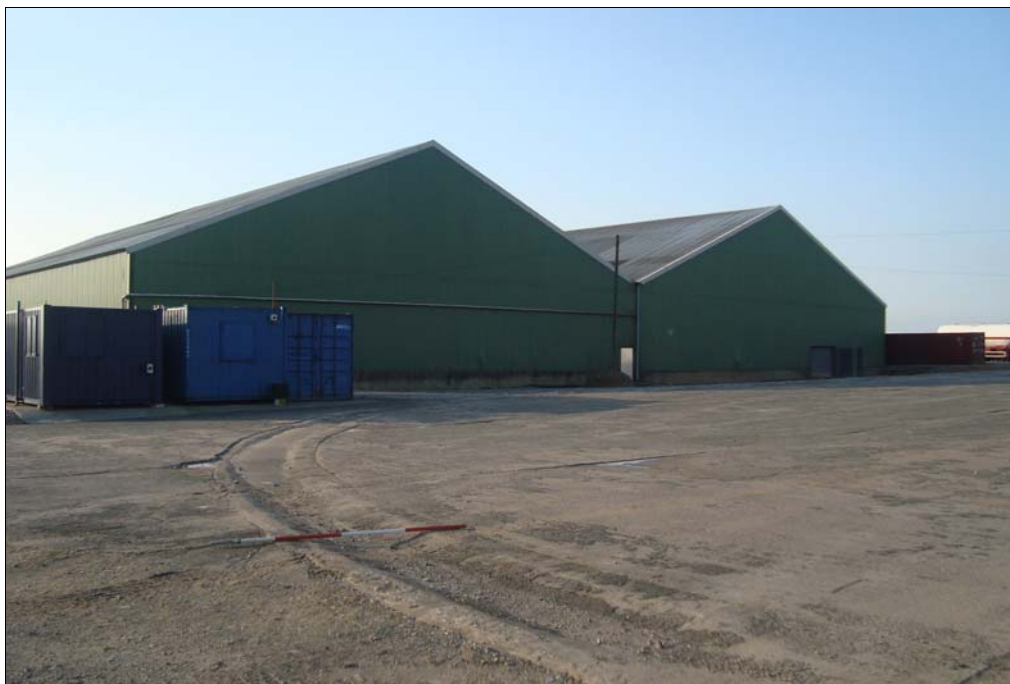
ID No	SD12
PRN	06342m
Name	BOULTON & PAUL AIRCRAFT VR.2 SHED
NGR	SS8413980016
On Air Ministry Plan?	Yes
MoD Building No	22
In Use	Yes
Description	A double-span aircraft hangar designed by Boulton & Paul of London and Norwich. The steel-framed hangar has been completely re-clad in corrugated steel sheeting. The Air Ministry schedule lists the shed as the home of Maintenance Unit 'N'. This type of shed was mainly used on aircraft factory sites and at Armament Training Schools.
Condition	Converted
Condition rating	Fair
Period	Modern
Group Value	No
Form	Building
Associated PRN sites	06330m, 06340m, 06341m, 06343m
Linked to airfield function?	No
Of technical/Structural interest?	No
Historical association?	No

Plate 58: Profile of the double-span VR2 aircraft shed (north facing elevation)

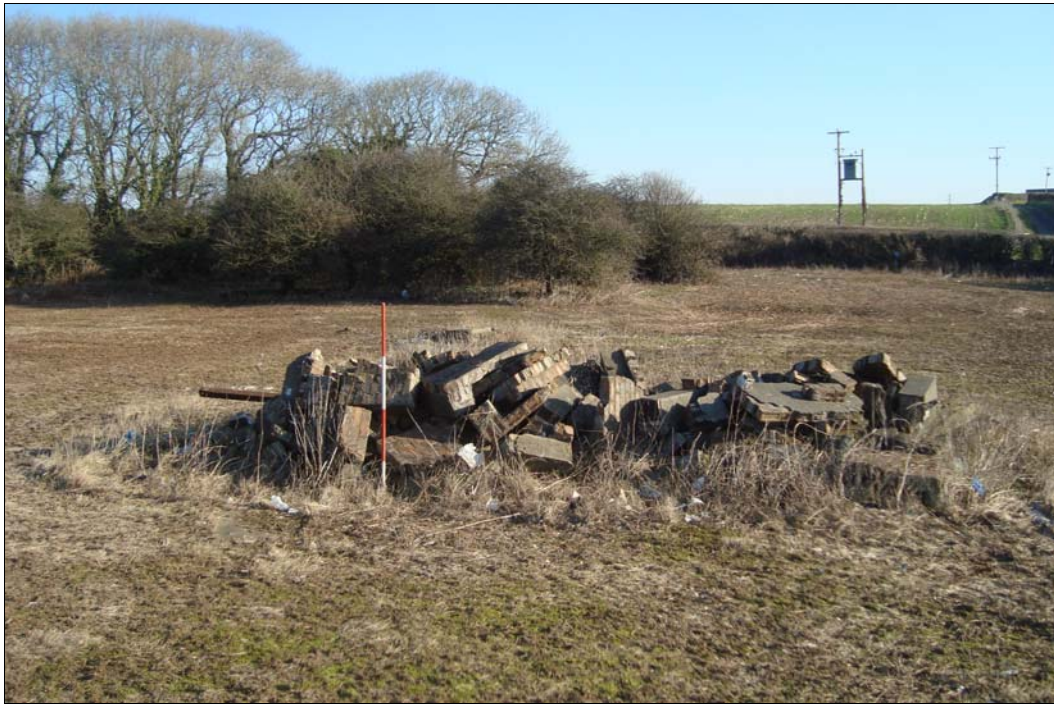
Condition	Destroyed
Condition rating	Destroyed
Period	Modern
Group Value	Yes
Form	Other structure
Associated PRN sites	06330m, 06345m, 06346m, 06347m
Linked to airfield function?	No
Of technical/Structural interest?	No
Historical association?	No

Plate 60: Remains of the airfield Armadillo shelter

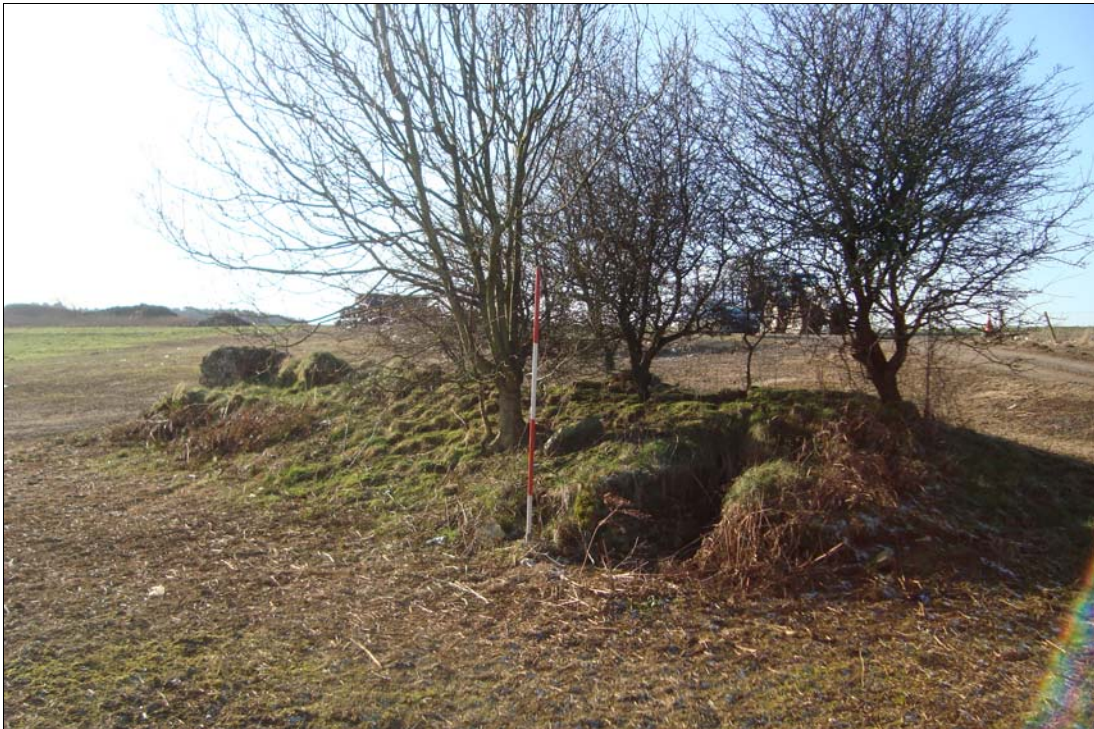
Plate 61: Semi-sunken munitons store. View to the southwest

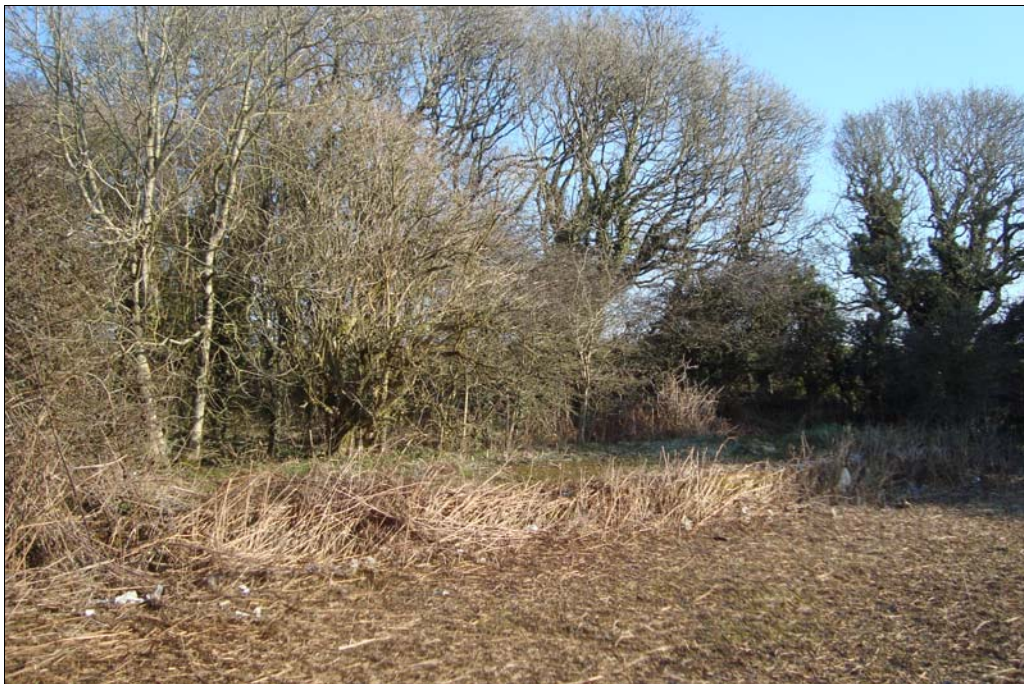
Plate 63: A linear brick platform is all that survives of the hut. (View to the southeast)

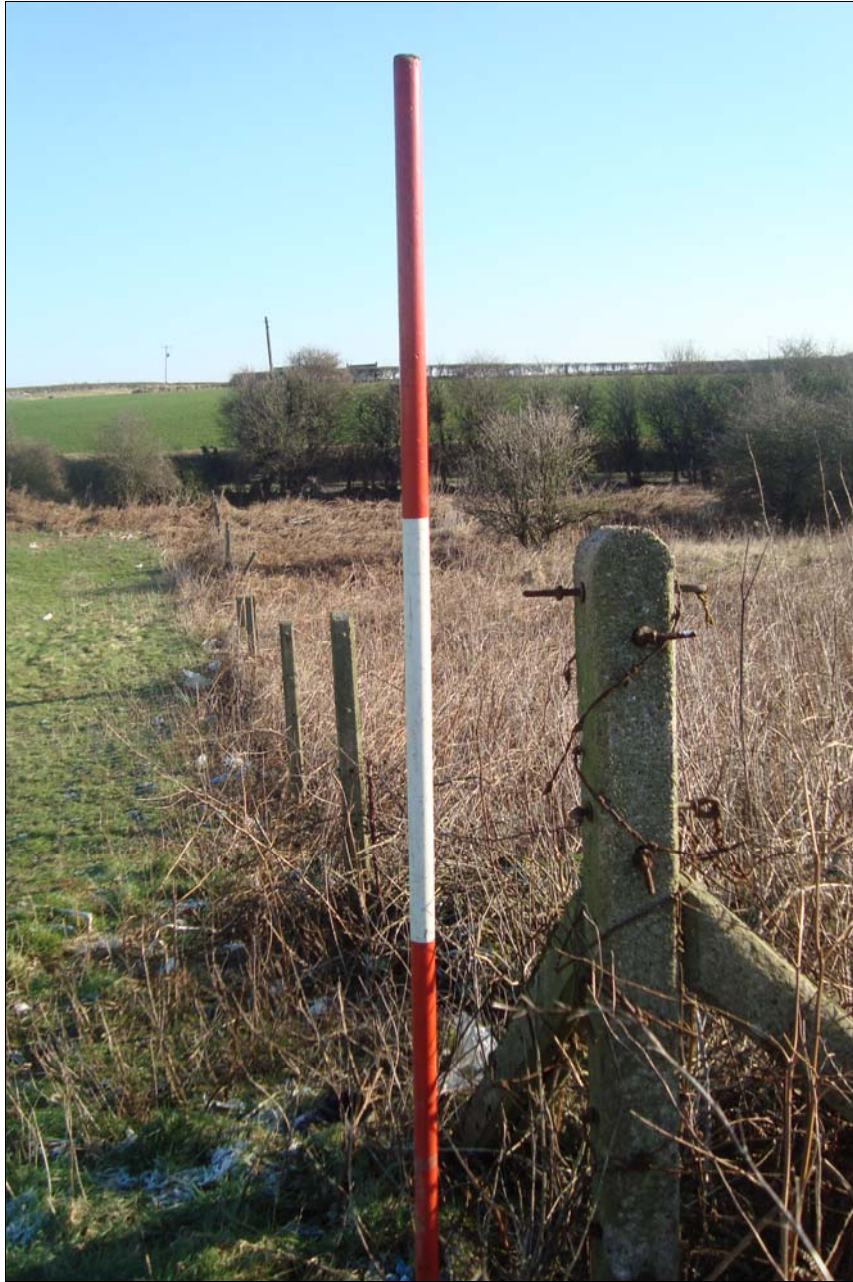
Plate 64: Remain of the airfield boundary. Note remnants of the original barbed wire deterrent

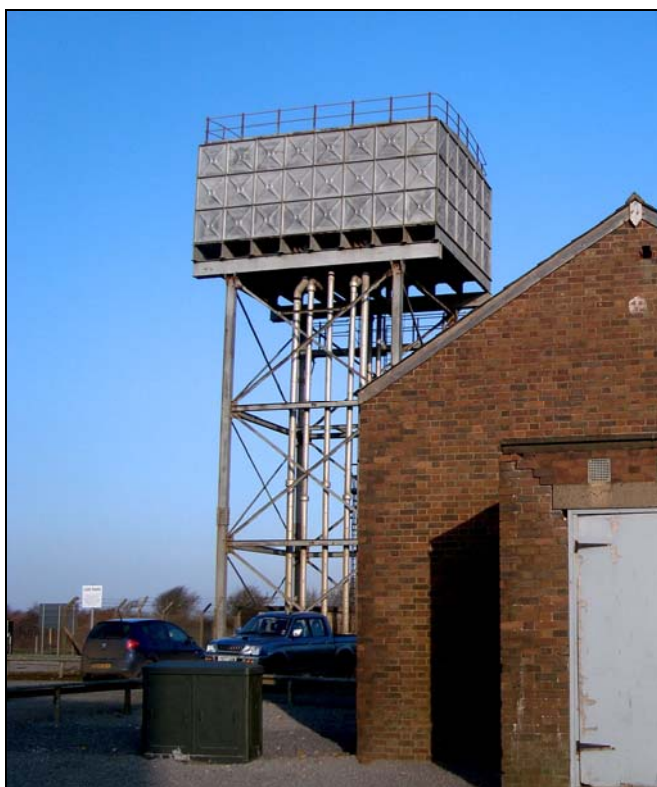
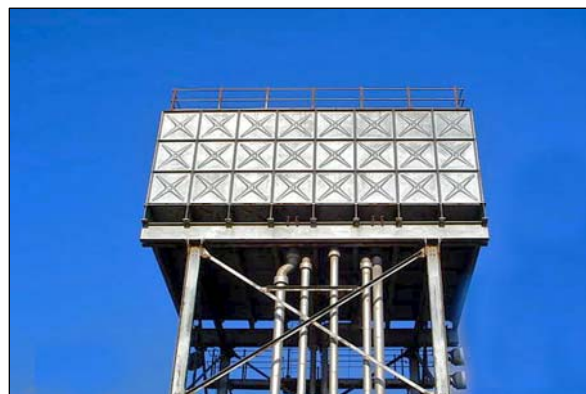
Plate 65: The well-preserved water tower at Stormy Down

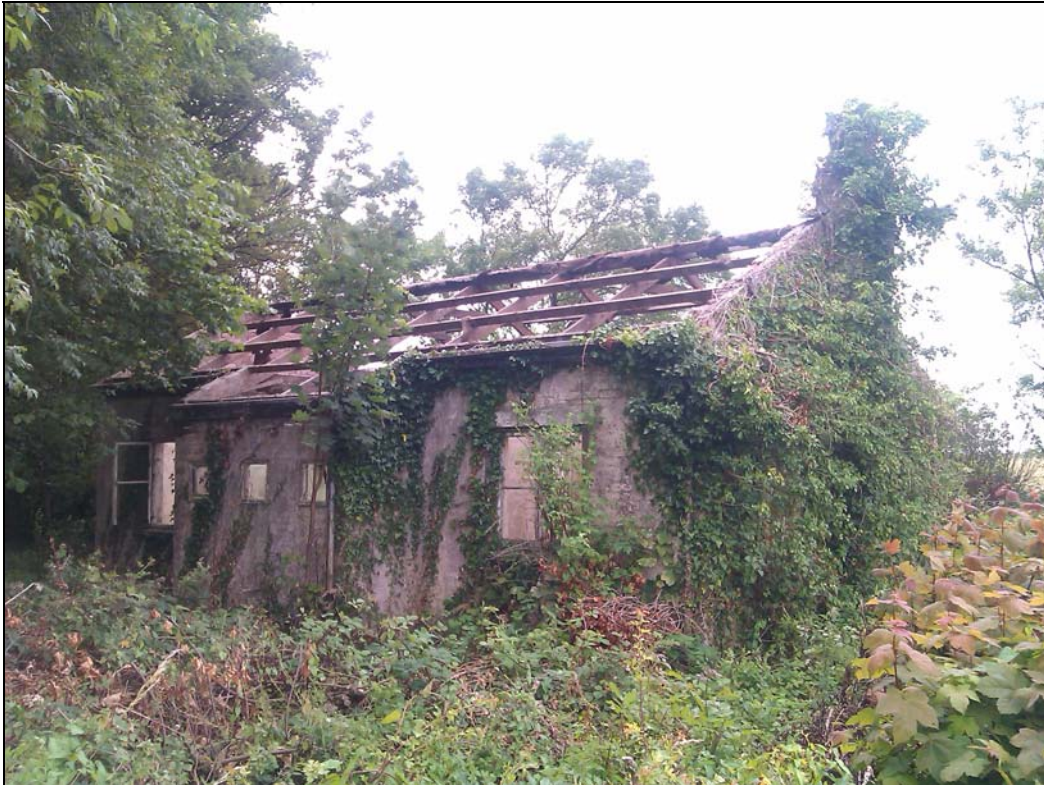
*Plate 66: Rear elevation of the Satellite Station Watch Office.
Note the latrine extension with its three square windows*

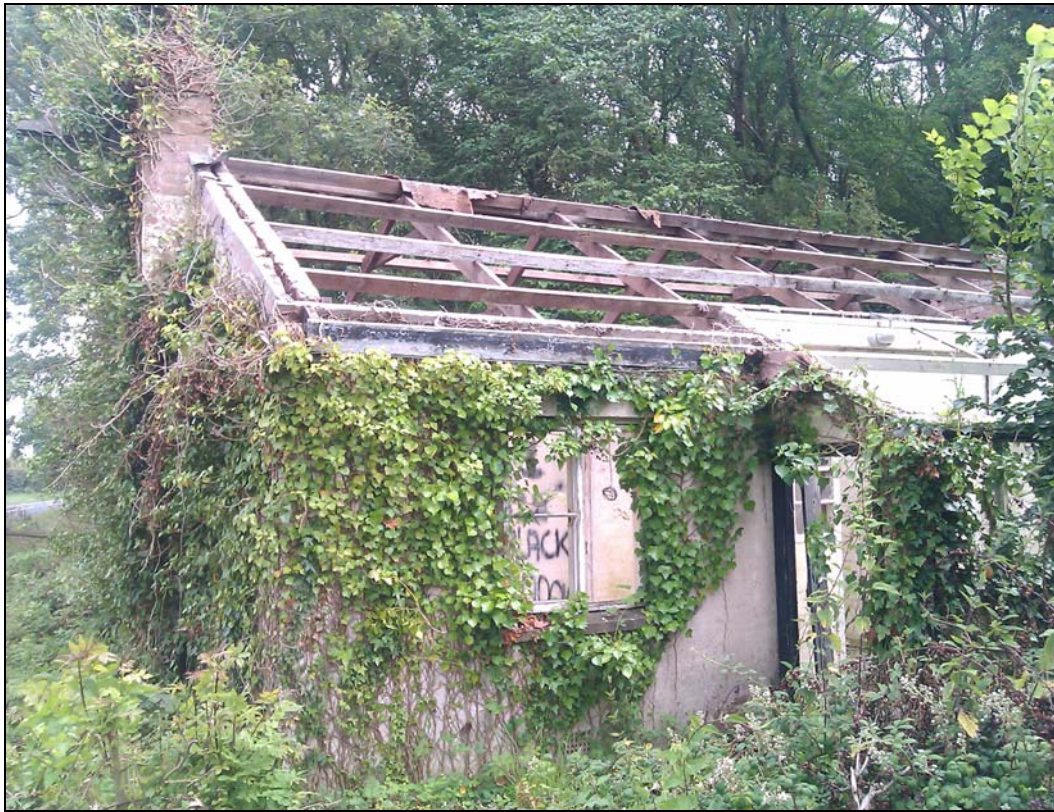
Plate 67: Front elevation of the Satellite Station Watch Office

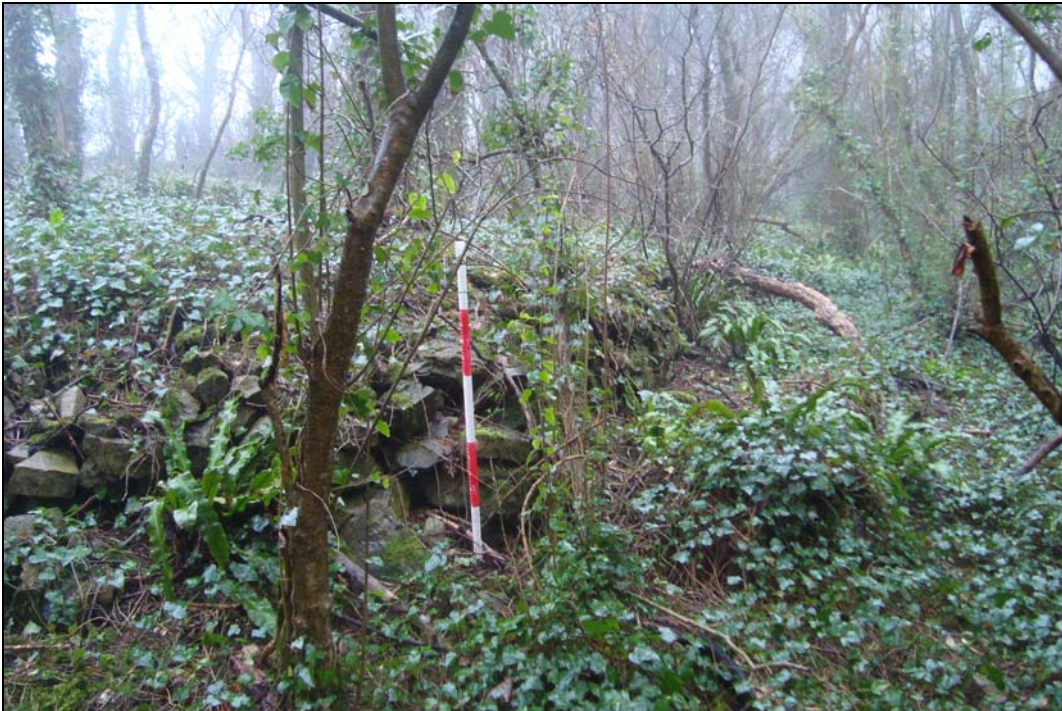
Plate 70: Remains of the dispersal platform. View to the north

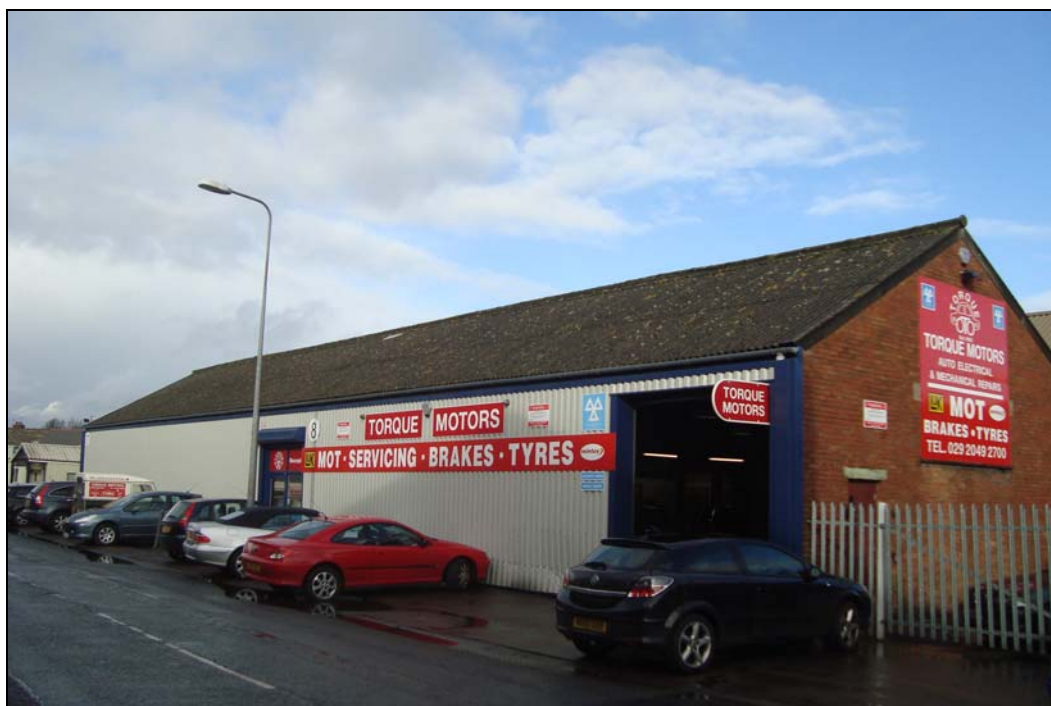
Plate 76: MT Shed and Offices looking northwest

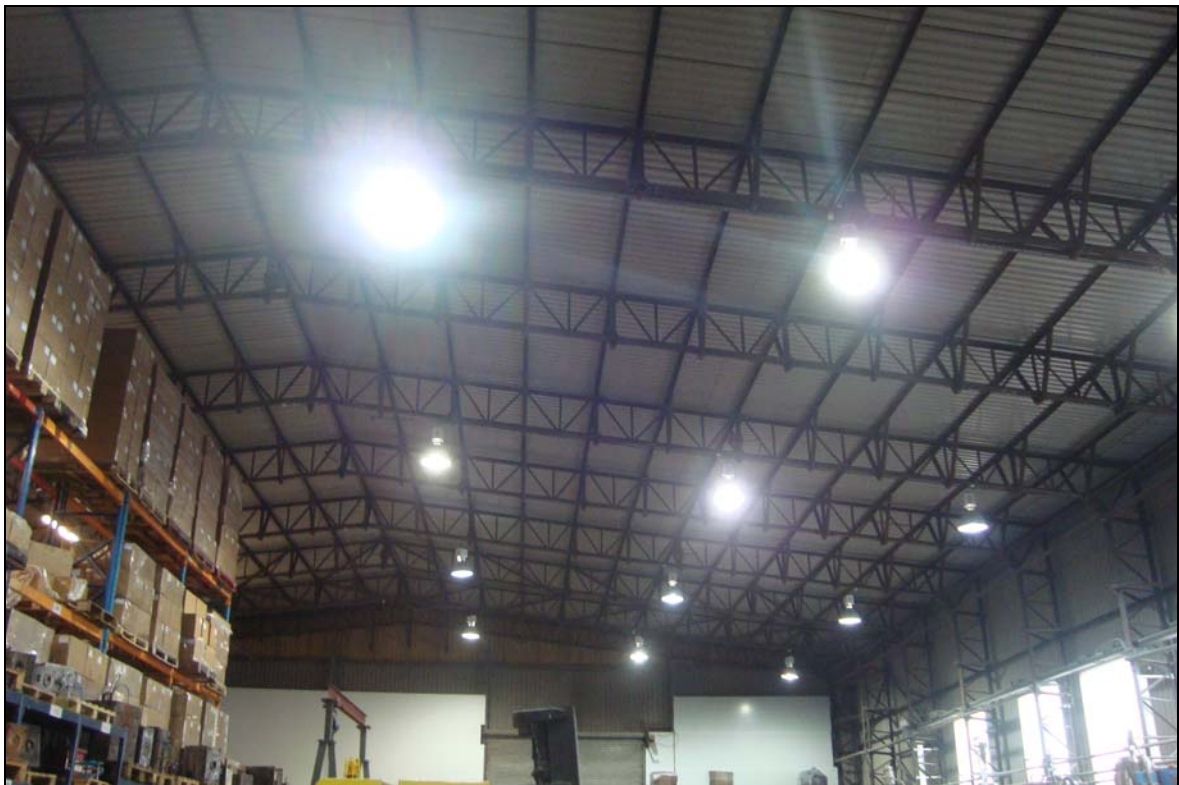
Plate 79: Internal steel frame structure of hangar 116.

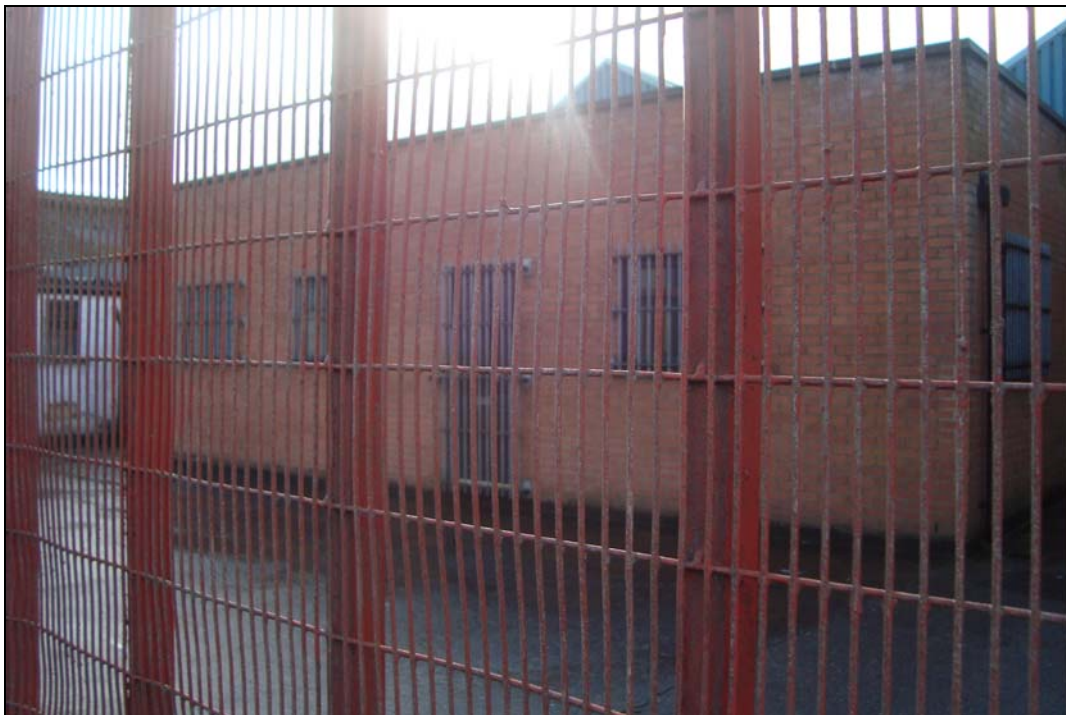
Plate 81: Battery charging block
