**Re: LWW5 End of Panel Report for Ulan Underground Mine**

Subsidence Management Plan (SMP) Approval (File No.09/5344) for Longwalls (LW) LW27 - LW29 and LWW4 & LWW5 was issued to Ulan Coal Mines Pty Limited (UCMPL) on 29 May 2013. Secondary extraction of LWW5 commenced on 18 December 2018 and was completed on 22 January 2020 at the Ulan Underground Mine.

**Robyn Stoney**  
**Environment and Community Manager**  
**Ulan Coal Mines Pty Limited**  
**Attachment A: End of Panel Report LWW5 – Ulan Underground Mine**

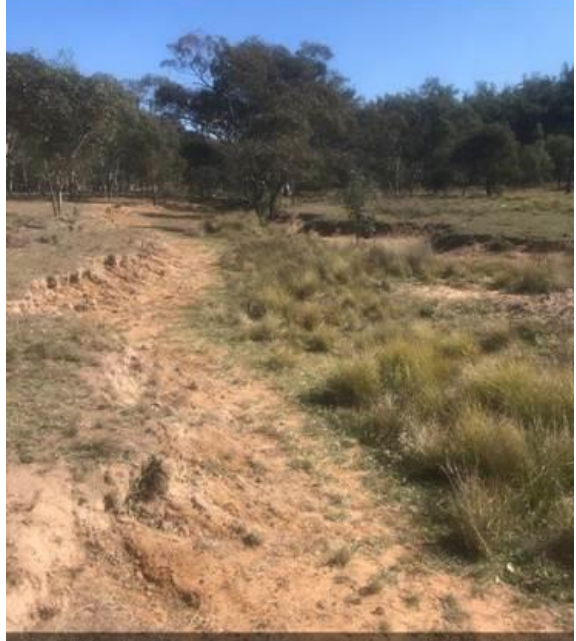
<p>LWW5 Pre-mining Flow line      2019-05-23 11:31:47+10:00</p> </div>	<div data-bbox="783 1173 1358 1928"> <p>SW      W      NW 240      270      300      330</p> <p>283°W (T)    55 S 756465 6438425 ±4m ▲ 488m</p>

<p>LWW5 - Flow Line      19 Mar 2020 11:30:07</p> <p><b>Notes:</b> No surface cracking noted along flow line, however recent signs of erosion noted along the bank edge and most likely due to the 140mm rainfall event recorded in the Bobadeen area on the 17 February 2020.</p> </div>

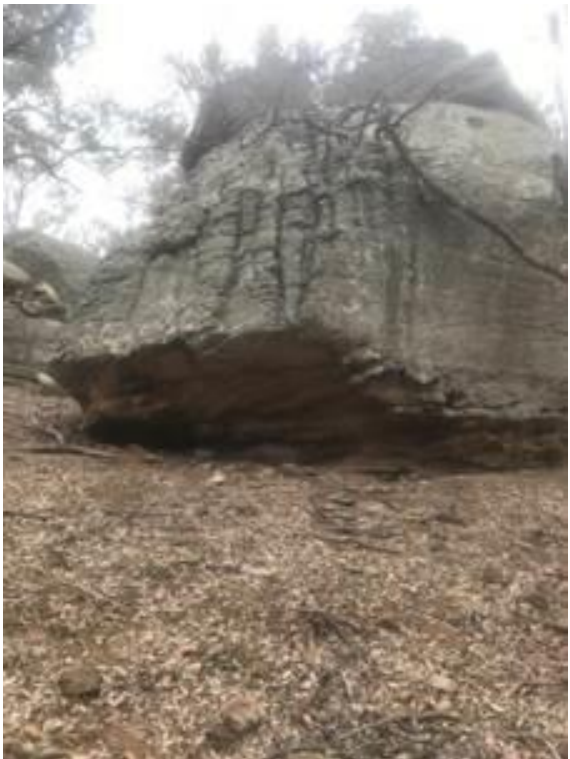
<p>88°E (T) 55 S 756378 6438553 ±4m ▲ 504m</p> <p>LWW5 Ulan ID#599 19 Mar 2020, 11:12:41</p>

<p>75°E (T) 55 S 756373 6438556 ±7m ▲ 504m</p> <p>LWW5 Ulan ID#599 19 Mar 2020, 11:13:32</p>
	<p><b>Notes:</b> No rock falls, only very minor cracking was perceptible within the rock shelter.</p>

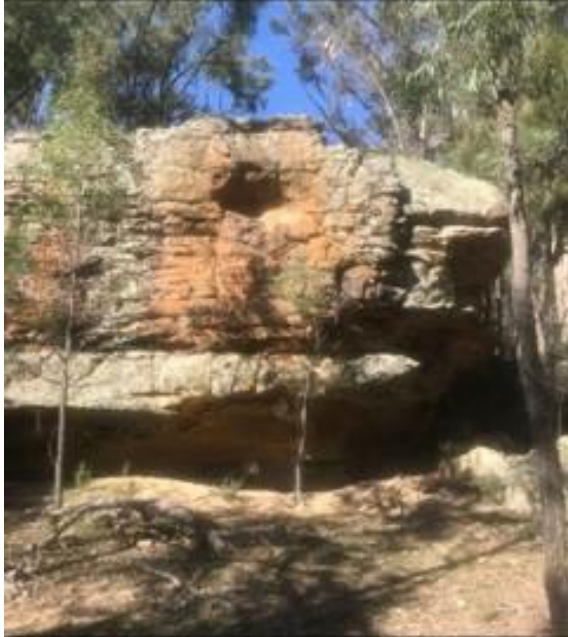
<p>LWW5 Ud/630 2019-05-23 10:56:42+10:00</p>	<p>E SE S 90 120 150 180 210</p> <p>141°SE (T) 55 S 756126 6438361 ±4m ▲ 493m</p>

<p>LWW5 Ulan ID#630 19 Mar 2020 11:02:18</p> <p>Notes: No rock falls &amp; no perceptible change to rock shelter when compared to pre-mining condition.</p>

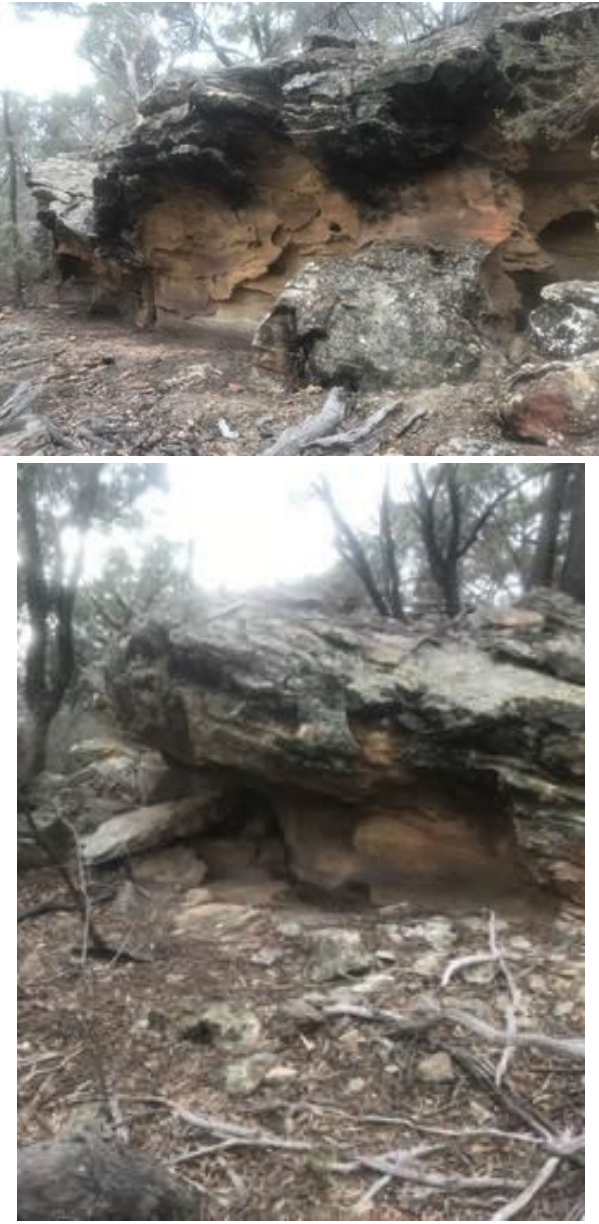
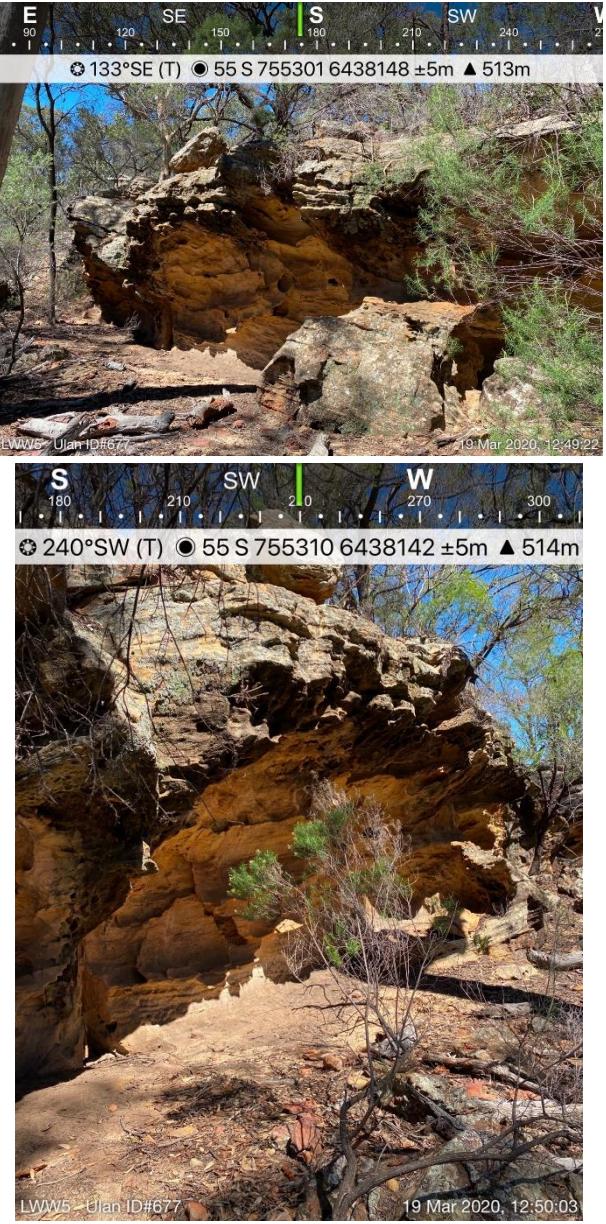
Table 7 Pre & Post Mining Inspections Rock Shelter ID#677 (LWW5)

<p><b>Notes:</b> No rock falls &amp; no perceptible change to rock shelter when compared to pre-mining condition.</p>

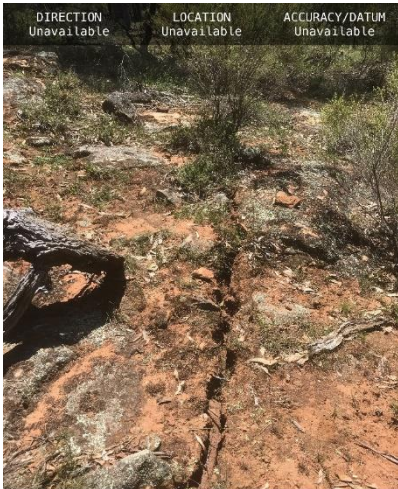
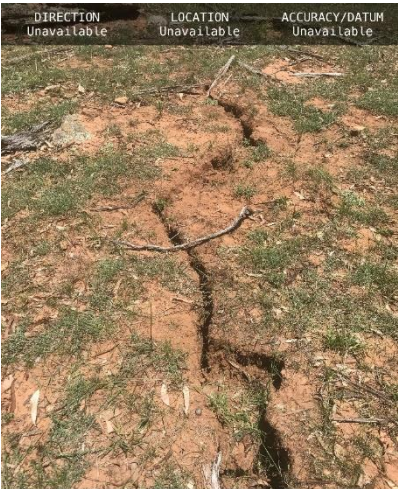
<p>DIRECTION Unavailable LOCATION Unavailable ACCURACY/DATUM Unavailable</p> <p>Lww5 cracking near fence</p> <p>2019-02-07 13:06:56+11:00</p>

<p>DIRECTION Unavailable LOCATION Unavailable ACCURACY/DATUM Unavailable</p> <p>Lww5 cracking near fence</p> <p>2019-02-07 13:12:16+11:00</p>

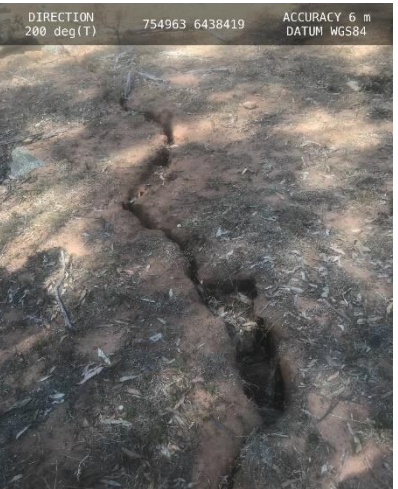
<p>DIRECTION 200 deg(T) 754963 6438419 ACCURACY 6 m DATUM WGS84</p> <p>LWW5 fence lines impacts</p> <p>2019-03-22 10:52:12+11:00</p>

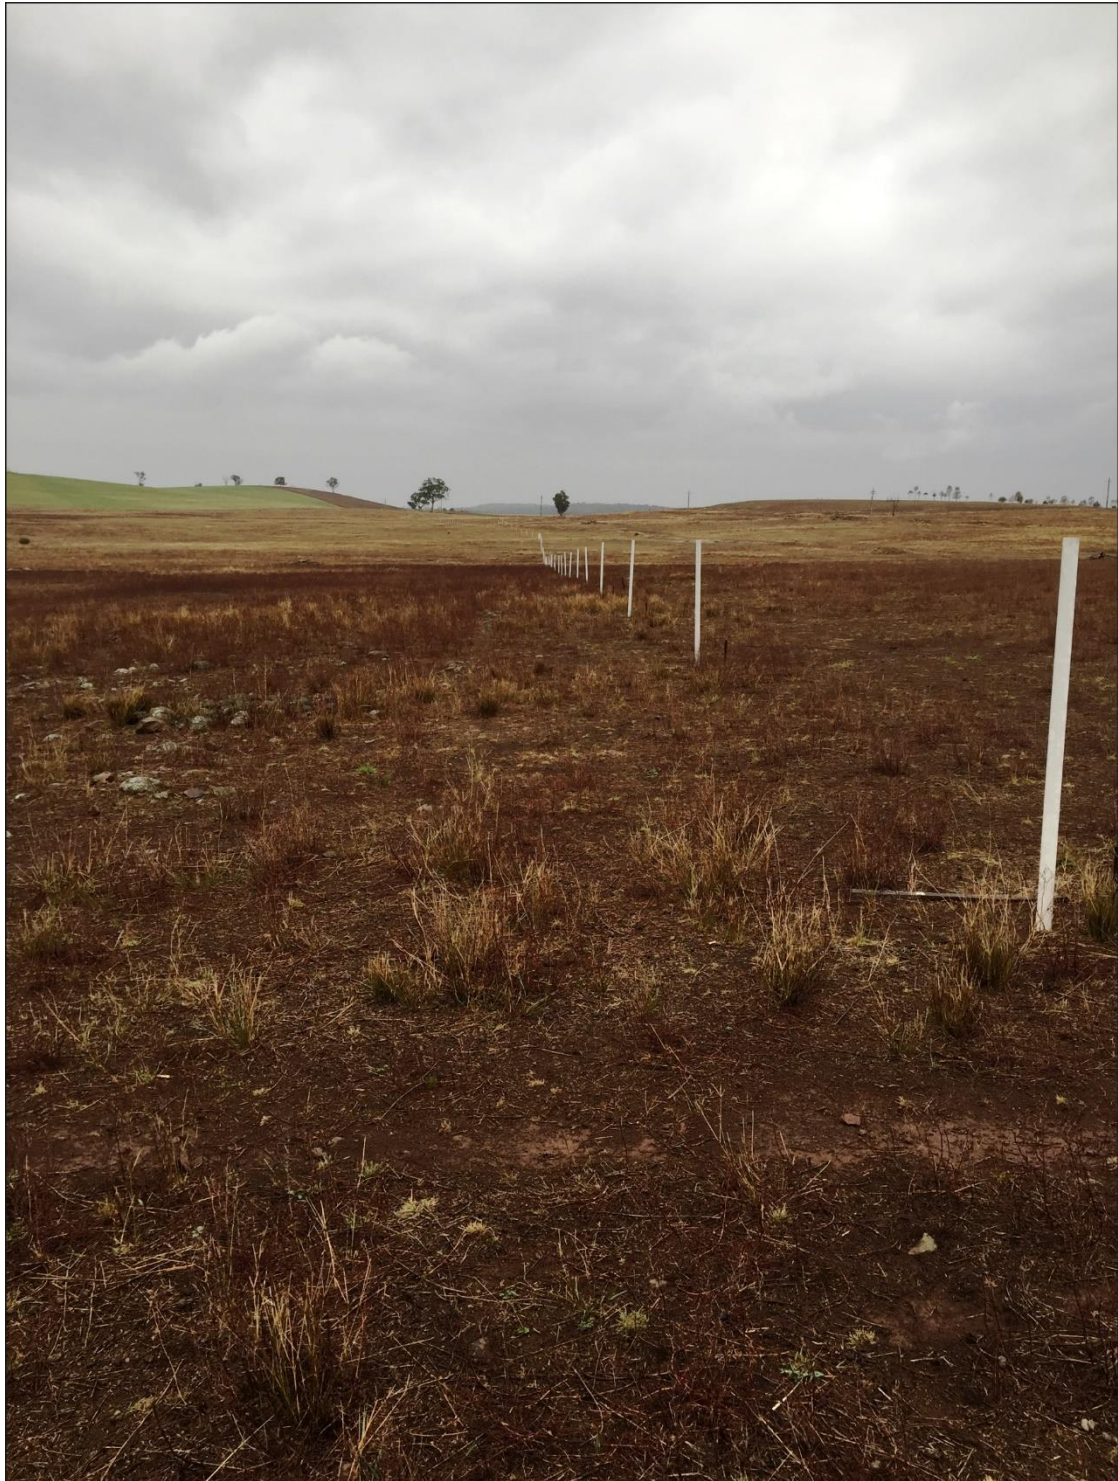
**Figure 3: Surface along H Line.**

Maximum vertical subsidence measured above Longwall W5 is 1.27m. This value is less than the maximum 1.6m forecast in the SMP/EP for Longwalls 27-29 and W4 and W5.

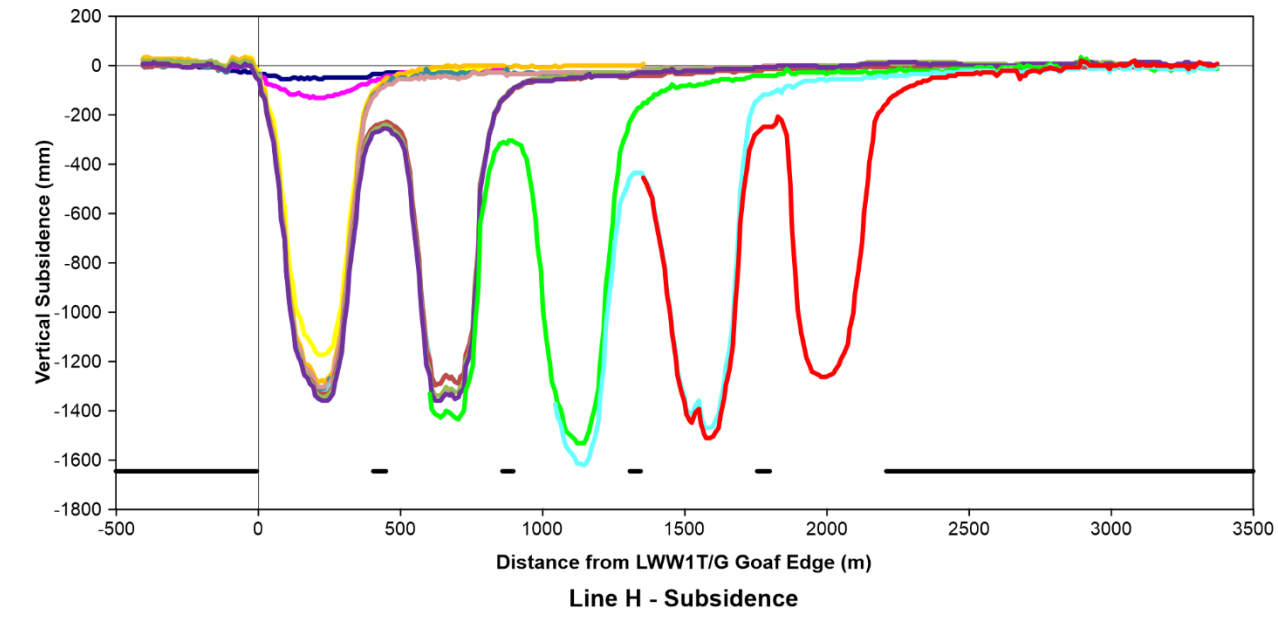
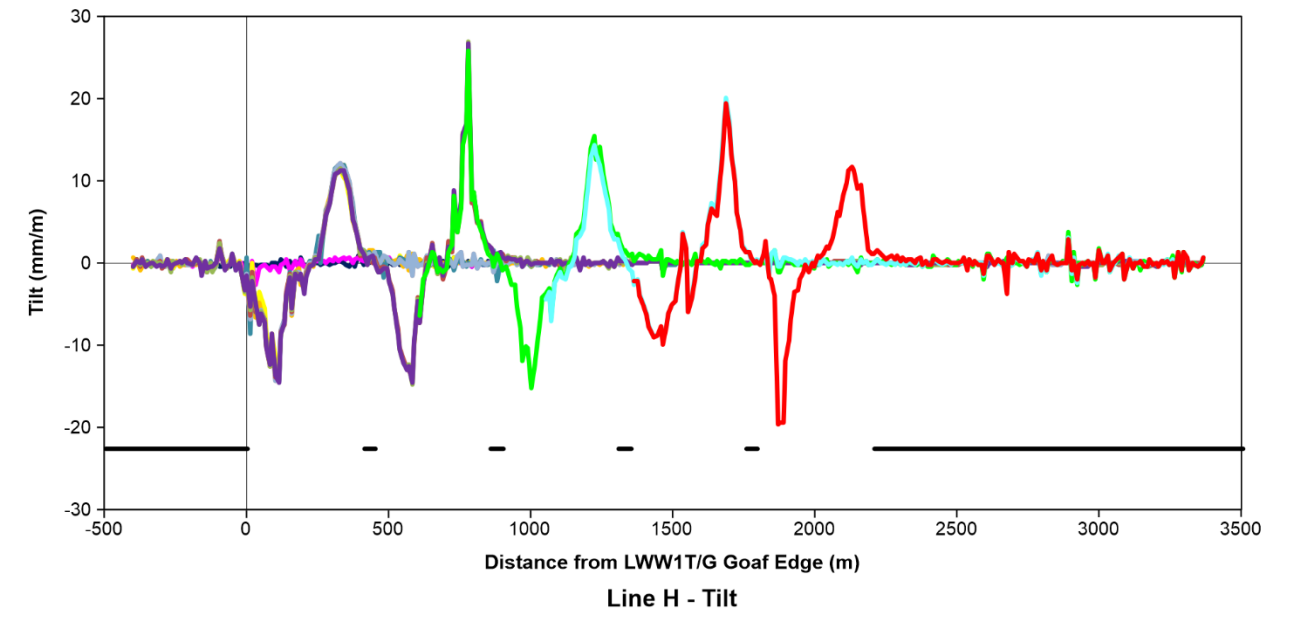
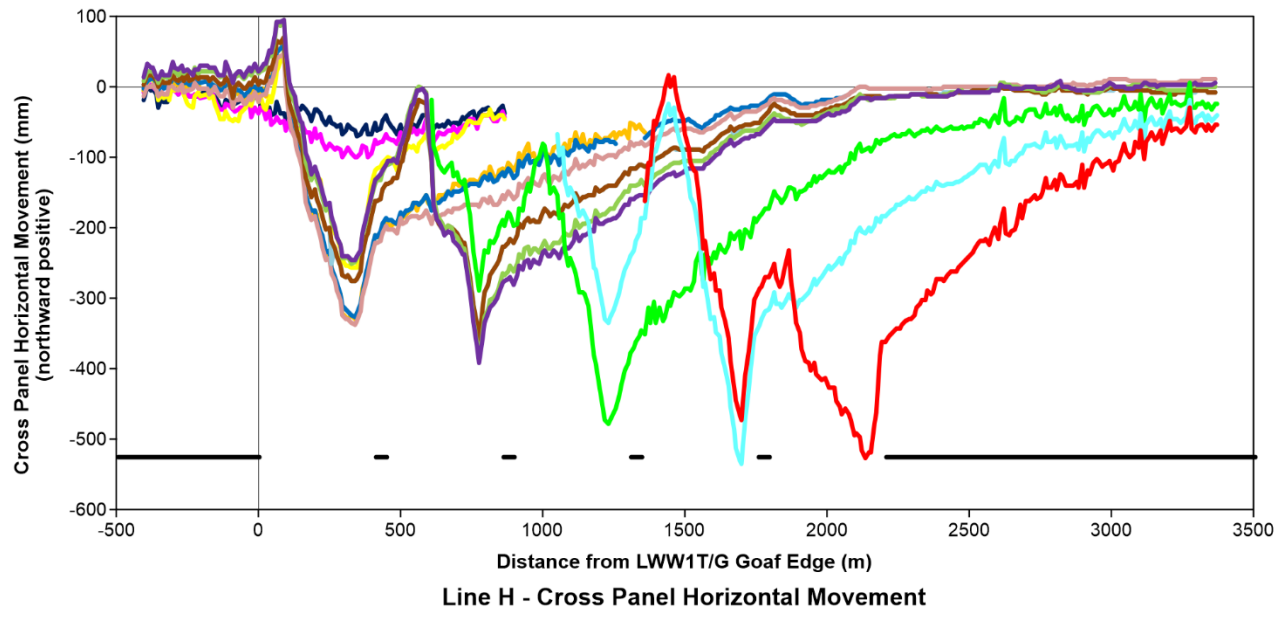
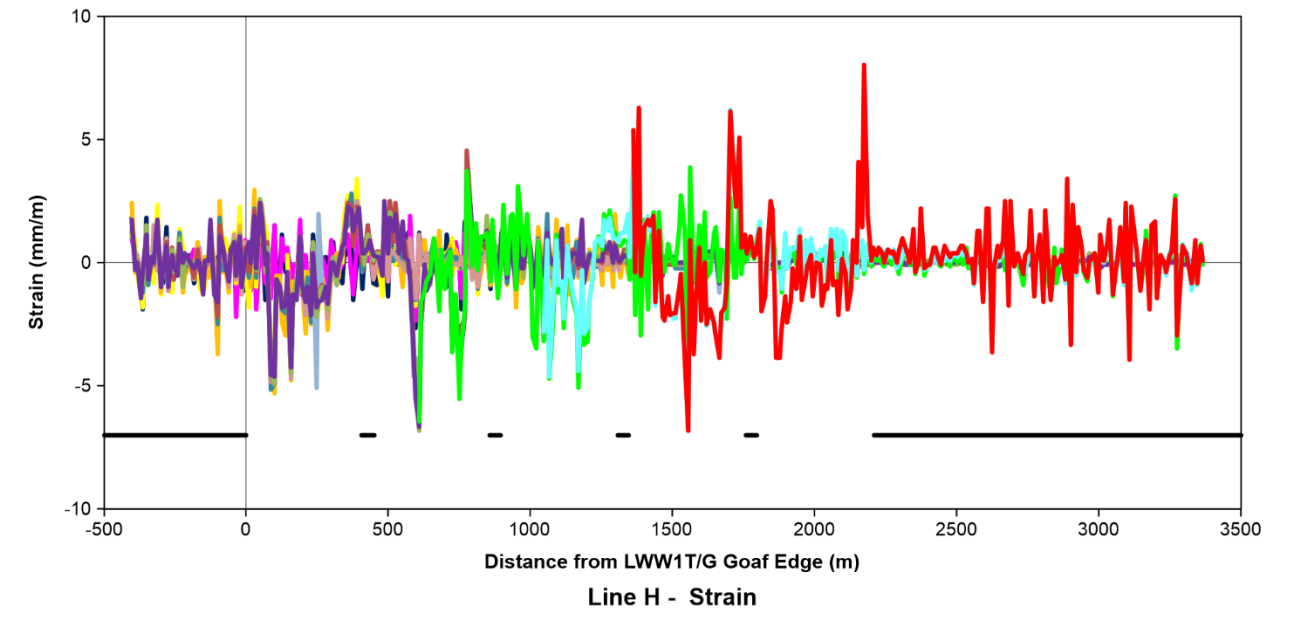
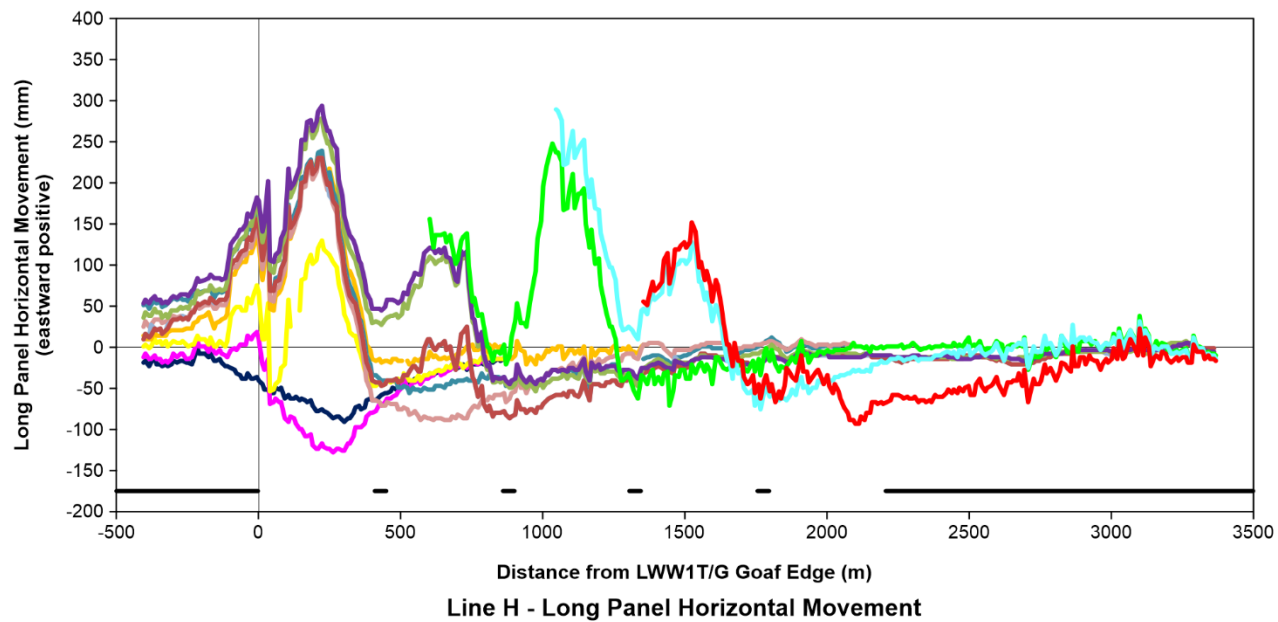
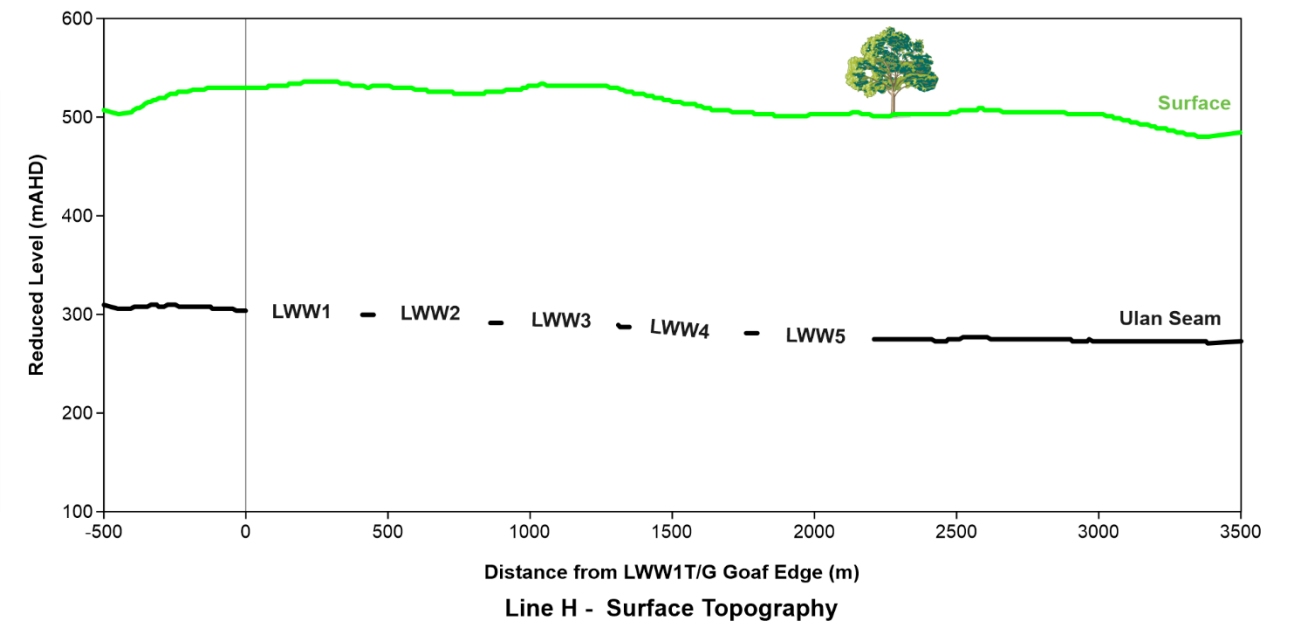
**Figure 4: Subsidence summary of the main parameters of subsidence from the monitoring on H Line at the completion of Longwall W5.**

Longwall Dates	
—	LWW1 - 28/08/08
—	LWW1 - 05/09/08
—	LWW1 - 19/09/08
—	LWW1 - 12/03/09
—	LWW2 - 20/05/10
—	LWW2 - 09/06/10
—	LWW2 - 28/06/10
—	LWW2 - 19/07/10
—	LWW2 - 14/09/10
—	LWW2 - 17/12/10
—	LWW3 - 26/07/17
—	LWW4 - 17/12/18
—	LWW5 - 06/02/20
—	Coal

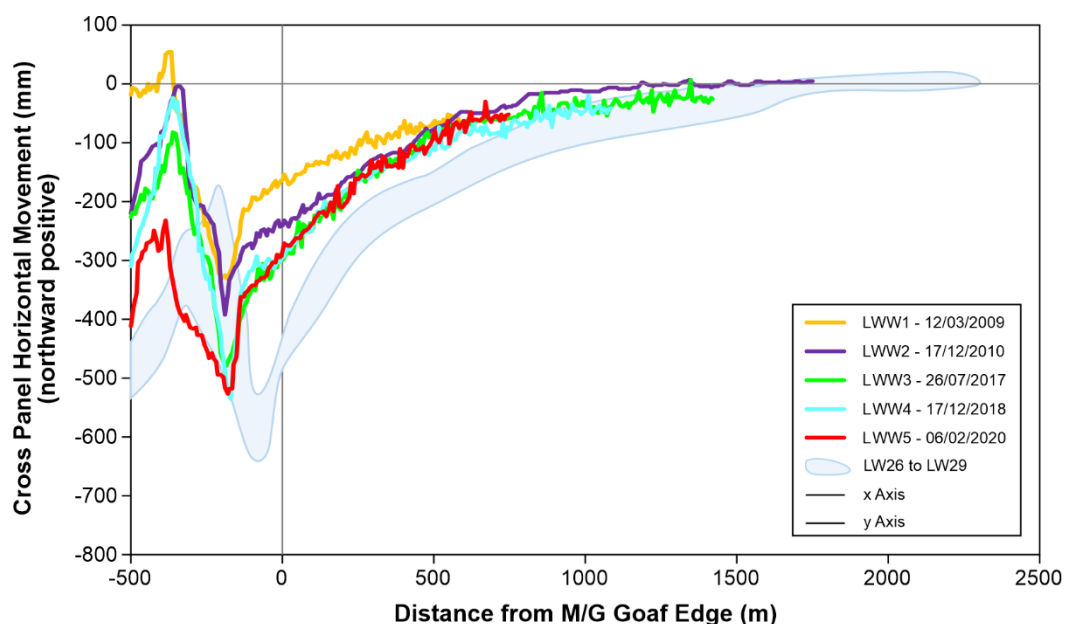
**Figure 5: Cross panel horizontal movements measured on H Line at the end of Longwall W1, W2, W3, W4 and W5.**

The horizontal movements measured over the goaf and panel edge of Longwall W5 are almost the same as those measured for Longwalls W4 and W3 and less than the those measured over Longwalls 26-29 where the overburden depth is greater.

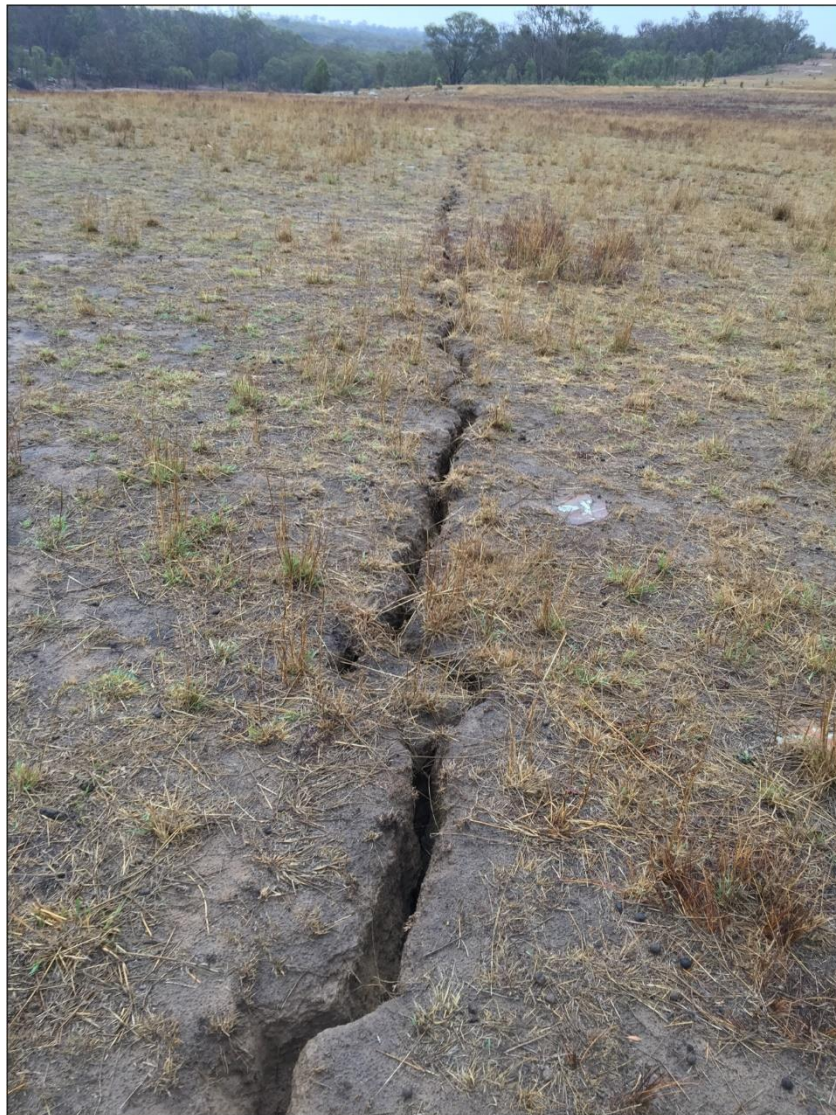
**Figure 6: Surface crack that crosses H Line.**

Figure 6 shows a crack, parallel to and inside the northern panel edge of Longwall W5 where it crosses H Line.

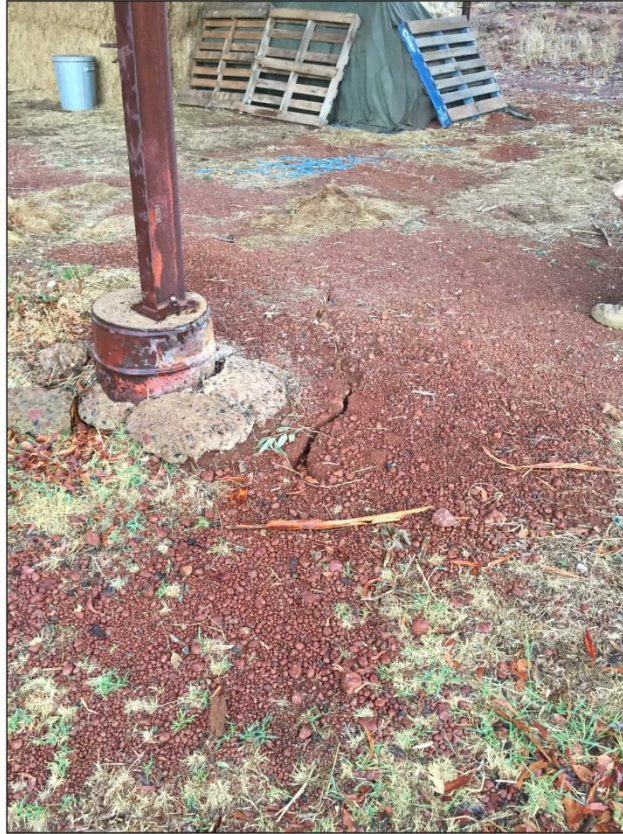
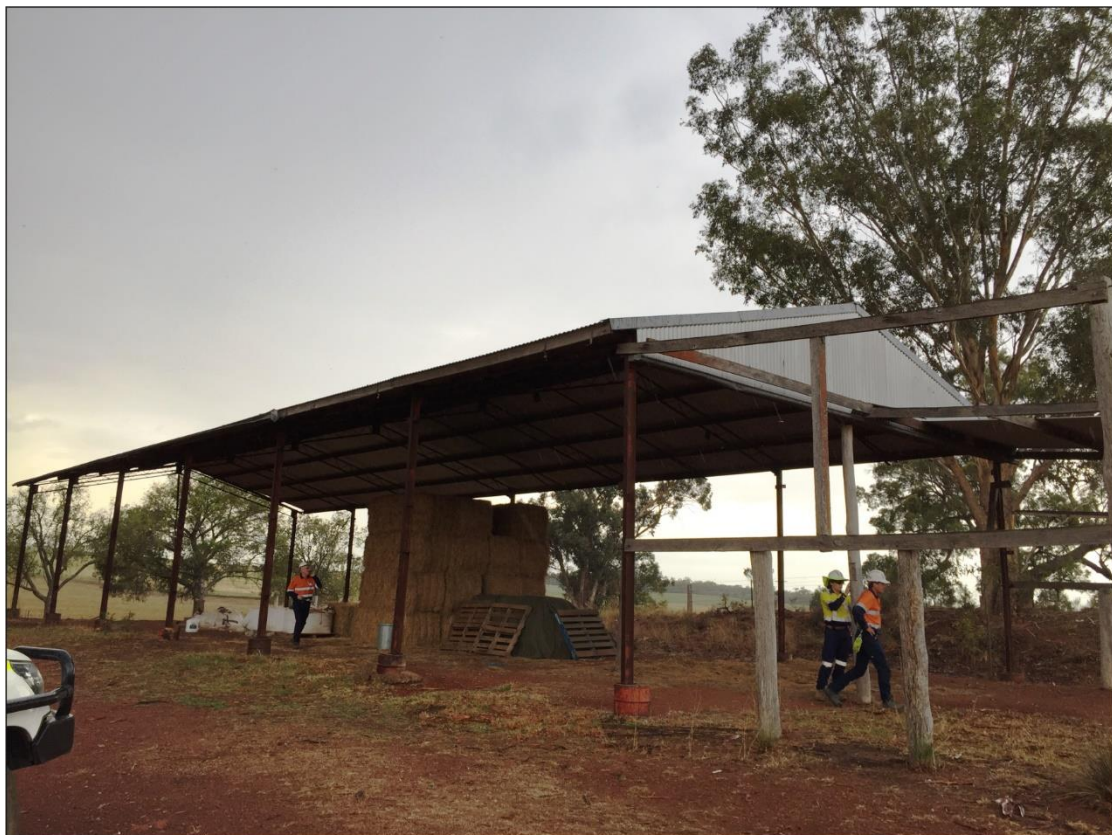
Minor cracking was also observed above the southern side of Longwall 5 at the hay shed 500m to the west of the Bobadeen Homestead site. Figure 8 shows the cracking parallel to and approximately 40m in from the southern panel edge at the hay shed location. There were no perceptible impacts to the hay shed structure.

**a) Cracking near foundation.**

**b) Overview of hay shed structure.**

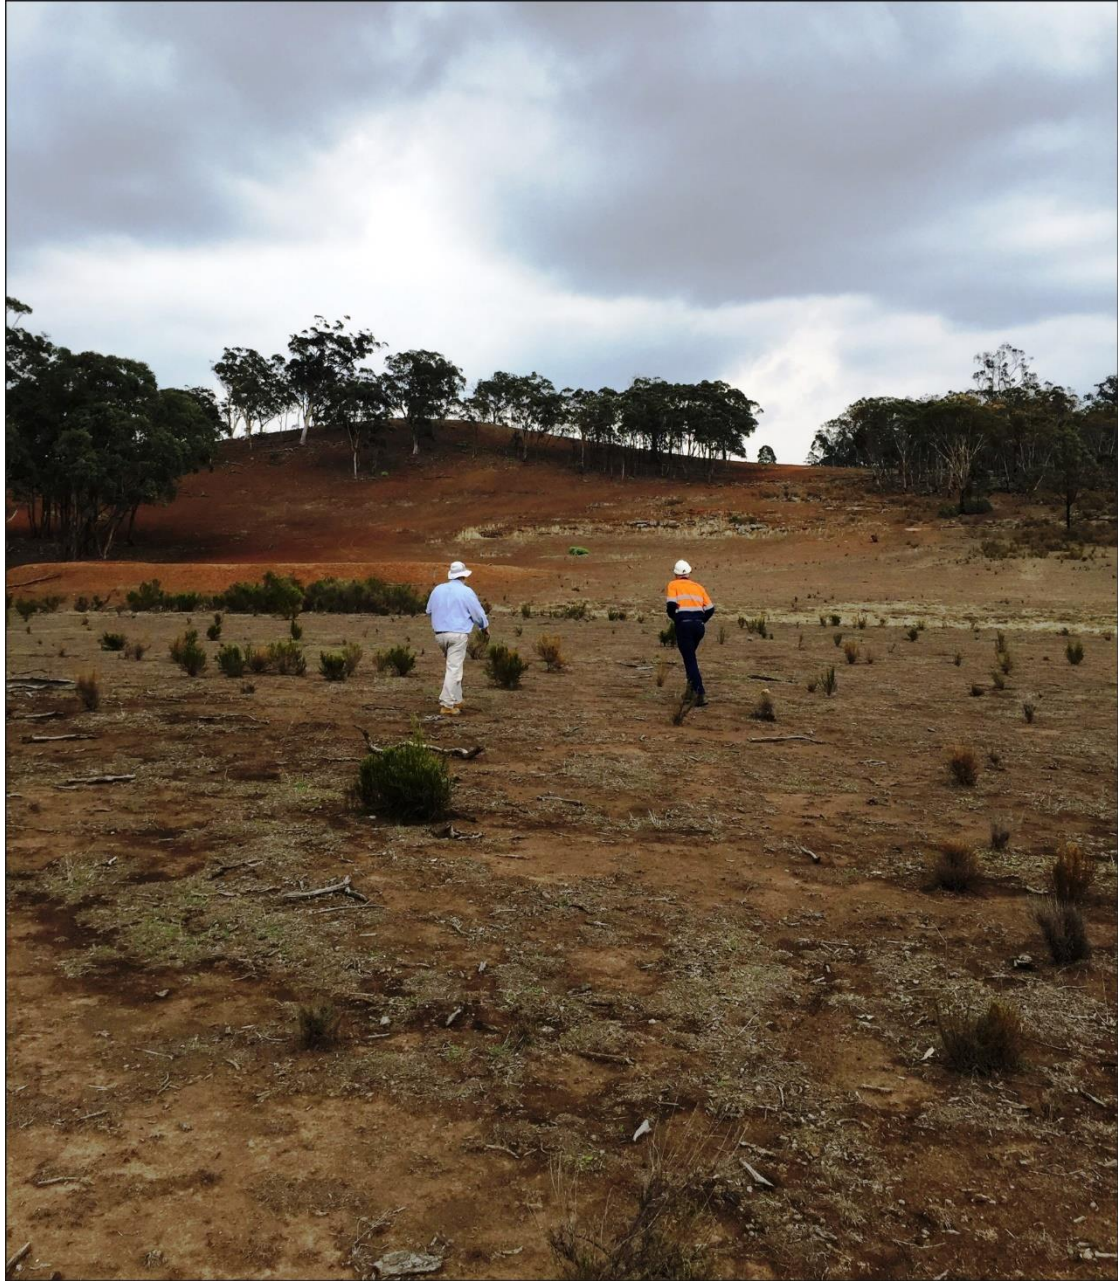
**Figure 9: General view of section of 'Woodbury' property above Longwall W5.**

Figure 9 shows a general view of the surface above Longwall W5. The farm dam embankment just east of the start line of the panel is in the middle ground on the left in the photograph. Cracking was observed near the panel edges both inside and outside the panel edge. The sandy soil was observed to slump into cracks in some places giving the appearance of “potholes”. Figure 10 shows an example of this type of impact.

The width of cracks parallel to the start line of Longwall W5 are expected to be larger than elsewhere along the panel because of the subsidence mechanics that generate horizontal movement. Crack width at the start of Longwall W5 is further magnified by the surface terrain sloping in the direction of mining. The largest horizontal movements occur at the start of longwall panels with the direction of movement in the direction of mining.

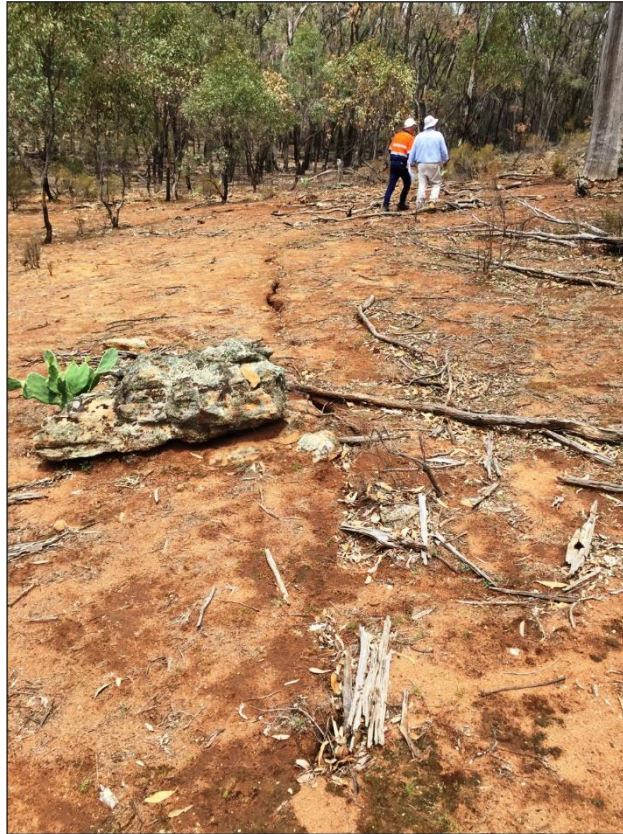
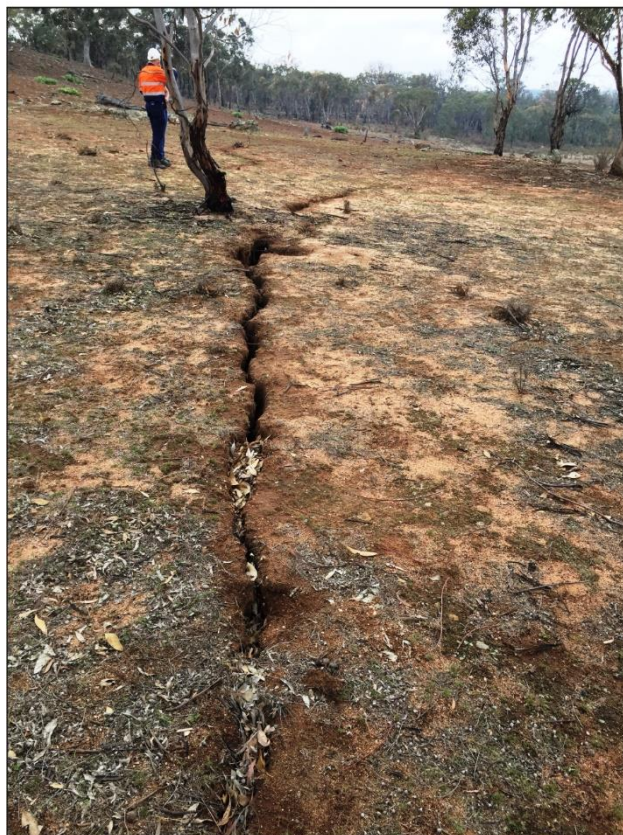
**Figure 11: Cracking in sloping terrain near start line of Longwall W5.**

Cracks that form above the start line of longwall panels are permanent and usually larger than elsewhere. The interaction of subsidence and sloping terrain causes horizontal movements to develop in a downslope direction. This effect is greatest when mining from high ground towards lower ground. The combination of sloping terrain in the direction of mining at the start of a longwall panel leads to the type of cracking shown in Figure 11.

**a) Looking South.**

**b) Looking North.**

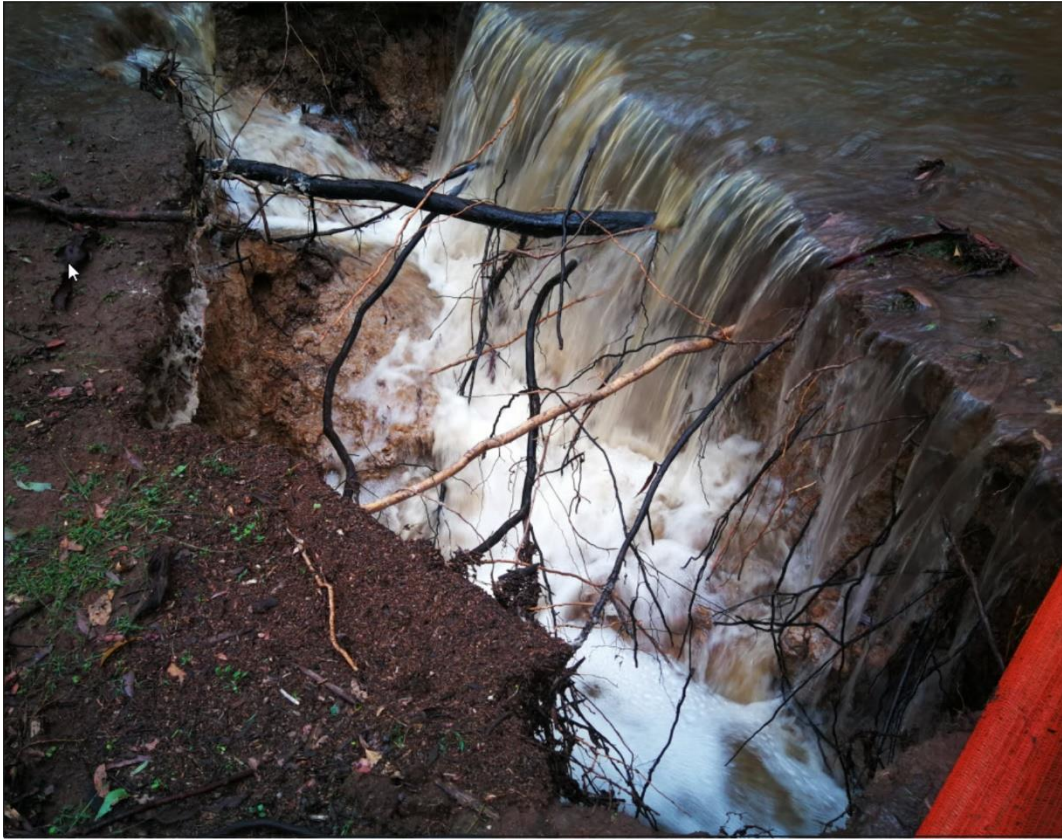
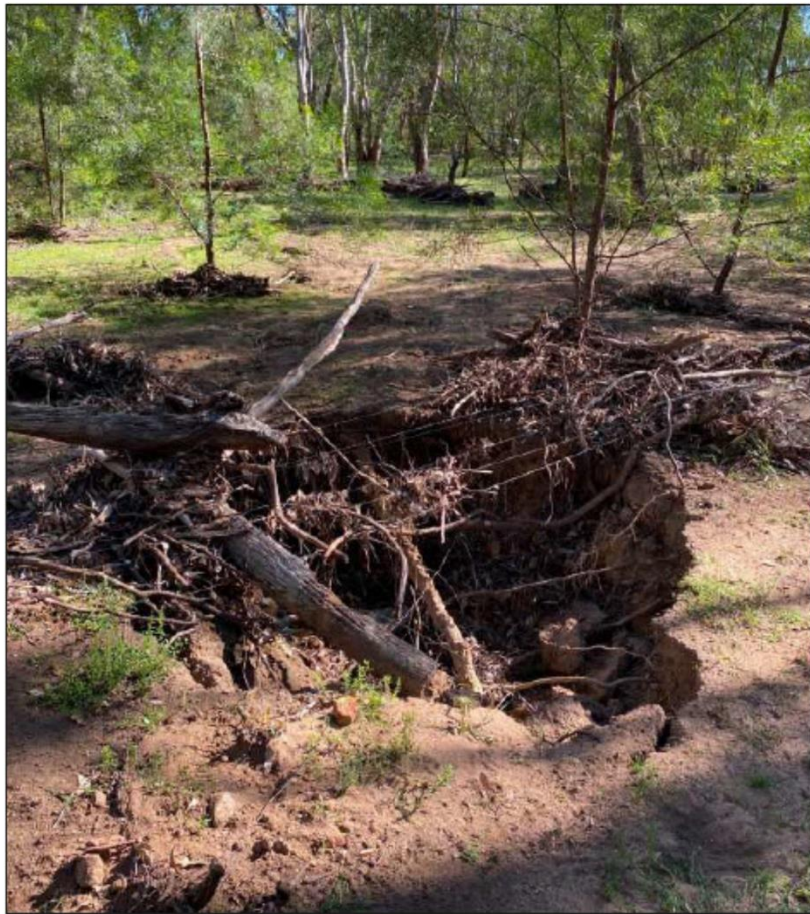
Subsidence impacts on privately owned land at the start of the panel are consistent with expectation. A coincidence of mining induced cracking, a drainage line and recent heavy rainfall events, approximately 14 months after the area was mined, has led to flow into subsidence cracks and localised erosion of surface soils. The details of these impacts are being assessed separately together with a suitable remediation strategy.

**a) Example of flow into a subsidence crack during an overland flow event.**

**b) Example of erosion along a drainage line following an overland flow event.**

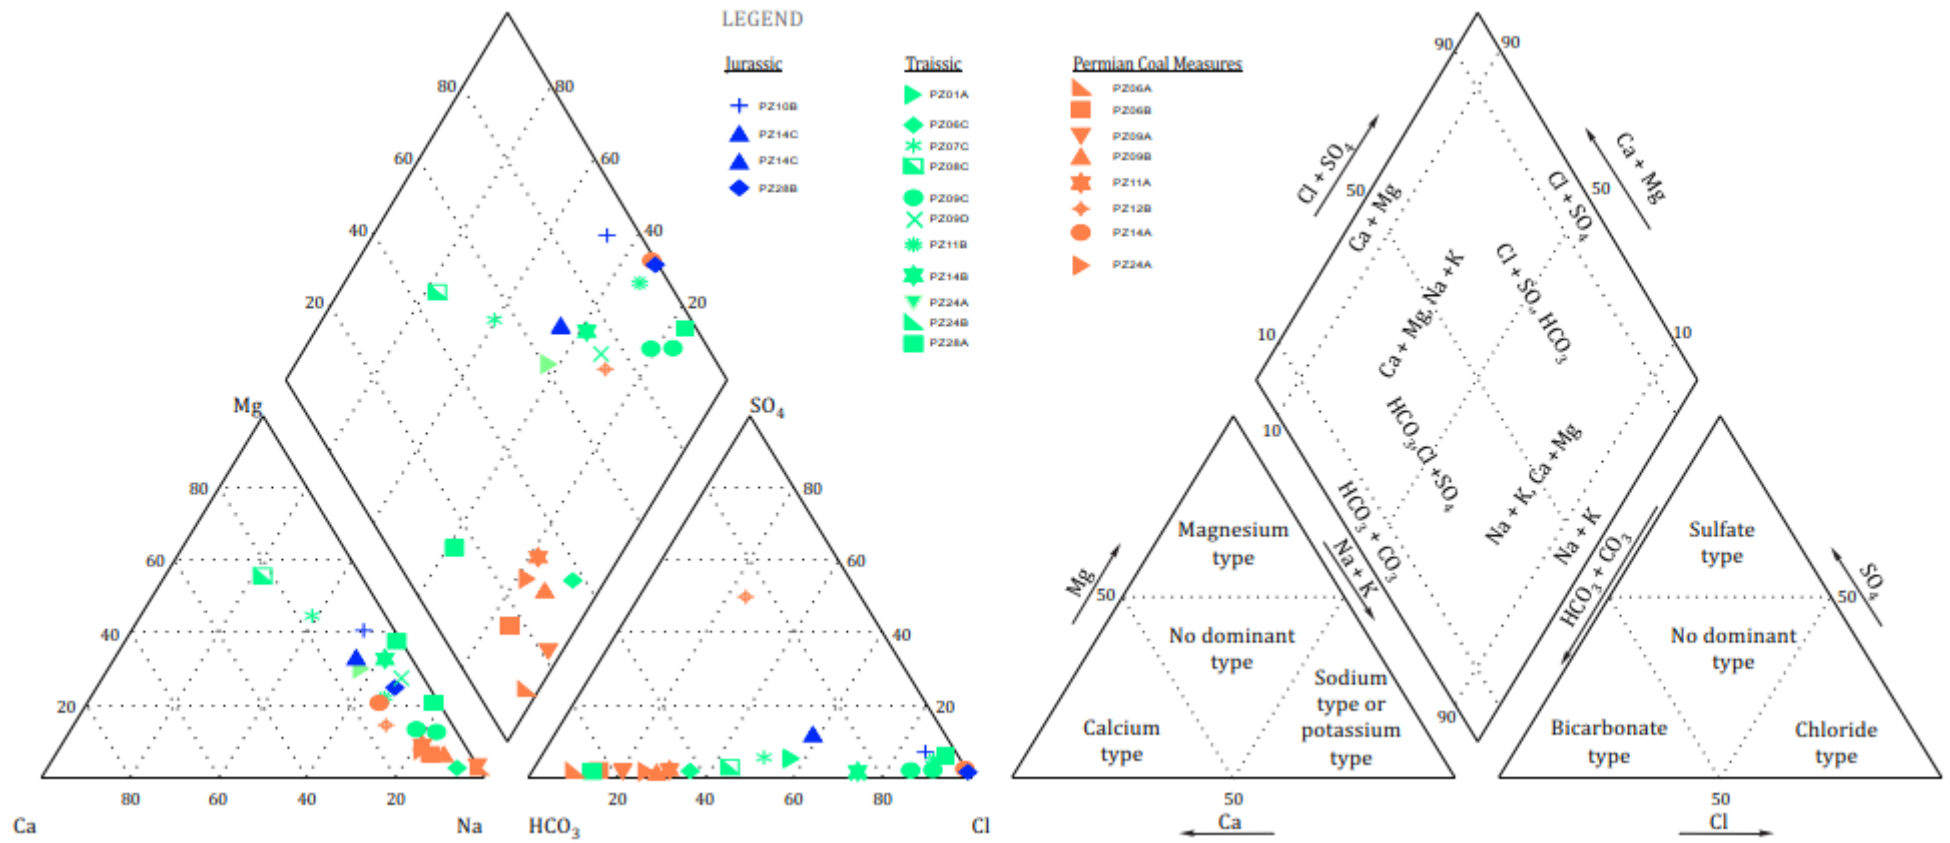
Figure 7.4 NMN Piper plot

- Triassic sediments continue to exhibit Na-Cl, Na-Mg-HCO<sub>3</sub>-Cl and Na-Mg-Cl-HCO<sub>3</sub> type water;
- Jurassic sediments exhibit Na-Mg-Cl and Na-Mg-Cl-HCO<sub>3</sub> type water; and
- Permian coal measures, including the Ulan Seam, exhibit Na-HCO<sub>3</sub>, Na-Cl-CO<sub>3</sub>, Ca-Na-Mg-SO<sub>4</sub> and Na-HCO<sub>3</sub>-Cl type water.

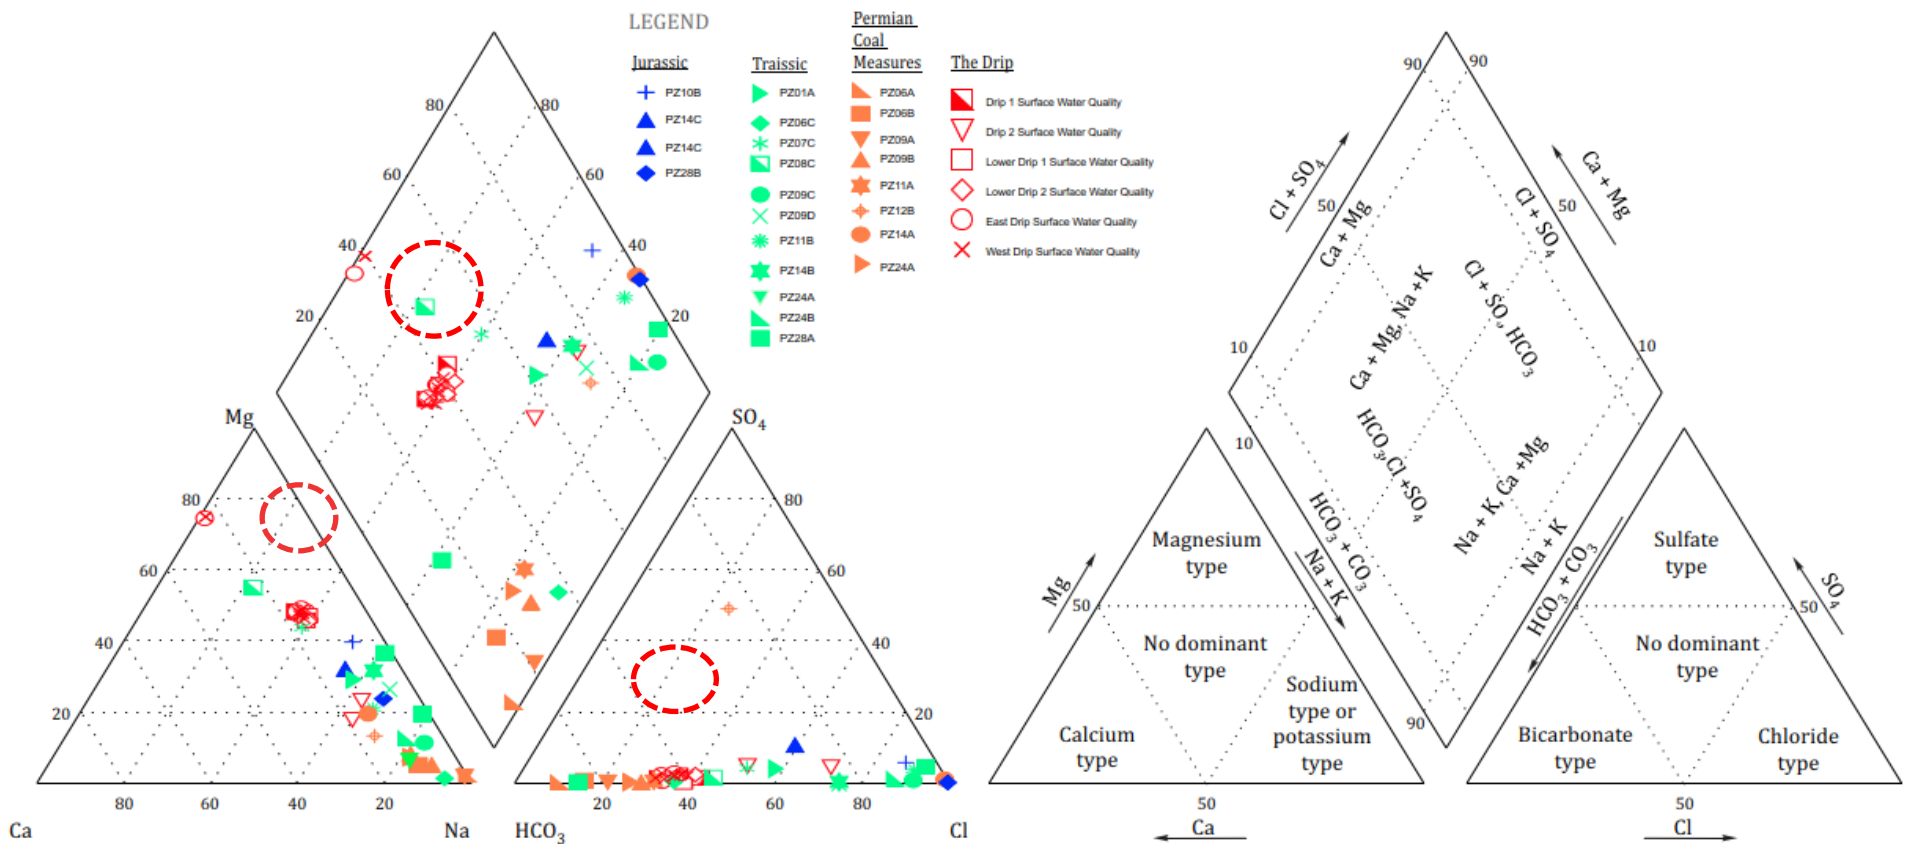
**Figure 7.6 Piper Plot - The Drip**

Overall, The Drip water quality continues to exhibit proportions of major ions that are different to those collected from other Triassic sediments in the rest of the monitoring program. This difference in major ion composition suggests the influence of a different recharge source for The Drip.

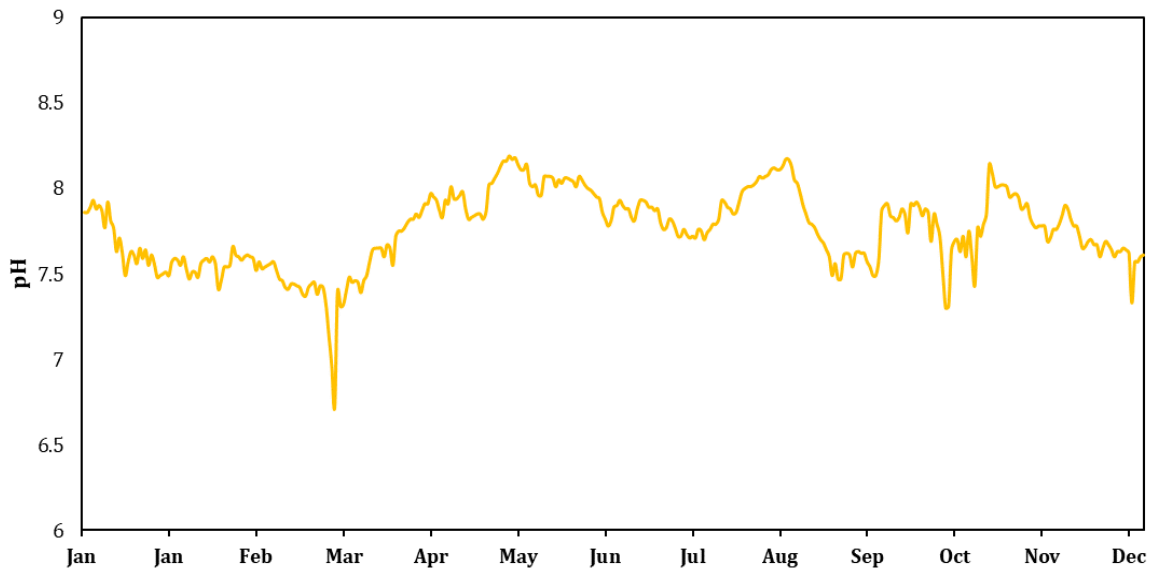
**Figure 8.4 Goulburn River discharge, EC and pH**

Ulan Mine measures stream flow in the Goulburn River. During the 2019 monitoring period, stream flow measured at monitoring point SW02 which is located downstream of Ulan Mine in and downstream of the Ulan Creek confluence. Both catchment runoff and Ulan Mine discharge contribute to stream flow measured at SW02. Measured flow ranged between 0.3 ML/day and 37.5 ML/day with an average flow of 12.7 ML/day. Goulburn River stream EC and pH is also measured SW02. During the year, EC within the Goulburn River ranged between 624  $\mu\text{S}/\text{cm}$  and 914  $\mu\text{S}/\text{cm}$ , and pH ranged between 6.4 and 8.5. Graphs and time series of Goulburn River discharge (ML/day), EC and pH measured at SW02 are shown on Figure 8.4.
