**Re: LWW5 End of Panel Report for Ulan Underground Mine**

Subsidence Management Plan (SMP) Approval (File No.09/5344) for Longwalls (LW) LW27 - LW29 and LWW4 & LWW5 was issued to Ulan Coal Mines Pty Limited (UCMPL) on 29 May 2013. Secondary extraction of LWW5 commenced on 18 December 2018 and was completed on 22 January 2020 at the Ulan Underground Mine.

**Robyn Stoney**  
**Environment and Community Manager**  
**Ulan Coal Mines Pty Limited**  
**Attachment A: End of Panel Report LWW5 – Ulan Underground Mine**

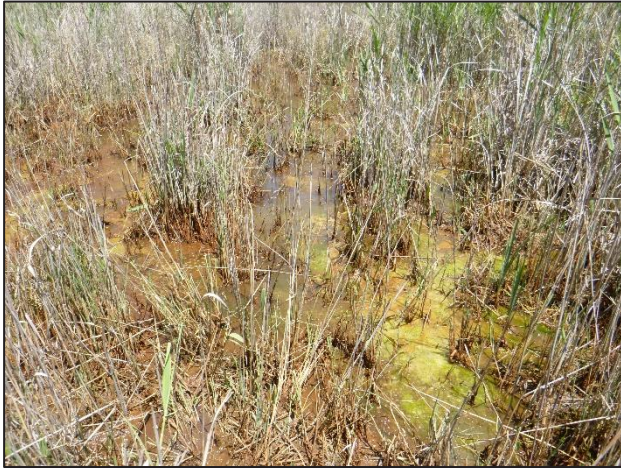
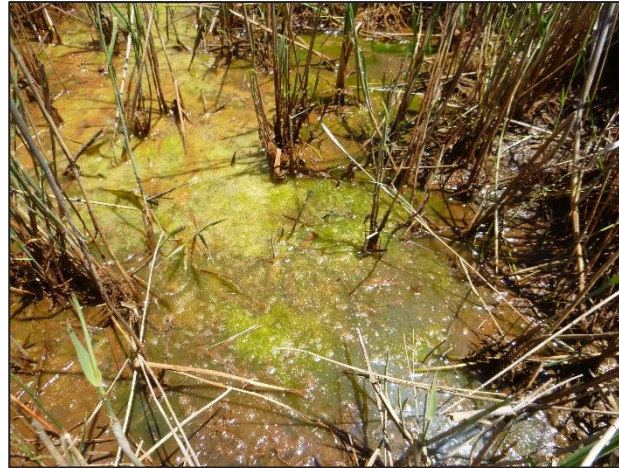
**Site AQ2 macroinvertebrate sampling habitat demonstrating isolated stagnant pools with abundant macrophyte growth within the Goulburn River Diversion**

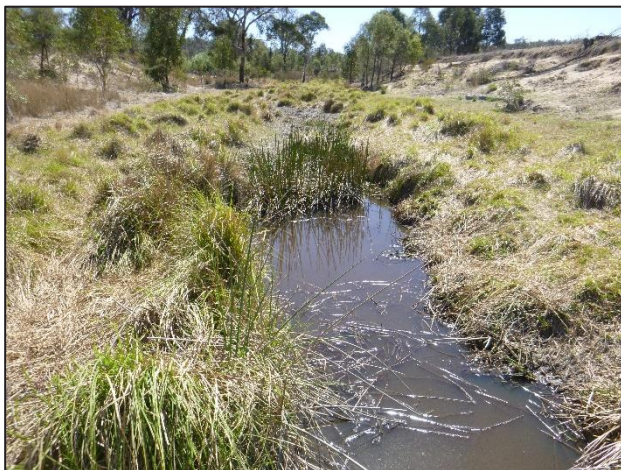
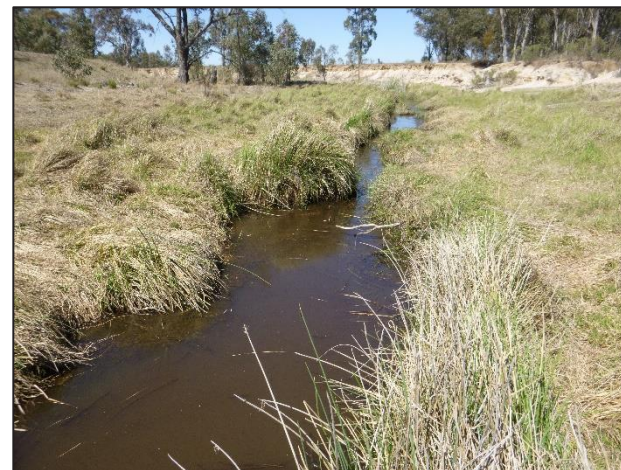
**Site AQ20 macroinvertebrate sampling habitat upstream and downstream demonstrating isolated stagnant pools**

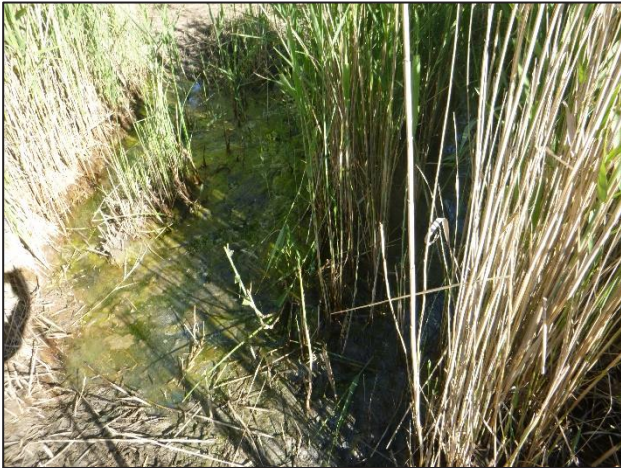
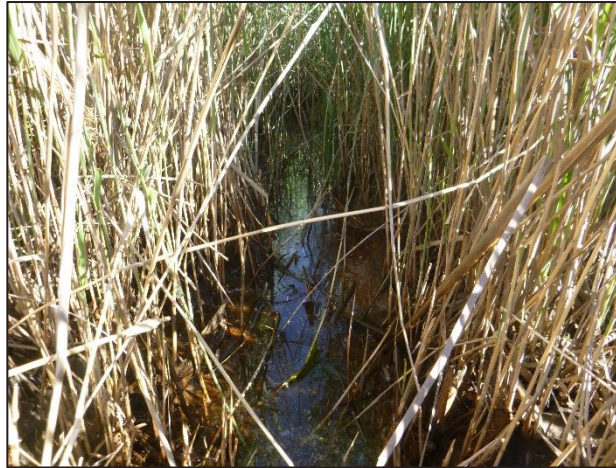
Site AQ21 macroinvertebrate sampling habitat demonstrating isolated stagnant pools with abundant macrophyte growth within the Goulburn River Diversion

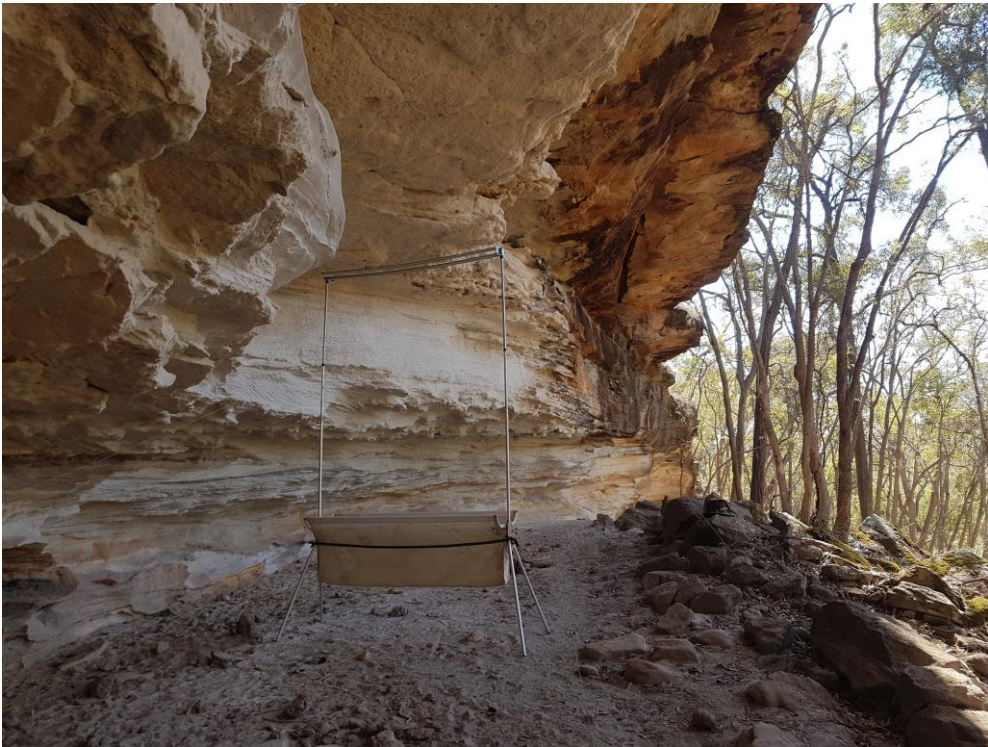
Figure 3 Harp trap set in cave overhang at site BO1.
