**Virginia Department of Transportation**  
**INTER-AGENCY COORDINATION MEETING**  
**Joint Permit Application**

| Route: 669 | UPC#: 109314 |
| VDOT Project Number: 0669-046-682, C501, P101, USGS Quadrangle: Bennis Church R201 | |

The proposed Nike Park Road Extension project will consist of a new approximately one-mile, two-lane collector roadway that will also include the construction of a multi-use path that will run parallel to the new facility. The project will impact approximately 157,068 SF of nontidal forested wetland; 165 SF of nontidal emergent wetland; and 48.2 LF of jurisdictional ditch. In addition, temporary impacts to 1800.7 SF of nontidal forested wetland; 109.4 SF of unconsolidated bottom and 64LF of intermittent stream are proposed at ten separate crossings.

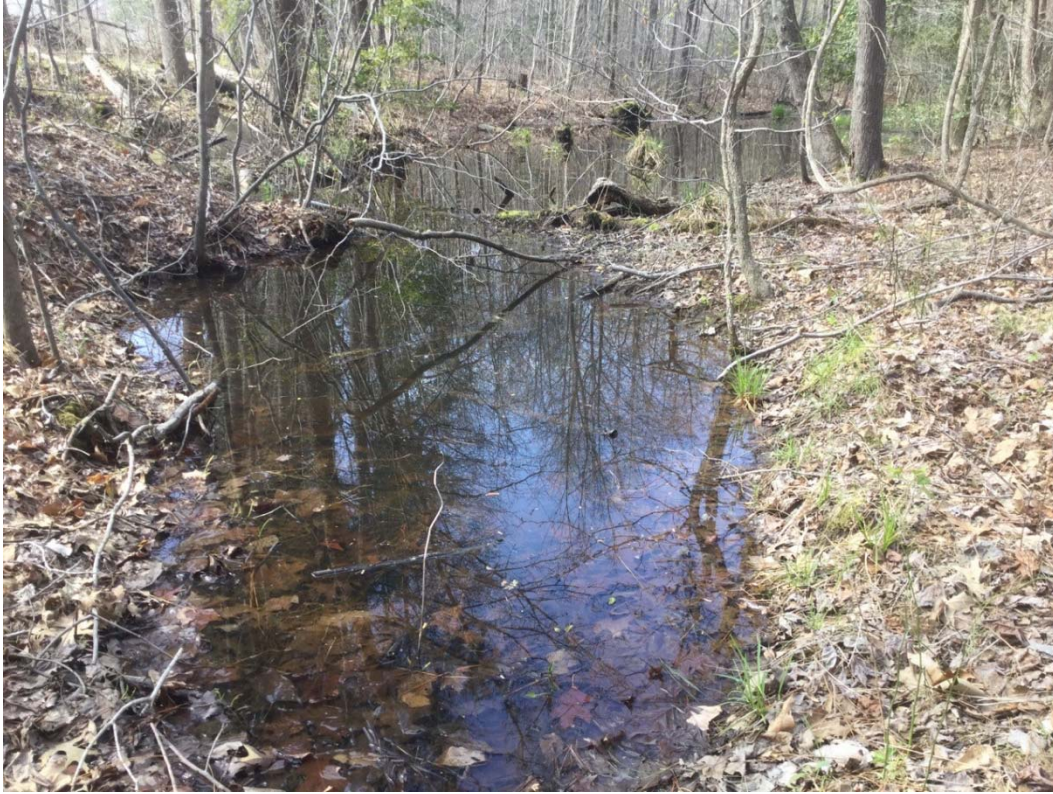
Photograph 1: View of VPA in April. This pool is formed by a blocked stream.

Pools VPA, VPK, and VPP were found to be the result of man-made alterations. Pool VPA in the easternmost side of the study area was formed by fill placed within a narrow drainageway years ago that prevents the natural flow of surface water to a nearby stream. Pool VPK is the a very small ( $\pm 0.02$  acre) man-made depression within the metal scrap yard. This pool occurs in a cleared area disturbed by heavy equipment, and is dominated by cattails (*Typha latifolia*). VHB dismissed this pool from listed amphibian habitat due to the poor condition and continuous

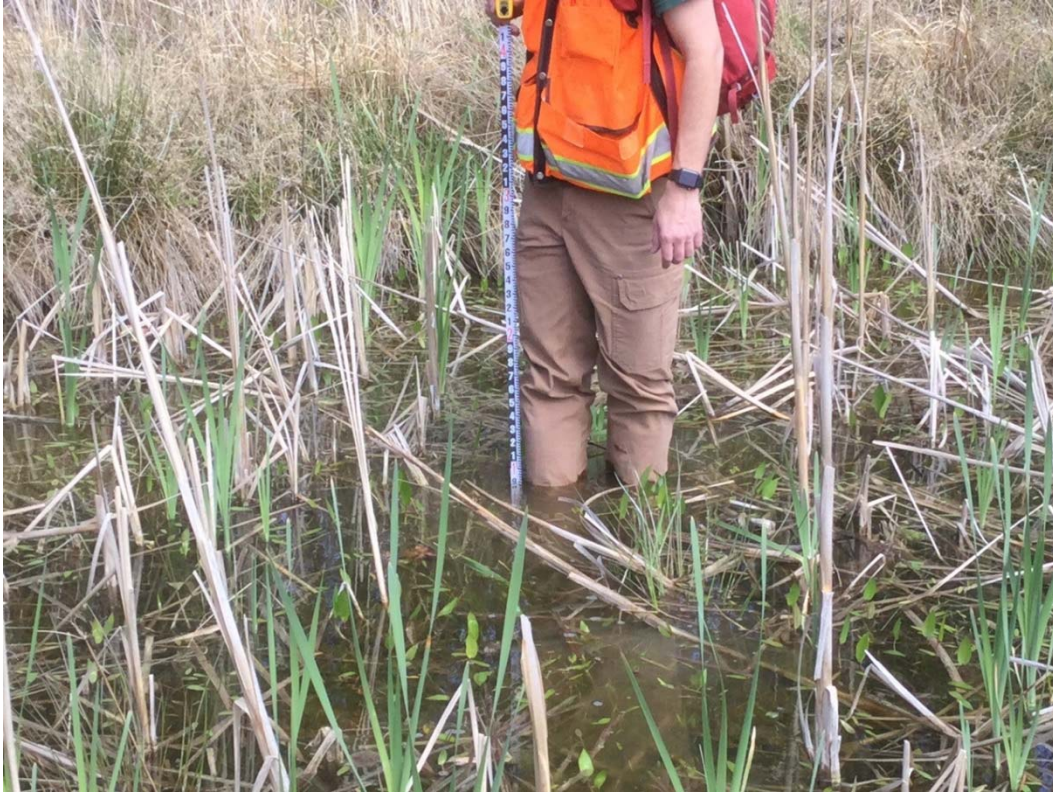
Photograph 3: View of water depth at VPK in April. This system is located on the edge of a metal scrap yard.

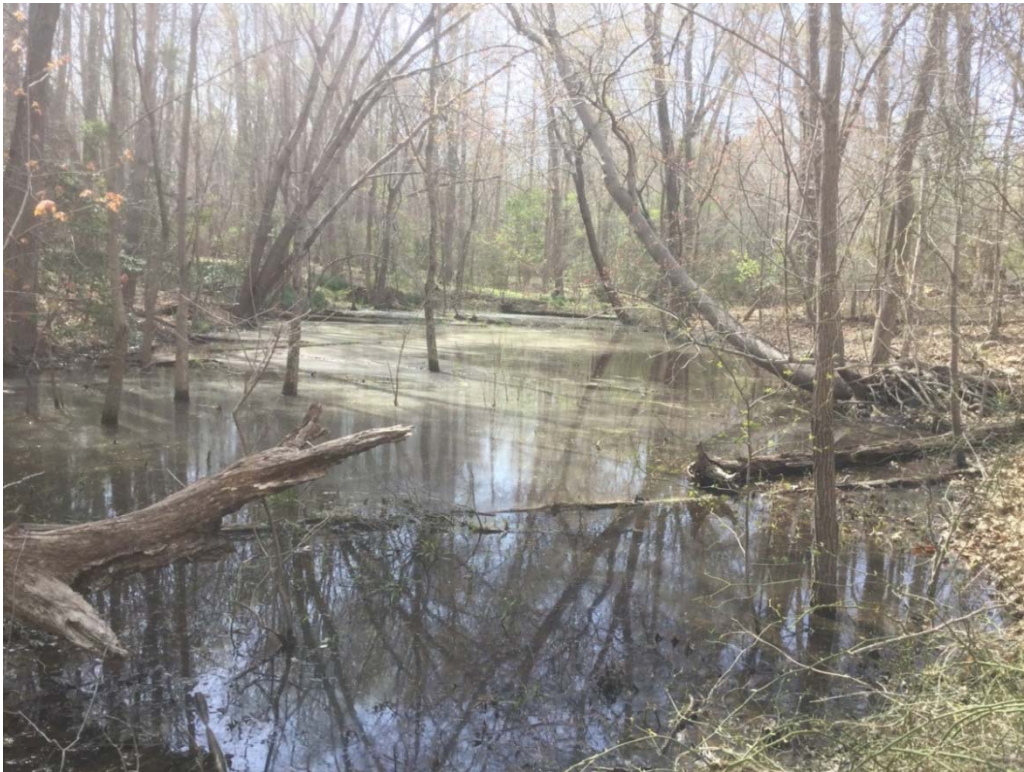
Photograph 6: View in April of VPP, a stream fed pool with a partially blocked culvert at Reynolds Drive.

disturbance by equipment. Pool VPP was found in the northern portion of the site immediately south of Reynolds Drive. This pool was fed by a small stream that flows northward into the pooled area and underneath Reynolds Road. Approximately 80 percent of the culvert opening underneath Reynolds Road is blocked by sand and debris, contributing to the damming of water. VPP occupies about 0.4 acres within the study area, with varying water depths from 4-10 inches. Visible water marks on trees in VPP indicated peak water levels reached an additional 3 inches (13 inches total). Trees growing along the edges of VPA and VPP had buttressed trunks and hypertrophied lenticels, suggesting extended duration of inundation.

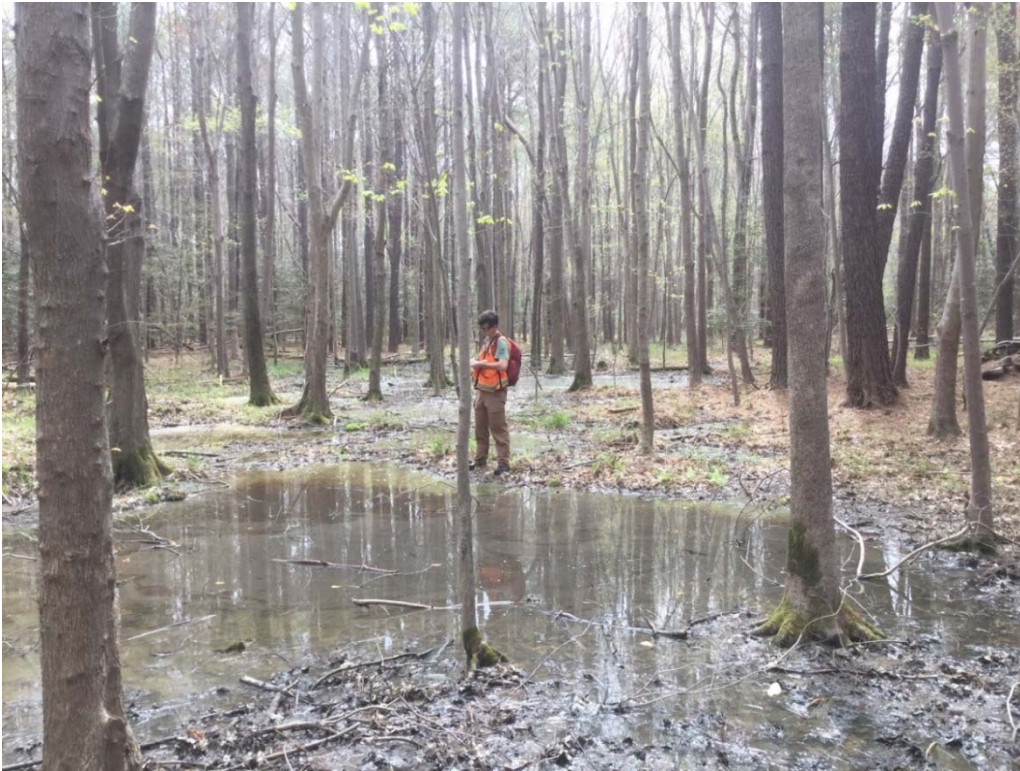
Photograph 7: View in April of VPQ, a large wetland with scattered pools. Majority of western side is bordered by open field and yard.

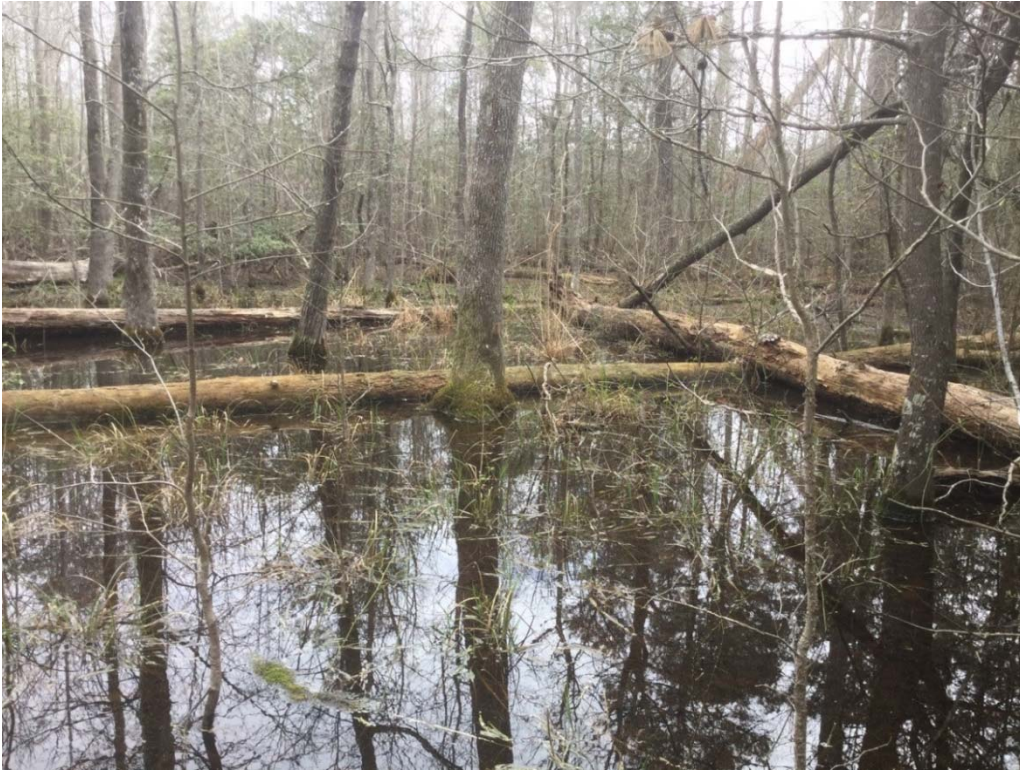
Photograph 9: View in April of VPR, a natural vernal pool roughly 300 feet north from the powerline easement.

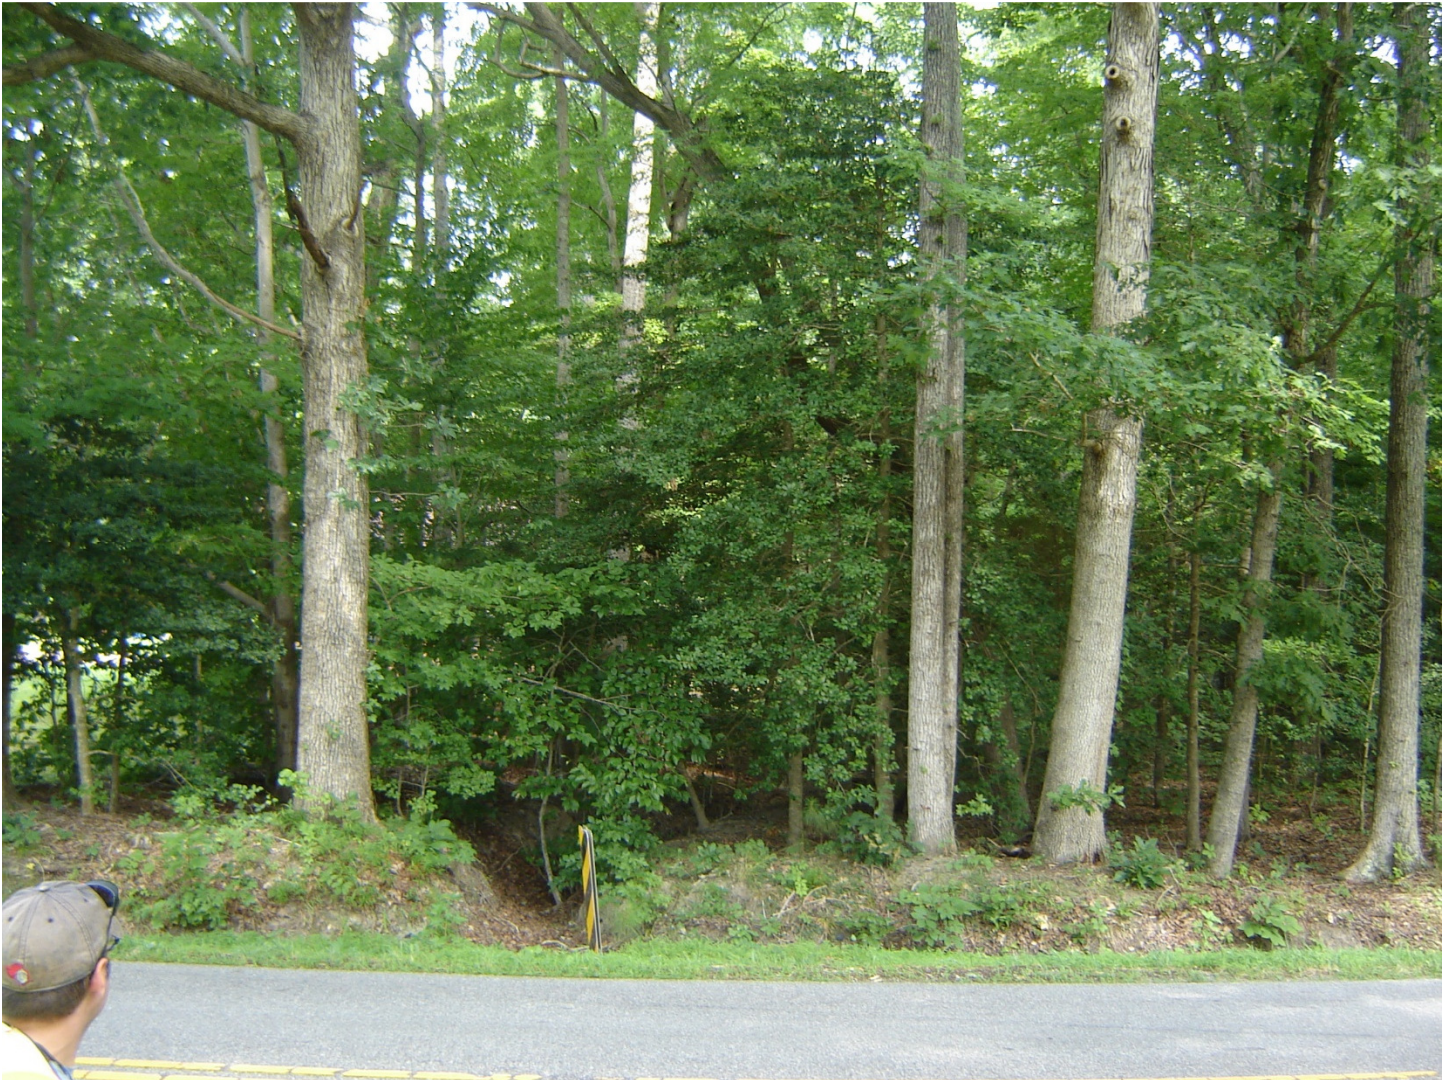
**Impact Area Number:** Crossing #3\_Reynolds Drive PFO\_north

**Description:** narrow PFO fringe located between Reynolds Drive and aerial utility easement in background.

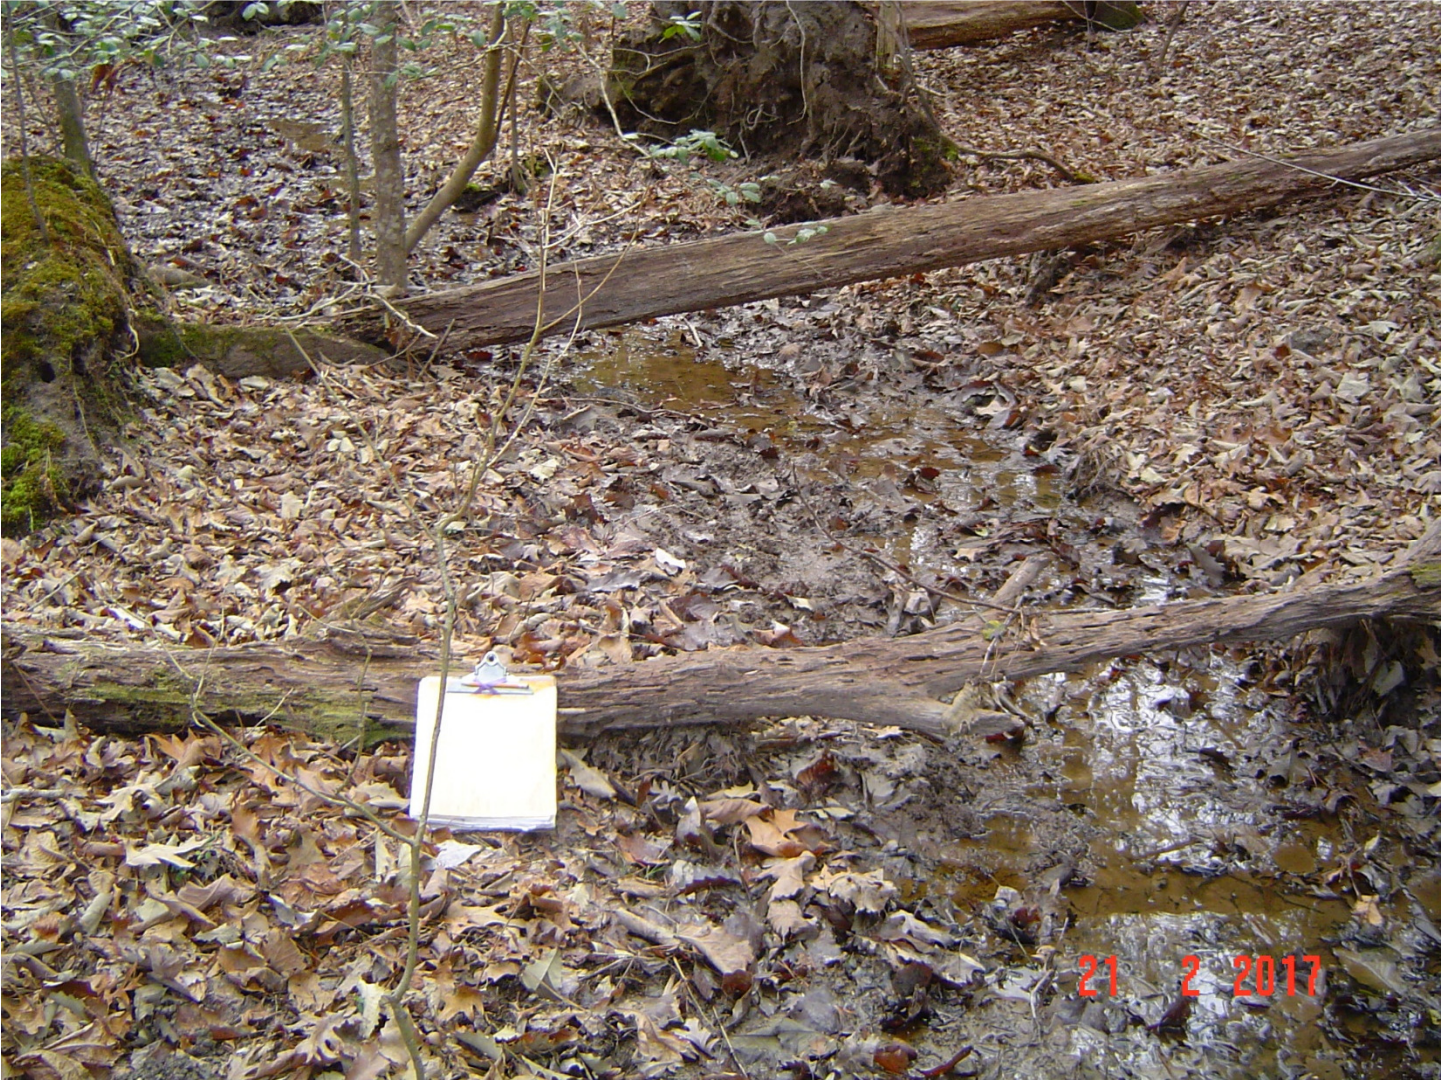
**Impact Area Number:** Crossing #5 looking downstream

**Description:** proposed PUB impact area upstream of the clipboard

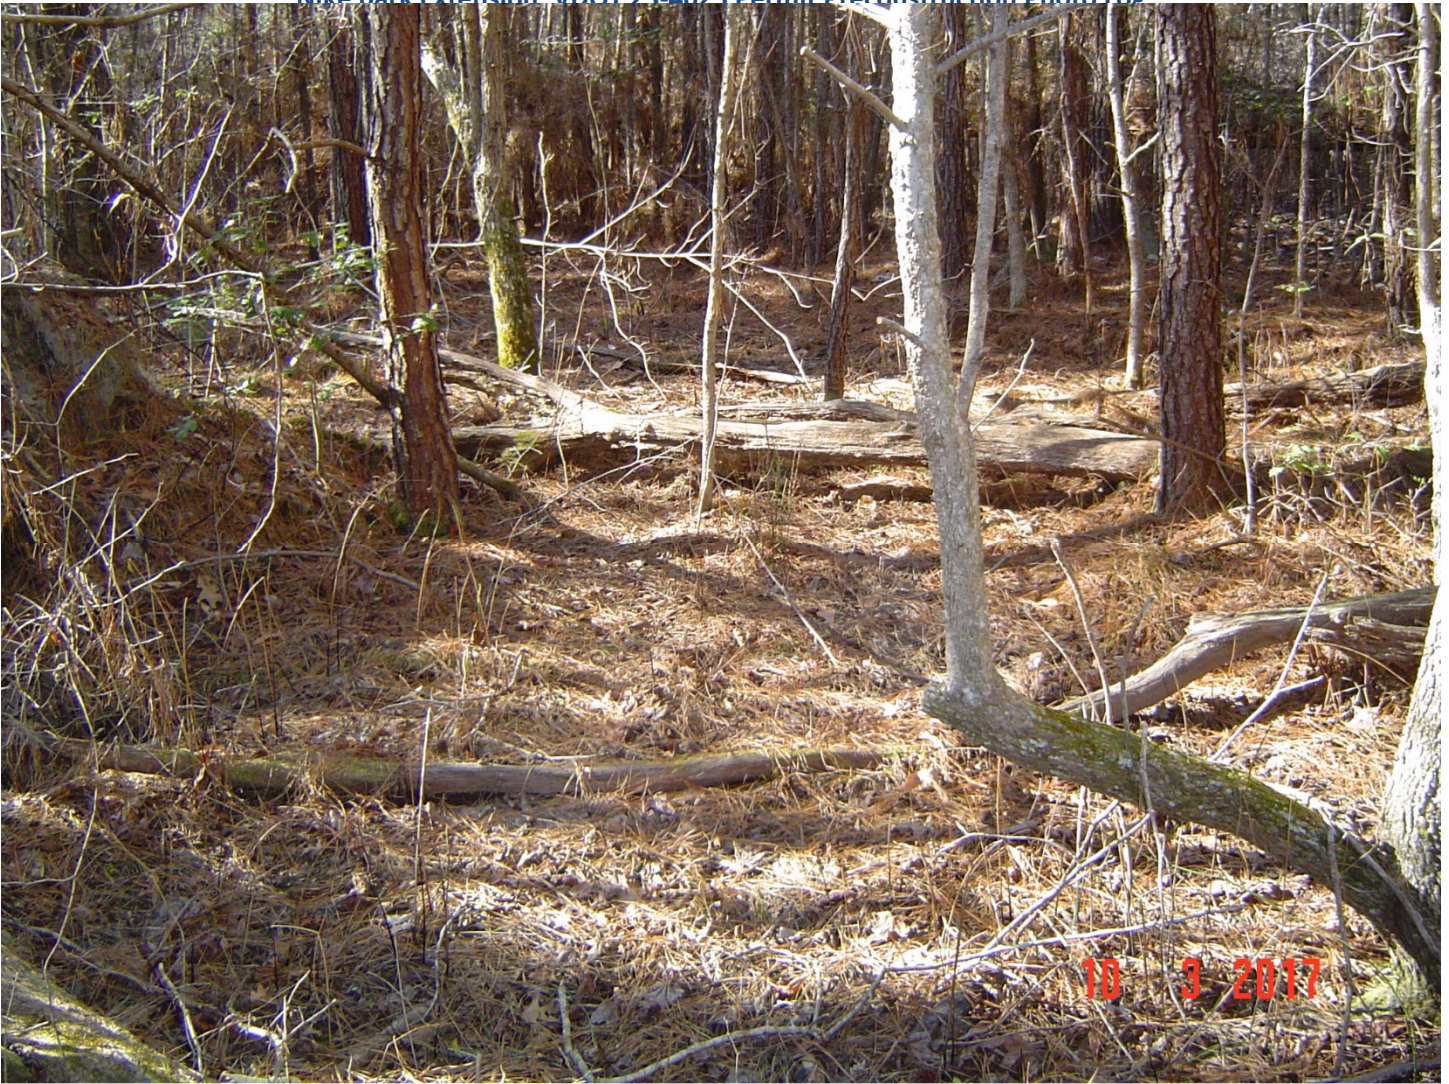
**Impact Area Number:** crossing #7

**Photograph Orientation:** Facing south **Description:** Young Mixed softwood PFO
