**1-Biological Diversity**

Okutadami Dam

**Project Name:** Okutadami and Ohtori Expansion Hydropower Project

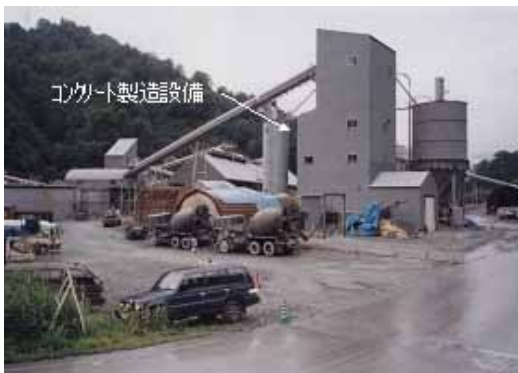
Photo 3 A Concrete Production Facility  
Housed in a Building

(Within the Temporary Facility Site at the Okutadama Outlet)

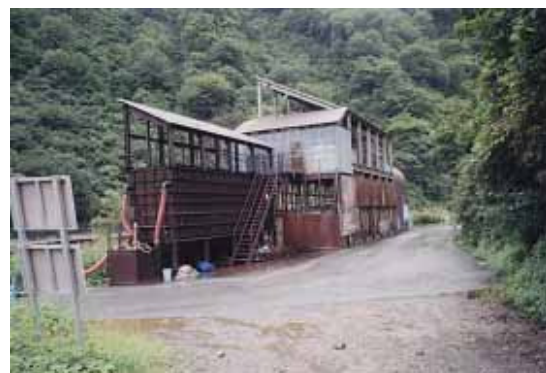
Photo 4 Muddy Water Treatment System  
(Processing Capacity of 200 m<sup>3</sup>/h)

- 1) All construction drainage was treated by a muddy water treatment system and released to public water after the quality of the treated water was checked.
- 2) A double layer of pollution prevention membranes were installed for the underground construction (of a head gate) in order to prevent the spreading of polluted water.

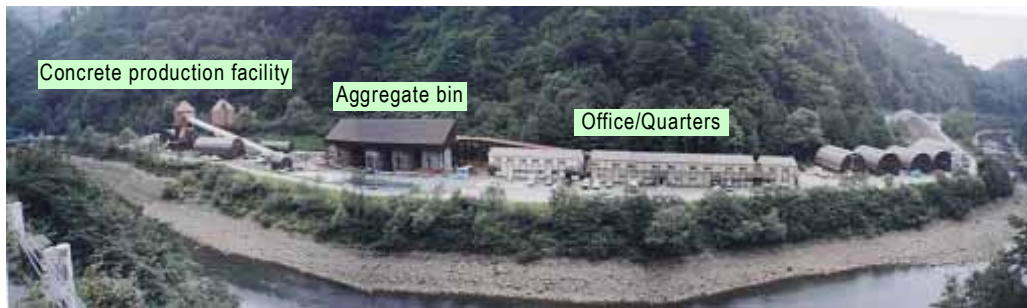
Photo 5 Entire View of the Temporary Facility Site in Ohtori

- 1) Minimum nighttime lighting necessary for construction safety was used. The high voltage sodium lamp was used because it has only minor effects on insects and plants.
- 2) Blinds were hung from the windows of temporary buildings so as not to allow interior lighting to leak to the outside and headlights of vehicles were turned off when vehicles were at a stop.
- 3) The use of colors disliked by birds (yellow and red) was restricted as the exterior colors of temporary facilities and construction machines.

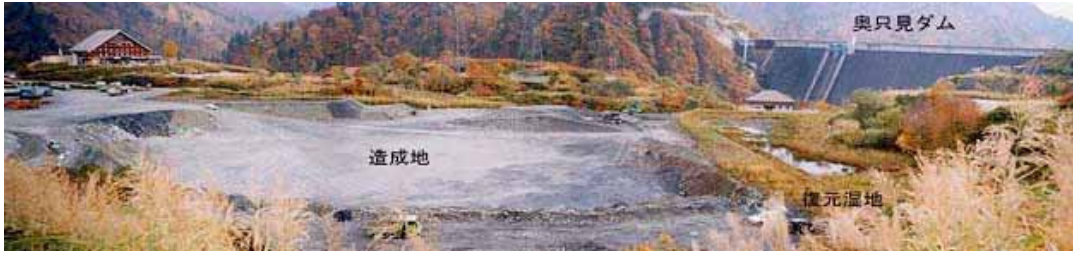
Photo 6 Restoration of the Marshland Environment in Yasaki Reclamation Site  
(Restored Marshland – in the Right of the Photo)

- 1) Since restricting conditions made it difficult to transport excavated rocks generated from the underground construction outside the construction site, a plan was made to reclaim the marshland (hereafter referred to as the “existing marshland”) within the construction site using excavated rocks. However, since the existing marshland was inhabited by aquatic plants and dragonfly species, it was considered essential to take measures to compensate for the use of the marshland environment. These measures comprised the construction of a new marshland as a replacement within the reclamation site and the restoration of the original marshland environment. More specifically, a site next to the existing marshland was reclaimed to construct a replacement and the existing and replacing marshland were used until the existing marshland was completely reclaimed. These measures allowed animals inhabiting the marshland including dragonflies to freely travel between the two marshlands and thus made natural changes of generations possible.

Since the marshland constructed as a replacement in the reclamation site was found inhabited by animals and plants that previously inhabited the existing marshland, the compensating measures appear to have succeeded.
