RED FLAG INVESTIGATION Re:

Des. No. 1601102, State Project

State Road 827 Pavement Replacement

Fremont, Steuben, Indiana

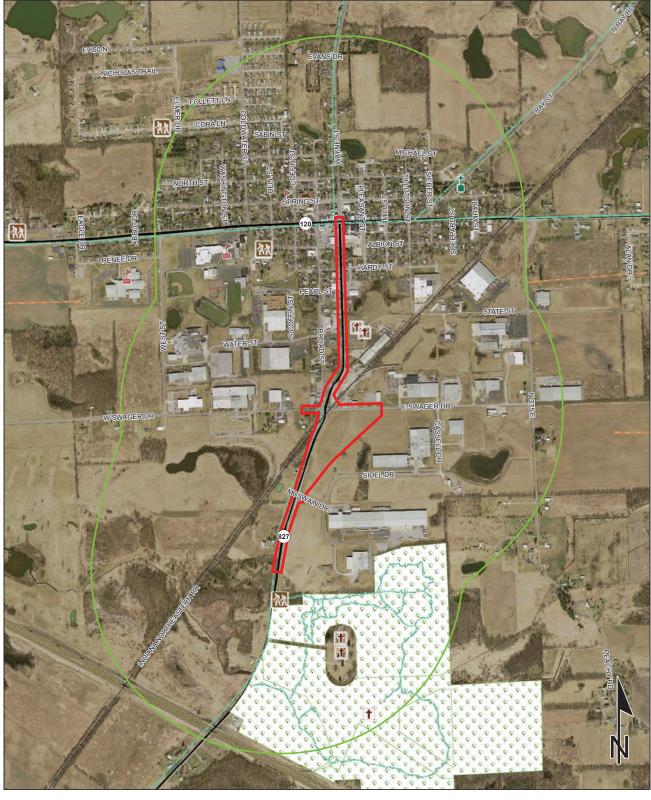
Red Flag Investigation - Infrastructure SR 827 Pavement Replacement Des. No. 1601102 Steuben County, Indiana

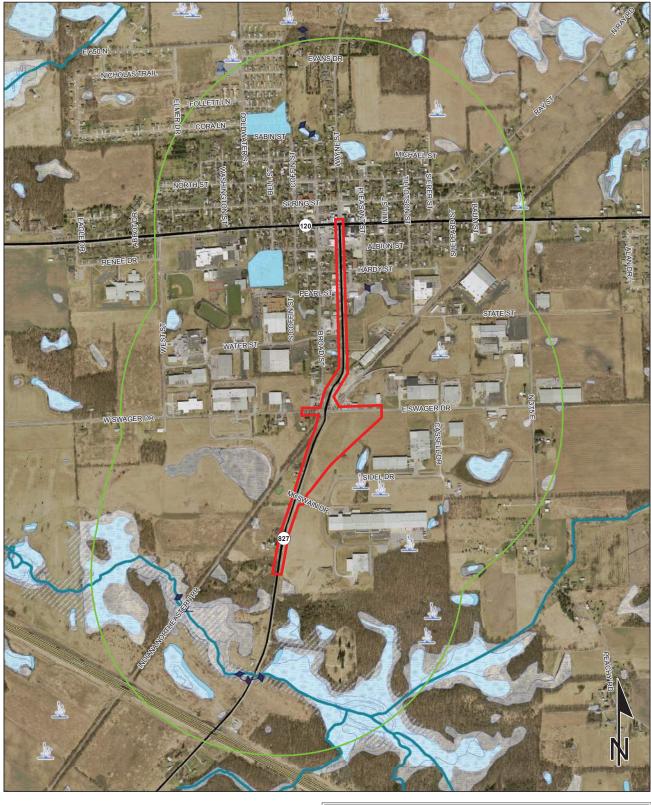
Red Flag Investigation - Water Resources SR 827 Pavement Replacement Des. No. 1601102 Steuben County, Indiana

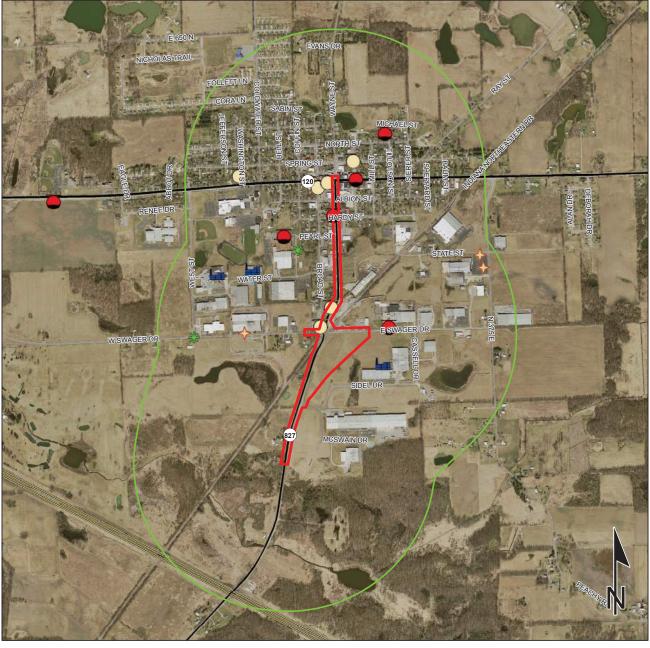
Red Flag Investigation - Hazardous Material Concerns SR 827 Pavement Replacement Des. No. 1601102 Steuben County, Indiana

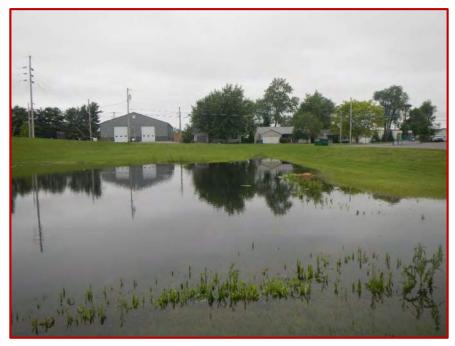
Photo 10. Looking west across Pond 1 located along the west side of SR 827, approximately 0.1 mile north of Broad Street.

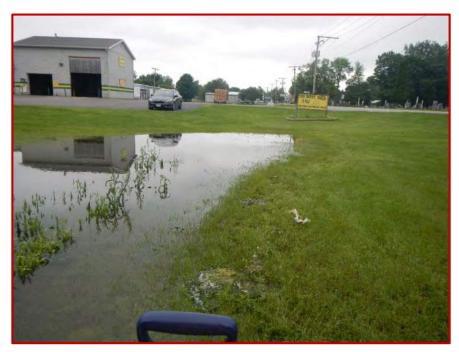
Photo 11. Looking north along Pond 1

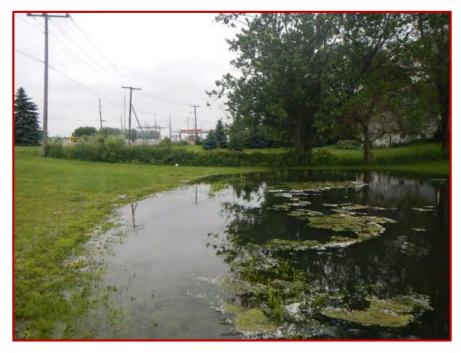
Photo 12. Looking south along Pond 1 located along the west side of SR 827, approximately 0.1 mile north of the intersection of SR 827 and Broad Street.

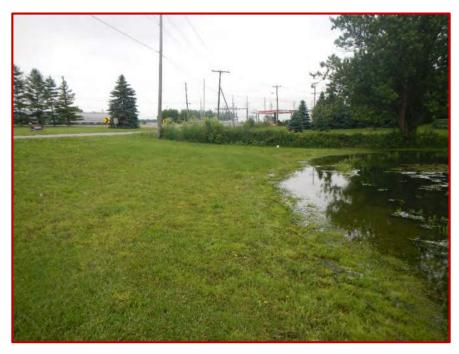
Photo 13. Looking south along Pond 1, located along the west side of SR 827, approximately 0.1 mile north of the Broad Street.

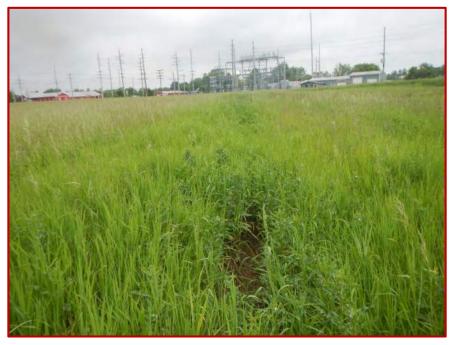
Photo 43. Looking southeast, downstream, UNT 1 to Marsh Lake and at surrounding vegetation dominated by smooth brome (*Bromis inermis*), located approximately 0.04 mile south of Swager Drive and 0.09 mile east of SR 827.

The flow regime of UNT 1 appears to be ephemeral. The stream was not visibly flowing during the June 6, 2019 site visit. The stream is highly-channelized with some in-stream cover. Non-hydrophytic vegetation, predominantly smooth brome (*Bromis inermis*) and Canada thistle (*Cirsium arvense*) were observed growing within the channel. The dominant substrate was silt. The ordinary high water mark (OHWM) and top of bank at the assessment location was 1.8-feet wide by 0.3-feet deep. UNT 1 to Marsh Lake would be classified as a Non-Relatively Permanent Water (Non-RPW), Riverine, Unconsolidated Bottom, Mud (RUB3) habitat using the Cowardin Classification System. The Cowardin Classification System does not include a subsystem for ephemeral flow regimes.

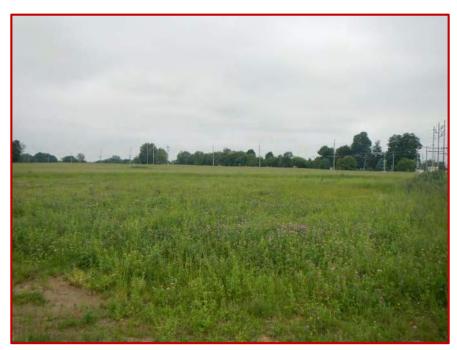
Photo 44. Looking northwest, upstream, UNT 1 to Marsh Lake along investigated area located approximately 0.04 mile south of Swager Drive and 0.09 mile east of SR 827.

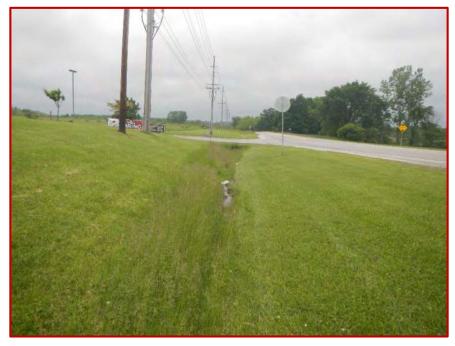
Photo 52. Looking south along investigated area towards Wetland A located on the east side of SR 827, approximately 0.04 mile north of McSwain Drive.

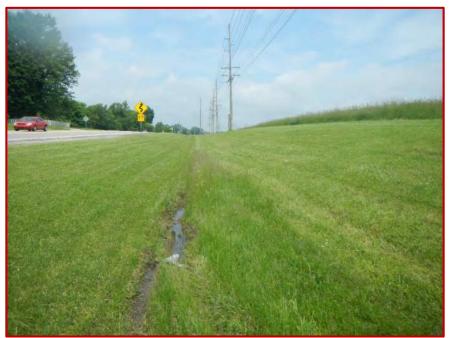
Photo 53. Looking at DP1 and the soil profile in Wetland A located on the west side of SR 827, approximately 0.02 mile north of McSwain Drive.

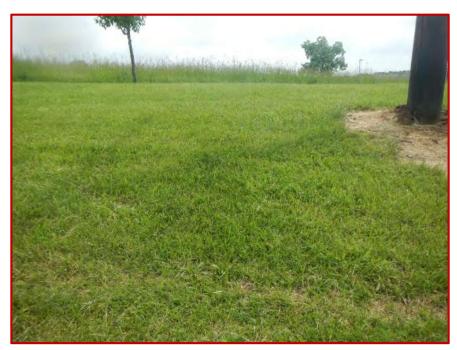
Photo 56. Looking at DP2 and the soil profile in the upland area around Wetland A located on the west side of SR 827, approximately 0.02 mile north of McSwain Drive.

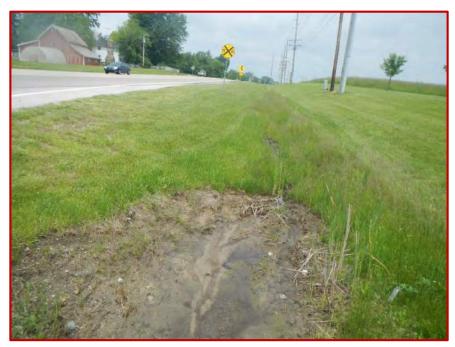
Photo 59. Looking north along Wetland A located on the west side of SR 827, just north of McSwain Drive.

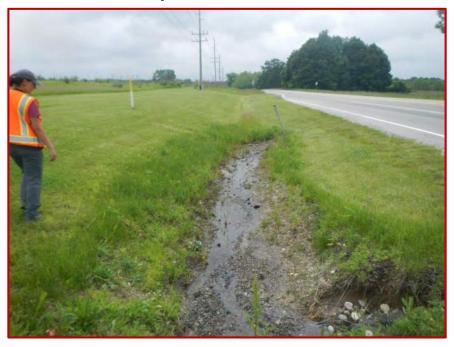
Photo 60. Looking south along Wetland A located on the west side of SR 827, just south of McSwain Drive.

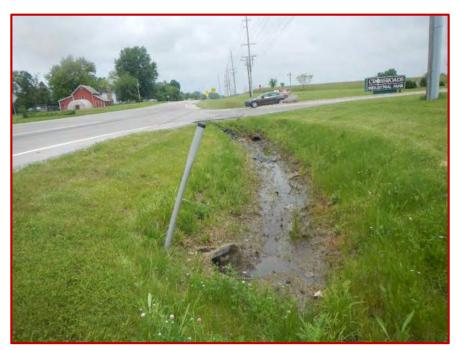
Photo 61. Looking north along Wetland A located on the west side of SR 827, approximately 0.02 mile south of McSwain Drive.

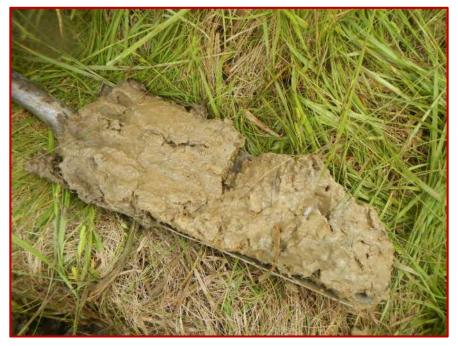
Photo 64. Looking at DP3 and the soil profile in Wetland B located on the east side of SR 827, approximately 0.06 mile south of McSwain Drive.

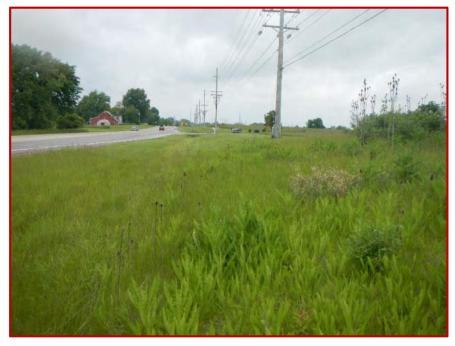
Photo 67. Looking at DP4 and the soil profile in the upland area around Wetland B located on the east side of SR 827, approximately 0.06 mile south of McSwain Drive.

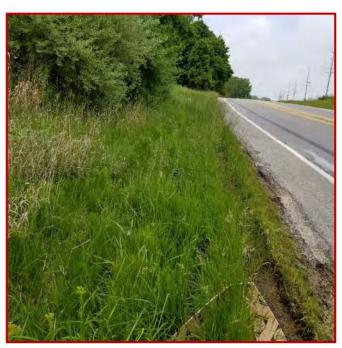
Photo 74. Looking at DP5 and the soil profile in Wetland C located on the west side of SR 827, approximately 0.16 mile south of McSwain Drive.

The dominant vegetation consisted of *Typha angustifolia* and *Barbarea vulgaris* within the herbaceous stratum. Hydric soil indicators included Depleted Below Dark Surface (A11) and Depleted Matrix (F3). Hydrologic indicators included High Water Table (A2) present at 4 inches, Saturation (A3) present at the surface, Water-Stained Leaves (B9), Geomorphic Position (D2), and FAC-Neutral Test (D5). Wetland D would be considered PEME under the Cowardin Classification System. Wetland D was delineated at 0.02 acre within the investigated area and extends west beyond the investigated area. Because Wetland D derives water from roadway runoff and contains prevalent invasive vegetation (*Typha angustifolia*), Wetland D is considered poor quality. For reference to field data collected for this wetland see DP 7 included in Appendix B. DP 8 included in Appendix B is representative of the upland areas surrounding Wetland D. DP 8 did possess hydric soil but lacked the hydrology and hydrophytic vegetation to be determined a wetland.

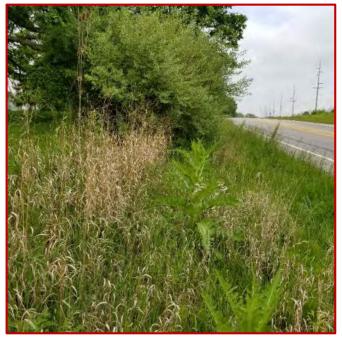
Photo 77. Looking at DP6 and the soil profile in the upland area around Wetland C located on the west side of SR 827, approximately 0.16 mile south of McSwain Drive.

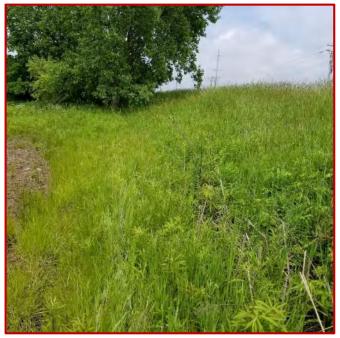
Photo 83. Looking at DP7 and the soil profile in Wetland D located on the west side of SR 827, approximately 0.04 mile south of McSwain Drive.

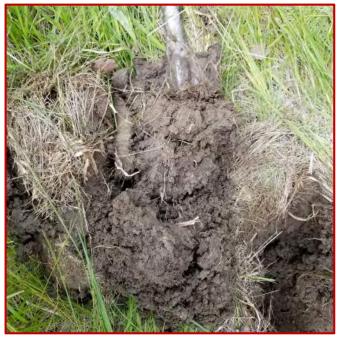
Photo 86. Looking at DP8 and the soil profile in the upland area around Wetland D located on the west side of SR 827, approximately 0.04 mile south of McSwain Drive.

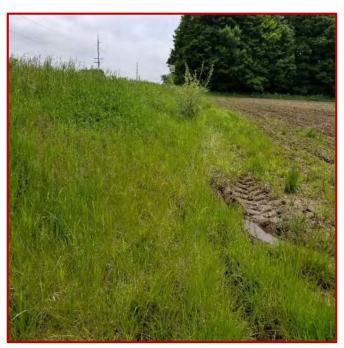
Photo 87. Looking north from DP8 at the upland area around Wetland D located on the west side of SR 827, approximately 0.04 mile south of McSwain Drive.

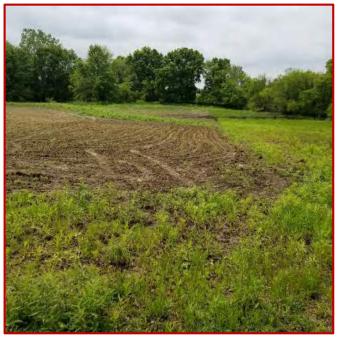
Photo 88. Looking west from DP8 at the upland area around Wetland D located on the west side of SR 827, approximately 0.04 mile south of McSwain Drive.

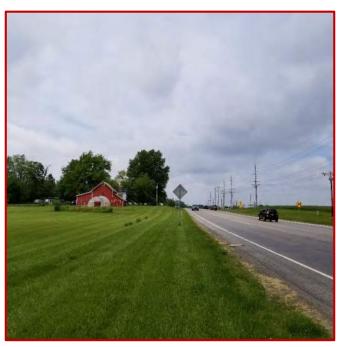
Photo 89. Looking north along investigated area located on the west side of SR 827, just north of McSwain Drive.

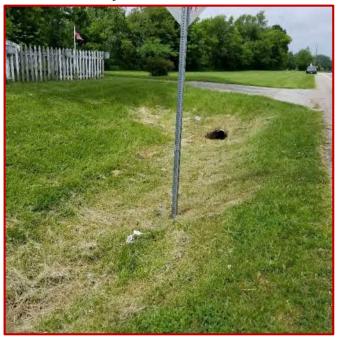
Photo 90. Looking north along investigated area located on the west side of SR 827, approximately 0.06 mile north of McSwain Drive.

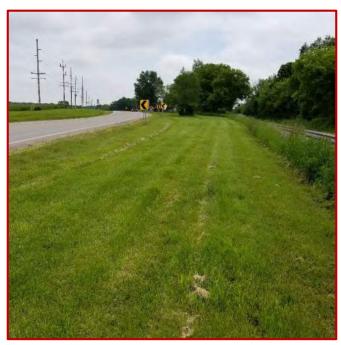
Photo 91. Looking south along investigated area located on the west side of SR 827, approximately 0.04 mile south of Swager Drive

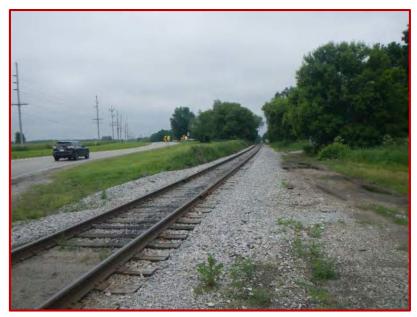
Photo 92. Looking southwest along Indiana Northeastern Railroad, located in the southwest quadrant of the intersection of SR 827 and Swager Drive.

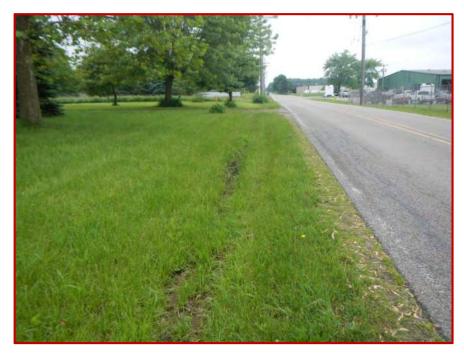
Photo 93. Looking west along investigated area located on the south side of Swager Drive, approximately 0.01 mile west of SR 827.

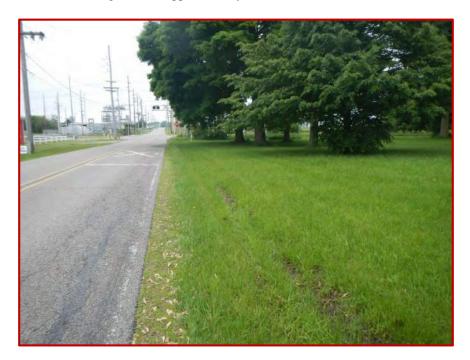
Photo 94. Looking east along investigated area located on the south side of Swager Drive, approximately 0.06 mile west of SR 827.
