ROTTING ROOFS: CAUSES, MITIGATION AND CODE REQUIREMENTS

CASE STUDIES – ROTTING ROOF EVALUATIONS

MN Multi-Family Residential Buildings

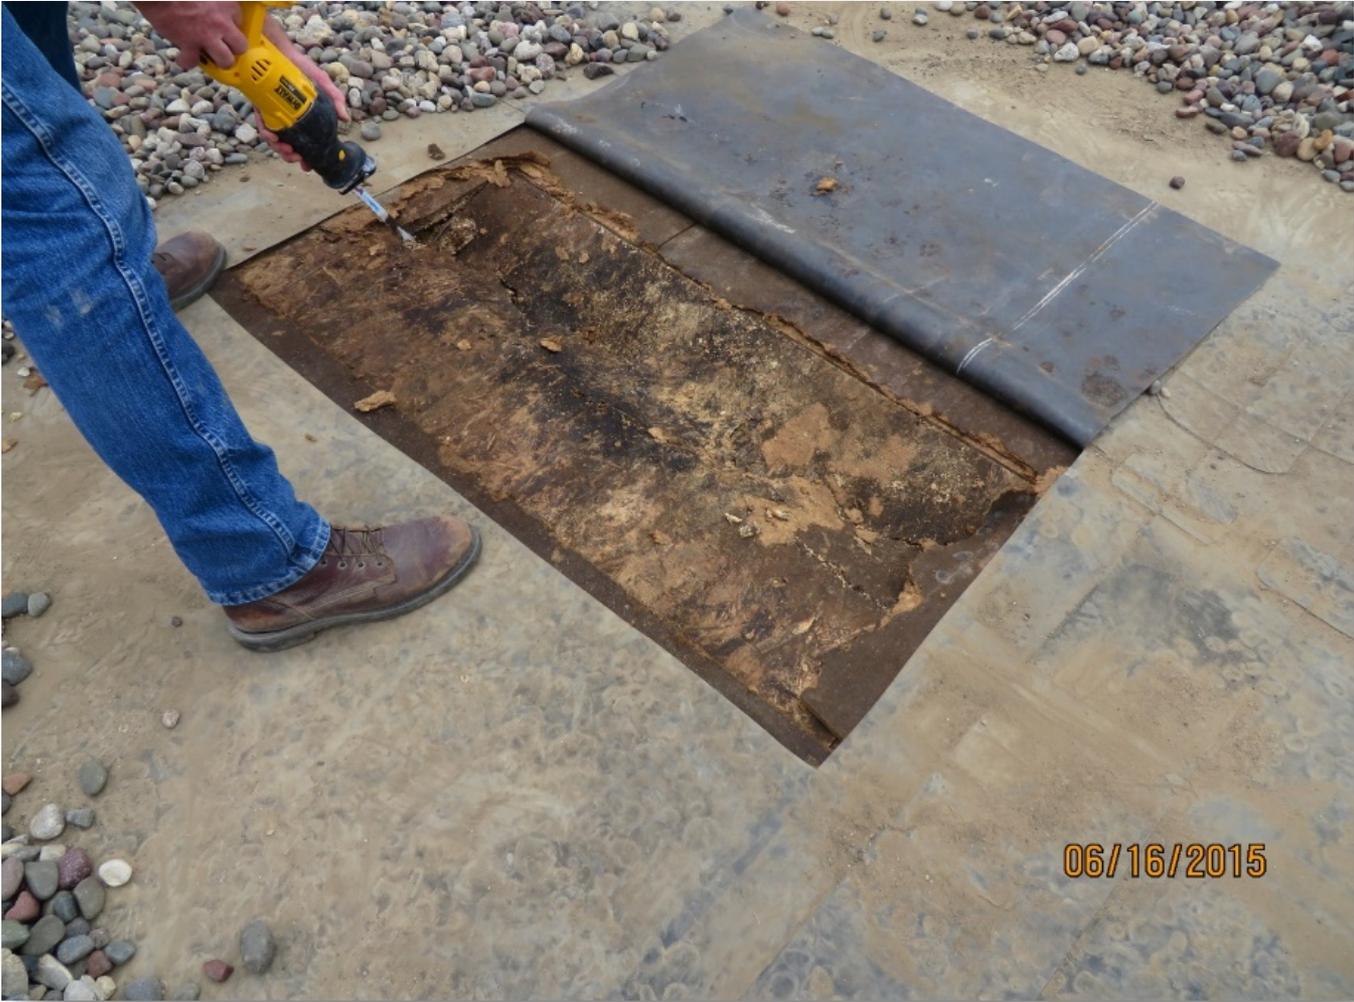
Destructive Test Opening Results

- Roughly 10 years old
- Wood open truss roof construction
- Conventional roofs BU, BSP, MFSP
- Ceiling vapor retarder

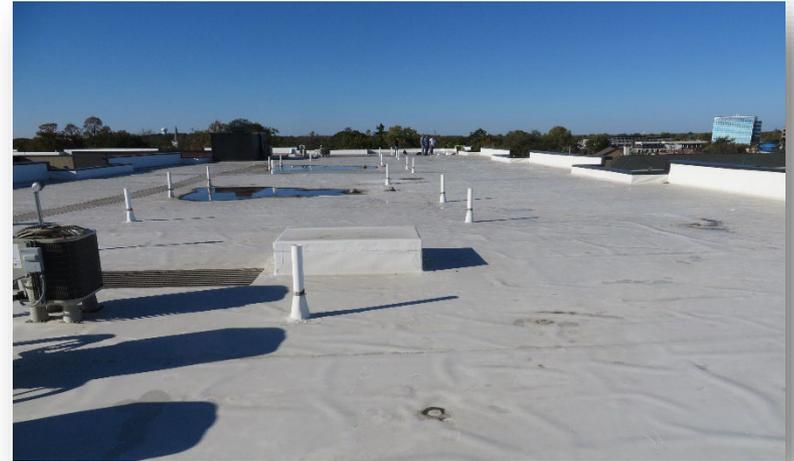
- CONSTRUCT A COMPLETE CEILING VAPOR RETARDER FROM OUTSIDE THE BUILDING
- CONSTRUCT A COMPLETE VAPOR RETARDER VIA THE BUILDING TRUSS PERIMETER

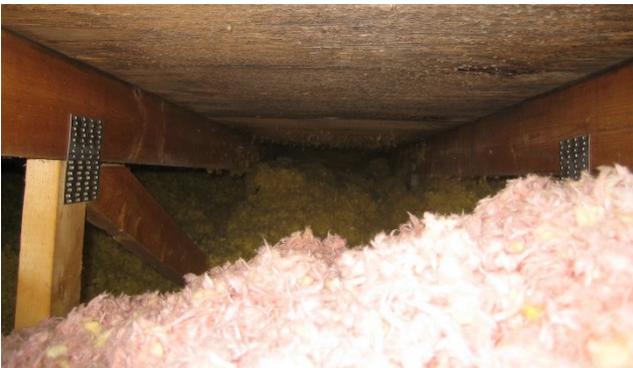
- Cold climates require freeze protection (e.g. dry sprinkler systems, antifreeze, heat, insulation, or some combination).
- Wet or dry systems and insulation, or lack thereof, can be problematic.

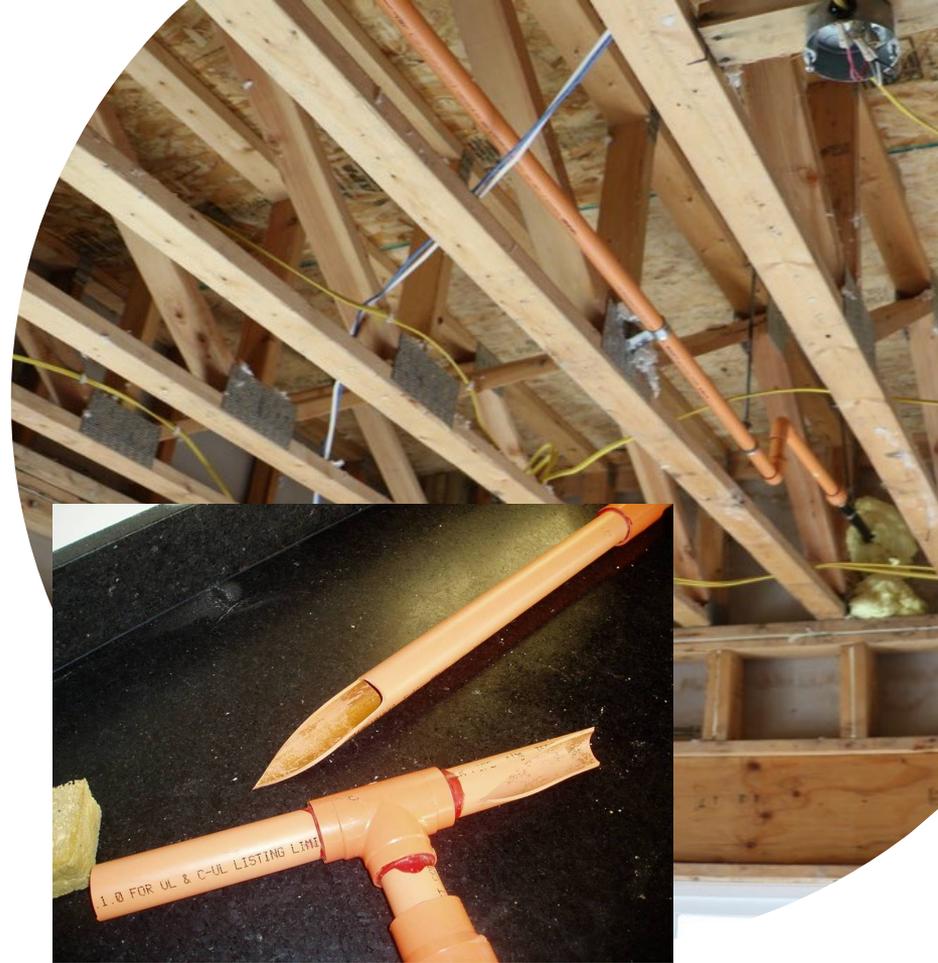
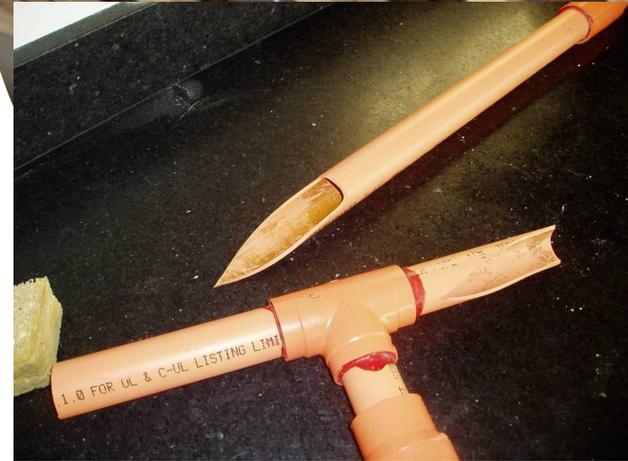
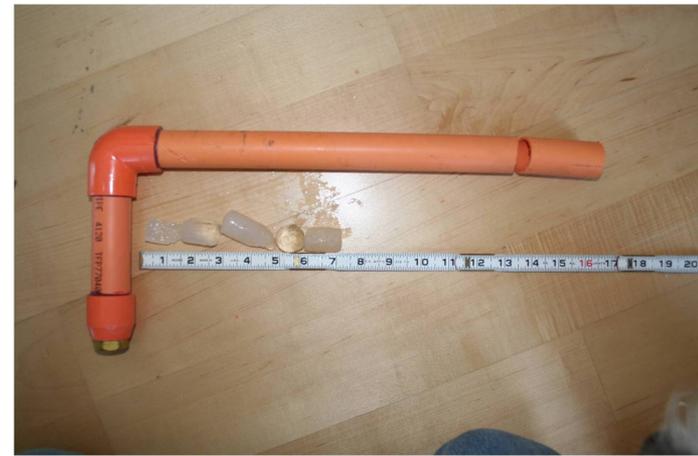
Insulation Related Failures

- Freeze failures because:
 - Floor / ceiling space filled with insulation.
 - Rim joist not properly sealed / insulated.
 - Exterior penetrations not properly sealed.
 - Water-filled domestic and sprinkler pipe too close to exterior walls and insulated from heat.

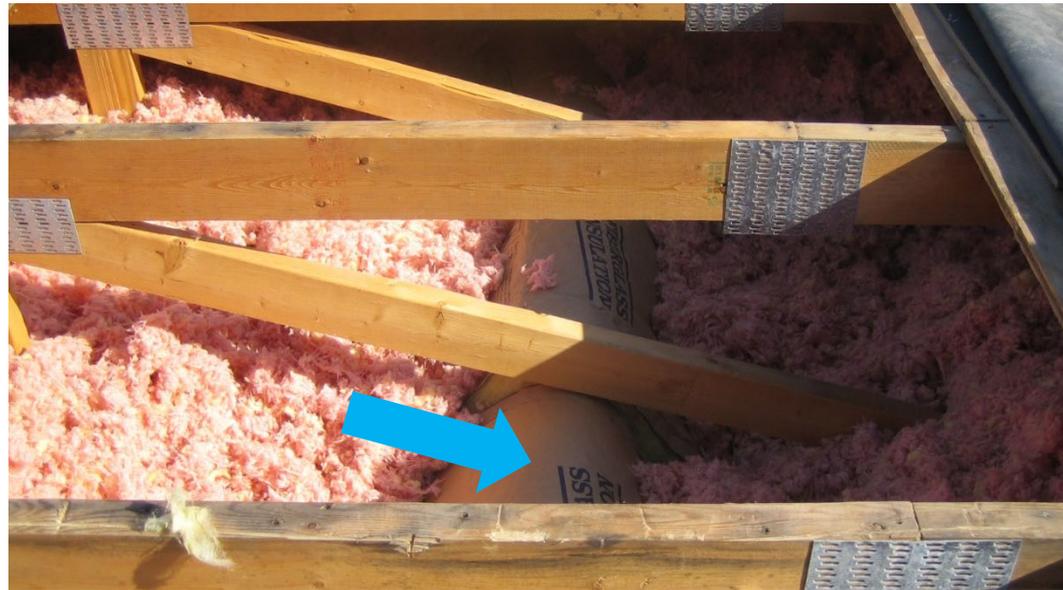
Avoiding Insulation Related Failures

- “Tenting” / sealing water-filled pipe in joist / ceiling / floor spaces.
- “Tents” have to be sealed completely.
- Heating the attic space and using water-filled sprinkler systems.
- Non-combustible roof construction eliminating fire sprinkler requirements.

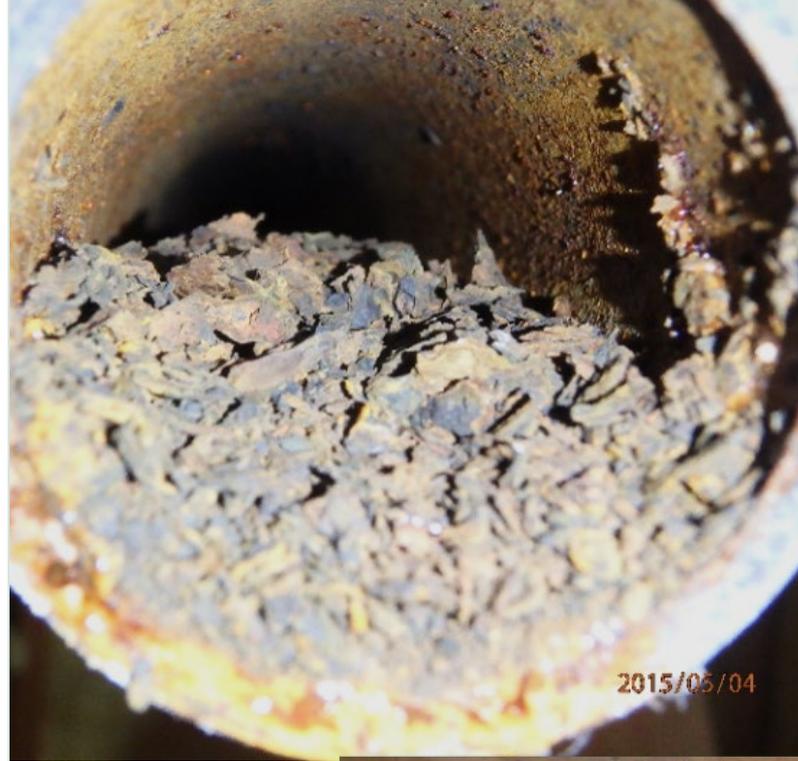
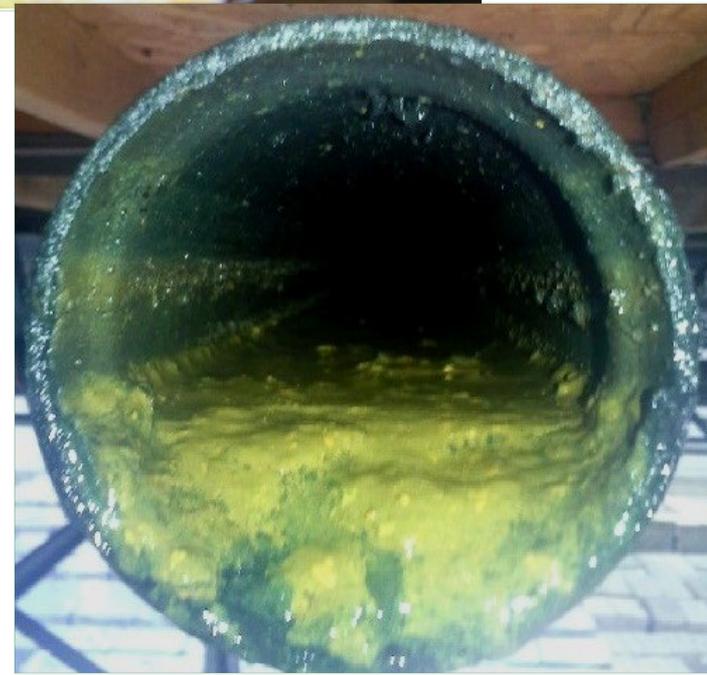
Corrosion in Dry Systems

- Causes freeze failures.
- Can obstruct sprinklers and piping from waterflow in a fire condition.
- Reduces the life expectancy of steel pipe systems to 7-12 years with thinwall pipe.
