Re: Individual Permit Application, Moda Ingleside Oil Terminal, LLC, Berth Expansion Project,  
Corpus Christi Ship Channel, Ingleside, San Patricio County, Texas

Moda Ingleside Oil Terminal, LLC (Moda) proposes the dredging of approximately 3,900,000 cubic yards to increase the permitted size of the West Ship Basin by approximately 35.28 acres. Moda additionally proposes to implement improvements at their existing East Basin, 2A barge dock, as well as the construction of new West Basin barge dock Berths 7A, 7B, 7C, 8, and 9. The project site is located on the north side of the Corpus Christi Ship Channel (CCSC), more precisely located between Stations 520+07 and 540+08, at 262 Coral Sea Road, Ingleside, San Patricio County, Texas.

**MODA INGLESIDE ENERGY CENTER**  
**BERTH 7/8/9 EXPANSION**  
**VICINITY MAP**

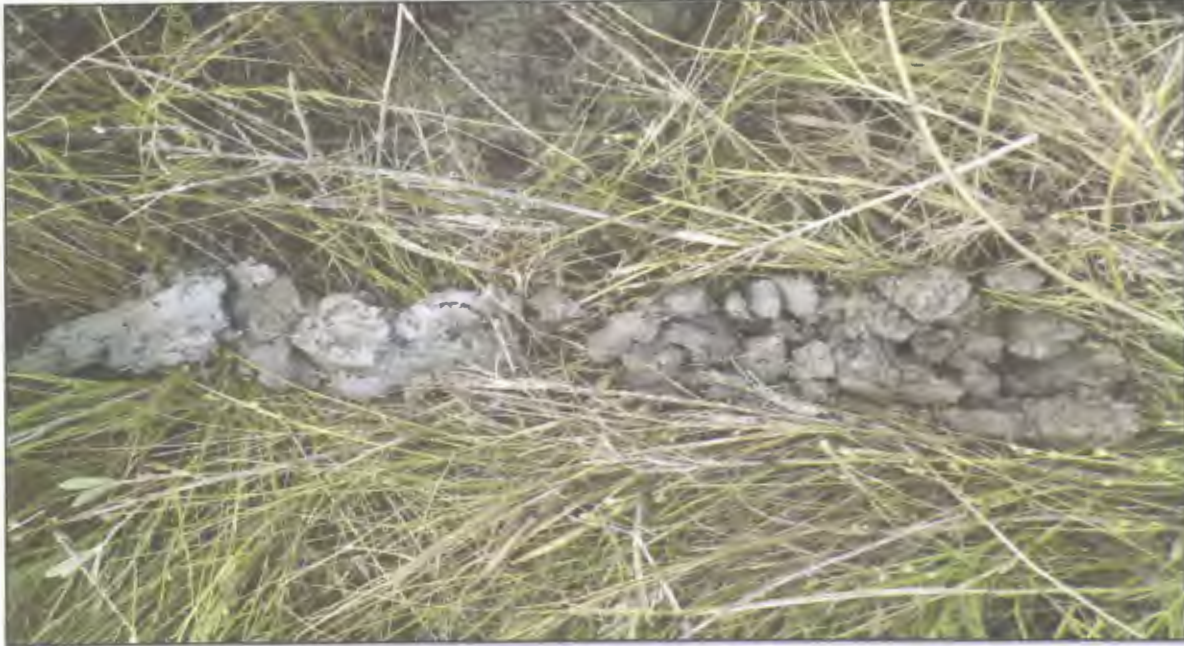
Photo 7. Soil pit T2 SP04, located in emergent wetlands.

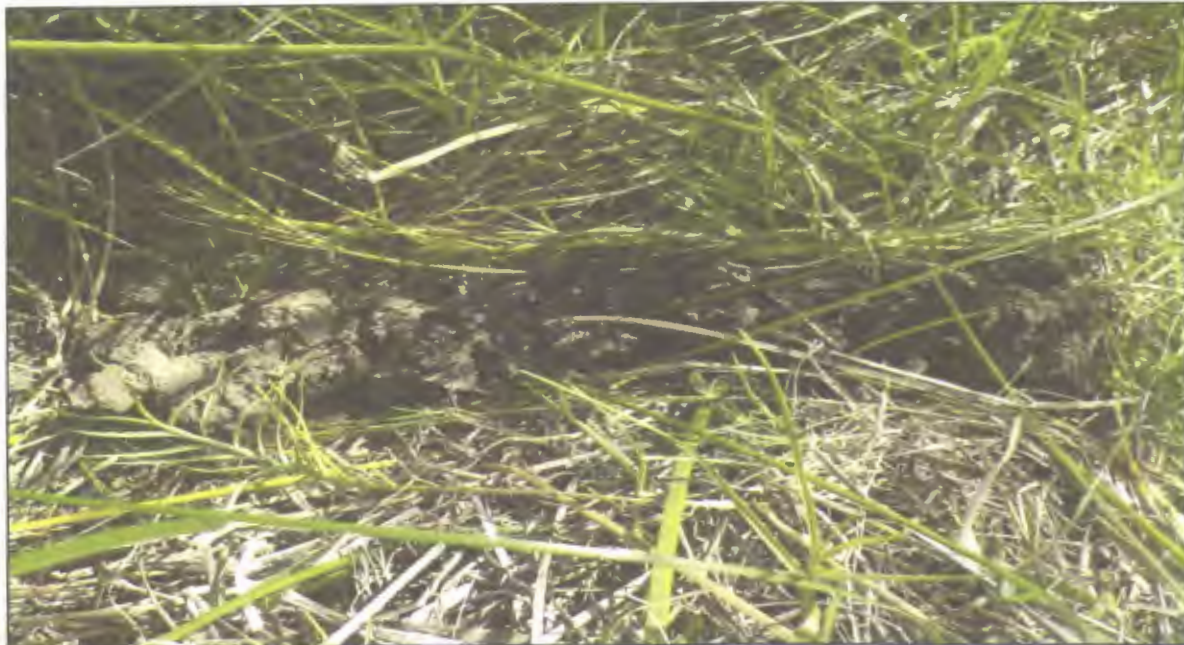
Photo 8. Soil pit T3 SP01, located in palustrine emergent wetlands.

Wetland Vegetation Community C was approximately 0.33-acres in size, contained a palustrine emergent wetland (Wetland 2), and was represented by T3 SP01 and T3 SP02. Wetland 2 contains persistent wetland vegetation and is seasonally flooded due to low topography. Herbaceous vegetation within this vegetation community was dominated by broad-leaf cattail, three-square, gulf dune crown grass, and salt-meadow cord grass. Non-dominant species included of bushy bluestem, poison-bean, narrow leaf carpet grass, and coastal marsh pennywort. Primary wetland hydrology indicators observed within this vegetation community included High Water Table (A2) and Saturation (A3). Secondary wetland hydrology indicators observed within this vegetation community included Saturation Visible on Aerial Imagery (C9) and Geomorphic Position (D2). Sample point T3 SP02 provides an accurate representation of the soils observed within Wetland Vegetation Community C. From 0 to 2 inches, soils were loam in texture and had a matrix color of 10 YR 3/2 at 100% with no redoximorphic concentrations observed. From 2 to 4 inches, soils were sands in texture and had a soil matrix color of 10 YR 4/2 with 2% 10 YR 4/6 redox concentrations observed in the matrix. From 4 to 18 inches, soils were sand in texture and had a soil matrix color of 10 YR 5/2 with 5% 10 YR 6/6 redox concentrations observed in the matrix. Soils present at T3 SP02 met the criteria of hydric soil indicator Sandy Redox (S5). Soils present at T3 SP01 were assumed to be hydric based on all dominant species having a wetland indicator status of OBL or FACW and the presence of an abrupt wetland boundary, consistent with the 1987 manual. Based on the dominance of hydrophytic vegetation, the presence of wetland hydrology, and the presence of hydric soils, the sample points located within this vegetation community were determined to be located within wetlands.

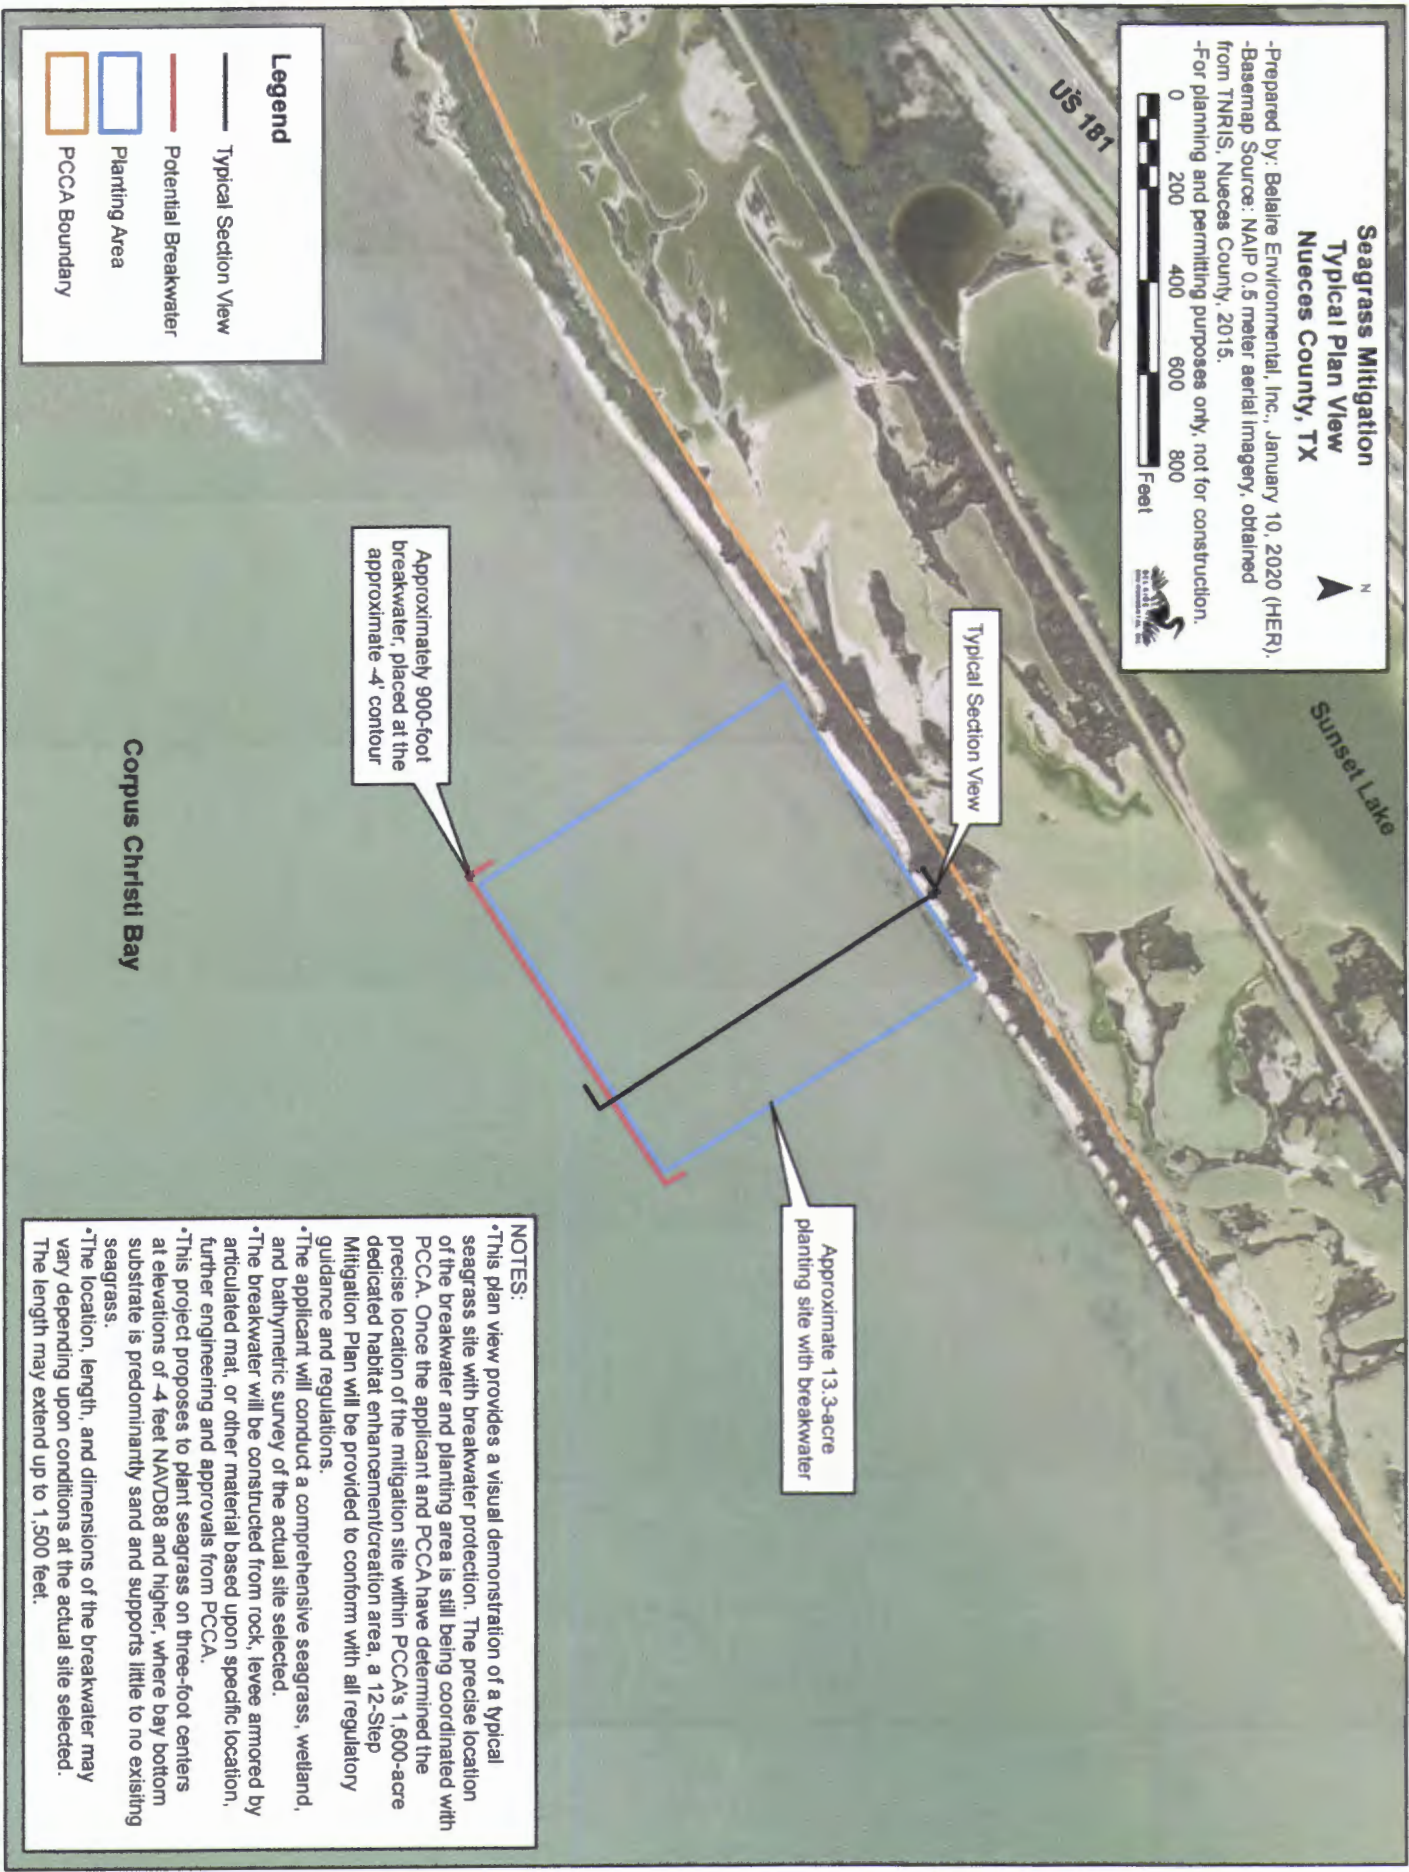
Approximately 900-foot breakwater, placed at the approximate -4' contour

- Cross section represents typical cross section for seagrass planting adjacent to breakwater and will be refined when a precise location is determined.
- Seagrass will be planted where bay bottom substrate is predominately sand with little to no existing seagrass.
- 13.3-acre site will be planted on three-foot centers from approximately -4.0 to 0.0 feet NAVD 88. Planting elevations will be refined based upon specific location and/or nearby reference bed.
- Breakwater height represented is typical but will be refined based upon specific location and further engineering analysis.
- Breakwater to be constructed from rock, levee armored by articulated mat, or other material based upon specific location, further engineering and approvals from PCCA.
- Prepared by Belaire Environmental, Inc. on January 10, 2020 (JAM).
