## Gulf State Park Master Plan and Phase 1 Methods

This investigation was conducted as part of the Landscape Architecture Foundation's 2022 *Case Study Investigation (CSI)* program. CSI matches faculty-student research teams with design practitioners to document the benefits of exemplary high-performing landscape projects. Teams develop methods to quantify environmental, social, and economic benefits and produce Case Study Briefs for LAF's *Landscape Performance Series*.

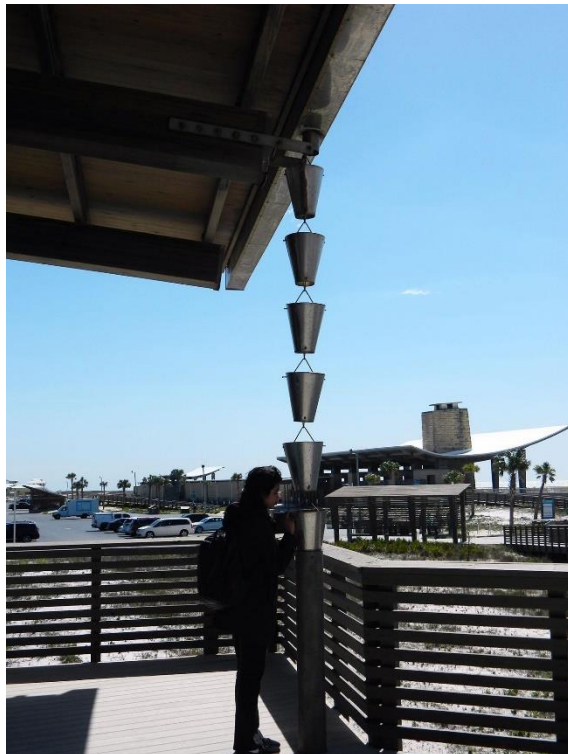
Figure 5. Decorative rain chains help direct rainwater into the cistern (LeBleu, 2022).

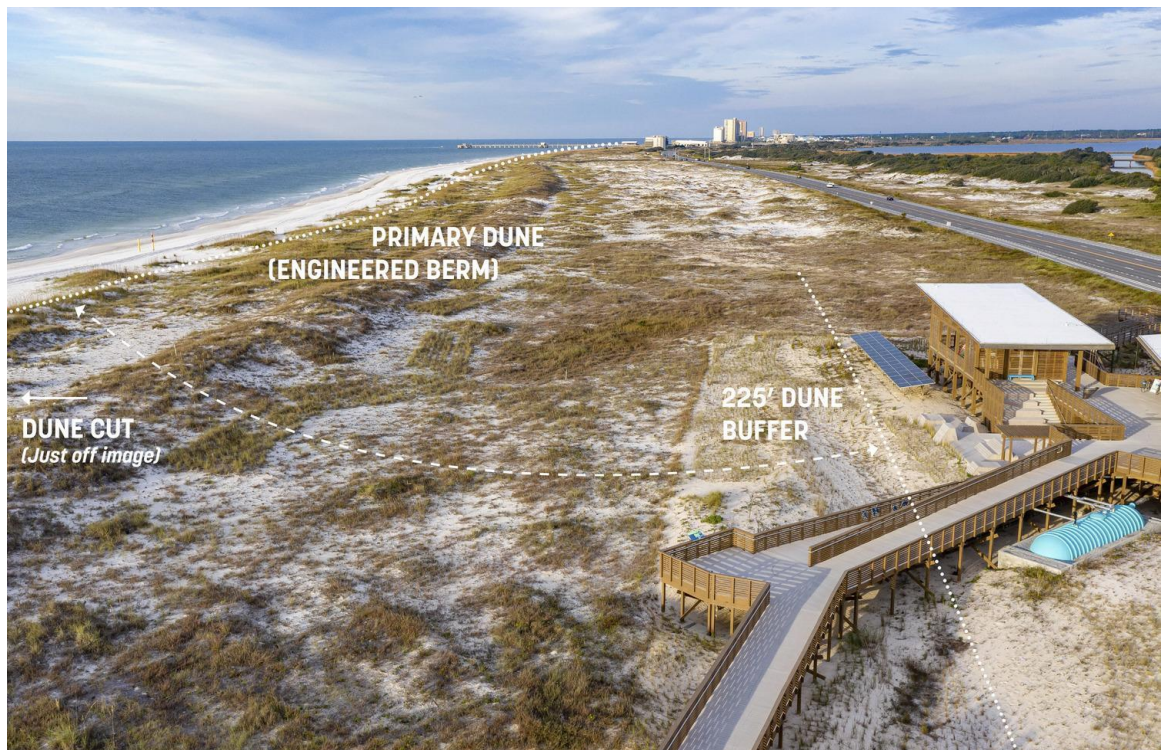
Figure 10. Dune buffer and restoration improves resilience (Sasaki, 2018).

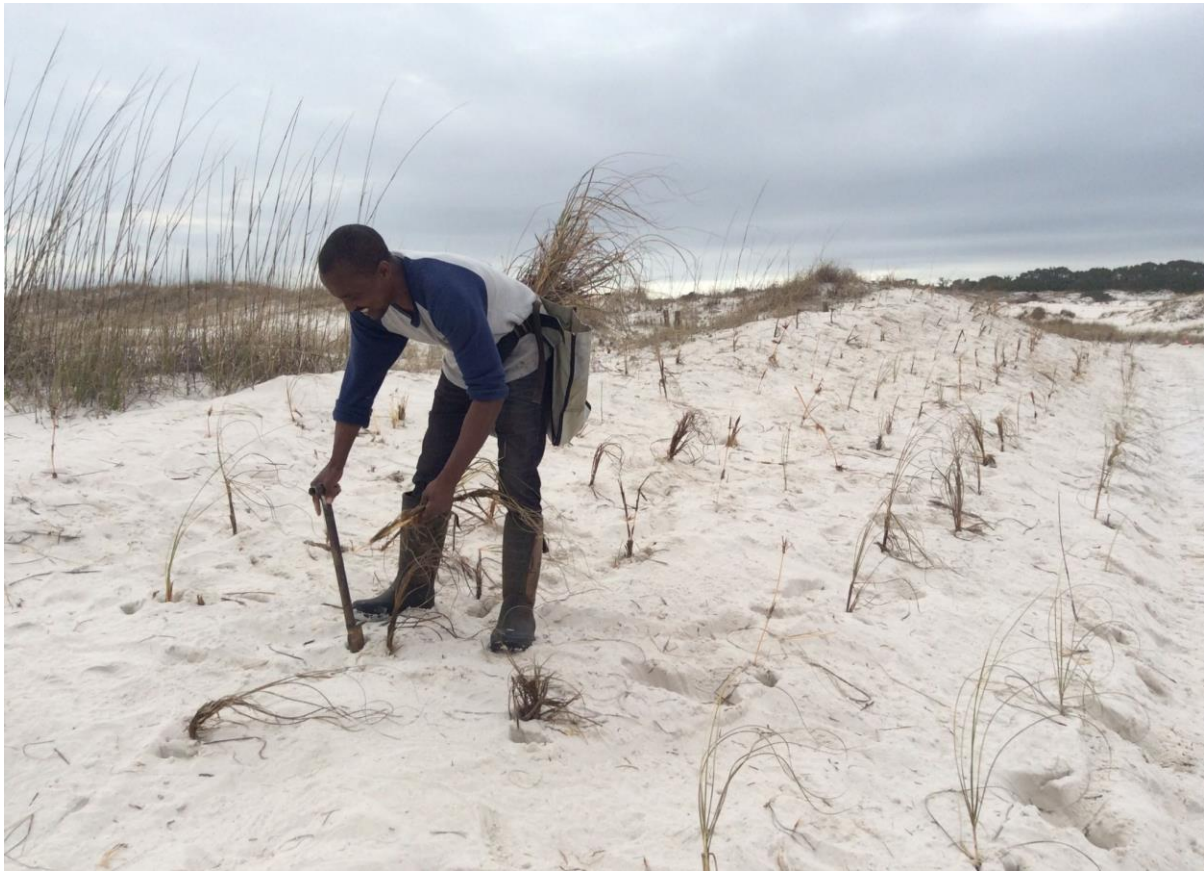
Figure 11. Planting sea oats and salt grass for dune stabilization and habitat (Sasaki, 2016).

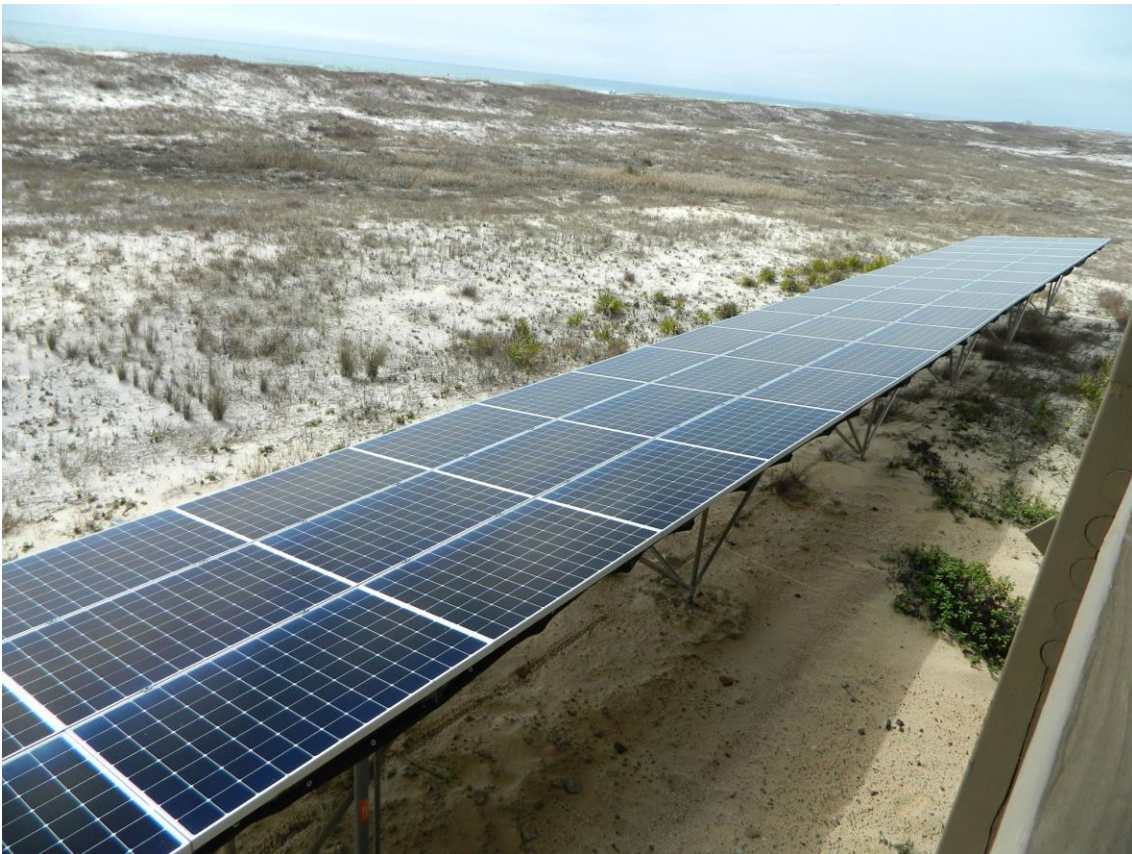
Figure 18. Solar panels are used to power the Interpretive Center (LeBleu, 2022).

The Interpretive Center at GSP is a gateway to the park and introduces visitors to the environment. The Center was designed for net-positive energy, water, and carbon. The 7,500-sf (696.8 sqm) facility is located at the GSP Beach Pavilion and produces its electricity using a 1.48-kW solar array (51 solar panels) installed upon the Center’s completion in 2018 (Figure 18). Solar system production, weather, carbon dioxide emissions avoided, and consumption are continuously monitored online using apps SolarEdge and Green Hub (Figure 19).

A kiosk on the exterior of the Center shows how the building uses electricity and water in real-time. On an average day, the system generates 68 kWh of electricity, more than enough to meet the 52 kWh used on a typical day. During a power outage, the Center’s two batteries can keep things running for up to a week. The Center is LEED Platinum-certified and received the FORTIFIED commercial certification. The Center also needs to generate more energy than it needs to meet the *Living Building Challenge* energy petal criteria.

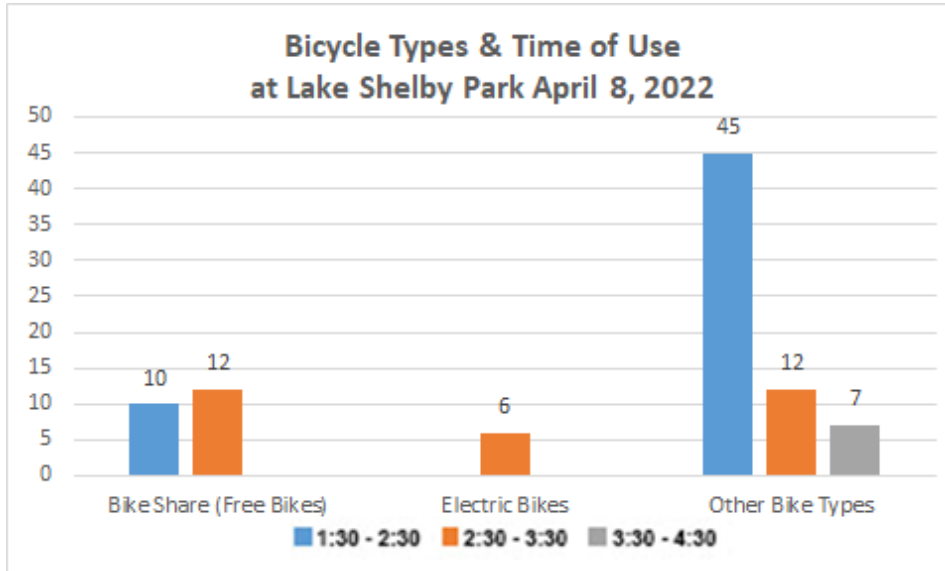
Figure 33. Bicycle Types and Time of Use at Lake Shelby Park April 8, 2022 (LeBleu, 2022).

Most of the bicycles observed were *other bike types* (64), with most of these seen between 1:30 pm to 2:30 pm. 22 GSP Bike Share Program (free) bikes were observed from 1:30 pm to 3:30

pm. An additional six electric bikes were observed between 2:30 and 3:30 pm (Figure 33).

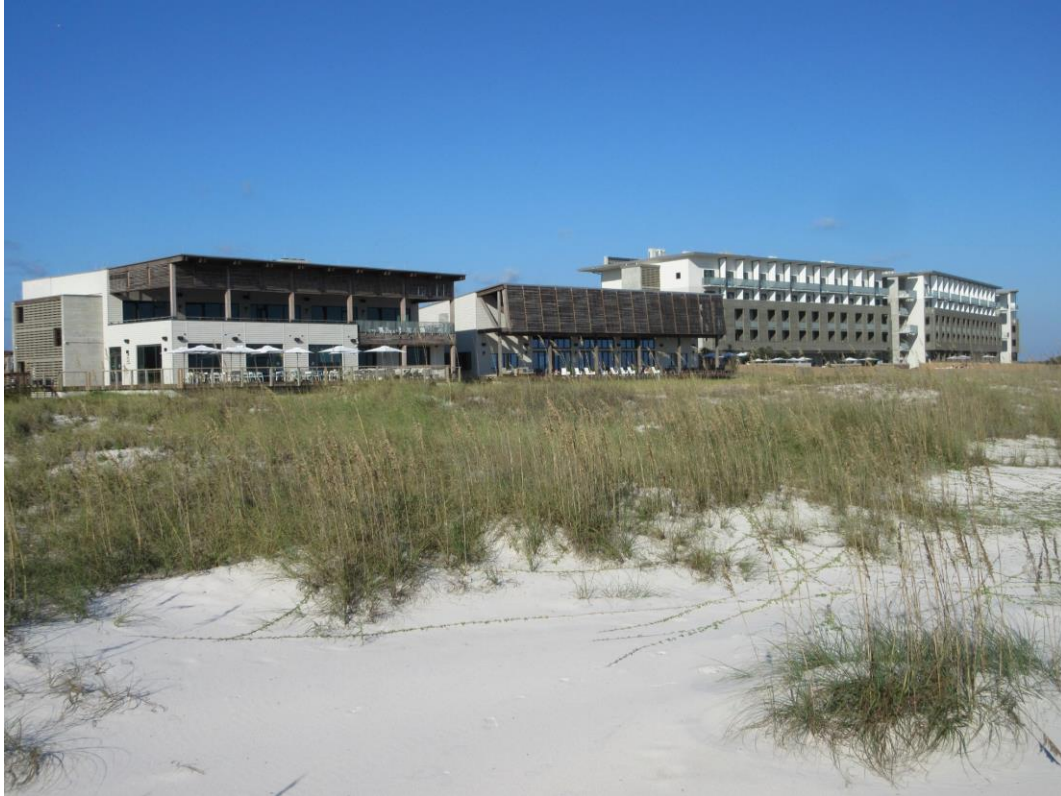
Figure 35. The Gulf Shores State Park Lodge was built with a FORTIFIED roof (Sasaki, 2018).

The FORTIFIED design required more fasteners, more adhesive, and more labor. On top of the increased safety factor, the roof was subject to at least two inspections by certification engineers that flew in from Miami (Figure 35).
