Report to EURISOL

Investigations of the Party Wall Thermal Bypass in Timber Frame Dwellings

Final Report

June 2010

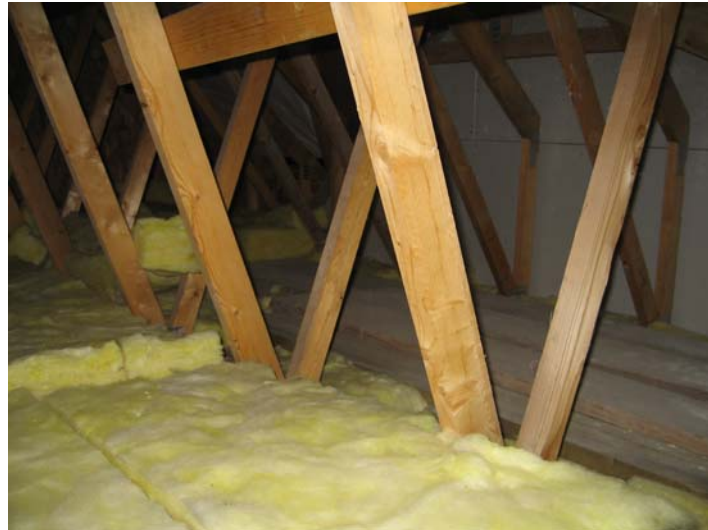
Figure 6 – Loft in House No.15 as Found

8 Prior to commencement of testing, the dwellings were surveyed for any construction issues that might affect the testing processes and also to check consistency with the as-built design drawings. The first issue identified was the condition of the loft insulation. There were found to be large areas of missing loft insulation, especially adjacent to the party wall as illustrated by the photographs of the loft in House No.15 (Figure 6) and in House No.16 (Figure 7). The presence of boarding in the loft indicates that the insulation was left out to enable work to take place on the party wall, but was not put back later. The developer was asked to remove the boarding and replace the loft insulation.

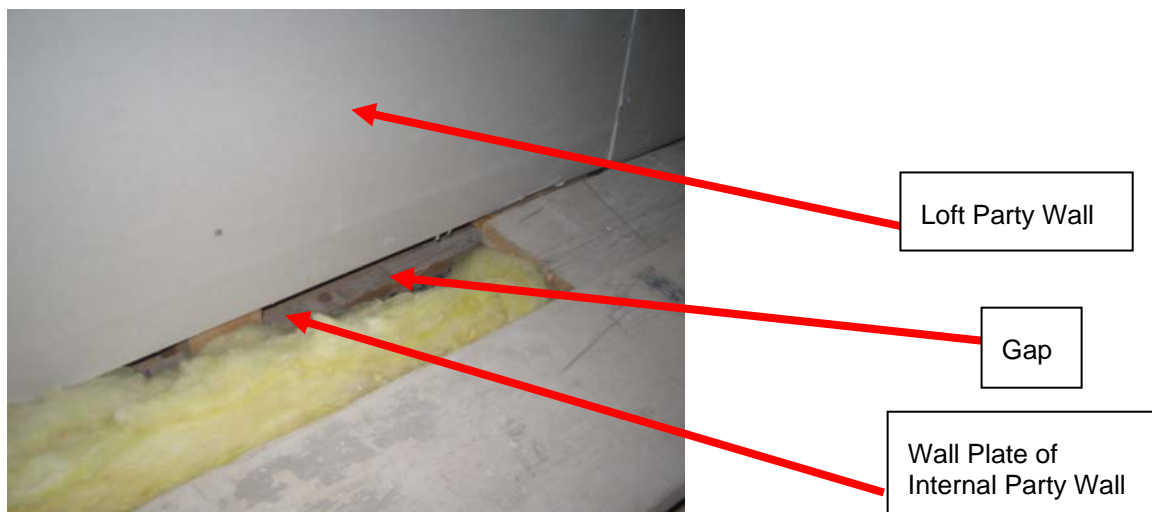
Figure 8 – Gap between Top of Internal Party Wall and Party Wall in Loft

- 9 A gap was observed between the wall plate at the top on the internal party wall and the loft party wall. This gap continued across the whole width of the party wall on both sides. The drawings for the junction in both E-WT-1 and E-WT-2 Robust Details show the party wall as being continuous up to the roof line with no gap (see Figure 9). It was not possible to do anything to change this detail in the two test dwellings, so the gap remained as found for the duration of the testing.

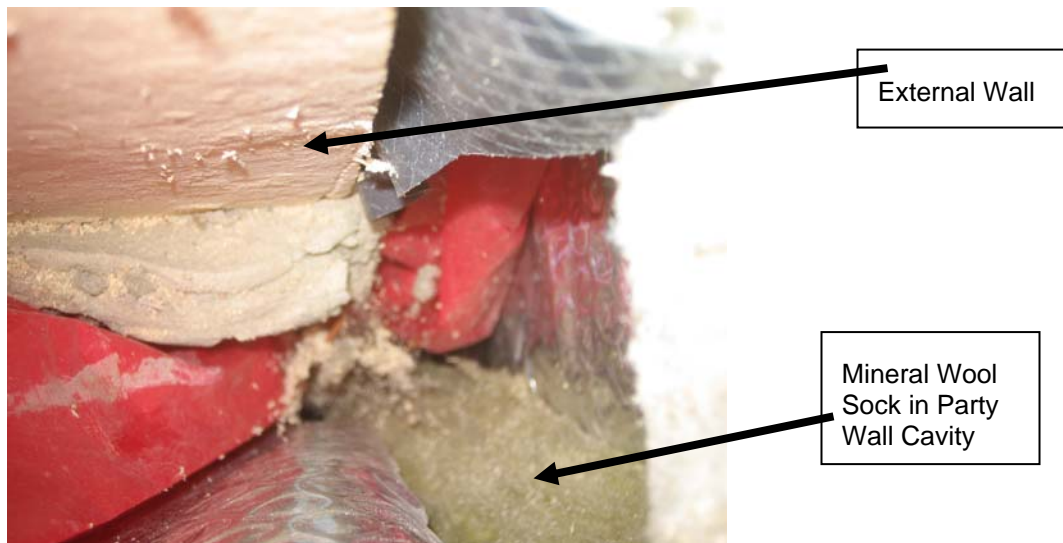
Figure 11 – Junction between External Wall and Party Wall Cavity (Viewed from Above)

- 11 In addition to the vertical cavity socks in the external walls, it was found that a mineral wool batt had been inserted part way into both vertical edges of the party wall cavity (see Figure 11).

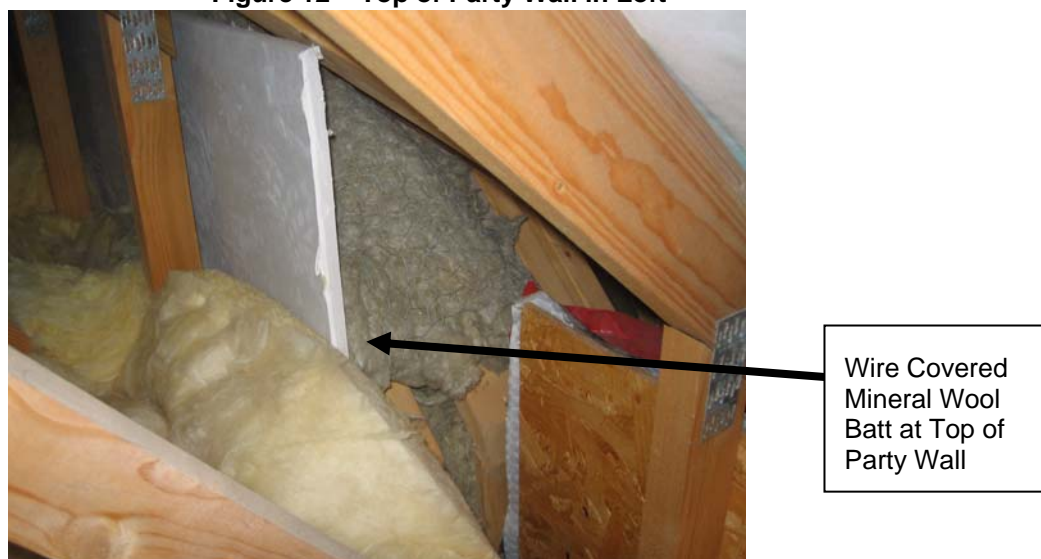
Figure 12 – Top of Party Wall in Loft

- 12 The top of the party wall in the loft at the junction with the roof had been fitted with a mineral wool batt restrained in a wire mesh, as shown in Figure 12. The same wire mesh/mineral wool batt had also been used in the inner cavity of the party wall in the loft, although this does not appear to be a requirement of Robust Details.

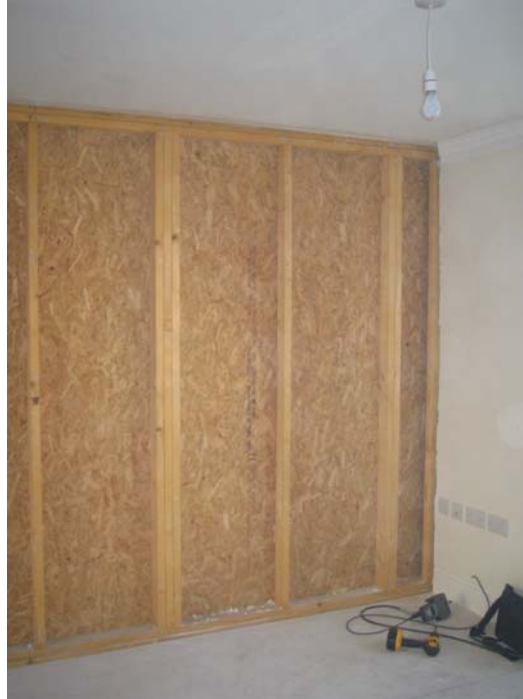
Figure 13 – Exposed OSB Sheathing and Timber Studwork in Party Wall (Living Room No.16)

- 15 The party wall was filled by a CIGA approved contractor using blown Knauf Supafil 40 glass fibre insulation. In order to access the inner layer of OSB sheathing, the plasterboard and insulation batts were first removed from one side of the party wall. This was done from House No.16 as there was only one partition wall and one radiator on that side of the party wall. It was interesting to note that, on the ground floor, the 90mm cavity between the plasterboard and OSB sheathing was fully filled using 100mm glass fibre quilt. By contrast, on the first floor, the 90mm cavity was only partially filled using ~50mm glass fibre batts. A photograph showing the exposed sheathing layer and studwork in the party wall in the living room of No.16 is illustrated in Figure 13.

- 16 Measurements taken of the width of the cavity between the two OSB sheathing layers showed that the depth was quite variable, ranging from a low around 35 mm towards the middle of the party wall and increasing to a high of around 80 mm towards the edges of the party wall. This compares to a minimum requirement in Robust Detail E-WT-2 of 50 mm between the inner faces of the sheathing. The nominal cavity width according to the design drawings is 66 mm.

- 17 Deconstruction of the facing of the party wall showed that it comprised of two layers of plasterboard, the inner board being of 19 mm thickness and the outer board being of 12.5 mm thickness, giving a total of 31.5 mm. The plasterboard had no foil facing. The inner layer of OSB sheathing was 9 mm thick.

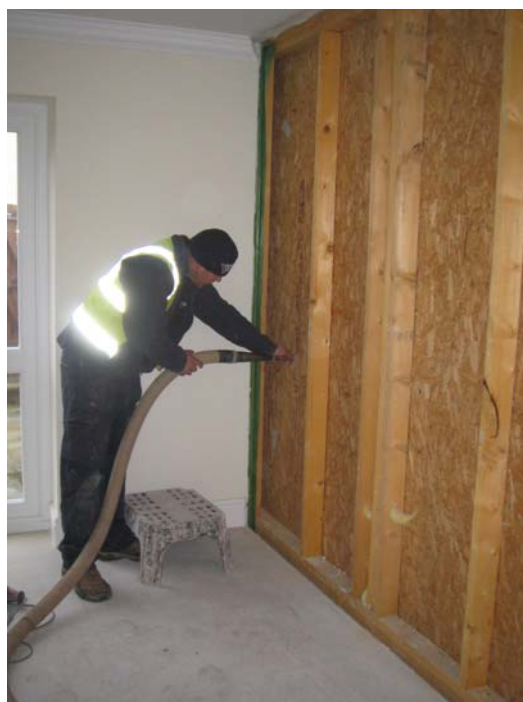
Figure 14 – Cavity Wall Technician Filling Party Wall at Darlington

- 18 Filling of the party wall cavity was achieved by drilling holes through the OSB. The pattern of the holes was set initially at a spacing that would be normal for a conventional masonry wall. However, the installation technicians had difficulty maintaining consistent flow. They believed that this was partly due to the variable cavity depth and possibly due to the difference in wall friction of the OSB compared to masonry. To alleviate this problem the technicians drilled additional holes and also adjusted the insulation injection settings. The fill density was nominally set at 20 kg/m^3 for the initial settings. The installers used $2 \frac{1}{2}$ bags of insulation, with each bag containing 17.6 kg , giving a total of 44 kg of insulation. The area of the party wall is 25.8 m^2 , plus approximately 5 m^2 for the area due to the terrace step, giving a total fill area of 30.8 m^2 . With a nominal 50 mm cavity width, the volume of the party wall cavity filled with insulation would be 1.54 m^3 . So the mean fill density based on these data is $44/1.54 = 28.6 \text{ kg/m}^3$. This assumes that the estimate of the number of bags of insulation used is correct and also that there was no loss of insulation to the sides of the cavity. A photograph of the technician filling the party wall cavity is shown in Figure 14.

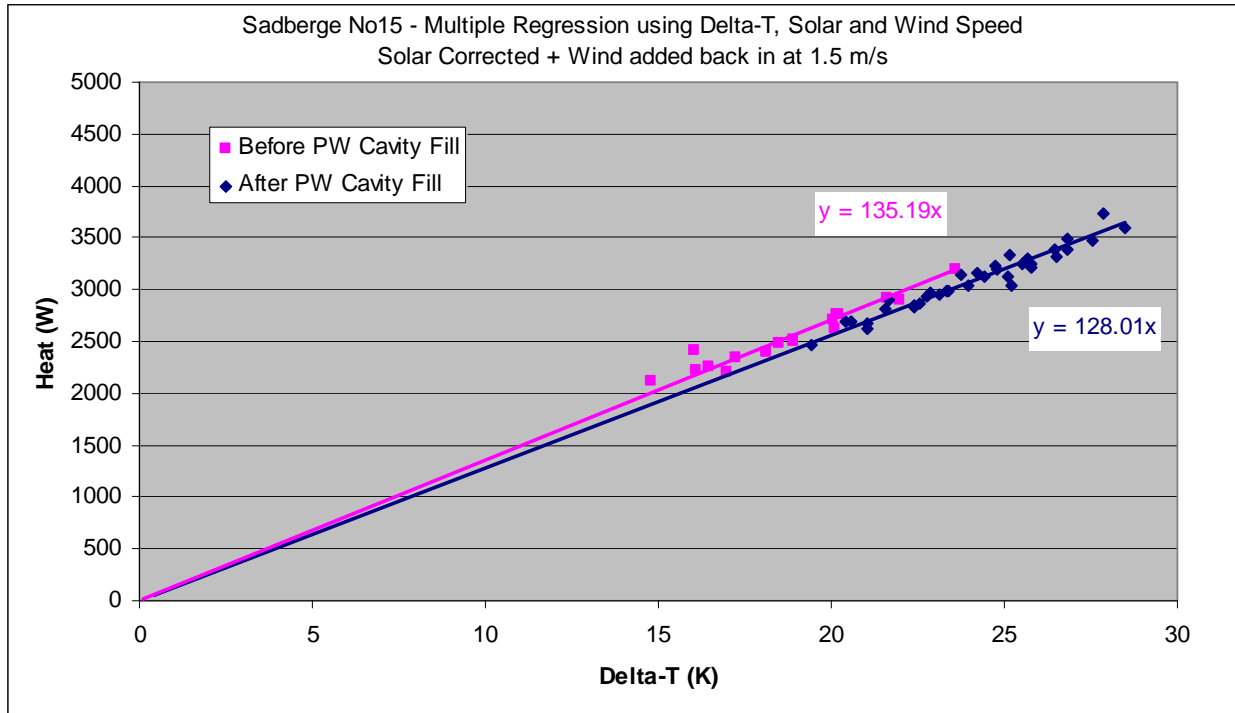
Figure 18 – Heat Loss Curves before and after Filling – House No.15 – Wind Corrected Data

27 The coheating test data show that wind speed has a small effect on heat loss. Example data that show increased heat loss at high wind speed are highlighted by the red circle shown on the heat loss graph in. In order to allow for this wind effect, a second multiple regression analysis was carried on the data from both test houses with delta-T, solar insolation and wind speed as the three independent regression terms, with heat as the dependent term and with the fitted curve forced through the origin. The resultant regression coefficients are given in Table 19. In order to normalise the heat loss data for wind speed it is necessary to correct the delta-T variable to a standard wind speed for the data both before and after filling the party wall cavity. The mean wind speed over the whole test period was 1.5 m/s, so all data were corrected using the appropriate wind regression coefficient for a wind speed of 1.5 m/s. The heat loss curves using the data normalised for wind speed at 1.5 m/s are shown in Figure 18 and Figure 19. A summary of the heat loss coefficients derived from these data are shown Table 20. The magnitude of the party wall bypass U-value was recalculated using the wind normalised data as shown in Table 21. Using the data the effective U-value for the party wall thermal bypass is 0.42 W/m²K for House No.16 and 0.40 W/m²K for House No15.

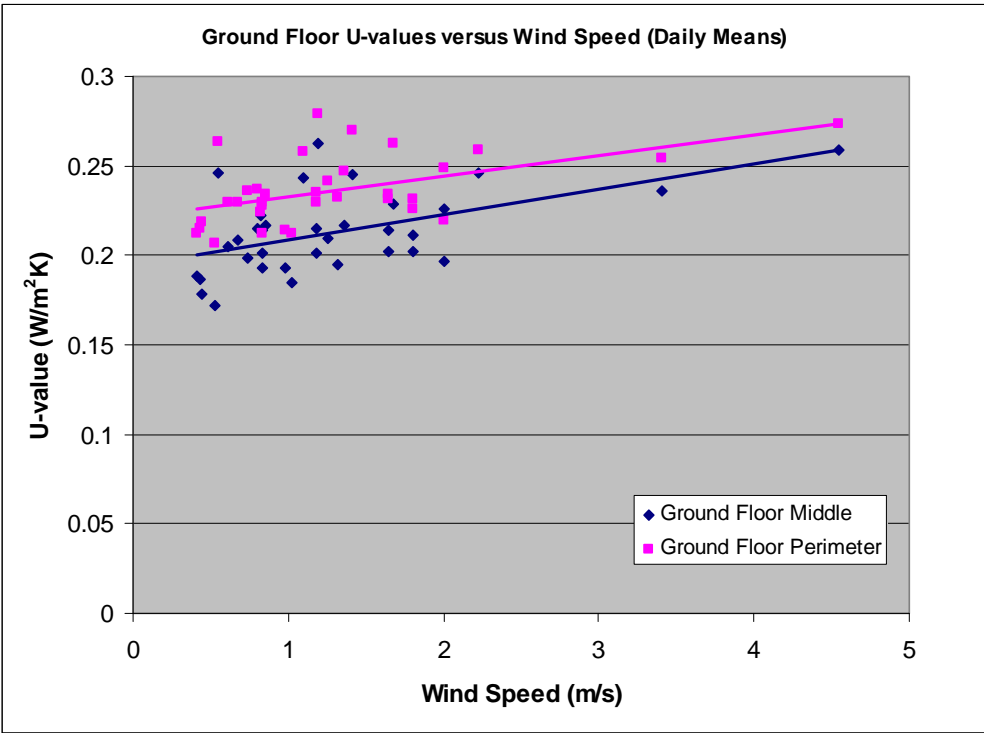
Figure 25 – Darlington: Measured Ground Floor U-values versus Wind Speed

35 A summary of measured U-values obtained from the heat flux sensors on other elements (ground floor, ceiling and glazing) are given in Table 23. It can be seen that, like the external wall, the measured U-values are in general agreement with the nominal design data. A small dependency of the U-value on external wind speed was noted for the floor and ceiling U-values. The can be seen in the plots shown in Figure 25 and Figure 26.

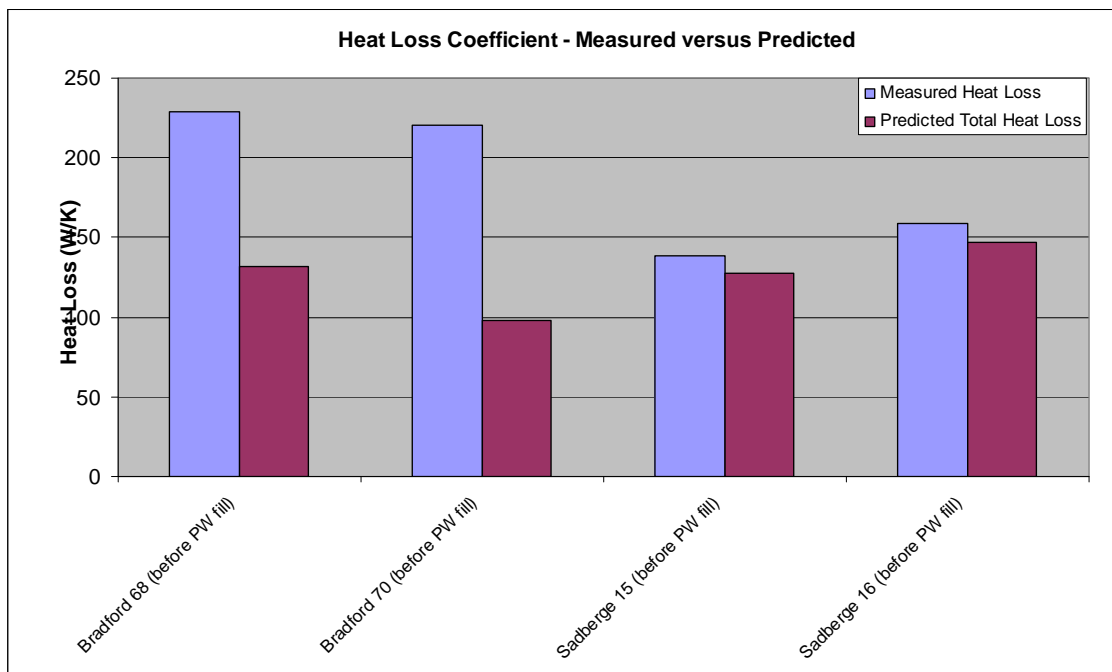
Figure 32 – Eurisol Test Houses: Measured & Predicted Whole House Heat Loss

- 40 A comparison of the calculated and measured heat loss coefficients before and after filling the party walls in both the timber frame Darlington test houses and the masonry test houses at Bradford is shown by the graph in Figure 32. The graph highlights the relatively poor performance of the Bradford houses compared to the Darlington houses. This is in part due to the large party walls in the Bradford houses combined with a high effective party wall U-value.

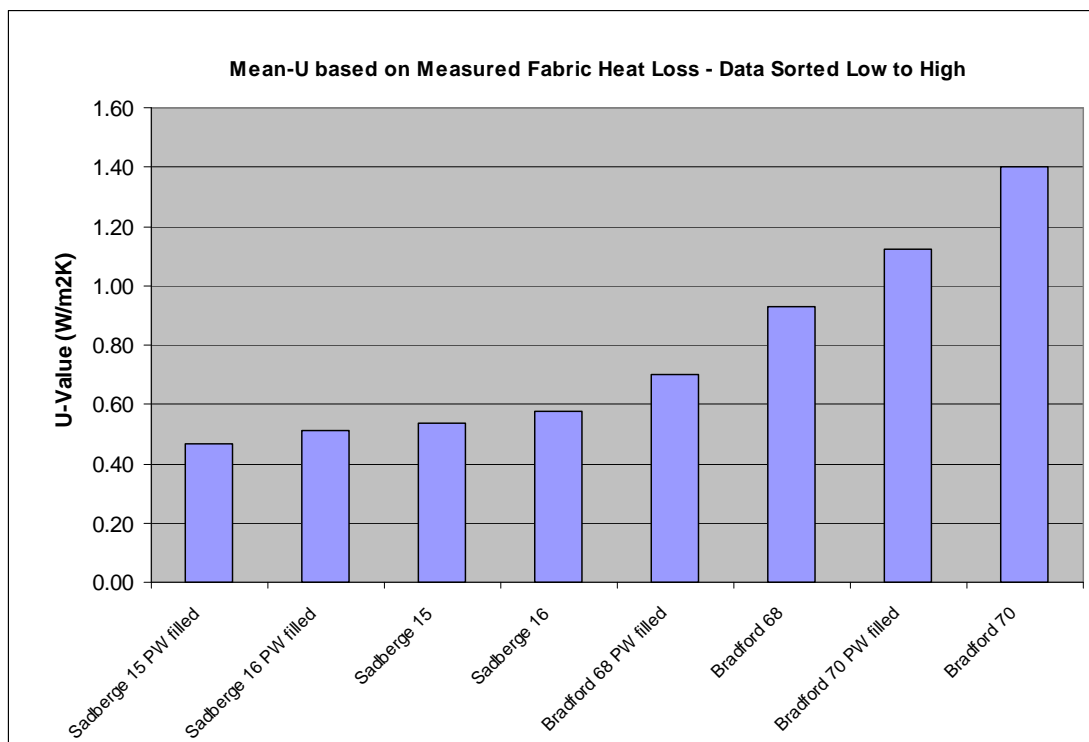
Figure 33 – Measured Mean Fabric U-values: Data Sorted Low to High

- 41 Another way to compare the performance of the test houses is to derive a mean U-value for fabric heat loss. This is calculated from the difference between the measured whole house heat loss coefficient and the ventilation heat loss (derived from air permeability) divided by the exposed area (excluding party walls). The advantage of comparing fabric U-values is that it excludes the effect of changes in ventilation loss due to the testing, and normalises the data. Fabric U-values are given in

Table 25 and also shown in Figure 33 with the data sorted from lowest to highest. The house with the lowest mean U-value (0.47 W/m²K) was Darlington No.15 after filling the party wall, compared to the highest U-value (1.4 W/m²K) for the mid terrace at Bradford.
