**WETLAND FUNCTIONAL ASSESSMENT
OF THE GRAMCKOW
PROPERTY PROJECT,
RANCHO MATILJA, CALIFORNIA
(COUNTY OF VENTURA PROJECT: ZO 04-0000008)**

**Wetland Functional Assessment of the
Gramckow Property Project,
Rancho Matilija, California**
(County of Ventura Project: ZO 04-0000008)

14 July 2006

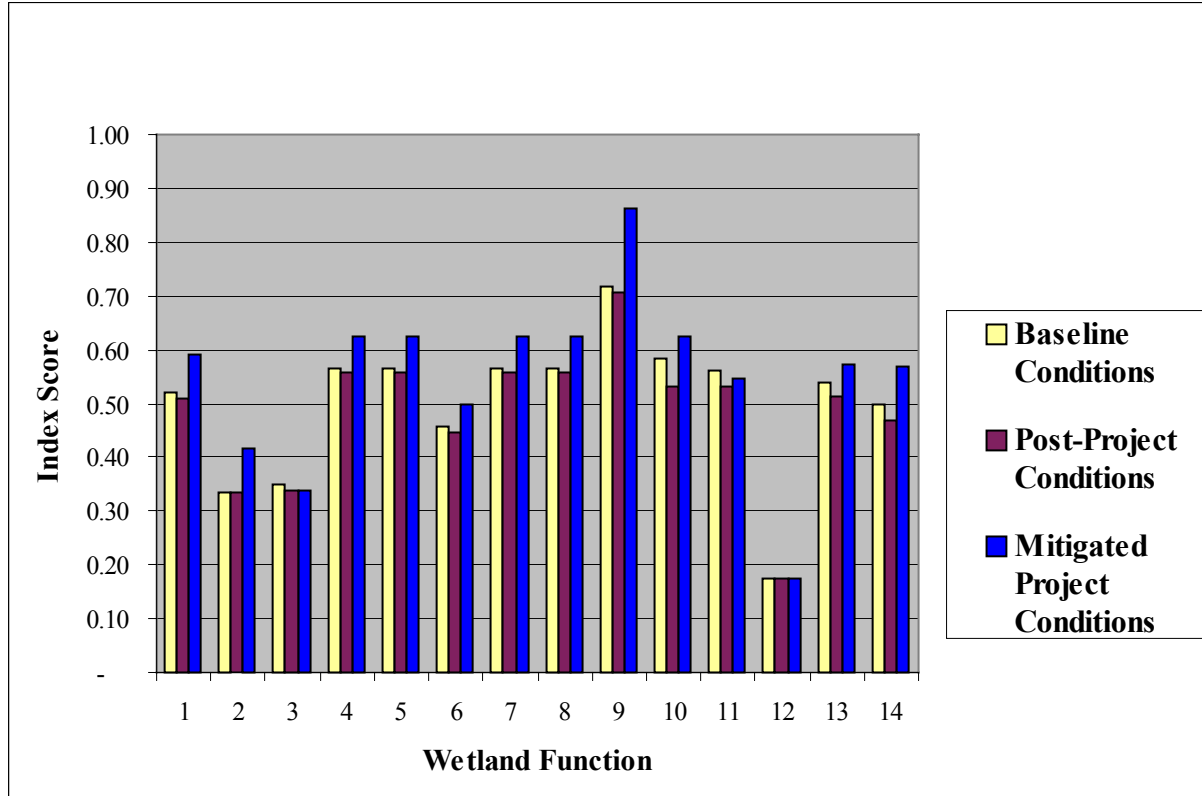
Figure 6a. West Tributary of Live Oak Creek – Change Comparison Chart of Wetland Functions between Pre-, Post-, and Mitigated-Project Conditions

This section discusses and compares the three parts of the HGM assessment; the baseline (pre-project), the post-project, and the mitigated-project. Tables 10 a & b, Comparison of Pre-, Post-, and Mitigated-Project Wetland Function Index Scores, display the results of the three assessments side-by-side so that comparisons can be made. Figures 6 a & b, Change Comparison Chart of Wetland Functions Between Pre-, Post-, and Mitigated-Project Conditions, are intended as companions to Tables 10 a & b, and graphically illustrate the wetland function index scores for baseline (existing) conditions and compare them to projected post-project and mitigated-project index scores. These figures illustrate the differences between the three scenarios.

The proposed project is expected to have no effect on the surface and subsurface water storage and exchange capabilities on either tributary, with the index score remaining unchanged at 0.33 for the west tributary and 0.28 for the east tributary. due to the poor condition of the buffer zone under existing conditions. (See Table 10 and Figure 6.) There would be *no impact* to this function.
