# Clearing Assessment Report – CPS 818

## **Broome-Cape Leveque Road Upgrade**

SLK 0-13

December 2020

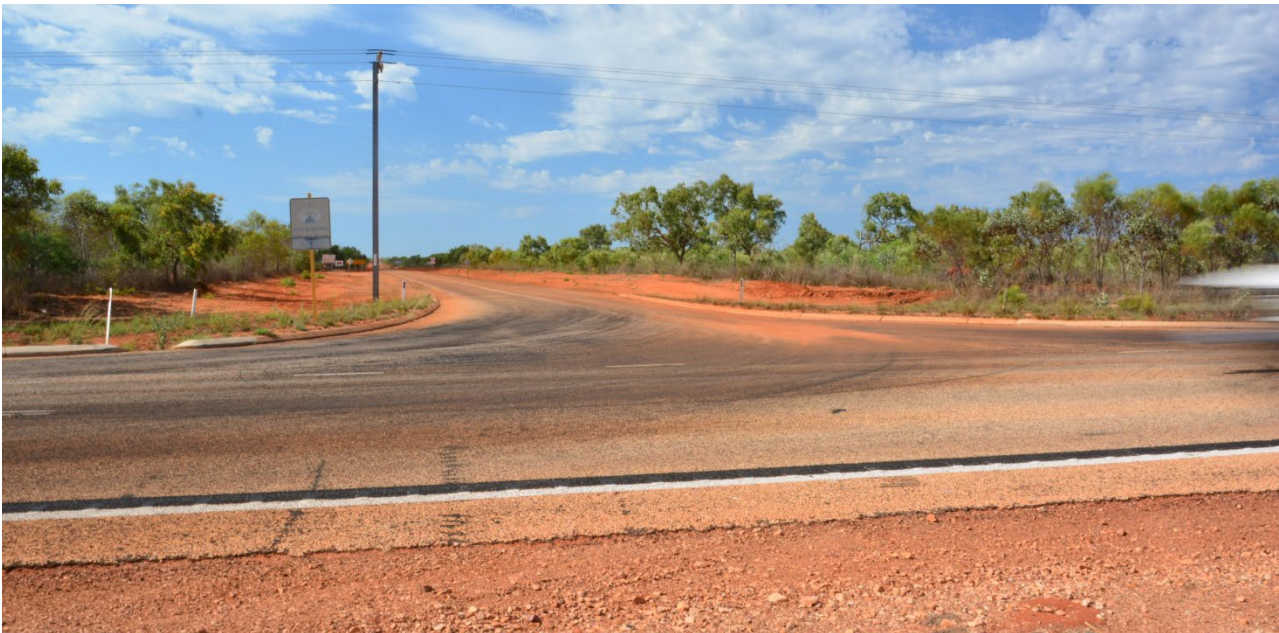
**Plate 1: Existing Intersection of the Broome-Cape Leveque Road with Broome Highway**

Road and reconstruction and sealing of SLK 0 to 13 to improve road safety. Plate 1 and Plate 2 show the existing road between SLK 0 to 13 and is the focus of this assessment.

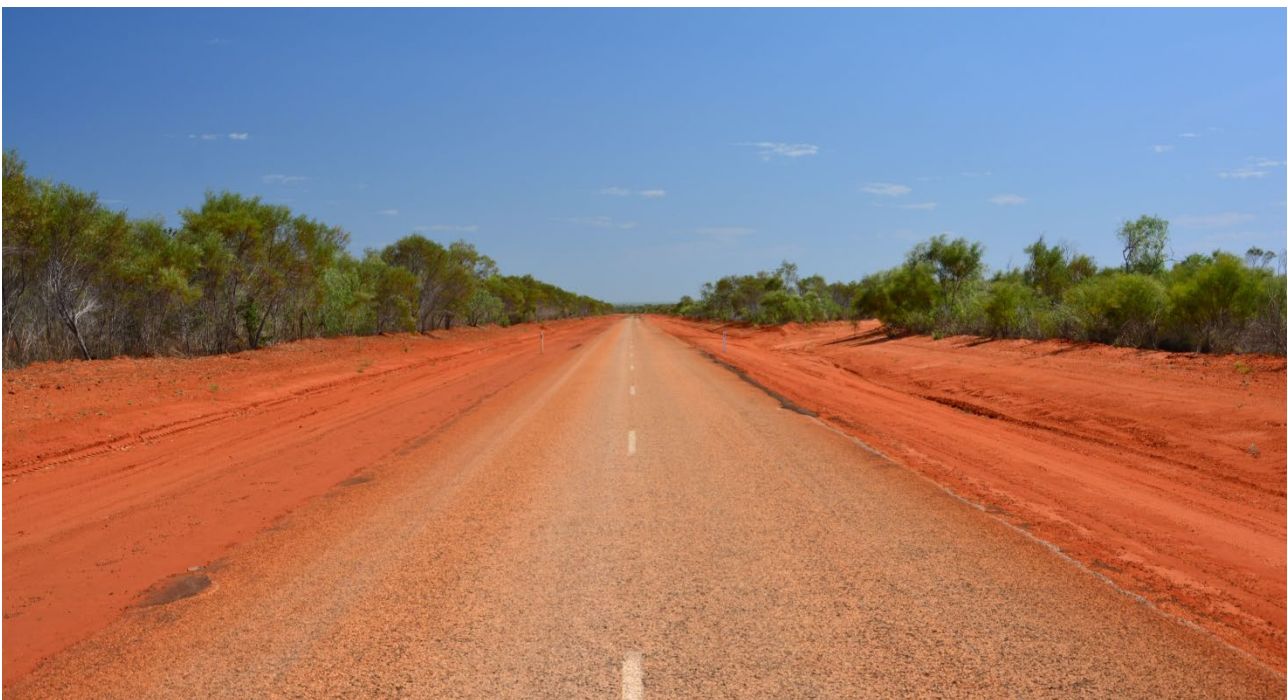
**Plate 2: Typical view of sealed section between SLK 0 and 13**

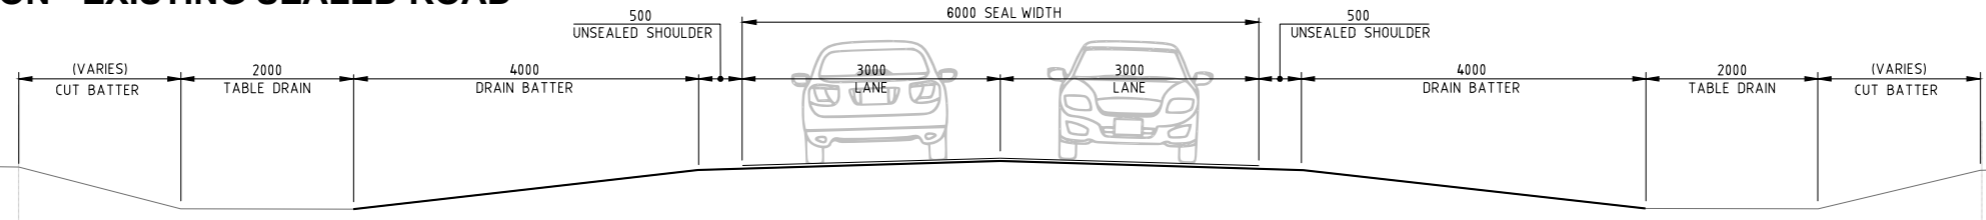
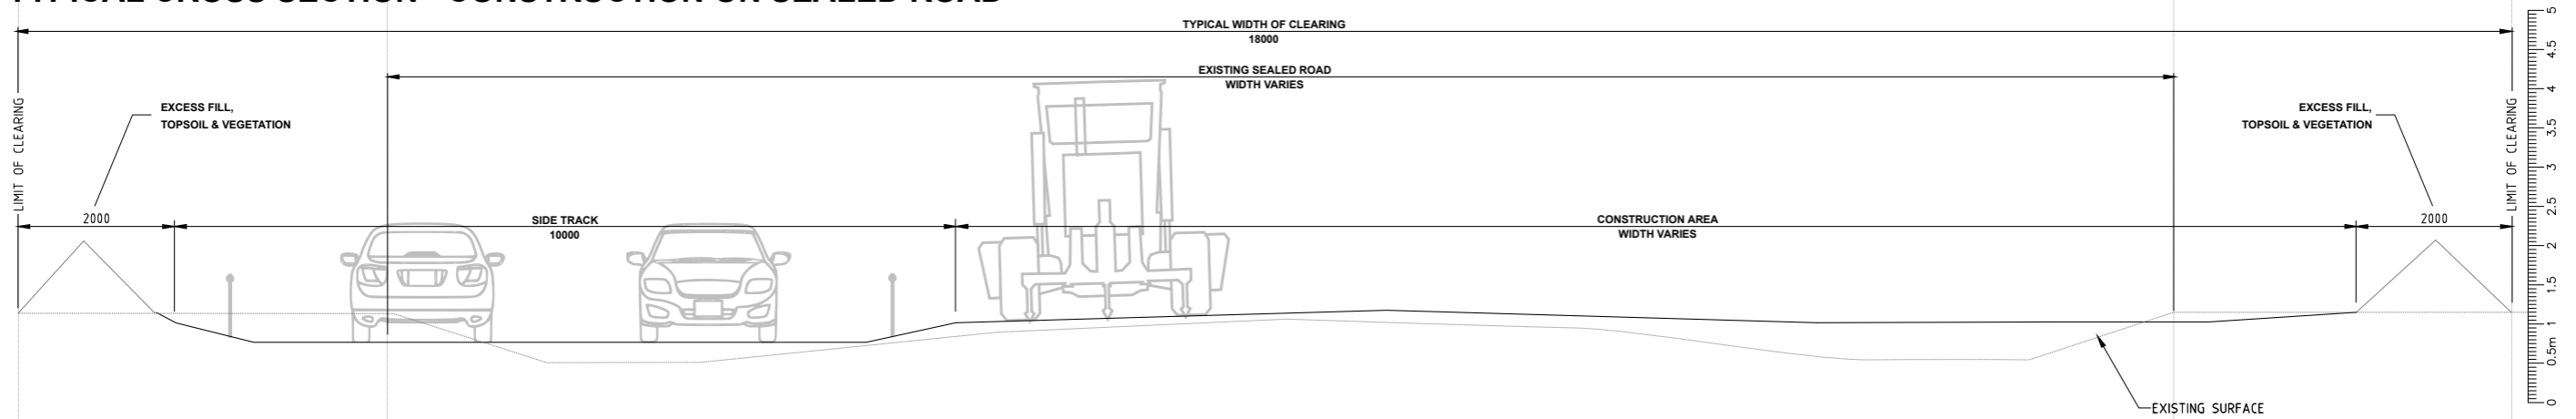
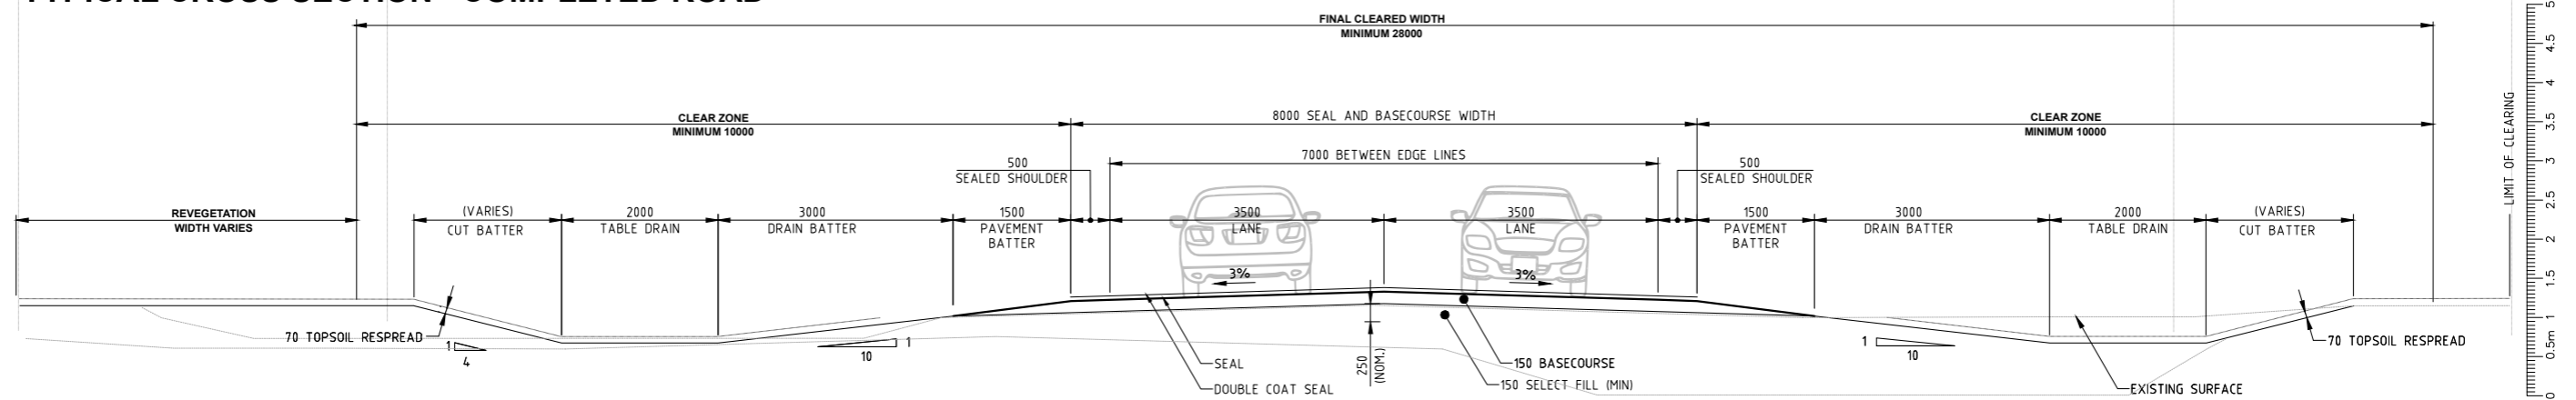
## TYPICAL CROSS SECTION - EXISTING SEALED ROAD

## TYPICAL CROSS SECTION - CONSTRUCTION ON SEALED ROAD

## TYPICAL CROSS SECTION - COMPLETED ROAD

Figure 4. Typical Cross Sections at various construction phases

There is no alternative to avoid clearing, as the shoulder of the existing road must be widened for safety requirements of road users. This requires the drains to be offset to ensure a reduced chance of damage to the road during the wet seasons.

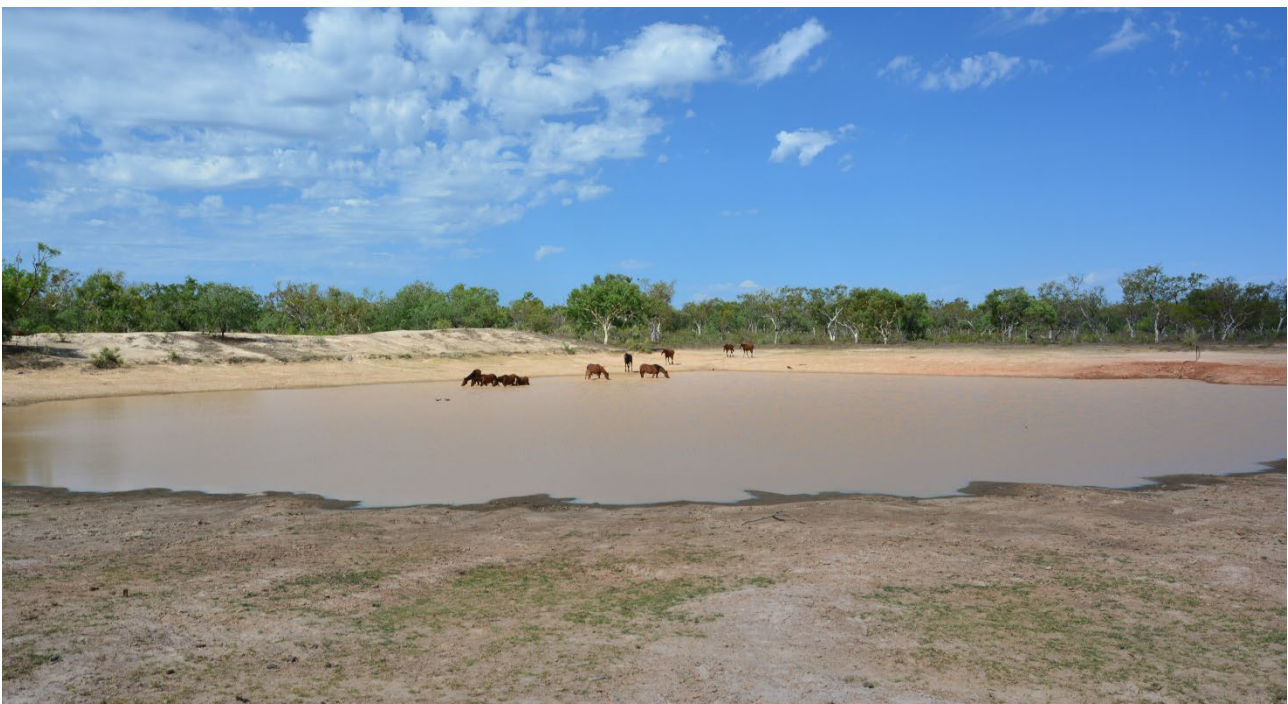
**Plate 3: Man-made earth dam (Nimalaragan Dam) located at SLK 11.7**

A man-made dam is located at SLK 11.7. The dam is clay lined with relatively stable water levels indicating it is at least partially groundwater replenished particularly when considering the shallow water table known to be present in the area surrounding this dam from monitoring records on the DWER Water Information Reporting Tool (DWER 2021). The dam, whilst man-made, also provides fauna habitat. For these reasons, the man-made dam has been excluded from the clearing boundary and will not be utilised or impacted by the proposed activities. Plate 3 shows the man-made dam at SLK 11.7.

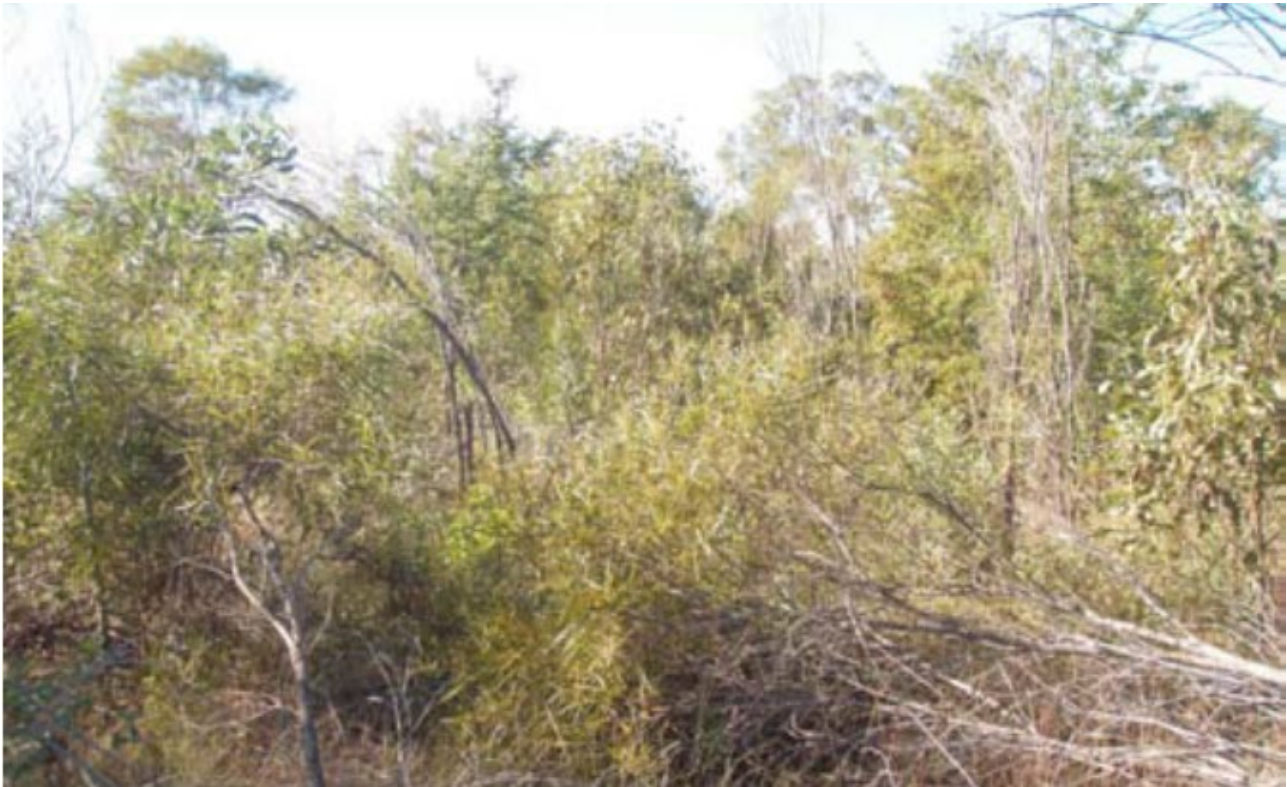
**Plate 4: Typical view of the existing vegetation adjacent to the Broome-Cape Leveque Road (from Biota 2018)**

Vegetation across the RUE is relatively contiguous and consists of typical 'Pindan' vegetation of Scattered *Corymbia* overstorey over an *Acacia* dominated mid-storey and a grassy understorey, over deep red sands. Plate 4 shows the typical vegetation along the BCLR.

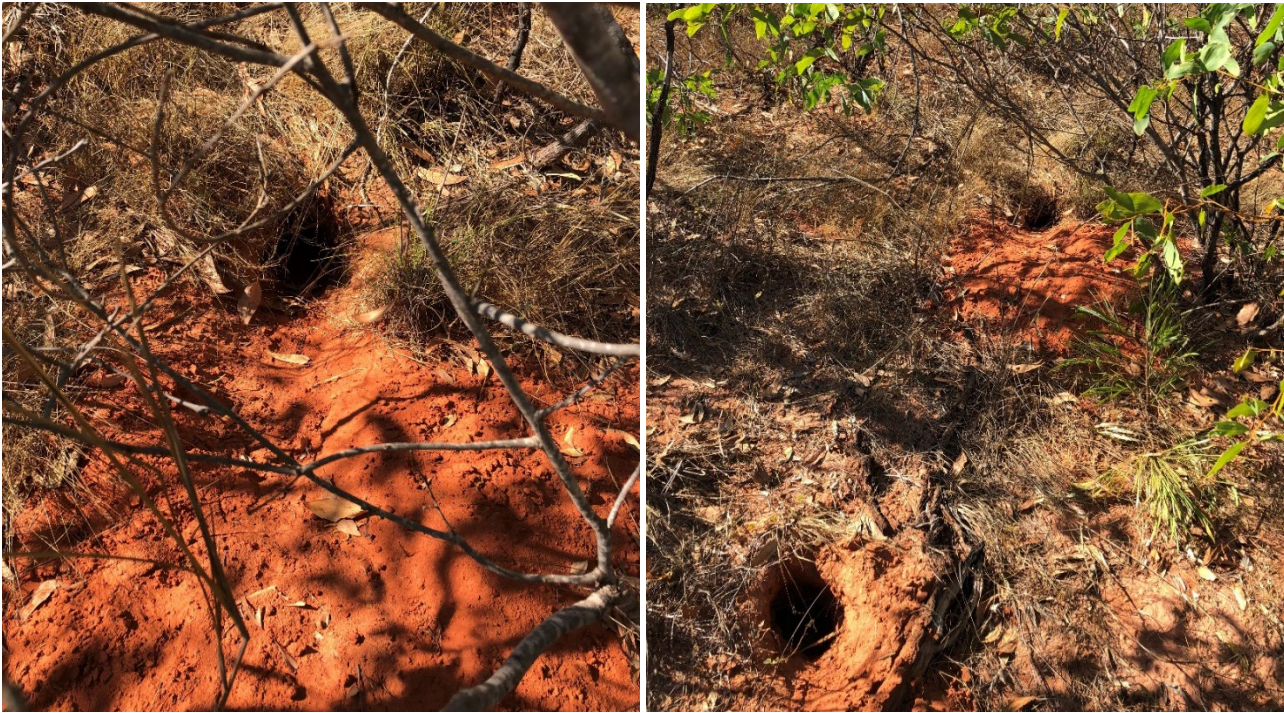
**Plate 6. Greater Bilby burrows located at SLK 17.25**

In addition to loss of overall habitat, no active burrows are directly affected by the Project as of 2018. However, as Bilby often move between areas and can excavate burrows in a relatively short amount of time, further management will be undertaken to ensure no direct impacts as a result of clearing activities will occur in the future.
