NorthLinkWA
Perth-Darwin National Highway

Condition Environmental Management Plan

Flora and Vegetation – Construction

Perth–Darwin National Highway (Swan Valley Section)

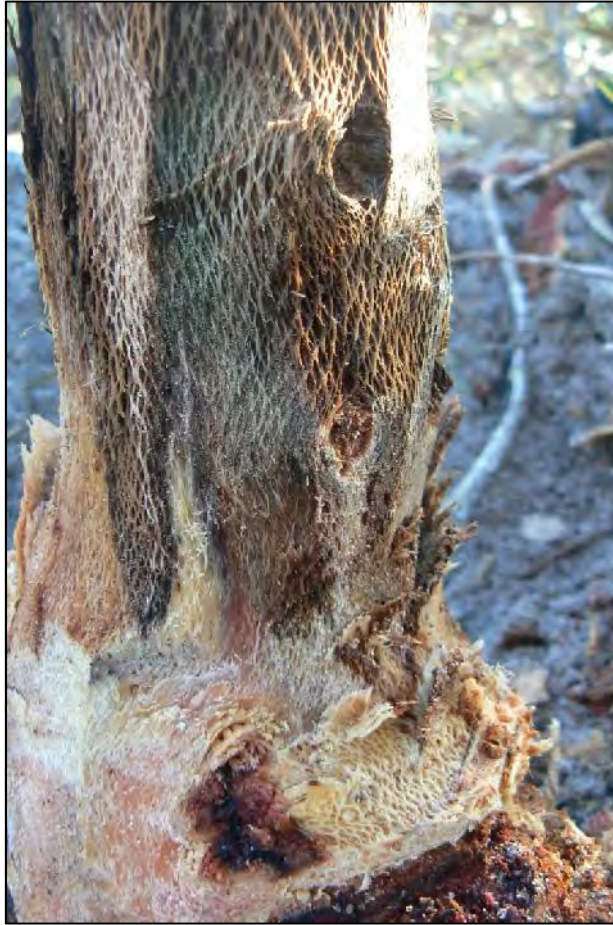
Plate 2: Uninterpretable vegetation dominated by resistant species *Melaleuca raphiophylla*
