Till Regeringen, Miljödepartementet

Beträffande regeringens pågående prövning av kärnbränsleförvaret enligt miljöbalken (M2018/00217/Me) och kärntekniklagen (M2018/00221/Ke)

Corrosion-induced microstructure degradation of copper in sulfide-containing simulated anoxic groundwater studied by synchrotron high-energy X-ray diffraction and *ab-initio* density functional theory calculation

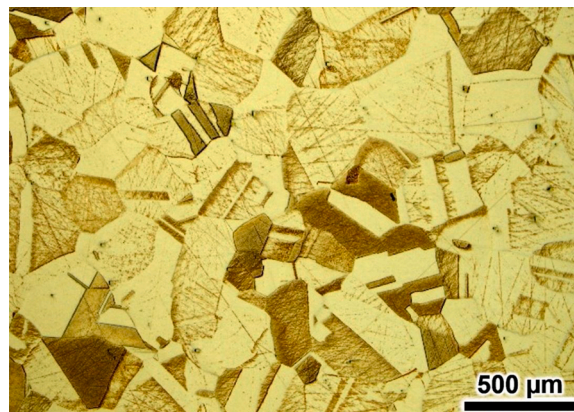
Fig. 1. Optical micrograph of an etched copper sample showing typical microstructure (large grains and annealing twins) of canister material.

spacing values expected for the Cu lattice, with small deviations across the measured depth reflecting the heterogeneities in the microstructure, such as grain boundaries and grains in different sizes as shown in Fig. 1. In contrast, the magnitude and scatter of the d -spacings increased for the pre-oxidized sample (Fig. 3b). The sulfur-exposed sample had the largest d -spacings, indicating most degradation (Fig. 3c). While the pre-oxidation affected the near-surface region down to a depth of 20–40 μm (see also Fig. 5), the sulfur-exposure resulted in large lattice expansion down to 400 μm , with some expansion occurred on individual sites in the microstructure between 400 μm and 900 μm in depth. It seems that compensating lattice contraction occurred in the sub-surface microstructure as compared to the non-exposed and pre-oxidized specimens (Fig. 3c). Hence, the exposure to the simulated groundwater caused both heterogeneous lattice expansion and contraction. The size of the large grains of the microstructure was 200–500 μm and thus much larger than the X-ray beam size (20 $\mu\text{m} \times 55 \mu\text{m}$), which explains the discrete heterogeneities in the d -spacings. Each scan line contained signals from approximately 50–100 grains, which is well-representative for the entire microstructure. Compensating lattice contraction, to a small extent, was also observed for the pre-oxidized specimen (Fig. 3b).

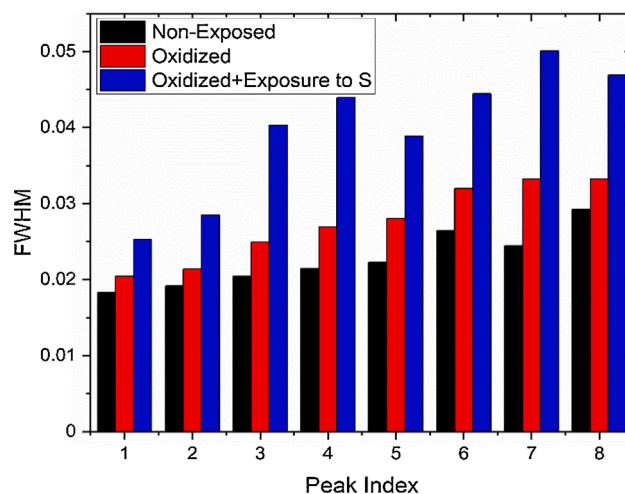
Fig. 6. Full-width at half maximum (FWHM) values from all measured diffraction peaks for the analyzed copper specimens, averaged over the entire sample thickness.

The fitting results of the full-ring diffraction data in Fig. 6 revealed that the full-width at half maximum (FWHM) values of all Bragg peaks increased by the pre-oxidation and exposure to the S-containing water, with the latter having the most severe effect. Increase of FWHM typically indicates the formation of micro-deformation, i.e., the deformation within grains, and/or the reduction of the grain size. The deformation of the surface layer due to the formation of corrosion products result in heterogeneous grain deformation, which is reduced with increasing depth in bulk. However, the exposure to the S-containing water resulted in larger surface deformation (lattice expansion) and also sub-surface deformation (lattice contraction). The oxidation on the surface was rather homogeneous and caused a widening of the lattice, but the degradation caused by the exposure to the S-containing water exhibited a more heterogeneous nature. During the exposure to the simulated groundwater, Cu sulfides can form as a result of the corrosion of Cu. Moreover, pre-formed Cu₂O film can also be converted to the Cu₂S film, which was reported to extend into the bulk of Cu for about 100 nm from

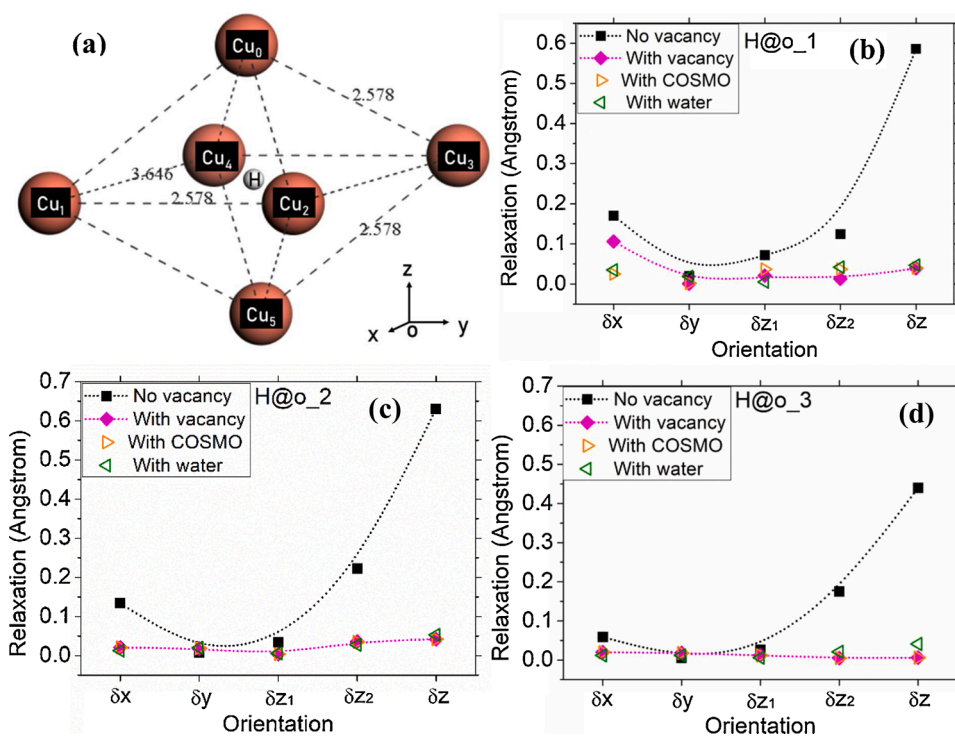
Fig. 9. (a) Configuration (before optimization) with one H atom located at the center of the octahedron comprised by six Cu atoms, which gives initial atomic distances between two Cu atoms: Cu₁₋₄ = Cu₂₋₃ = 3.646 Å (x direction), Cu₁₋₂ = Cu₃₋₄ = 2.578 Å (y direction), while Cu₀ and Cu₅ are both 2.578 Å away from the other four Cu atoms (denoted as z₂, z₁ direction, respectively); Cu₀₋₅ = 2.578 Å is denoted as z direction. (b)–(d) Comparison between the relaxations induced by H insertion within o₁, o₂, o₃ under different situations.

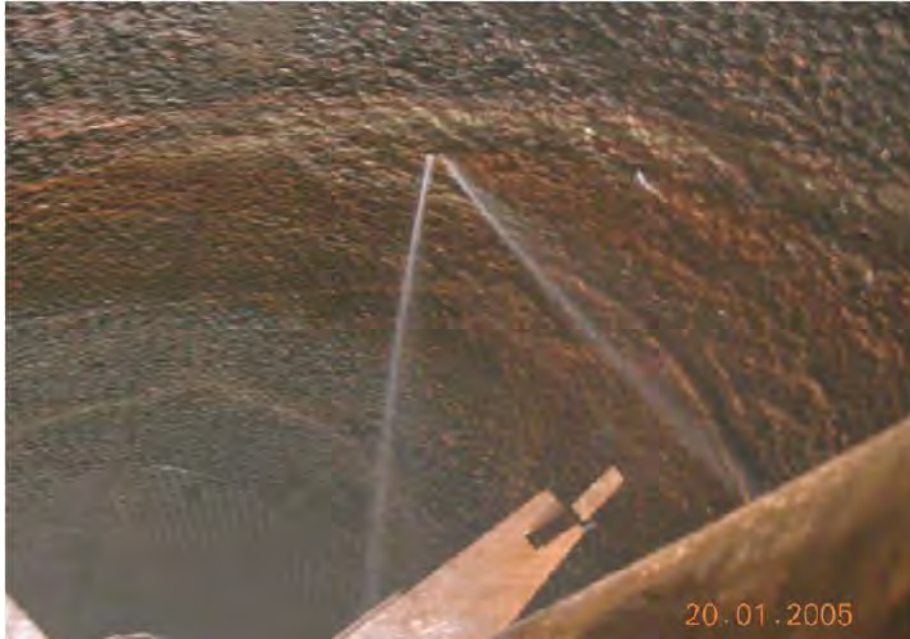
Figure 2.2. From Figure 3 in SKB-report R-05-44. Typical inflow pattern in Äspö hard rock laboratory showing high pressurized groundwater seeping out of a drilled rock surface. This photo is taken from a depth of only 220 m, i.e. the water pressure is around 22 bar, only half of that prevailing in a real repository. The cracks in the deposition holes in Forsmark are believed to be smaller but the pressure of the ground water is still 50 bar.

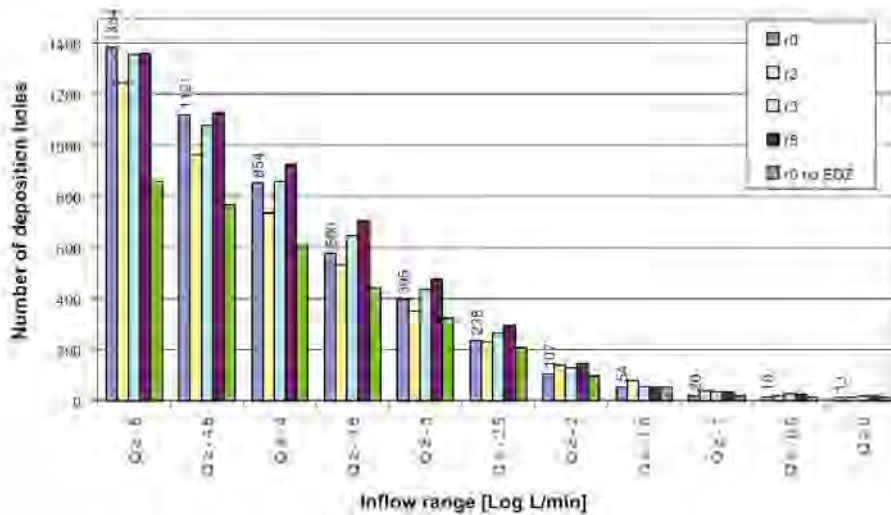
Figure 2.3. From SKB-report R-13-21, Fig. 3-4. Complementary cumulative distributions of the total inflow to each deposition hole for each case. According to case r0 (the five simulations r0-r5, give roughly the same outcome) there are 1384 deposition holes out of 6916 that have at least one crack that gives an inflow of ground water more than 10^{-5} L/min (≥ 5.3 litre/year). 854 deposition holes have an inflow of more than 10^{-4} L/min (≥ 53 litre/year) and 395 deposition holes has an inflow of more than 10^{-3} L/min (≥ 530 litre/year).

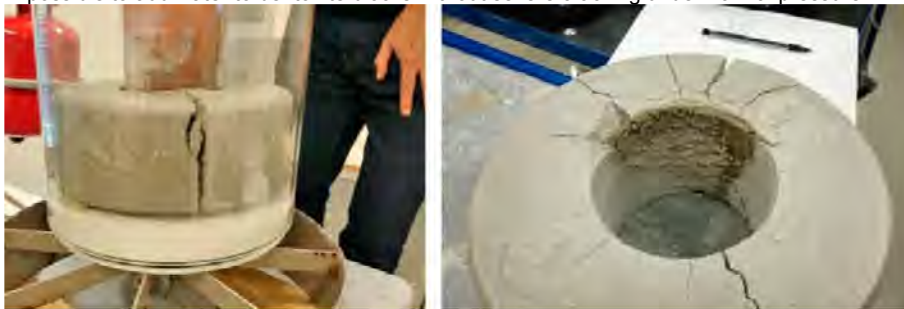
Figure 2.6. From Figure 2-8 in SKB TR-15-09. Left: Test 3 at termination. Right: Bottom side of the bentonite ring showing a condensation “nucleus” and cracks. Severe cracking of the bentonite rings occurred already within 7 days, which was the experiment duration time.

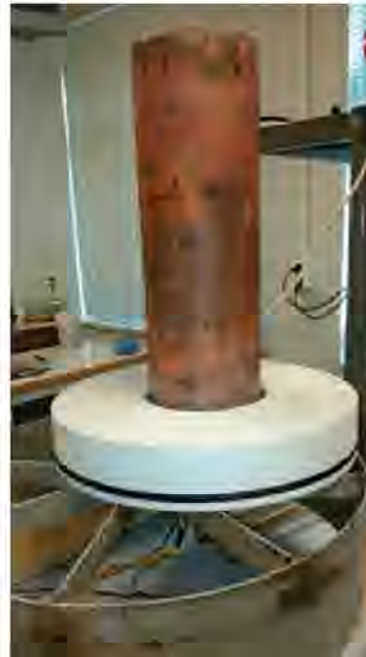
Figure 2.7. From Figure 2-1 in TR 15-09. The test set-up, which to a certain extent is a model of a KBS-3 deposition hole. Mounted on a plastic plate is a copper tube which is heated by circulating water to approximately 80 °C. “Water injection” seen to the left is actually a hole for low pressure water vapour to enter the slot between the Cu-heater and the bentonite rings. The outside of the set-up was covered by a plexiglass tube (not visible here).

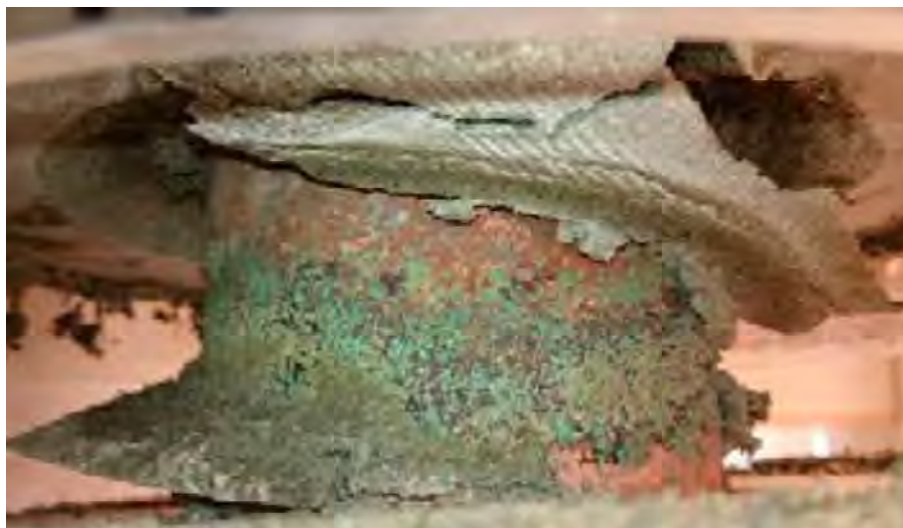
Figure 2.8. Detail from Figure 2-27 in TR 15-09. Severe corrosion of the copper heating tube after only seven days of laboratory exposure that at least reminds of the true Sauna effect, i.e. with only indirect contact with 0.6M chloride solution.

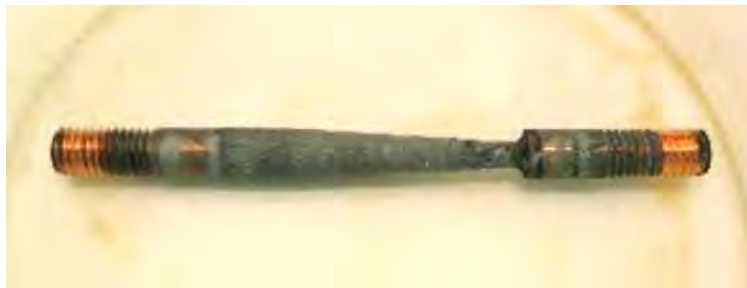
Figure 3.3. Example of SSRT exposed sample, 9 % strain at the thinnest part of the tapered sample (not exposed to final fracture).

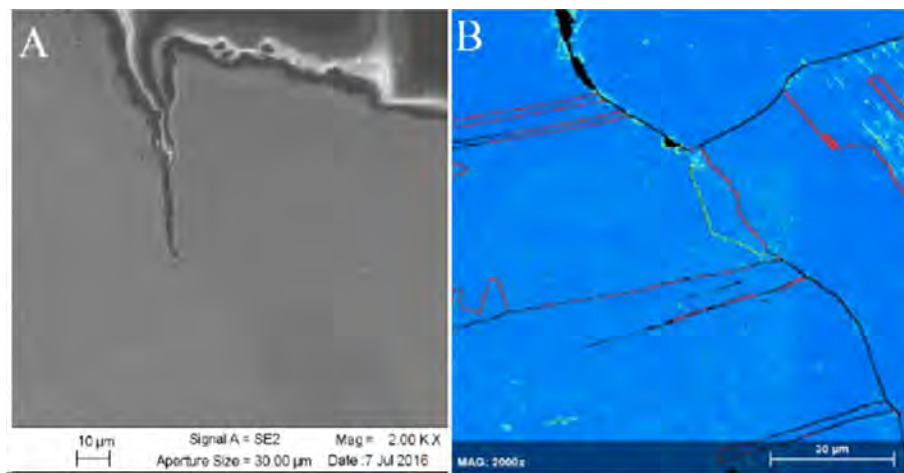
Figure 3.6. From Figure 3 in /Forsström A. et al. 2017/. Cross-section images of a SCC crack in the narrow section of Specimen #3. EBSD image showing crack propagation along a random grain boundary. Twin boundaries are marked in red and local misorientation in shades of green.

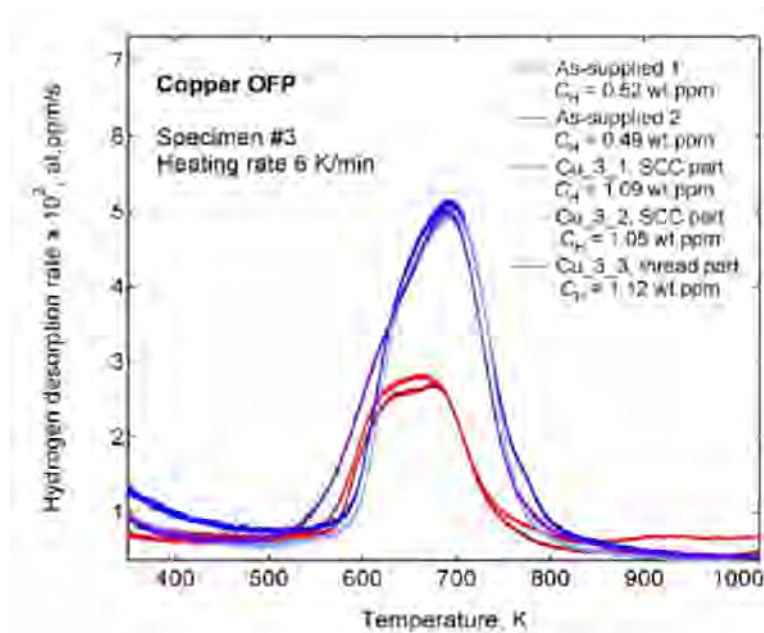
Figure 3.9. Hydrogen desorption curves (TDS) from /Forsström A. et al. 2017/ shows a systematically higher hydrogen content in the SSRT-exposed copper samples (blue and purple curves) compared with the as supplied SKB-copper metal (red curves). The TDS curves look similar for all tested samples, i.e. #3, #5 and #7. The systematic increase in hydrogen content in combination with the detected blisters in the inner sections of the copper samples (crack like defects, see Fig. 3.8) shows that copper exposed in an anoxic corrosive environment will suffer not only from SCC (surface cracking) but also from hydrogen induced grain boundary blisters and eventually cracking inside the bulk metal. This represents, in other words, the evidence for hydrogen embrittlement in oxygen free copper.

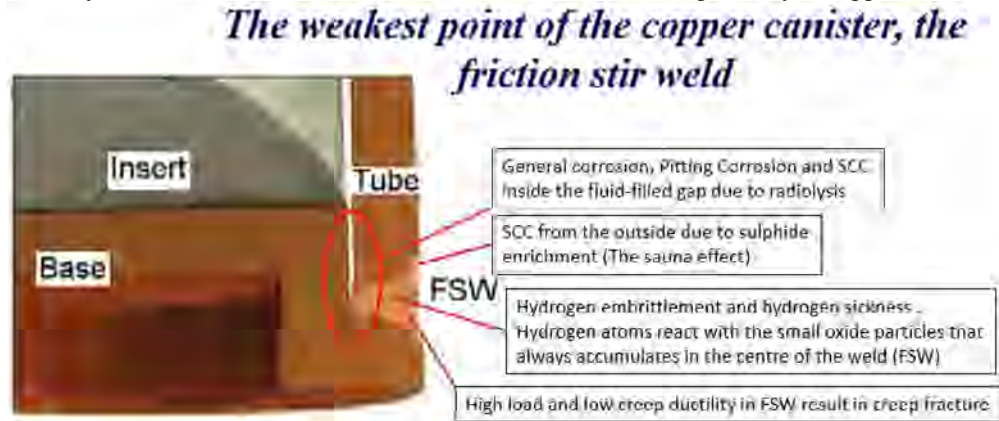
Figure 3.11. Detail from /Szakálos P. et al. 2017/. The weakest point of the canister is the Friction Stir Weld (FSW) and the fastest degradation mechanism is “hydrogen sickness” in the welds.

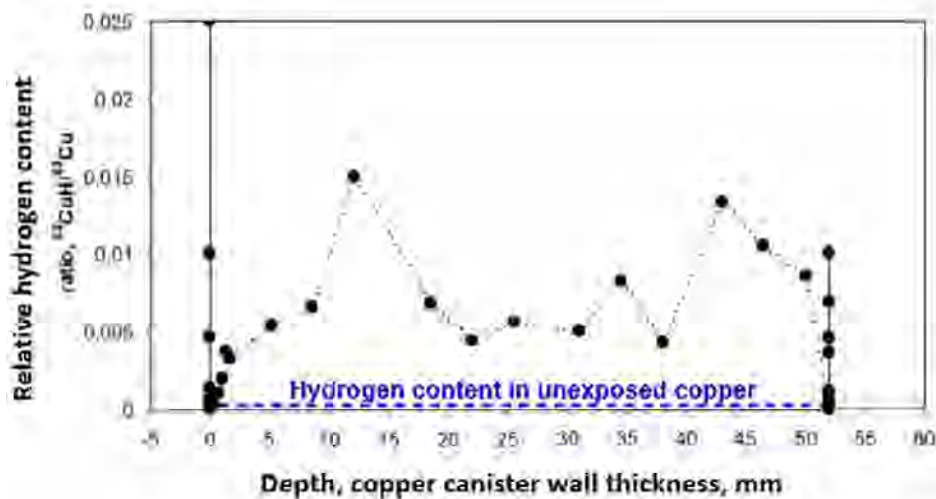
Figure 3.12. Full thickness canister copper exposed to the Swedish groundwater for seven years in the heated prototype repository, 80-90°C, at Äspö hard rock laboratory. The remarkable result shows that the copper canister is hydrogen charged throughout the whole thickness. The outermost surfaces have a very high H-content due to formation of corrosion products containing hydrogen and hydroxide. The hydrogen content in the first 10 mm of the inner/outer thickness has been subjected to spontaneous de-gassing when exposed to air since the hydrogen activity in the copper metal in contact with air is close to zero. The accepted hydrogen content in canister copper is 0.6 weight-ppm which coincide with the blue dotted line (unexposed copper). The hydrogen is detected by SIMS measurements and based on the H/Cu-ratio it can be estimated that the average hydrogen content in the copper is significantly higher than 1 wt-ppm.

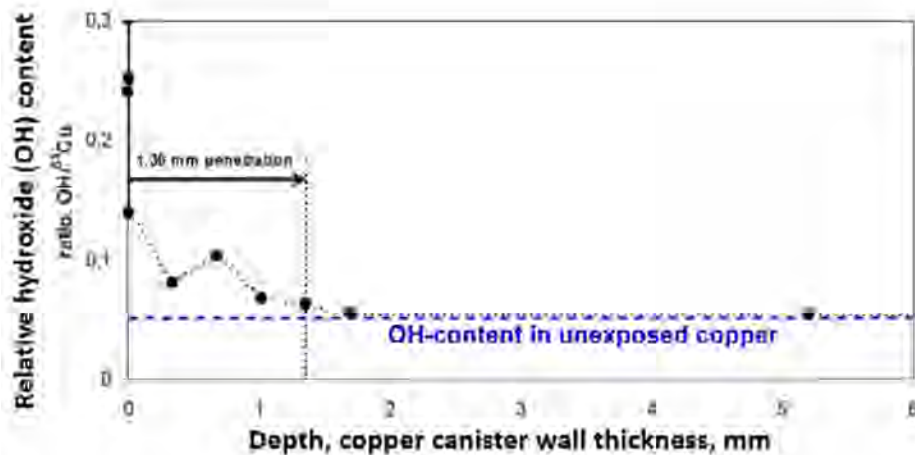
Figure 3.13. The hydroxide content of the first few mm of the full thickness canister copper exposed to the Swedish groundwater for seven years in the prototype repository at Äspö hard rock laboratory. The graph shows that hydroxide penetrates the copper metal, most probably in defects including grain boundaries. Once OH has entered the metal it is accumulated there, i.e. it is thermodynamically stable, i.e. evidence for internal anoxic corrosion. The hydroxide is detected by SIMS measurements.

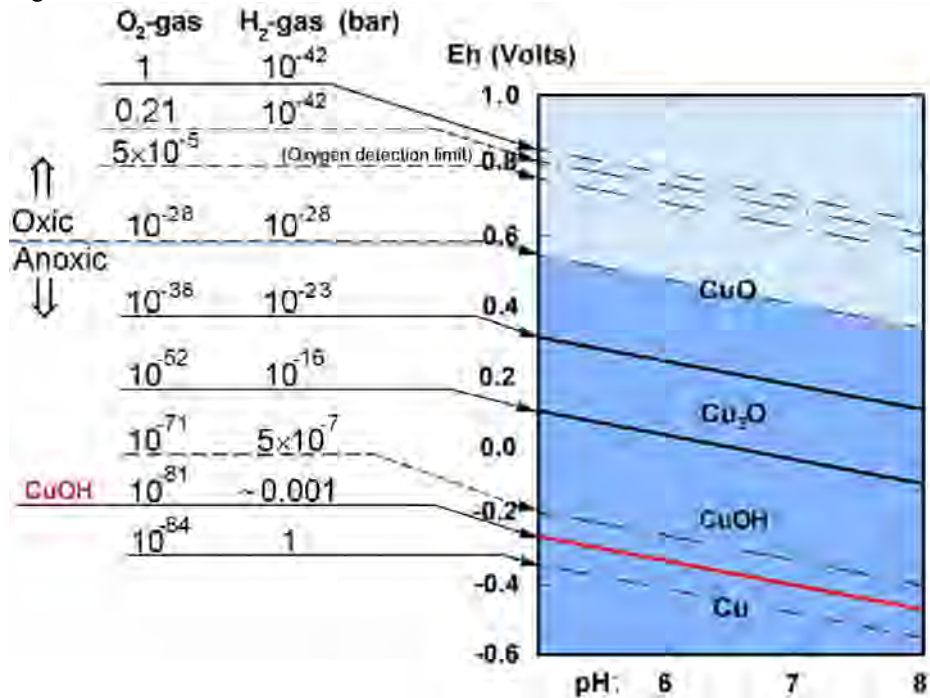
Figure 4.1. Pourbaix diagram based on /Szakálos P et al. 2007/. The light blue area at the top shows the oxic region with predominantly dissolved oxygen gas. The somewhat darker blue area shows the anoxic region with predominately dissolved hydrogen gas. The anoxic corrosion product Cu₂O (cuprite) is only formed at very low oxygen and hydrogen partial pressures represented by the black solid lines. The solid red line marks the lower stability region for the monovalent hydroxide CuOH, which is stable up to around 1 mbar hydrogen gas pressure.

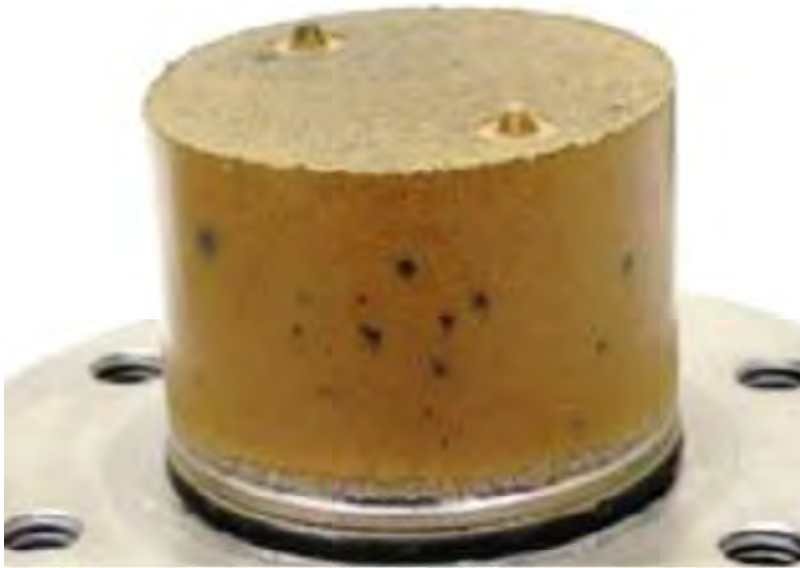
Black colonies of iron sulphide produced by sulphide producing bacteria in Asha bentonite at 1750 kg/m³ wet density and with addition of lactate and sulphide producing bacteria

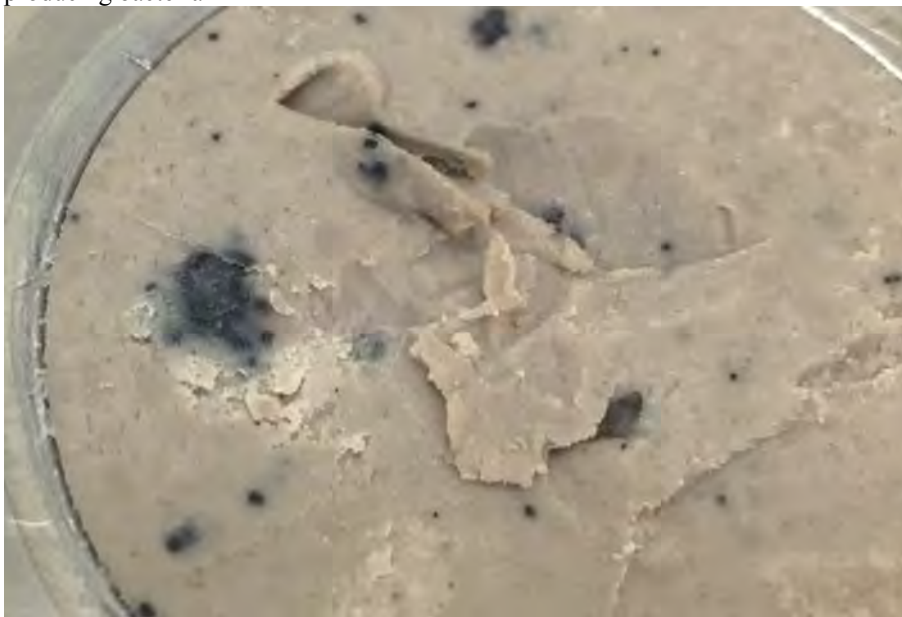
Black colonies of iron sulphide produced by sulphide producing bacteria observed during sampling of test cell with GMZ bentonite.

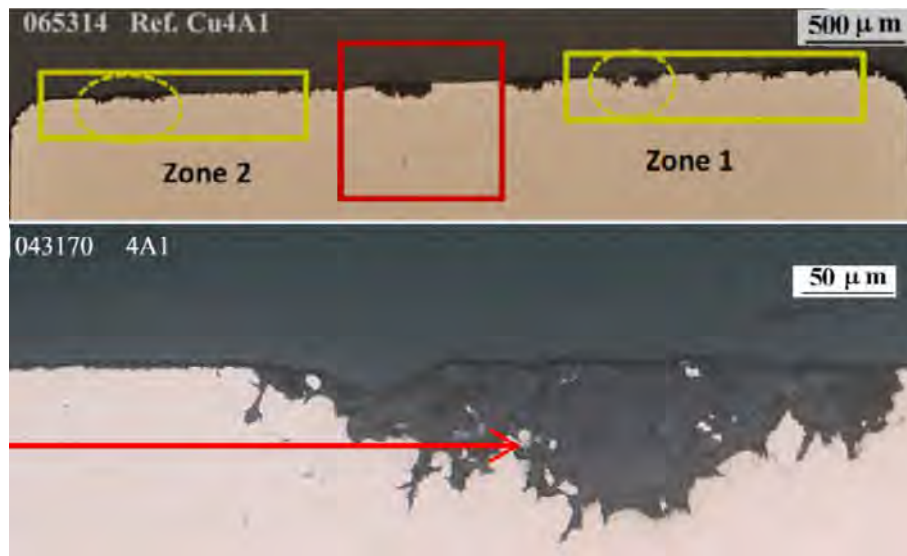
Figure 4.6. Metallographic cross-sections showing the exposed copper sample with pitting corrosion, up to 100μm in depth. From Appendix B in the FEBEX-report /Wersin P. and Kober F 2017/.

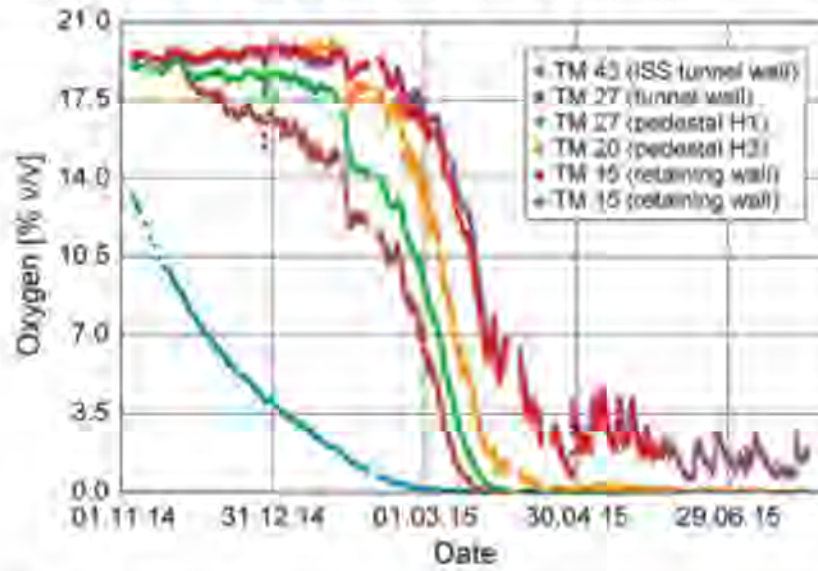
Fig. 11 Oxygen concentrations at different measurement locations along the FE tunnel from November 2014 (shortly after backfilling started) until July 2015

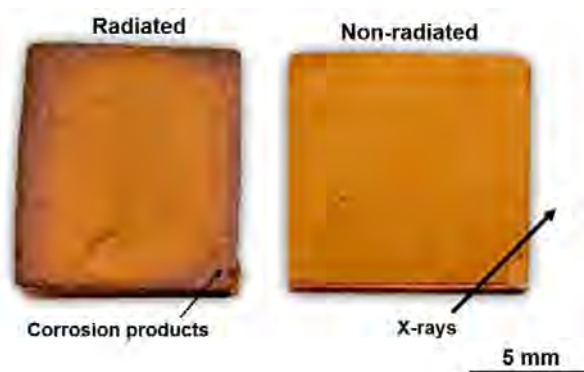
Figure 5.2. Photograph of some of the copper samples to be investigated. The radiated specimen in this case was exposed to oxygen-free water for 64 hours with a simultaneous exposure to 28.6 kGy of gamma radiation. The non-radiated specimen was exposed to oxygen-free water for 64 hours only. The bar shows the scan direction of x-rays through the specimen.
