City of Rockville Safer Walkways to Transit Final Report

Rev A | May 2011

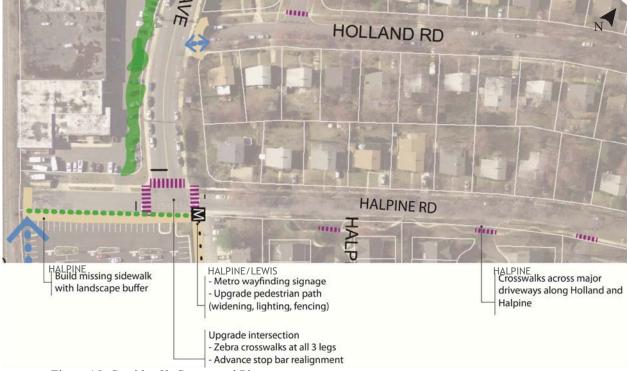
Figure 15: Corridor 2b Conceptual Plan

Holland Road and Halpine Road shown in Figure 15 above, in addition to Lewis Avenue described in Corridor 2a, make up the major routes to the station for pedestrians in the single-family neighborhood east of Twinbrook Station. These are low vehicle-volume streets and are fairly safe for pedestrian movement. Safety improvements along these routes include adding crosswalks across streets and driveways leading to multi-family developments such as Halpine Court, where a higher number of vehicles entering and exiting onto Halpine Road and Holland Road would be expected than from a the driveway of a single family residence.
