Bayswater Vehicles Ltd

93 Carlyle Street, Napier

Cut Slope Design Report

17367
28 March 2019

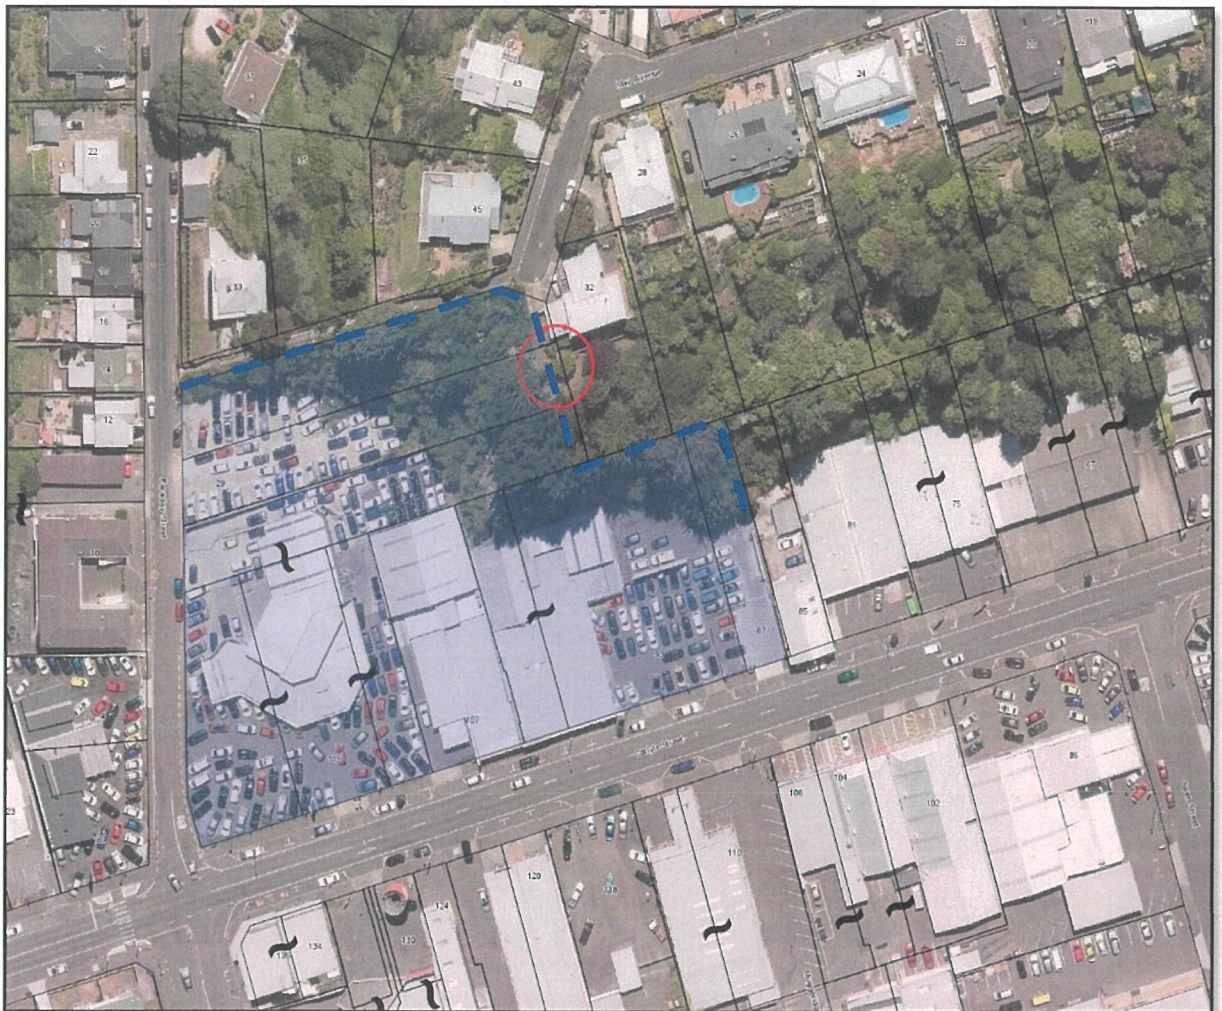
Figure 1: Location Plan – Bayswater Vehicles

The site is located on gently sloping ground that extends from the toe of Napier Hill (Scinde Island) to Carlyle Street (area shaded blue on Figure 1). However, to accommodate some of the new buildings, part of the existing hill slope will need to be excavated to extend the current building platform(s) and a small amount of fill will be required. The maximum height of the proposed cut profile is expected to be 27m (approx.) and the volume will be in the order of 22,500m³. The fill will be wedge shaped with a maximum depth of 1.5m and a volume of 800m³.

The intention is to carry out all earthworks within the client's legal boundary, and the existing slopes that will be modified by earthworks have been indicated on Figure 1 by a thick blue line. Note, this line is approximate only.

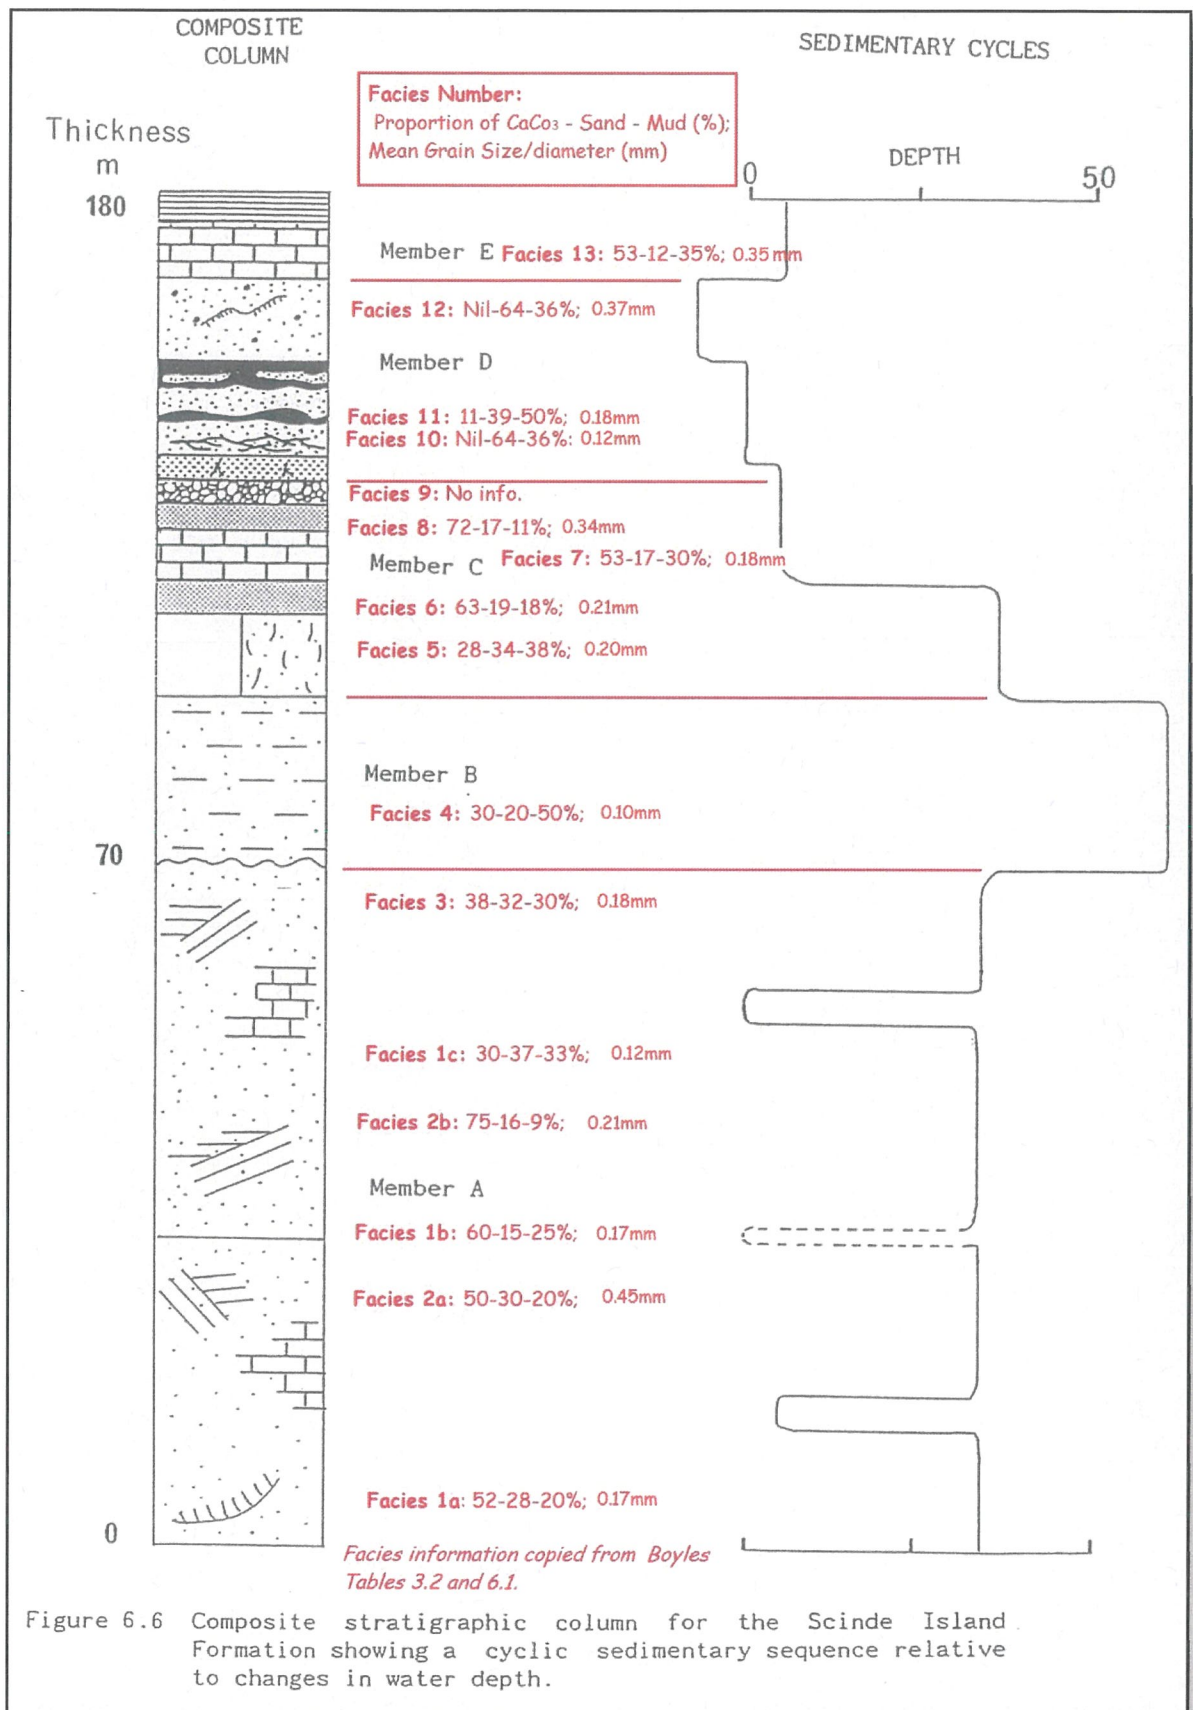
Figure 6.6 Composite stratigraphic column for the Scinde Island Formation showing a cyclic sedimentary sequence relative to changes in water depth.

Figure 2: Graphical representation of Scinde Island Formation (after Boyle 1987)

The Scinde Island Formation was subdivided into 5 separate members by Boyle (1987)¹, and labelled A to E in terms of decreasing age (i.e. A = oldest, E = youngest). Figure 2 below, is copied from Boyle's thesis (Figure 6.6) and is a graphical representation of the 5 separate parts of the formation. Information from tables in the thesis outlining the composition (i.e. proportion of calcium carbonate, sand and mud – Table 6.1) and mean grain size (Table 3.2) from different samples taken by Boyle. Note, the grain size in the original table is expressed in terms of Phi (Φ). These have been converted to diameter (mm). The samples represent different "Facies", which is a geological term that describes a type of depositional environment, rather than just the rock type itself. The following is a brief summary of each member based on information from the thesis.

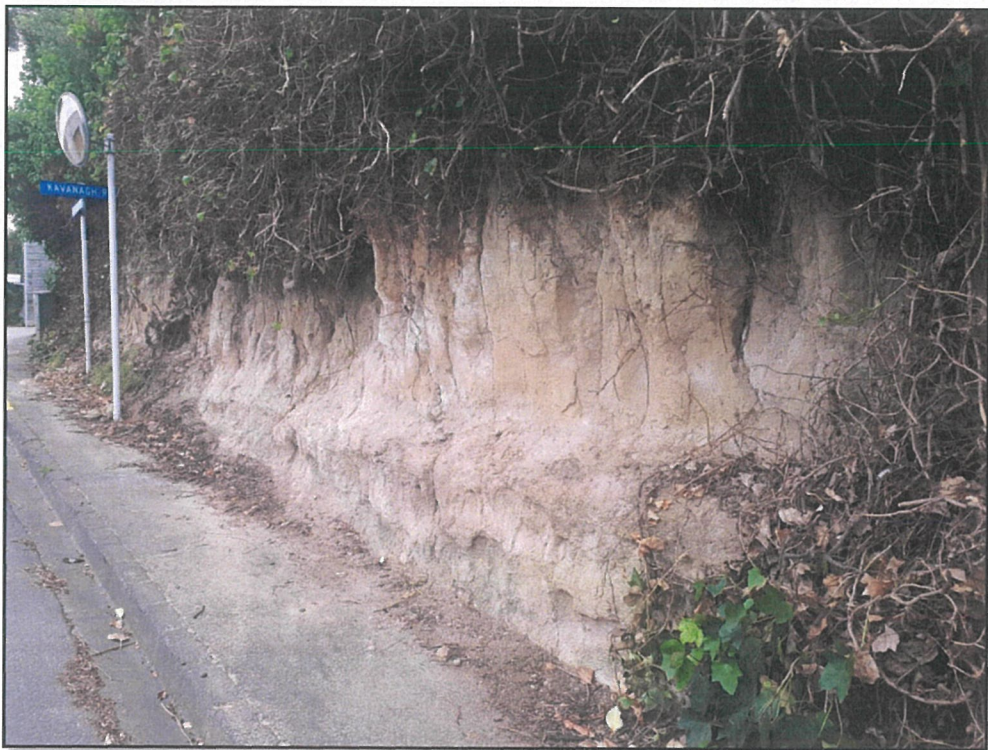
Photo 1: Loess exposed in near vertical cut batter

Photos 1, 2 & 3 were taken of a road cutting on Simla Terrace, opposite the start of Kavanagh Road (Hospital Hill), and shows a typical exposure of the Pleistocene aged Loess. This face is approximately 2.5m - 3m high and is standing sub-vertical. The material shown in Photo 2 has a weak columnar structure formed from vertical jointing. This is characteristic of the Loess seen in Napier and is likely to correspond to the "blocky" material described in Boyle's section of the Pleistocene cover beds (Figure 4).

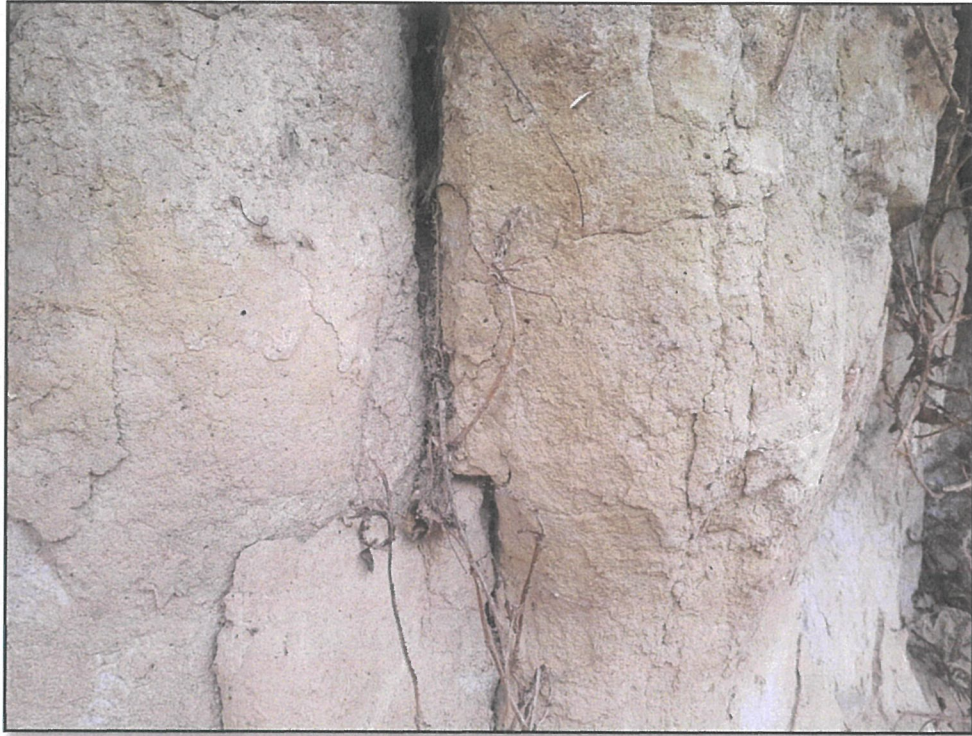
Photo 2: Natural jointing in Loess forming weak columnar structure

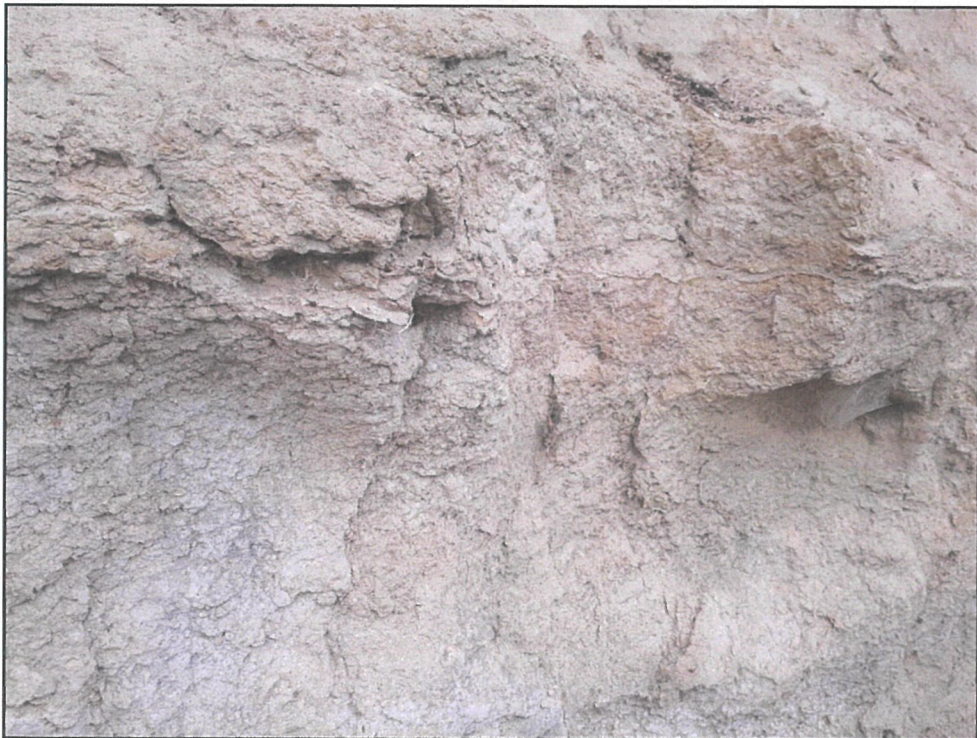
Photo 3: Typical exposure of Loess including a thin sub horizontal siliceous layer

At a finer scale, the Loess structure typically include a fine porous texture, and in Photo 3 a thin white band of very fine grained material can be seen running across the face. This is likely to be the same feature as described as siliceous material in Section 3.2.

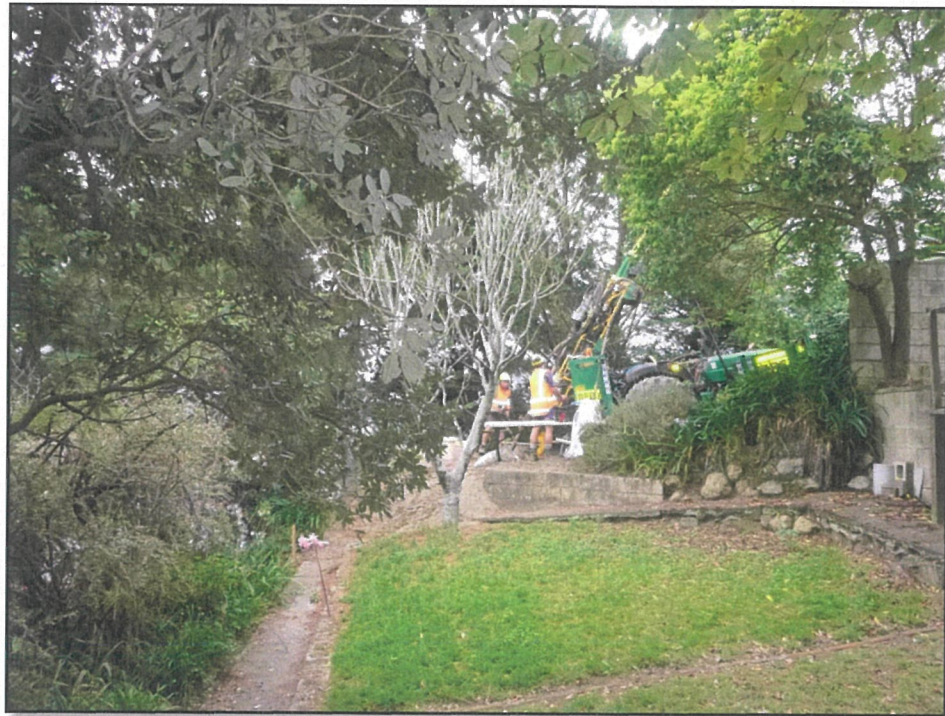
Photo 4: Drilling Rig set up at top of existing hill slope

A small working platform was constructed to support the drill rig at a Reduced Level (RL) of 45.5m, and the hole extended 40m in length to a final depth at RL9.25m (an equivalent vertical depth of 36.25m).

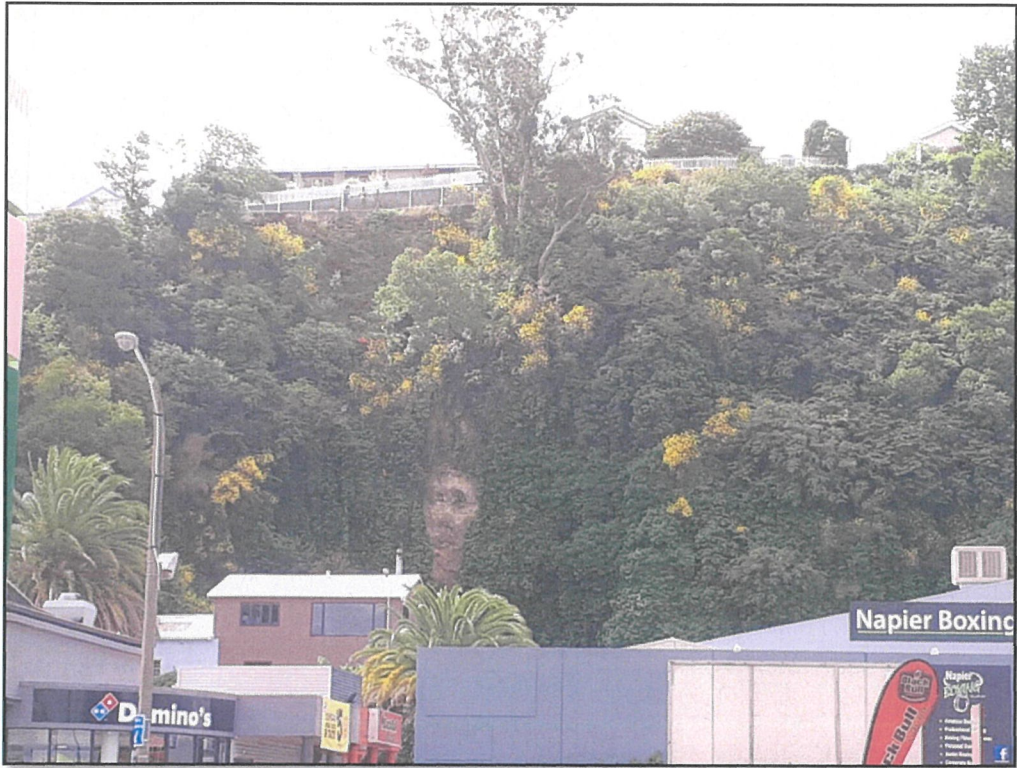
Photo 5: Cut Slope above Craven Terrace

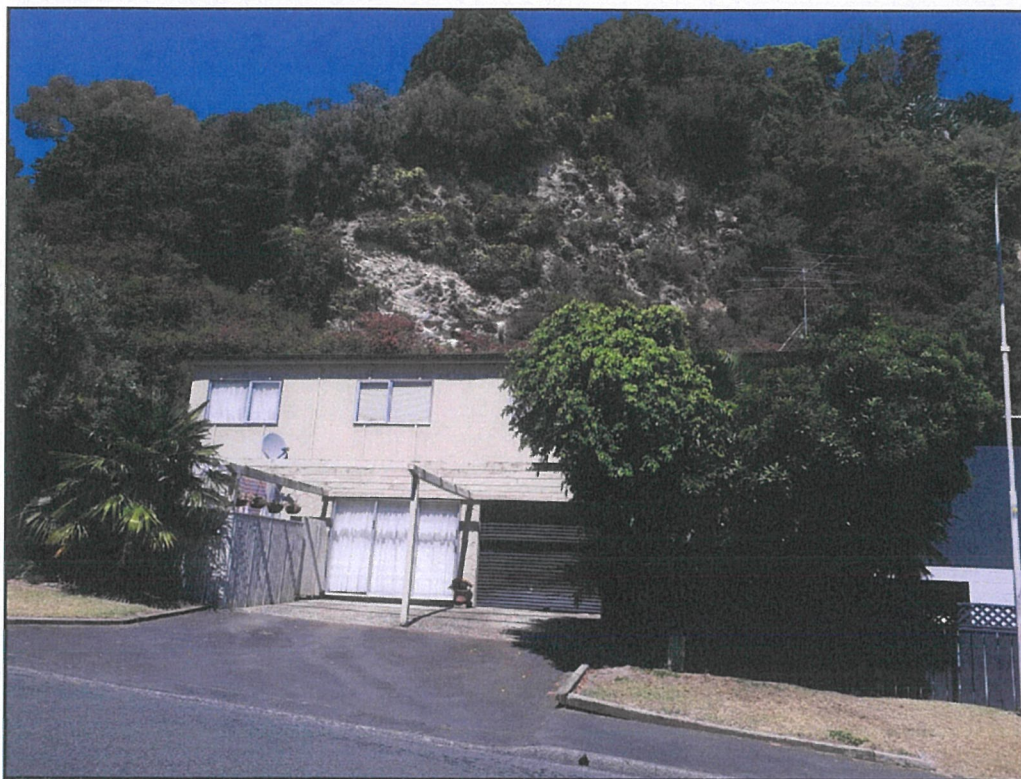
Photo 7: Cut Slope above lower Burns Road

Photo 7 shows an exposed rock face at the base of Burns Road. The face is sub-vertical and approximately 30m high.

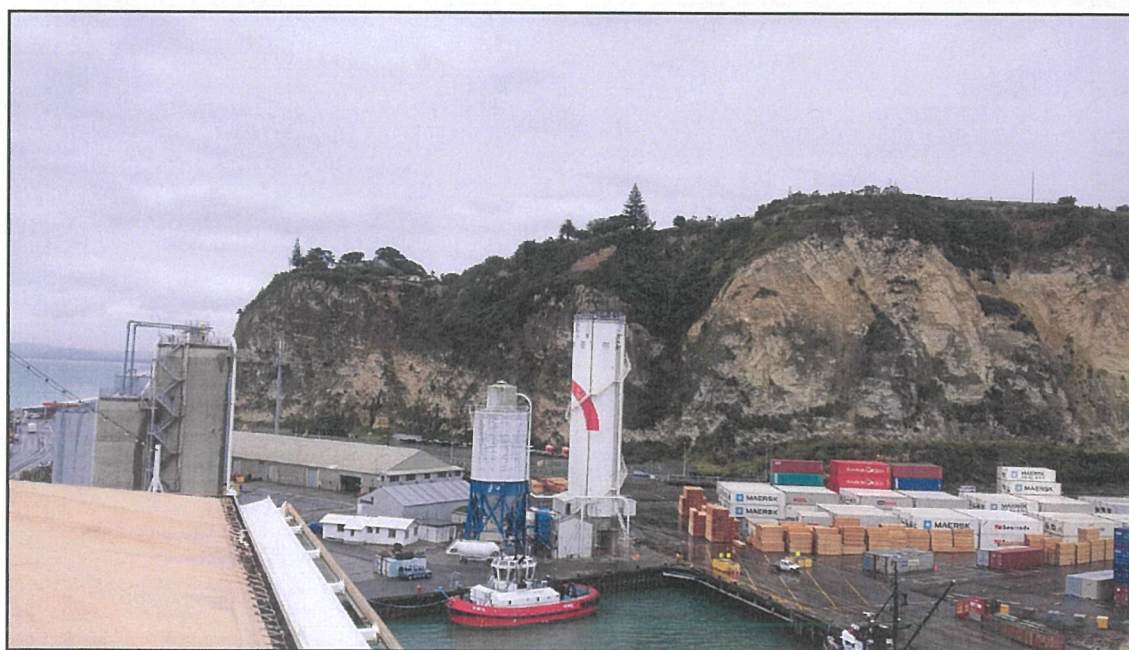
Photo 8: Natural Slopes of Bluff Hill (approx. 100m high)

In addition to the 3 examples presented there is the notable limestone bluff (Bluff Hill) that overlooks the Napier Port. This face is a natural feature and was mapped by Boyle (1986) as representing Member A, with part of Member B exposed at the top. The total height of the Bluff is approximately 100m, but there are sub-vertical sections of rock face that are at least 75m high (Photo 8).
