Helge Hicken

NDT Engineer
Materials & Processes
Testing Technology

Rudders structural inspections

- The maintenance program of A310 / A300-600 rudder Pre MOD 8827 and A330 / A340 Pre MOD 40904 has been improved to introduce additional inspection on the rudder, specifically at the Z-Profile.

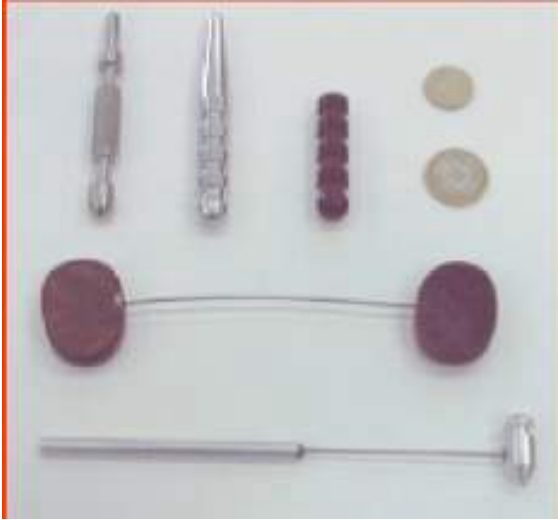
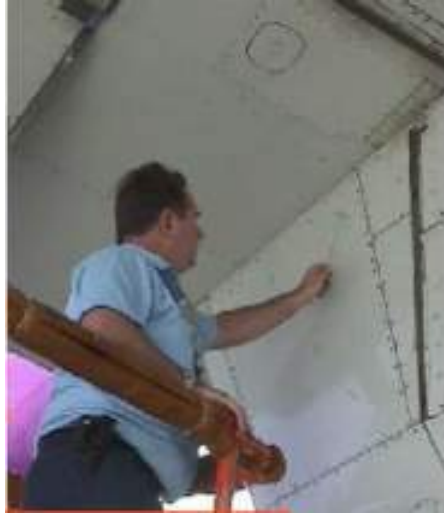
Manual Tap Test

Extremely simple NDT instrument
Pocket size, ultra low cost
Available everywhere

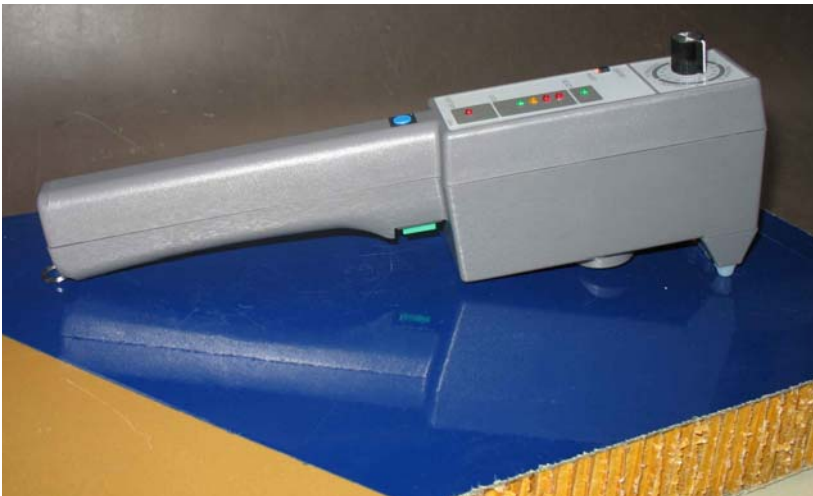
Mitsui Woodpecker

- Simple NDT instrument
- Pocket size, low cost
- Available
- Simple use
- Allows detection of outer skin disbonding
- Procedure in NTM

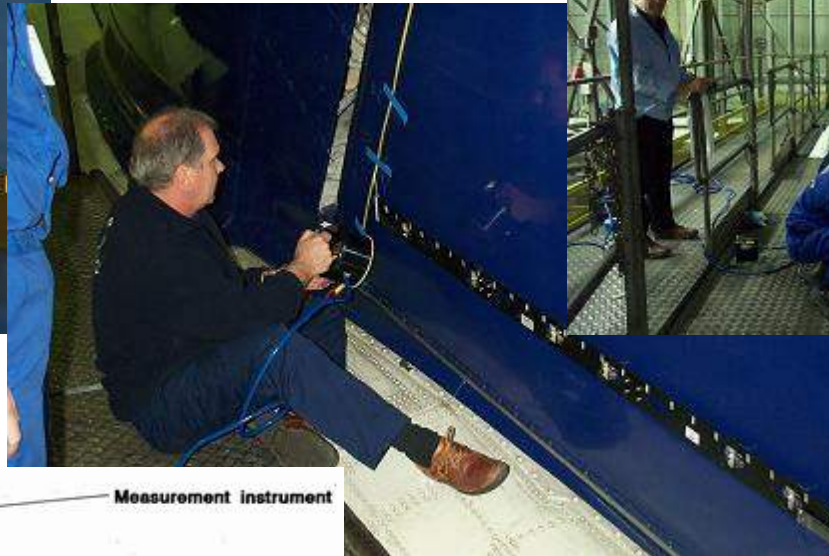
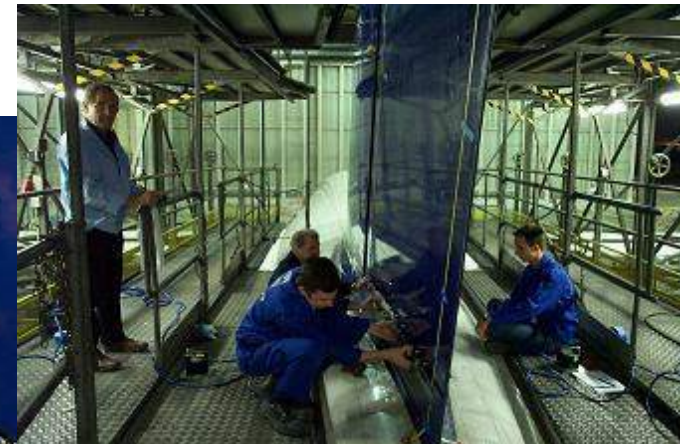
Functional Principle of ELCH Measurement

- The ELCH puts a defined force perpendicular to the surface, all expected disbonding cases will be detected as a stiffness loss comes with the disbonding

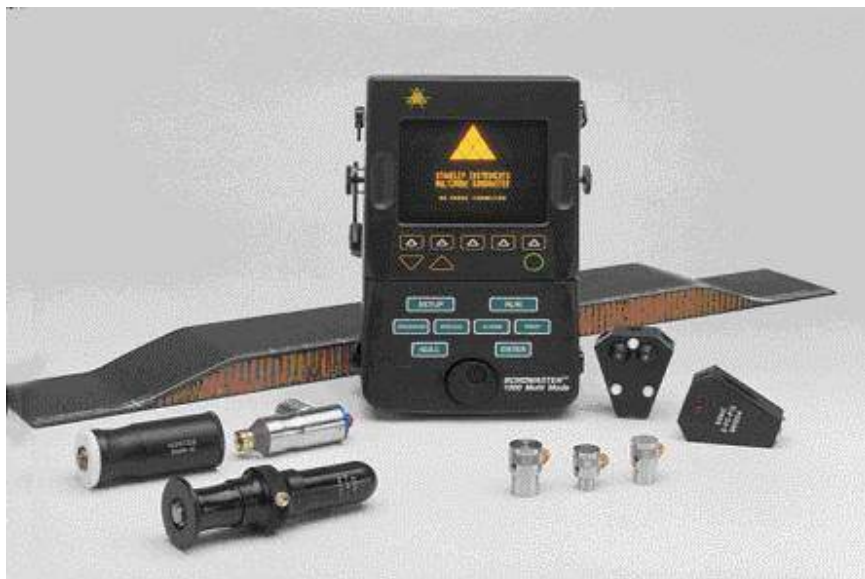
BONDMASTER is a resonance testing device used already for several inspection tasks on the AIRBUS NTM.

Procedures exist for top skin disbonding inspection on sandwich, for bond testing Al-structures (FOKKER-BOND-TEST alternative) etc.

- External defects can be found.
- Procedure in NTM.
- Rear side defect detection is under investigation.
- Equipment pocket size, battery powered, easy to carry, easy to handle, quick in use

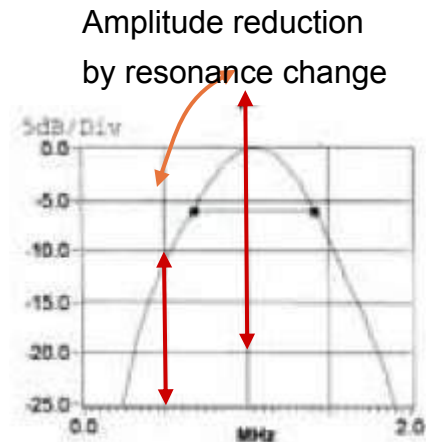
Physical effect of measurement

- The UT Procedure uses a kind of guided wave.
- System must be tuned to core height (membrane length = $\frac{1}{2} \lambda$)
- Therefore UT equipment should fulfil specific characteristics:
 - square wave pulse excitation (preferred)
 - good filter capabilities to tune the receiver

Transducer operates with a certain bandwidth – disbonding causes a resonance shift to longer wavelength $\lambda =$ lower frequency, echoes with lower frequency excite only reduced amplitude in transducer: back wall echo loss between 6db and 12 db

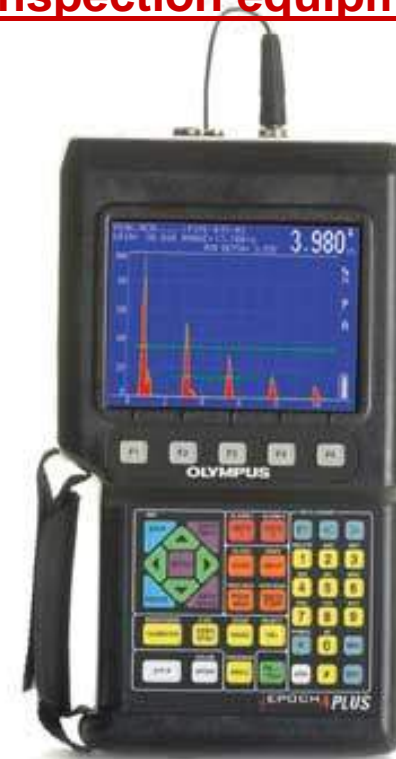
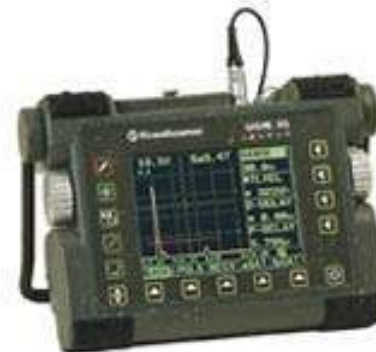
Inspection equipment

- Instrument: Panametrics EPOCH 4Plus from OLYMPUS NDT
- Search Unit: K1SM, 0°, 1 MHz from GE IT C539, 0°, 1 MHz from OLYMPUS NDT

This flaw detector has filter capabilities, which can be directly accessed and a square wave pulse – feature which enhance the signal.

- Instrument: USM25/35 from GE IT
- The GE flaw detectors lack suitable filter capabilities and have only spike excitation – with the settings provided by Airbus the inspection can be done, the sensitivity is sufficient, but reduced resolution compared to EPOCH 4 Plus

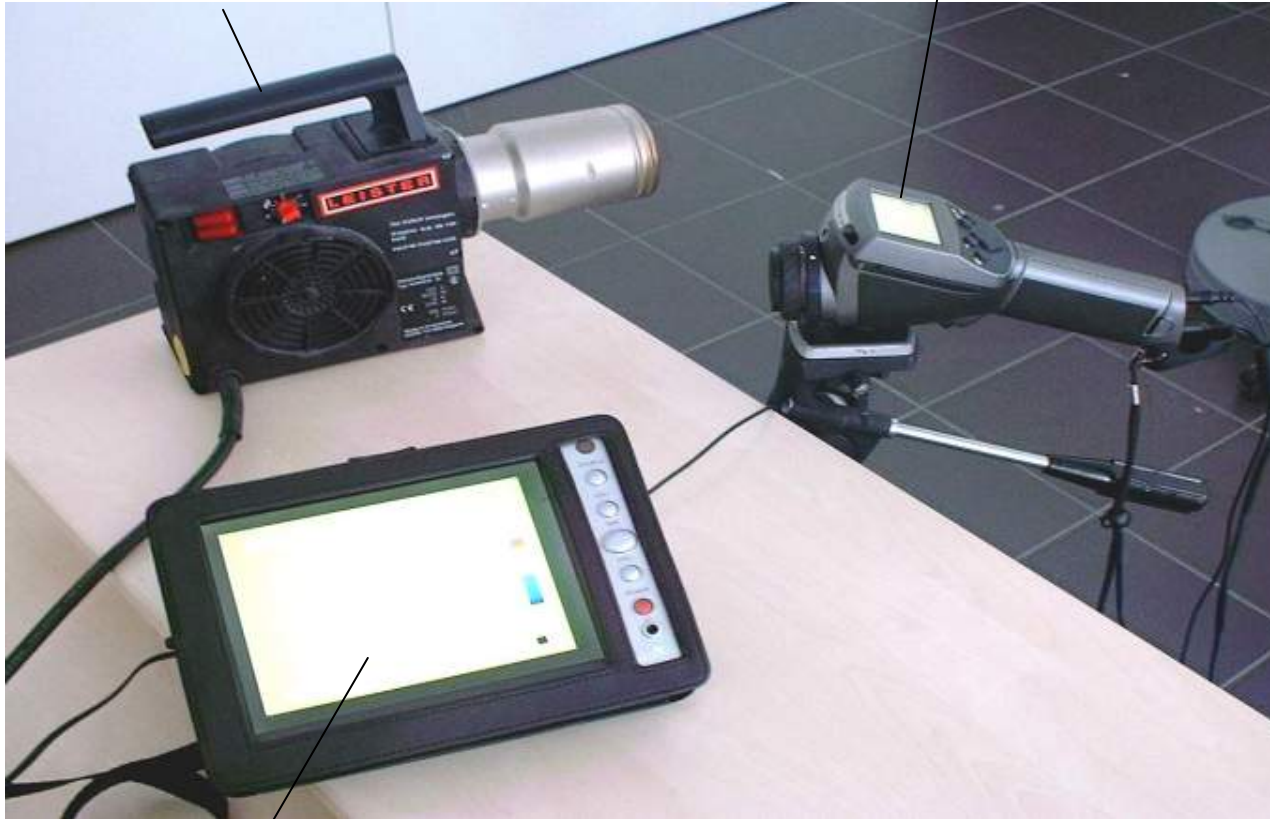
Hot-Air Fan

Portable Thermo Camera

Portable Display

- Allows detection of fluids in honeycomb cells

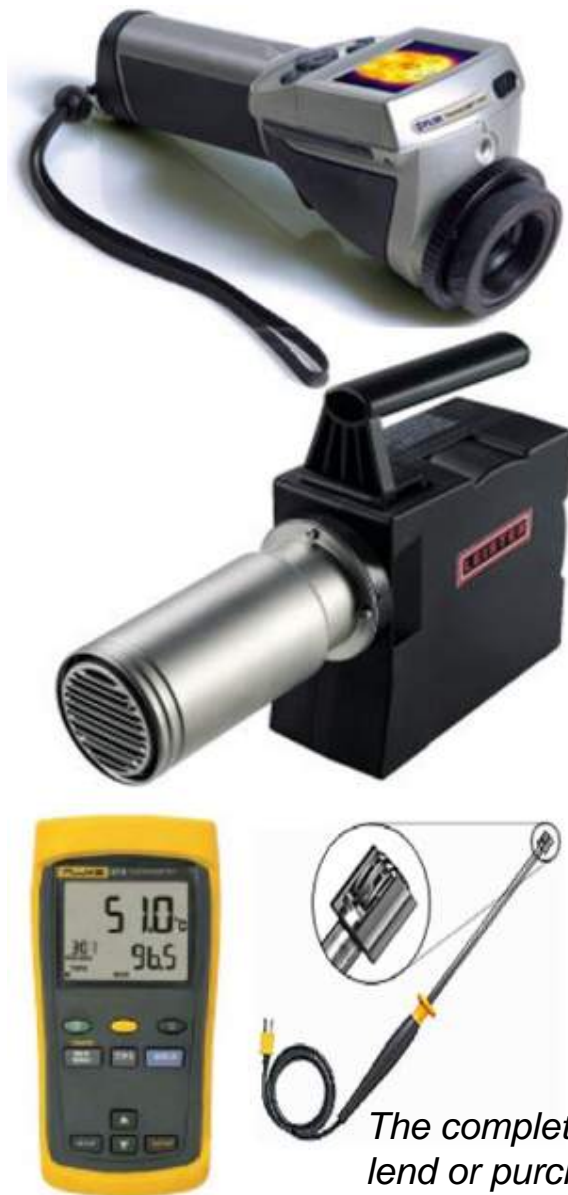
Equipment kit

Infrared camera FLIR E45

- Real time imaging
- Auto-adjustment of contrast and brightness
- Resolution $<0,2^{\circ}\text{C}$ near ambient temperature
- Temperature range 0°C to 100°C
- Chart of color range = Grey (white = hot)
- Filed of view min. = $24^{\circ}\times 18^{\circ}$, max. $34^{\circ}\times 25^{\circ}$
- Focus range lower value <500 mm
- If possible, a tripod can be used

Hot air Fan Leister Hotwind S

- 400 l/min
- 2 mbar
- Temperature range 150°C up to 200°C max.

In use at the Rudder the outlet temperature of the Hot Air Fan shall not exceed 160°C .

Heating-up with the help of an hot air fan (convection heating) is the optimum compared to other means of heating
