# Spandrel Walls - Managing the Risks

Lessons Learnt

March 2012  
Network Rail

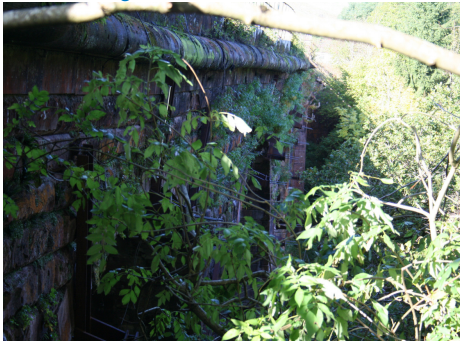
Figure 2.1: Tilting failure

This defect is the **forward rotation** of the spandrel wall.

A key clue to the presence of a tilting defect can be the leaning / mis-alignment of handrailing and / or the stringcourse.

This type of defect can be relevant to all masonry arch bridges, but in particular those structures with significant cover above the arch barrel.

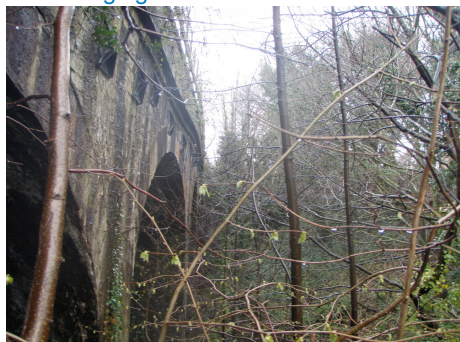
Figure 2.2: Bulging failure

This defect is the **bulging** or **distortion** of the spandrel wall.

As for the tilting defect, a key clue to the presence of this defect can be the leaning / mis-alignment of handrailing and / or the stringcourse.

This type of defect can be relevant to all masonry arch bridges, but in particular those structures with significant cover above the arch barrel, or on a curve.

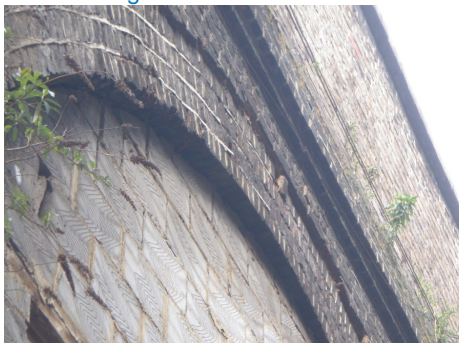
Figure 2.3: Sliding failure

This defect is the **lateral movement** or **oversailing** of the spandrel wall above the arch barrel.

This defect is characterised by the lateral displacement of brickwork above the arch barrel. The defect can also occur by the lateral displacement of brickwork within the arch face ring.

This type of defect can be relevant to all masonry arch bridges.

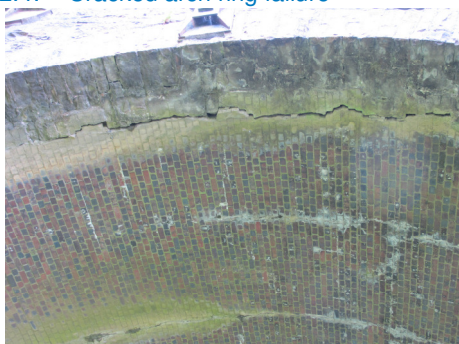
Figure 2.4: Cracked arch ring failure

This defect is a **longitudinal crack** within the arch barrel, located below the spandrel wall.

The key clue to look for is evidence of cracking within the arch barrel, including sheared brickwork and leachate / seepage staining.

This type of defect can be relevant to all masonry arch bridges, but in particular those structures with a material change between the voussoir and the arch barrel.

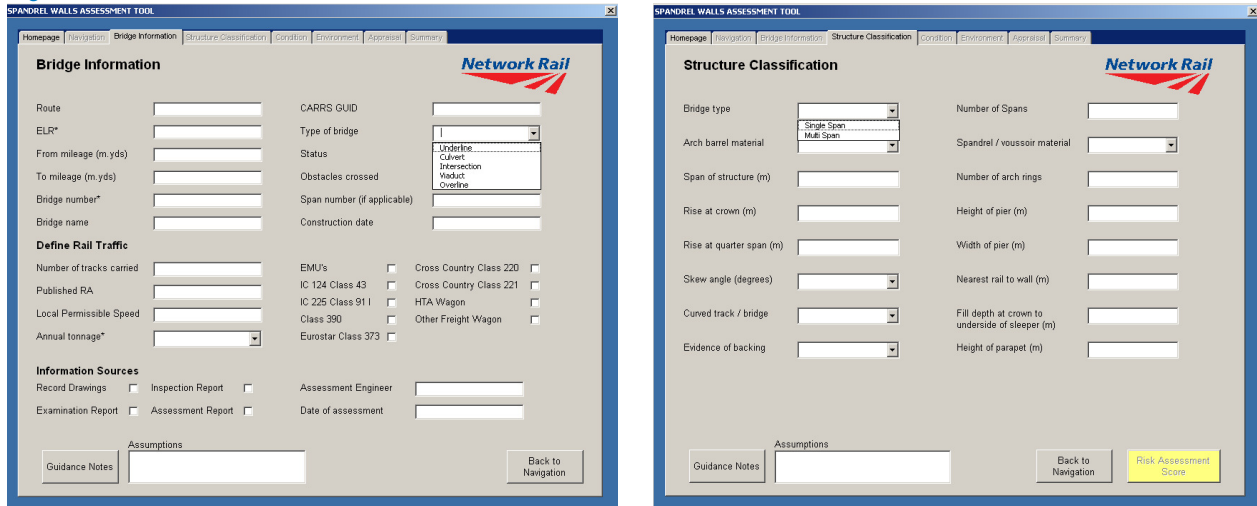
Figure 3.2: Screen shots from tool

The risk assessment tool will provide a **risk score** based on the above parameters for a specific masonry arch bridge. The user is able to determine a risk score under **steady state conditions**, but also consider the impact of introducing a **change**, e.g. a change to freight traffic.

The tool will also provide **recommended actions** to Network Rail, dependent on the risk score generated.

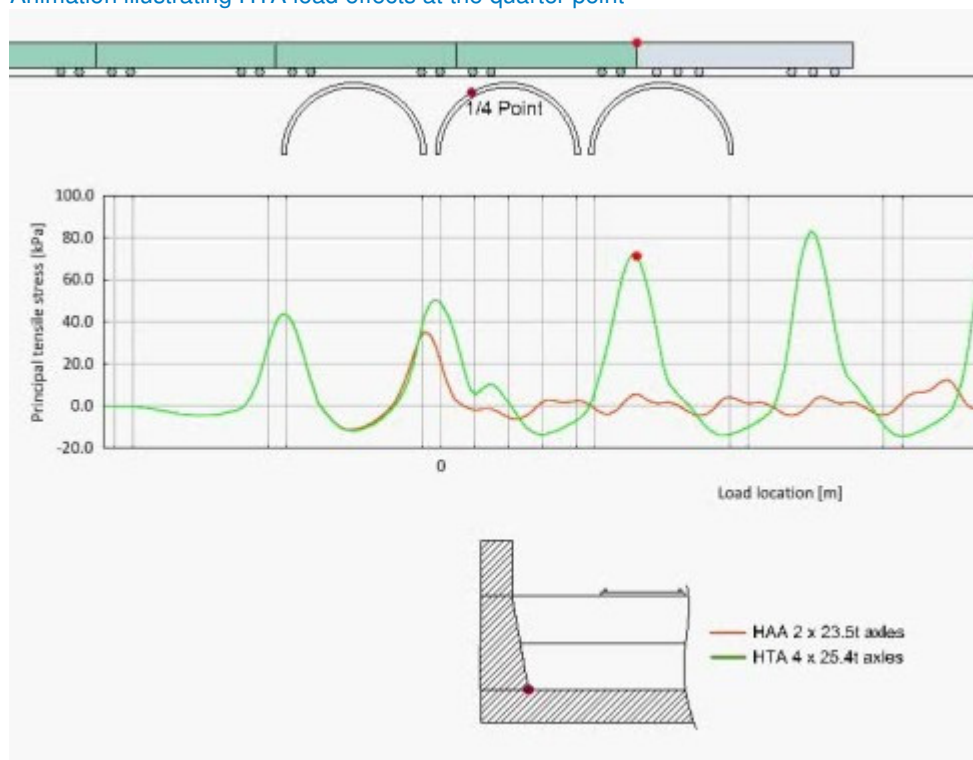
Figure 4.1: Animation illustrating HTA load effects at the quarter point

The worst loading condition for an arch is when a high load is applied in the area of the quarter point of span with no load on the opposite quarter point. As the load traverses across the span a reversal of this effect takes place. The joint between the spandrel and the barrel is then subject to high cyclic stresses increasing the risk of fracture.

It can be seen then that different wagon wheelbase will affect different span lengths to a greater or lesser extent depending on whether the maximum and minimum loading occur simultaneously. In most cases this is the HTA wagon that has a long wheelbase and high load (two adjacent 50 tonne bogies on one side of the arch whilst spanning beyond the far abutment hence leaving the other side of the arch span unloaded).

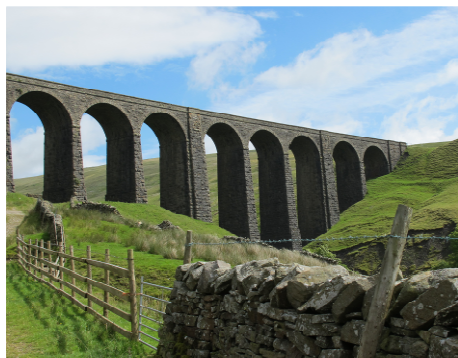
Figure 4.2: Slender multi span viaduct, Arten Gill, Cumbria

**Structures with brick barrels and a stone voussoir (e.g. multi span viaducts with tall / slender piers) with spandrel wall defects, typically exhibit longitudinal cracks in the arch intrados between the brick and stone components.**

The reason for this is that there is a significant change of elasticity and stiffness between the two components / materials coupled with change in bond and difference in weathering. This results in a discontinuity that will concentrate cracking at that point.

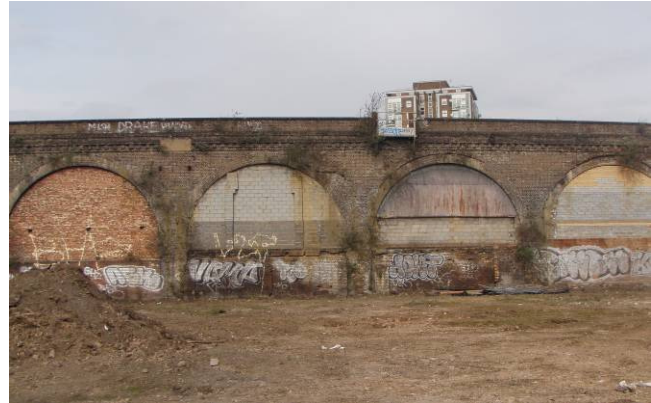
Figure 4.3: 'Stocky' type viaduct, Brixton, London

**Multi span brick viaducts with stocky piers (and spandrel wall defects), typically exhibit lateral displacements of the spandrel wall.**

Viaducts with stocky piers are constrained and generally have much less global flexibility and lower deflections. Because of this the change in stiffness between the spandrel and barrel is less significant and the shear forces on the horizontal mortar joint become more dominant hence the spandrel is more likely to be displaced laterally.

Viaducts with stocky piers can be considered to act more like a series of individual spans and where defects occur in adjacent spans the engineer should also consider the possibility that the pier settlement may have occurred.

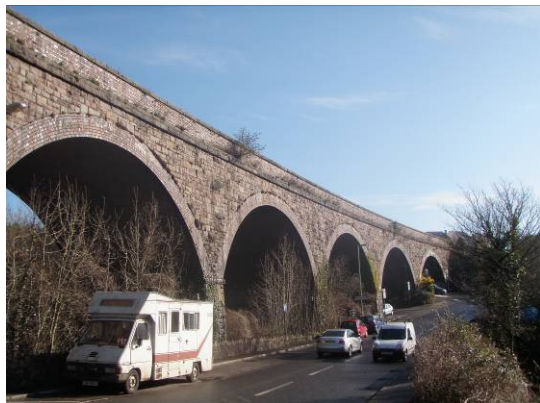
Figure 4.4: Viaduct with medium height piers

**Multi span viaducts with medium height piers (typically constructed of stone) are less likely to exhibit spandrel wall defects.**

The proportions of this type of viaduct (e.g. relative stiffness of arch barrel and piers) may be the 'optimum arrangement' (with respect to detrimental spandrel wall behaviour), and as such will exhibit fewer spandrel wall defects.

This type of viaduct may also have been constructed from stronger and better bonded material, that is less prone to fracture and shear.

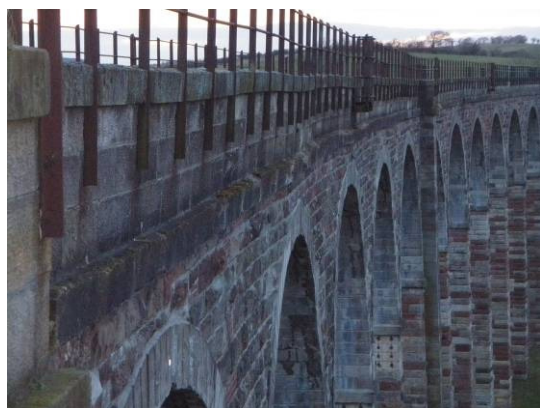
Figure 4.5: Mis-aligned stringcourse, Burnton Viaduct

**Viewing the stringcourse along the line of the spandrel walls and along the length of the structure may highlight spandrel wall defects (e.g. bulging or tilting of wall).**

The original function of the string course was cosmetic; it was primarily there to disguise the initial deflection that occurred in the arch on striking the centring. On many single short span arches this was unnecessary but the string course was retained as an architectural feature.

By viewing along the string course any bulging or tilting of the spandrel can be easily seen. Often there is also sagging over each span usually a caused by long term creep.

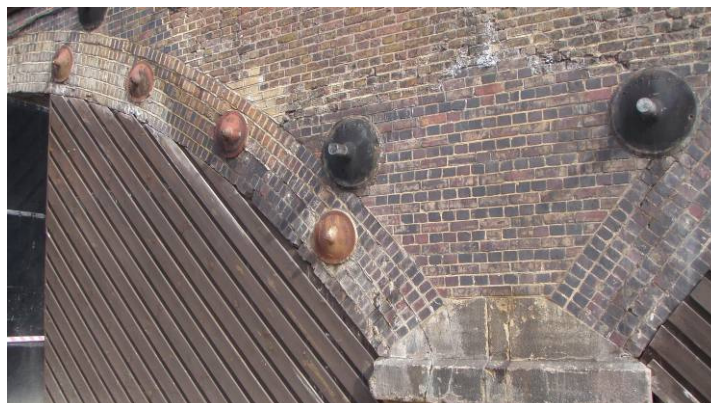
Figure 4.6: Extensive strengthening, Chelsea River Bridge northern approach

In some instances, the installation of tie rods and pattress plates has been found to be poor both in terms of provision and location. Spandrel ties need to be located either at the centroid or about the centroid (in the case of multiple ties) of the area of masonry being retained.

In determining where to place ties the level of the arch backing needs to be established so that the true shape of the spandrel and hence its centroid can be determined. If this is not done there is a risk of tying through the backing and producing a stress concentration. This will occur at the level of the backing which results in further fracture and continued movement of the spandrel above this level.

Note: the word centroid above refers to the geometric centroid; the centroid of forces can be assumed to approximate to this unless the detached spandrel is deep or a large section of masonry as in a high viaduct. In which case a more detailed assessment to establish the forces acting and enable the design and location of ties to be determined.

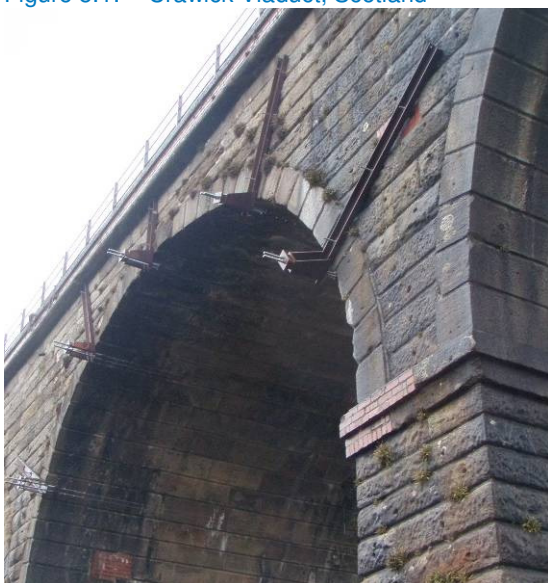
Figure 5.1: Crawick Viaduct, Scotland

- Temporary speed restrictions over the bridge
- Temporary operational restrictions over the bridge, e.g. single track operations or diversions
- Temporary traffic restrictions over the bridge, e.g. weight restrictions
- Special / sensitive examinations
- Manual monitoring using traditional surveying techniques
- Structural monitoring using automated instrumentation. Refer to Section 5.1.2
- Temporary strengthening works, e.g. external tie bars. Refer to Figure 5.1

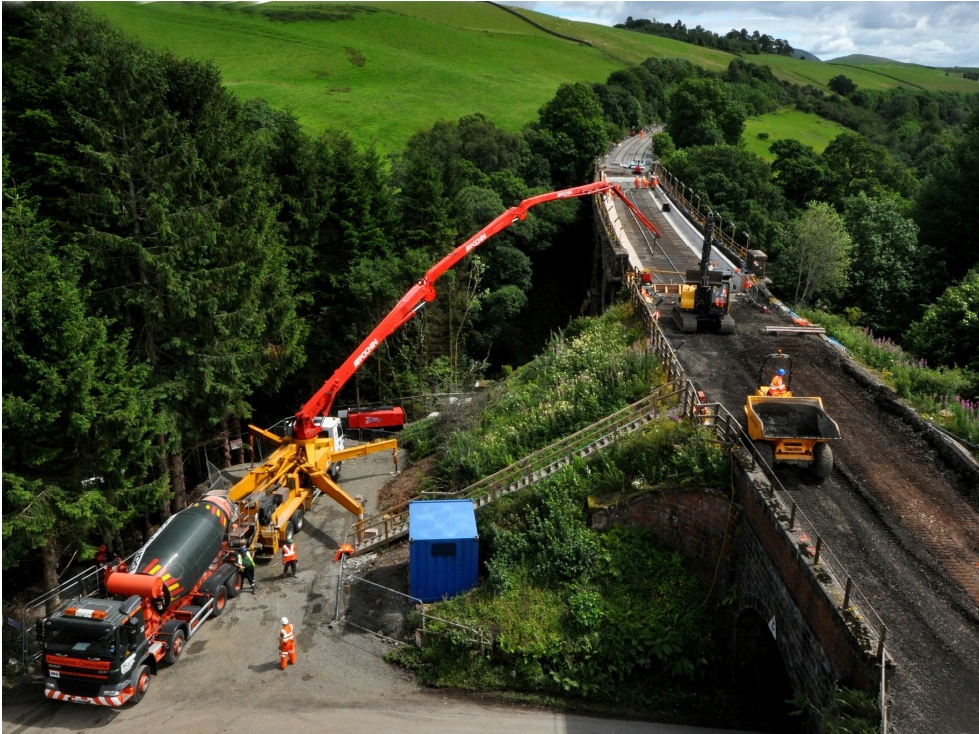
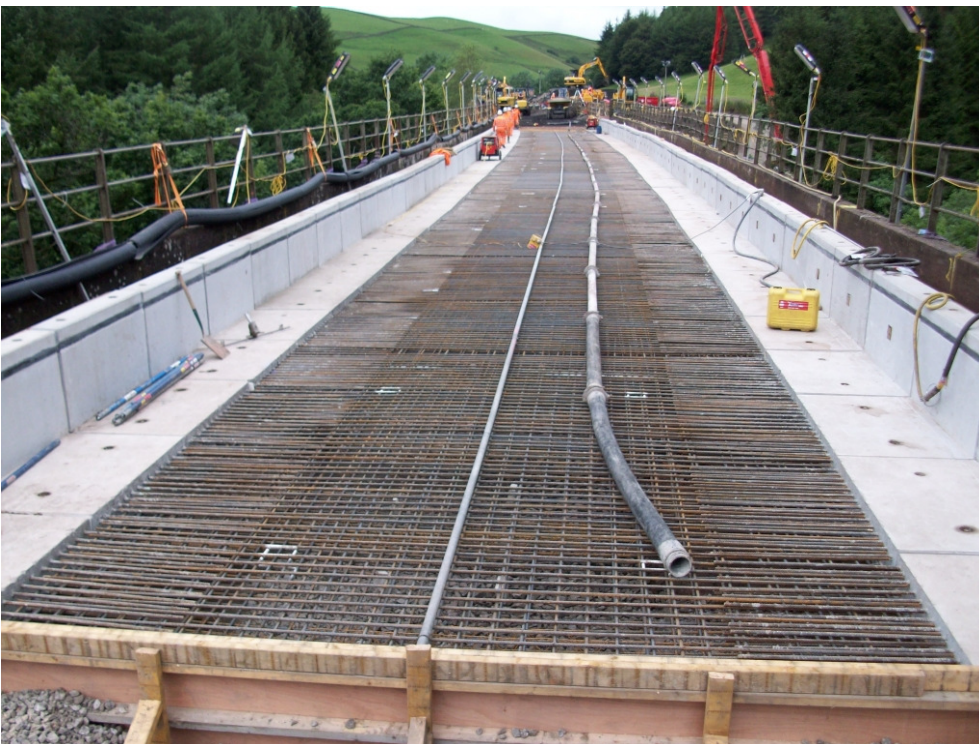
Figure 5.5: Construction of concrete saddle at Enterkin Burn, Scotland

This method of strengthening is implemented to essentially ensure that the existing (defective) spandrel walls are redundant. The new concrete trough provides lateral support to the ballast / fill material, and is usually only implemented on multi span structures that suffer from severe or extensive spandrel wall defects that are beyond simpler repair solutions.

Recent examples were implemented at Crawick and Enterkin Burn Viaducts in Scotland.

- The implementation of a concrete trough at Crawick and Enterkin Burn Viaducts has been effective in curtailing further spandrel wall movement. This was demonstrated with the structural monitoring programme completed for these structures.

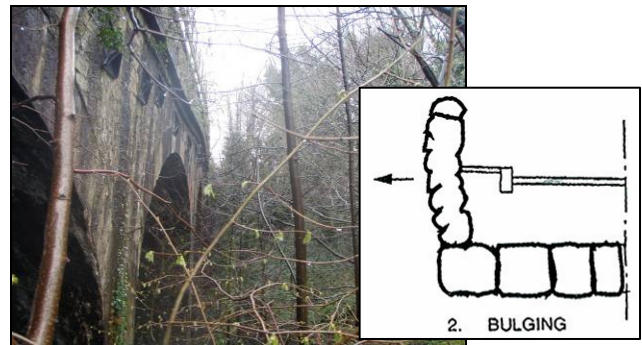
### 2. Bulging

- *Bulging/distortion of spandrel wall.*

- *All masonry arch bridges, in particular structures with significant cover.*

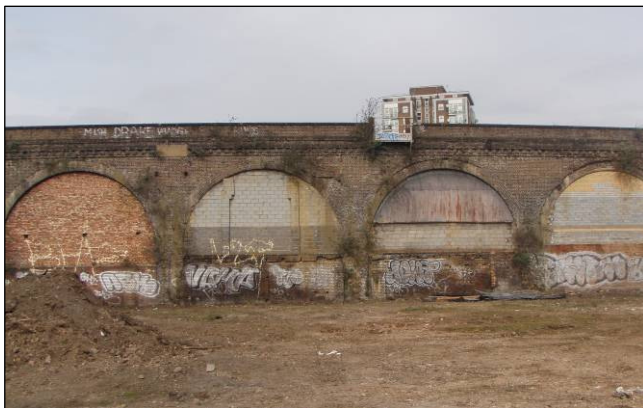
4. Multi span brick viaducts with stocky piers typically exhibit lateral displacements of the spandrel wall.

*Viaducts with stocky piers are constrained and generally have much less global flexibility and lower deflections. Because of this the change in stiffness between the spandrel and barrel is less significant and the shear forces on the horizontal mortar joint become more dominant hence the spandrel is more likely to be displaced laterally.*

*Viaducts with stocky piers can be considered to act more like a series of individual spans and where defects occur in adjacent spans the engineer should also consider the possibility that the pier settlement may have occurred.*

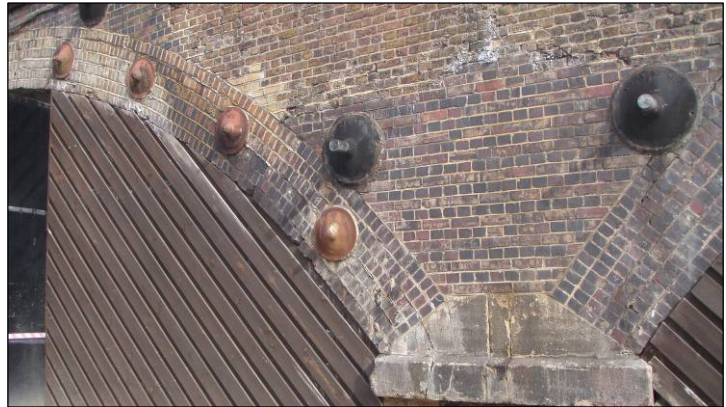
*In determining where to place ties the level of the arch backing needs to be established so that the true shape of the spandrel and hence its centroid can be determined. If this is not done there is a risk of tying through the backing and producing a stress concentration. This will occur at the level of the backing which results in further fracture and continued movement of the spandrel above this level.*

*Note: the word centroid above refers to the geometric centroid; the centroid of forces can be assumed to approximate to this unless the detached spandrel is deep or a large section of masonry as in a high viaduct. In which case a more detailed assessment to establish the forces acting and enable the design and location of ties to be determined.*
