# CULTURAL LANDSCAPE REPORT FOR ASPET

## SAINT-GAUDENS NATIONAL HISTORIC SITE

### VOLUME II: RECENT HISTORY, EXISTING CONDITIONS, AND ANALYSIS

Olmsted Center for Landscape Preservation  
National Park Service, Boston, Massachusetts, 2009

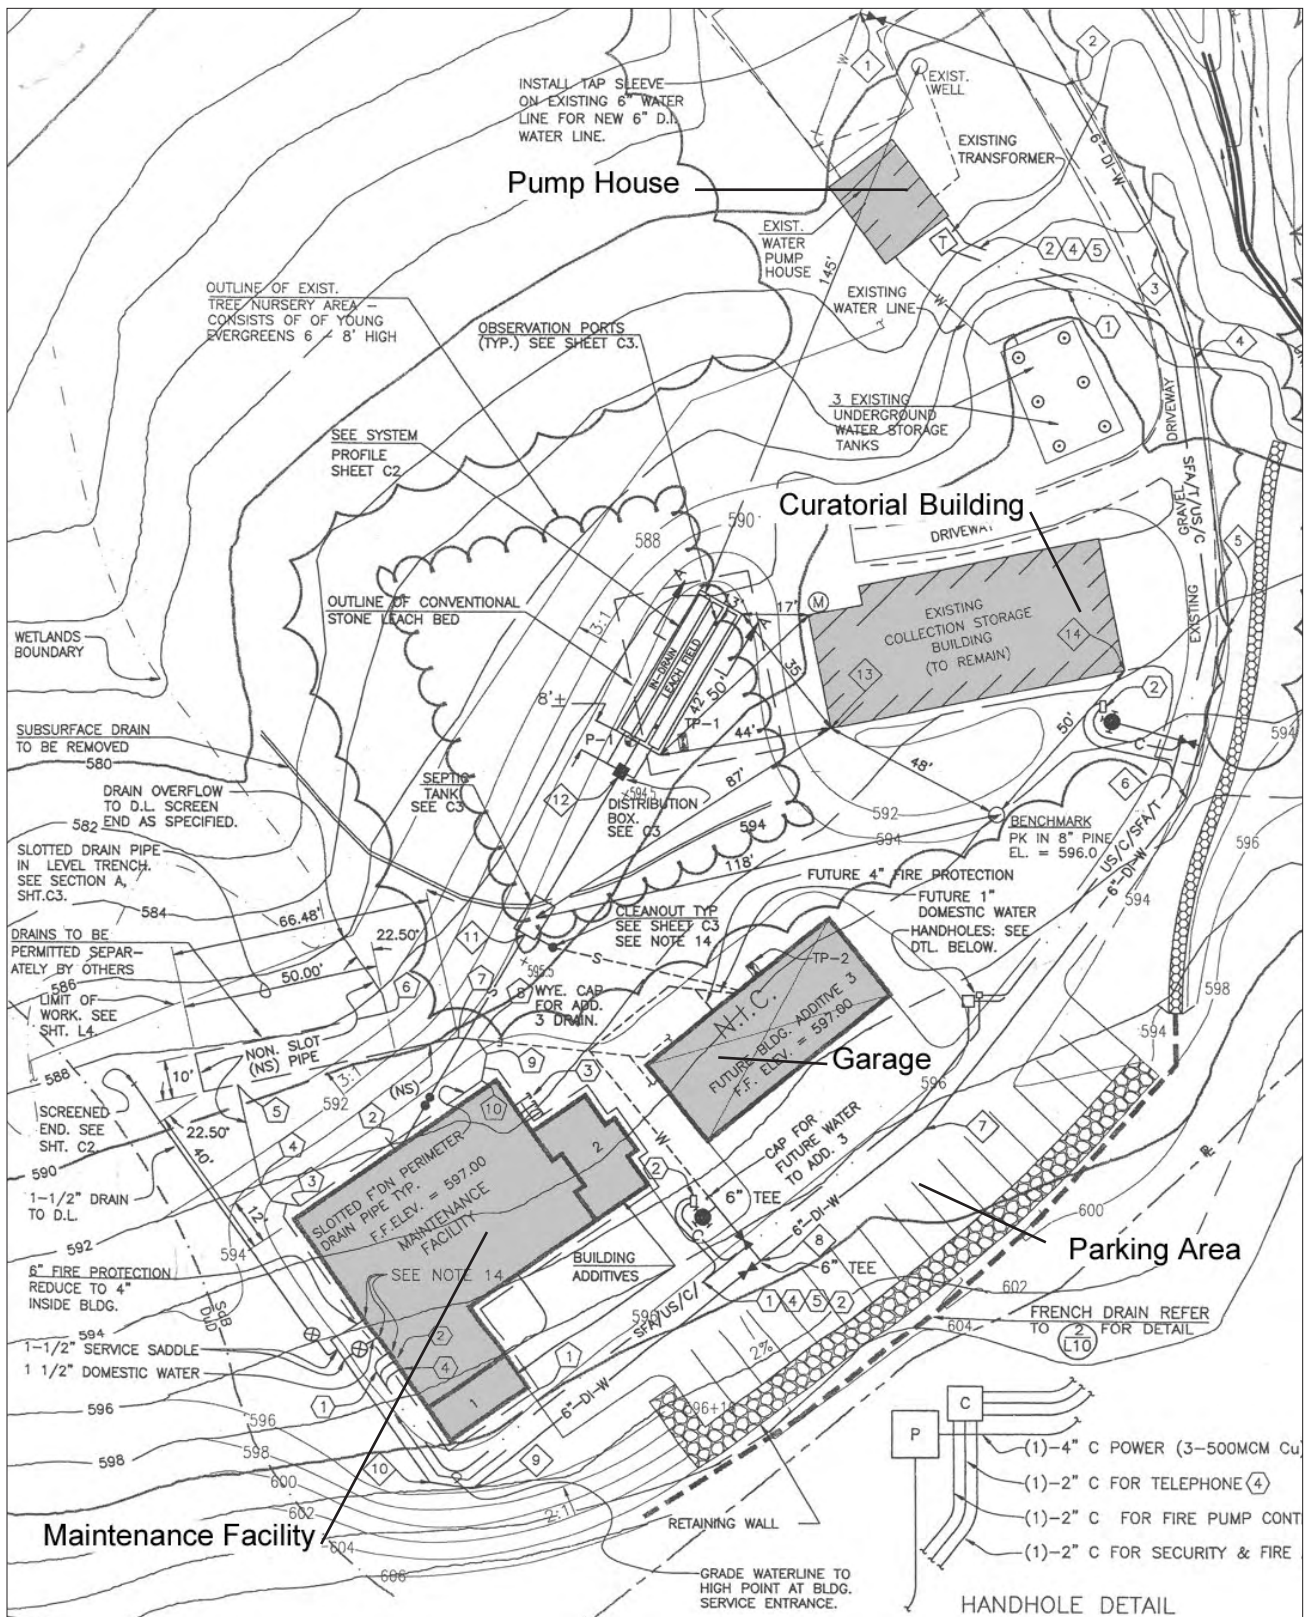
Figure 2. Construction drawings of the new Maintenance Facility, located on the south side of Saint Gaudens Road. The Collections Building and Pump House pre-dated the Maintenance Facility and its associated Garage (Sheet C1, Project Drawings, February 19, 1997, Saint-Gaudens National Historic Site, 14431B450097904, New Maintenance Building, CX 2000 92 007, SAGA files).

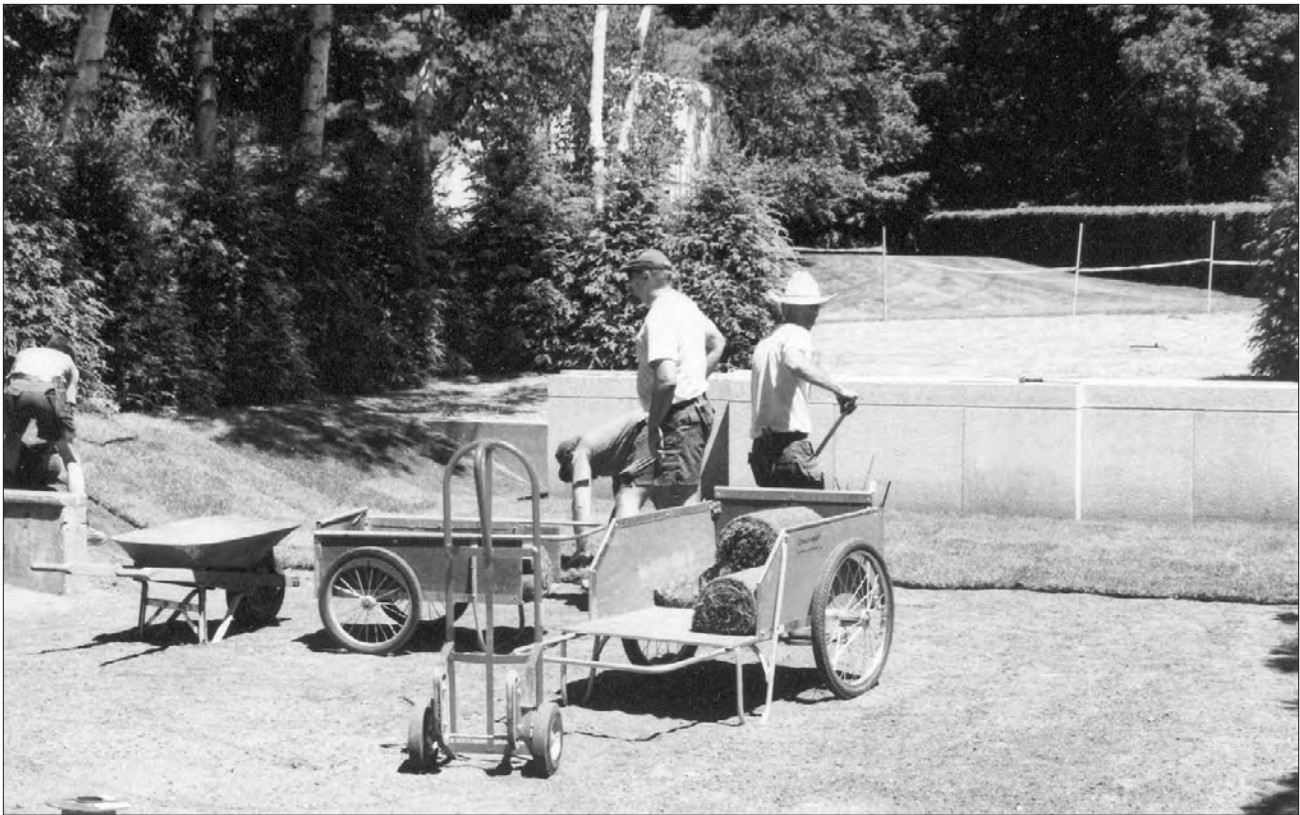
Figure 3. Laying sod at the newly constructed Shaw Memorial base. Hedges east of the statue base were removed to provide access to the area and the area was regraded (SAGA, 1997).

As identified in the *General Management Plan*, it was desired to replace the plaster Shaw Memorial with a cast of the bas relief statue to protect the original from further deterioration. Exposure to the elements threatened the integrity of the fragile statue despite its protective enclosure that was built during the Memorial period. As a solution, the National Park Service and the Trustees of the Saint-Gaudens Memorial entered into a cooperative agreement in 1997 to re-cast the Shaw Memorial in bronze.<sup>6</sup> The bronze cast and a new base were installed in February 1997 in the same location as the original plaster (Figure 3).<sup>7</sup> Portions of the bowling green hedge were removed during the construction process and replanted the following spring. The bronze statue is now displayed in the open air without any enclosing structure to obscure views of the work, mimicking the conditions of the original memorial that is displayed on the Boston Common (Figure 4). The park has on a long-term museum loan to the National Gallery of Art in Washington, D.C. the original plaster statue for conservation and display.

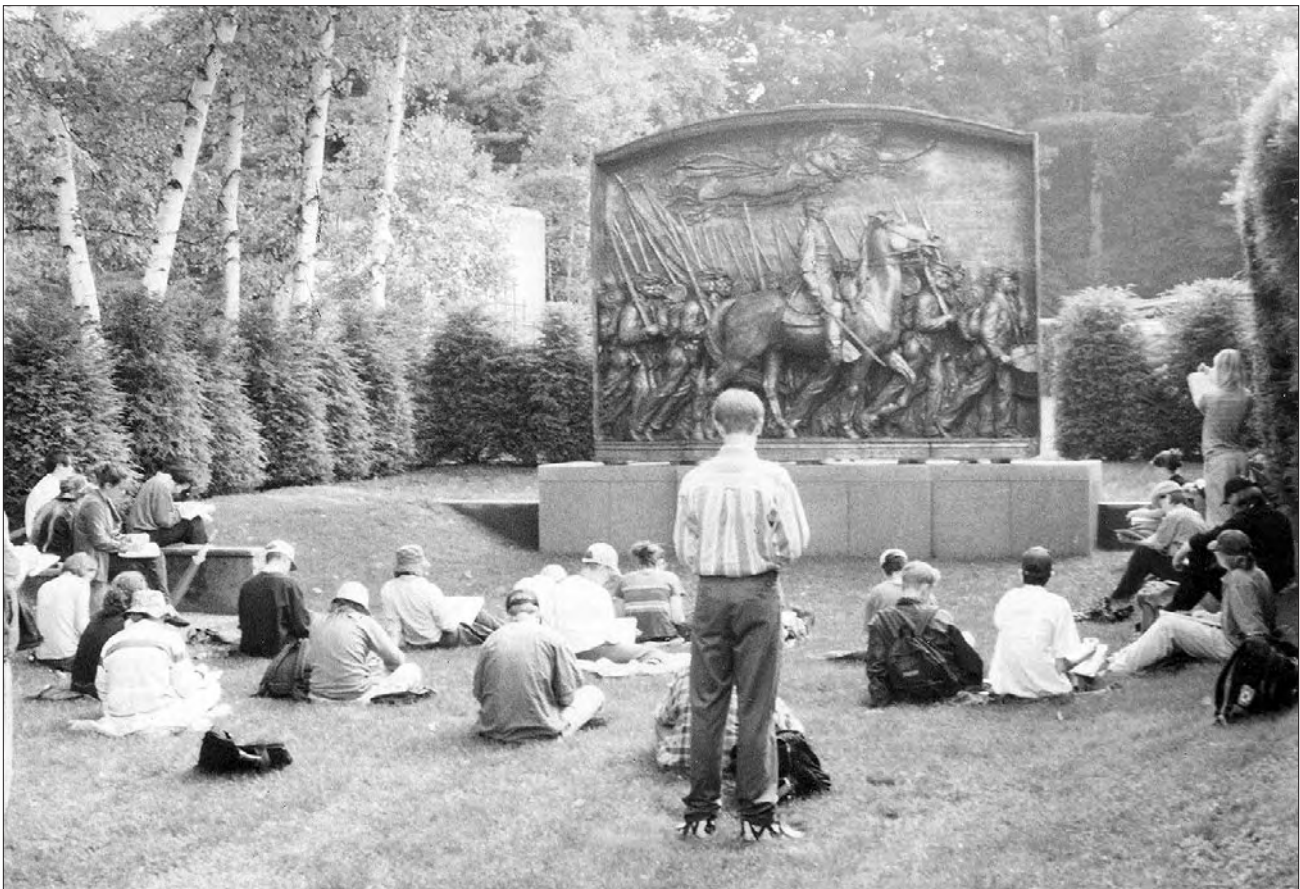
Figure 4. The newly renovated Bowling Green with the Shaw Memorial bronze cast. New hemlock hedges were planted around the north and east sides of the statue (SAGA 1997).

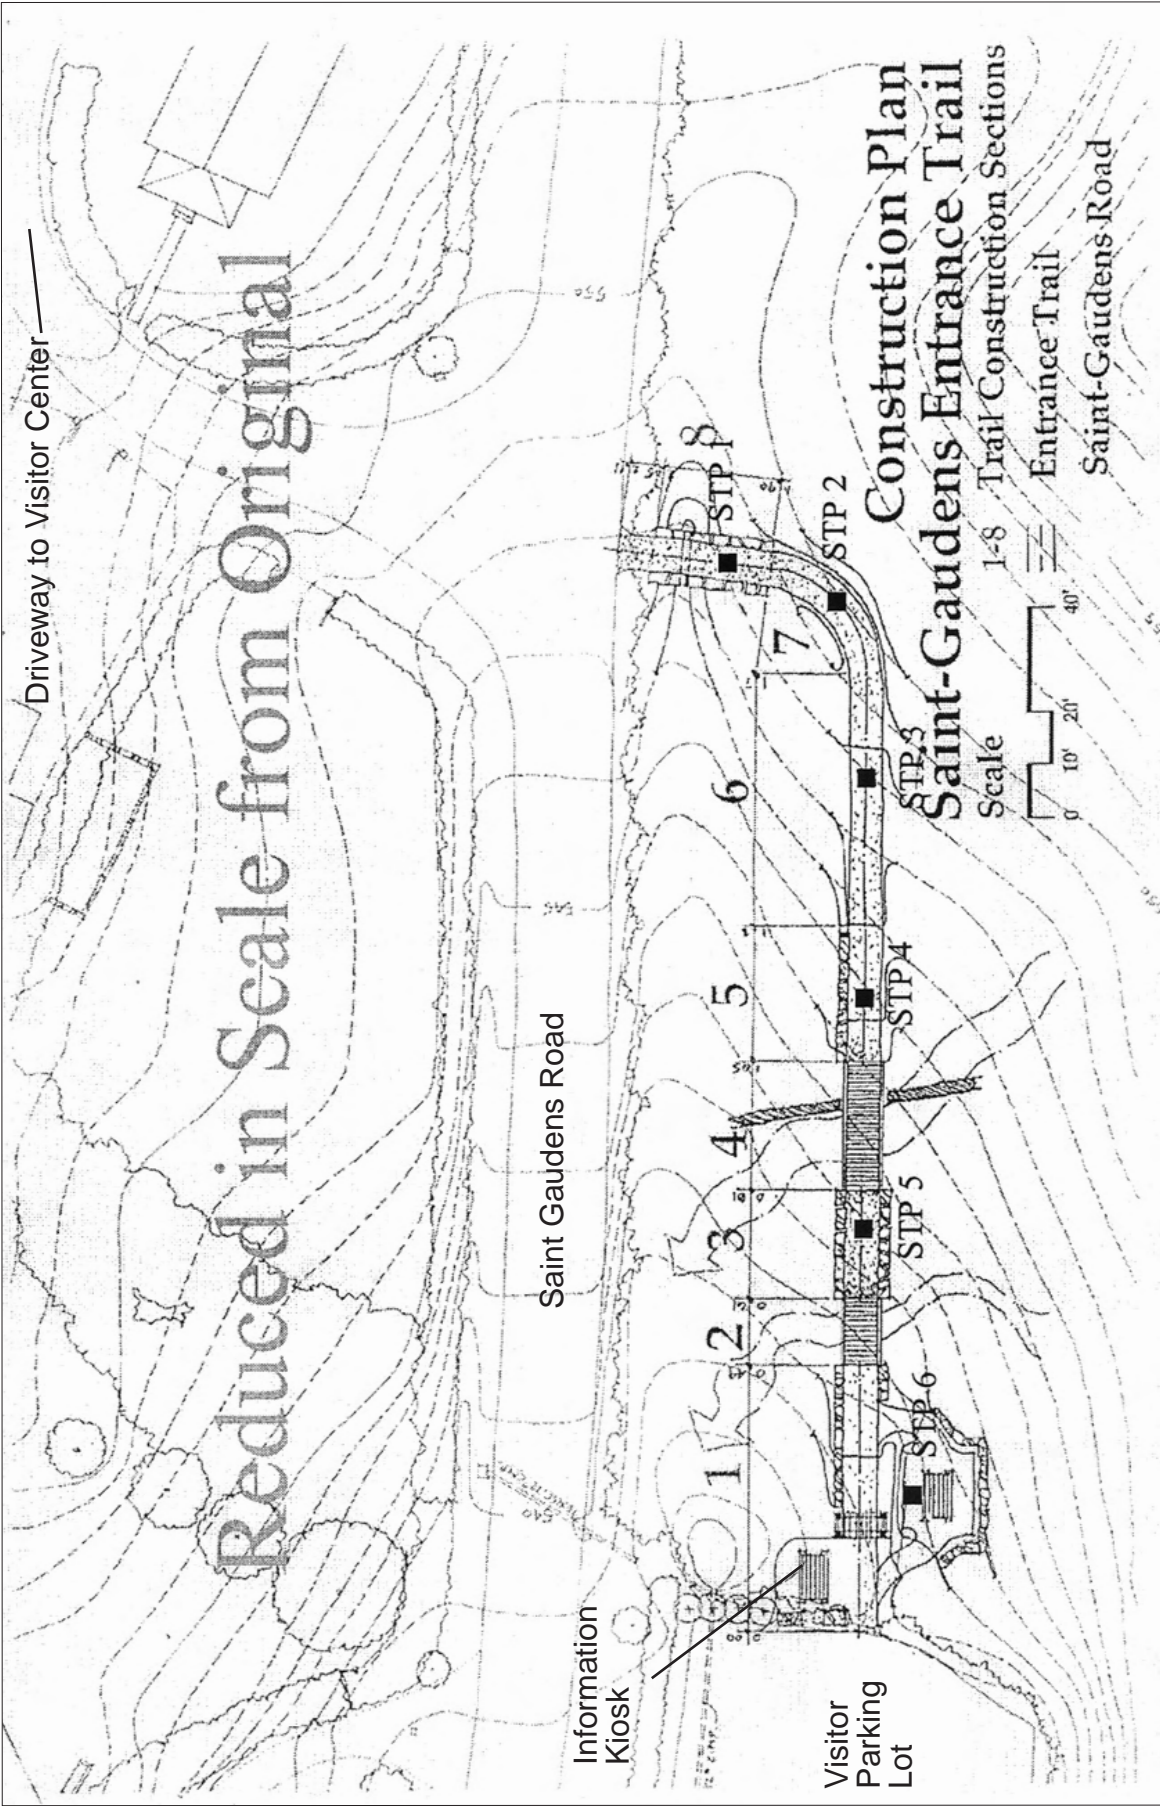
Figure 5. Project drawing of the trail between the visitor parking lot and the visitor center (Trail Construction Section, Project Documents for Entrance Trail, June 21, 2000, SAGA files).

As the visitor center was planned to be the contact point for site orientation, getting pedestrians safely between the parking lot on the south side of Saint Gaudens Road and the proposed visitor center was paramount. Also of concern was that the main house was directly in view from the parking lot—especially after the overgrown horseshoe hedge was replaced in 1996—drawing visitors to the house where no orientation services were available. In response, and prior to the dedication of the new visitor center, the park built a compacted gravel pedestrian path in 2000 along the south side of the road, connecting the east side of the parking lot to the east entry drive (Figures 5 and 6).<sup>10</sup> The path extends through a forested area and incorporated natural materials such as rough stone retaining walls and wooden footbridges to blend with the surrounding landscape. A small wooden kiosk was placed in the parking lot to provide an initial point of contact, directing visitors along the new path and to the visitor center.

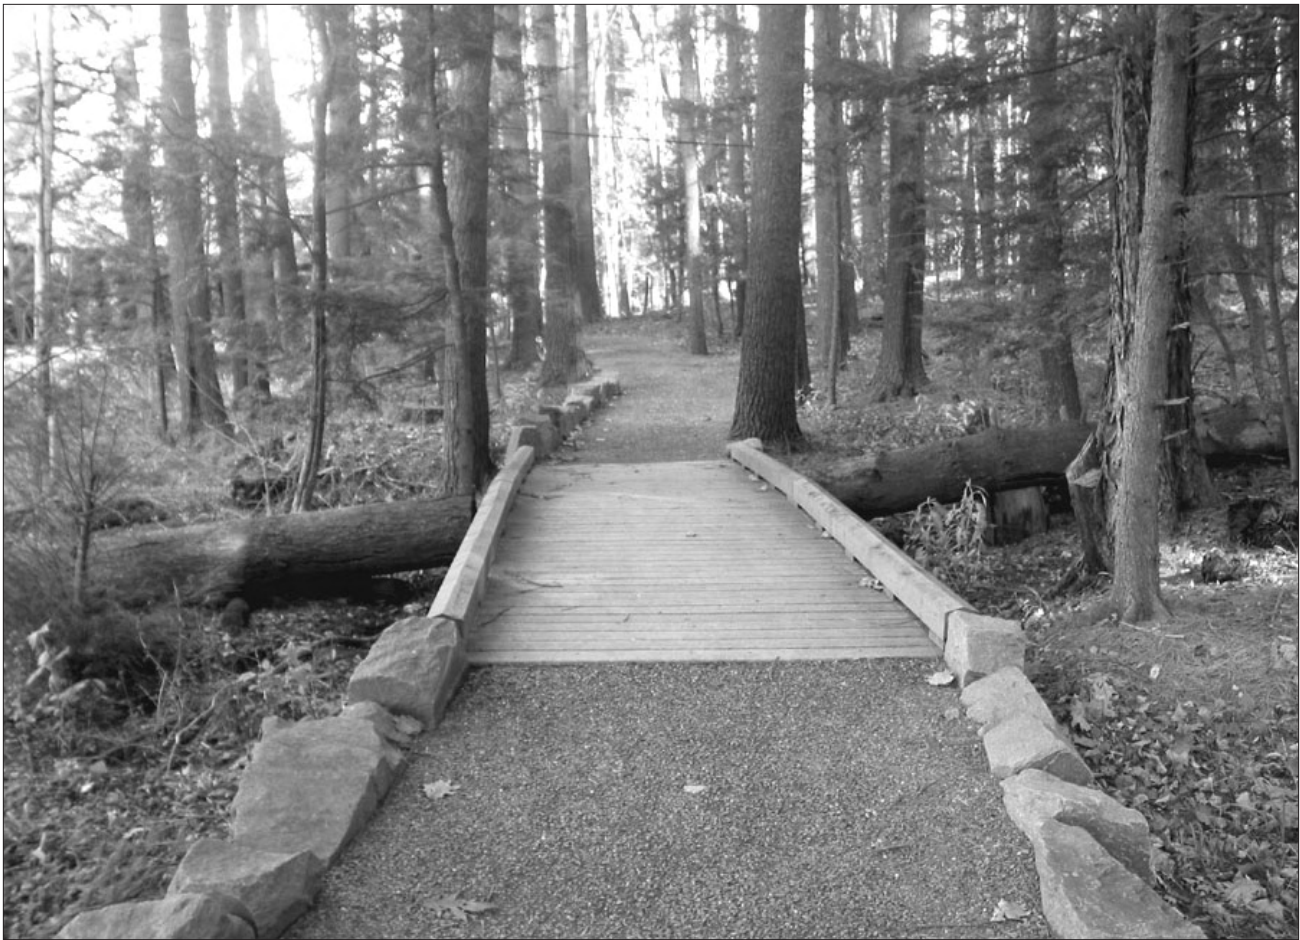
Figure 6. The trail between the parking lot and visitor center (OCLP, 2006).

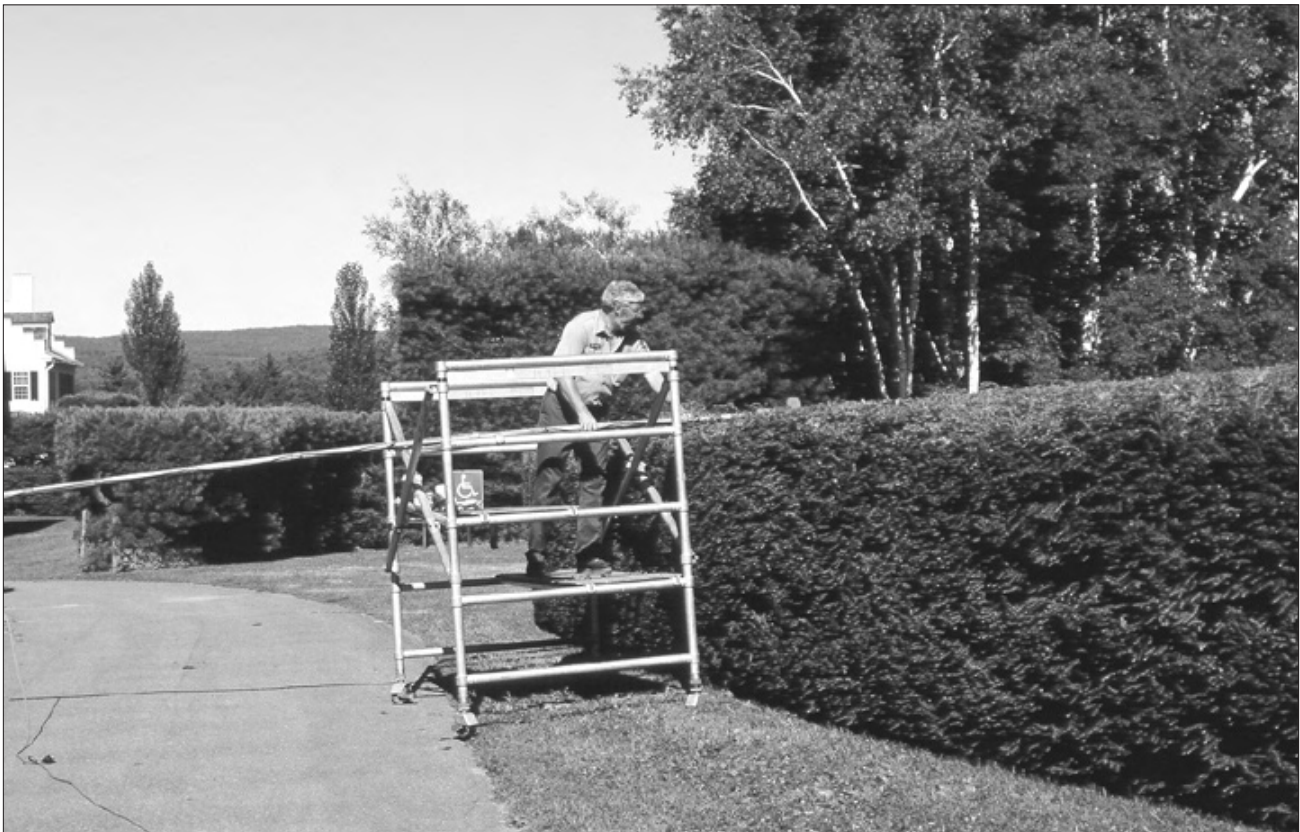
Figure 7. Hedge trimming on scaffolding north of the Caretaker's Cottage (OCLP, 1993).

The hedges of Saint-Gaudens NHS are one of the most distinctive features of the landscape. Many create enclosed garden rooms or serve to separate spaces from one another. The hedges are pruned once a year, using two different techniques, one for the white pine and another for the hemlock hedges (Figure 7). Prior to the year 2000, the white pine hedges were pruned by pinching off the new growth, or candles, by hand. Since then, staffing constraints preclude such an expenditure of time and the white pine hedges are clipped in a more expedient manner. The white pines are now clipped with hand pruners and the hemlocks are sheared with mechanical trimmers. Though less in recent years, the hedges received fertilization on a two-year cycle to help retain health and vigor.<sup>12</sup>

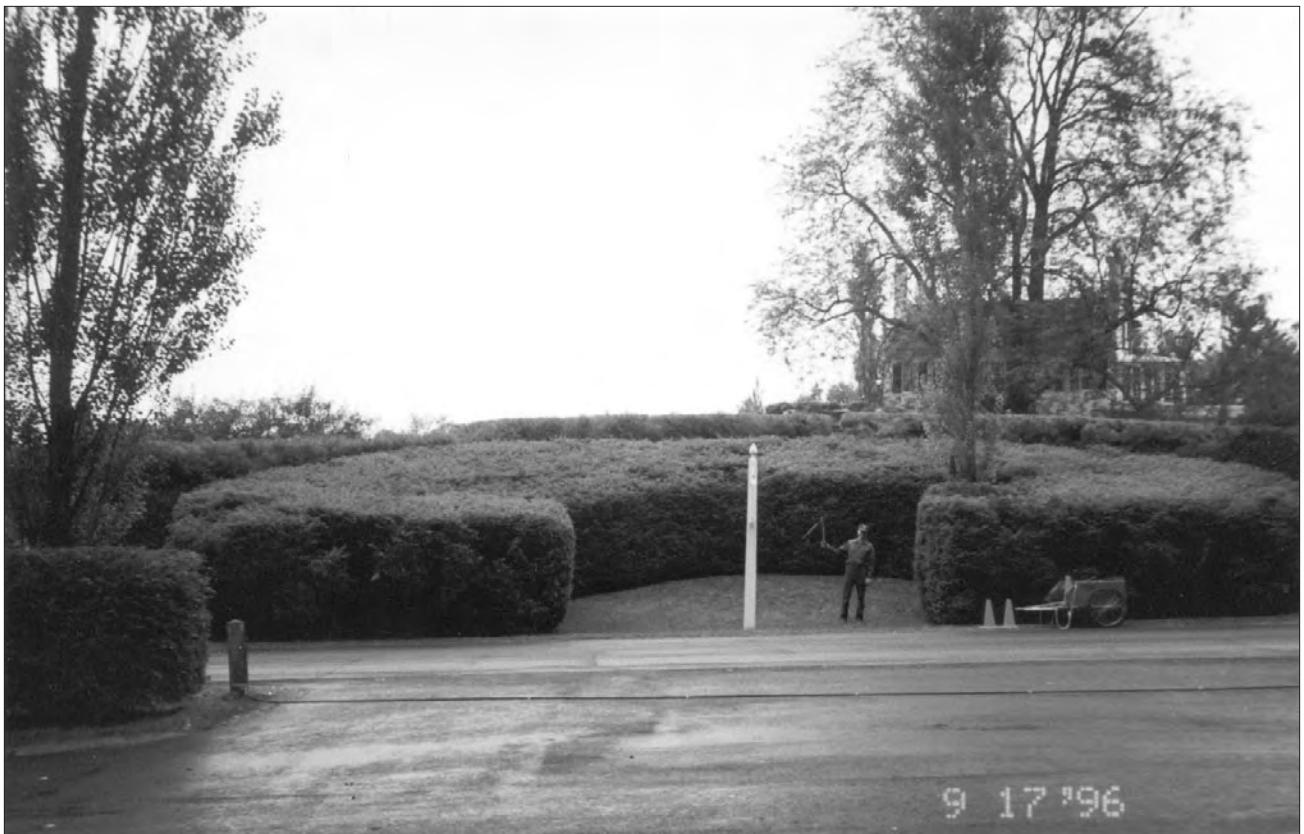
Figure 8. Horseshoe hedge at Aspet's main entrance before replacement (SAGA, 1996).

A few hedges have been replaced in their entirety due to poor condition or over-maturation. The park has used supplemental planting, or in-fill planting, more commonly when trying to breach gaps in existing hedge segments. The few hedge sections that were replaced include the horseshoe hedge at the carriage turn-around in 1996, the hedge at the Lincoln bust in 1998, and the section of white pine hedge along Saint Gaudens Road, south of the carriage turn-around (Figures 8 and 9). This segment was removed in 2006 and replaced in the spring of 2007. All replacements have been in-kind, using the same species as the existing specimens.

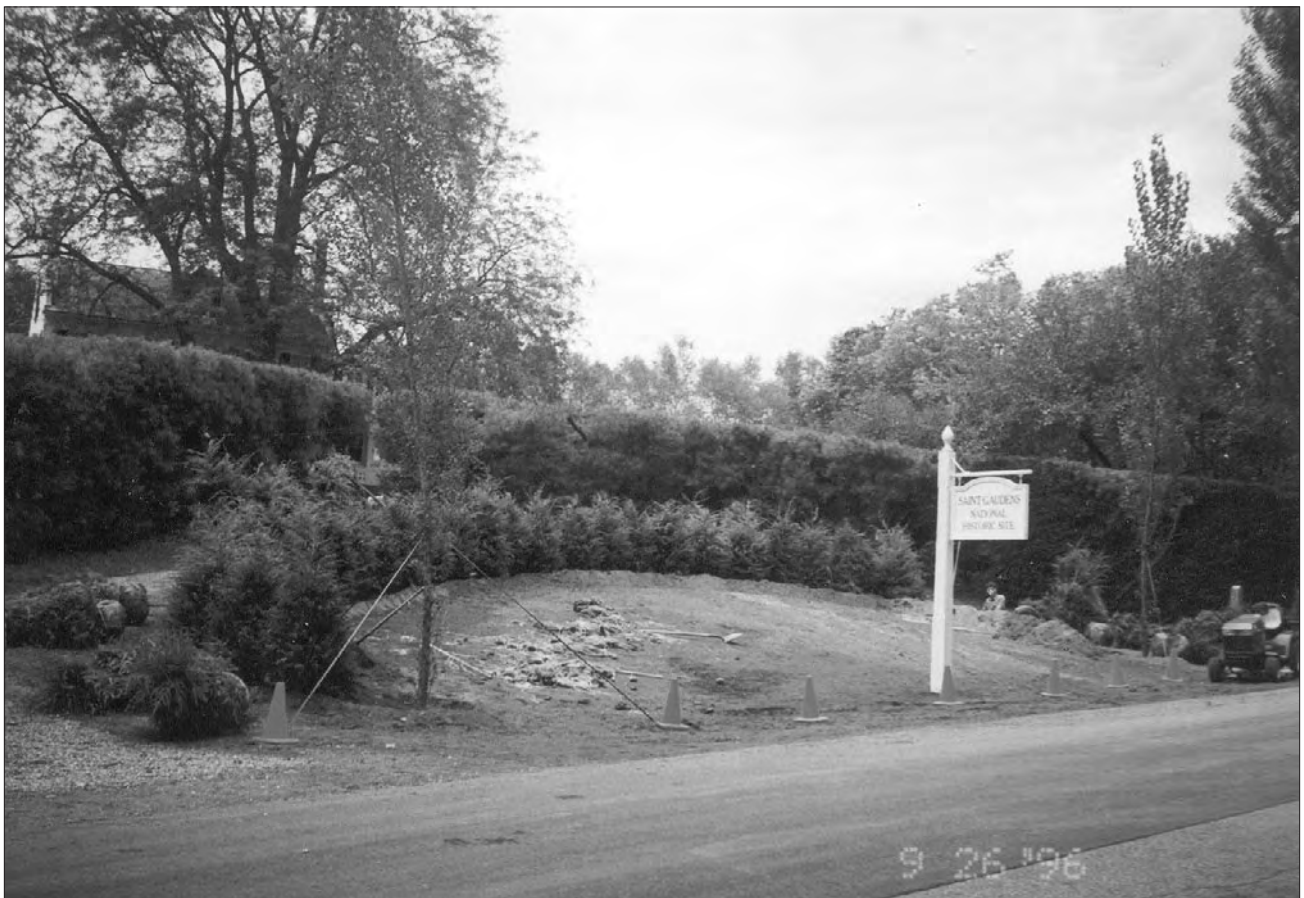
Figure 9. The horseshoe hedge at Aspet's main entry shortly after replacement. The lawn inside the semi-circle and gravel path behind the hedges were opened up considerably with the smaller plant material (SAGA, 1996).

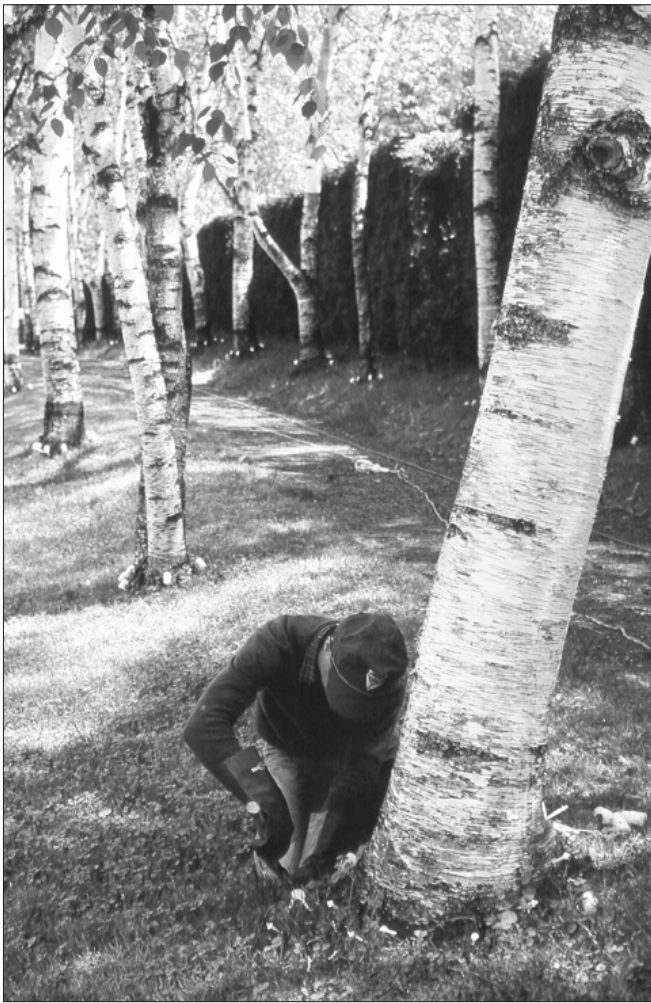
Figure 10. Left. The birch alley is treated with insecticide to combat bronze birch borer (OCLP, 1996).

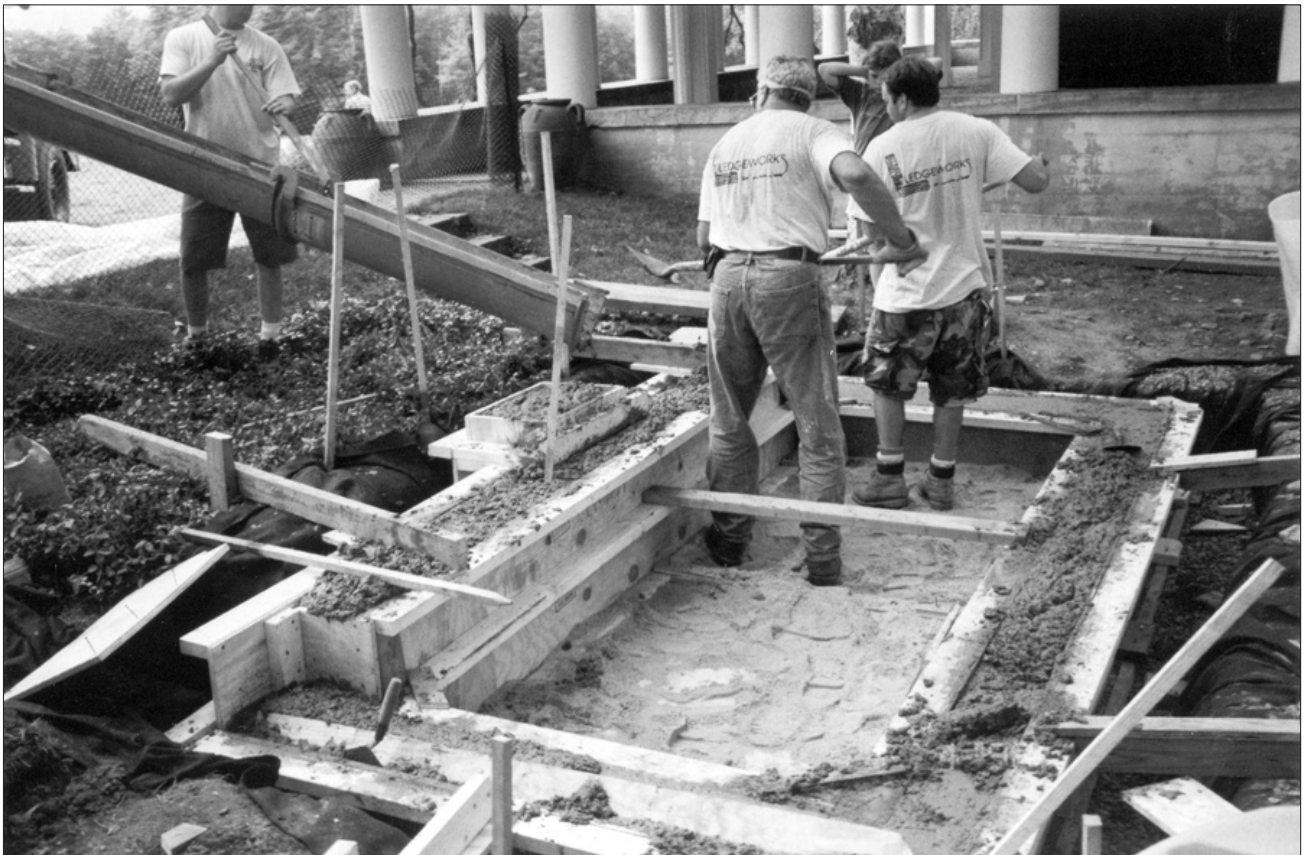
Figure 11. Below. Reconstruction of the Pan pool and fountain (SAGA, 1996).

Working with a contractor, the park rehabilitated the Pan pool in 1996. The statuary and white garden bench were temporarily removed to make way for a total replacement of the pool and its subsurface structure (Figure 11).

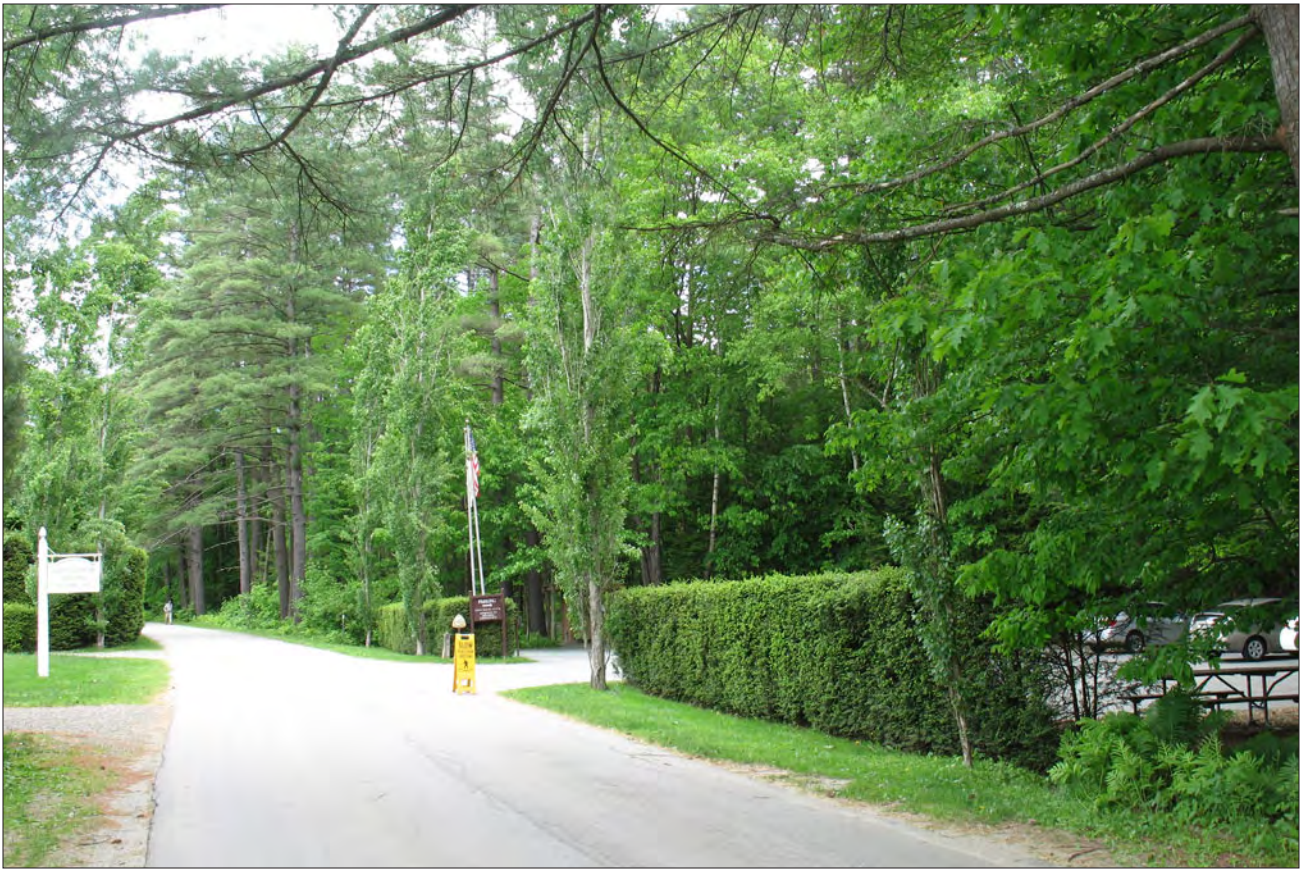
Figure 14. View southeast up Saint Gaudens Road of the entrance sign, visitor parking lot entrance, flagpoles, and four poplars at the ends of the hedges. The poplars at the far ends are heavily shaded by the adjacent trees (OCLP, 2009).

Several tall and columnar poplar trees, formerly Lombardy poplars, are located around the historic core. These are fast growing, short-lived trees that have been susceptible to disease. The park experimented with replacement cultivars and has used 'The Tower,' 'Theves,' and 'Swedish Columnar Aspen' in the park. The two distinctive poplars that used to grow on the east and west sides of Aspet's south terrace were removed and replanted in 2008. The honeylocust tree frequently shades out replacements on the east side of the terrace.

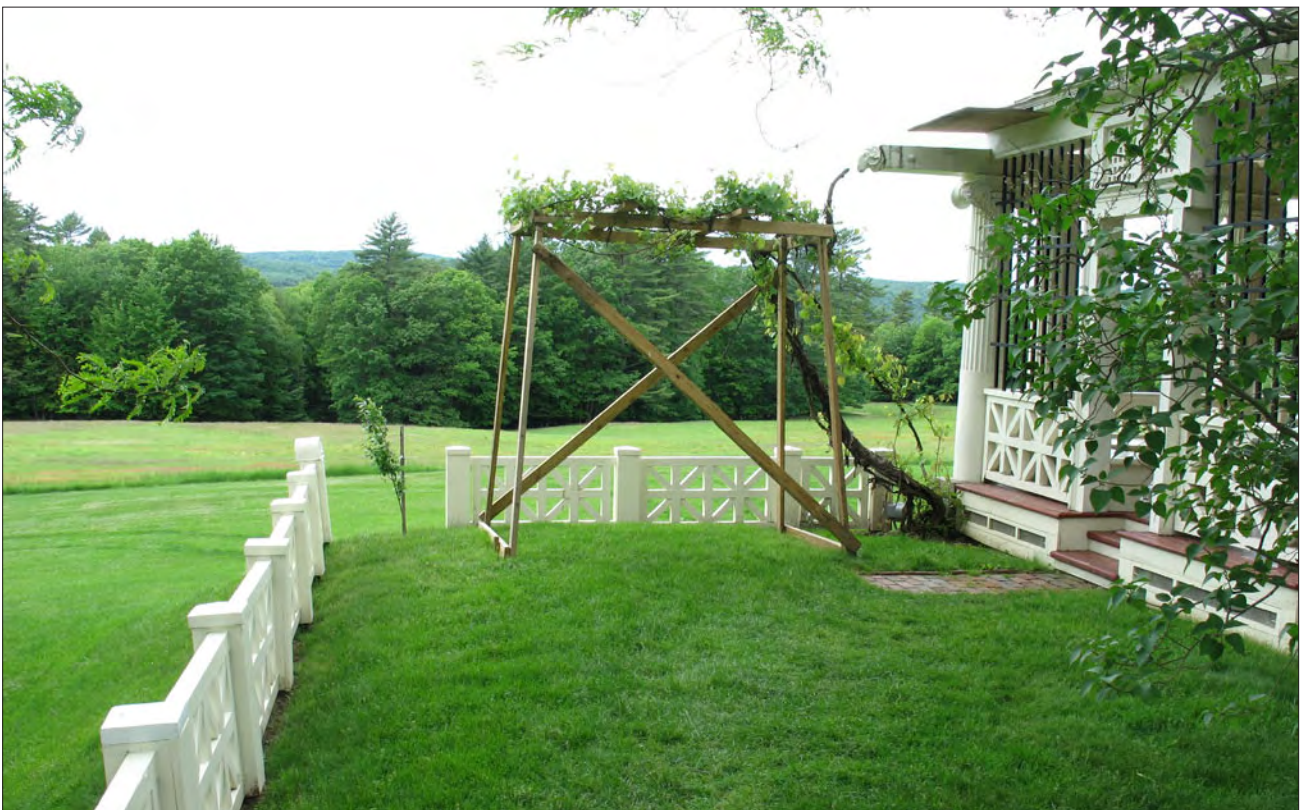
Figure 19. View west of the terrace balustrade, newly planted poplar, grape vine, lilac, brick walk, and piazza at the southwest corner of the house. The grape vine rests on a temporary structure while repairs are made to the piazza roof. The west meadow is visible in the background with Juniper Hill in Vermont partially visible in the distance (OCLP, 2009).

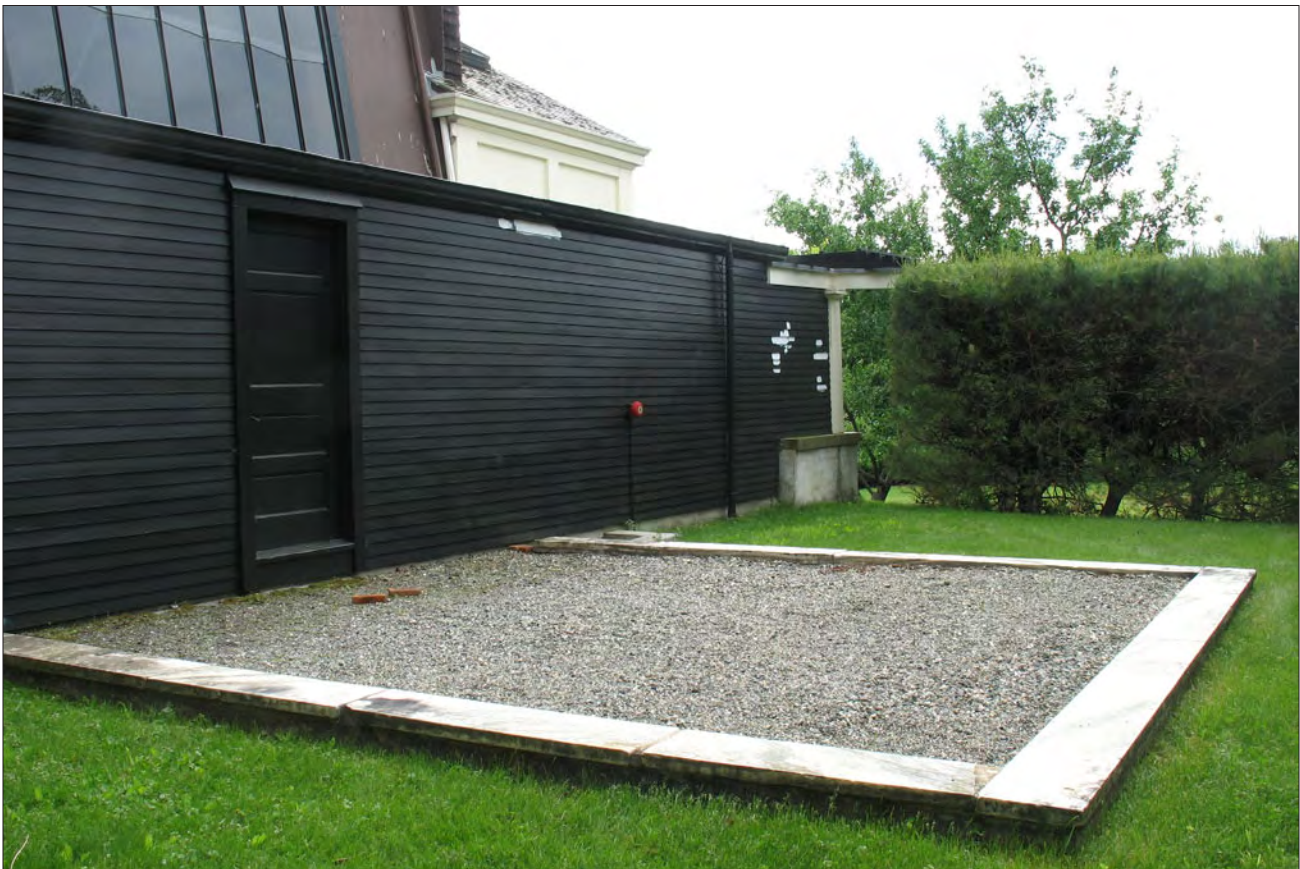
Figure 22. View west of the Little Studio pool, now filled with gravel, located on the north side of the building and surrounded by a white pine hedge (OCLP, 2009).

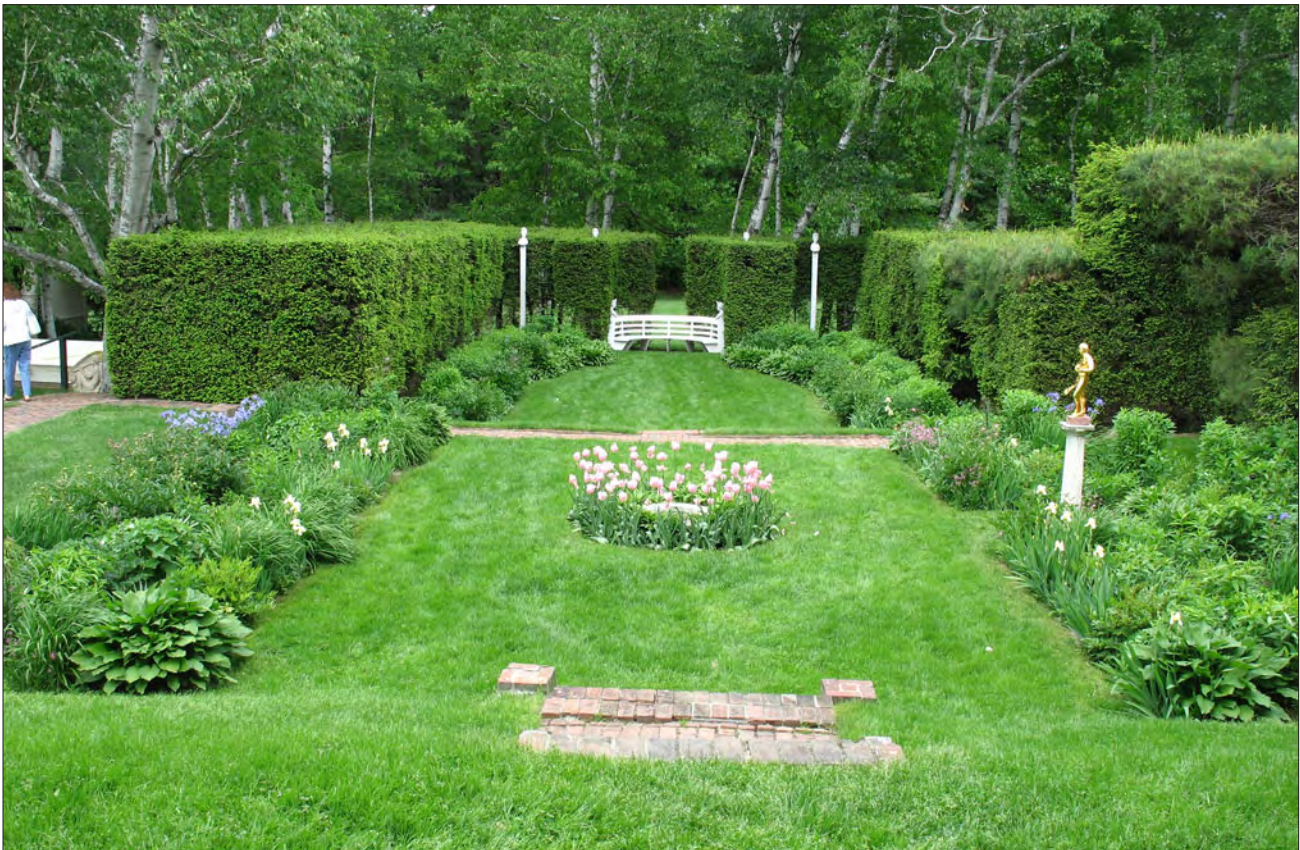
Figure 23. View north of the flower garden, with the small marble pool and bubbler in the center of the middle terrace and Hermes statue to the east (right). The semicircular zodiac bench and zodiac heads on posts are visible in the lower terrace (OCLP, 2009).

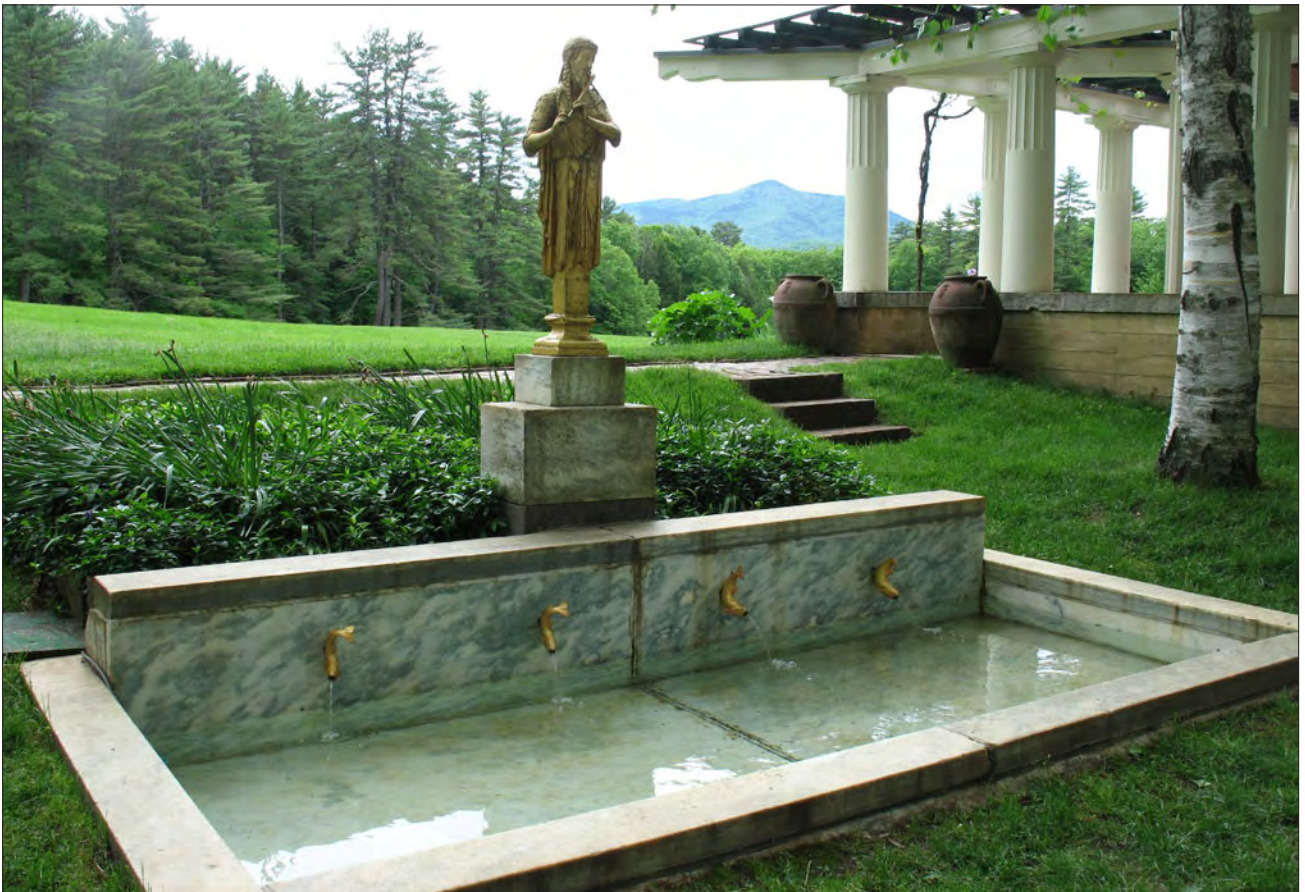
Figure 24. View southwest of the Pan statue and base, fish fountains, pool, and planting bed. The trunk of a mature paper birch and pair of terra-cotta jars by the Little Studio pergola are visible in the background (right), as well as Mount Ascutney in the distance (OCLP, 2009).

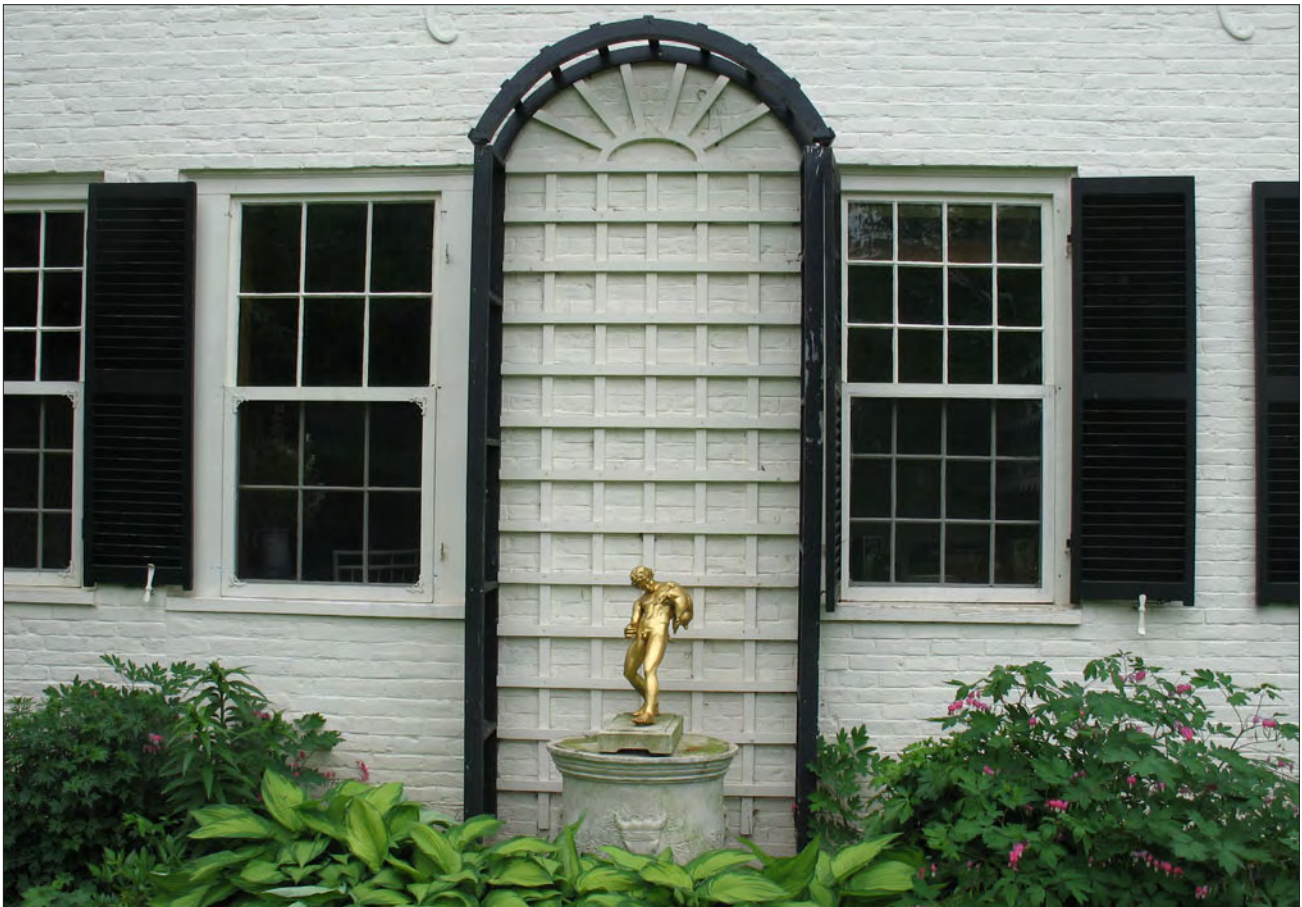
Figure 26. View south of the Boy with Wine Skin statue on a cistern base set against the north side of the house and framed with a lattice trellis (OCLP, 2009).

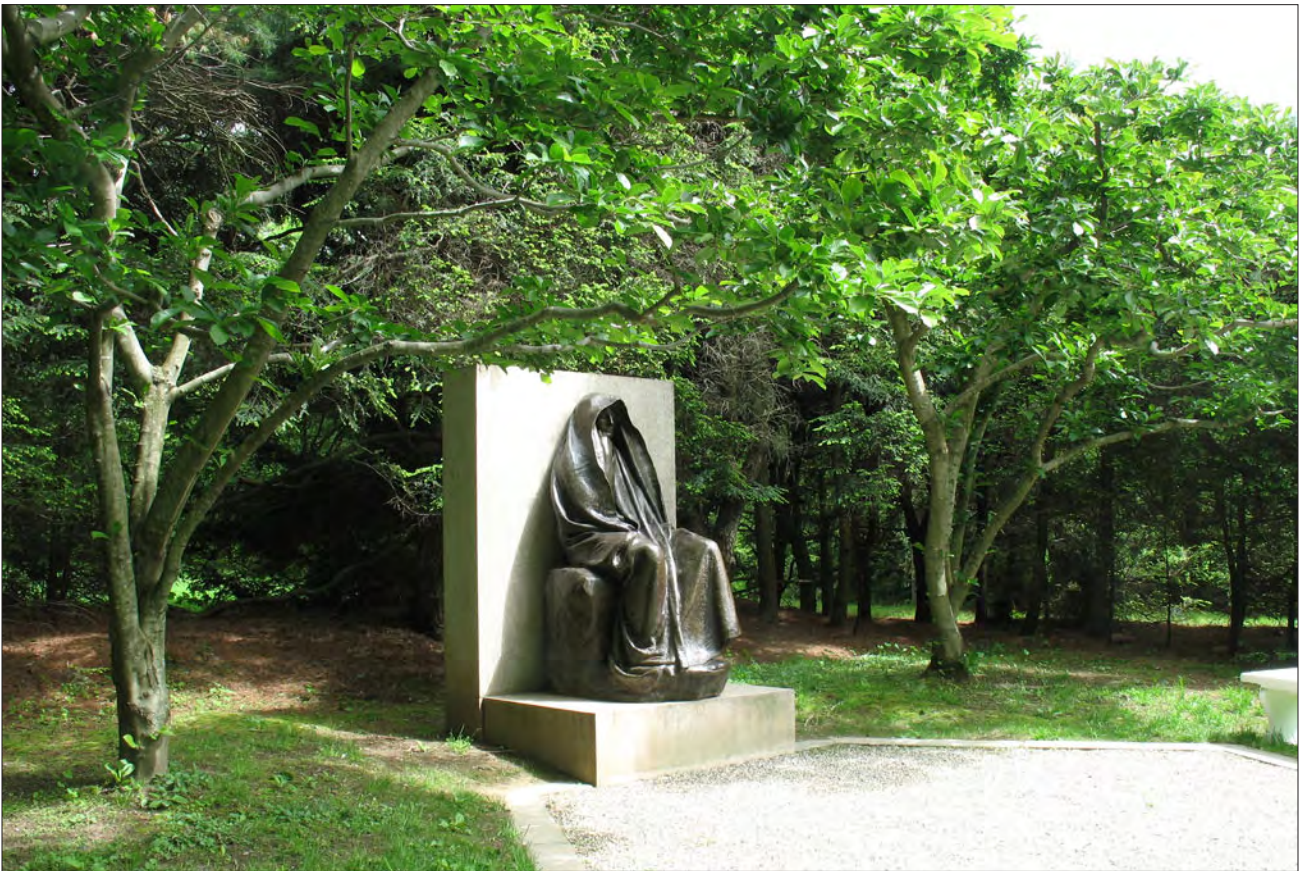
Figure 32. View southeast of the Adams Memorial in the former cutting garden framed by Dr. Merrill magnolias. A hexagon of granite blocks filled with pea-stone gravel frames the ground in front of the statue (OCLP, 2009).

The Adams Memorial space has been in a relative state of flux due to unresolved issues about suitable plant material and wear and tear on the ground surface. Two hornbeam trees framed the statue after its installation in 1968 but lighting conditions in the space were unsuitable and the trees were replaced with magnolias in the 1990s. Today, these trees have grown large and are pruned regularly so that the branches do not interfere with views of the statue. The trees achieve the design intent to create a canopy that arches over the sculpture, however, magnolias cast heavy shade, which has caused the surrounding turf and adjacent hedge to die back. While the ground was formerly covered in turf, constant foot traffic and heavy shade make maintaining healthy turf a challenge on an annual basis. In response, the park placed large flagstone pavers in the entry of the space to mitigate the damage caused by compaction.<sup>14</sup> In 2001, several hardscape features were added of which, today, remains a six sided figure of granite curbstone at ground level in front of the memorial.
