# CULTURAL LANDSCAPE REPORT FOR ASPET

## SAINT-GAUDENS NATIONAL HISTORIC SITE

### VOLUME II: RECENT HISTORY, EXISTING CONDITIONS, AND ANALYSIS

Olmsted Center for Landscape Preservation  
National Park Service, Boston, Massachusetts, 2009

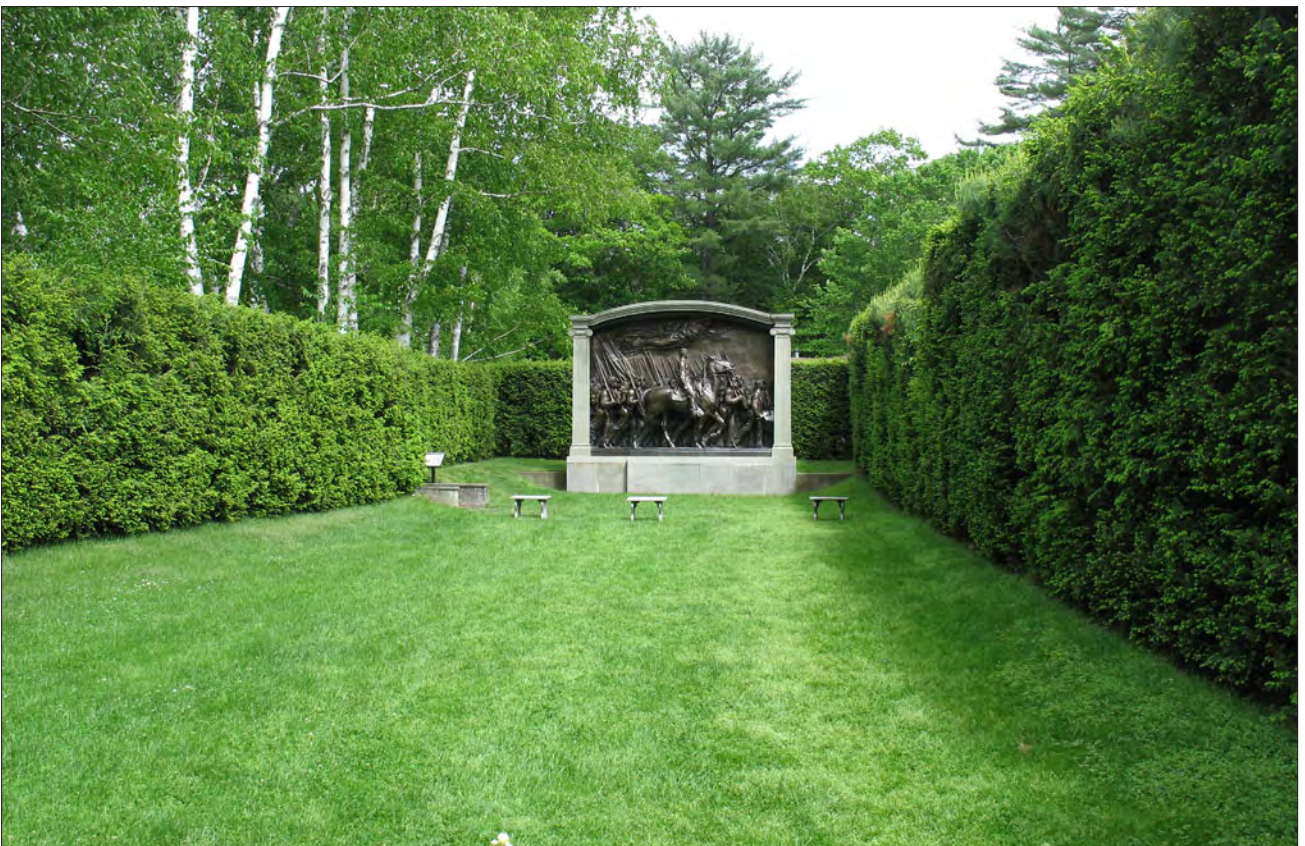
Figure 33. View east of the Shaw Memorial in the bowling green space with three short gray benches, a park wayside, and two retaining walls. The space is framed by mature hemlock and pine hedges and the birch allée to the north (left) (OCLP, 2009).

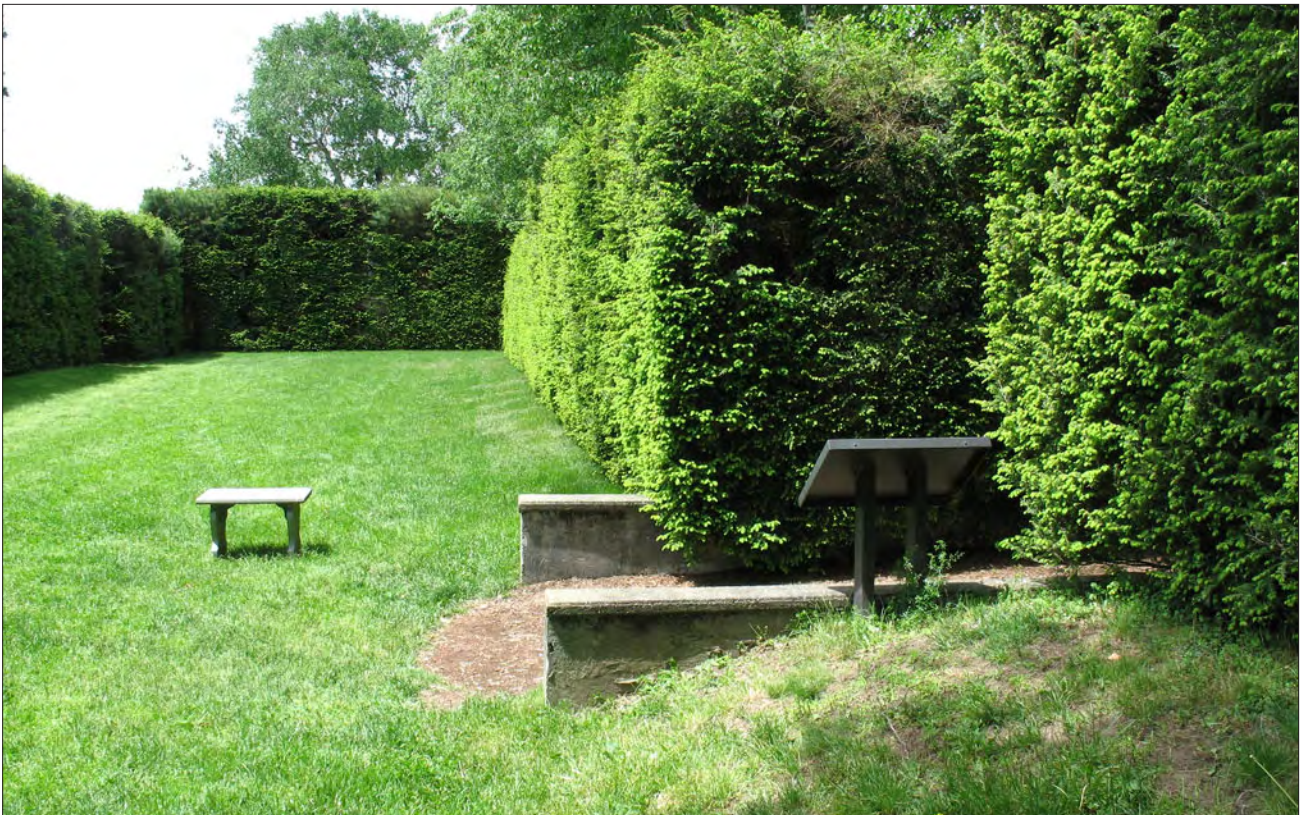
Figure 34. View west of the bowling green space. A gray bench is placed for viewing the Shaw Memorial. Short retaining walls remain from the 1959 installation. A park wayside provides information on the Shaw Memorial (OCLP, 2009).

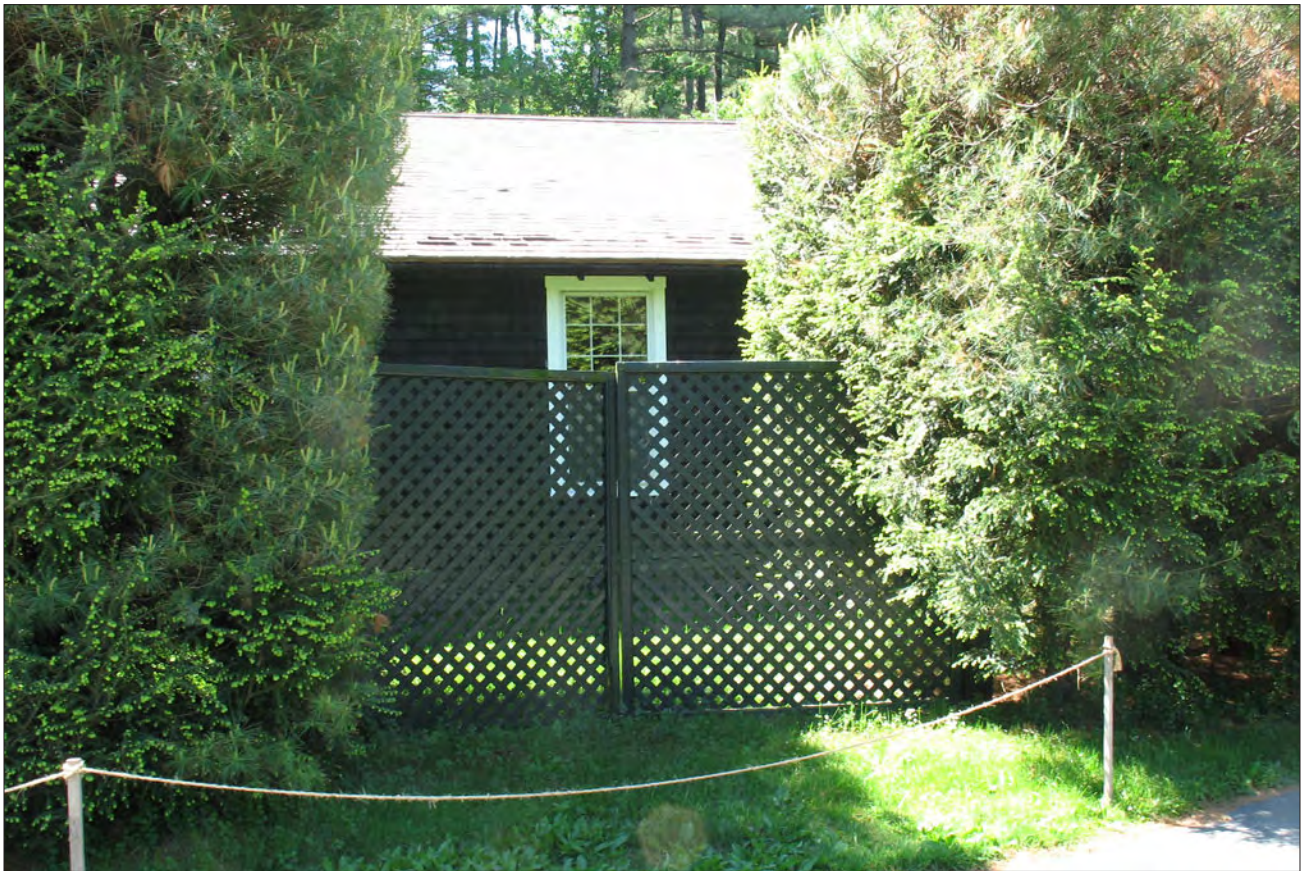
Figure 40. View south from the Caretaker's Cottage driveway of the Caretaker's Cottage and gate obscured by the overgrown hedge (OCLP, 2009).

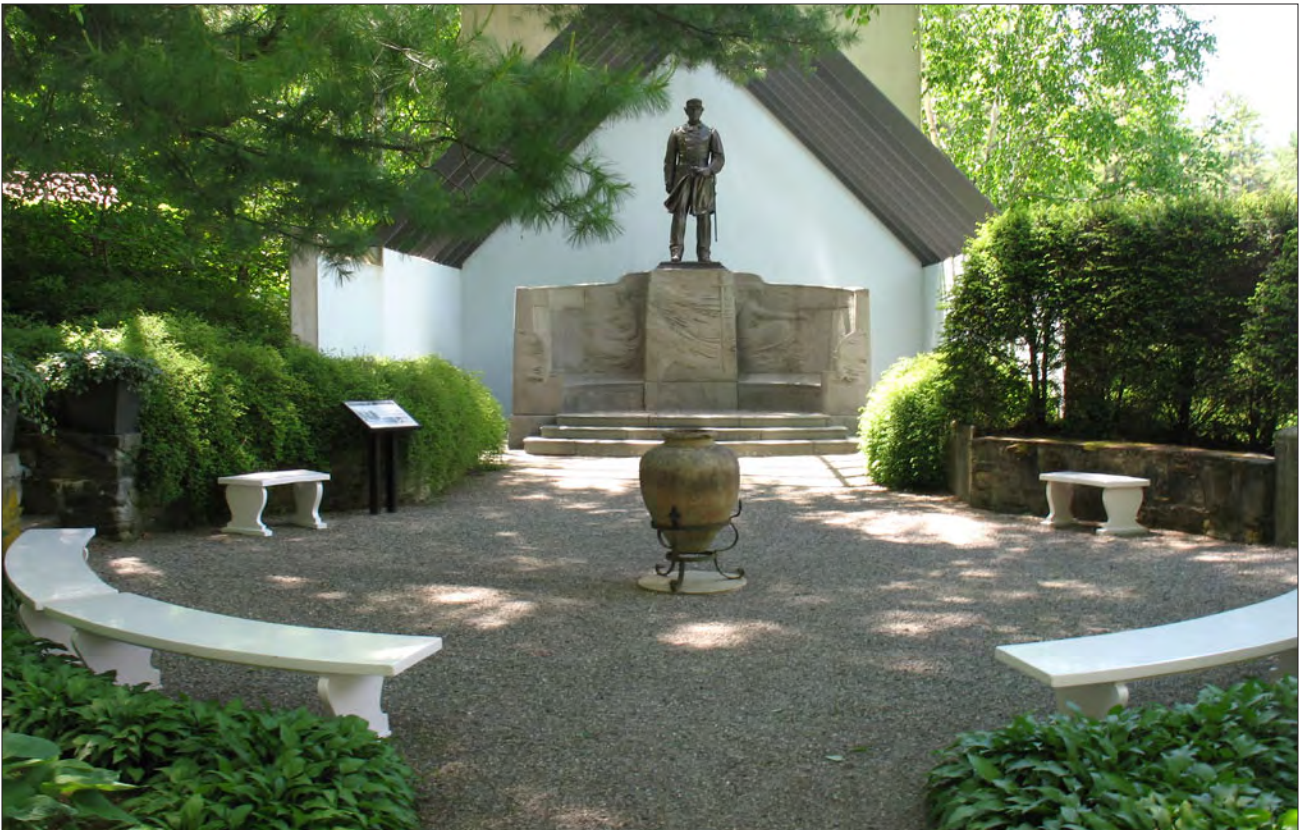
Figure 45. View south of the Farragut forecourt, base, statue, and enclosure. At the center is the terra-cotta oil jar in a wrought iron frame set on a marble disk. Curved short and long benches surround the circular forecourt and stephanandra cascades over the mortared field stone walls (OCLP, 2009).

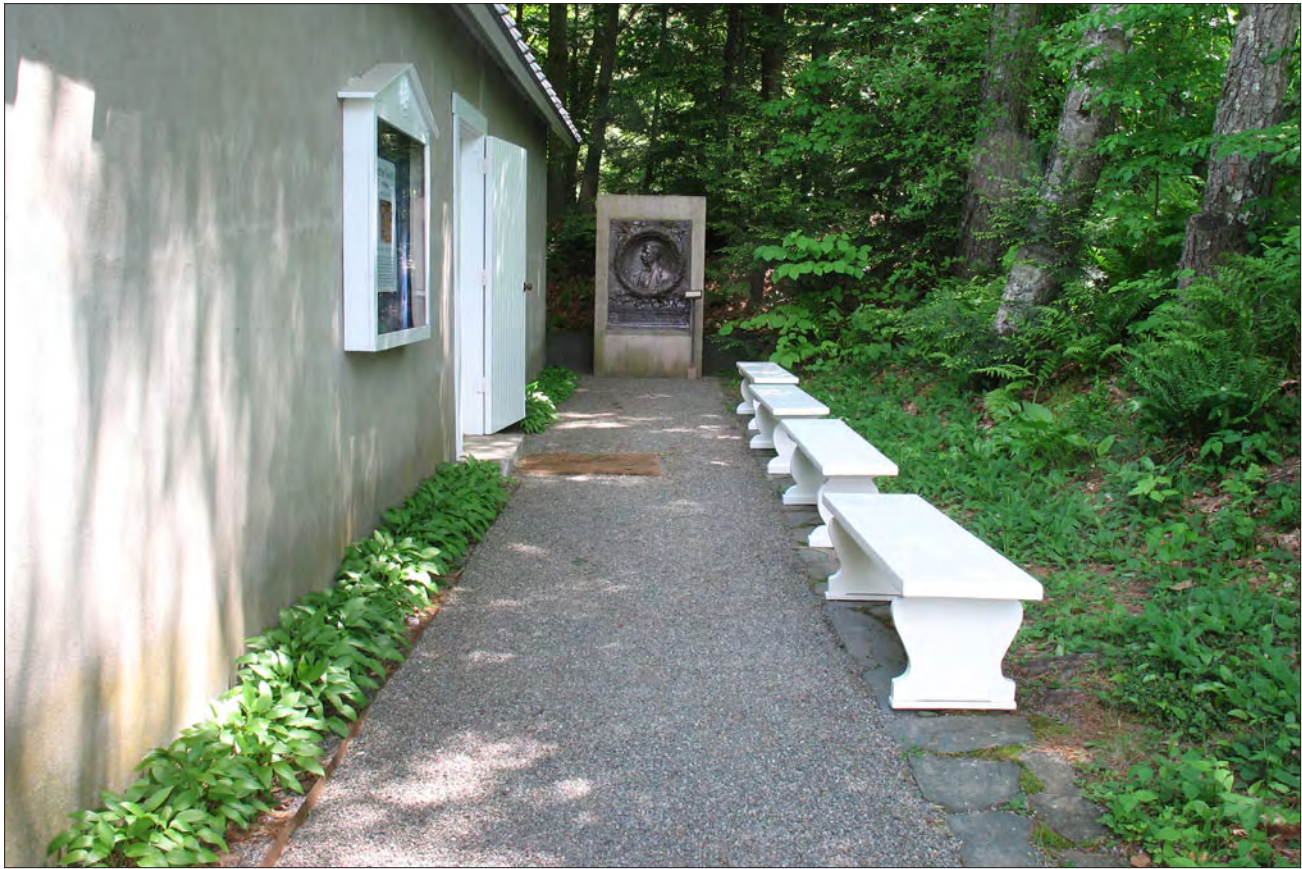
Figure 46. View east of the Picture Gallery entry door and pea-stone gravel path with a field stone edge, and Henry W. Maxwell relief (OCLP, 2009).

*Existing Conditions:* Routine maintenance has preserved the historic integrity of the Picture Gallery, which currently appears as it did during the period of significance (see Figure 46).

Four benches line the walkway to the Picture Gallery. The benches range in length, width and height (see Figure 46).

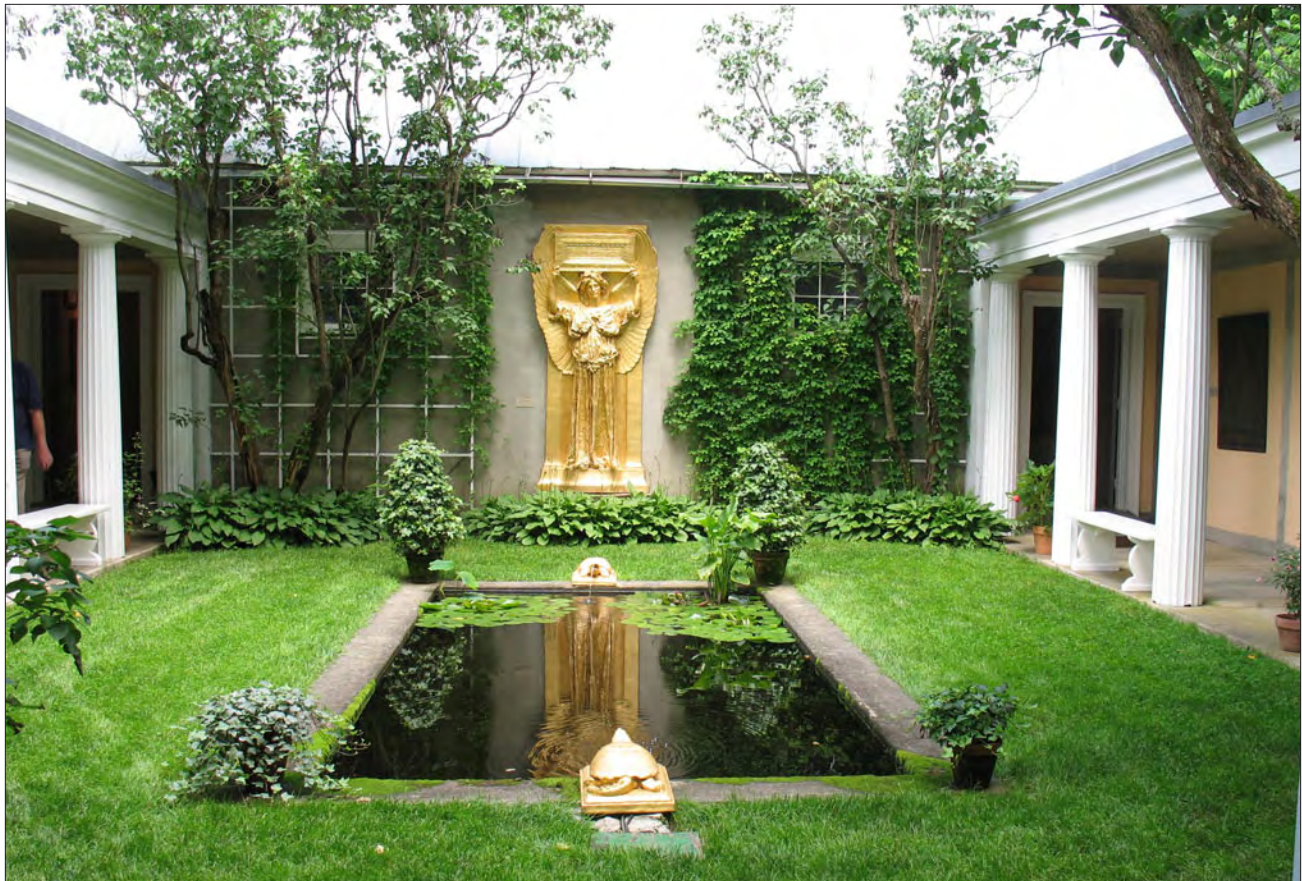
Figure 47. View north of the Atrium courtyard, Amor Caritas, reflecting pool, gold turtles, lilacs, and trellises with vines (OCLP, 2009).

*Existing Conditions:* All four lilacs remain in the Atrium and are now mature, top-heavy, specimens. New shrubs have been propagated from the originals and await replacement in the park’s nursery (see Figures 47, 49, and 50). There are no lilacs in the beds in the entrance circle/Farragut forecourt. A large purple-flowering lilac grows at the west corner of the New Gallery.

being replaced in July of 2009 were 72 inches long, 16 inches wide, and 16 inches high (see Figures 47, 49, and 50).

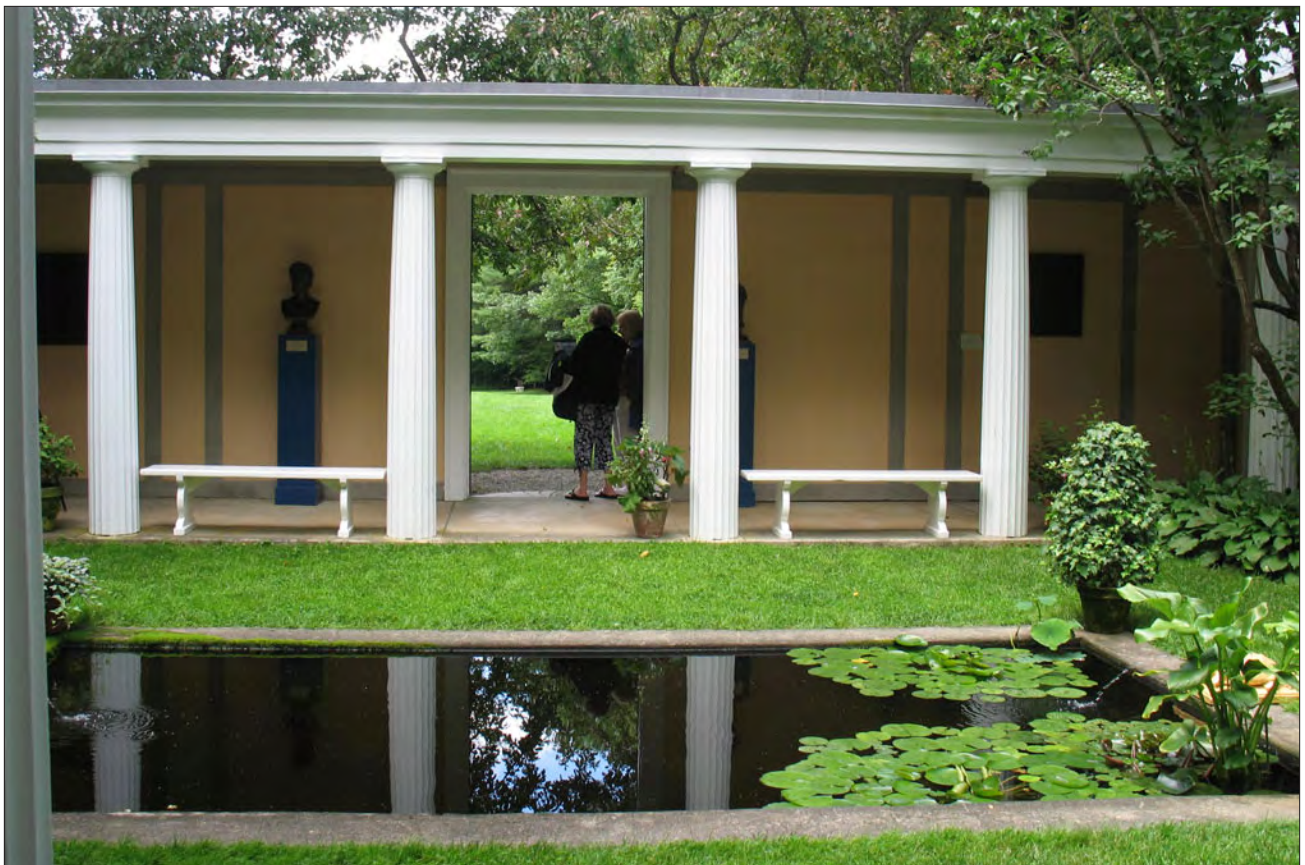
Figure 49. View west of the Atrium courtyard, pool, lilac (right), and doorway to the meadow (OCLP, 2009).

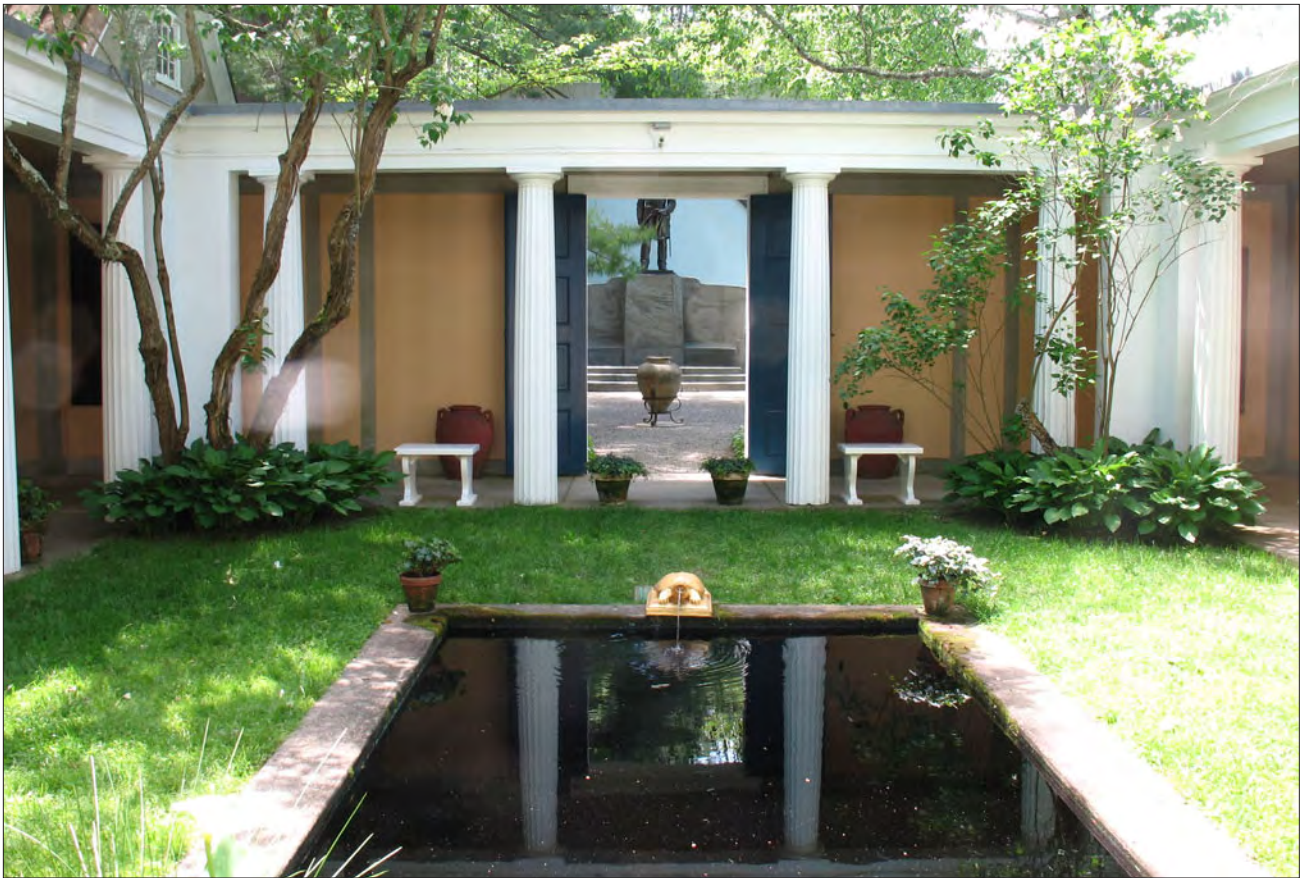
Figure 50. View south of the Atrium courtyard, reflecting pool, gold turtle, lilacs, benches, terra-cotta jars, terra-cotta oil jar in the Farragut forecourt, with the Farragut statue in the background (OCLP, 2009).

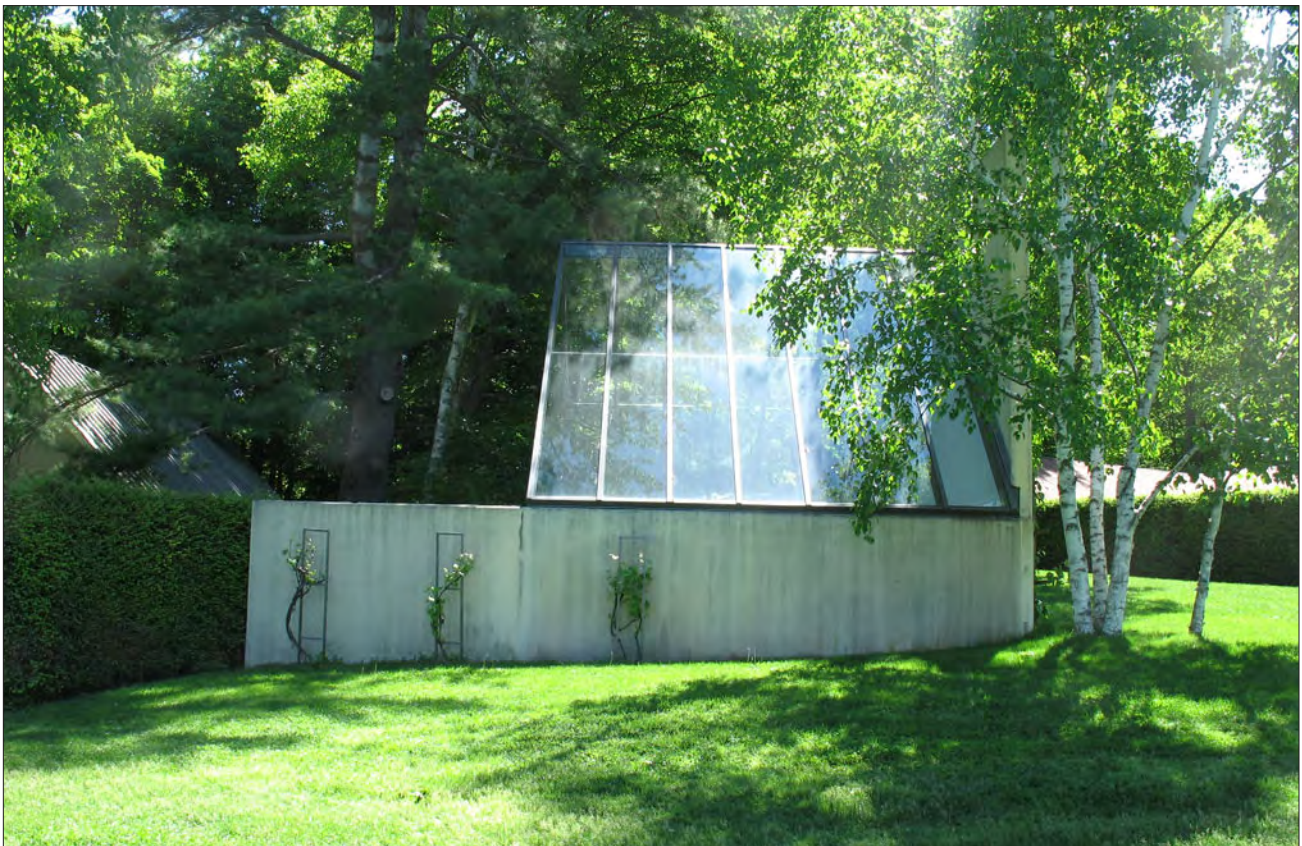
Figure 51. View east of the Farragut enclosure, forecourt hedge (left), grapes on small trellises, mature white pine, and birches (OCLP, 2009).

*Existing Conditions:* Grape vines (*Vitus* sp.) on small trellis structures were introduced along the 1986 Farragut enclosure shortly after its completion (see Figure 51).

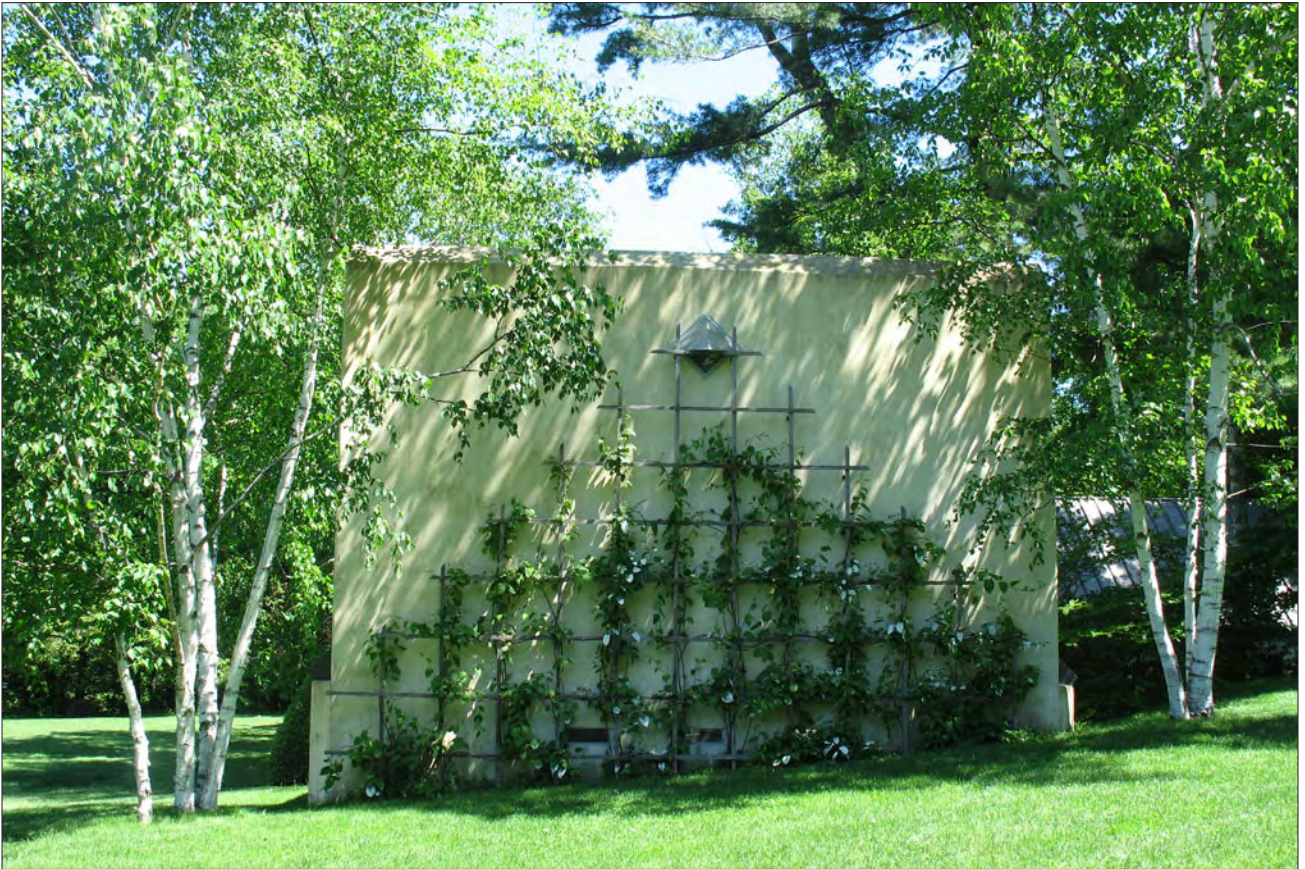
Figure 52. View north of the trellis structure with kiwi vine on the south facade of the Farragut enclosure. The building is framed by paper birches. Branches of a mature white pine hang over the structure (OCLP, 2009).

*Existing Conditions:* The Farragut enclosure was installed in 1986 with a trellis on its south façade. Initially two species of bittersweet vine were trained on the trellis, oriental and American (*Celastrus orbiculatus* and *C. scandens*). The vines were pruned regularly throughout the growing season to maintain views of the grid of the trellis structure. However, Oriental bittersweet is considered a non-native invasive and seedlings were appearing around the perimeter of the property. The bittersweet vines were removed in the 1990s and hardy male Arctic Beauty variegated kiwi vines (*Actinidia kolomikta* ‘Arctic Beauty’) installed in their place. The vines have spread throughout the trellis structure, but are pruned regularly during the growing season to preserve the grid of the trellis structure. The trellis is very visible from the lawn area to the northwest of the visitor center (see Figure 52).

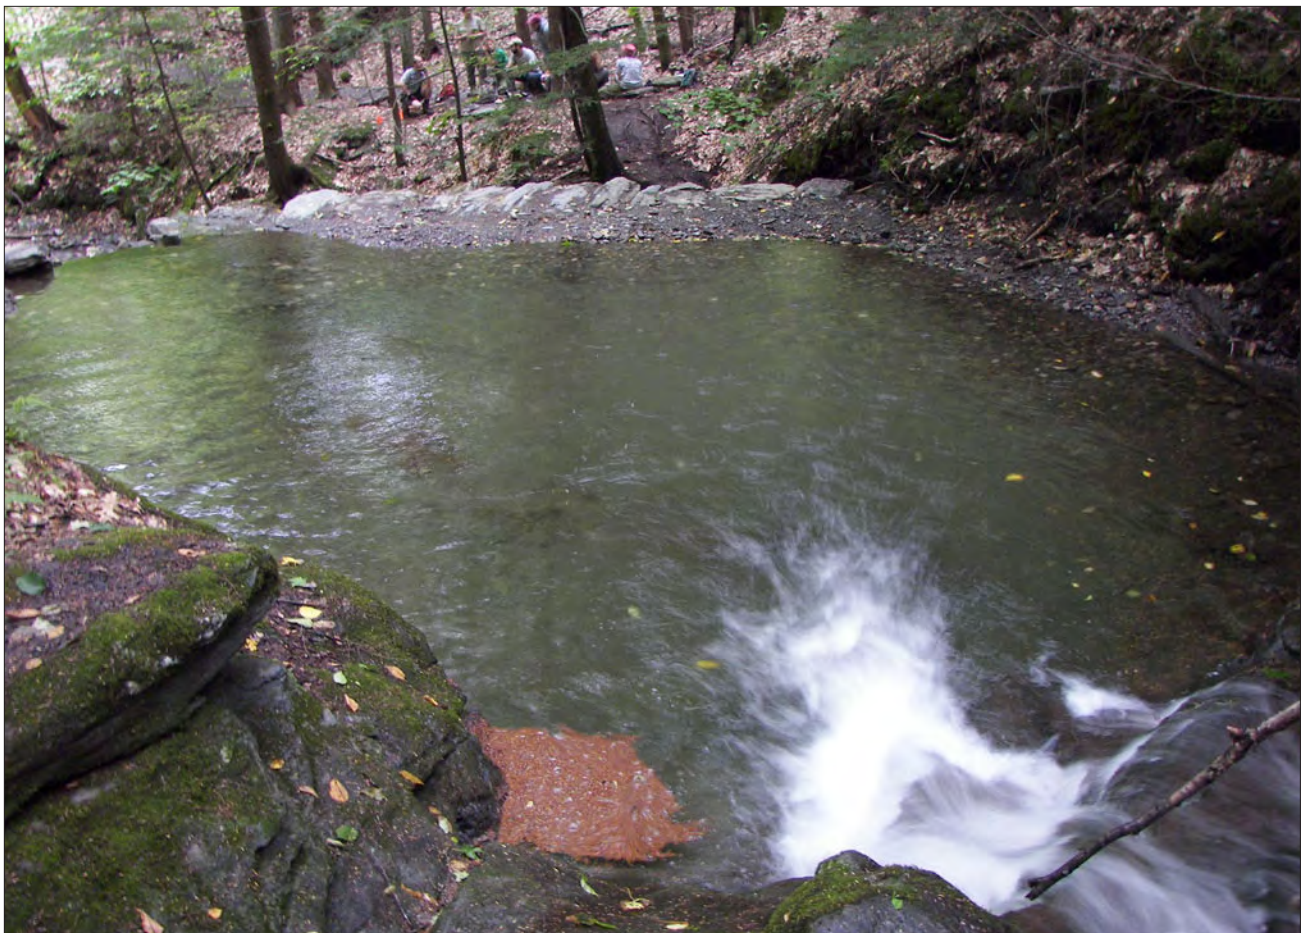
Figure 57. View east of the swimming hole and dam along Blow-Me-Up Brook in the ravine below Aspet after repairs (SAGA, 2008).

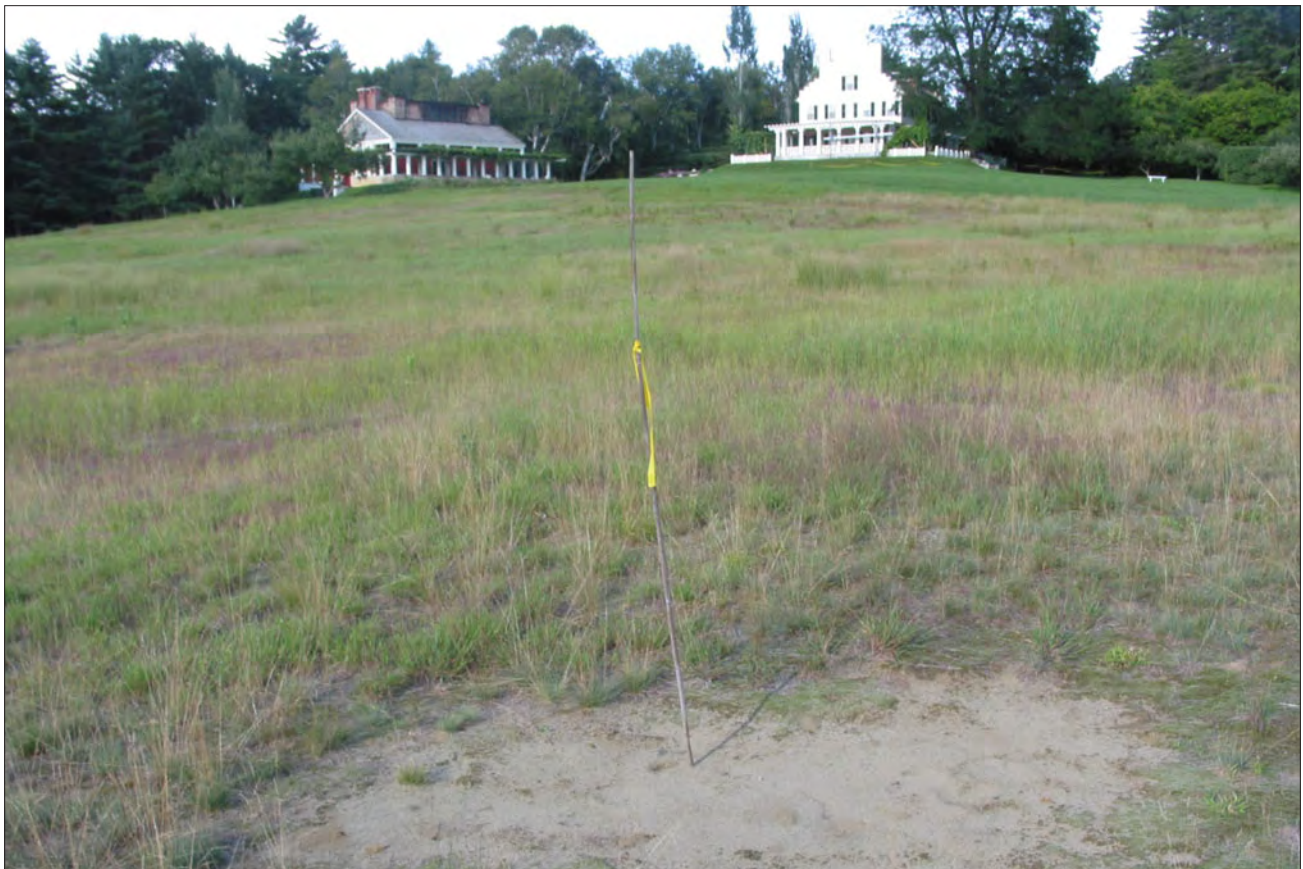
Figure 59. View northeast in the west meadow of a sand trap remaining from the former golf course (OCLP, 2008).

The Temple, installed in 1914, is a permanent replacement of the temple used for the Masque of the Golden Bowl in 1905, and stands at the northwest corner of the west meadow. The Temple is backed by a line of hemlocks (Figure 58). Remnants of the golf course in the meadow are still evident (Figure 59).

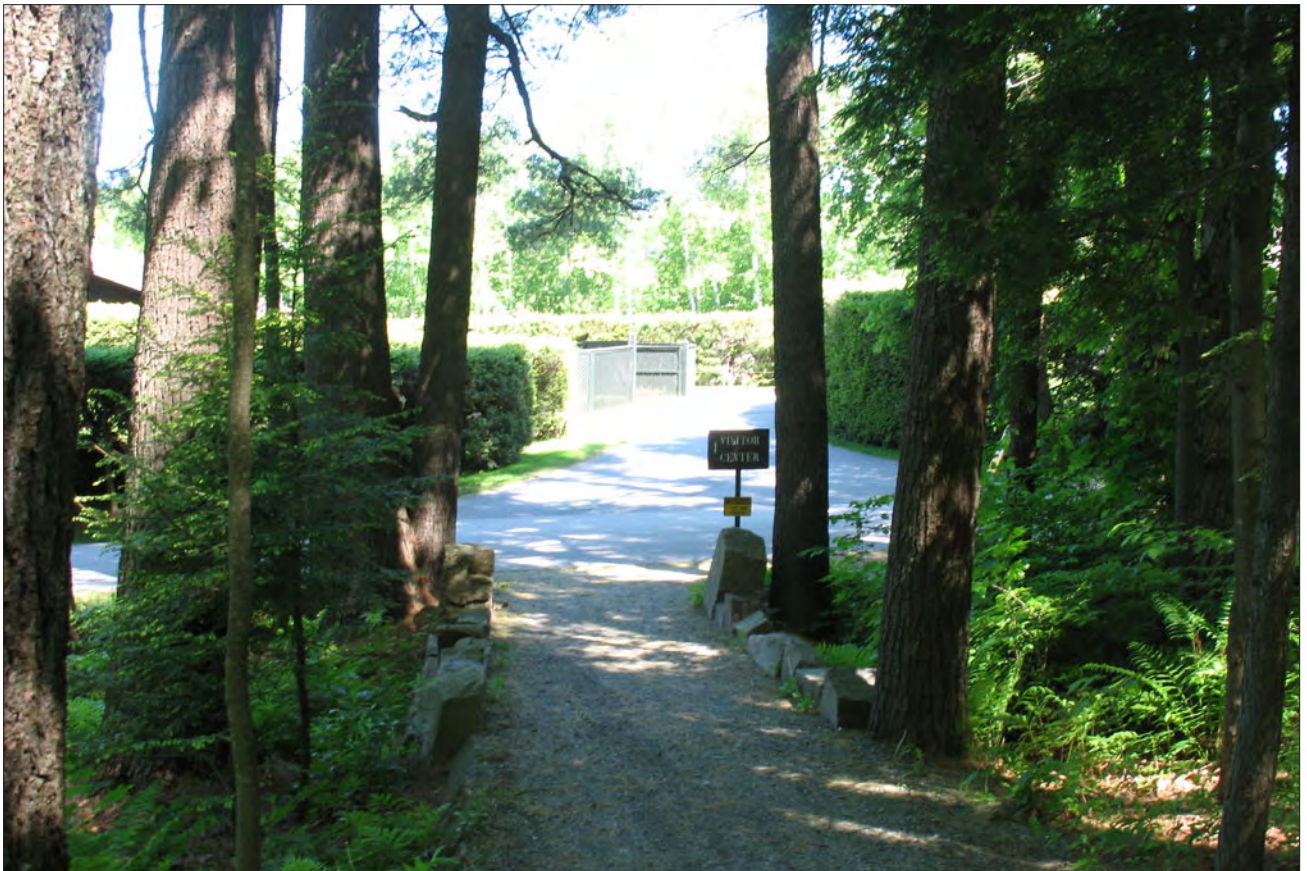
Figure 60. View north of the upper end of the gravel path from the visitor parking lot to the visitor center. Saint Gaudens Road and the east entry drive are visible beyond the terminus of the path, as well as a directional and road warning signs (OCLP, 2009).

*Existing Conditions:* After the historic period, the National Park Service began to utilize the land south of the road more intensively. A complex of park buildings, not accessed by visitors, was built southeast of the Caretaker's Cottage and Garage, set back from the road. The complex includes a collections building, pump station, maintenance facility, and plant nursery. Modifications to the visitor parking lot by the National Park Service include an expansion of parking spaces, the construction of a pedestrian path through the woods on the south side of the road, connecting the parking lot to the visitor center driveway, a ticket sales kiosk on the corner of the pedestrian trail and parking lot, and a Clivus Multrum restroom at the southwest corner of the parking lot. Despite these additions, the character of the land remains wooded and natural. The maintenance facility is screened from the road, as is the pedestrian path to the visitor center. Mature white pine trees and vegetative undergrowth comprise a thick forest south of the road, creating a vastly different character than the open fields of Augustus Saint-Gaudens' time and shading the hedges on the north side of the road along the cutting garden (see Figures 60 and 61).

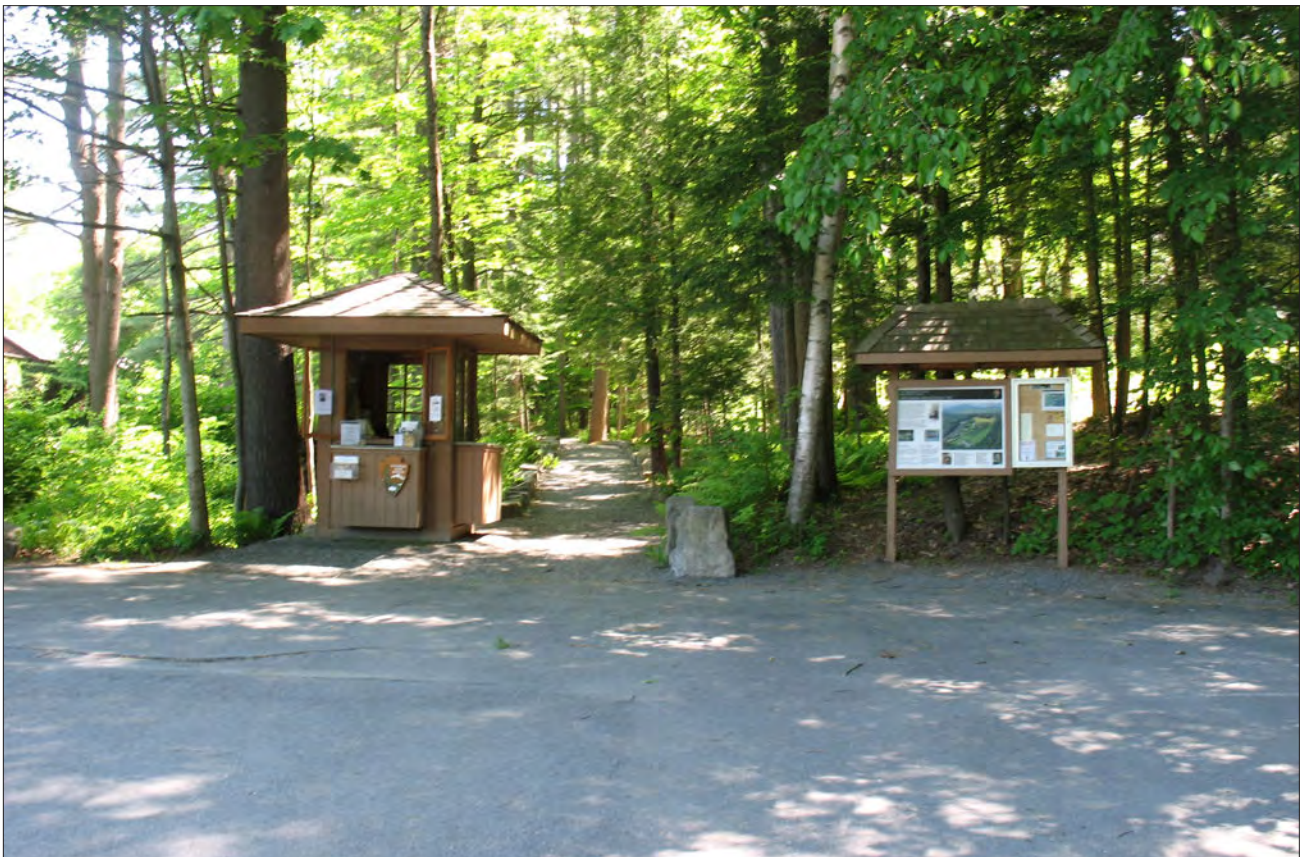
Figure 61. View east from the visitor parking lot of the information kiosk, park orientation sign, and path to the visitor center (OCLP, 2009).

*Existing Conditions:* The National Park Service added an information kiosk to the visitor parking lot in 1992 to collect fees and distribute park literature to visitors. It is a small, square, gable-roofed building with room for one person inside. The kiosk sits at the east side of the parking lot, at the entrance of the pedestrian trail to the visitor center (see Figure 61).

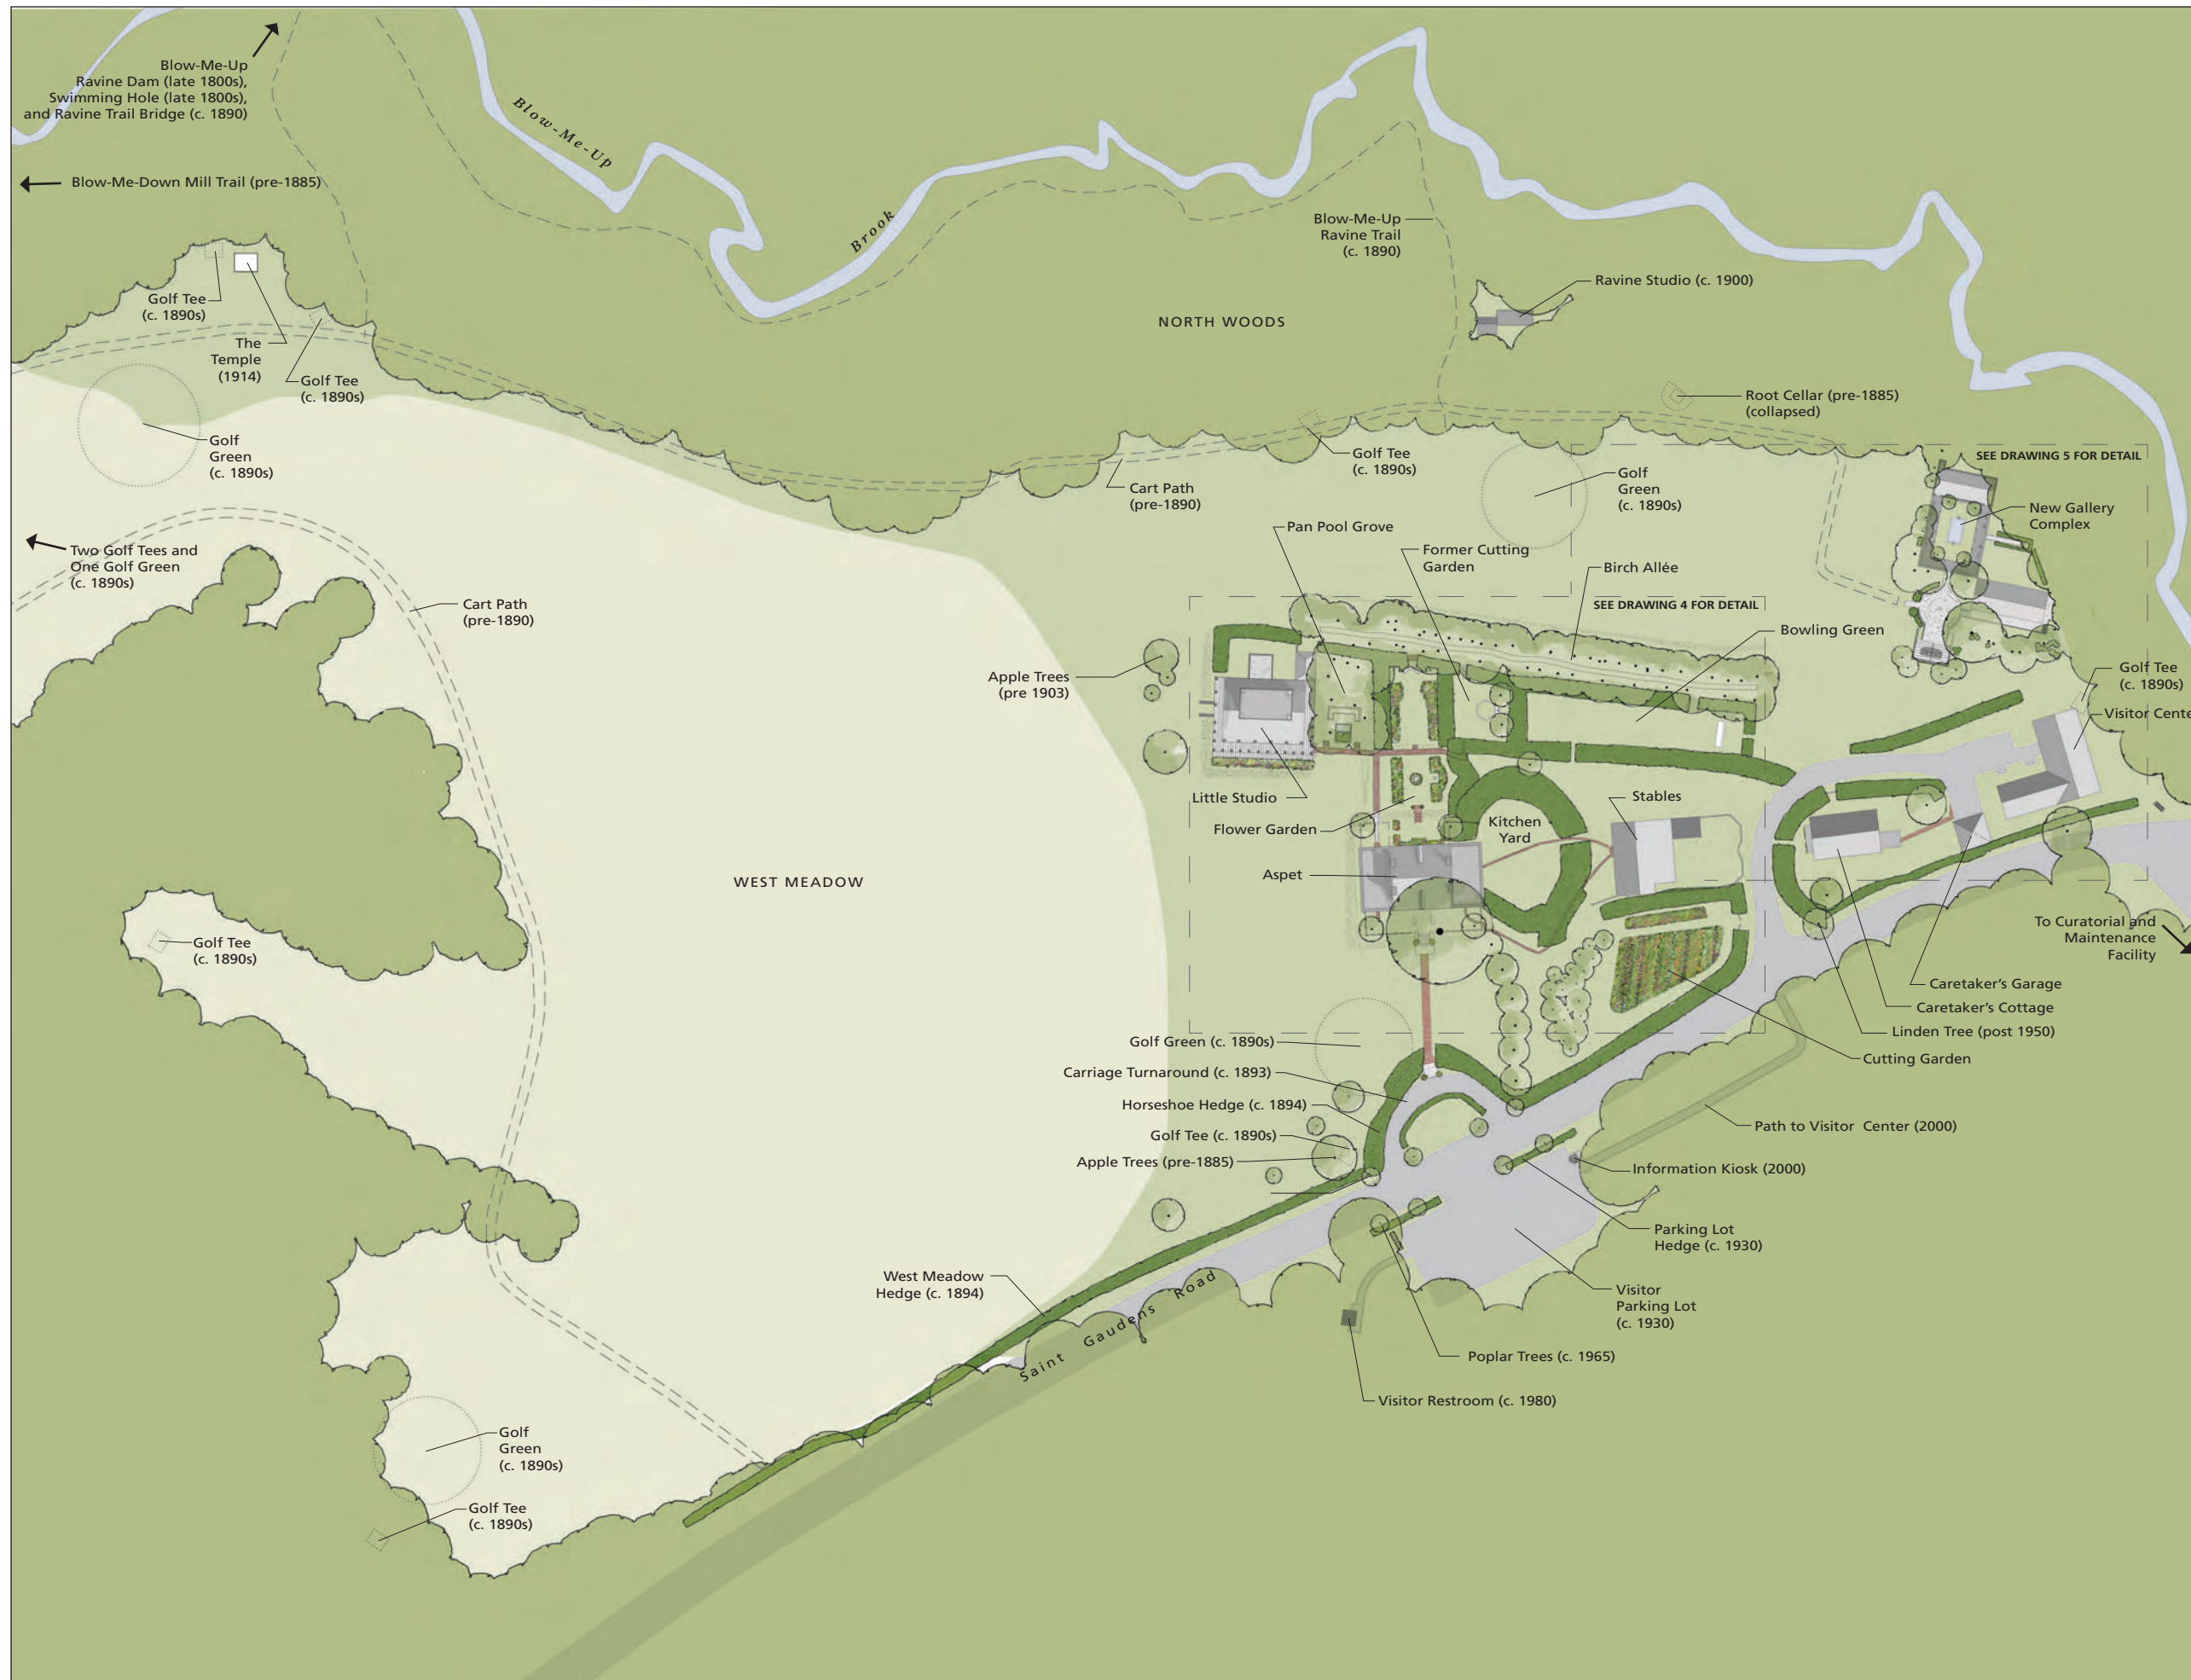
Drawing 3

### Existing Conditions 2009

See Drawings 4 and 5 for Details 1 and 2. Dates in parentheses indicate the original introduction of feature to the landscape. Features marked with an asterisk (\*) have been replaced since the historic period. Additional information on origin of features is found in Chapter 3 and Table 1. All vegetation shown in approximate scale and location.

The existing conditions chapter of this report provides an overview of the extant landscape characteristics for Aspet, within the historic core of Saint-Gaudens National Historic Site (Drawings 3, 4, and 5). The park is situated in a rural and scenic area, characterized by low population density, abundant native forest, and views west to the distant Vermont hills, notably Mount Ascutney.
