# CULTURAL LANDSCAPE REPORT FOR ASPET

## SAINT-GAUDENS NATIONAL HISTORIC SITE

### VOLUME II: RECENT HISTORY, EXISTING CONDITIONS, AND ANALYSIS

Olmsted Center for Landscape Preservation  
National Park Service, Boston, Massachusetts, 2009

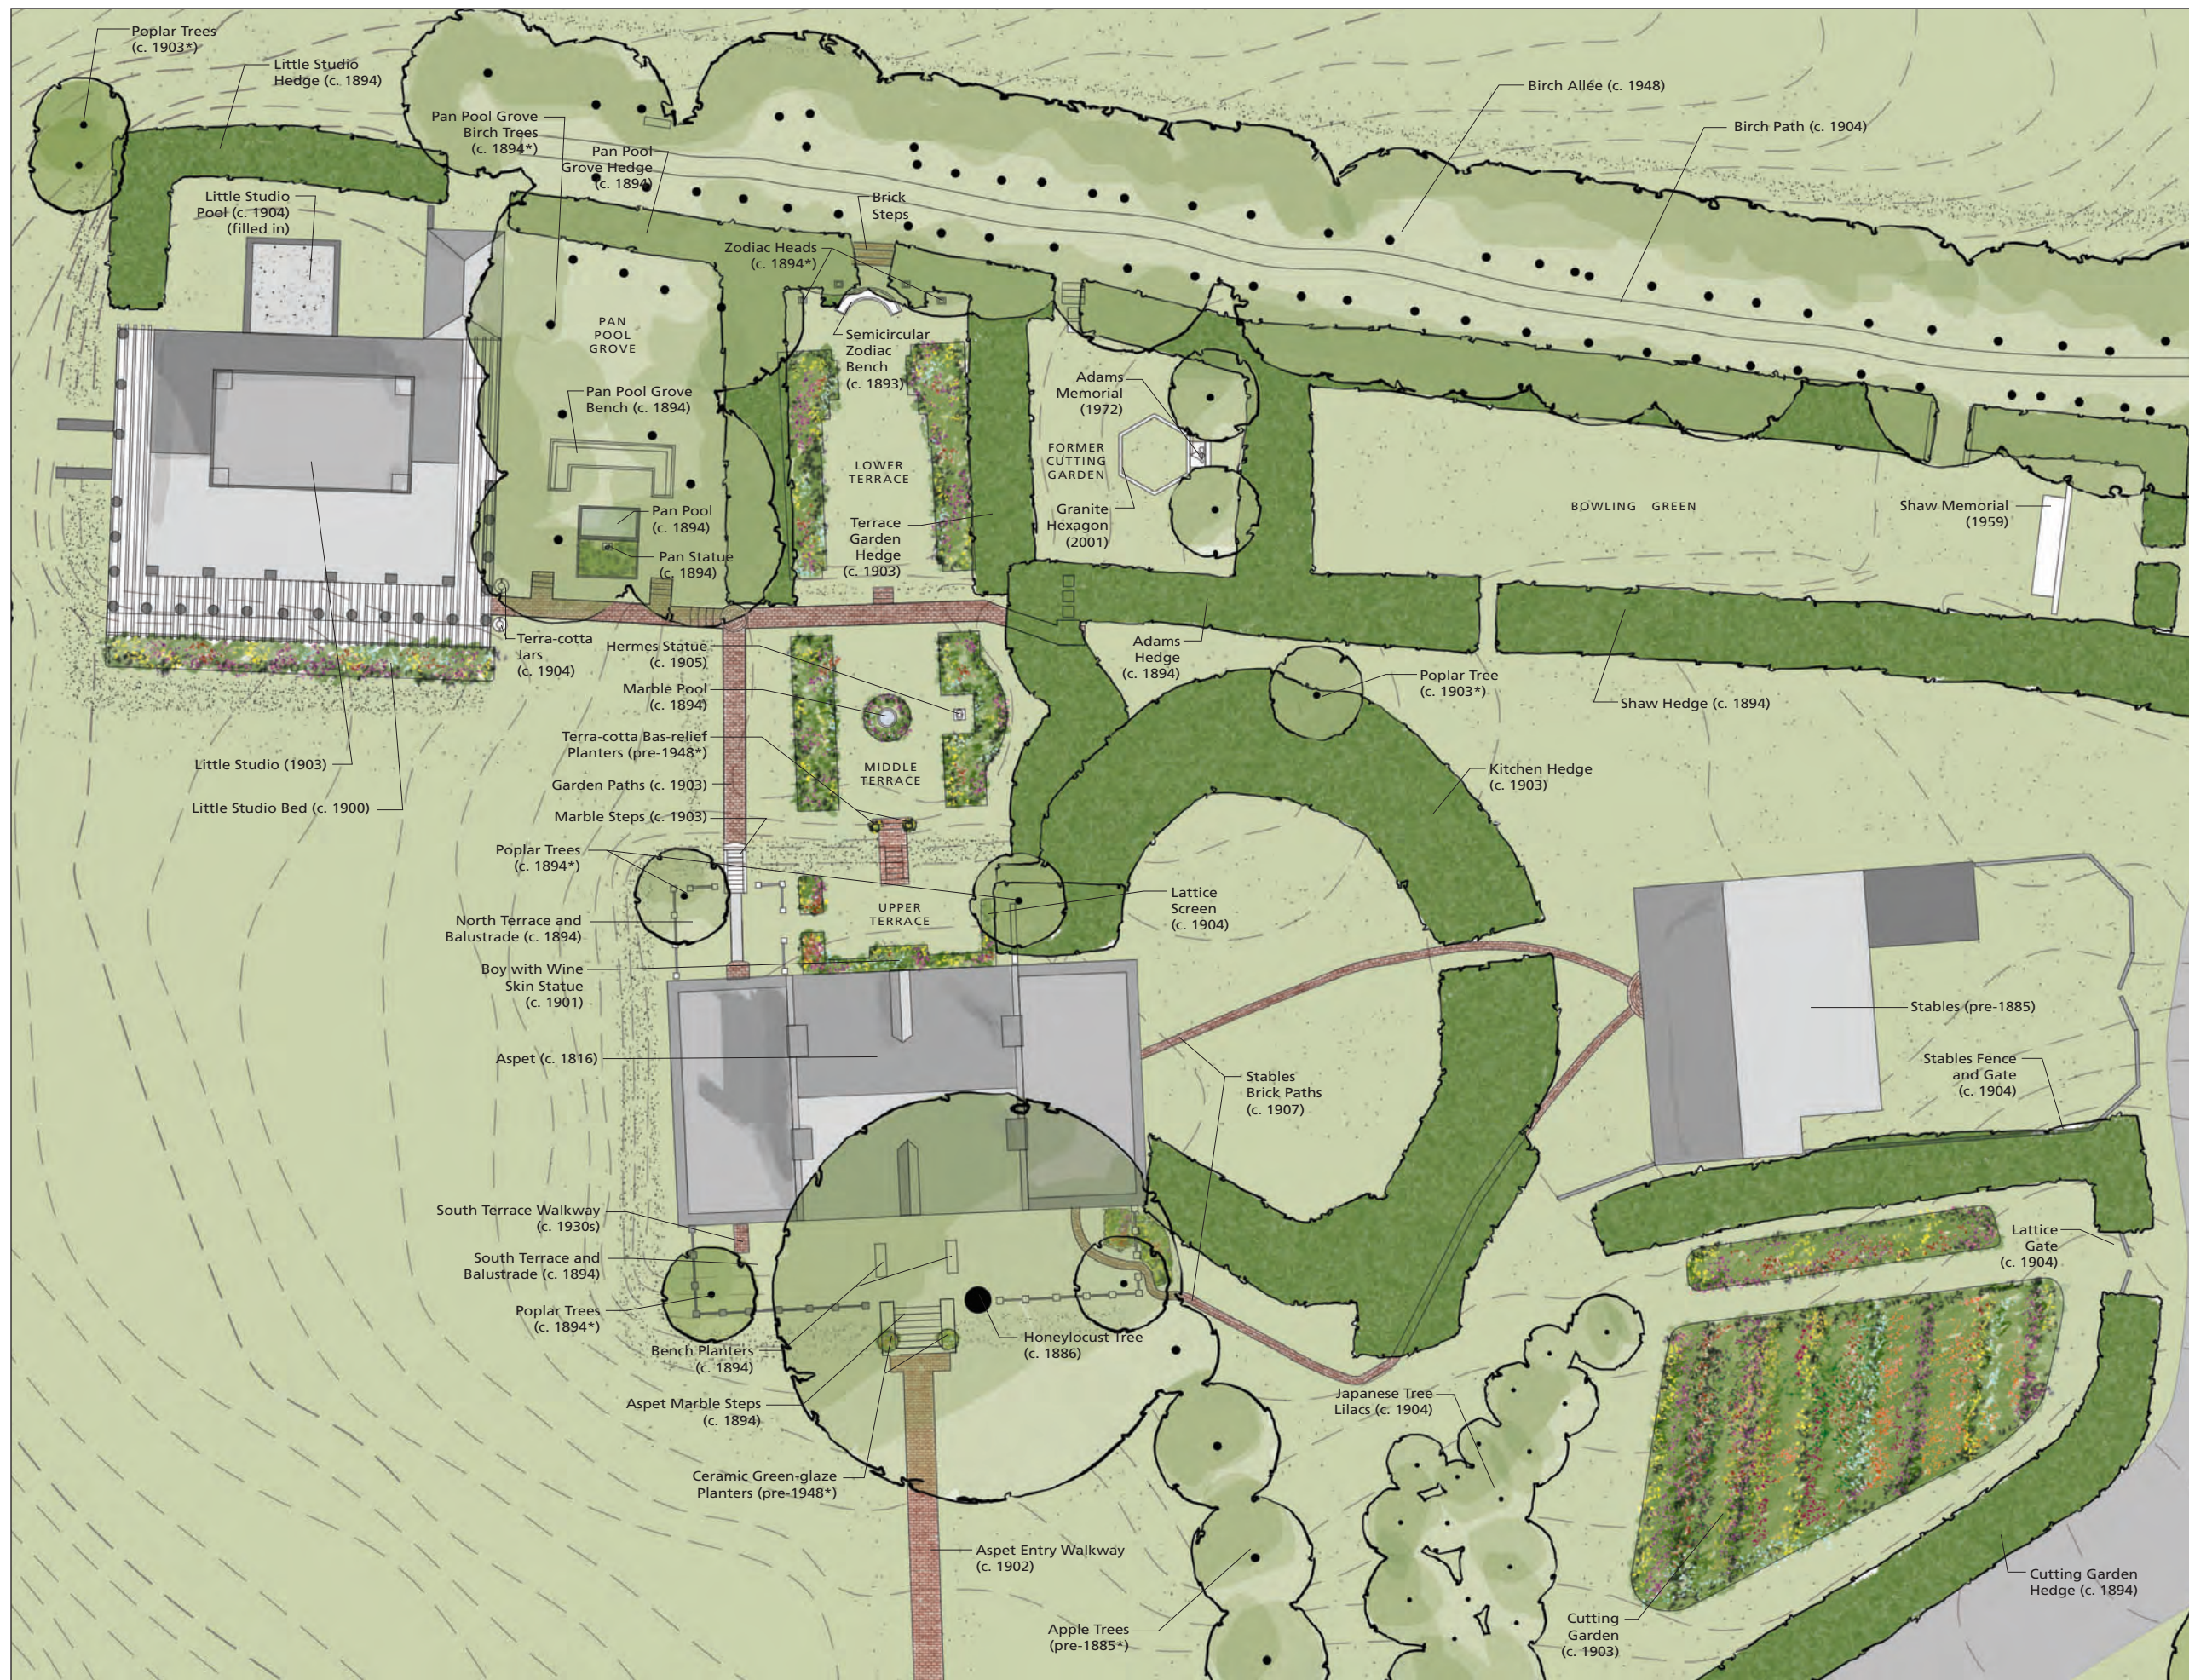
Drawing 4

### Existing Conditions 2009 Detail 1

Dates in parentheses indicate the original introduction of feature to the landscape. Features marked with an asterisk (\*) have been replaced since the historic period. Additional information on origin of features is found in Chapter 3 and Table 1. All vegetation shown in approximate scale and location.

See Drawings 4 and 5 for Details 1 and 2. Dates in parentheses indicate the original introduction of feature to the landscape. Features marked with an asterisk (\*) have been replaced since the historic period. Additional information on origin of features is found in Chapter 3 and Table 1. All vegetation shown in approximate scale and location.

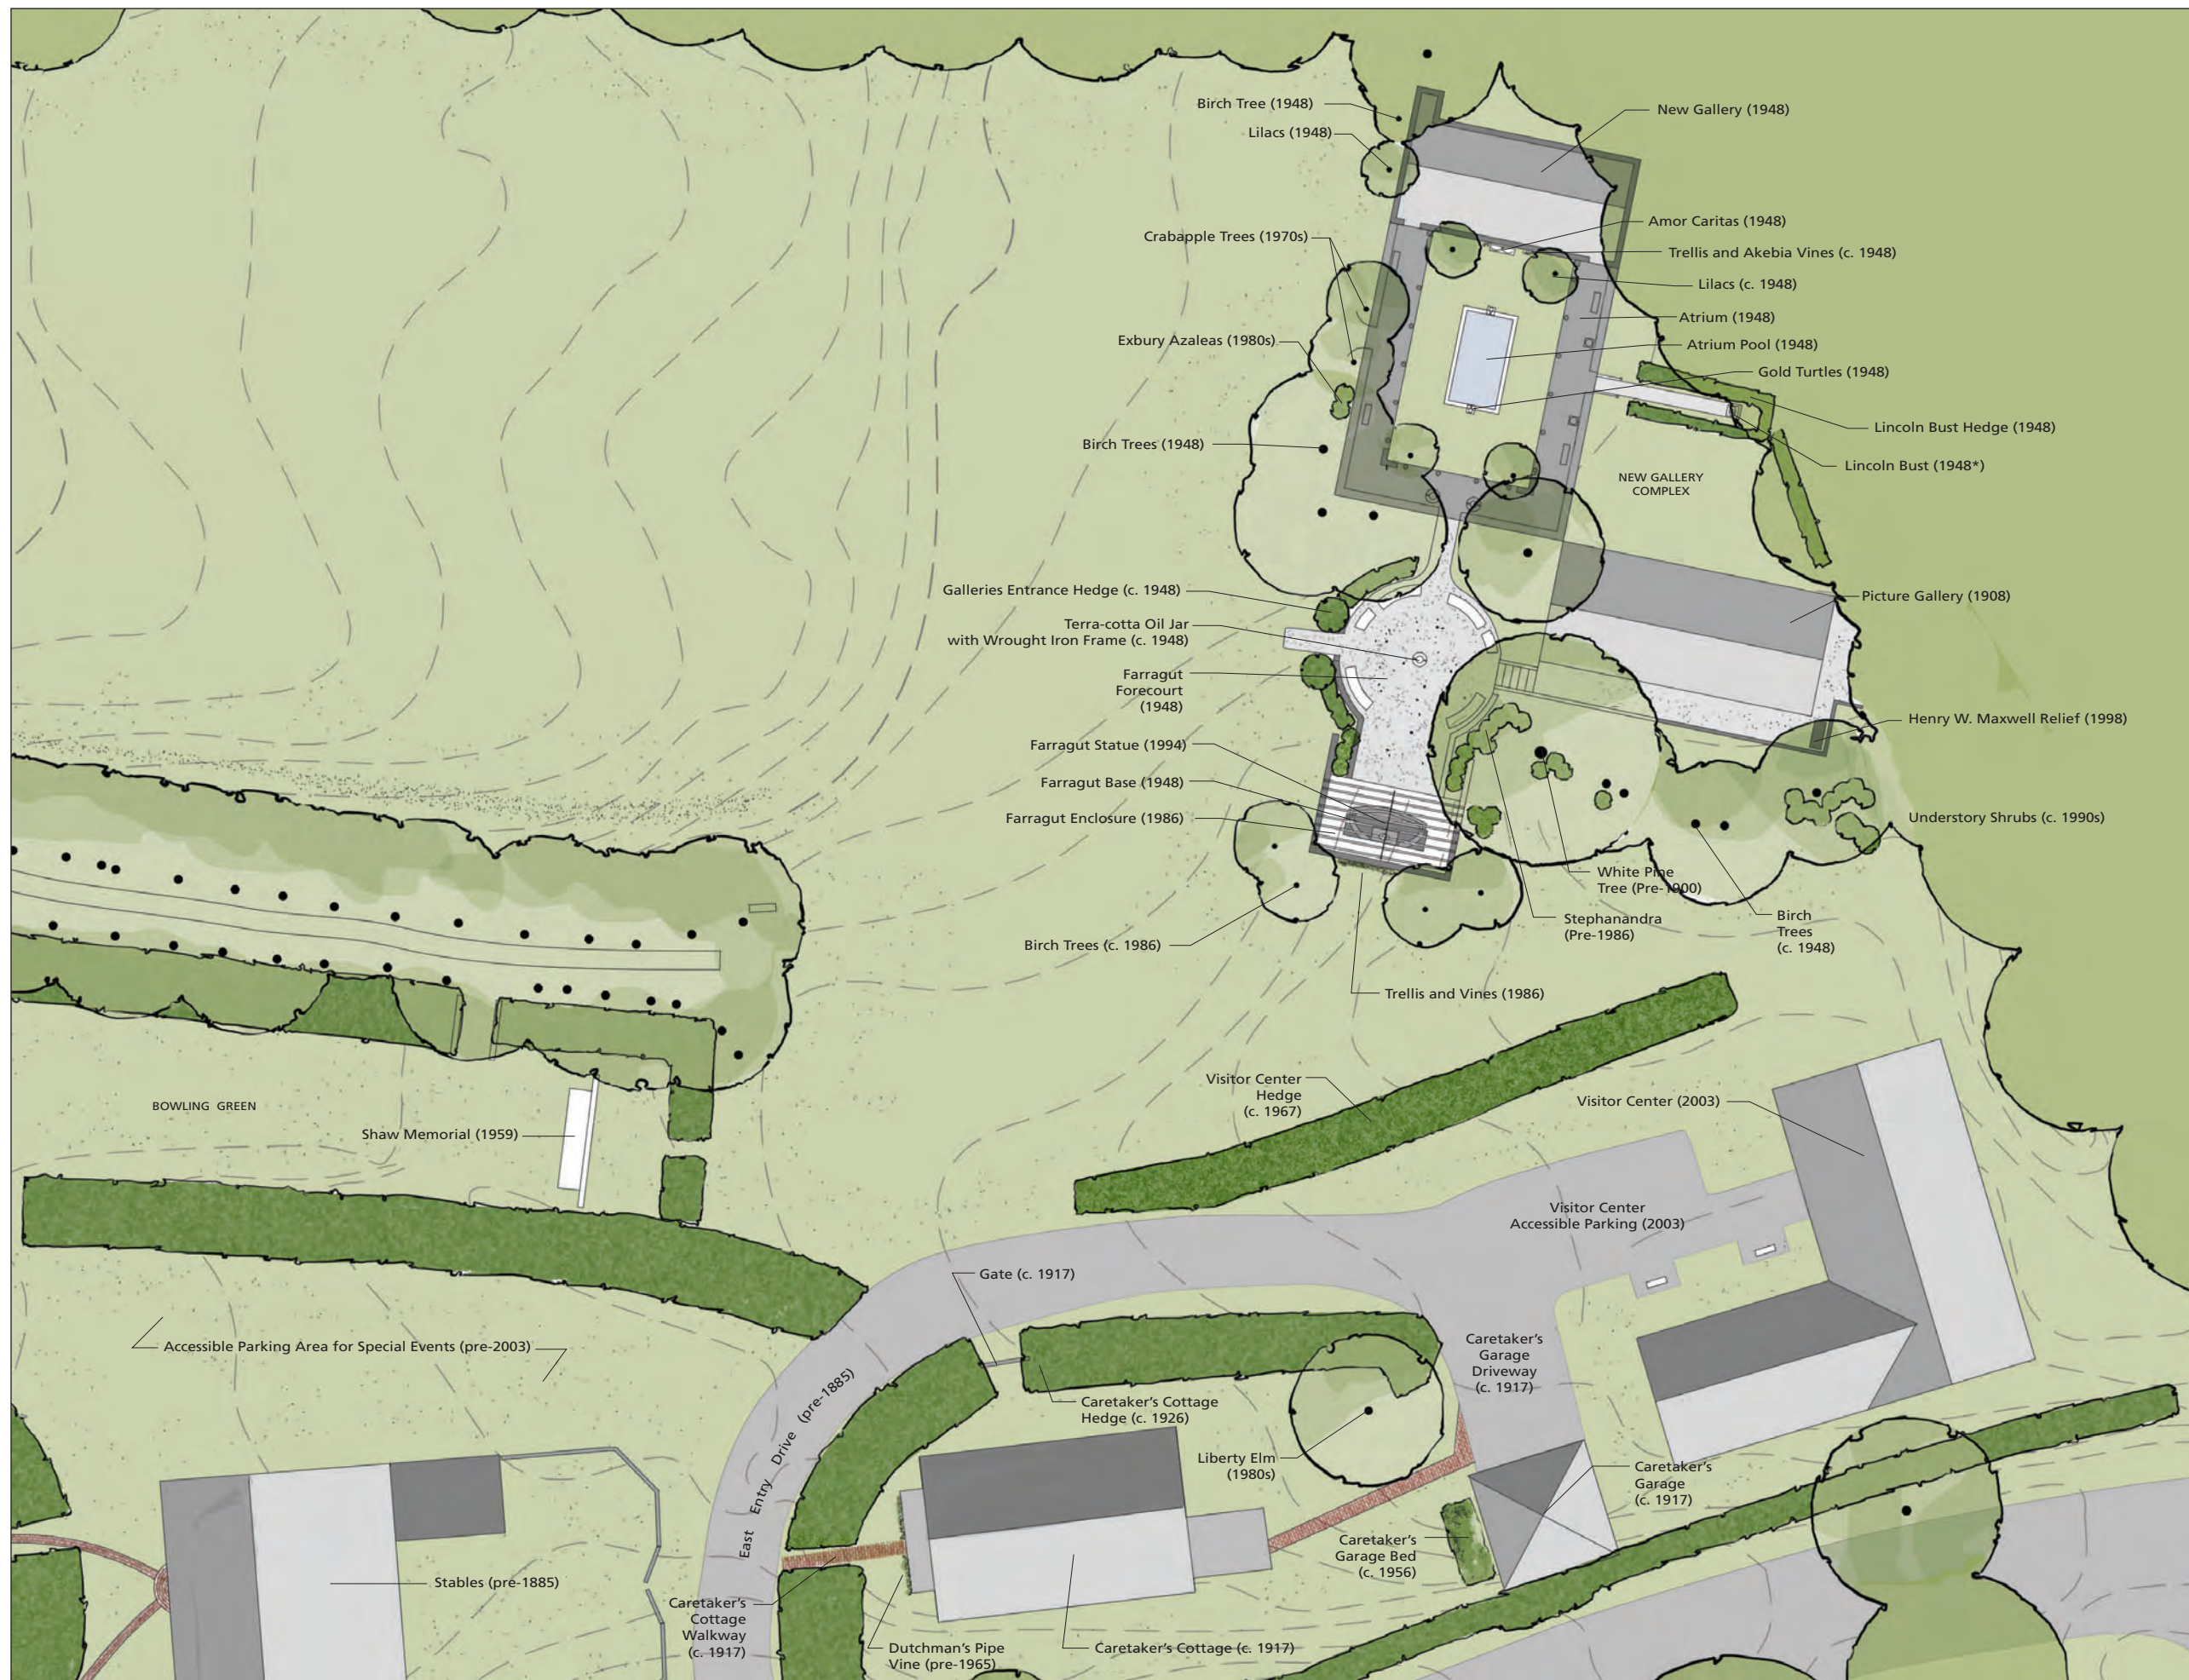
Drawing 5

### Existing Conditions 2009 Detail 1

Dates in parentheses indicate the original introduction of feature to the landscape. Features marked with an asterisk (\*) have been replaced since the historic period. Additional information on origin of features is found in Chapter 3 and Table 1. All vegetation shown in approximate scale and location.

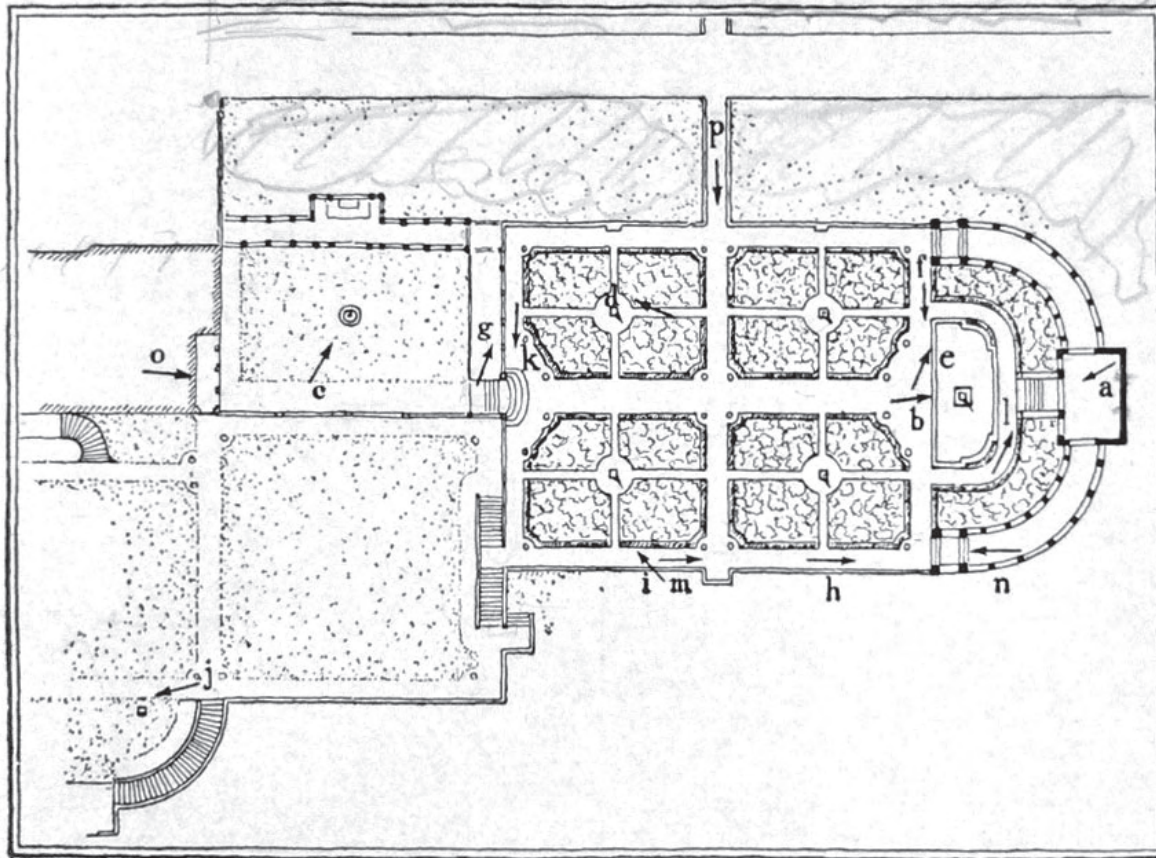
PLATE CVI. The Garden from the Casino *a*

Figure 65. “Faulkner Farm,” Charles Platt, Brookline, Massachusetts. Plan. Image from Guy Lowell’s, *American Gardens*, plate CVI.

Outside Cornish, some of Platt’s most important early work was done in Brookline, Massachusetts, including Faulkner Farm, the Charles F. Sprague estate (garden only), designed in 1897–98 and modeled in part after the early 17th-century garden of the Villa Gamberaia in Settignano, Tuscany. A plan of Faulkner Farm and a photograph of the garden as it appeared in 1902 are illustrated in Figures 65 and 66.<sup>87</sup>

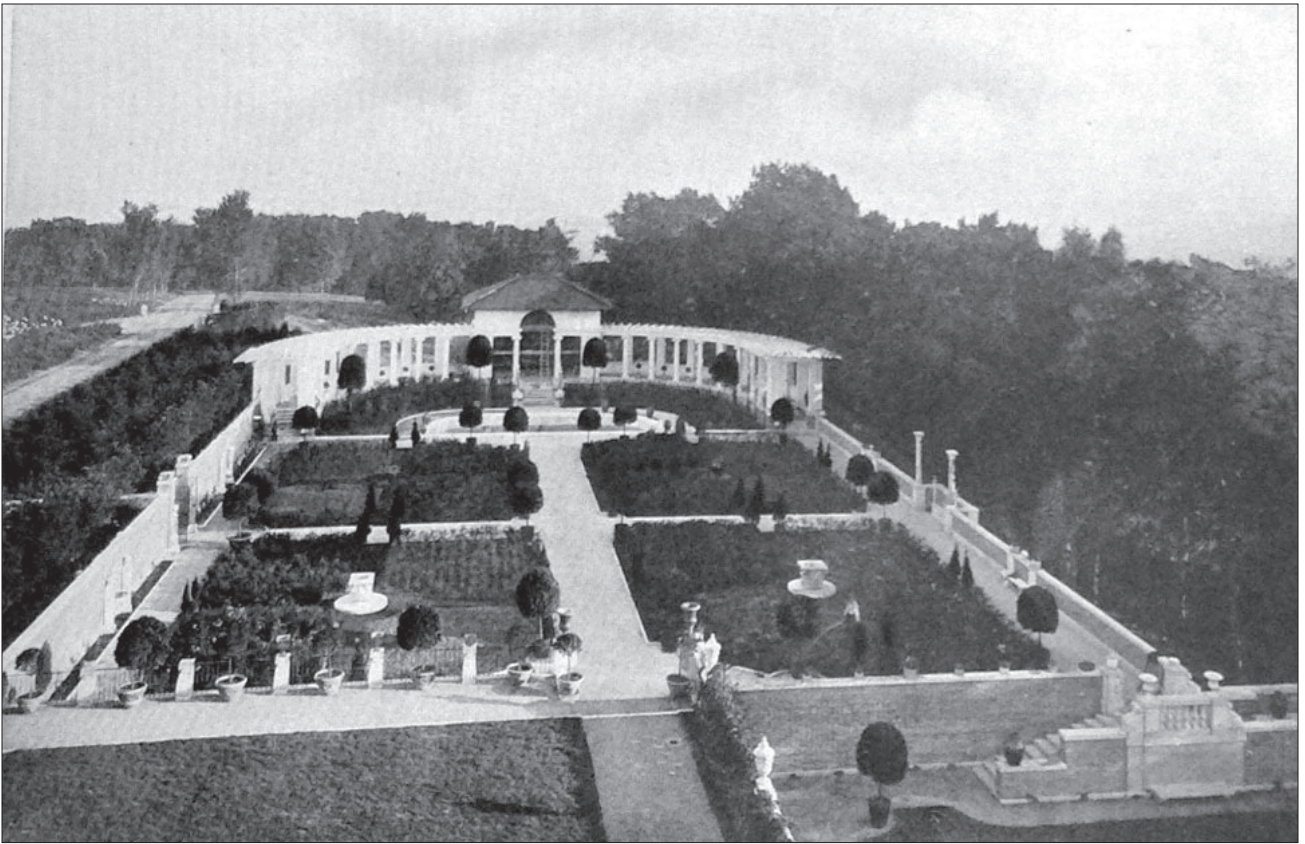
Figure 66. "Faulkner Farm," Charles Platt, Brookline, Massachusetts. Photograph, circa 1902. Image from Guy Lowell's, *American Gardens*, plate CVII.1.
