FINAL DESIGN REPORT
FOR
GLENBROOK CREEK RESTORATION PROJECT
GLENBROOK, NEVADA

January 2013

THE GLENBROOK PROJECT

Nevada Tahoe Conservation District
400 Dorla Ct.
PO Box 915
Zephyr Cove, NV 89448
(775) 586-1610

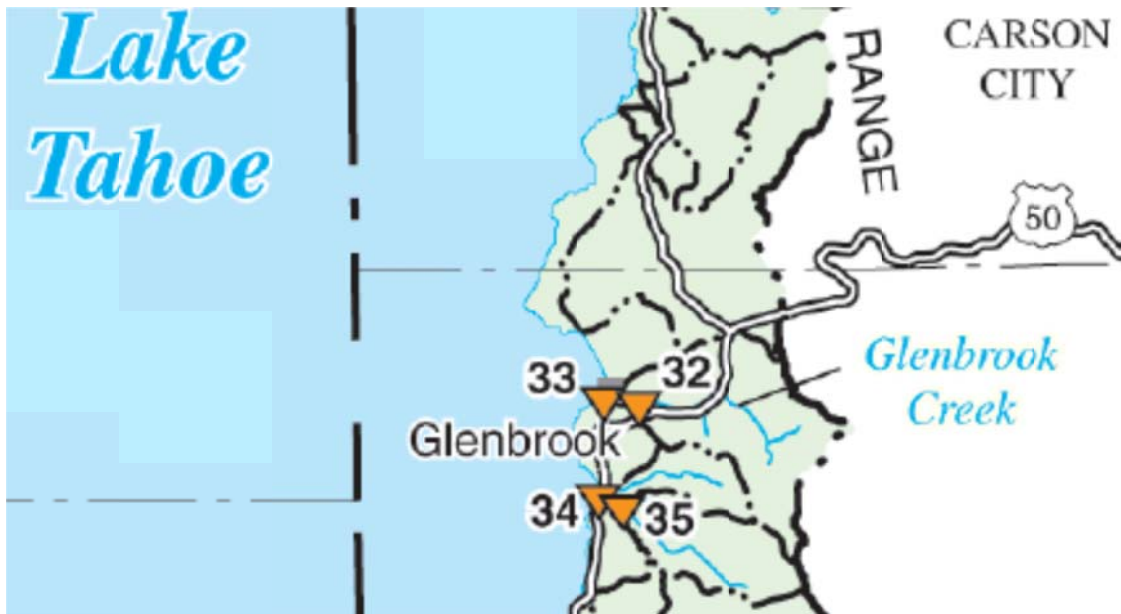
Figure 1. Glenbrook Creek and Watershed. Monitoring locations are indicated by the orange triangles 32 and 33. Monitoring occurred from (USGS, 2002)

The map in Figure 1 shows the location of Glenbrook Creek and the approximate Glenbrook Creek watershed.

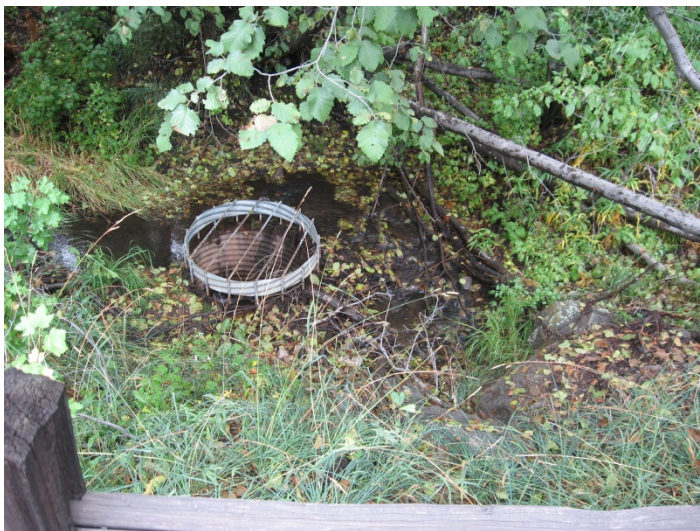
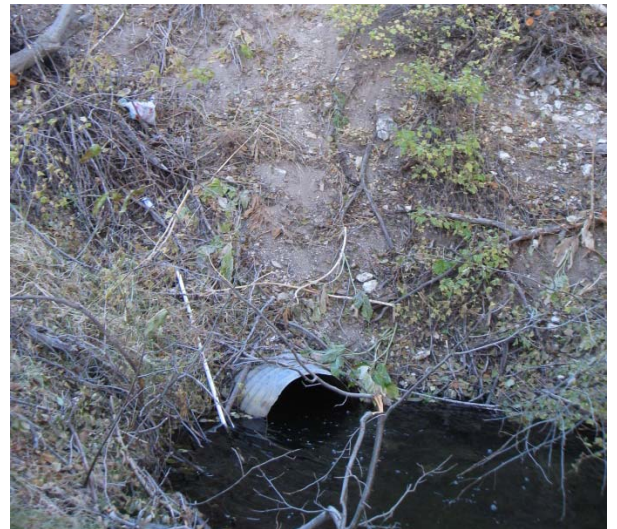
Figure 3. Existing culvert and standpipe at Old Highway 50.

Glenbrook Creek crosses Old Highway 50 through a standpipe to a culvert. The standpipe was installed in the early 1990s as a quick solution to prevent woody debris from clogging the existing culvert (Ramsdell, 2011). Old Highway 50 currently acts as a levee and the culvert restricts flow and drops the creek considerably in elevation. The culvert itself is failing – it has been retrofit with a smaller pipe to abate further collapse (Figure 2). Furthermore, runoff from Old Highway 50 is currently routed directly

The existing culvert is limiting fish passage and may be moderating the flow regime below Old Highway 50. The willow stand surrounding the creek below Old Highway 50 has become decadent (Figure 3). The impoundment upstream of the culvert may serve a role in eliminating peak flows downstream of Old Highway 50, though a detailed study has not been conducted. Removing the stand pipe could increase the frequency of floodplain inundation in the downstream meadow portion of the creek, improving floodplain connectivity and aiding with capture of fine sediment during large flows.

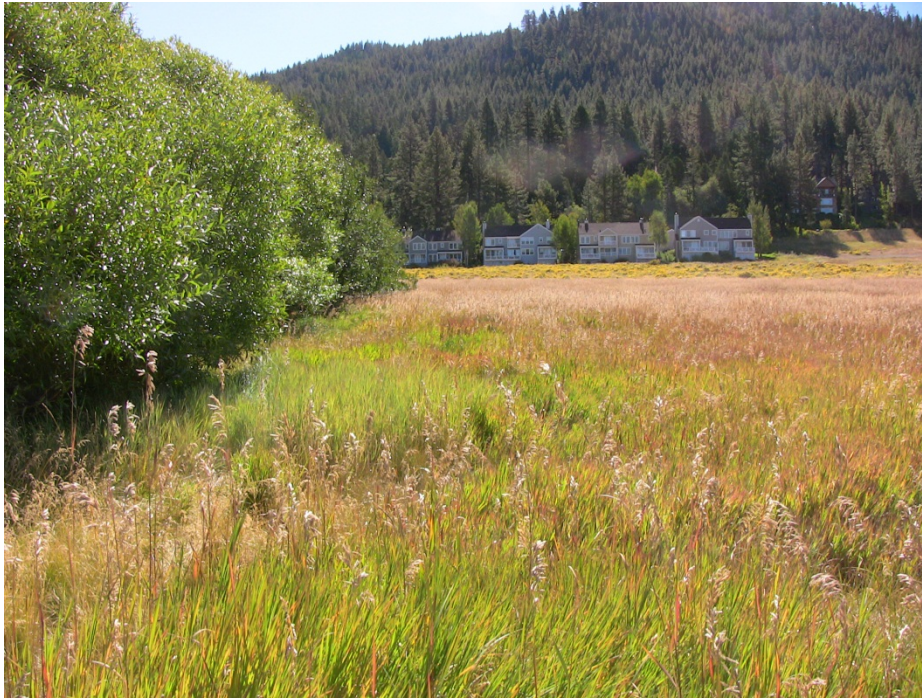
Figure 4. Decadent willows before vegetation management.

Below Old Highway 50, a remnant culvert and access road is causing entrenchment downstream and should be removed (Figure 4). When Glenbrook Creek becomes low gradient and enters the meadow, the majority of the stream has good width/depth and entrenchment ratios, but its riparian vegetation lacks diversity.

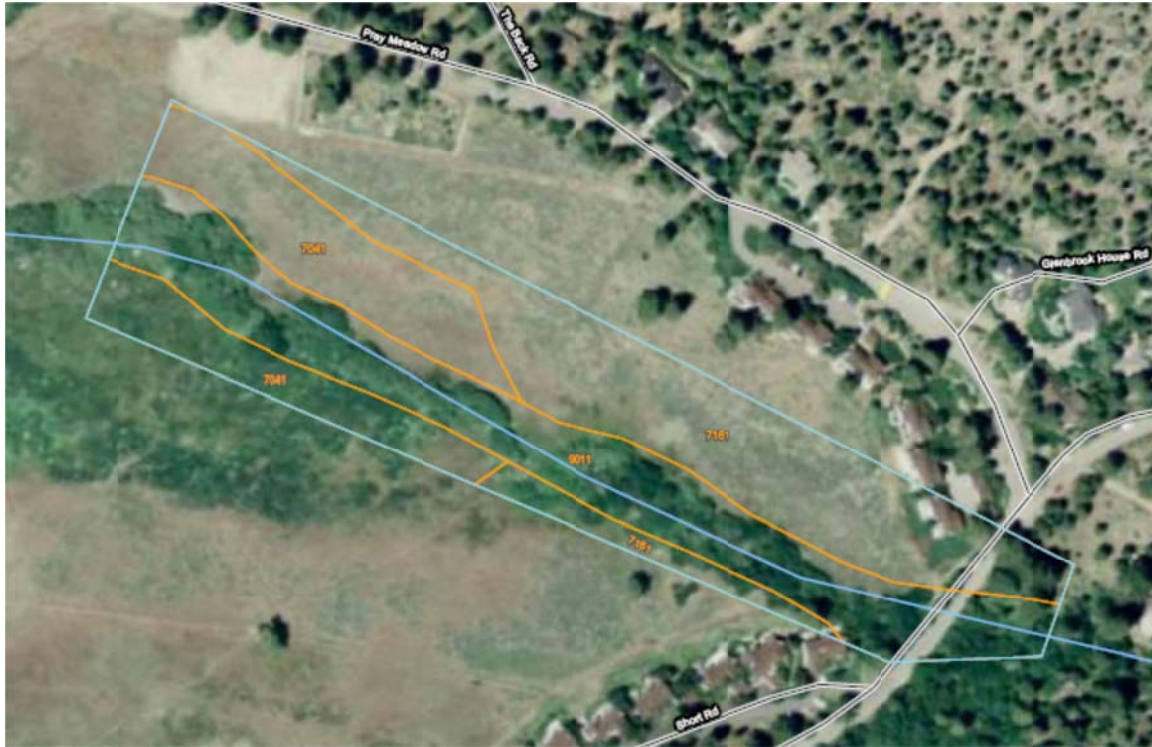
Figure 6. Project area NRCS soil map units. The project area is outlined in blue.

NRCS soil survey indicates that the project area is within soil map unit 9011—Oxyaquic Cryorthents-Aquic Xerorthents-Tahoe complex, 0 to 15 percent slopes (all restoration work) and 7161 Kingsbeach stony sandy loam, 2 to 15 percent slopes (access and staging and footpath only) (Figure 5). Appendix B contains the map unit descriptions from the USDA Soil Survey for the Tahoe Basin Area, California and Nevada (USDA, NRCS 2007).

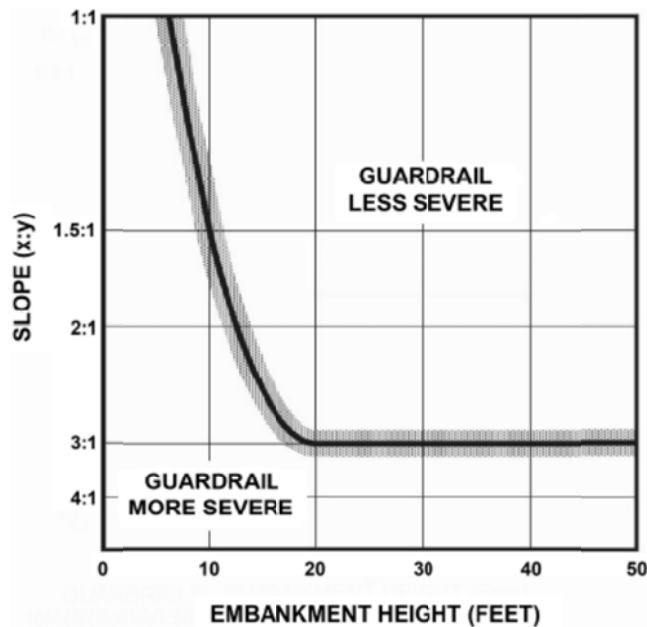
Figure 7. Equal Severity Curve from the California Department of Transportation's Traffic Manual. With an existing slope greater than 2:1 and an embankment height of 15 feet, a guardrail is recommended.

Guardrail is specified to replace the existing wooden fences for traffic safety on Old Highway 50 (Figure 7).

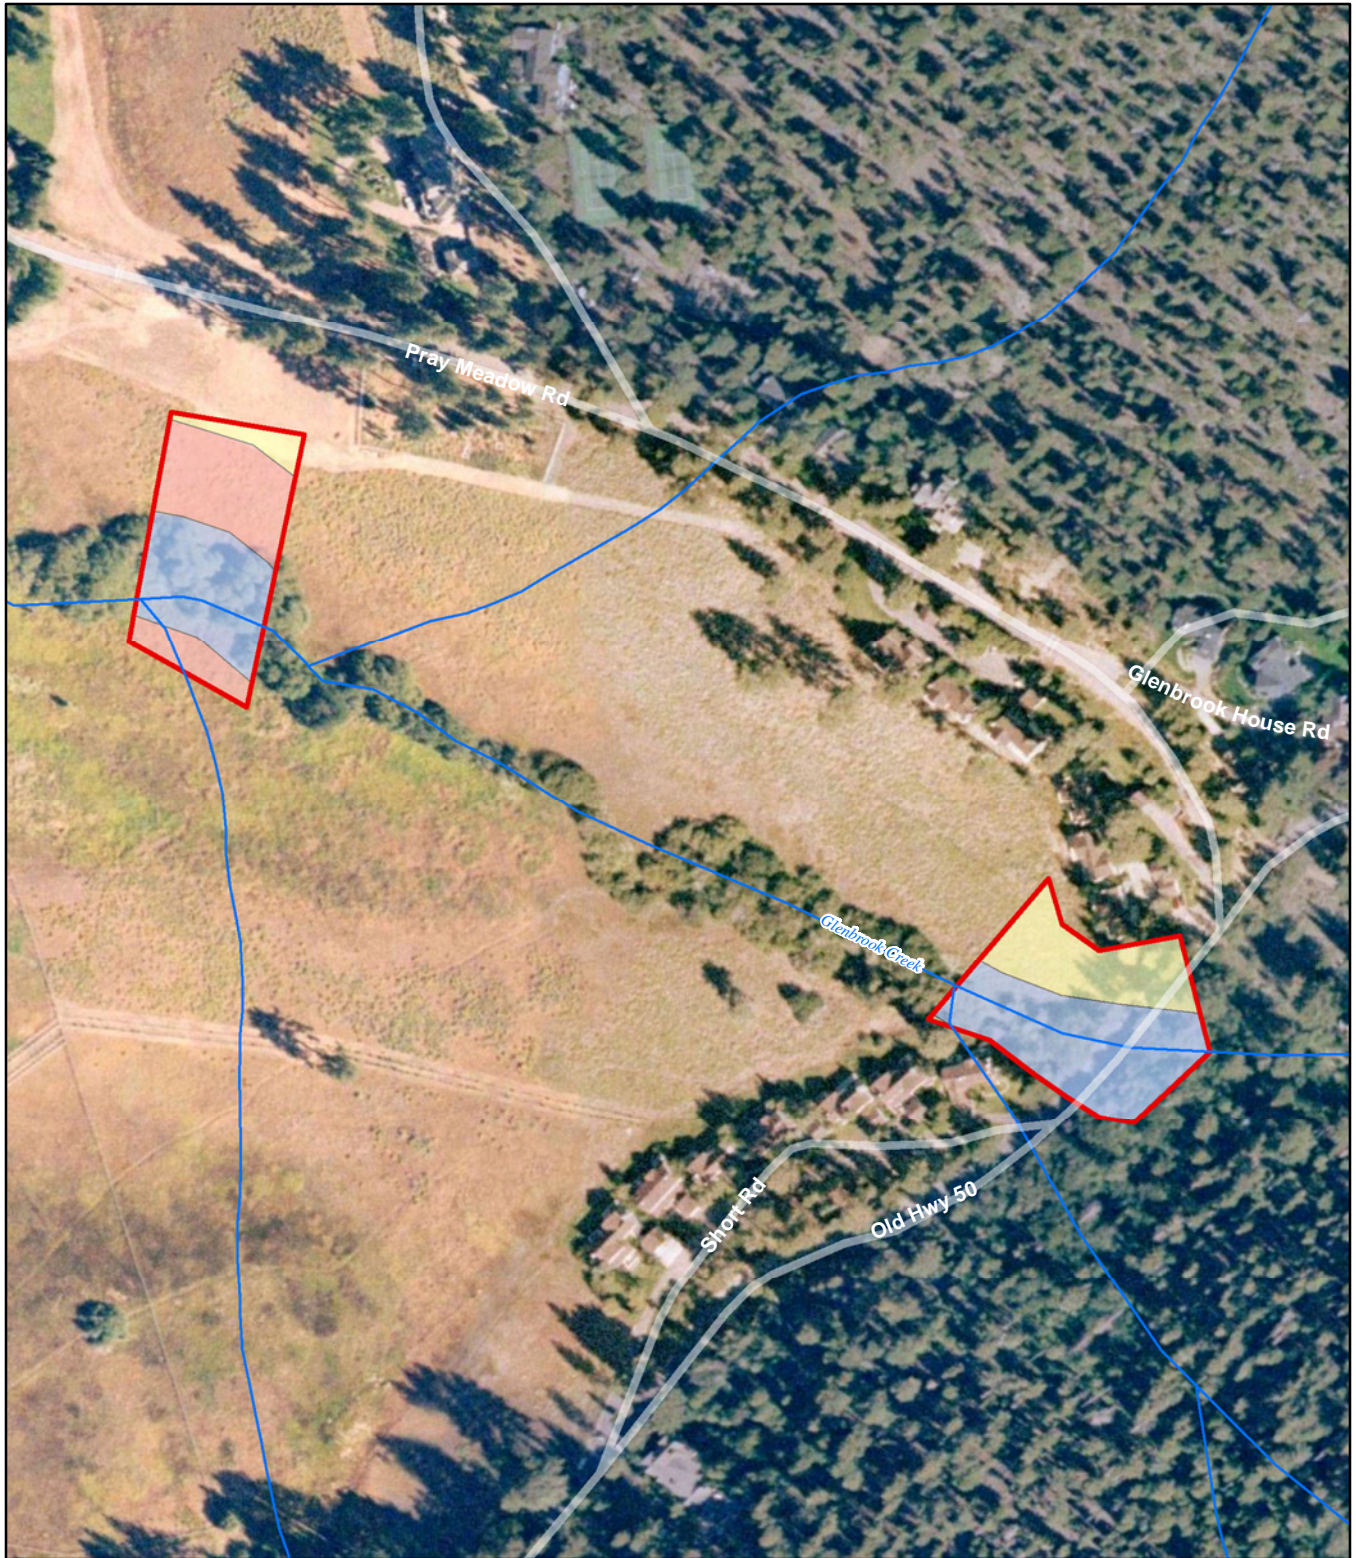
Soil Description

- Kingsbeach stony sandy loam, 2-15% slopes
- Oxyaquic Cryorthents-Aquic Xerorthents-Tahoe complex, 0-15% slopes
- Tahoe complex, 0-2% slopes

Kingsbeach stony sandy loam, 2 to 15 percent slopes (7161). This soil type is found on moderately sloped upland areas within the Study Area along north and south sides of Glenbrook Creek. This moderately drained soil occurs on alluvial fans and lake terraces and was formed in alluvium and/or colluviums derived from andesite over lacustrine deposits. This map unit is generally comprised of minor components of Tahoma, Jorge, very gravelly sandy loam soil map units. In a typical profile, this soil has a thin (less than one inch) organic layer made up of slightly decomposed plant material. The A horizon is a stony sandy loam to a depth of 6 inches. The B horizon consists of loam to 20 inches and sandy clay loam to 30 inches. The C horizon consists of clay loam down to 60 inches.

Tahoe complex, 0 to 2 percent slopes. This soil type is found within the Study Area at Trout Creek, Herbert Avenue North, and Van Sickle North. This map unit is generally comprised of 55 percent Tahoe silt loam, 25 percent Tahoe silt loam wet and 20 percent minor components such as Marla, Tahoe gravelly, and Watah soils. This poorly drained soil occurs on frequently inundated floodplains and valley flats and was formed in alluvium derived from granitic and volcanic rocks. In a typical profile, this soil is characterized as mucky gravelly silt loam in the upper ten inches, gravelly loam from ten to 27 inches, gravelly loamy fine sand from 27 to 32 inches, and gravelly fine sand from 32 to 46 inches. This soil map unit is classified as hydric, as soil components are poorly drained and/or are frequently ponded or flooded for a long or very long duration during the growing season when they occur in outwash terraces, flood plains, and valley flats (USDA, NRCS 2012).

Oxyaquic Cryorthents-Aquic Xerorthents-Tahoe complex, 0 to 15 percent slopes (9011). This soil type is found along the streambed and lower terrace of Glenbrook Creek in the central portion of the Study Area. This somewhat poorly drained to poorly drained soil occurs in drainageways, floodplains and valley flats and was formed in alluvium and/or colluviums from mixed parent material sources. This map unit is generally comprised of 30 percent oxyaquic cryorthents, 28 percent aquic xerorthents, 15 percent Tahoe, gravelly, and similar soils, and 27 percent minor components. This soil is classified as hydric and contains map unit components that are frequently flooded for long duration or very long duration during the growing season that: (USDA, NRCS 2012).

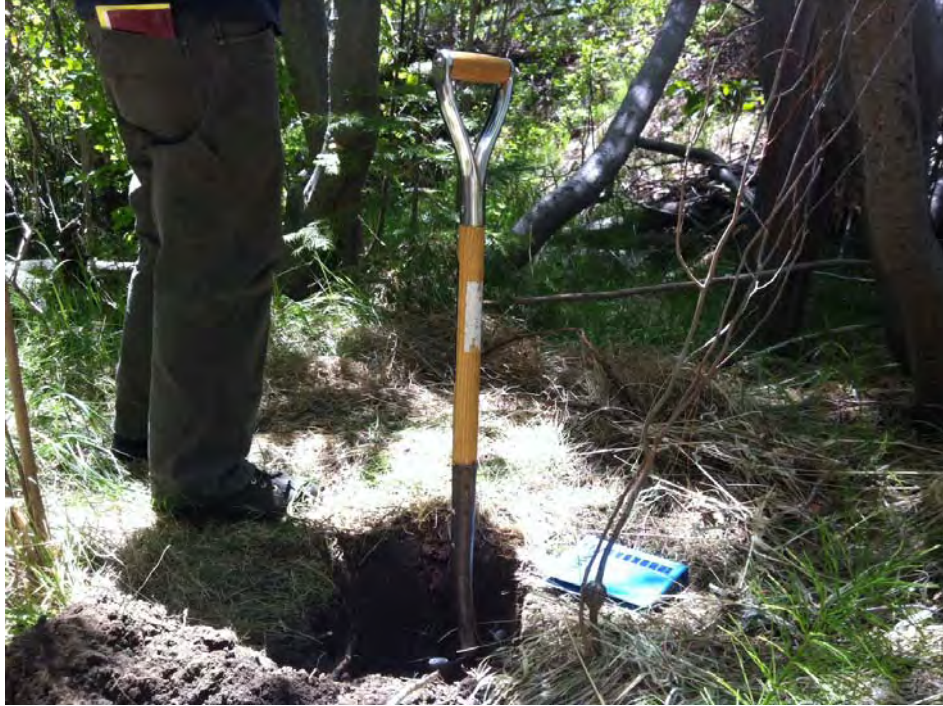
Photo 1: View of P1 in non-wetland riparian portion of Glenbrook Creek on fill soils within western portion of Study Area. May 28, 2012

Remarks:
 no wetland hydrology observed. Sample point taken on filled bridge over culvert.

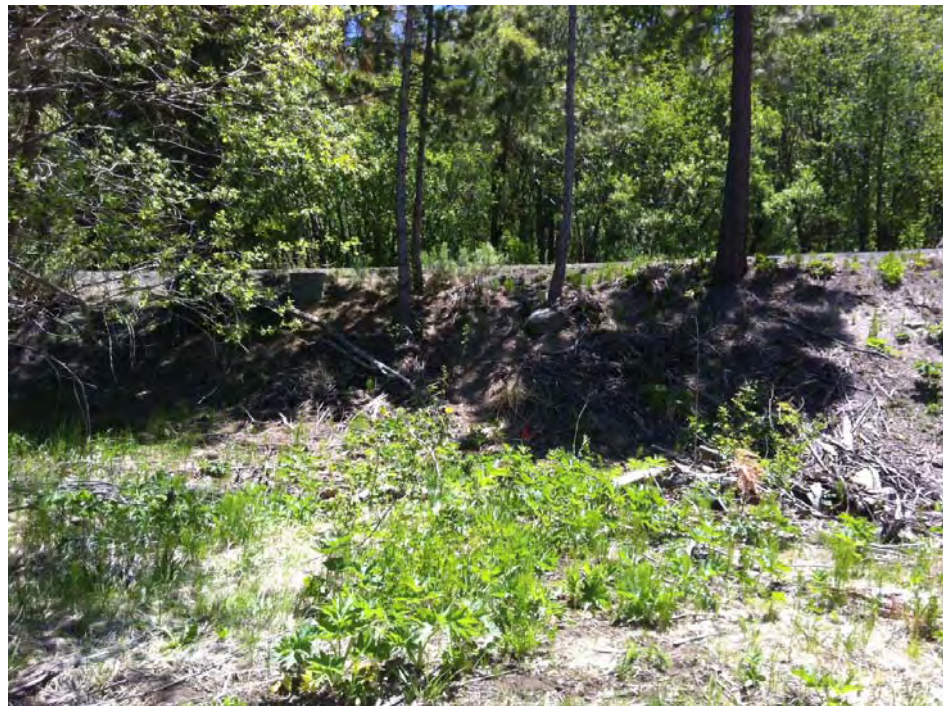
Photo 2: View of upland sample point P2 within proposed creek alignment, facing east. May 28, 2012.

Remarks: Damaged wood, cut branches + wood chips comprise the bare ground.

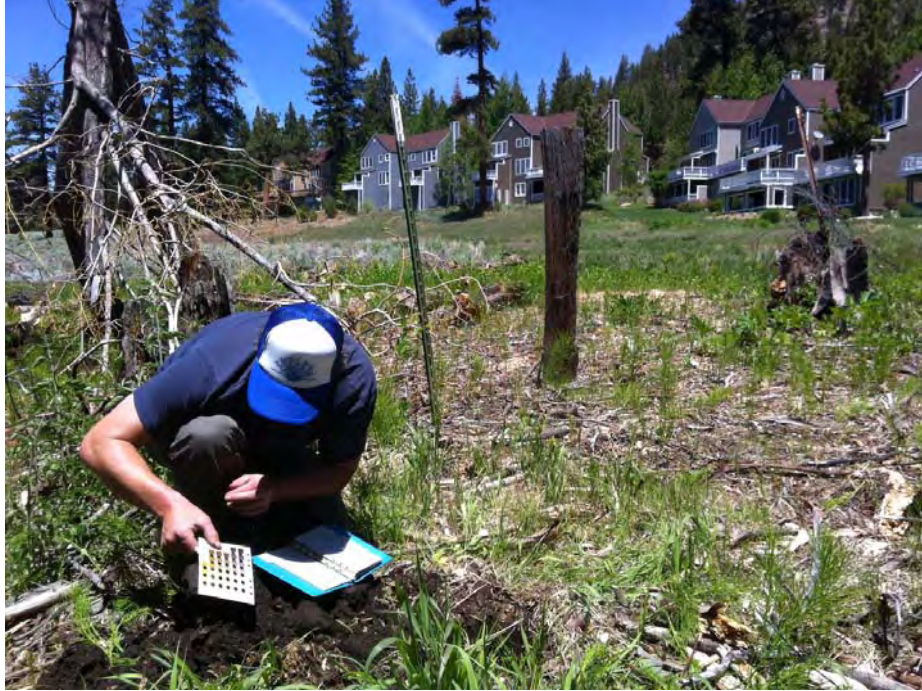
Photo 3: View of upland sample point P3 on upper terrace of Glenbrook Creek, facing northwest. May 28, 2012.

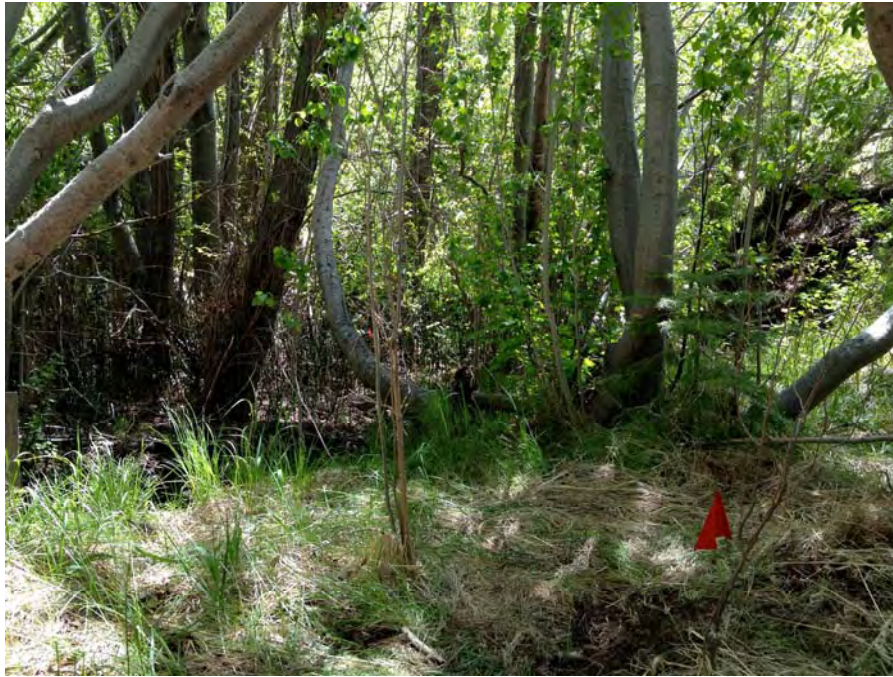
Photo 7: View of wetland sample point P7 at within active floodplain of Glenbrook Creek. May 28, 2012.

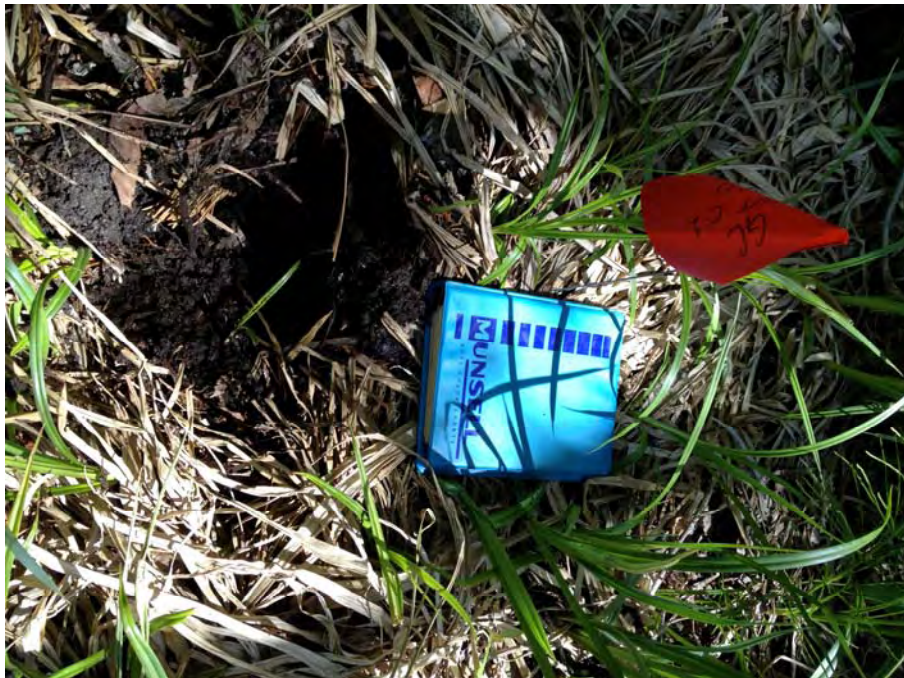
Photo 8: View of wetland sample point P8 collected within small-fruited bulrush dominated hillside seep. May 28, 2012.

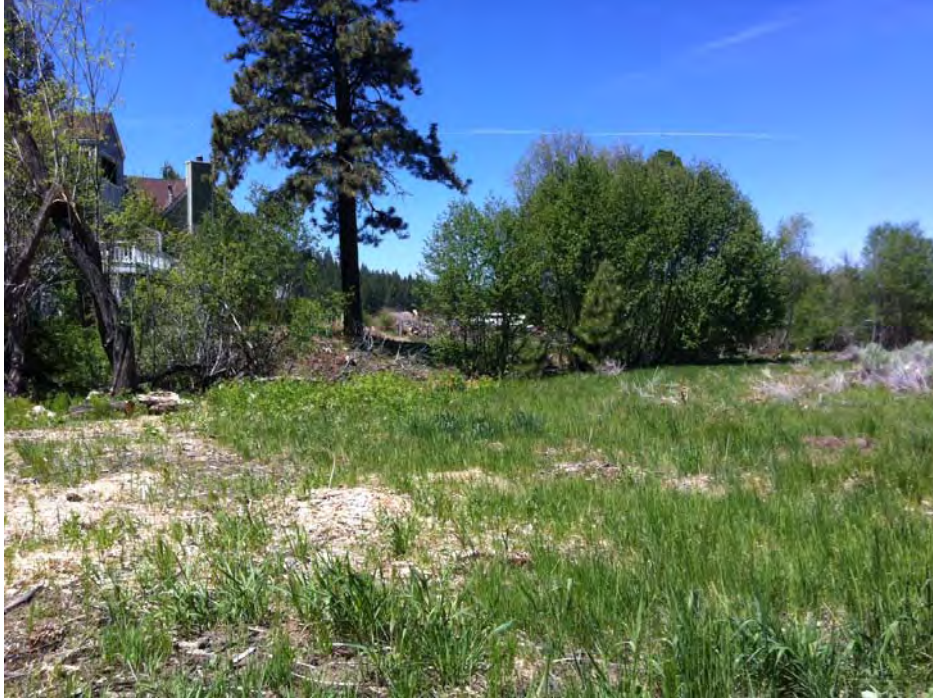
Photo 9: View of area to be restored by realignment of creek channel. June 28, 2012.

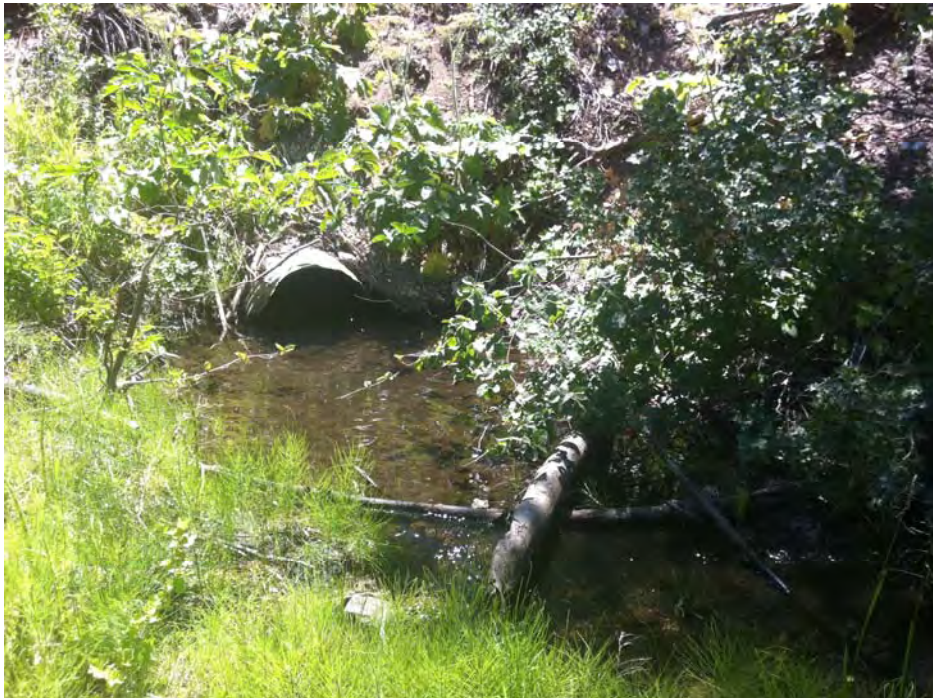
Photo 10: View of actively flowing creek channel mapped as other waters at the culvert opening under Old U.S. Route 50. June 28, 2012.

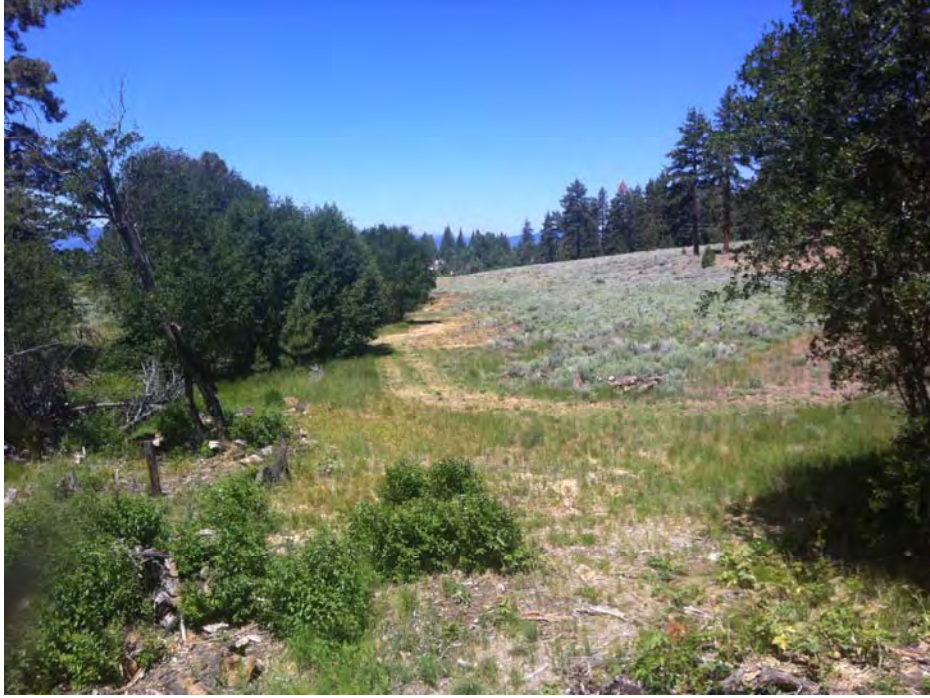
Photo 11: View of rabbitbrush scrub, ruderal grassland, and riparian woodland plant communities within the Study Area. June 28, 2012.

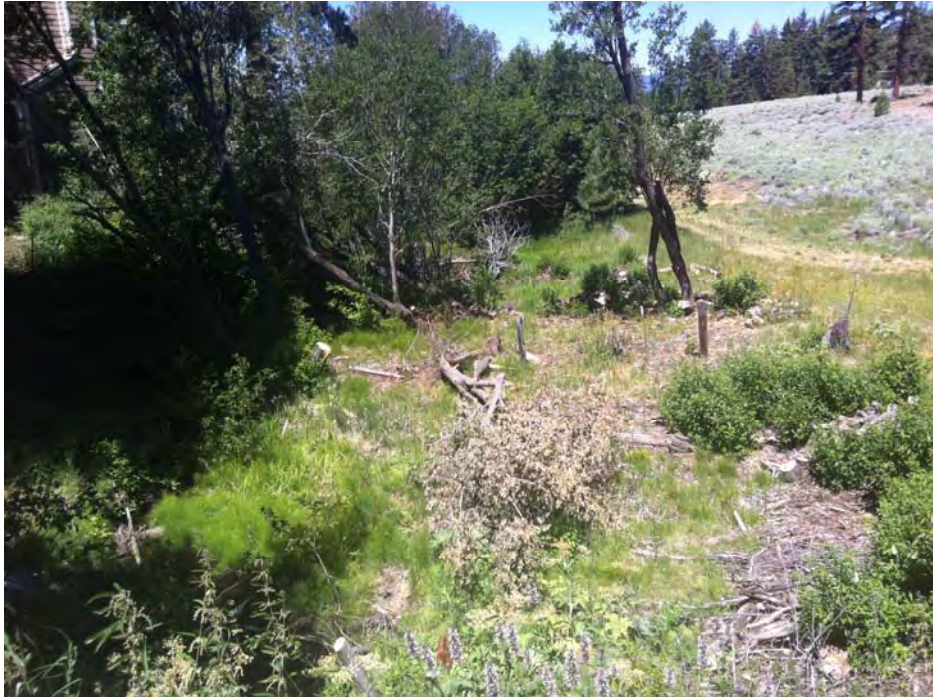
Photo 12: View of area to be restored downstream of existing culvert crossing, facing west. June 28, 2012.

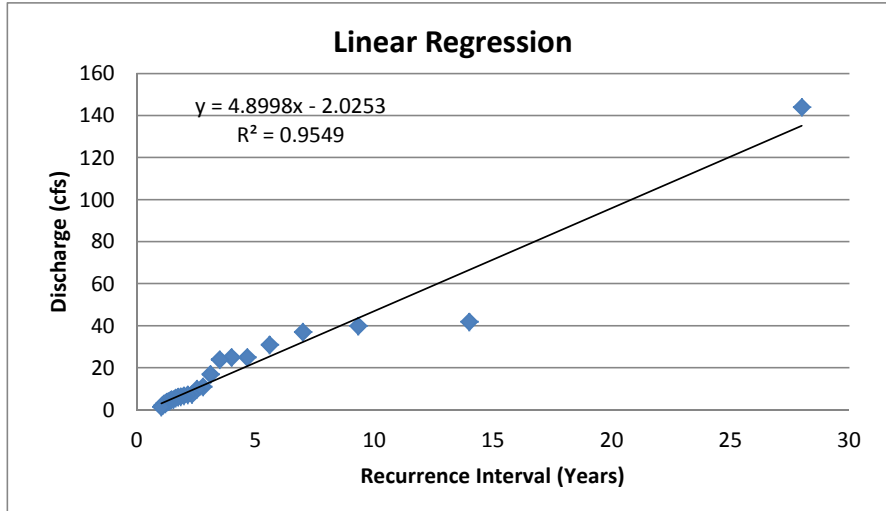
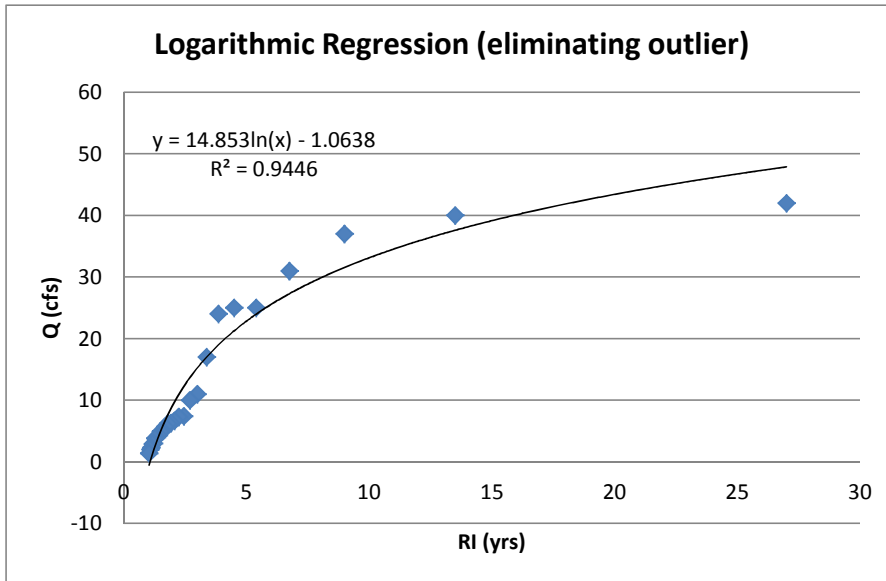
Calculation of Discharge Frequency for Glenbrook Creek

Linear Regression Results

Recurrence	Discharge (cfs)
1	2.8745
2	7.7743
5	22.4737
10	46.9727
20	95.9707
25	120.4697
50	242.9647
100	487.9547

Based on data from two USGS gages located above Old Highway 50 and near the outlet of the creek to Lake Tahoe, the two year design discharge was calculated at 9 cfs (Appendix D). The 100 year flood of 221 cfs was obtained from the downstream Glenbrook gage analysis found in the USGS report “Estimated Flood Flows in the Lake Tahoe Basin, California and Nevada” (USGS 2002).

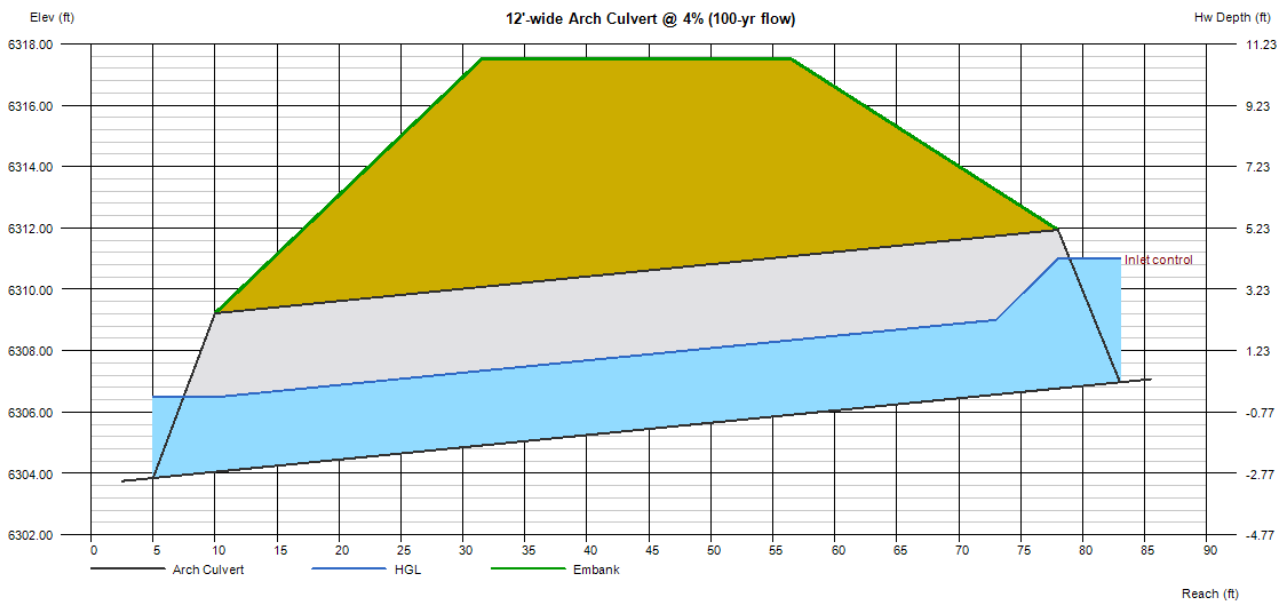
Engineered Streambed Material Calculations

The substrate gradations used in the engineered streambed material (ESM) were derived from methods recommended by the United States Bureau of Reclamation (USBR, 2007), the Washington Department of Fish and Wildlife (WDFW, 2003), and the California Department of Fish and Game (CDFG, 2009) (Appendix D). These methods predict the stable rock diameter for a given channel slope and unit discharge. Hydraulic modeling results for the 100-year flood event were used to design the ESM gradation and should therefore remain stable during the 100-year flood event. Channel substrate gradations are listed in the construction documents (See Special Technical Provisions and Project Plans).
