The Bulletin Kaikōura earthquake update

This Bulletin provides the latest information about the rebuild of road and rail networks damaged by the Kaikōura earthquake in November 2016. The Bulletin is produced by the North Canterbury Transport Infrastructure Recovery (NCTIR) - an alliance representing the NZ Transport Agency and KiwiRail, on behalf of Government.

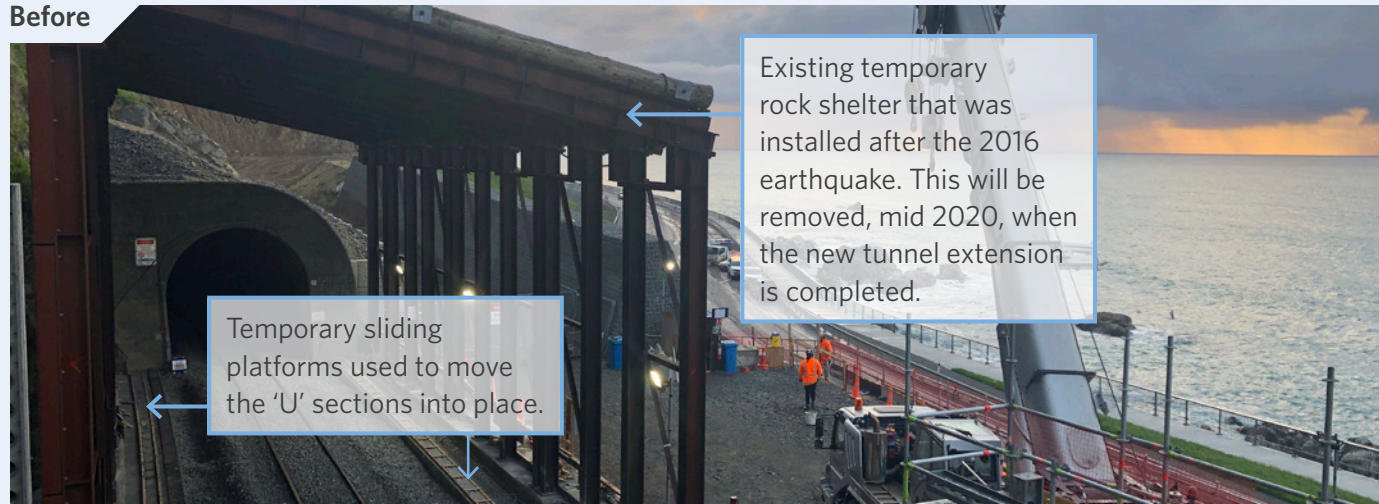
Before

Existing temporary rock shelter that was installed after the 2016 earthquake. This will be removed, mid 2020, when the new tunnel extension is completed.

Temporary sliding platforms used to move the 'U' sections into place.

Crews at Tunnel 19 south of Ōhau point have recently finished sliding a number of concrete sections against the tunnel mouth to form an extension. This will act as a permanent rockfall protection measure. This is similar to works underway at Tunnel 11, south of Kaikōura, except here crews need to work around the existing rockfall shelter. See below for an example of the process.

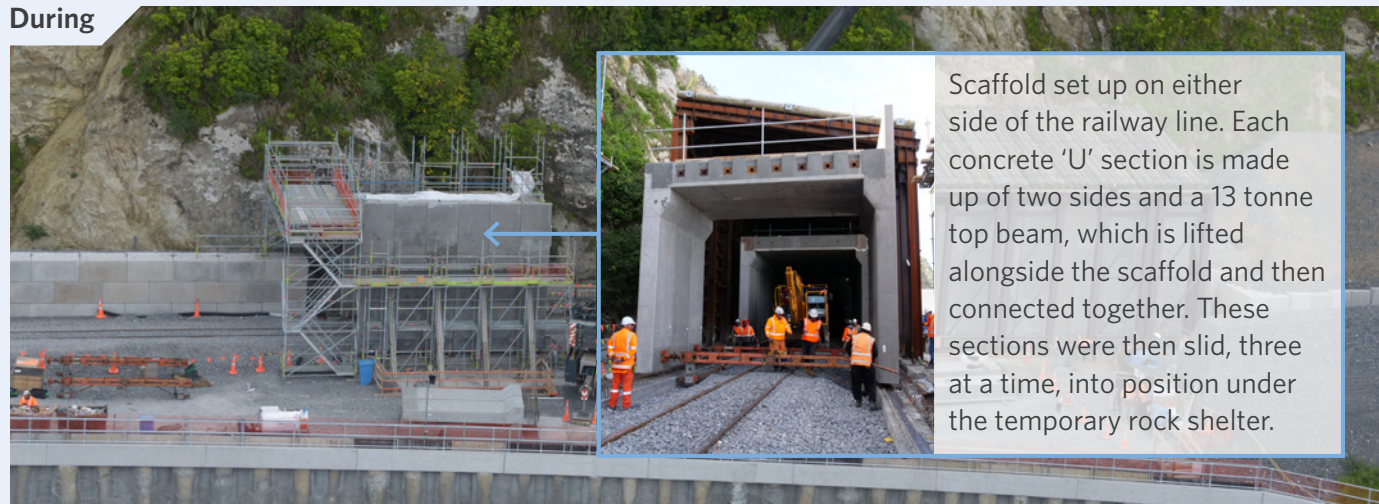
During

Scaffold set up on either side of the railway line. Each concrete 'U' section is made up of two sides and a 13 tonne top beam, which is lifted alongside the scaffold and then connected together. These sections were then slid, three at a time, into position under the temporary rock shelter.

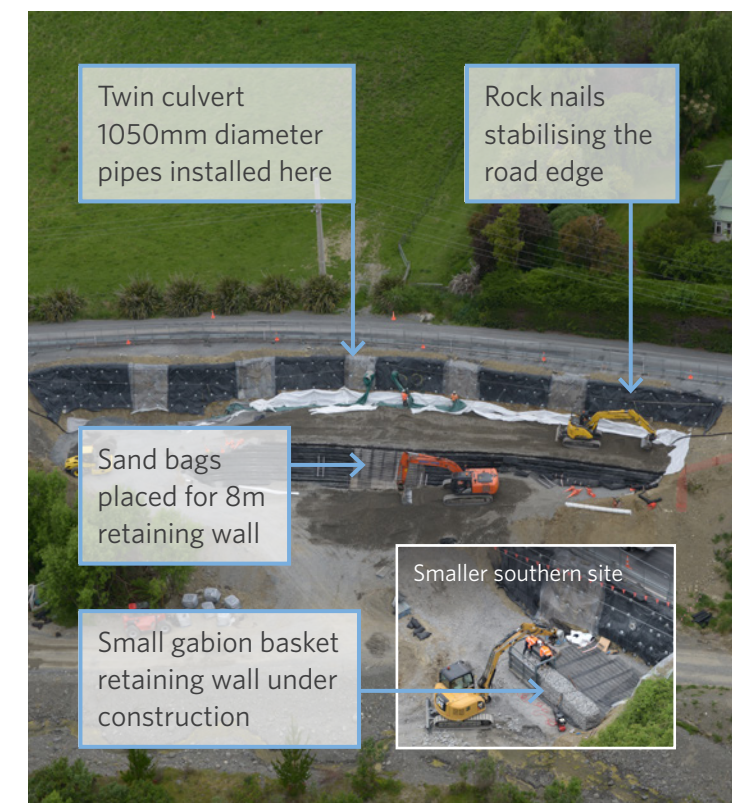
Twin culvert 1050mm diameter pipes installed here

Rock nails stabilising the road edge

Sand bags placed for 8m retaining wall

Small gabion basket retaining wall under construction

Smaller southern site

On the larger northern site the retaining wall is being constructed by hand. Instead of using gabion baskets the wall is being constructed of sandbags, containing 95% sand and 5% cement. Placing each sandbag by hand takes slightly longer, but makes for a more resilient structure, as hand placed sandbags have a 100-year guarantee, instead of the standard 50.

When the 8m high retaining wall is complete, and the twin 1050mm diameter culverts installed, the western side of the road will be backfilled to match the road height. Traffic will then switch onto this newly constructed lane while the culverts are installed on the eastern side. The road will then be stabilised and sealed ready for Christmas.

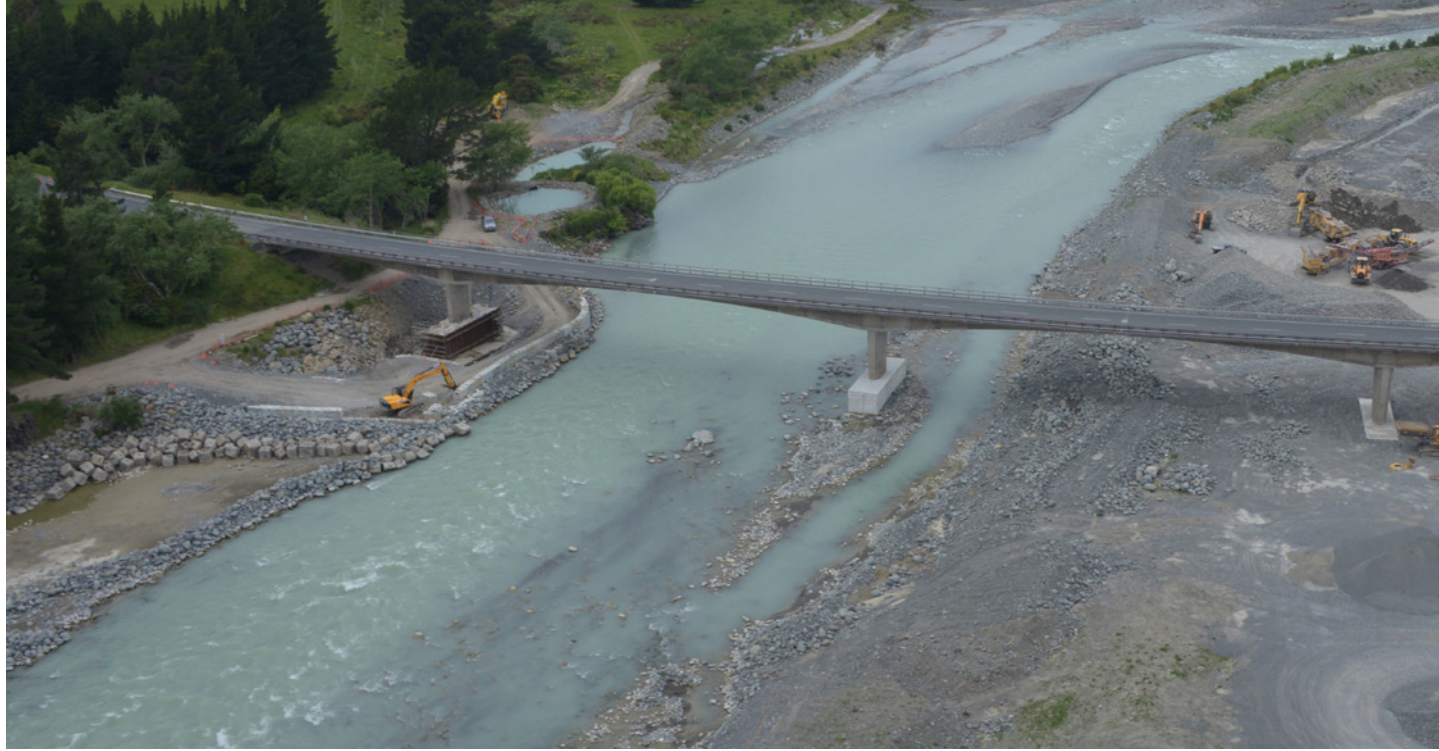
Crew at Clarence River Bridge recently hit a milestone, strengthening the last of the bridge's piers by pouring a 92m³ concrete 'jacket' around the existing Pier B structure. The pour lasted around six hours, with two 6m³ capacity concrete trucks taking turns to pour and then refill at an on-site concrete plant. Crews will now begin removing the river diversion, with work expected to wrap up before Christmas.

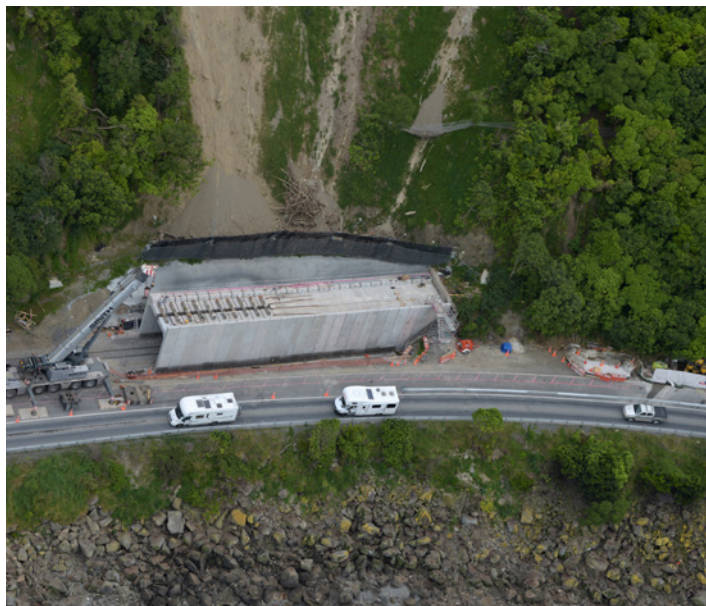
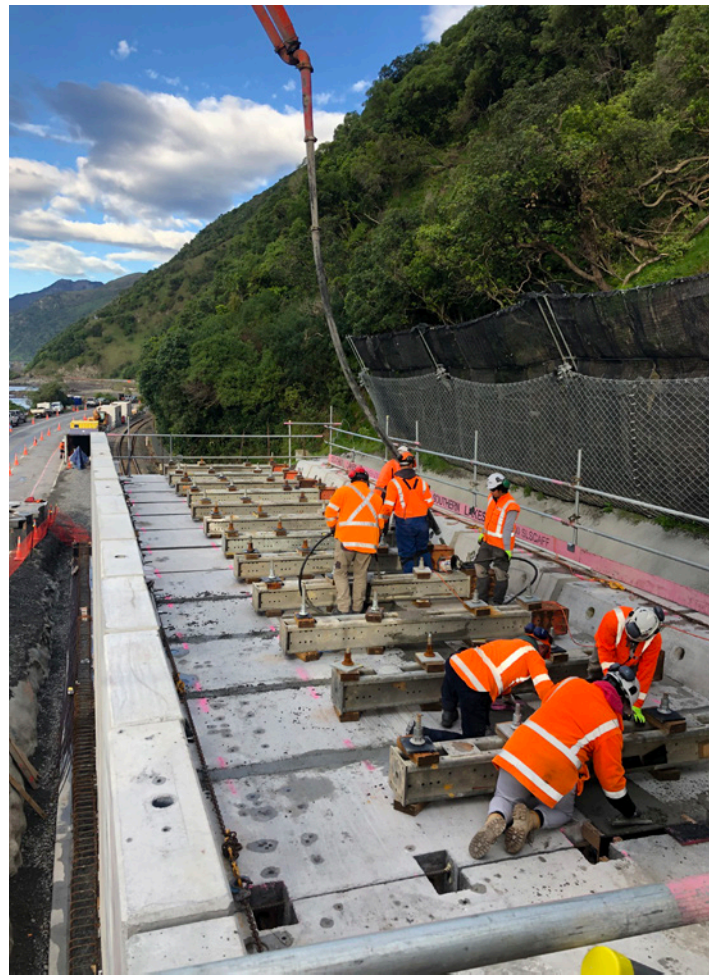
The 28th and final concrete 'U' section has recently been placed on the Tunnel 11 rail tunnel extension between the

Raramai and Paratitahi tunnels south of Kaikōura. Crews are now focussed on backfilling work, and will begin installing rock anchors above the tunnel in the new year, with work expected to wrap up in April 2020. Traffic will return to two lanes over the Christmas break.

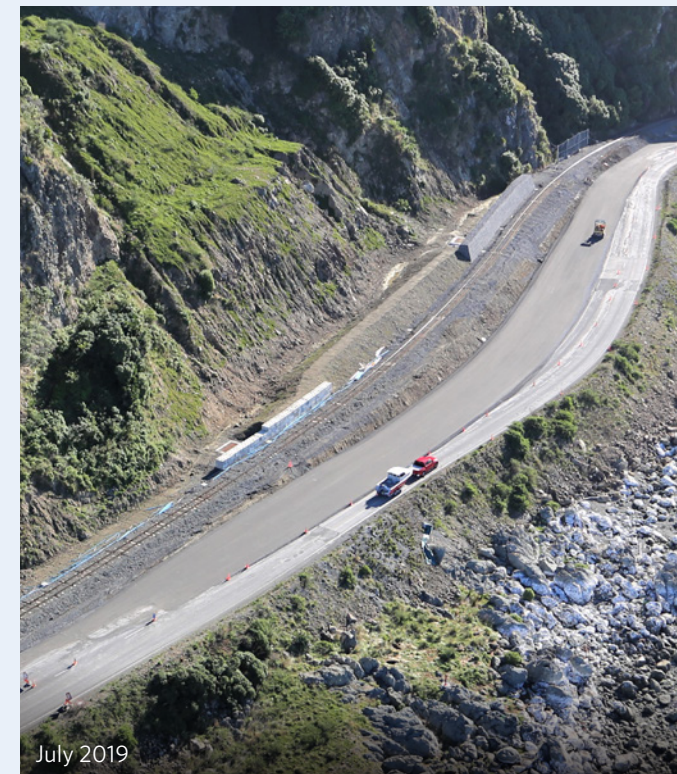
July 2019

Work is progressing on the southern end of Ōkiwi Bay where the road is being realigned to smooth out the curves, and to move the flow of traffic further from the rock face. Approximately 98% of the material to form the embankment has been placed, with 85% of the rock revetment completed. This project is scheduled to wrap up in late May 2020.
