# Lucy Islands Eelgrass Study

June 2011

Research carried out by **Ocean Ecology**

Prepared for: Mike Ambach  
Program Manager  
World Wildlife Fund - Prince Rupert  
#3-437 3rd Ave. West  
Prince Rupert BC  
V8J 1L6

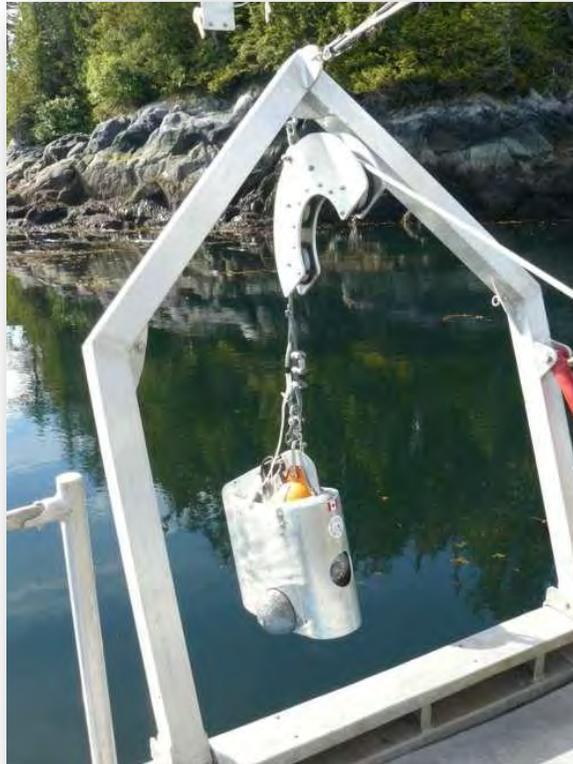
Figure 6. Towed video camera system about to be deployed.

A DGPS-positioned, towed video system was used to collect imagery of the seabed (similar to the Seabed Imaging and Mapping System [SIMS] used by CORI). This system was a custom-built model (e.g., not commercially available) designed for use in the steep, rugged terrain characteristic of British Columbia fjords (see Figure 6). Typical tow speed for the system was 0.9 knots. The towed video system has two video cameras - one in a forward-looking orientation and one in a downward-looking orientation. Both cameras have a Sony 1/3" super HAD color CCD with 480 lines horizontal resolution (768 x 494 pixels) and 0.5 lux @ F 2.0. These cameras provided composite video signals to an overlay unit that stamped the DGPS position data (latitude/longitude), together with date and time, on each video frame. The video signal was also displayed in real-time on the vessel, where it was used to adapt the survey to particular features that were seen while underway. High intensity white LEDs were mounted on the camera to provide additional illumination when it was required. On the April 20<sup>th</sup>, 2010 survey, the downward-looking camera was also equipped with a pair of scaling lasers with a center-to-center distance of 4 cm.

The altitude of the underwater camera was controlled using a hydraulic winch which was operated from the bridge while monitoring the real-time video feed from the camera. Typically, the camera was towed approximately 1 m above the seabed.

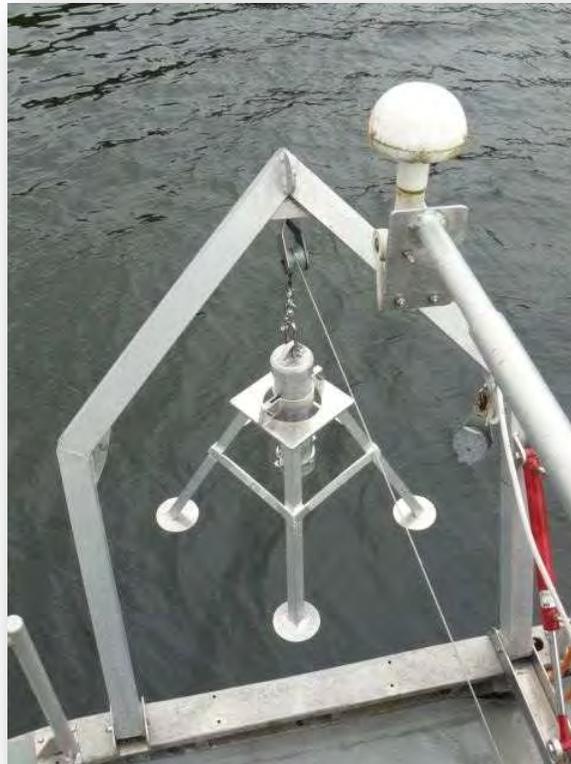
Figure 10. High definition drop camera in the lander frame.

A DGPS-positioned, high definition drop camera system was used to collect high resolution still photographs of the seabed. This system consisted of a dual Ethernet/analog output high definition video camera in a water tight housing mounted in a “lander” frame (see Figure 10). The lander frame was designed to hold the camera at a specific elevation above the sea floor with a known field of view, and to minimize movement of the camera system so that blurring of the photographs was reduced. The lander frame had a 0.25 m<sup>2</sup> base footprint, which matches the standard quadrat size used by many shore survey protocols. The height of the camera was adjusted in the frame such that the field of view of the camera matched the lander footprint, and was thus also 0.25 m<sup>2</sup>.

The camera used in the video system was a 5.0 MP IQeye 755 with a maximum resolution of 2560 x 1920 pixels. It operates very well in low-light conditions, with a 0.3 lux sensitivity for color images and < 0.05 lux sensitivity for black and white images. Power consumption is less than 2.5 W, which made the camera ideally suited for a remotely-powered system. The camera has both a full time analog video output (NTSC/PAL standard) and an Ethernet output which allows live streaming of high definition video and images, as well as control over the various camera settings. Since it was not possible to have an Ethernet connection to the camera while it was underwater, the camera was set up to record high definition images to an onboard CF card every 2 seconds. Live video from the camera was viewed real-time on the vessel during deployment using the analog output. When the camera was brought to the surface, the Ethernet cable was attached, and the recorded images were downloaded to a computer.

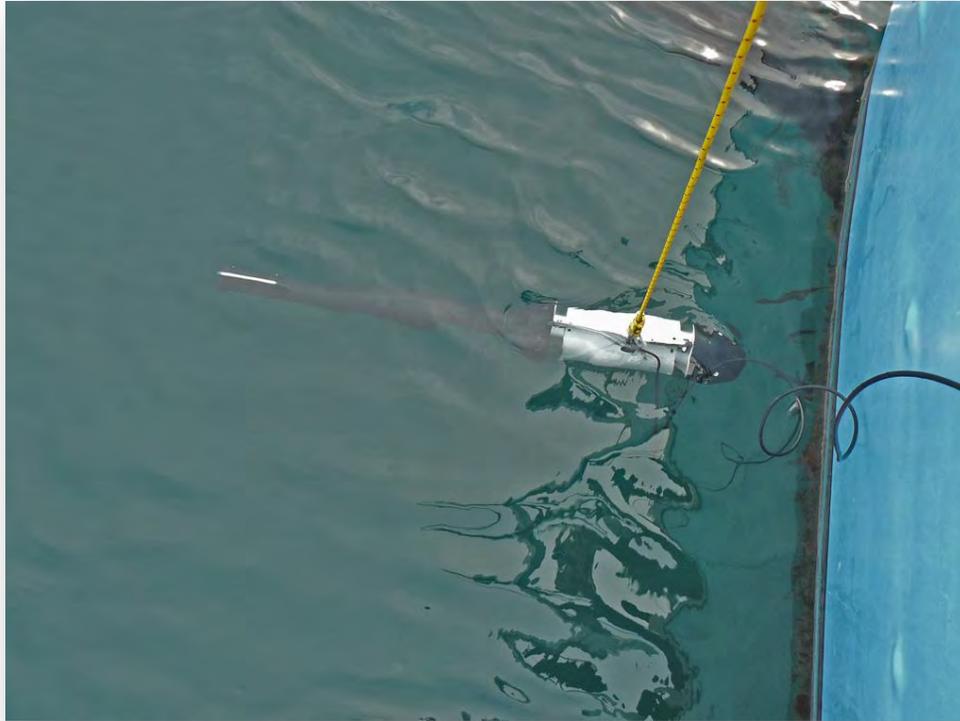
Figure 12. Side scan sonar towfish in towing position.

Side scan sonar images were collected using a Humminbird 997c SI sonar unit operating at 455 kHz. Simultaneously, the Humminbird unit also collected seafloor depth data using a downward-looking sonar operating at dual 83 and 200 kHz frequencies. The transducer for the Humminbird unit is mounted in a towfish which was towed from the stern of the vessel at 2 m depth (see Figure 12). Side scan and downward-looking sonar data were recorded to an SD card in the proprietary Humminbird SON file format.

The specifications of the side scan sonar towfish and associated data collection system were:

- Specifications of downward-looking sonar:
  - 200 kHz beamwidth at -3dB = 14°
  - 83 kHz beamwidth at -3dB = 42°
  - Transducer depth range: approximately 450 m
- Specifications of HDSI (high-definition side imaging) transducer (best for shallow water use) at 455 kHz:
  - Horizontal beamwidth at - 3dB = 1.7°
  - Vertical beamwidth at -3 dB = 59°
  - Transducer tilt angle from vertical = 48°
  - Transducer depth range: approximately 45 m
- Power output of unit: 1000 Watts (RMS)
- Swath width: 270 m in 30 m water depth and 18 m in 2 m water depth
- Positioning system: Electronic charting software using DGPS antenna mounted directly above the towfish

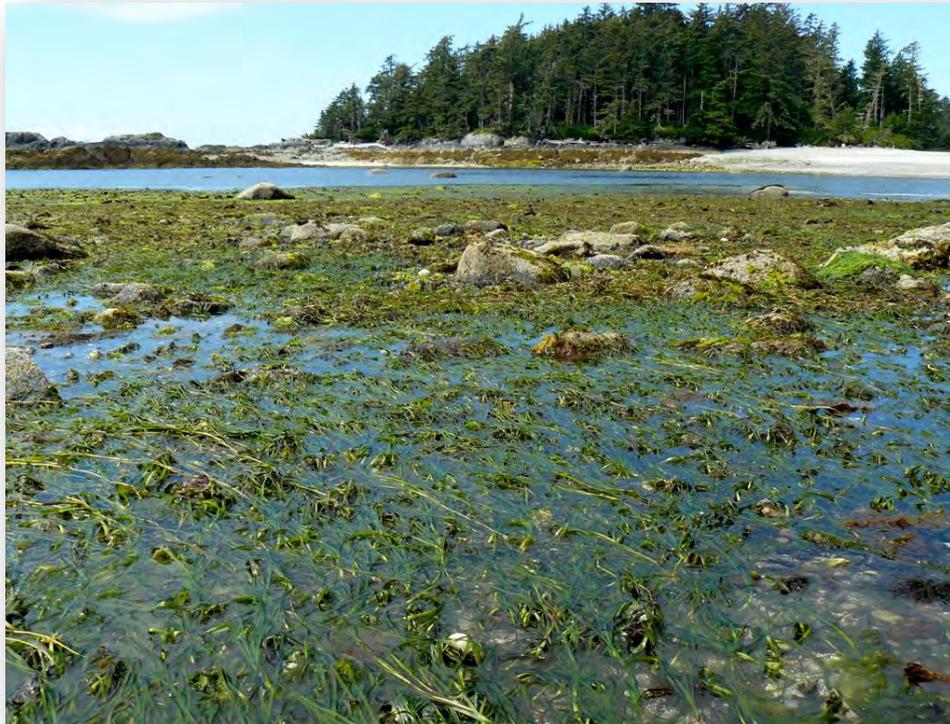
Figure 16. Eelgrass in the upper intertidal zone at Lucy Islands exposed during low tide.

In addition to the lower intertidal and subtidal eelgrass (*Zostera marina*), which was the focus of the Lucy Islands study, a significant amount of eelgrass was observed in the upper intertidal zone (see Figure 16). This eelgrass had not been observed and recorded during the North Coast 2000 Aerial Video Imaging Survey of the region (CORI, 2000). There are several possible reasons for this:

The intertidal eelgrass at the Lucy Islands site grew in mixed substrate (sand with cobbles and boulders, see Figure 16). As the upper limits of the intertidal zone were approached, the eelgrass became smaller and less abundant, possibly grading into the *Zostera marina typica* ecotype (primarily intertidal with low tolerance to current; has shorter, narrower blades; Precision Identification Biological Consultants, 2002). At the upper edge of the intertidal zone, as the eelgrass became less abundant, patches of surfgrass (*Phyllospadix scouleri*) started to appear (see Figure 17). In this transitional zone between eelgrass and surfgrass, differentiation between the two species became quite difficult, and often required finding the flowering heads (see Figure 18 and Figure 19). As a result of this, future surveys of the intertidal region of the Lucy Islands site should probably occur during the flowering season of both species (late spring to summer).

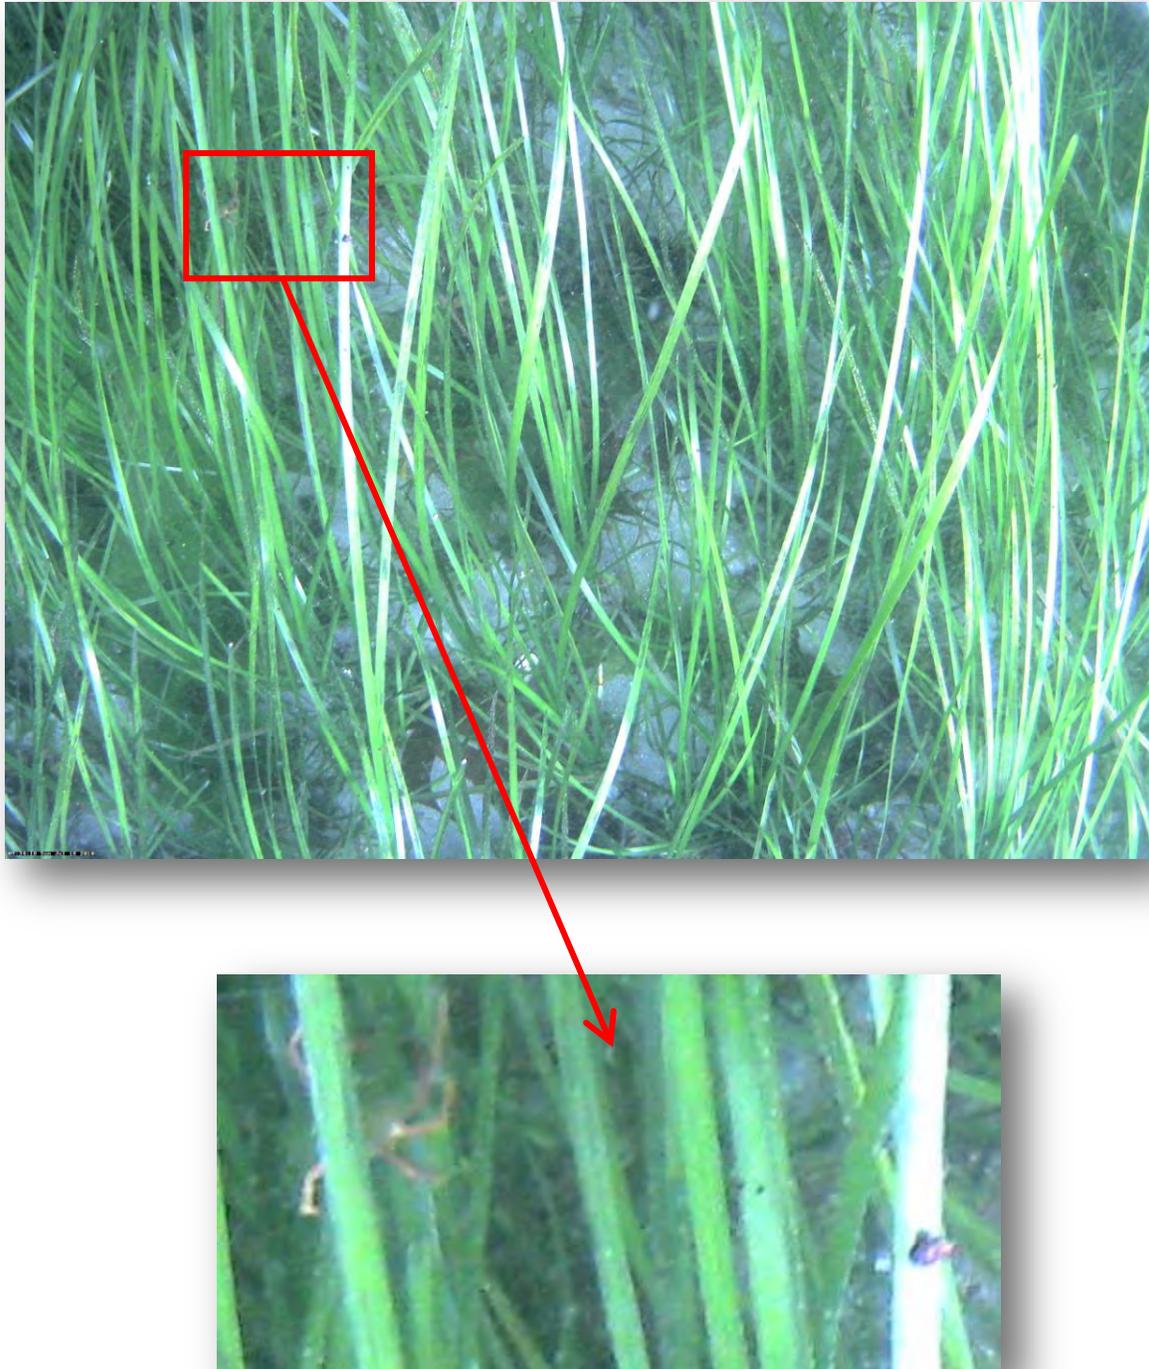
Figure 41. Image from the high definition drop camera showing a carinate dovesnail and a small kelp crab.

Shown below are two examples of images taken from the high definition drop camera survey at the Lucy Islands study site (see Figure 40 and Figure 41). These images demonstrate the level of resolution which can be achieved using this camera system.
