Historic Landscape
Character Assessment

Killeigh, County Offaly

Offaly County Council

Autumn 2006

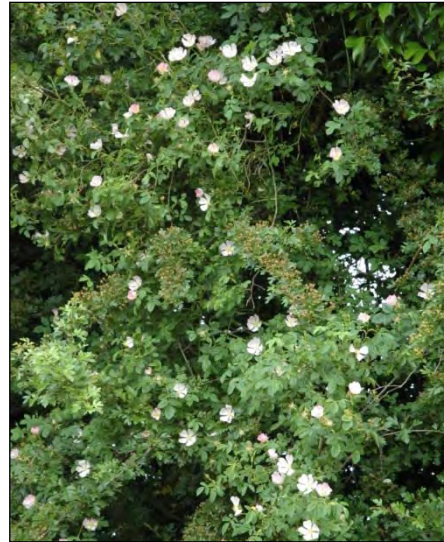
A further function of this hedgerow is intimately linked with the structure of the embankment. The trees and shrubs may in part protect the embankment from erosion and trampling and act to hold the embankment together through the network of roots. In the section of hedgerow adjacent to the national school, there are mature beech, ash, hawthorn and elder with occasional dog rose (see picture to the right).

Dog Rose

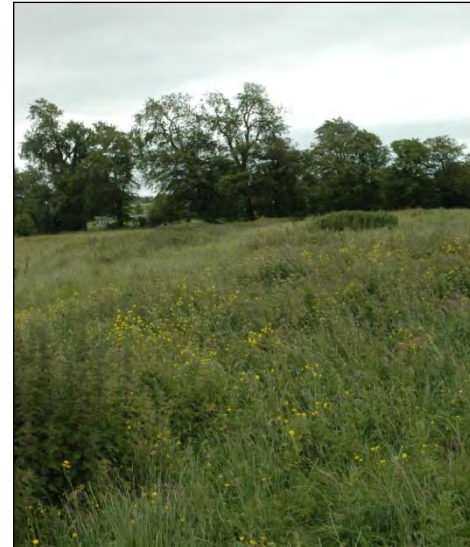
Overgrown hedgerow

The photos to the right show the overgrown nature of the hedgerow network in the Killeigh hinterland. In the foreground the land is rough pasture with a mix of grasses and buttercup (*Ranunculus repens*) predominating. The hedgerow runs east to west north of the national school. To the foreground are occasional hawthorn shrubs. These shrubs follow the line of the ancient entrenchment that rings the village. In the background mature beech, ash and occasional oak demarcate the line of the hedgerows.

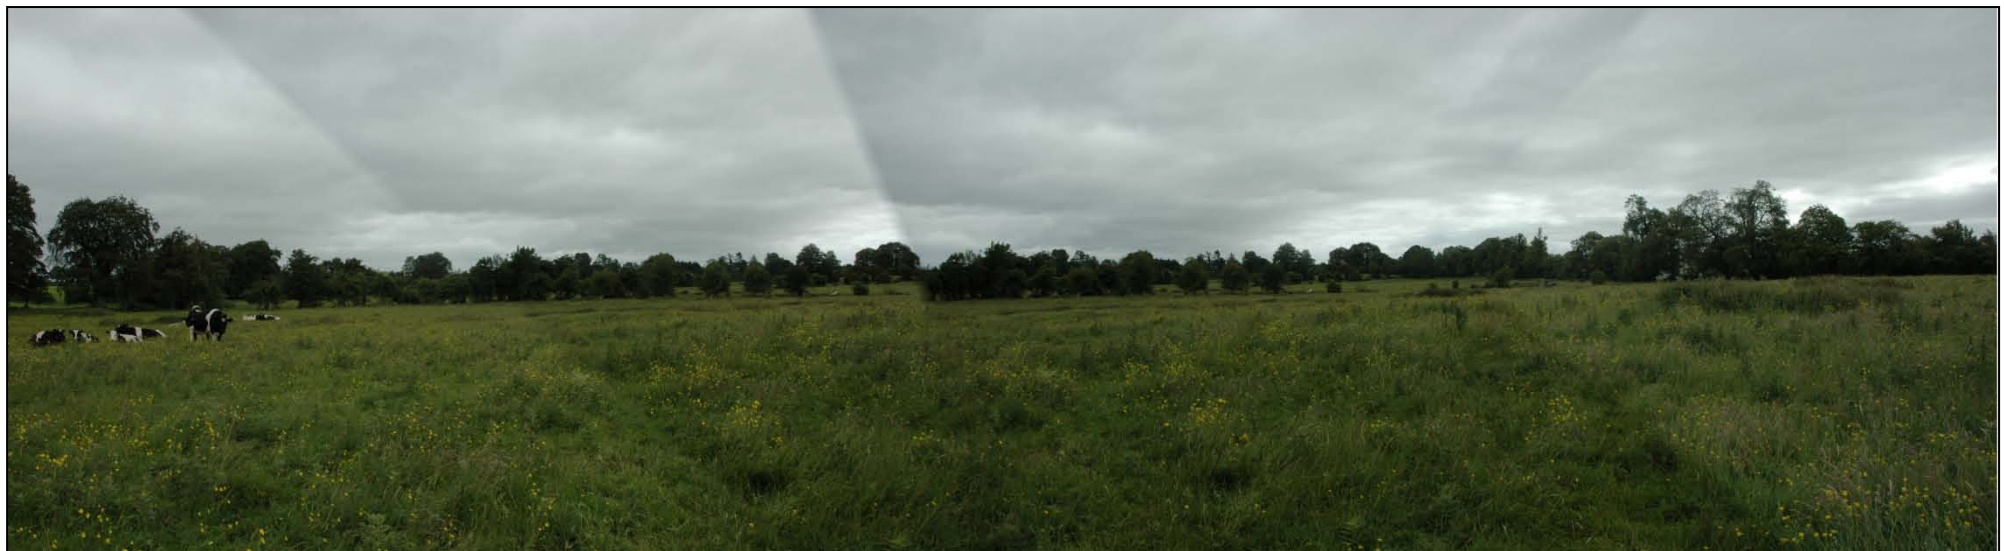
Extent of hedgerows and grassland in study area

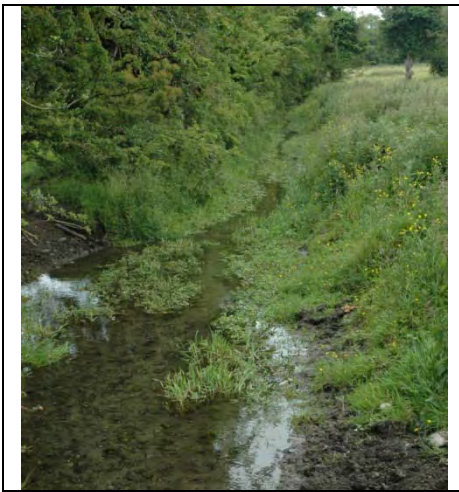
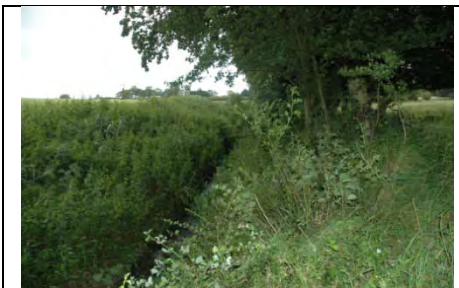
The streams that flow through the area were, in the past, used to drive mill wheels. Currently the waters are generally of good quality. Possible spillage of diesel was evident from the smell and discoloration of the stream adjacent to the village green. An accumulation of black organic deposits are evident in the photograph below and may indicate a number of polluting events that in the past produced anoxic conditions. Such activities will have a definite detrimental effect on stream biodiversity.

Stream along hedgerows

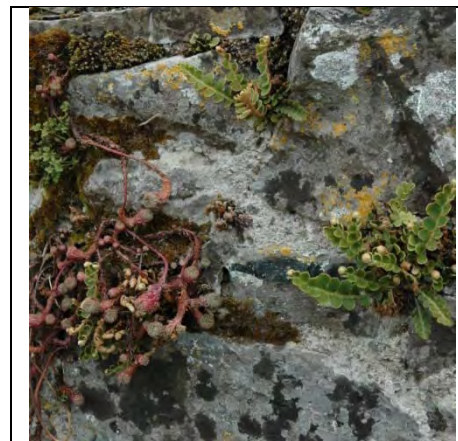
Stone walls within the village have a mix of species commonly found in such habitats including stone crop (*Sedum spp*), ferns, ivy, mosses and lichens

Stone wall with variety of plants

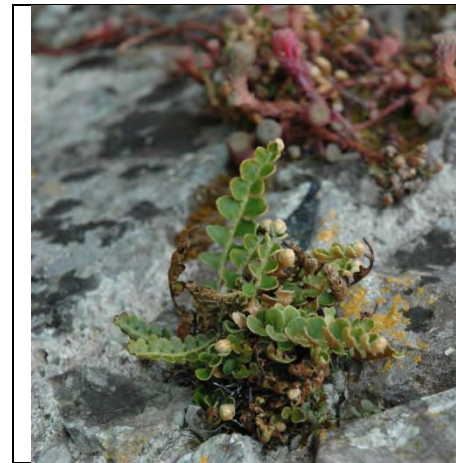
Detail of stone wall plants

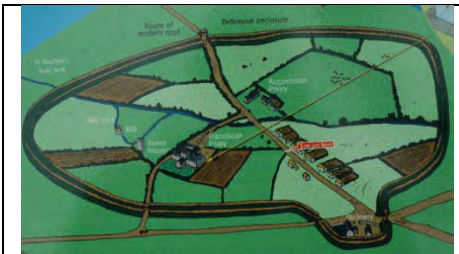
It would appear from other documents that Senchell was a contemporary of St. Kevin of Glendalough and Petrie suggested that buildings of contemporaneous age to those in Glendalough would have existed in Killeigh. However only suggestions of the site remain, predominantly in the survival of the surrounding enclosure.

Artist's Impression of Early Christian Enclosure at Killeigh (as seen on information in Killeigh Green)

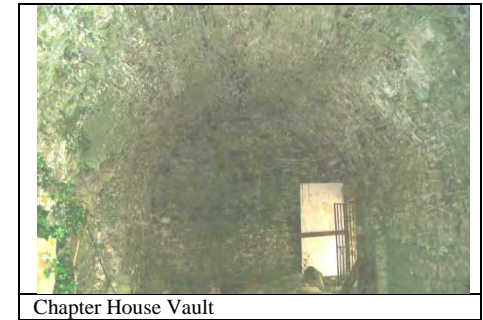
Chapter House Vault

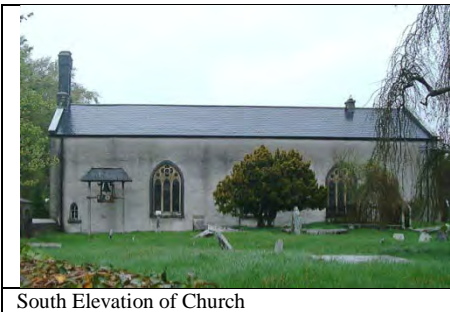
South Elevation of Church

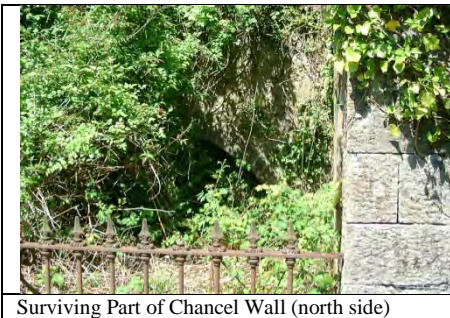
Surviving Part of Chancel Wall (north side)

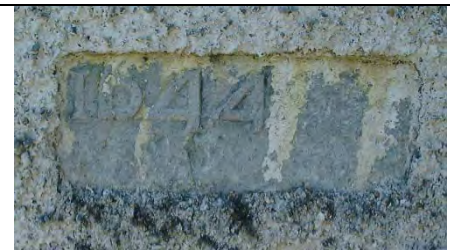
Date Stone: 1644

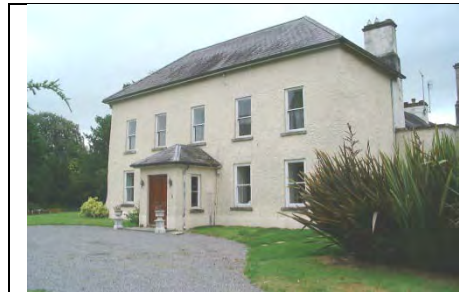
16/17th Century House, with annexe and outbuildings that were originally part of Franciscan monastery. Parts of the outbuildings seem to be part of the original domestic range of the monastery. The buildings are protected, although the house, annexe and outbuildings are now much altered

Abbey House, Front Elevation

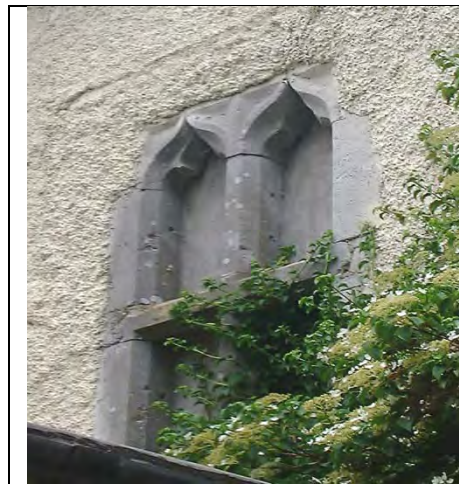
16/17th Window , Rear of House

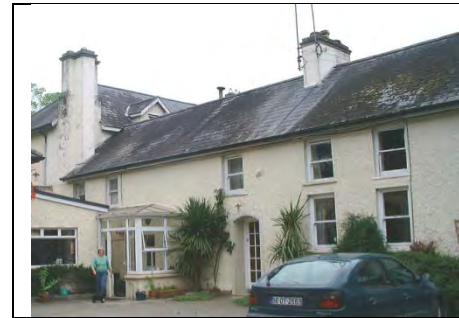
Rear Annexe to House

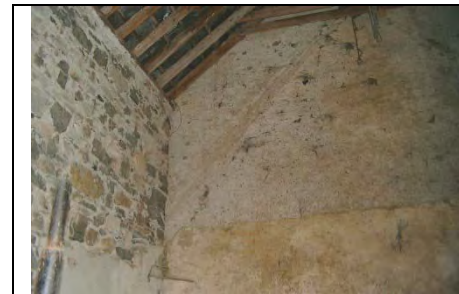
Outbuildings – internal view indicating original roof line

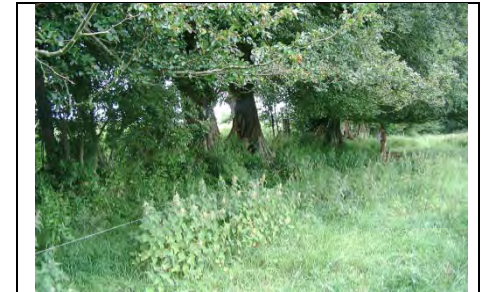
The early medieval ecclesiastical enclosure consisted of a double bank separated by a fosse. The enclosure is oval in outline with the sub-rectangular 'Nuns Enclosure' attached to the south-east side. Only sections of the enclosure survive above ground level. Nevertheless the full extent of the outline can be identified.

Northern Stretch of Enclosure

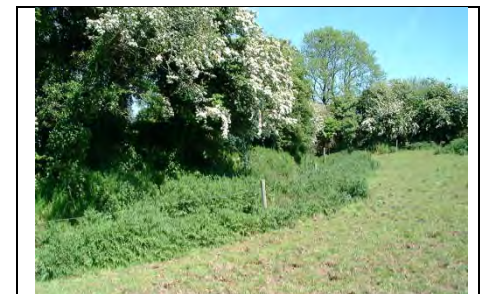
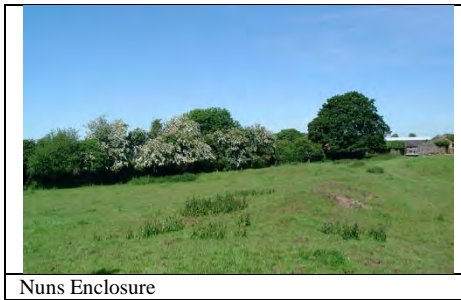
Nuns Enclosure

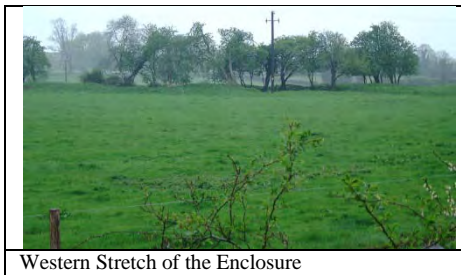
Western Stretch of the Enclosure

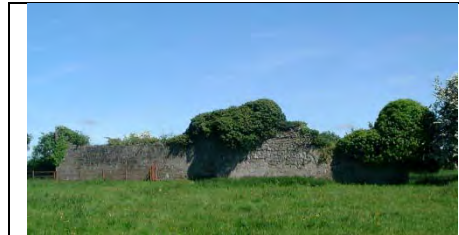
Little remains of the Augustinian Priory above ground except a short section of stone walling. However, the geophysical analysis discussed above identifies traces of a number of features, suggesting considerable remains of buildings underground.

Remains of Priory Wall

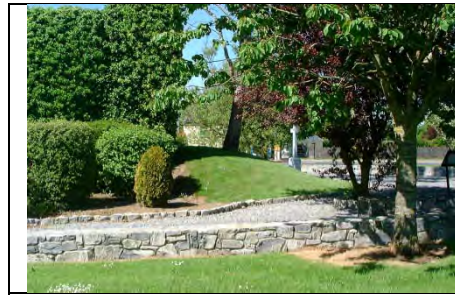
The mound in the Village Green is part of a once much larger feature and is possibly the remains of a barrow or motte.

Remains of Mound

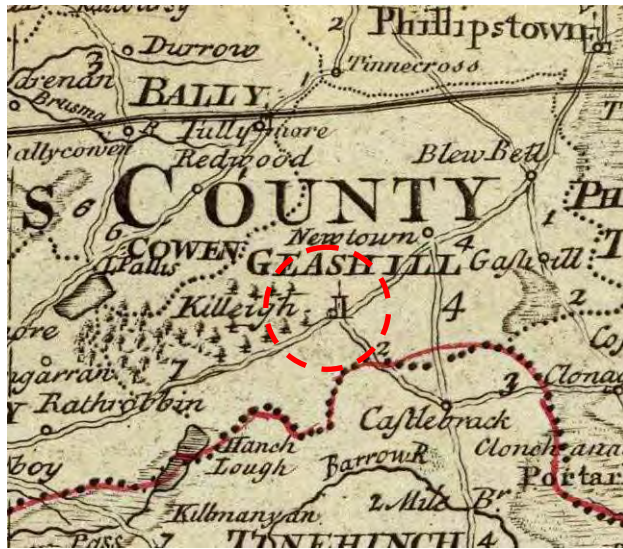
Map 5.5. - 1790 Roque

The maps on this page are far more informative, regarding the location of Killeigh. Interestingly Roque’s 1790 map illustrates Killeigh to the east of an extensive woodland. In this map the road to ‘Tullymore’ is not seen as important – reflecting the historical importance for communication of the northeast – southwest ridge upon which Killeigh is located. This east-west orientation continues in the 1797 map, with the northern route to Tullamore being of minor importance

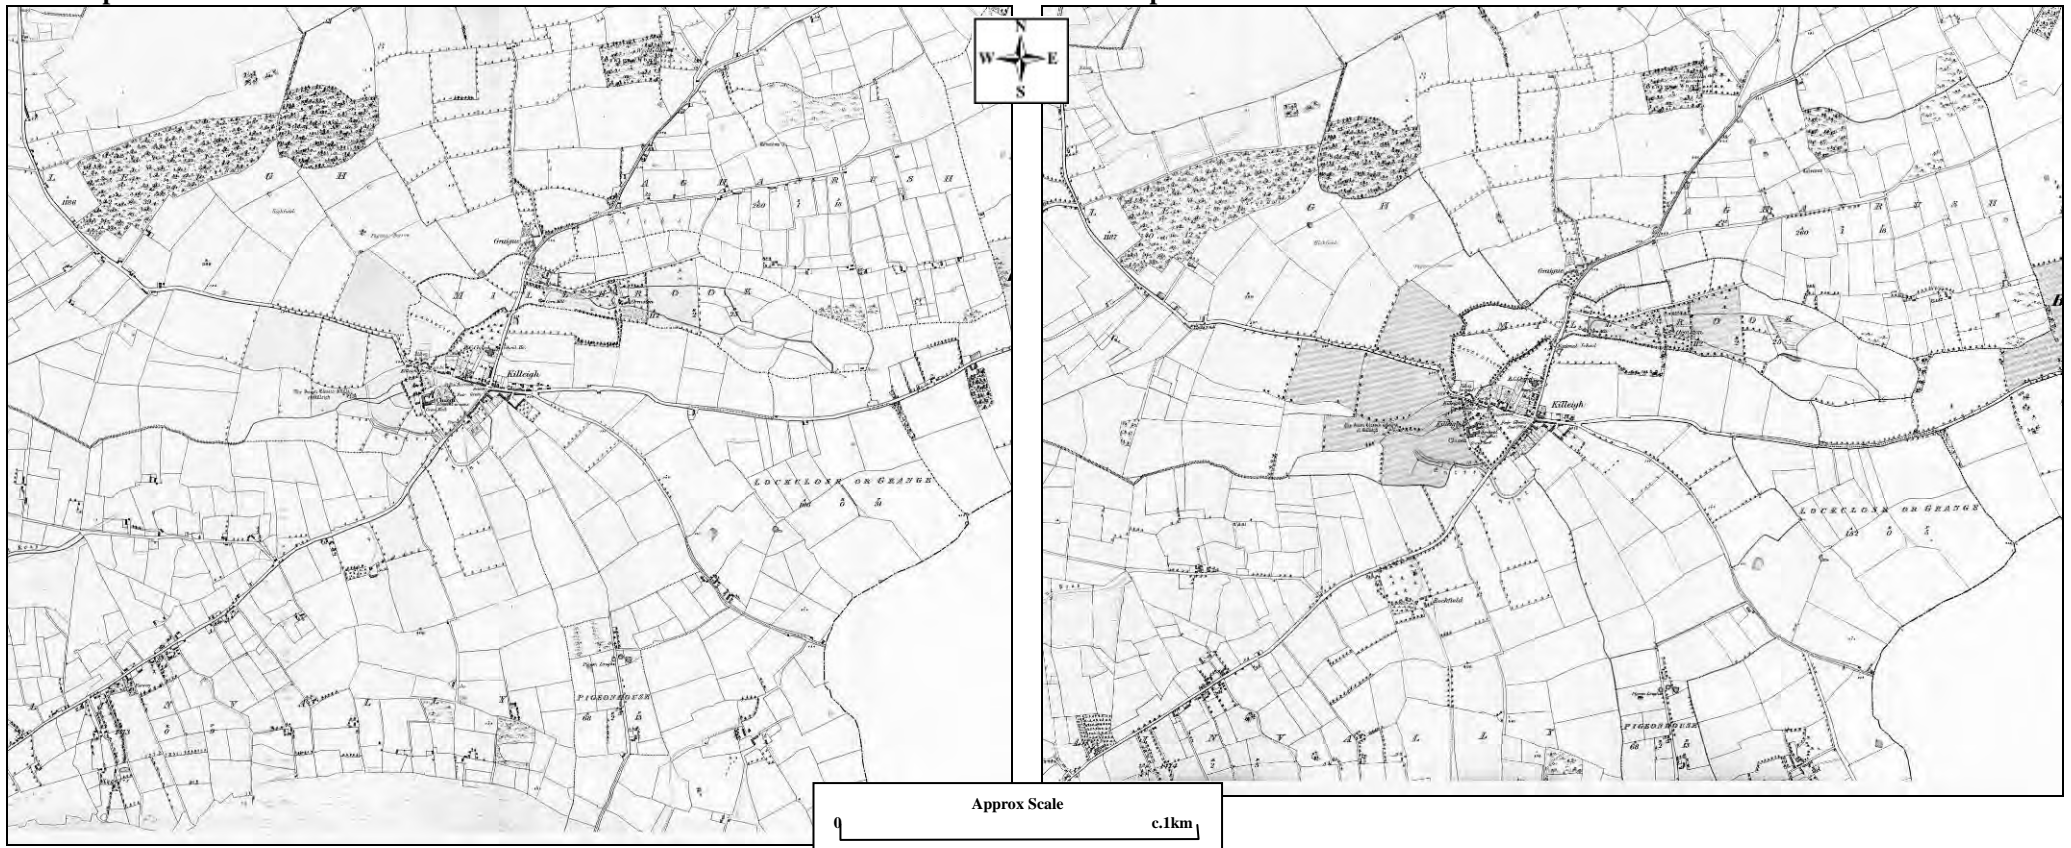
Points to note in map sequence:

Survival of central core area throughout all maps
 Continuity of boundaries – particularly townland boundaries (note survival of curvilinear northwestern border of Millbrook townland parcel throughout all maps - northwest of central Killeigh – see Section 6 for further commentary).

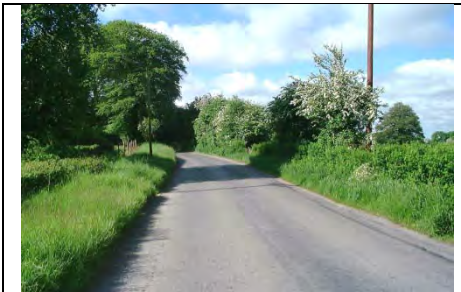
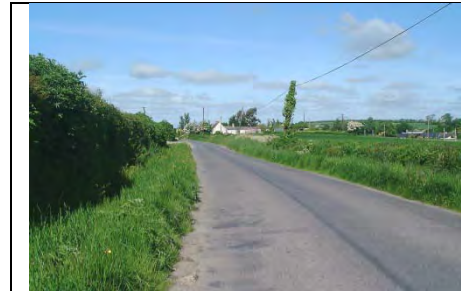
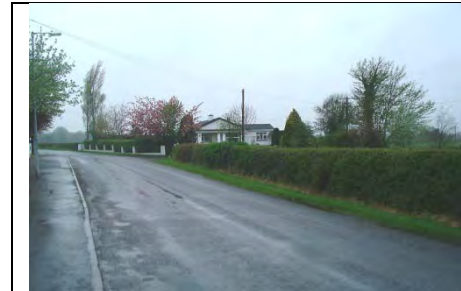
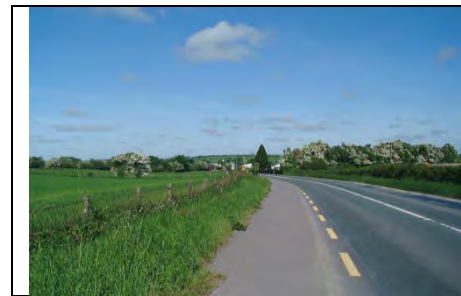
The approach roads to Killeigh are narrow, with grass margins and a range of hedgerow, tree and fence type boundaries. The Tullamore Road has a hard shoulder.

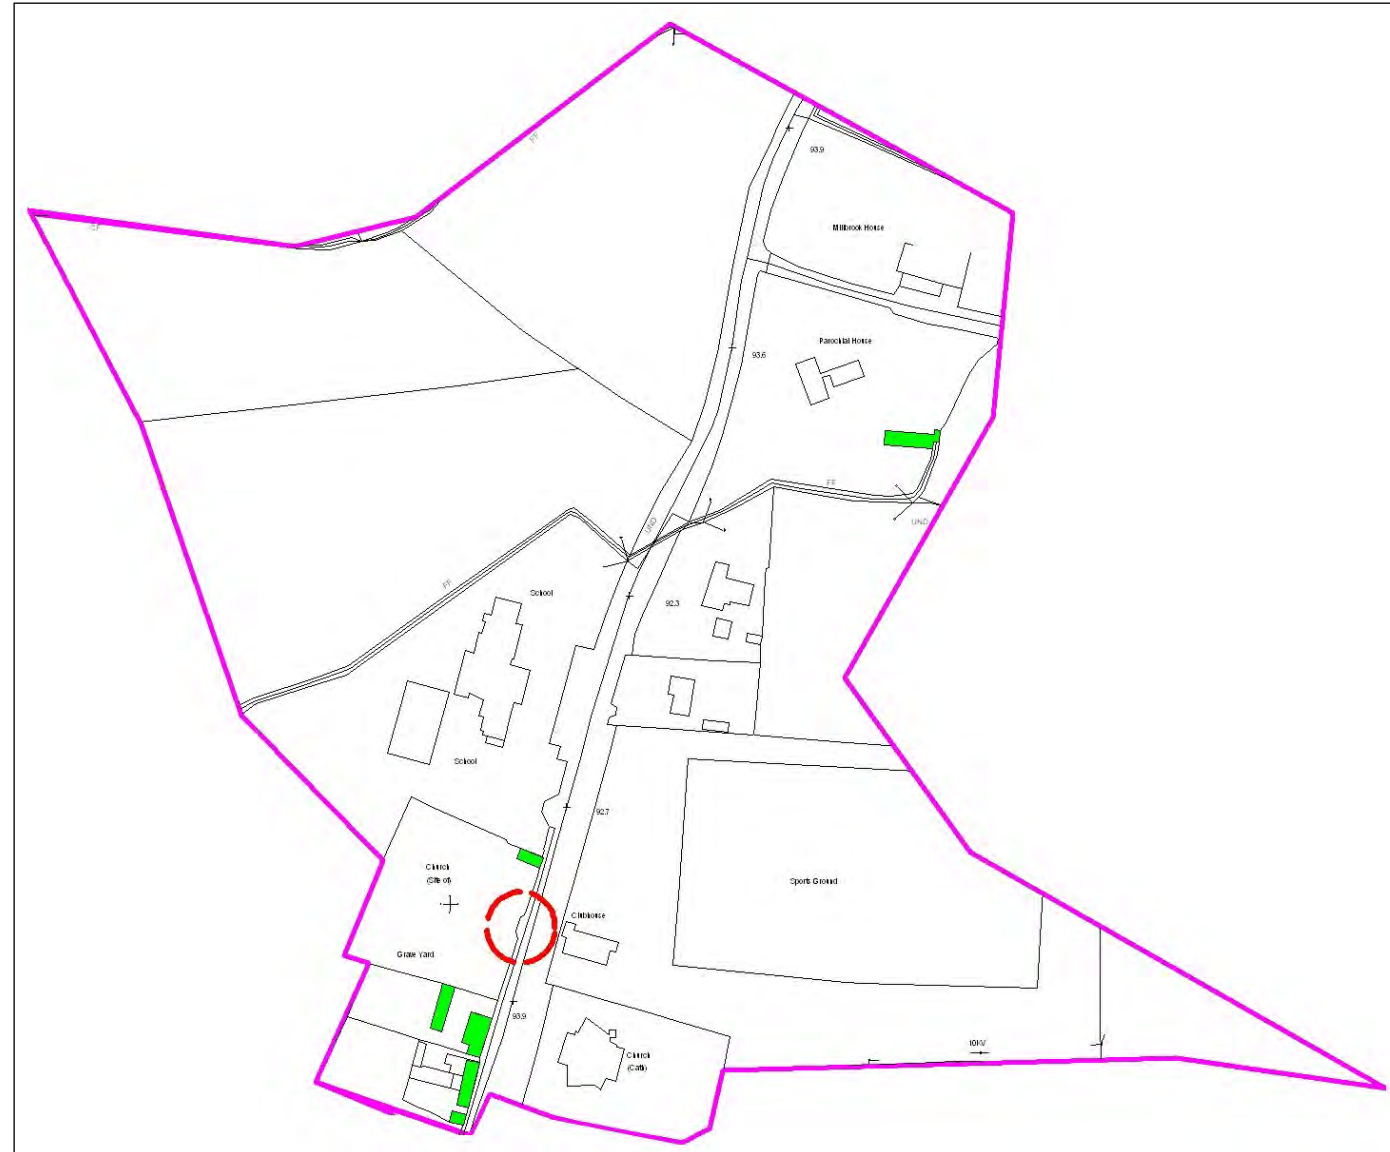
1 Ballingar Road (North Axis)

Historic Key	
Medieval	Red
16 th /17 th Century	Blue
19th Century	Green
Protected Buildings / Listed in Inventory of Irish Architecture	Red dashed line

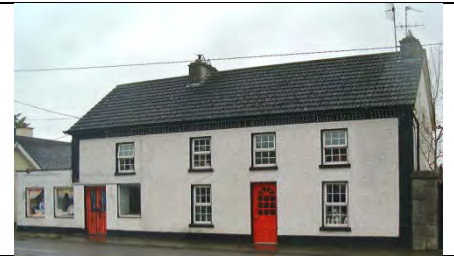
FORM: Double Storey House
 MATERIALS: Rendered stone wall, Slate roof, Replacement joinery
 SITE: Regular plot
 BOUNDARY: Stone boundary to rear
 HISTORY: Nineteenth century
 PROTECTION: In need of further study and protection

Two storey house

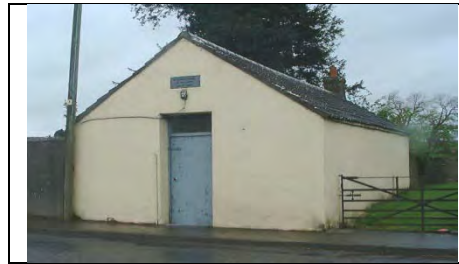
Old School House

FORM: Single storey school house
 MATERIALS: Rendered stone wall, Slate roof, Wooden joinery
 SITE: Regular plot
 BOUNDARY: Stone boundary to rear
 HISTORY: 1820
 PROTECTION: In need of further study and protection

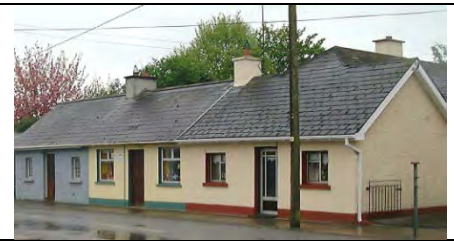
FORM: Terrace of single storey cottages
 MATERIALS: Rendered stone wall, Slate roof, Replacement joinery
 SITE: Regular plots
 BOUNDARY: Stone boundary to rear
 HISTORY: Nineteenth century
 PROTECTION: In need of further study and protection

Terraced cottages

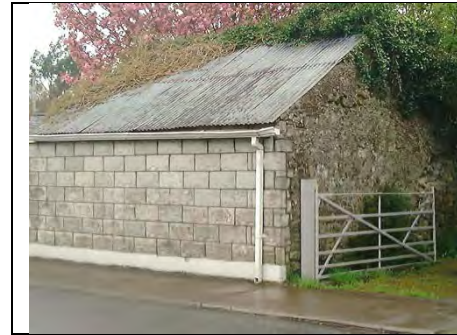
Stone outbuilding

FORM: Single story outbuilding
 MATERIALS: Partly surviving stone wall, metal deck roof
 SITE: Regular plot
 BOUNDARY: Stone boundary to rear
 HISTORY: Nineteenth century
 PROTECTION: In need of further study and protection

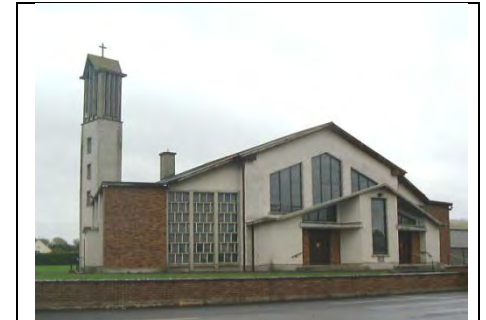
Parish Church - Roman Catholic

FORM: Range of twentieth century infrastructural buildings including Church, Sports pavilion and school
 MATERIALS: Rendered walling, Slate roof, Wooden joinery
 SITE: Regular plots
 BOUNDARY: Brick and concrete block walling
 HISTORY: late twentieth century

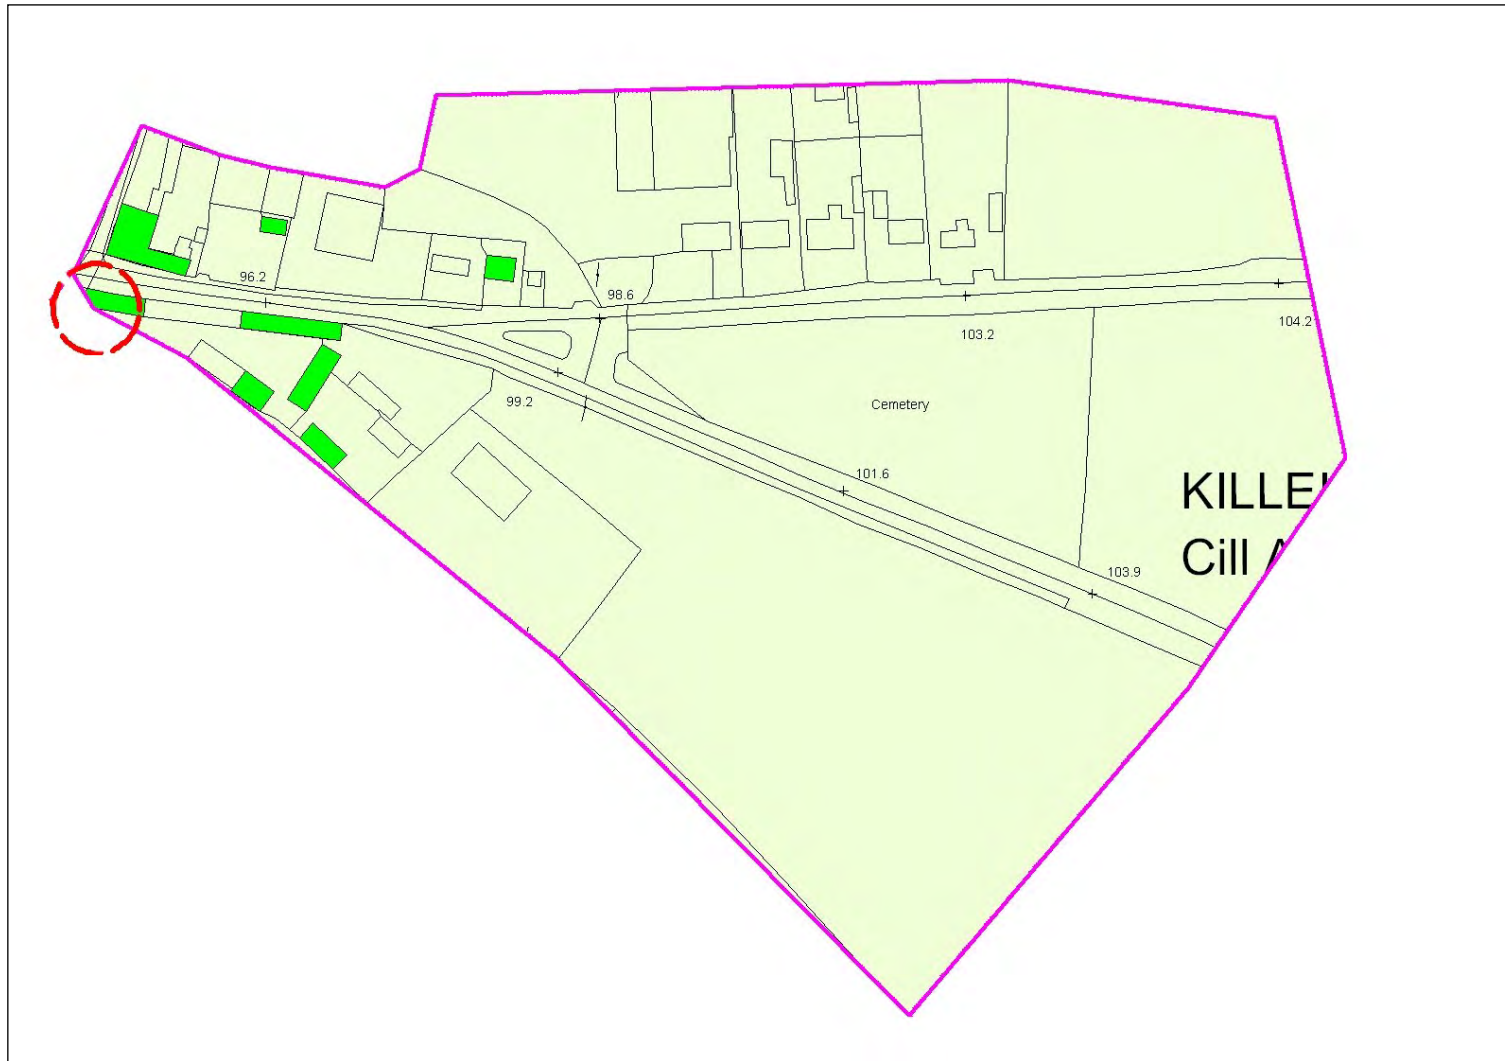
2 Mountmellick Road (East Axis)

Historic Key	
Medieval	
16 th /17 th Century	
19th Century	
Protected Buildings / Listed in Inventory of Irish Architecture

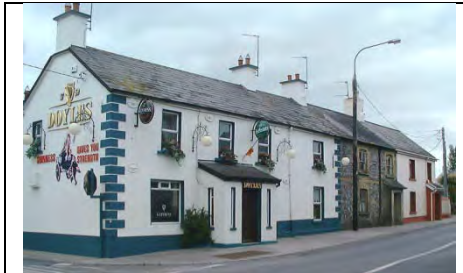
FORM: Terrace of double storey houses
 MATERIALS: Rendered stone wall, Slate roof, Replacement joinery
 SITE: Regular plots
 BOUNDARY: Stone boundary to rear
 HISTORY: Nineteenth century
 PROTECTION: In need of further study and protection

Terraced Houses

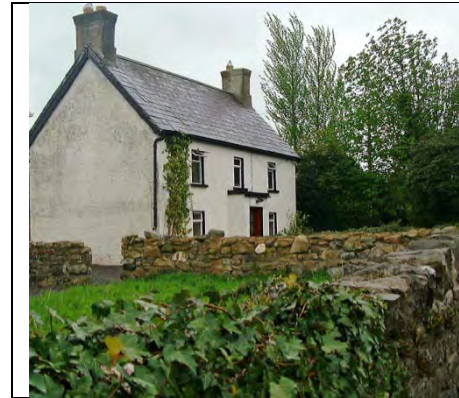
FORM: Double storey House
 MATERIALS: Rendered stone wall, Slate roof, Replacement joinery
 SITE: Regular plot
 BOUNDARY: Stone boundary
 HISTORY: Nineteenth century – much altered.
 PROTECTION: In need of further study and protection

House

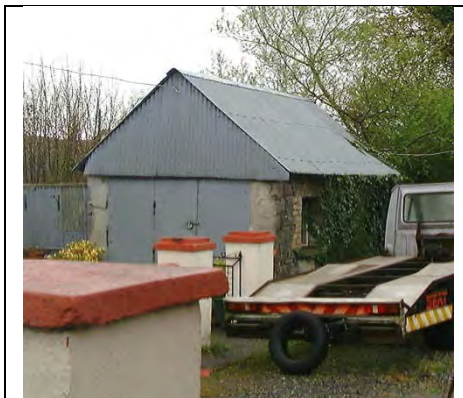
FORM: Single storey outbuilding
 MATERIALS: Rendered stone wall, Metal deck roof, Replacement joinery
 SITE: Regular plot
 BOUNDARY: Stone boundary to rear
 HISTORY: Nineteenth century
 PROTECTION: In need of further study and protection

Outhouse

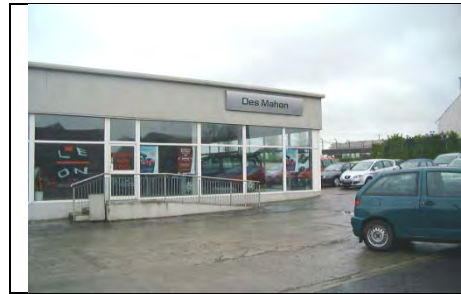
FORM: Former Brewery - Extensive range of single storey barns
 MATERIALS: Stone wall, Slate and metal deck roof, Replacement joinery
 SITE: Regular plot
 BOUNDARY: Stone boundary

Industrial Building

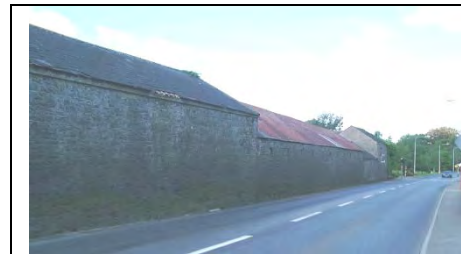
Barns (site of former brewery)

HISTORY: Nineteenth century
 PROTECTION: In need of further study and protection

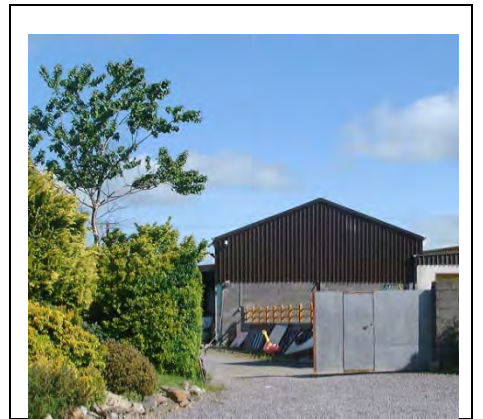
FORM: Single storey industrial building
 MATERIALS: Concrete block and metal deck walling, metal deck roof, wooden joinery
 SITE: Regular plot
 BOUNDARY: Concrete block boundary
 HISTORY: Late twentieth century

Industrial Building

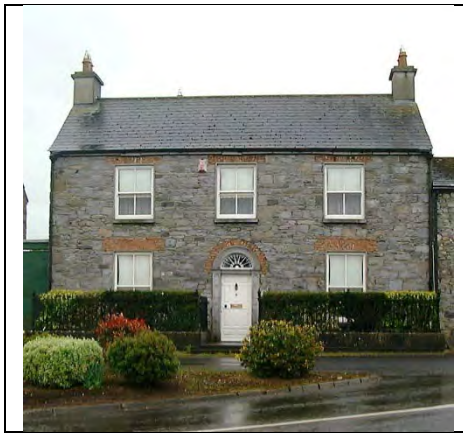
FORM: Range of linked and detached double storey houses
 MATERIALS: Rendered stone wall, Slate roof, Replacement joinery. One house with rendered removed
 SITE: Regular plots
 BOUNDARY: Stone boundary to rear
 HISTORY: Nineteenth century
 PROTECTION: In need of further study and protection

Detached House (Protected)

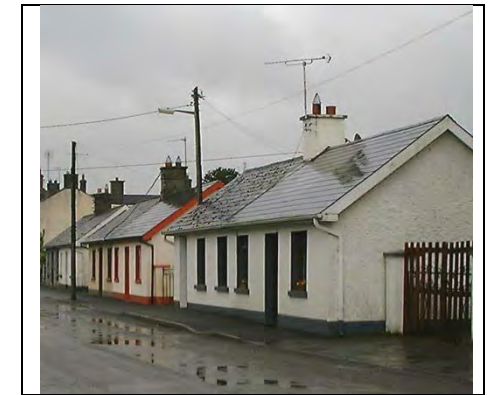
FORM: Terrace of single storey cottages
 MATERIALS: Rendered stone wall, Slate roof, Replacement joinery
 SITE: Regular plots
 BOUNDARY: Stone boundary to rear
 HISTORY: Nineteenth century
 PROTECTION: In need of further study and protection

Cottages

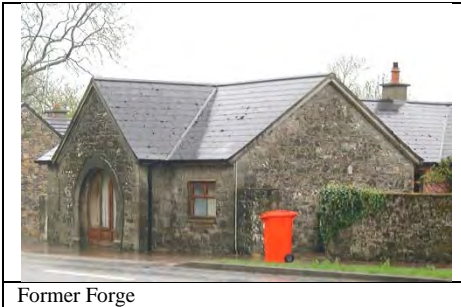
FORM: Detached single storey forge
 MATERIALS: Stone wall, Slate roof, Replacement joinery
 SITE: Regular plots
 BOUNDARY: Stone boundary
 HISTORY: Nineteenth century
 PROTECTION: Protected. Much altered, in need of further study

Former Forge

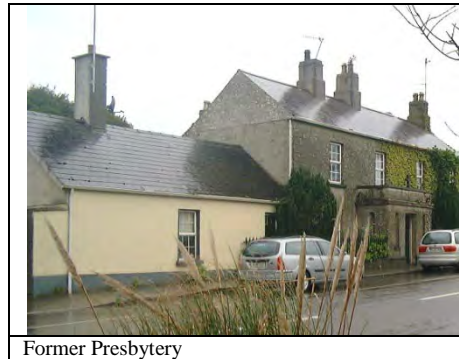
FORM: Detached double storey house with extensive outbuildings
 MATERIALS: Rendered stone wall, Slate roof, Replacement joinery.
 SITE: Regular plots
 BOUNDARY: Stone boundary to rear
 HISTORY: Nineteenth century
 PROTECTION: In need of further study and protection

Former Presbytery

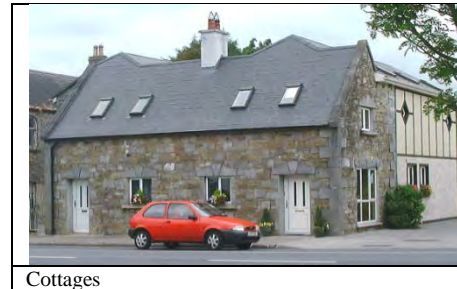
FORM: Pair of semi-detached cottages
 MATERIALS: Stone wall, Slate roof, Replacement joinery. It is unclear whether or not the buildings were originally rendered.
 SITE: Regular plots
 BOUNDARY: Stone boundary to rear
 HISTORY: Nineteenth century
 PROTECTION: Protected. Very much altered. In need of further study

Cottages

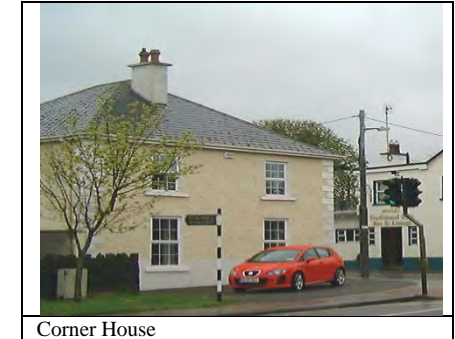
FORM: Detached corner house
 MATERIALS: Rendered stone wall, Slate roof, Replacement joinery
 SITE: Regular plots
 BOUNDARY: Stone boundary to rear
 HISTORY: Nineteenth century
 PROTECTION: In need of further study and protection

Corner House

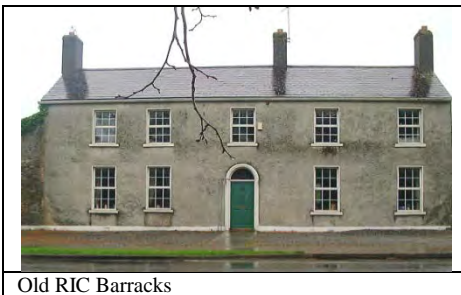
FORM: Detached double storey houses
 MATERIALS: Rendered stone wall, Slate roof, Replacement joinery.
 SITE: Regular plots
 BOUNDARY: Stone boundary to rear
 HISTORY: Nineteenth century
 PROTECTION: Protected. In need of further study

Old RIC Barracks

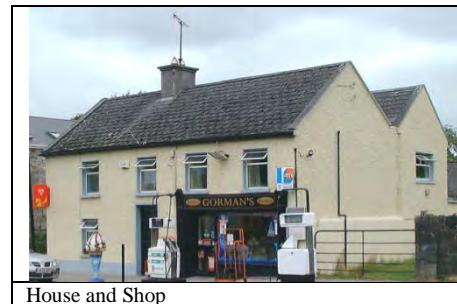
FORM: Pair of semi-detached houses. One used as forge
 MATERIALS: Rendered stone wall, Slate roof, Replacement joinery
 SITE: Regular plots
 BOUNDARY: Stone boundary to rear
 HISTORY: Nineteenth century
 PROTECTION: Protected. Very much altered. In need of further study

House and Shop

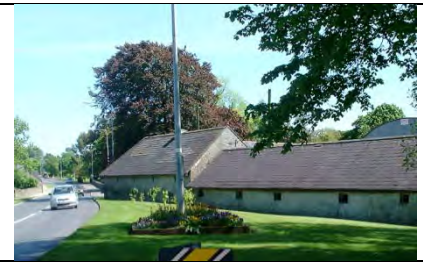
Barns

FORM: Range of single storey barns and farm buildings arranged around farmyard
 MATERIALS: Stone wall, Slate roof, Wooden joinery. Also twentieth century metal decked hay shed
 SITE: Regular plots
 BOUNDARY: Stone and natural boundaries
 HISTORY: Nineteenth century
 PROTECTION: In need of further study and protection

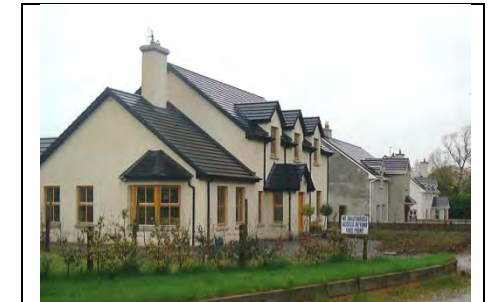
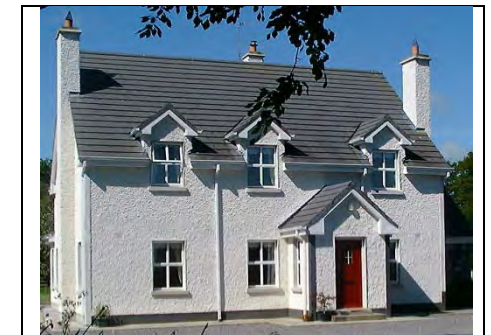
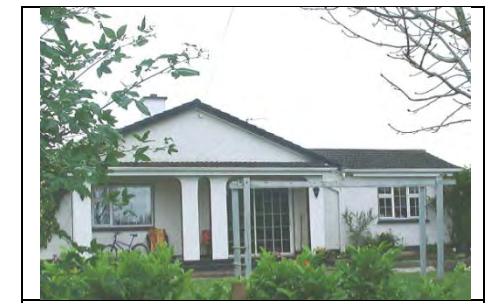
ADDRESS: *Housing, Village Green*
FORM: Range of Suburban -type houses
MATERIALS: Rendered walling, Tiled roofs, Wooden joinery
SITE: Regular
BOUNDARY: Fencing
HISTORY: Late twentieth century
