Challenges of Yellow Floating Heart Treatment With Non-Chemical Control

Barbara Mumblo (retired - Rogue River-Siskiyou National Forest)

Bruce Hansen (USFS Pacific Northwest Research Station)

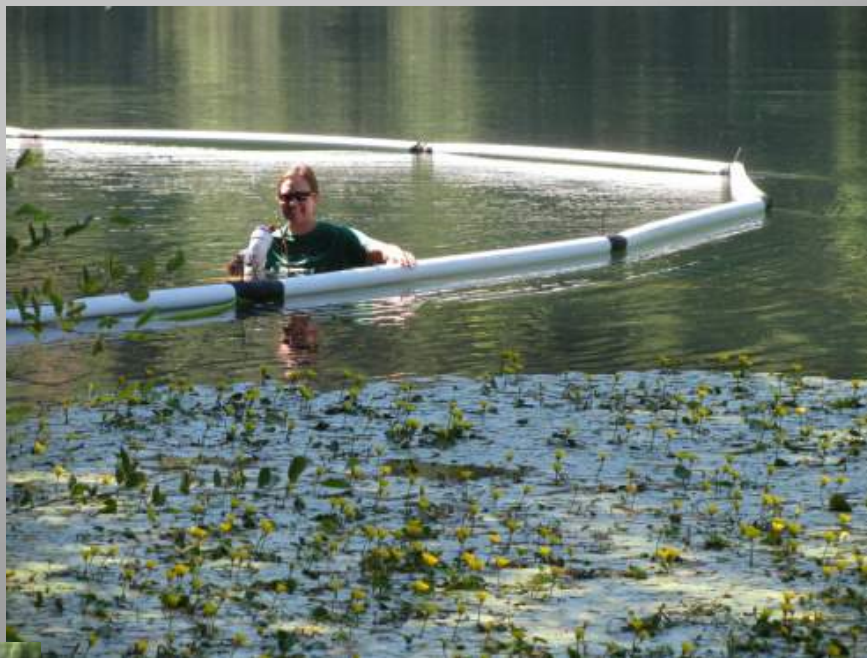
The large site took more time and creative ideas.....
We made booms to surround the site (not to lose floating material).

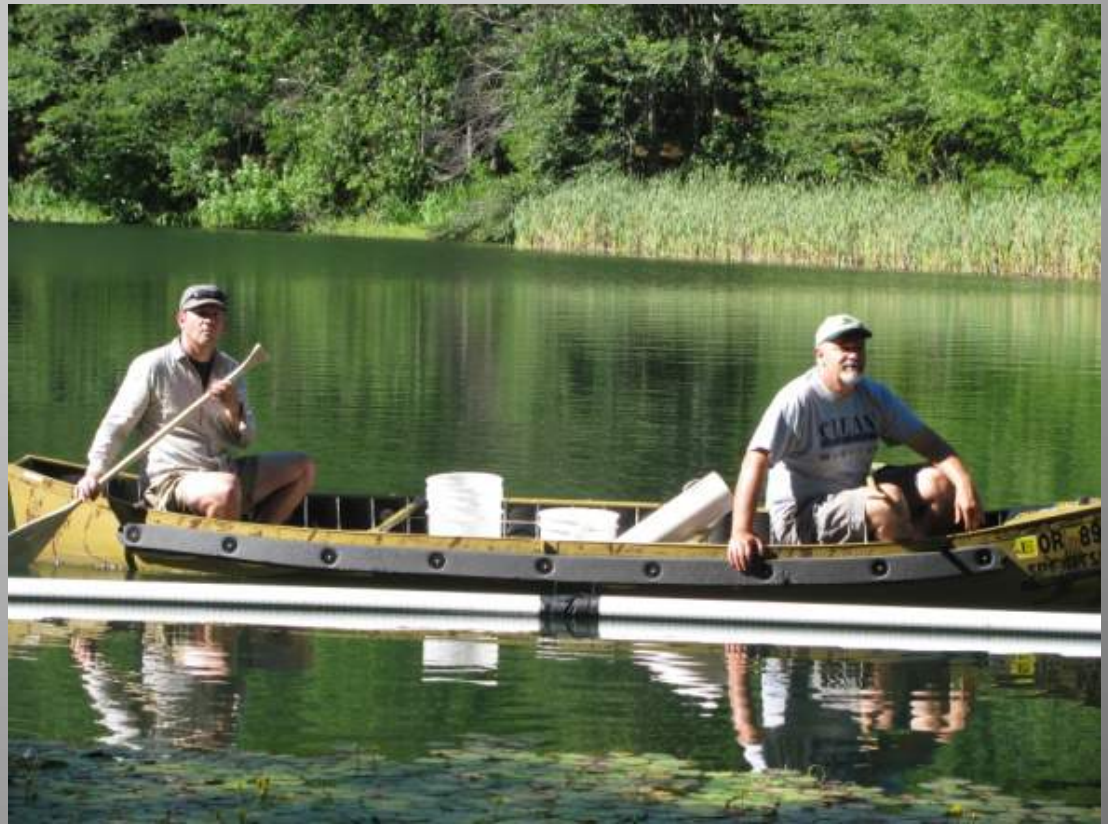
Mark Systma (Portland State) surveyed the site - suggested placing bottom barriers under water to cover the plants.

Plants grew back quickly - important to keep plants from seeding.

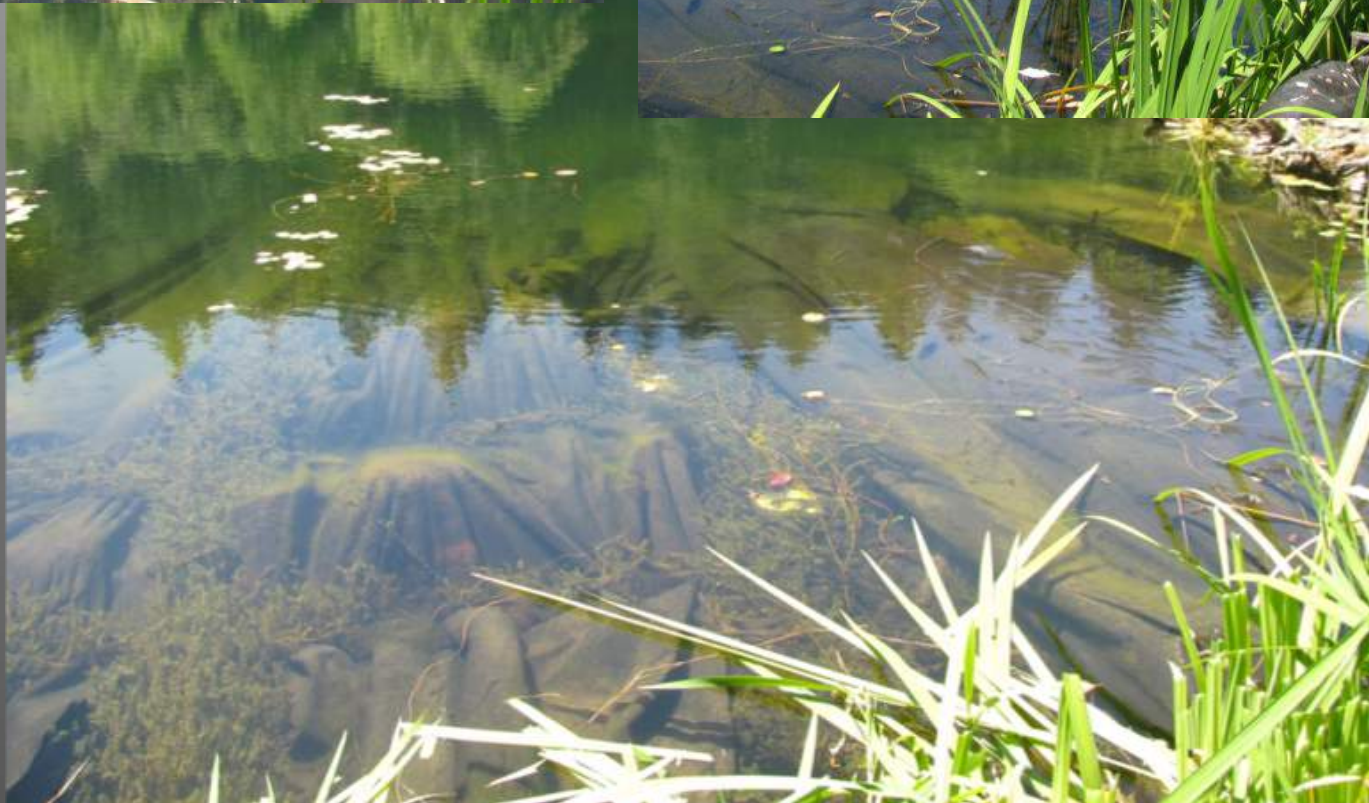
2012 –
fabric
doing its
job – but
plants
coming
up where
not
covered

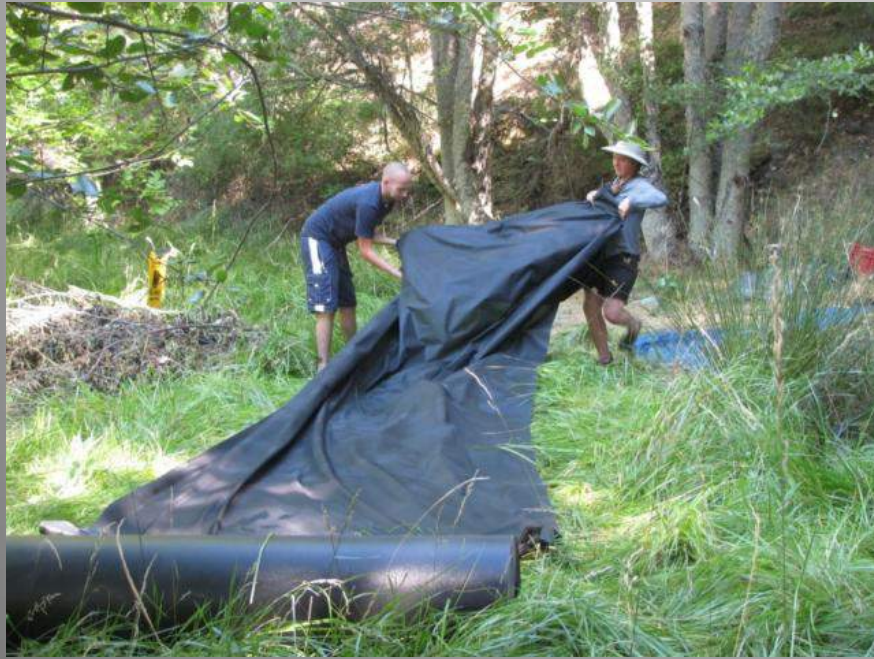
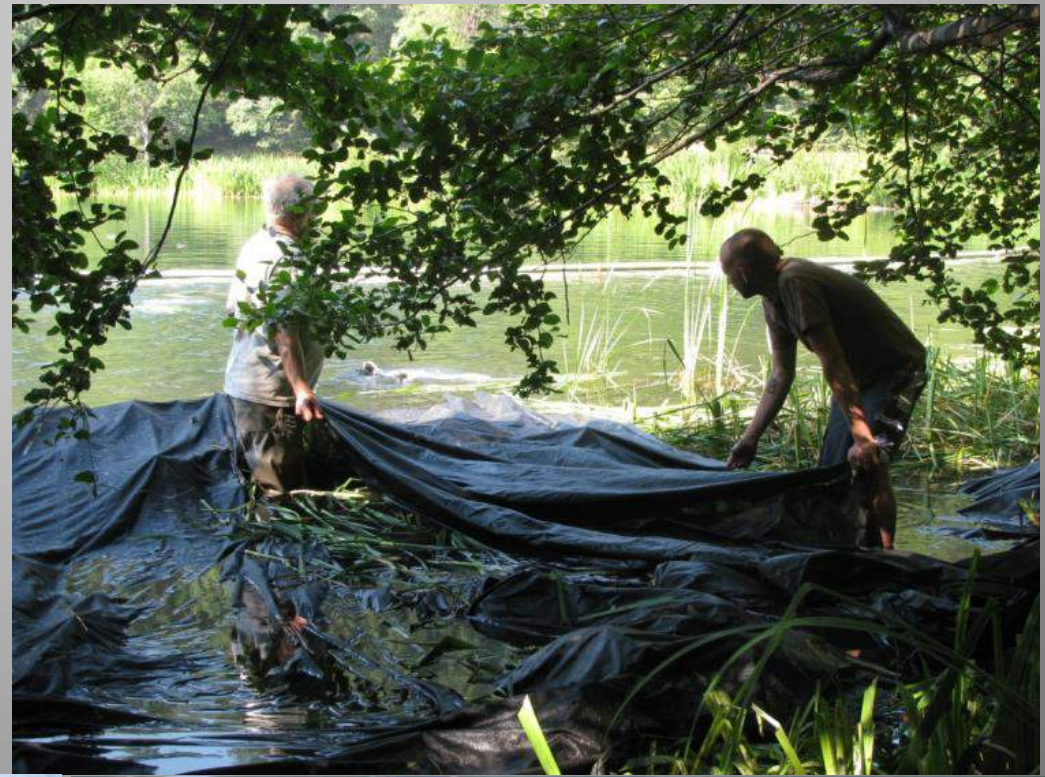
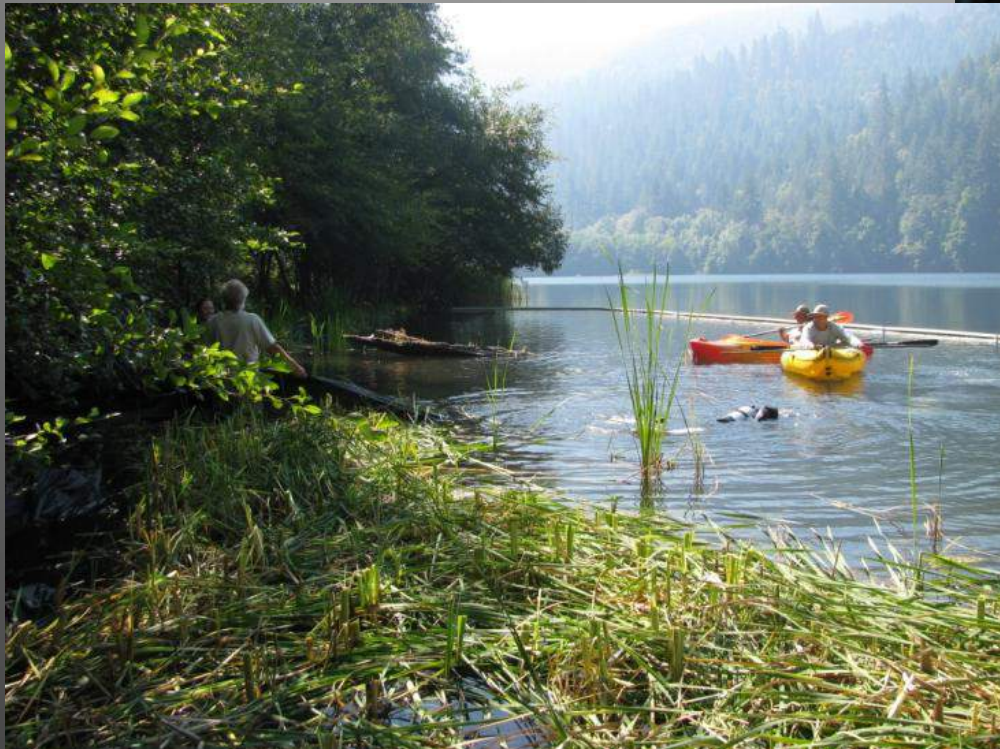
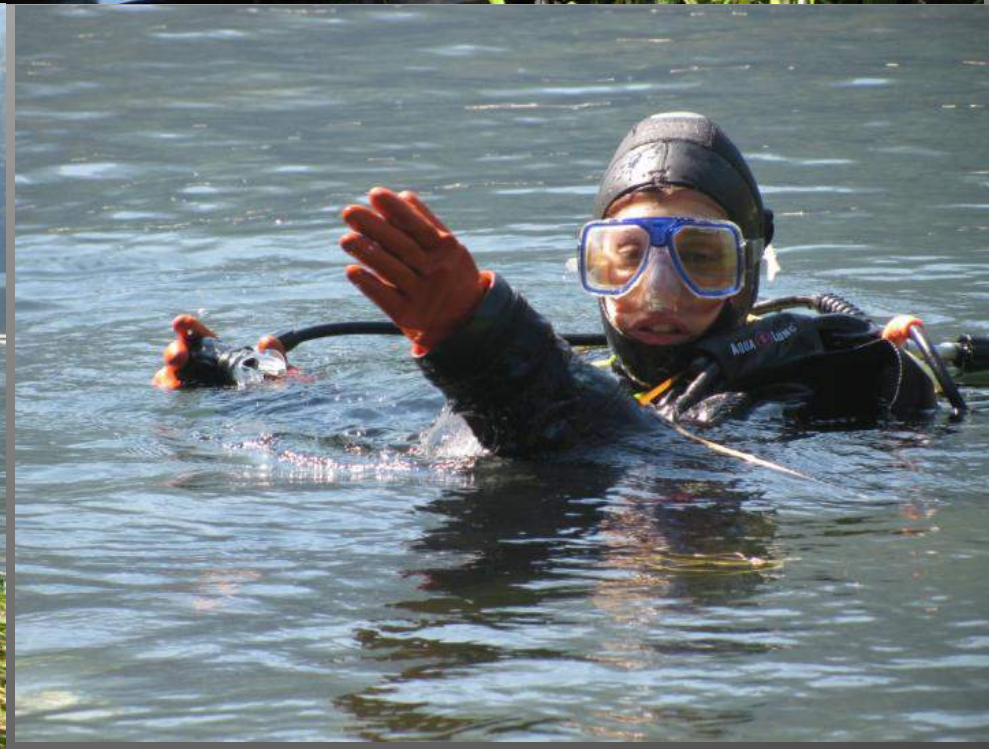
Laying out the fabric

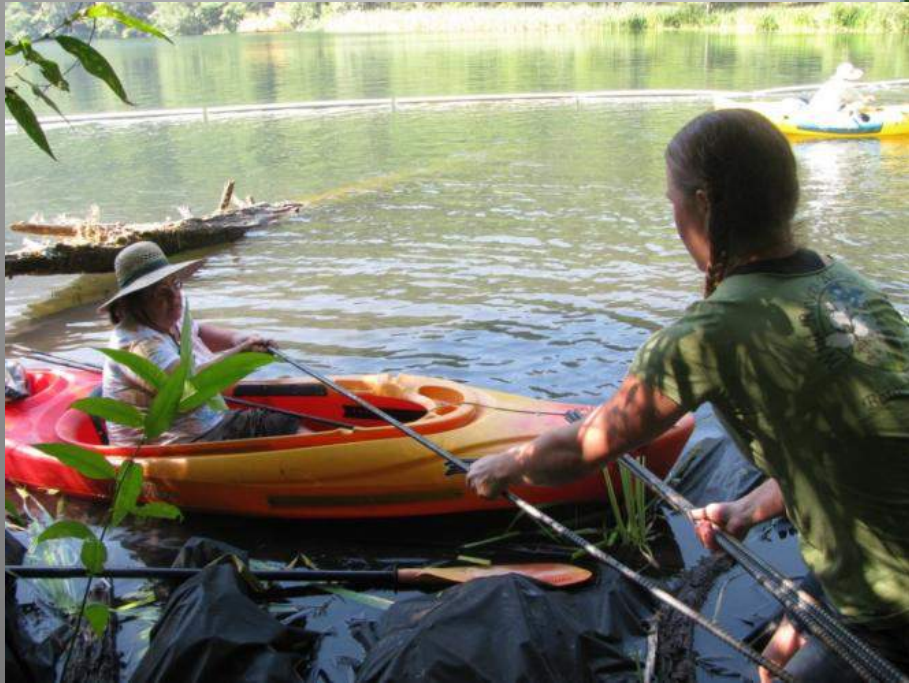
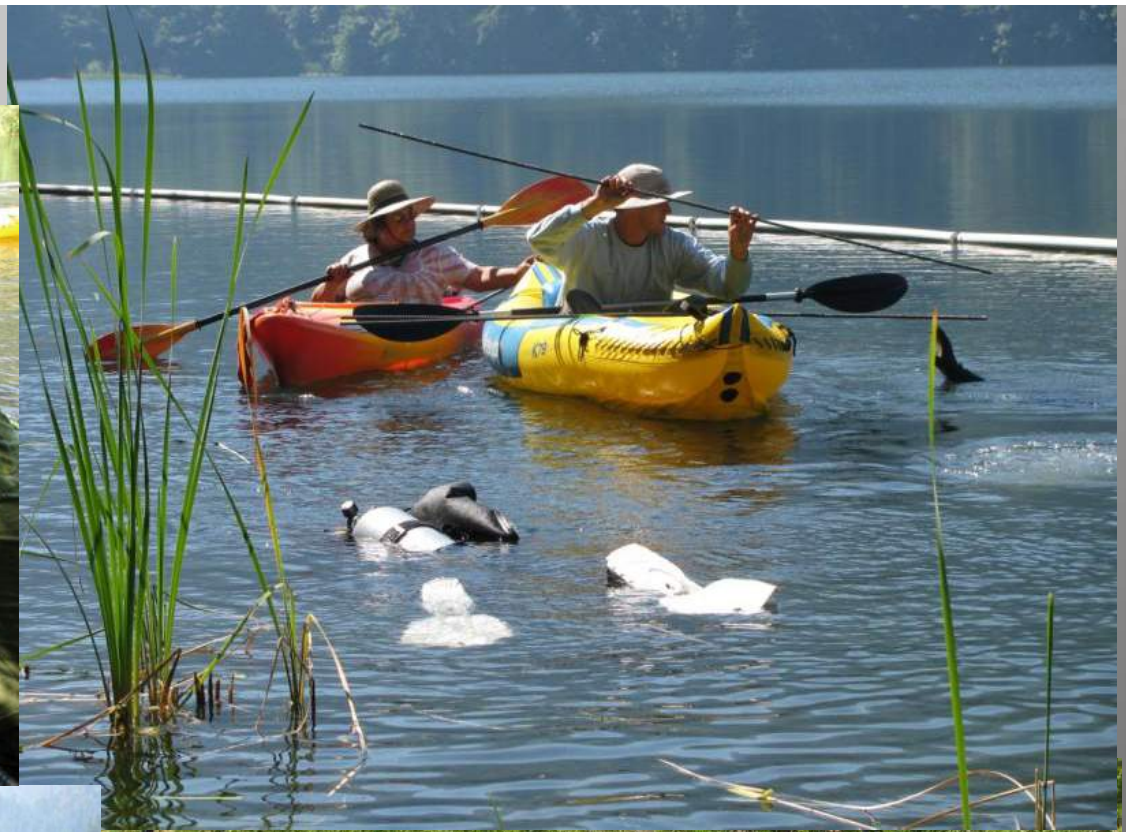
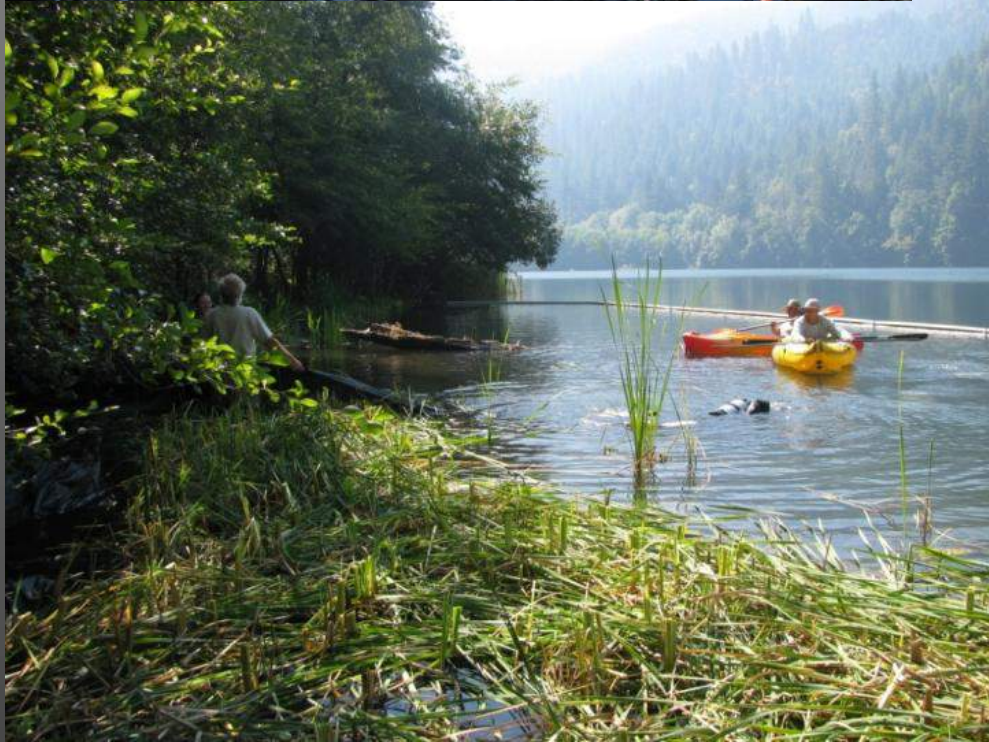
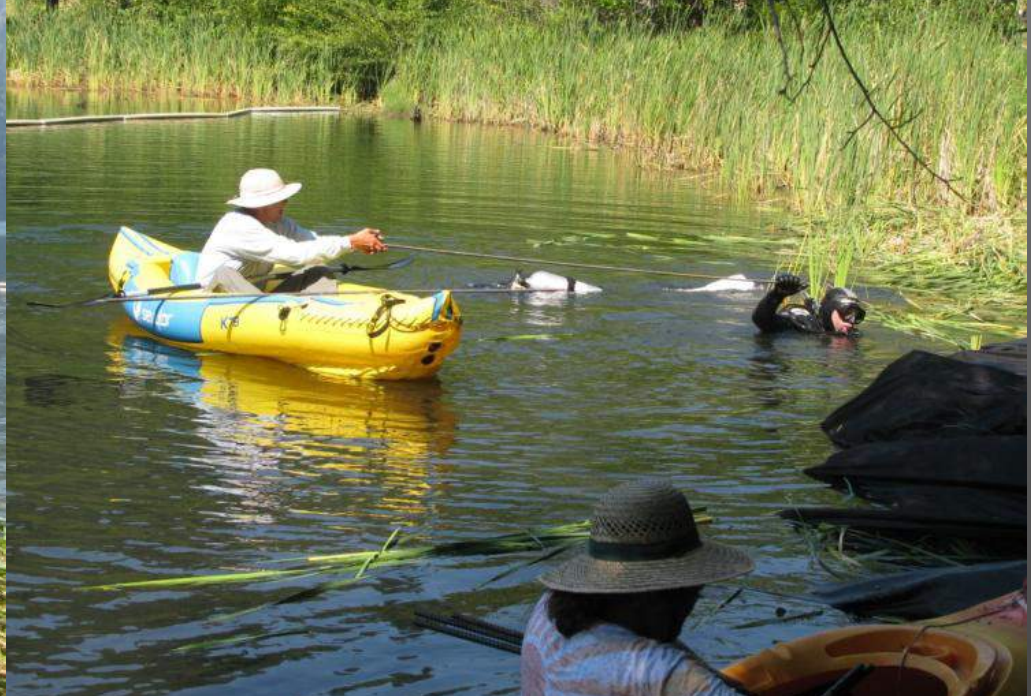
Laying rebar on the fabric

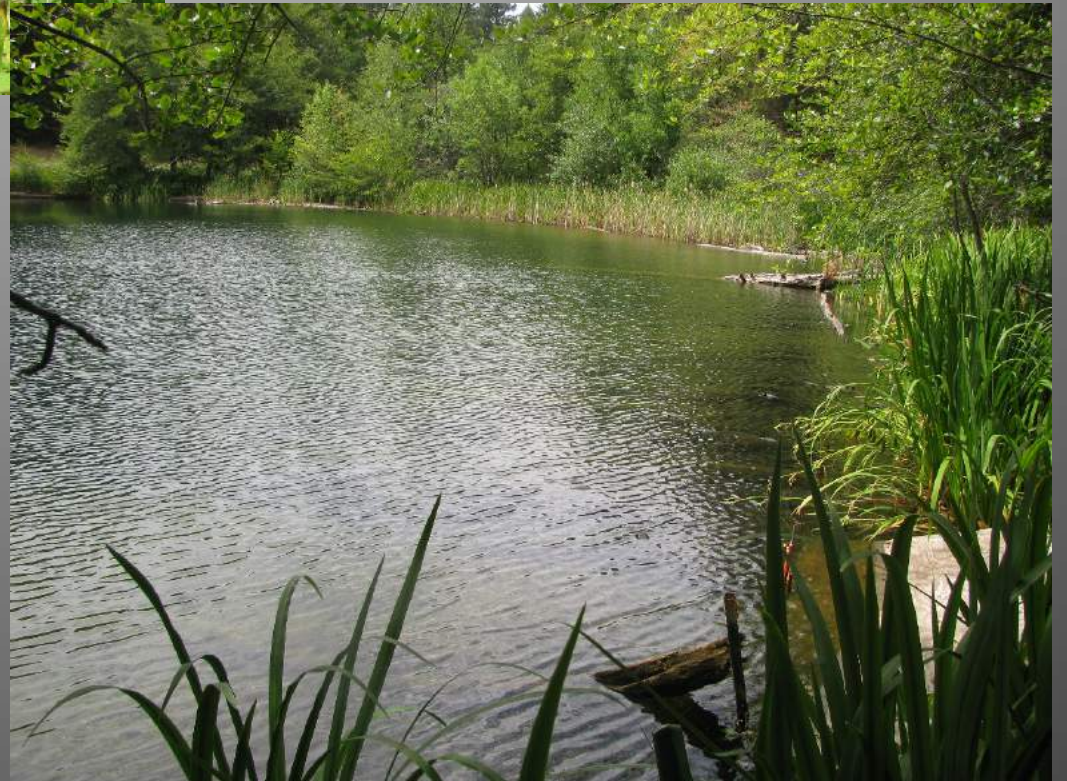
2017 - After treatment

In 2017 – No plants were located at any of the sites.
