A5 WTC
Western Transport Corridor

Section 2
A5 Western Transport Corridor
Northern Ireland

geophysical survey

report 2746, volume II
January 2012

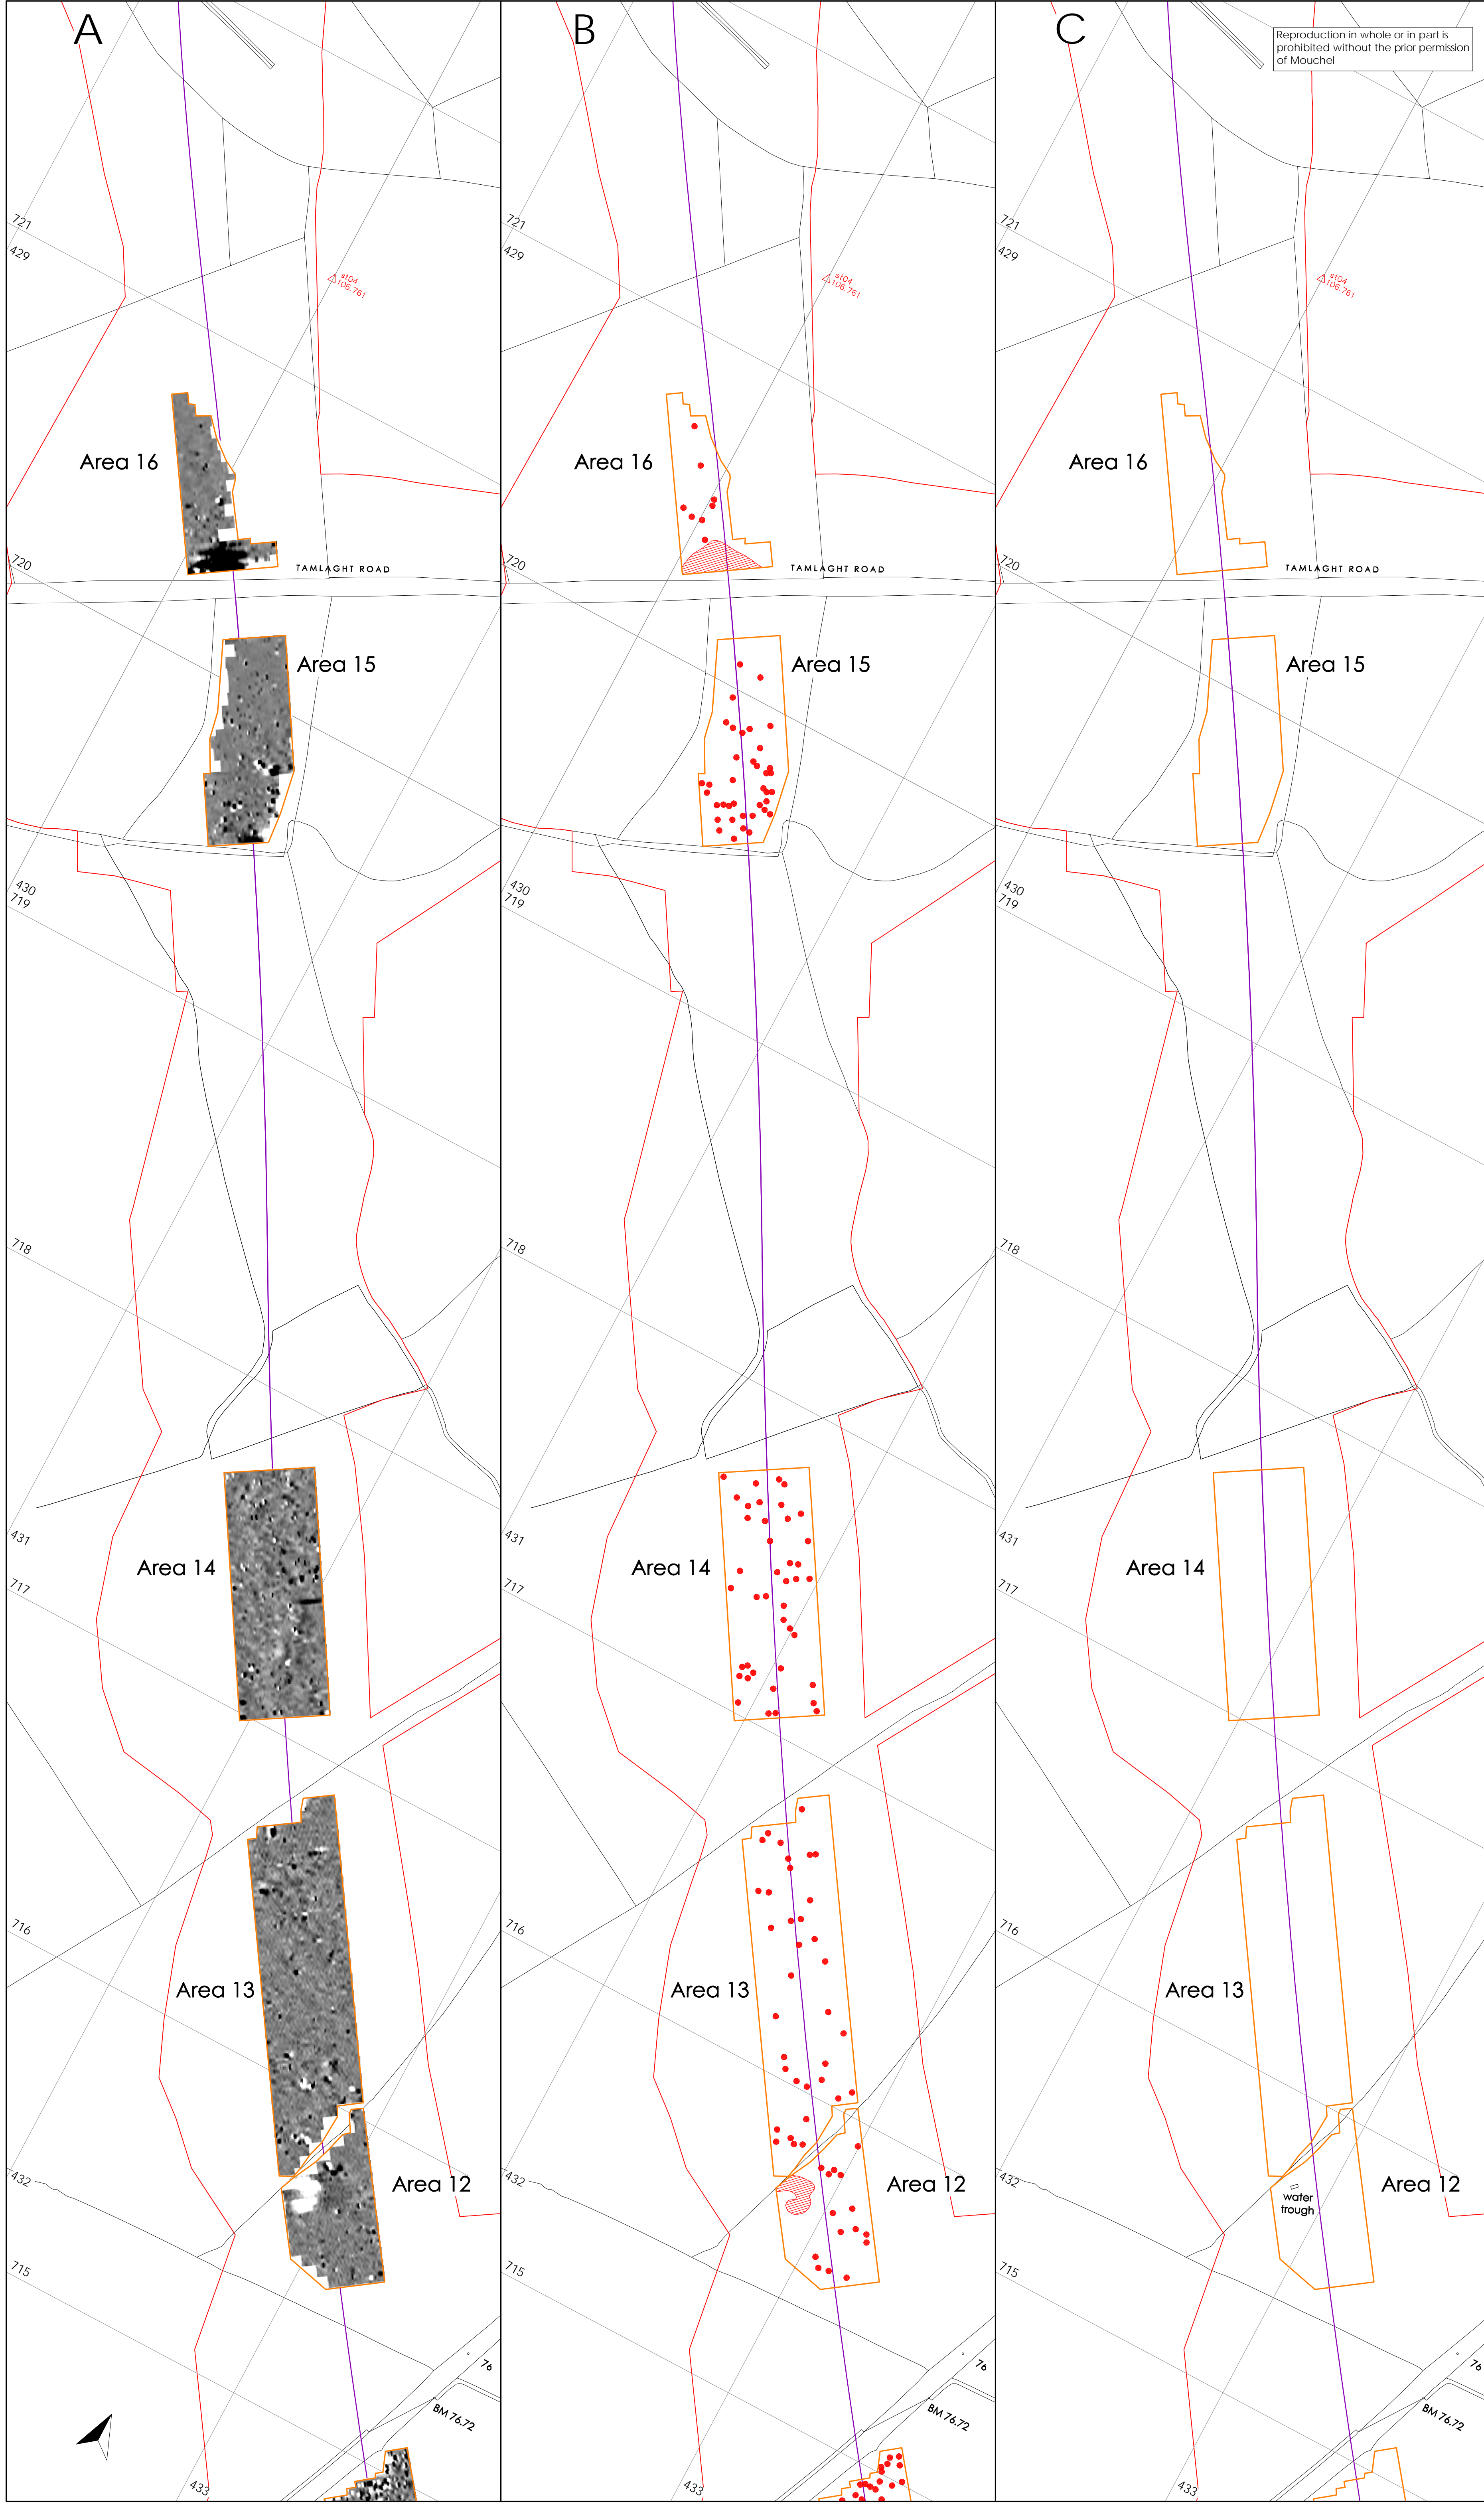
Figure 6: Areas 7, 8, 9, 10 and 11
geophysical survey and interpretations

A - geophysical survey

- magnetic survey
- road centreline
- vesting line

C - archaeological interpretation

- soil-filled feature

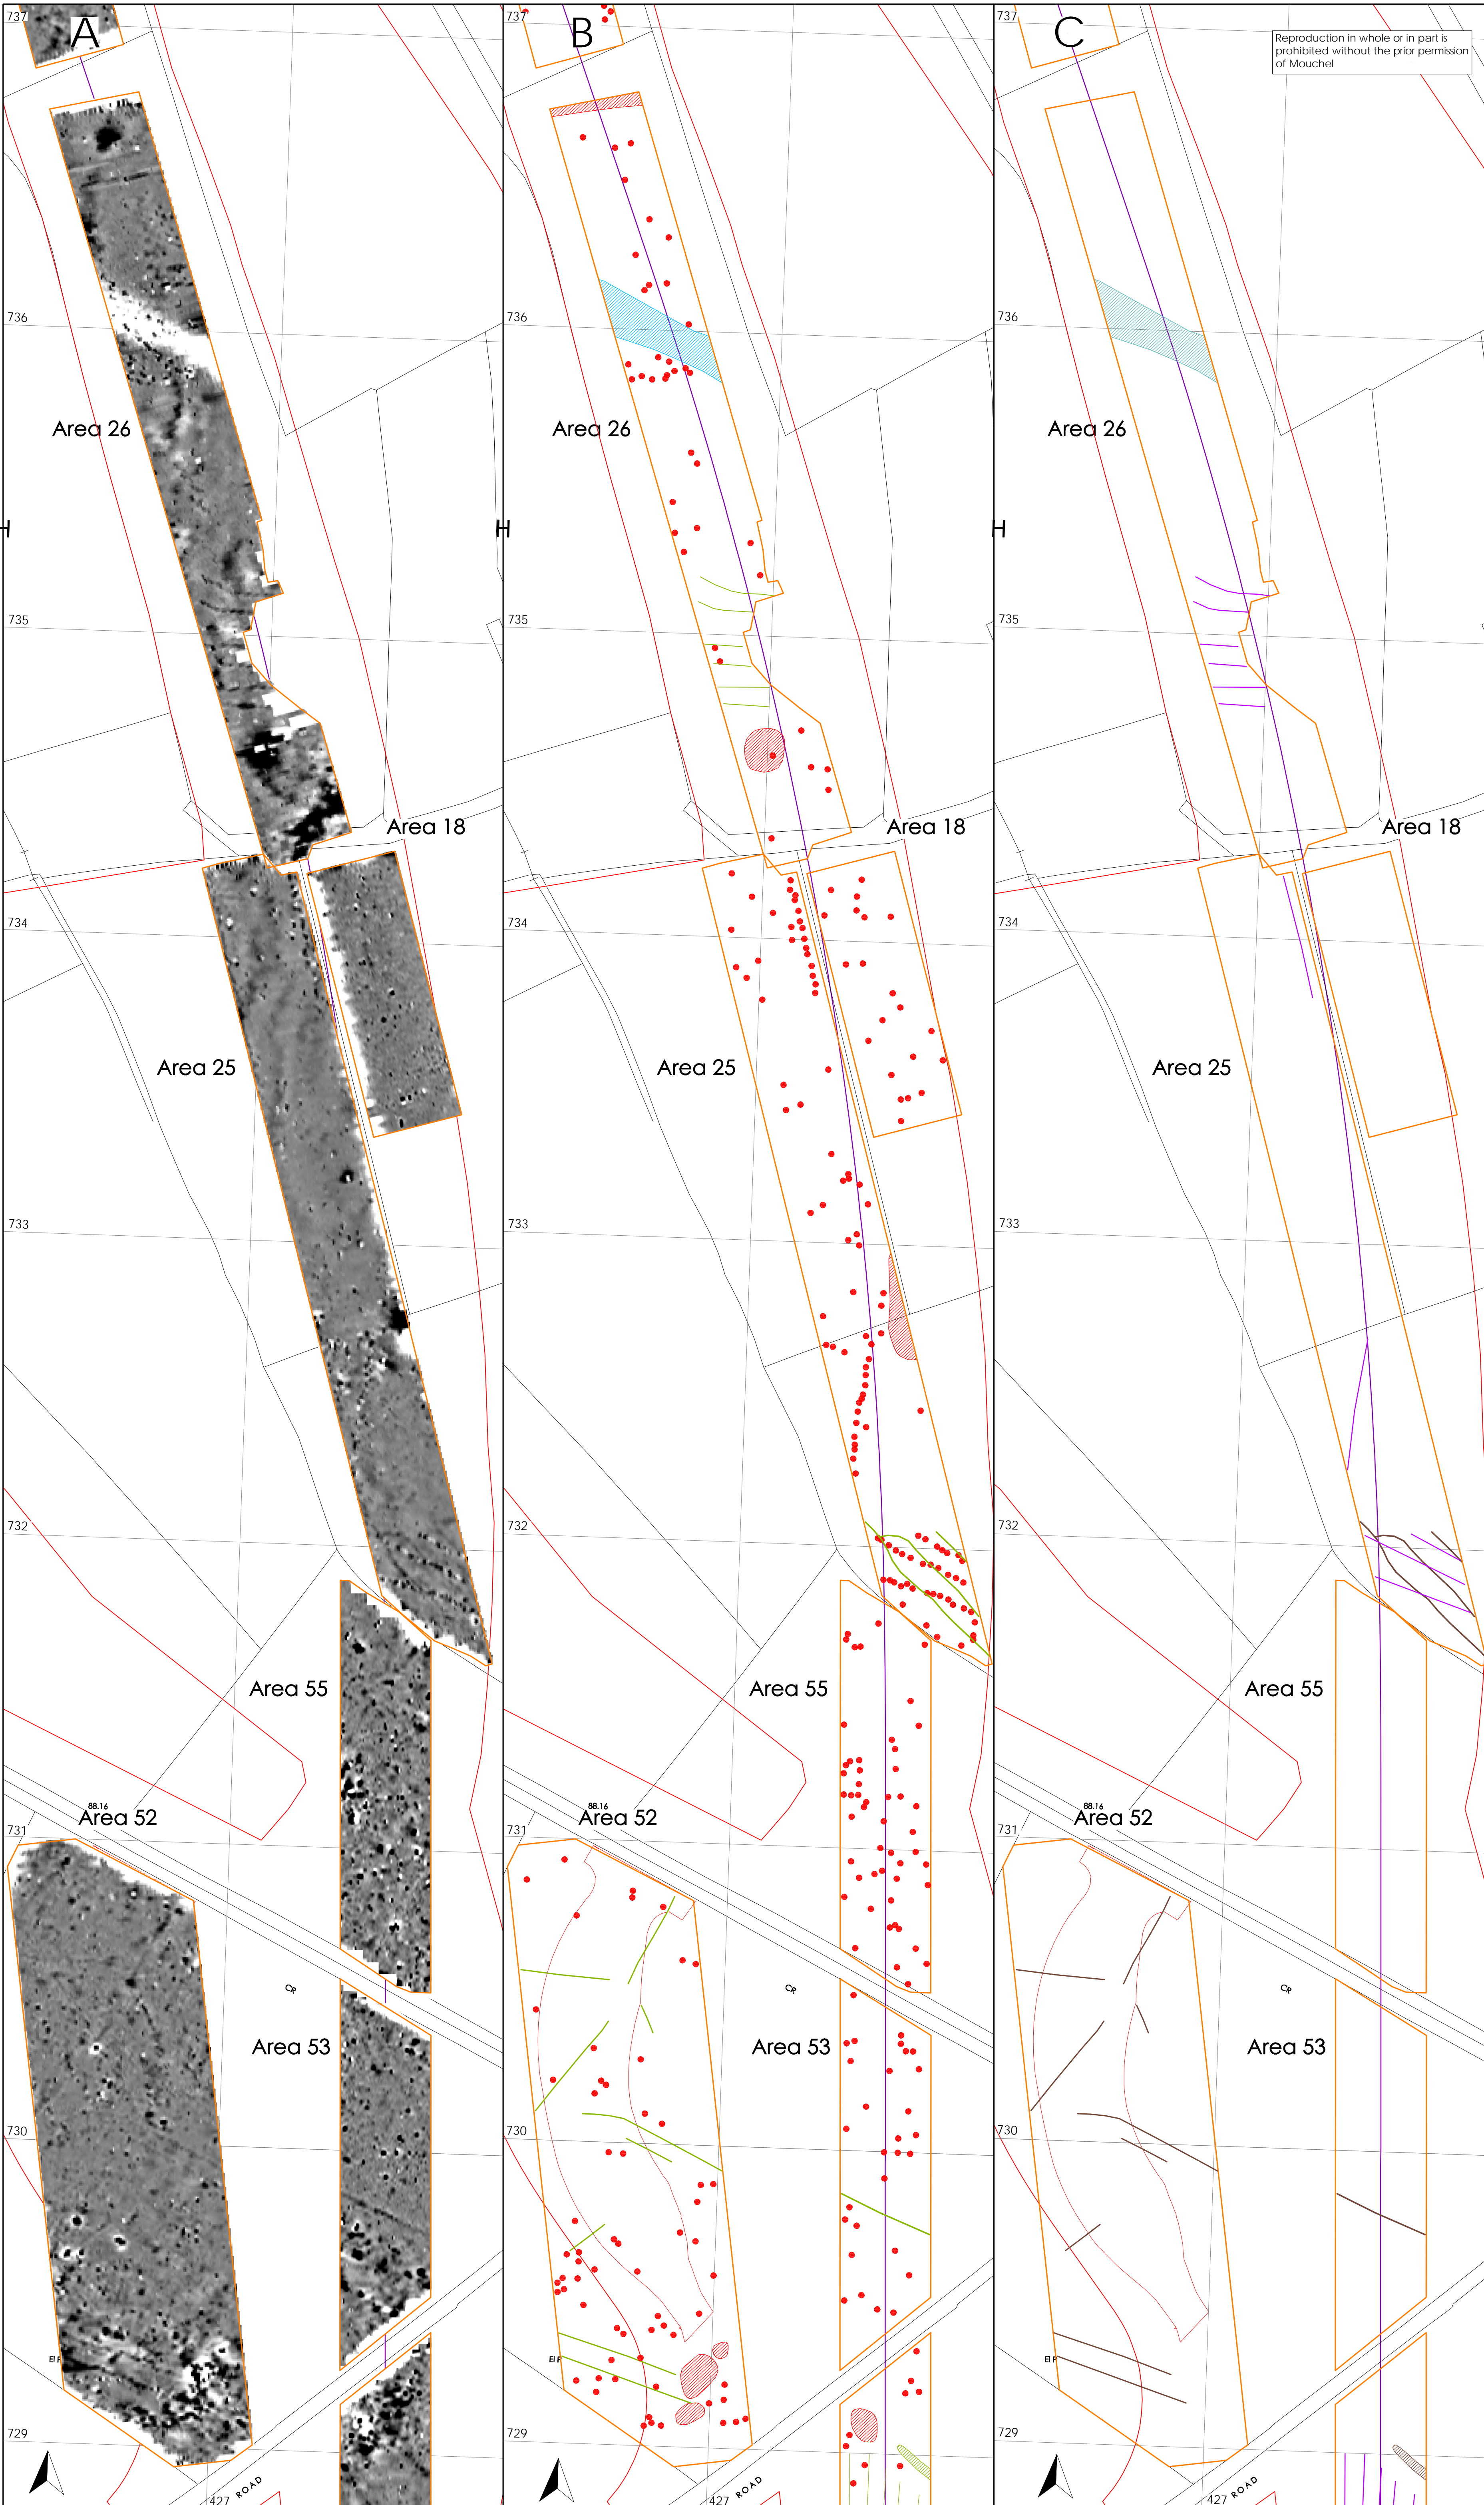
Figure 8: Areas 54, 56 and 149
geophysical survey and interpretations

- A - geophysical survey
- magnetic survey
 - road centreline
 - vesting line
- B - geophysical interpretation
- dipolar magnetic anomaly
 - positive magnetic anomaly
 - negative magnetic anomaly
- C - archaeological interpretation
- soil-filled feature
 - geological feature
 - land drain

- 6.11 Some of the potential archaeological features detected elsewhere are described below.
- 6.12 Two positive magnetic anomalies were detected in Area 149 (Figure 8), one weak and one strong. These could reflect the remains of soil-filled ditches and lie some 150m from the northern one of two known early medieval rath sites just west of Omagh.

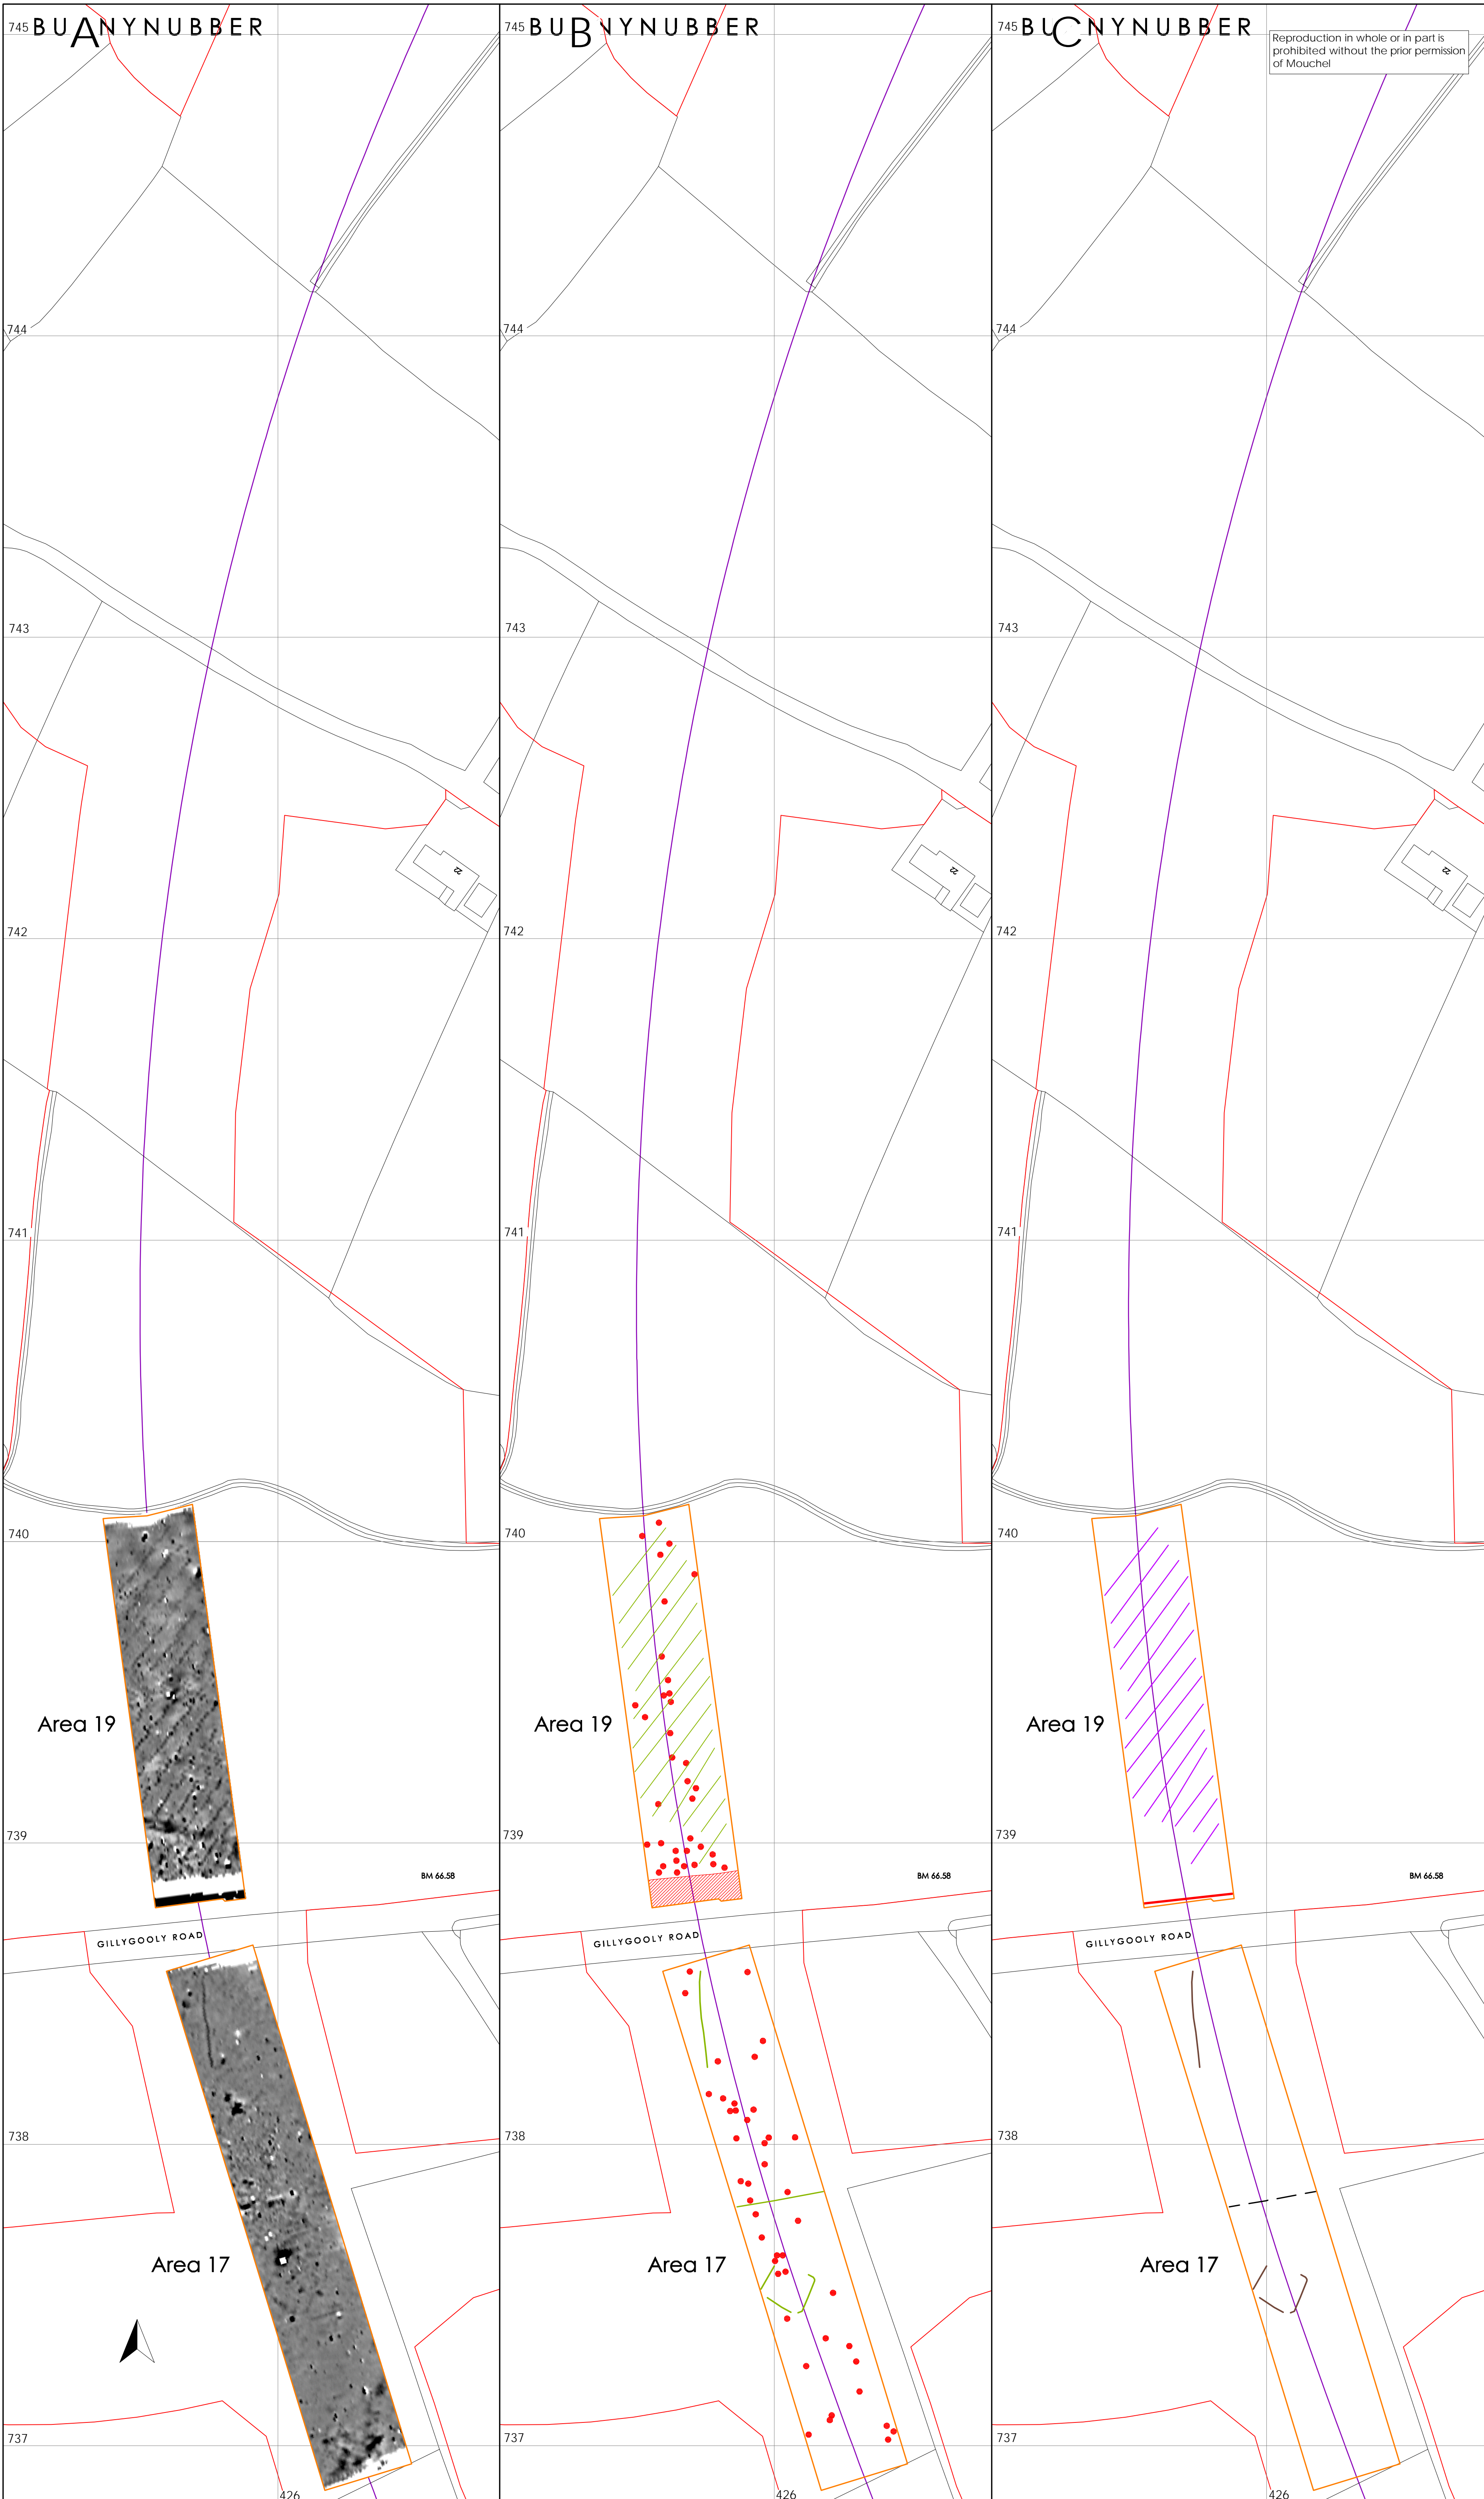
Figure 9: Areas 18, 25, 26, 52, 53 and 55
geophysical survey and interpretations

- A - geophysical survey
- magnetic survey
 - road centreline
 - vesting line
- B - geophysical interpretation
- dipolar magnetic anomaly
 - positive magnetic anomaly
- C - archaeological interpretation
- soil-filled feature
 - service pipe
 - land drain
 - former field boundary

- 6.19 Additional survey, off the centreline of the preferred route, was required in the angle of the Aghnamoyle Road and the Botera Road just west of Omagh due to the former presence of a deerpark. The survey (Area 52; Figure 9) detected a number of weak anomalies which could reflect soil-filled features such as gullies or small ditches. The features are all relatively straight and narrow and do not appear to form any particular pattern or arrangement. They may not be associated with the deerpark, and could simply reflect land drains.

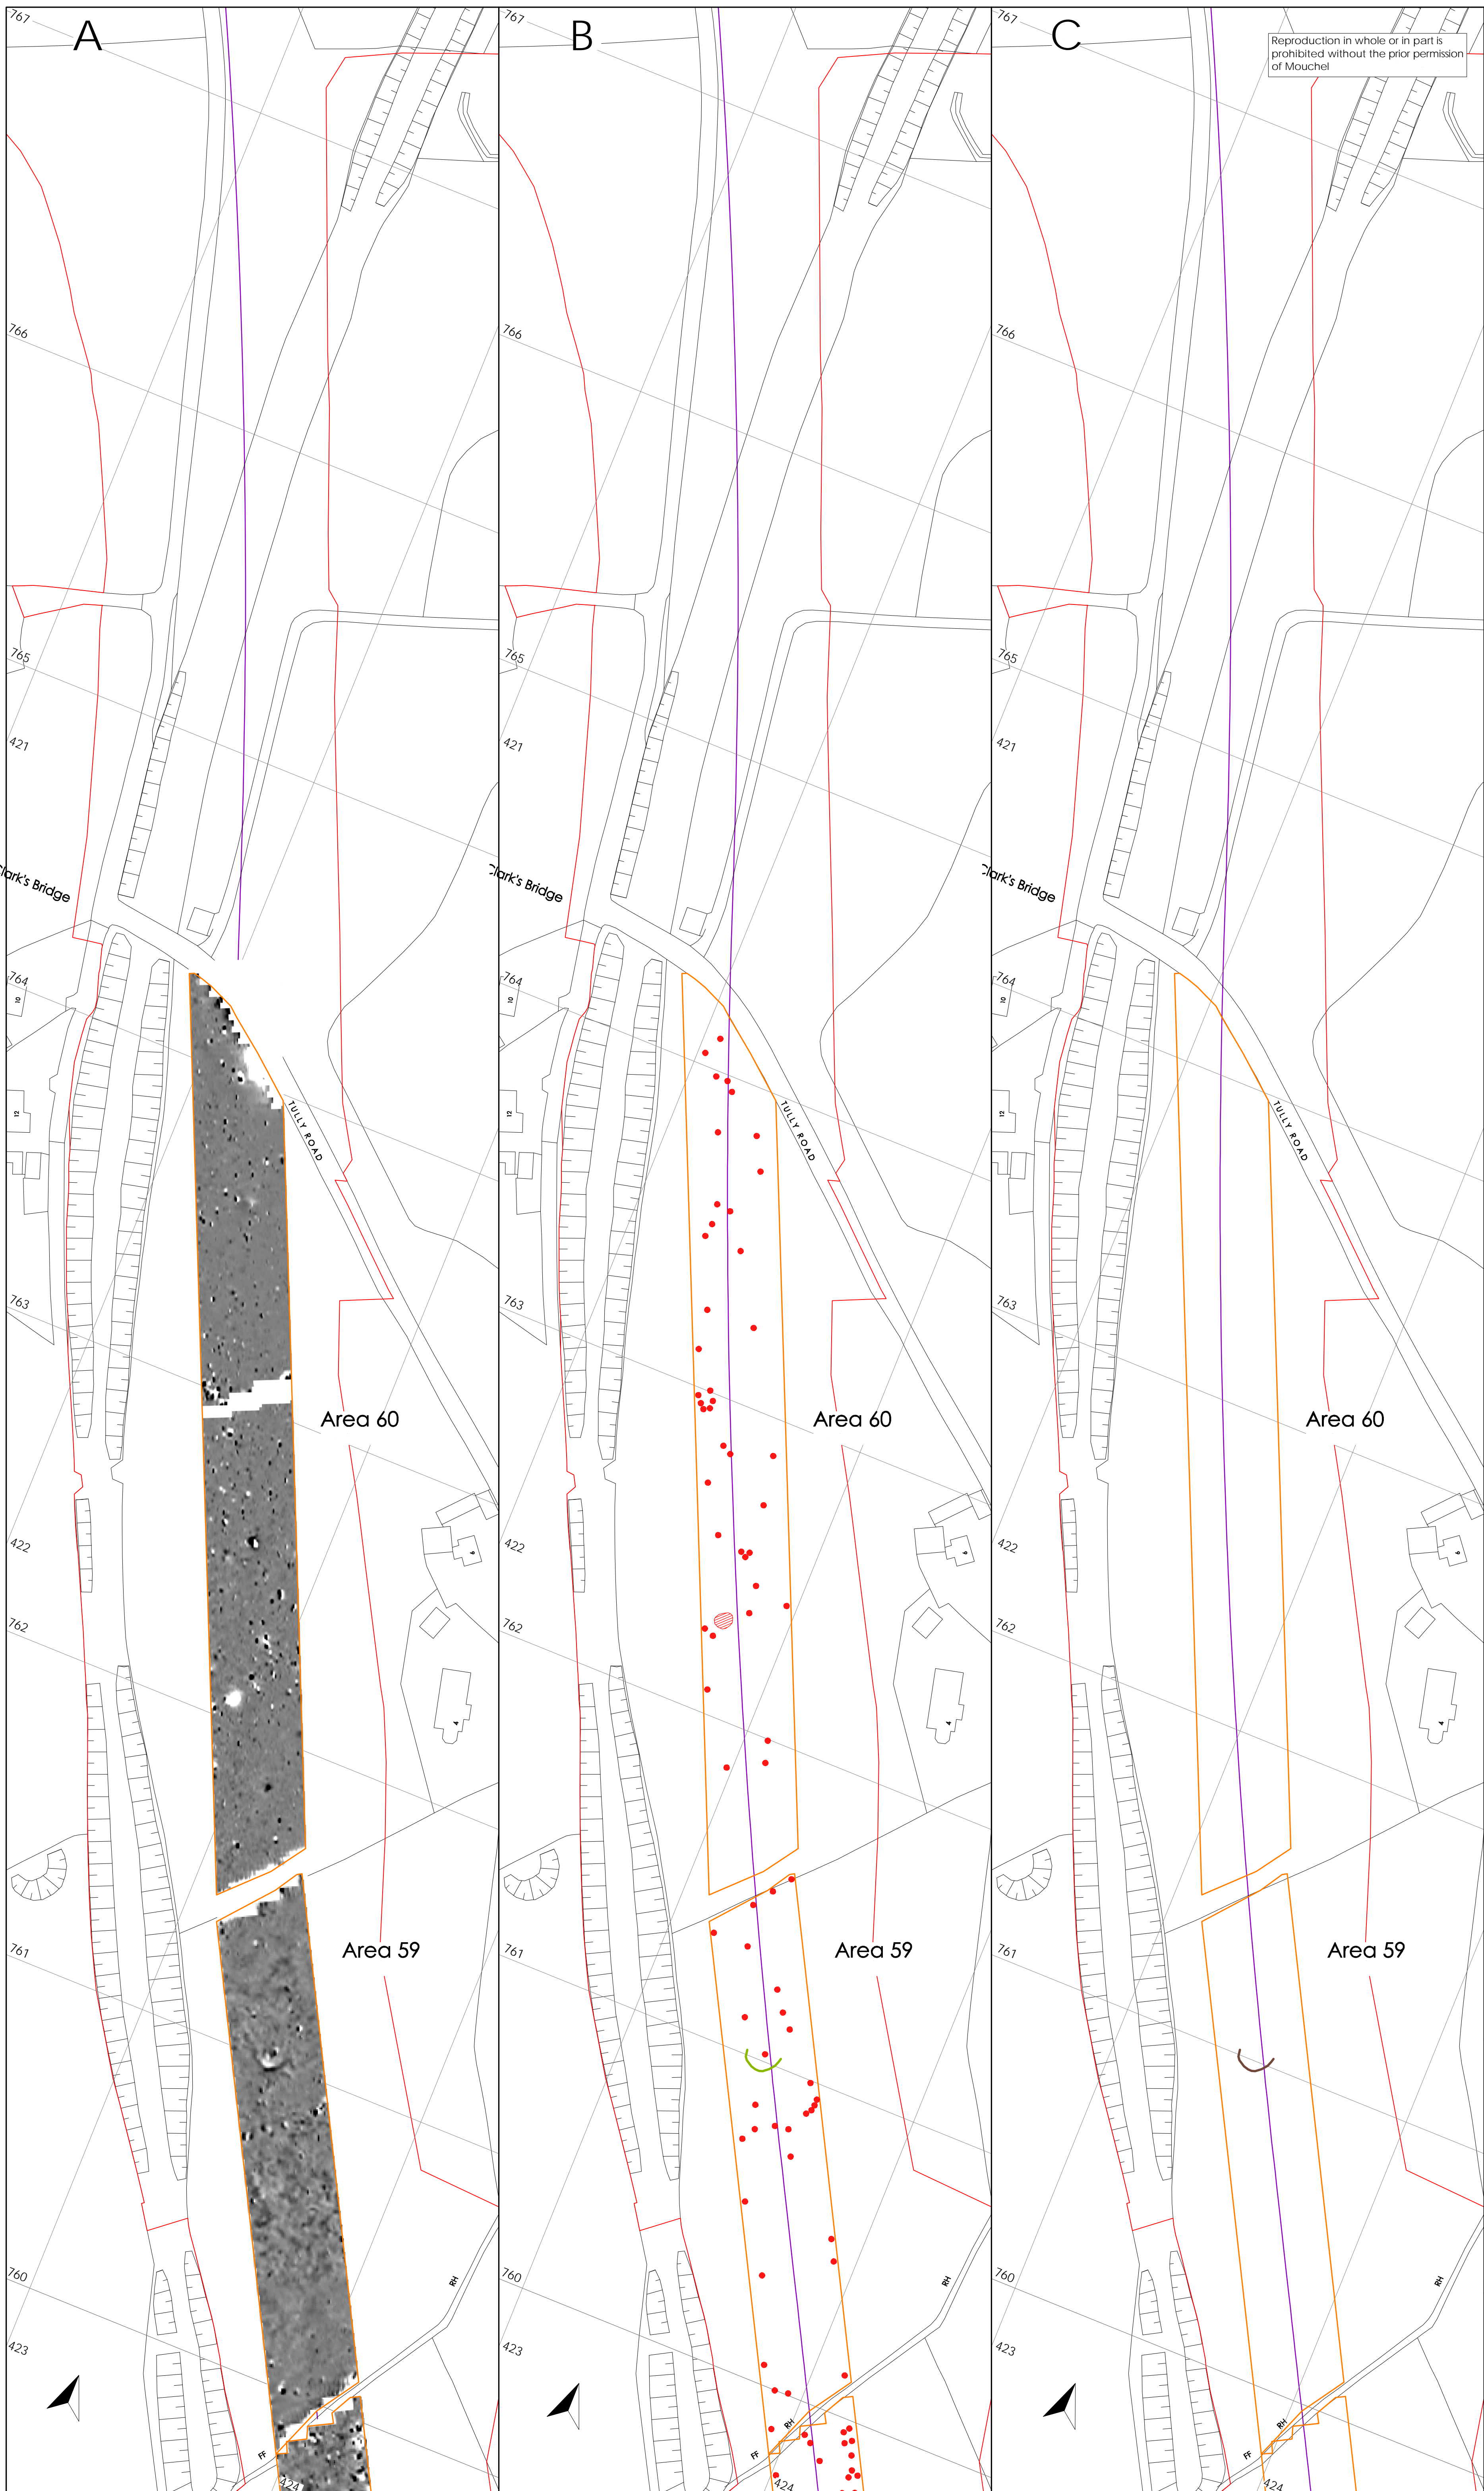
Figure 14: Areas 44, 45, 57 and 58
archaeological interpretation

- A - geophysical survey
 - magnetic survey
 - road centreline
 - vesting line
- B - geophysical interpretation
 - dipolar magnetic anomaly
 - positive magnetic anomaly
- C - archaeological interpretation
 - soil-filled feature

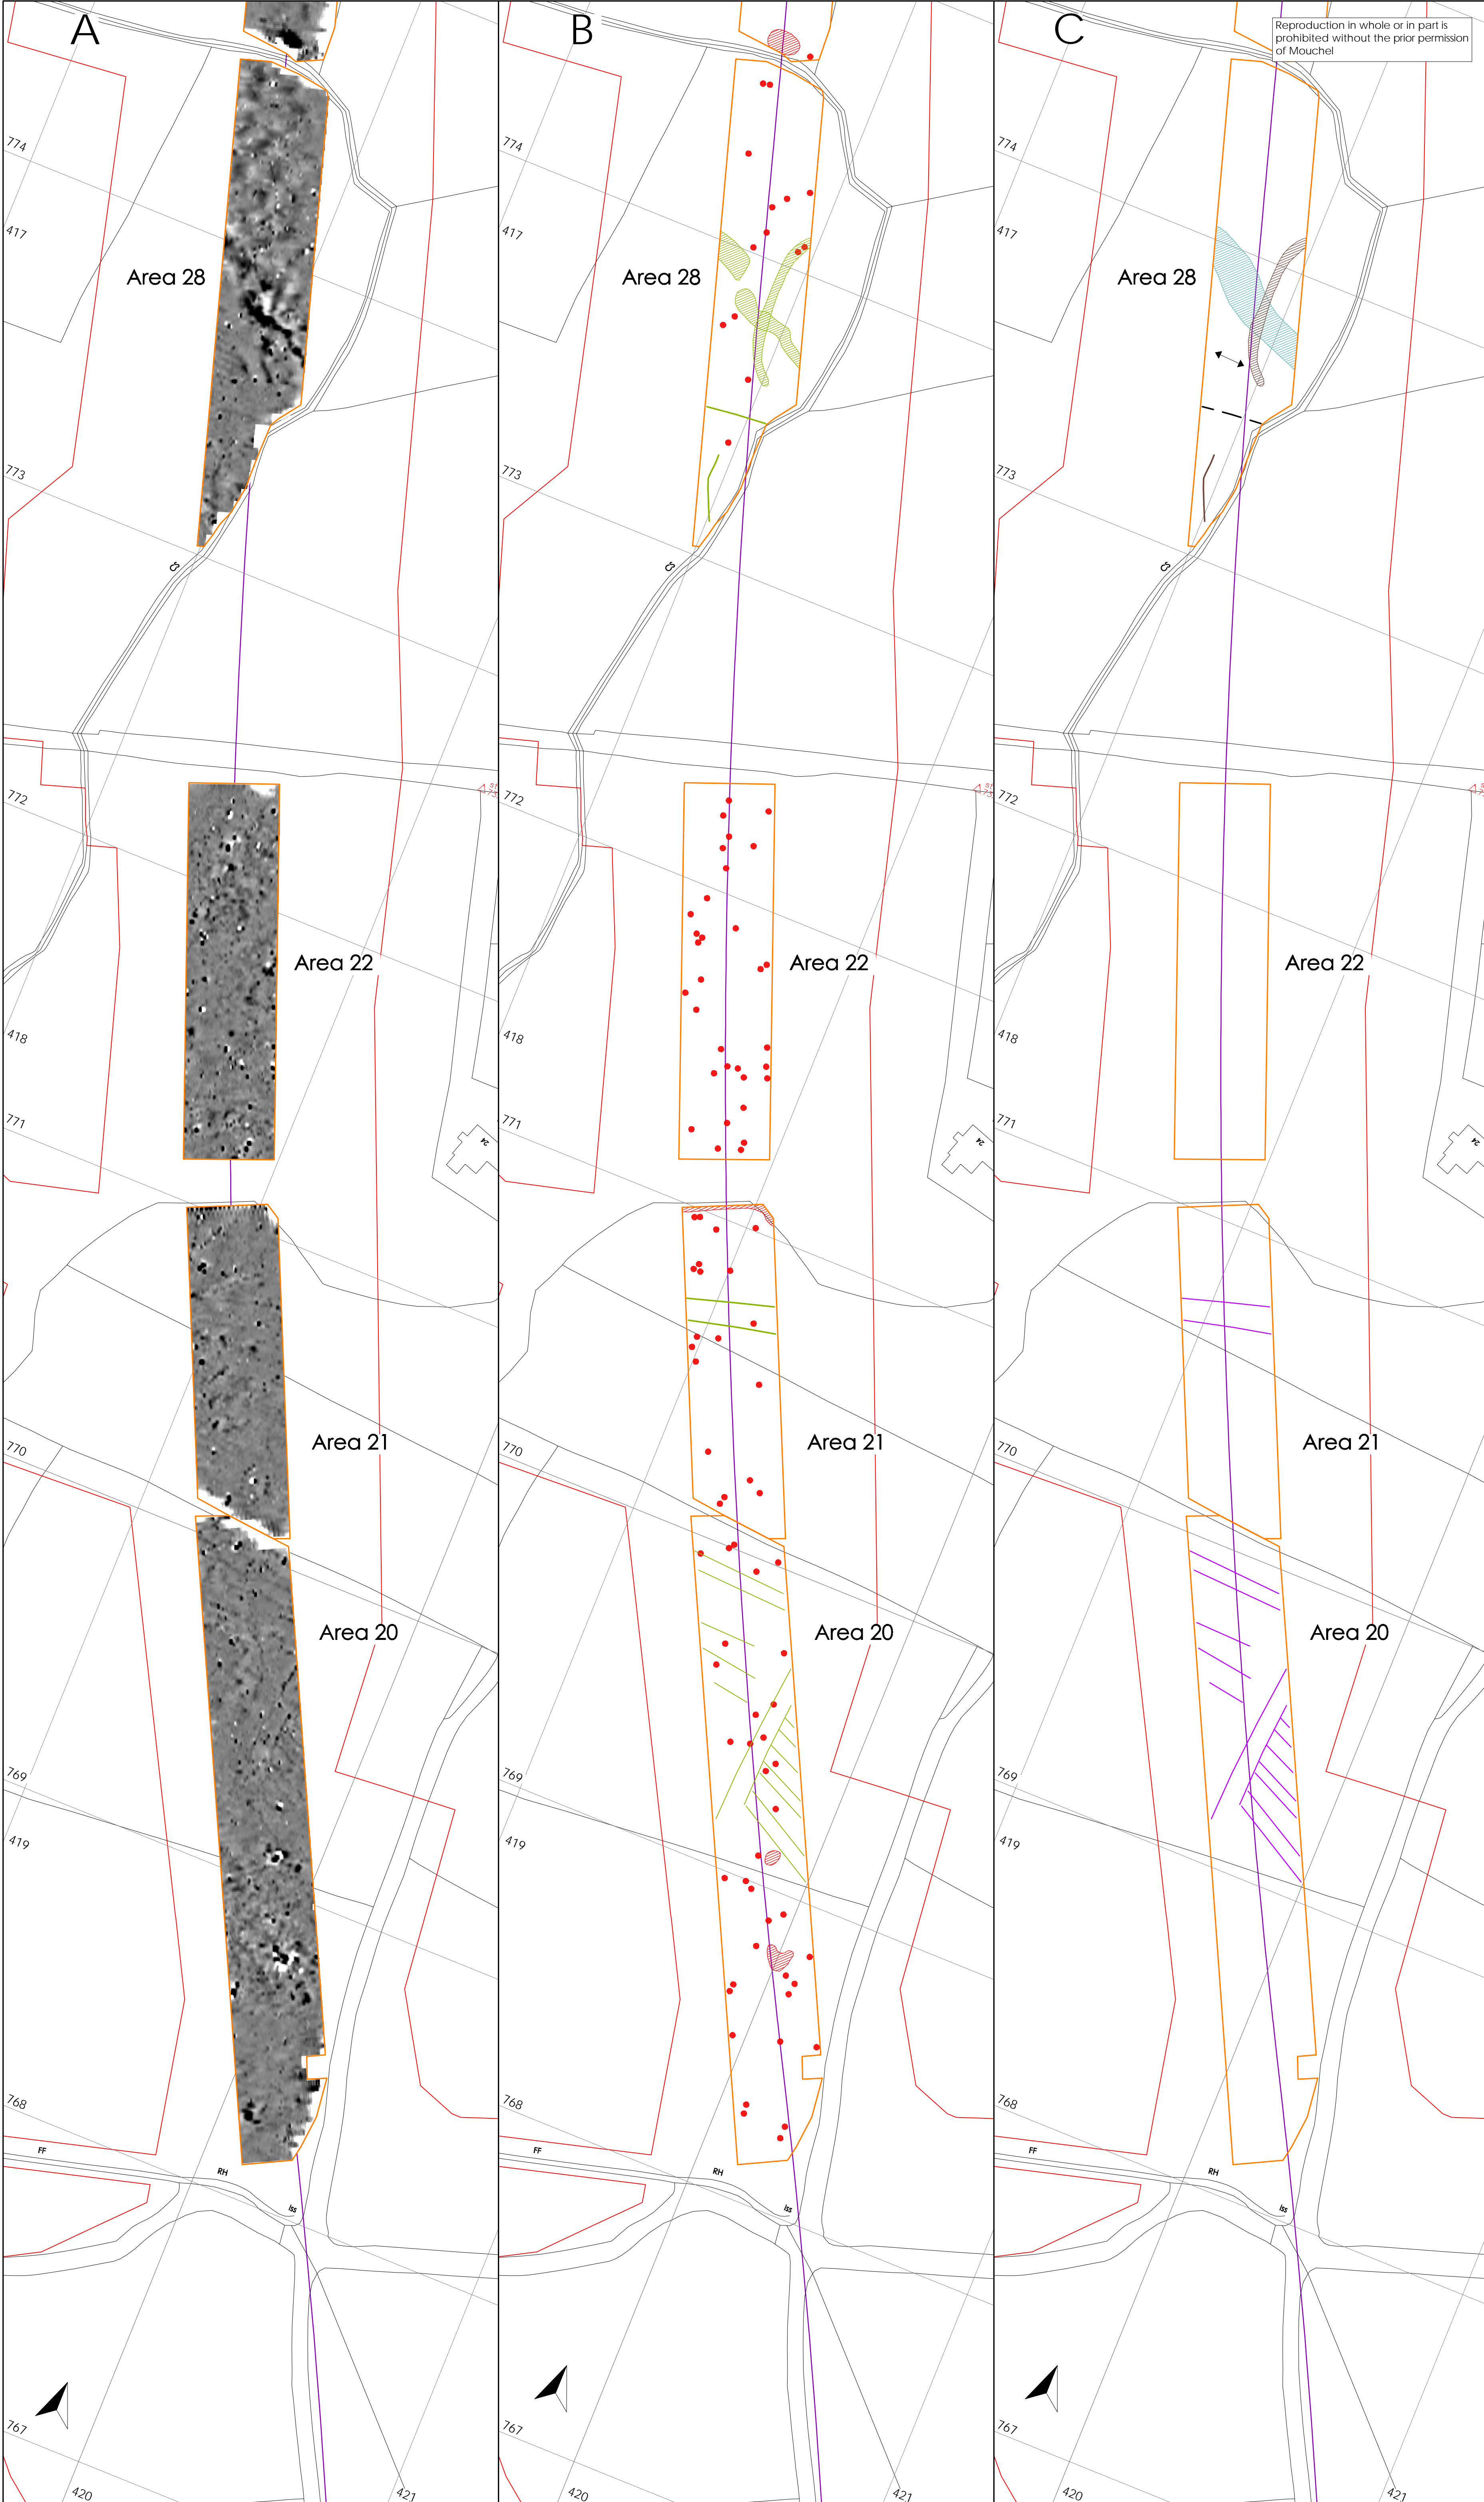
Figure 15: Areas 59 and 60 geophysical
survey and interpretations

- A - geophysical survey
 - magnetic survey
 - road centreline
 - vesting line
- B - geophysical interpretation
 - dipolar magnetic anomaly
 - positive magnetic anomaly
- C - archaeological interpretation
 - soil-filled feature
 - geological feature
 - former plough
 - land drain
 - former field boundary

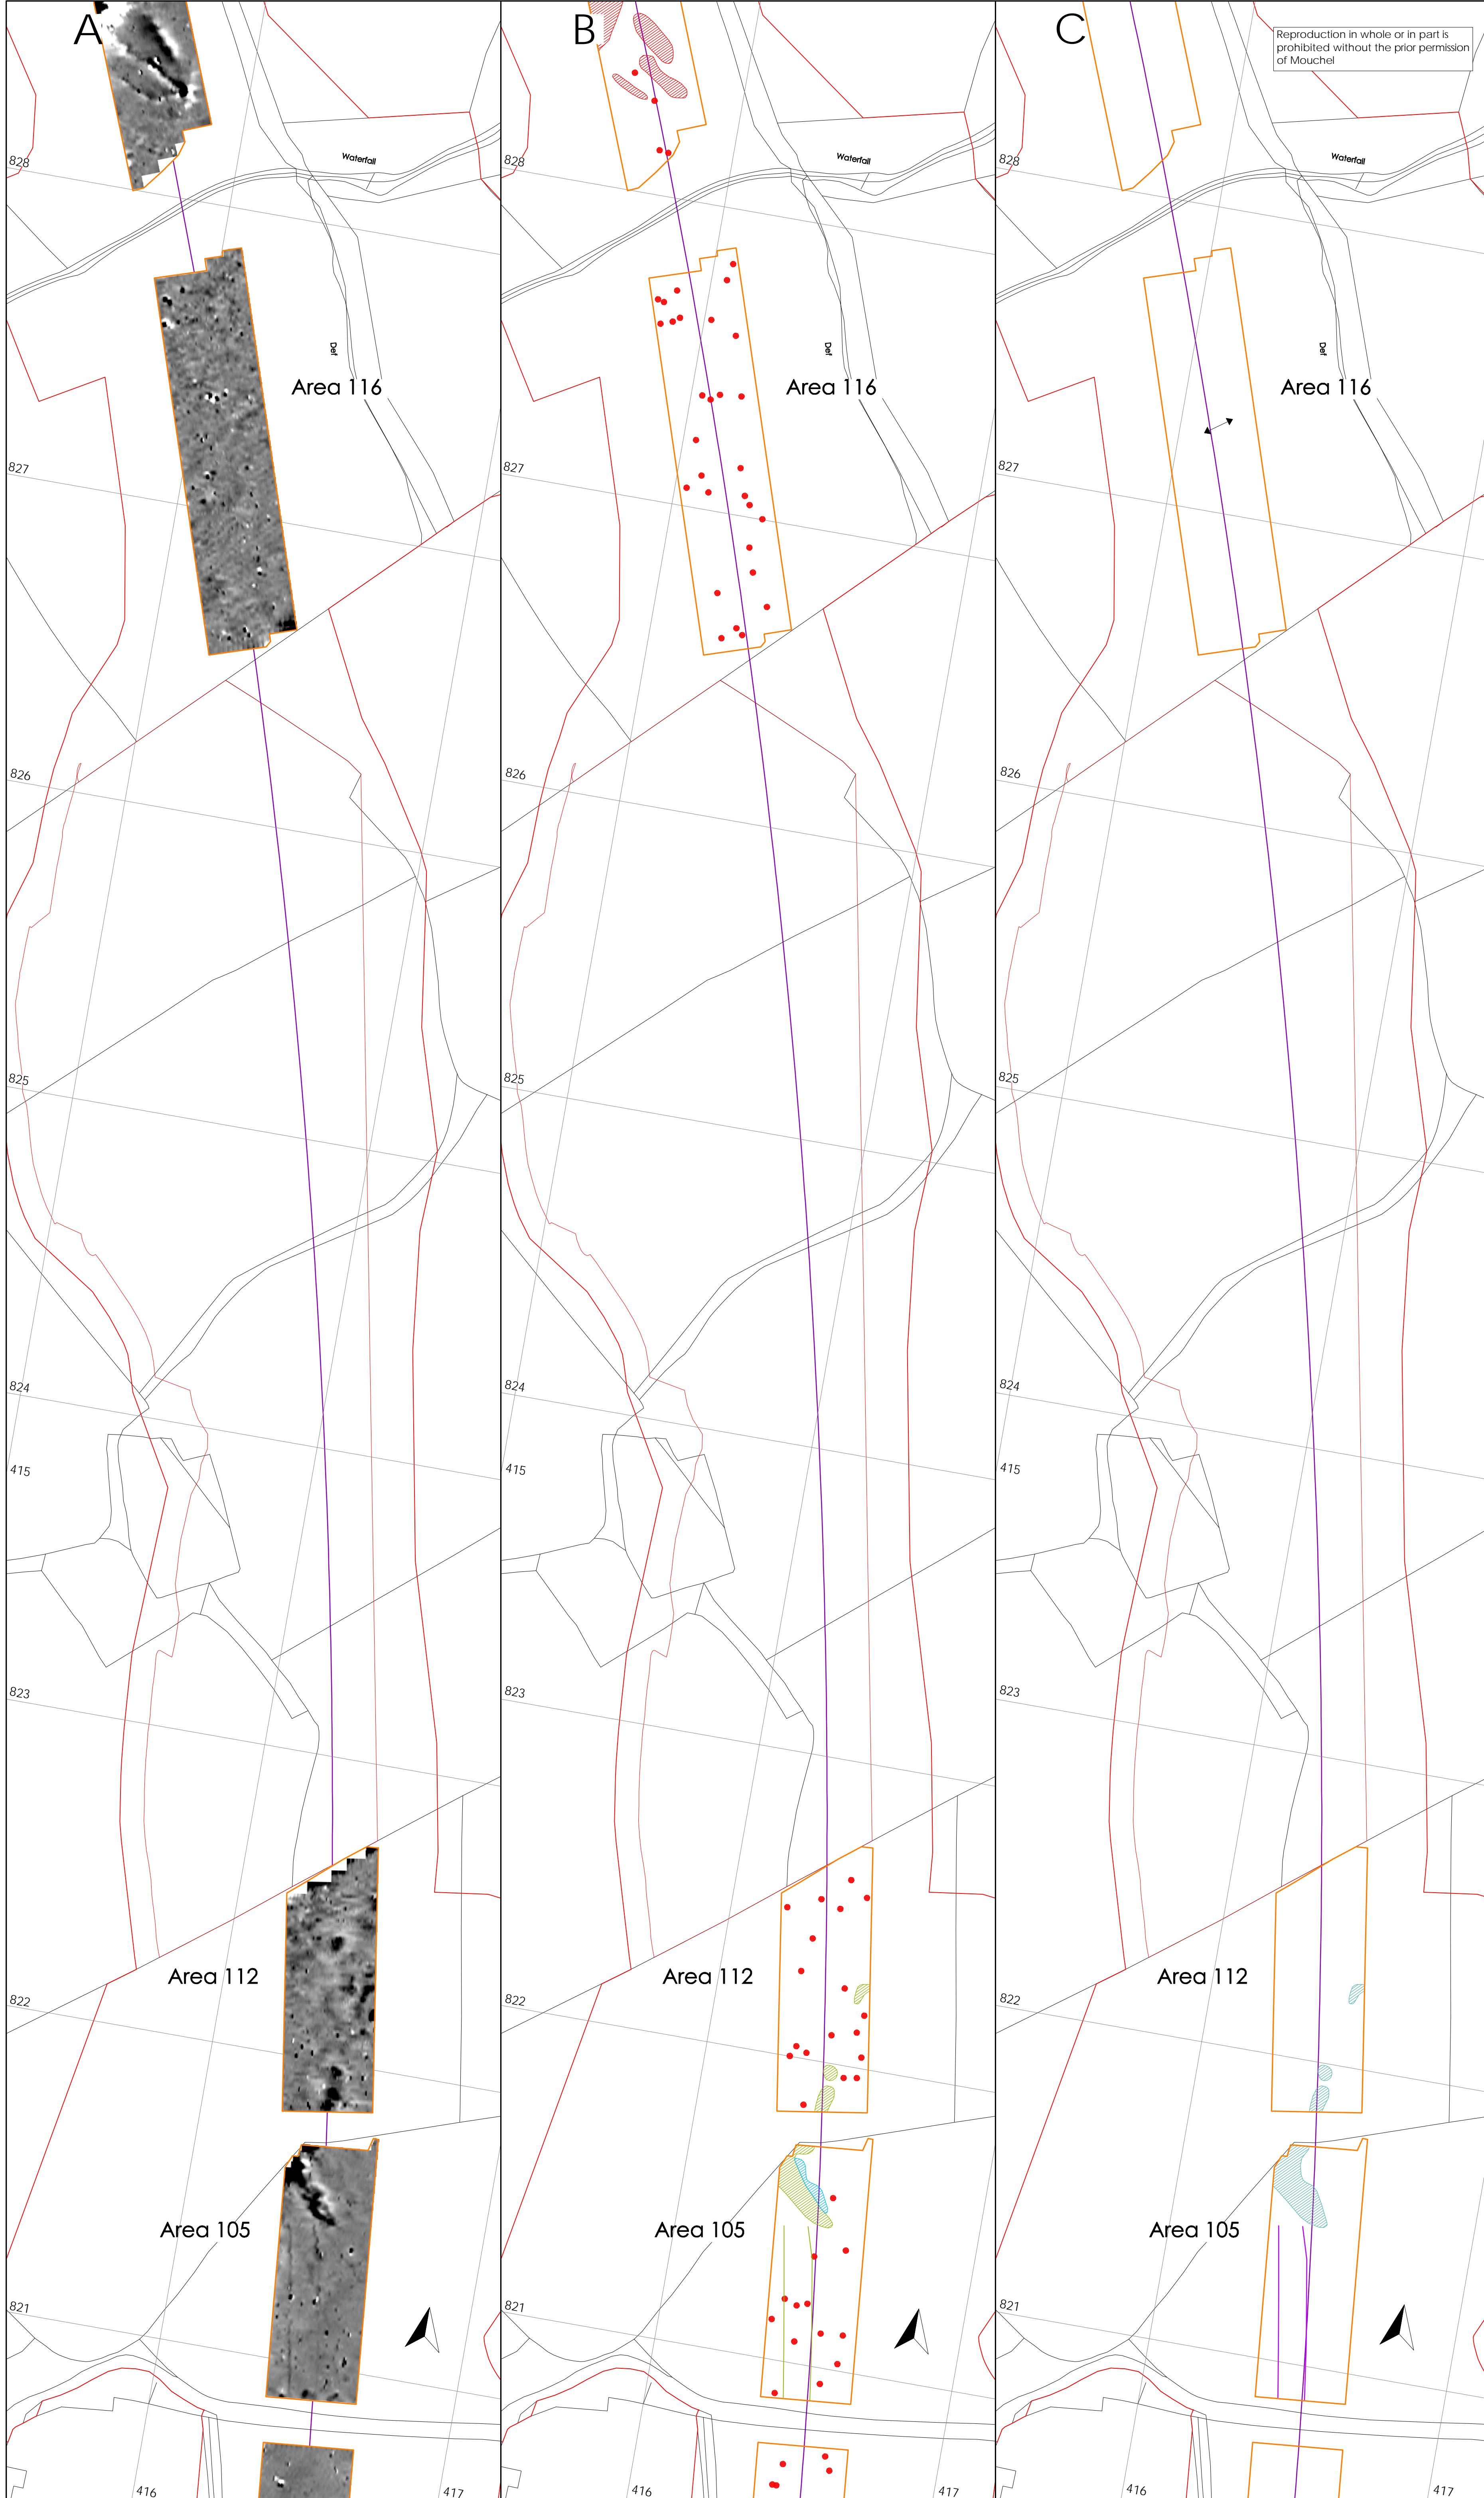
Figure 22: Areas 100, 106, 107, 108, 109, 110 and 111 geophysical survey and interpretations

- A - geophysical survey
- magnetic survey
 - road centreline
 - vesting line
- B - geophysical interpretation
- dipolar magnetic anomaly
 - positive magnetic anomaly
 - negative magnetic anomaly
- C - archaeological interpretation
- geological feature
 - former plough
