A5 WTC
Western Transport Corridor

Section 2
A5 Western Transport Corridor
Northern Ireland

geophysical survey

report 2746, volume II
January 2012

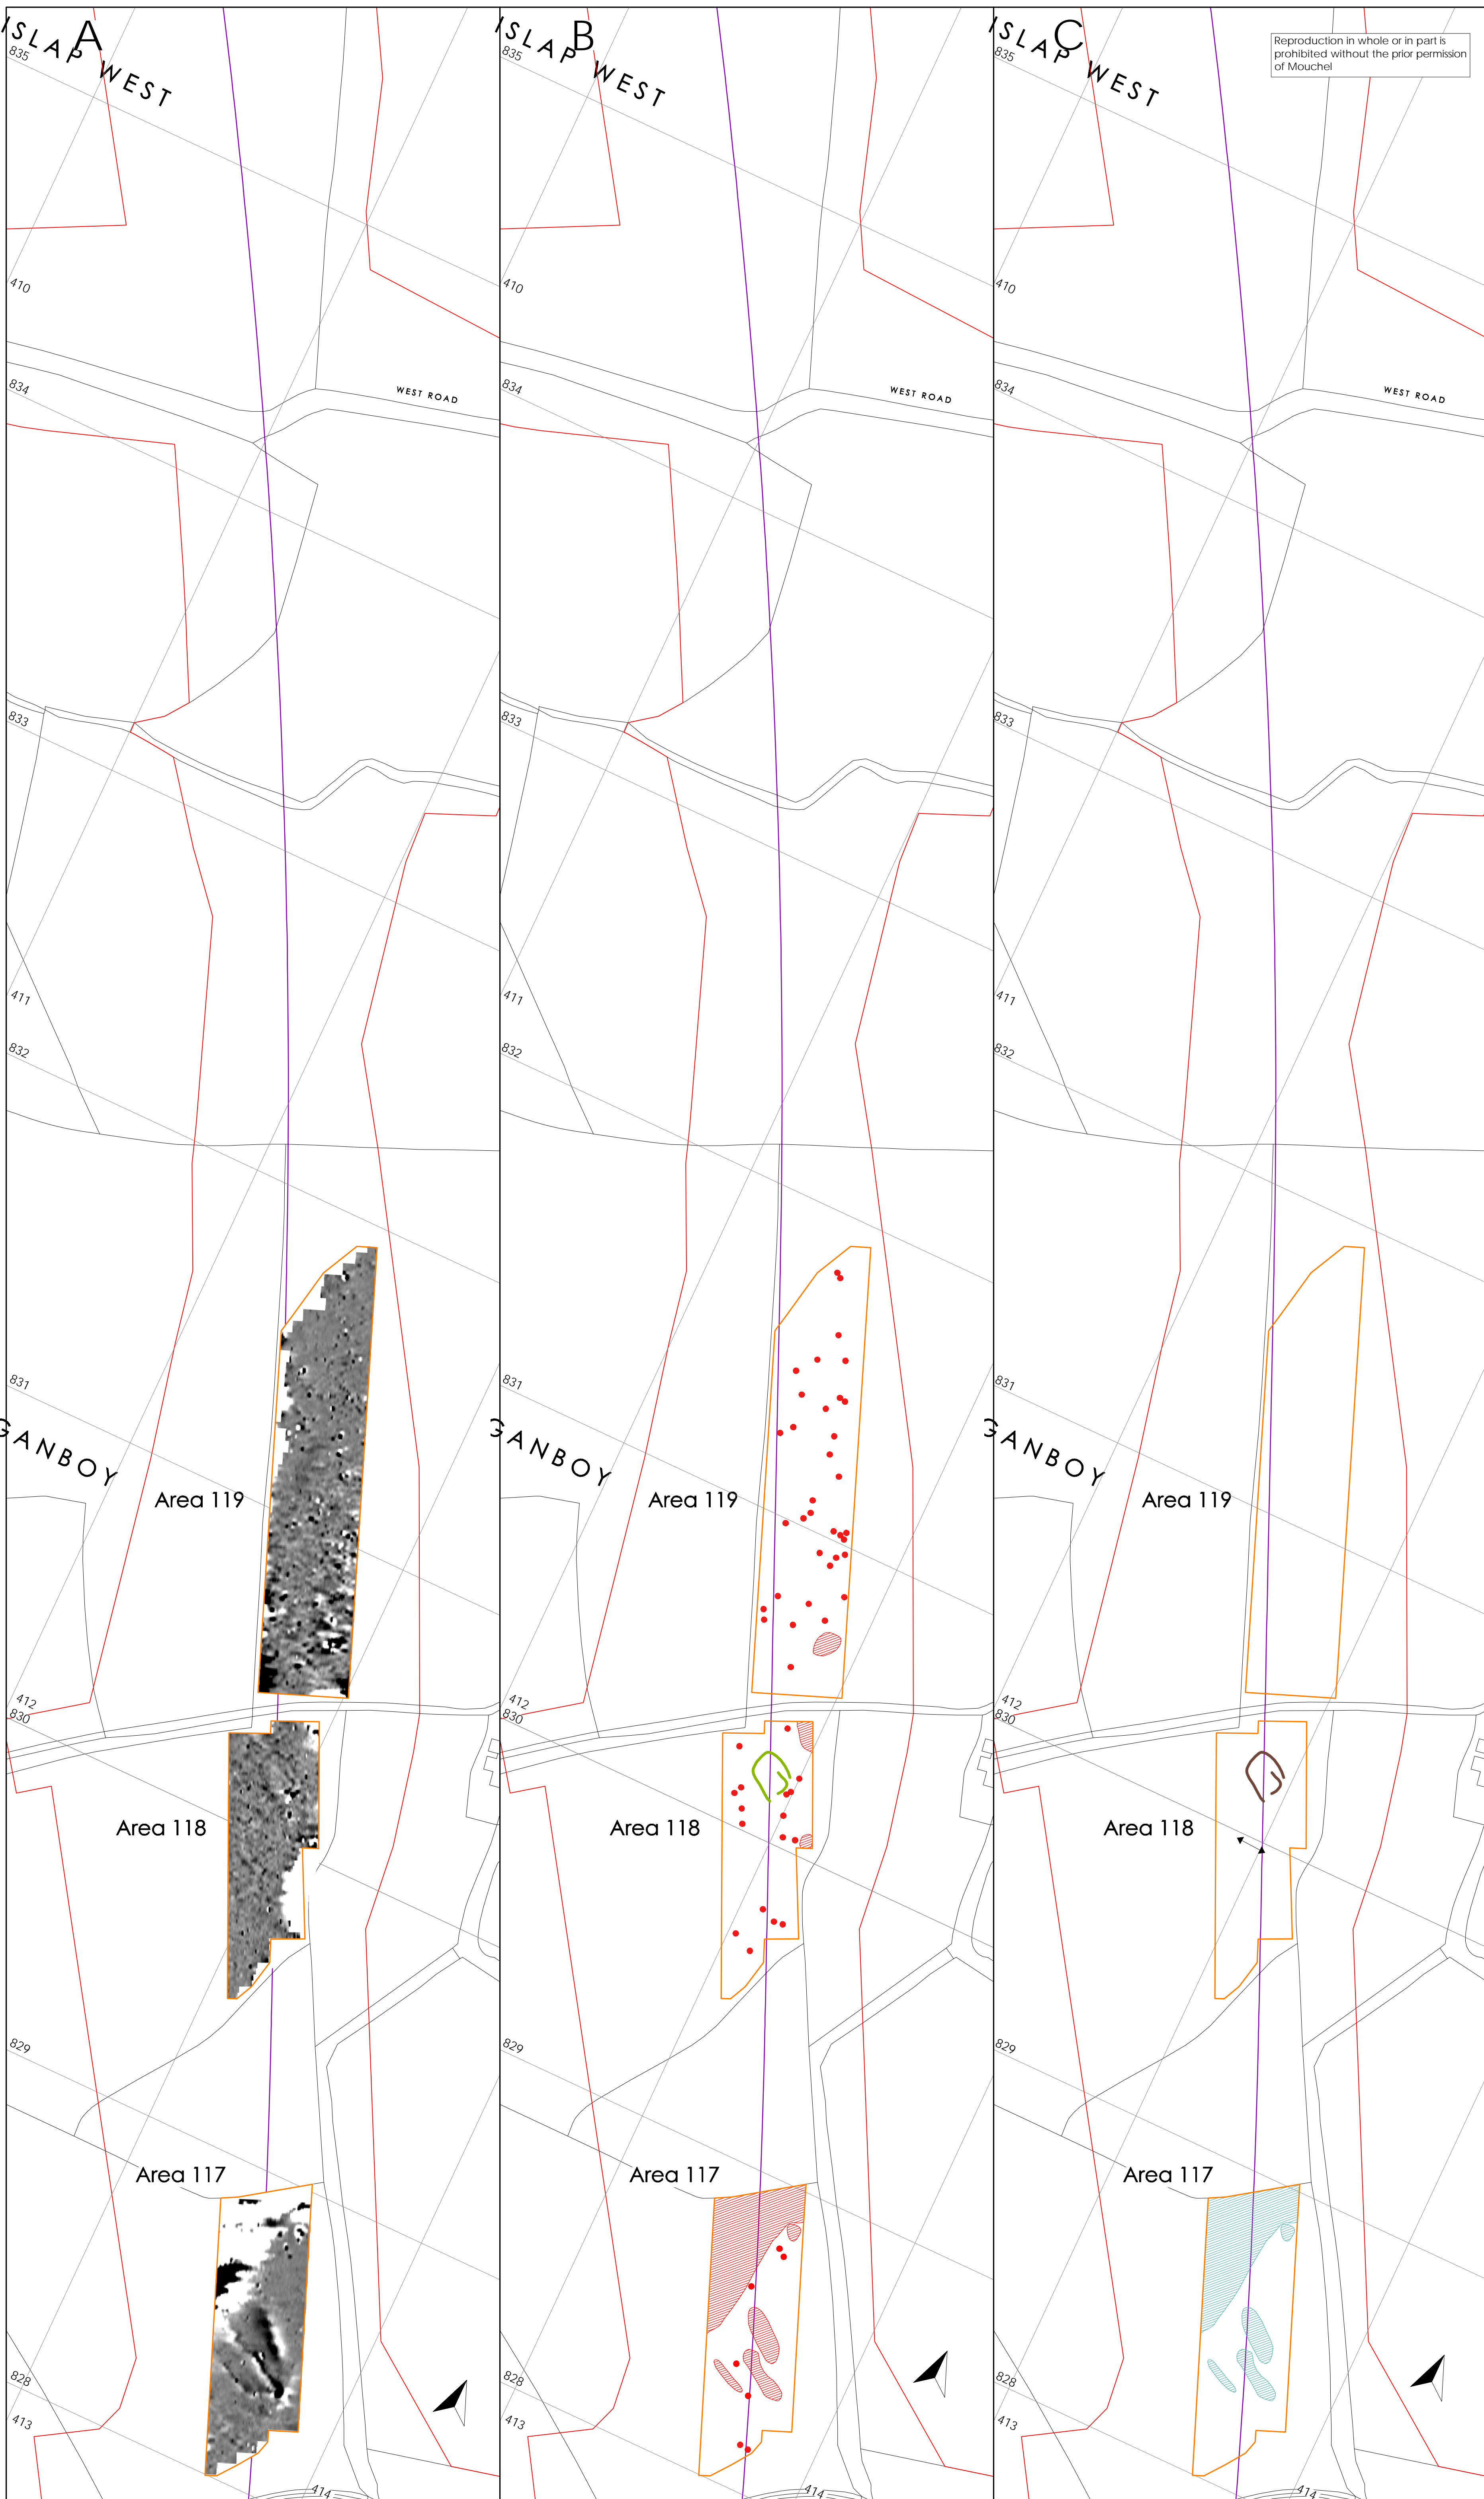
Figure 23: Areas 105, 112 and 116
geophysical survey and interpretations

- A - geophysical survey
 - magnetic survey
 - road centreline
 - vesting line
- B - geophysical interpretation
 - dipolar magnetic anomaly
 - positive magnetic anomaly
- C - archaeological interpretation
 - soil-filled feature
 - former plough
 - geological feature

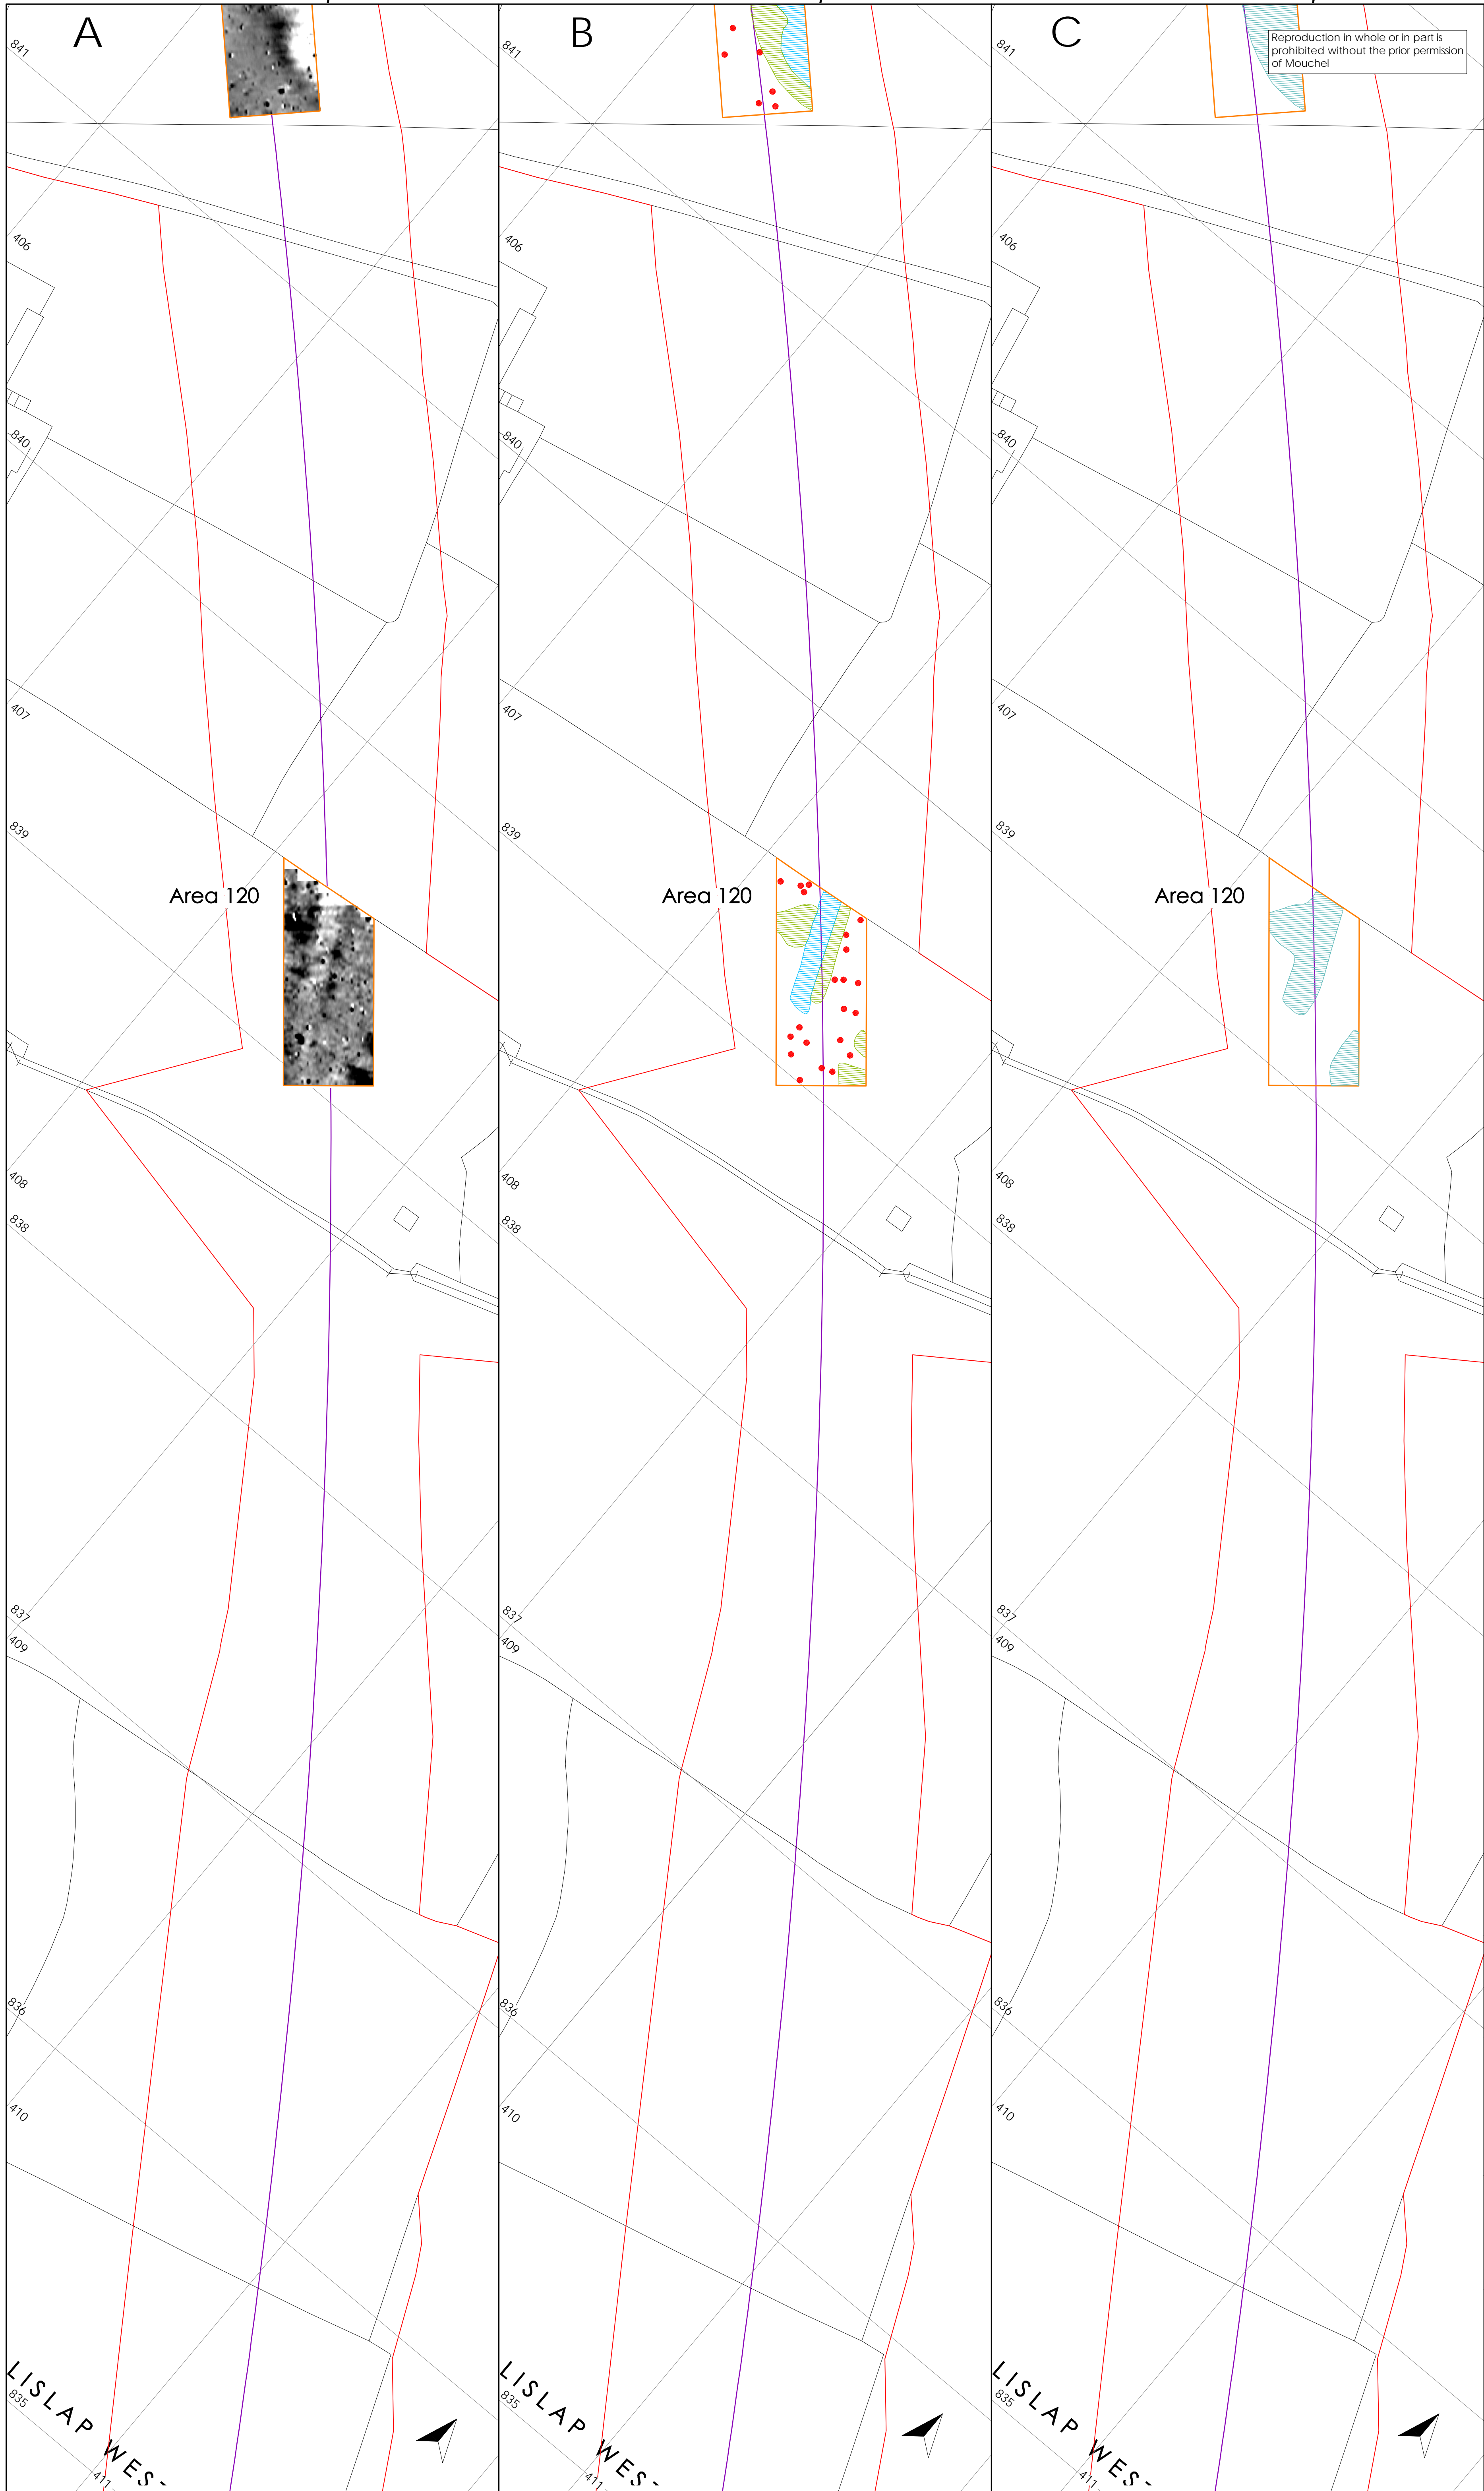
Figure 24: Areas 117, 118 and 119
geophysical survey and interpretations

- A - geophysical survey**
- magnetic survey
 - road centreline
 - vesting line
- B - geophysical interpretation**
- dipolar magnetic anomaly
 - positive magnetic anomaly
 - negative magnetic anomaly
- C - archaeological interpretation**
- geological feature

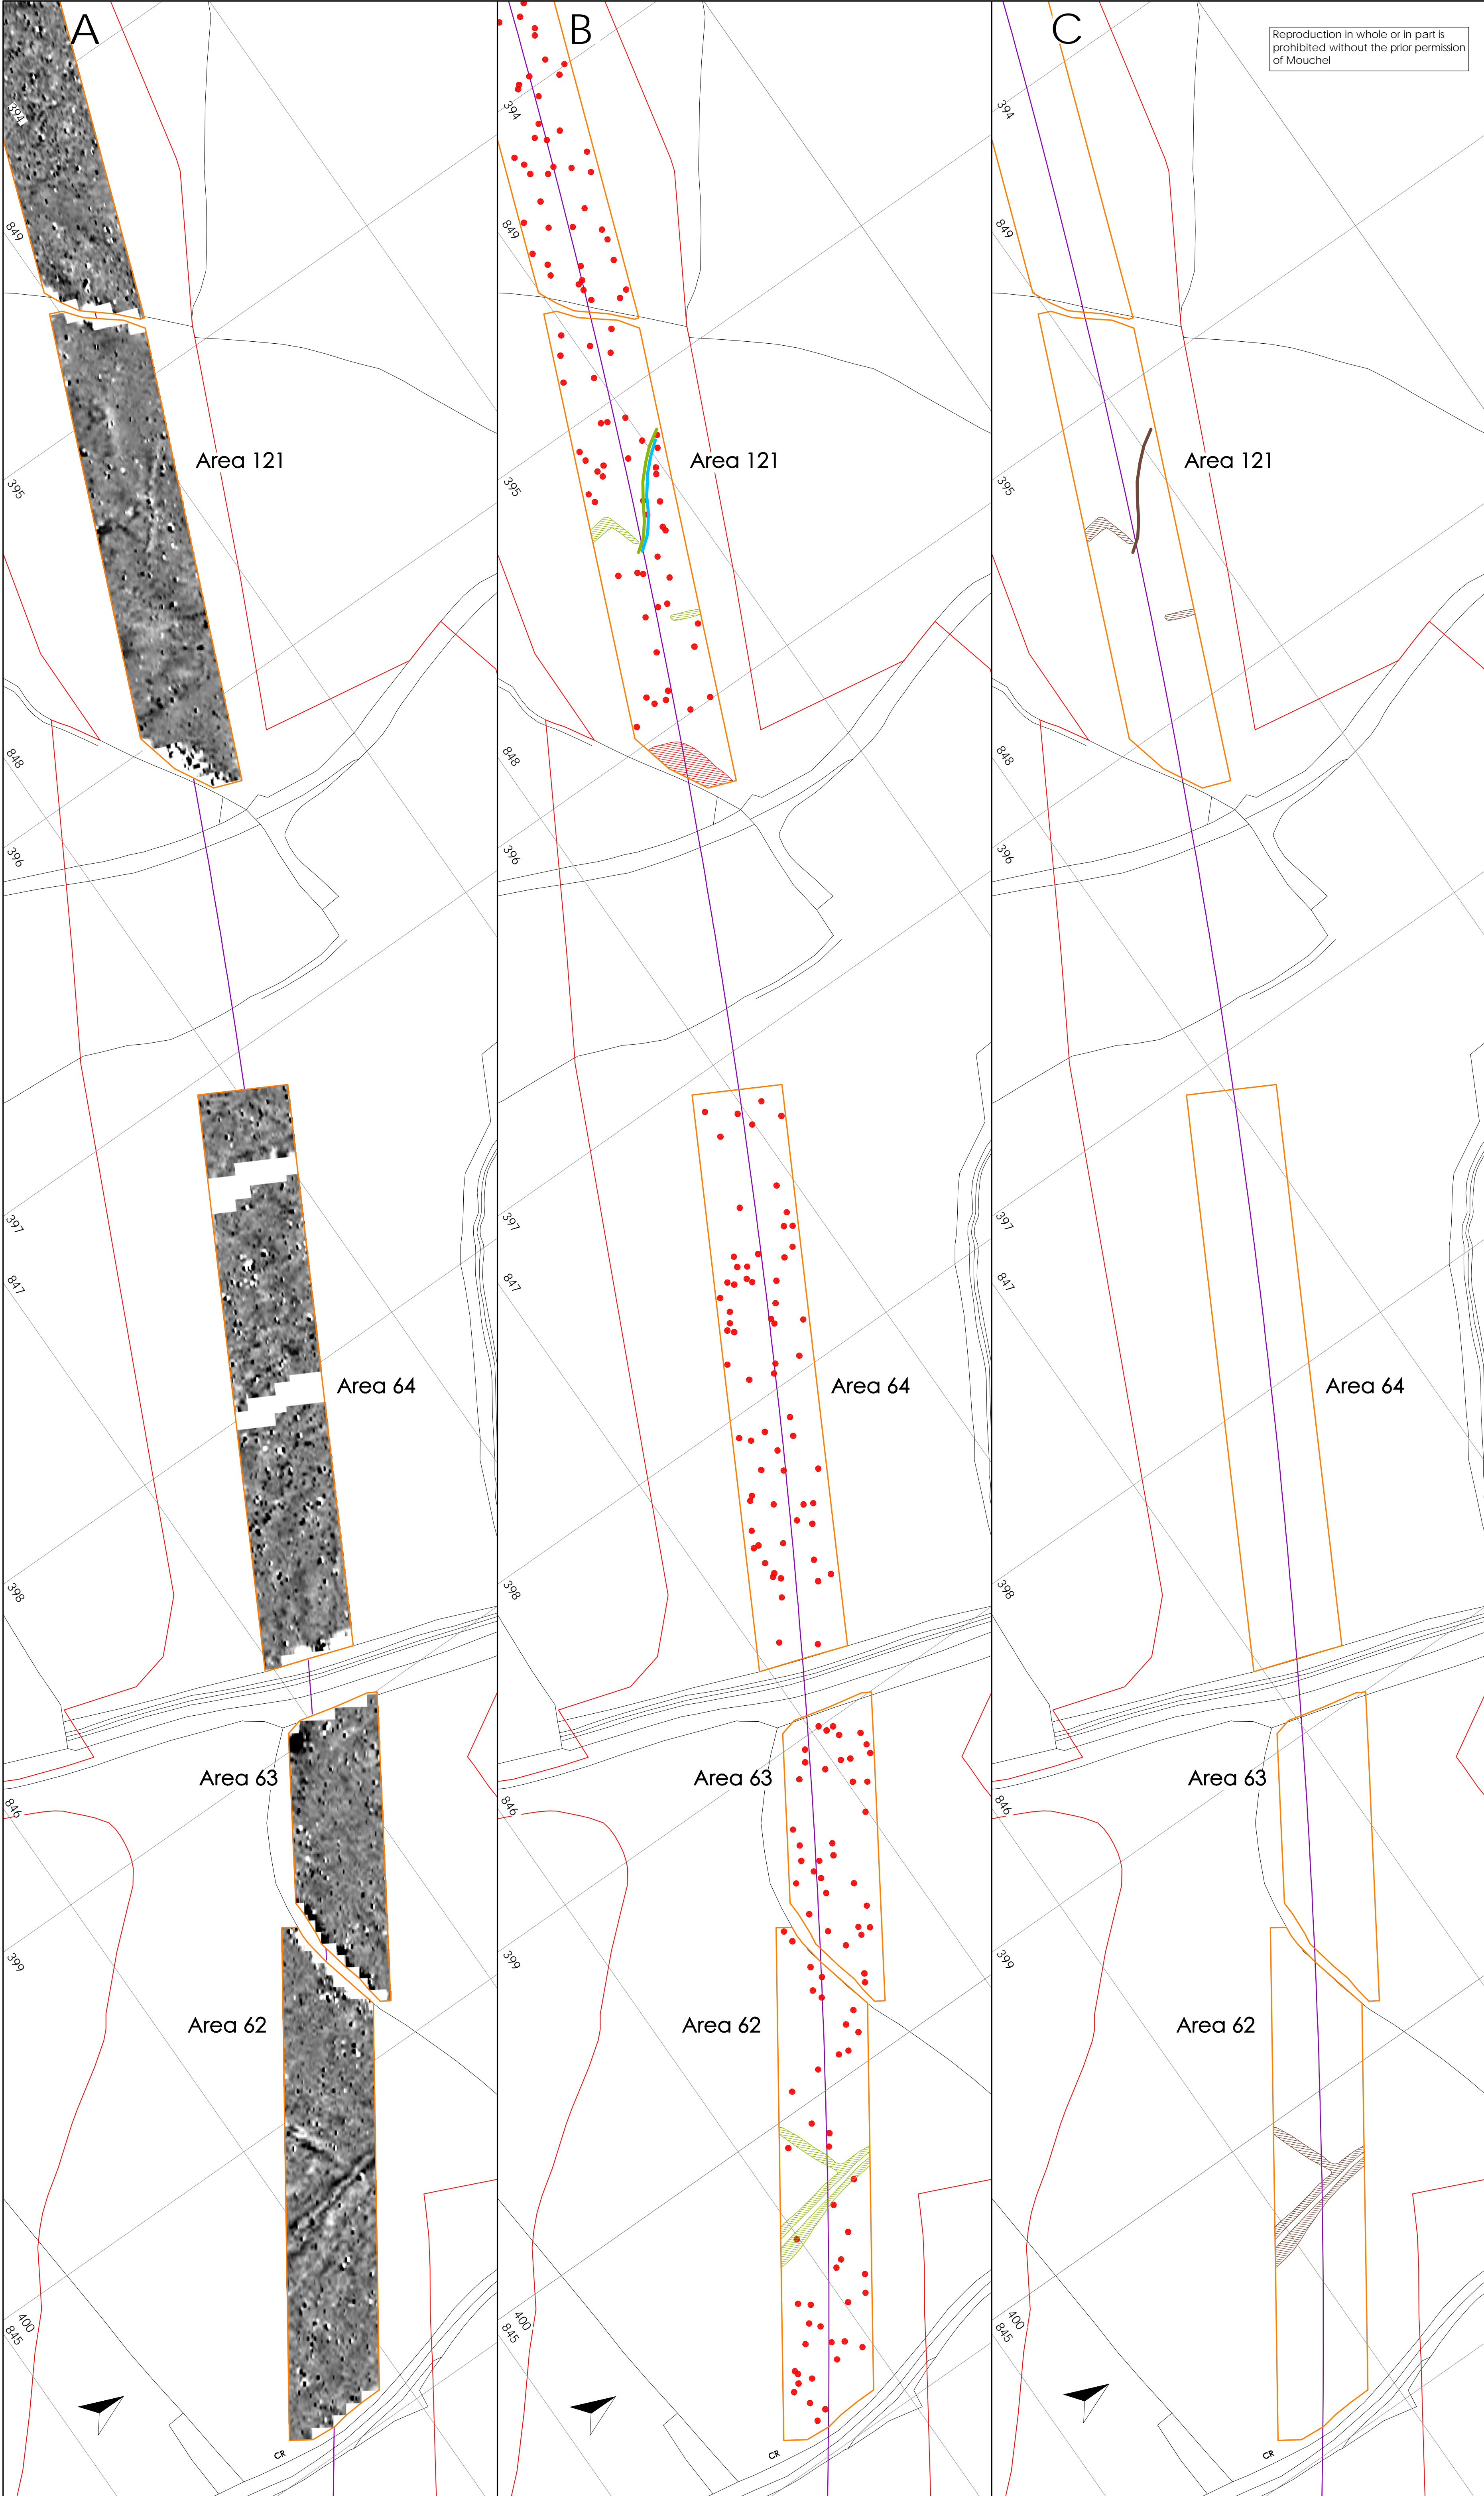
Figure 26: Areas 61, 140 and 141
geophysical survey and interpretations

- A - geophysical survey
- magnetic survey
 - road centreline
 - vesting line
- B - geophysical interpretation
- dipolar magnetic anomaly
 - positive magnetic anomaly
 - negative magnetic anomaly
- C - archaeological interpretation
- soil-filled feature

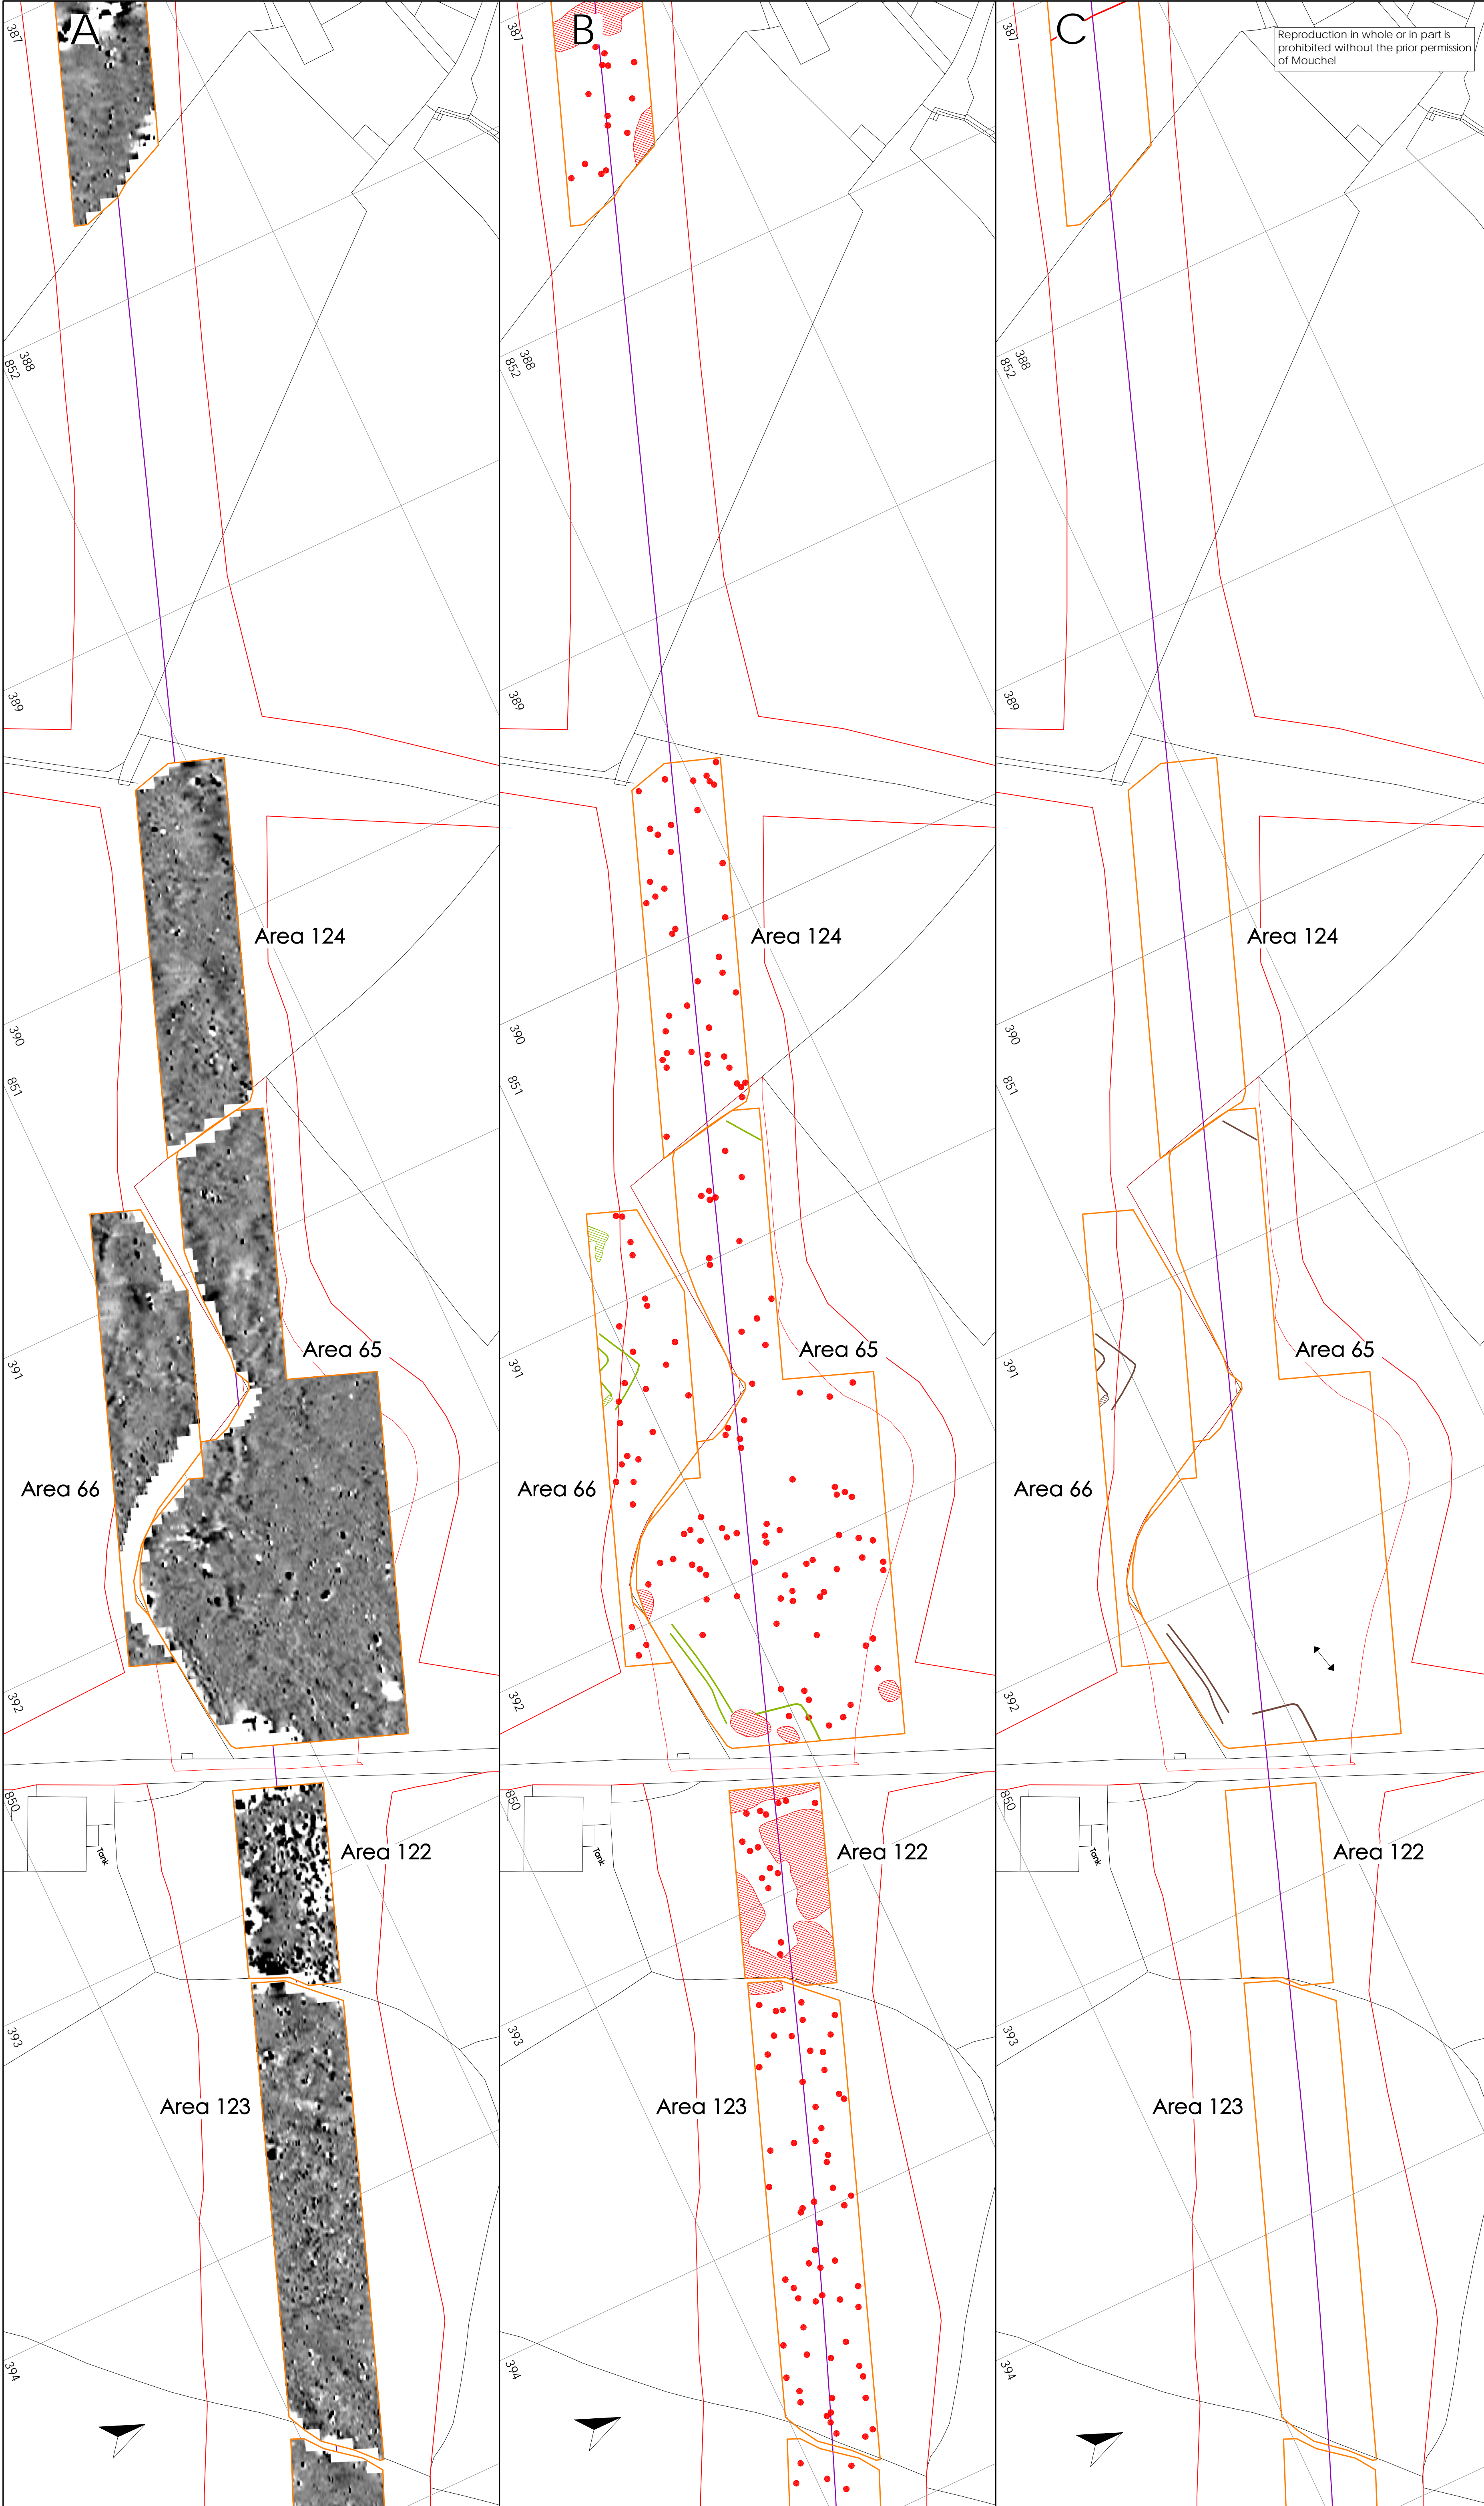
Figure 27: Areas 62, 63, 64 and 121
geophysical survey and interpretations

- A - geophysical survey
 - magnetic survey
 - road centreline
 - vesting line
- B - geophysical interpretation
 - dipolar magnetic anomaly
 - positive magnetic anomaly
- C - archaeological interpretation
 - soil-filled feature
 - former plough

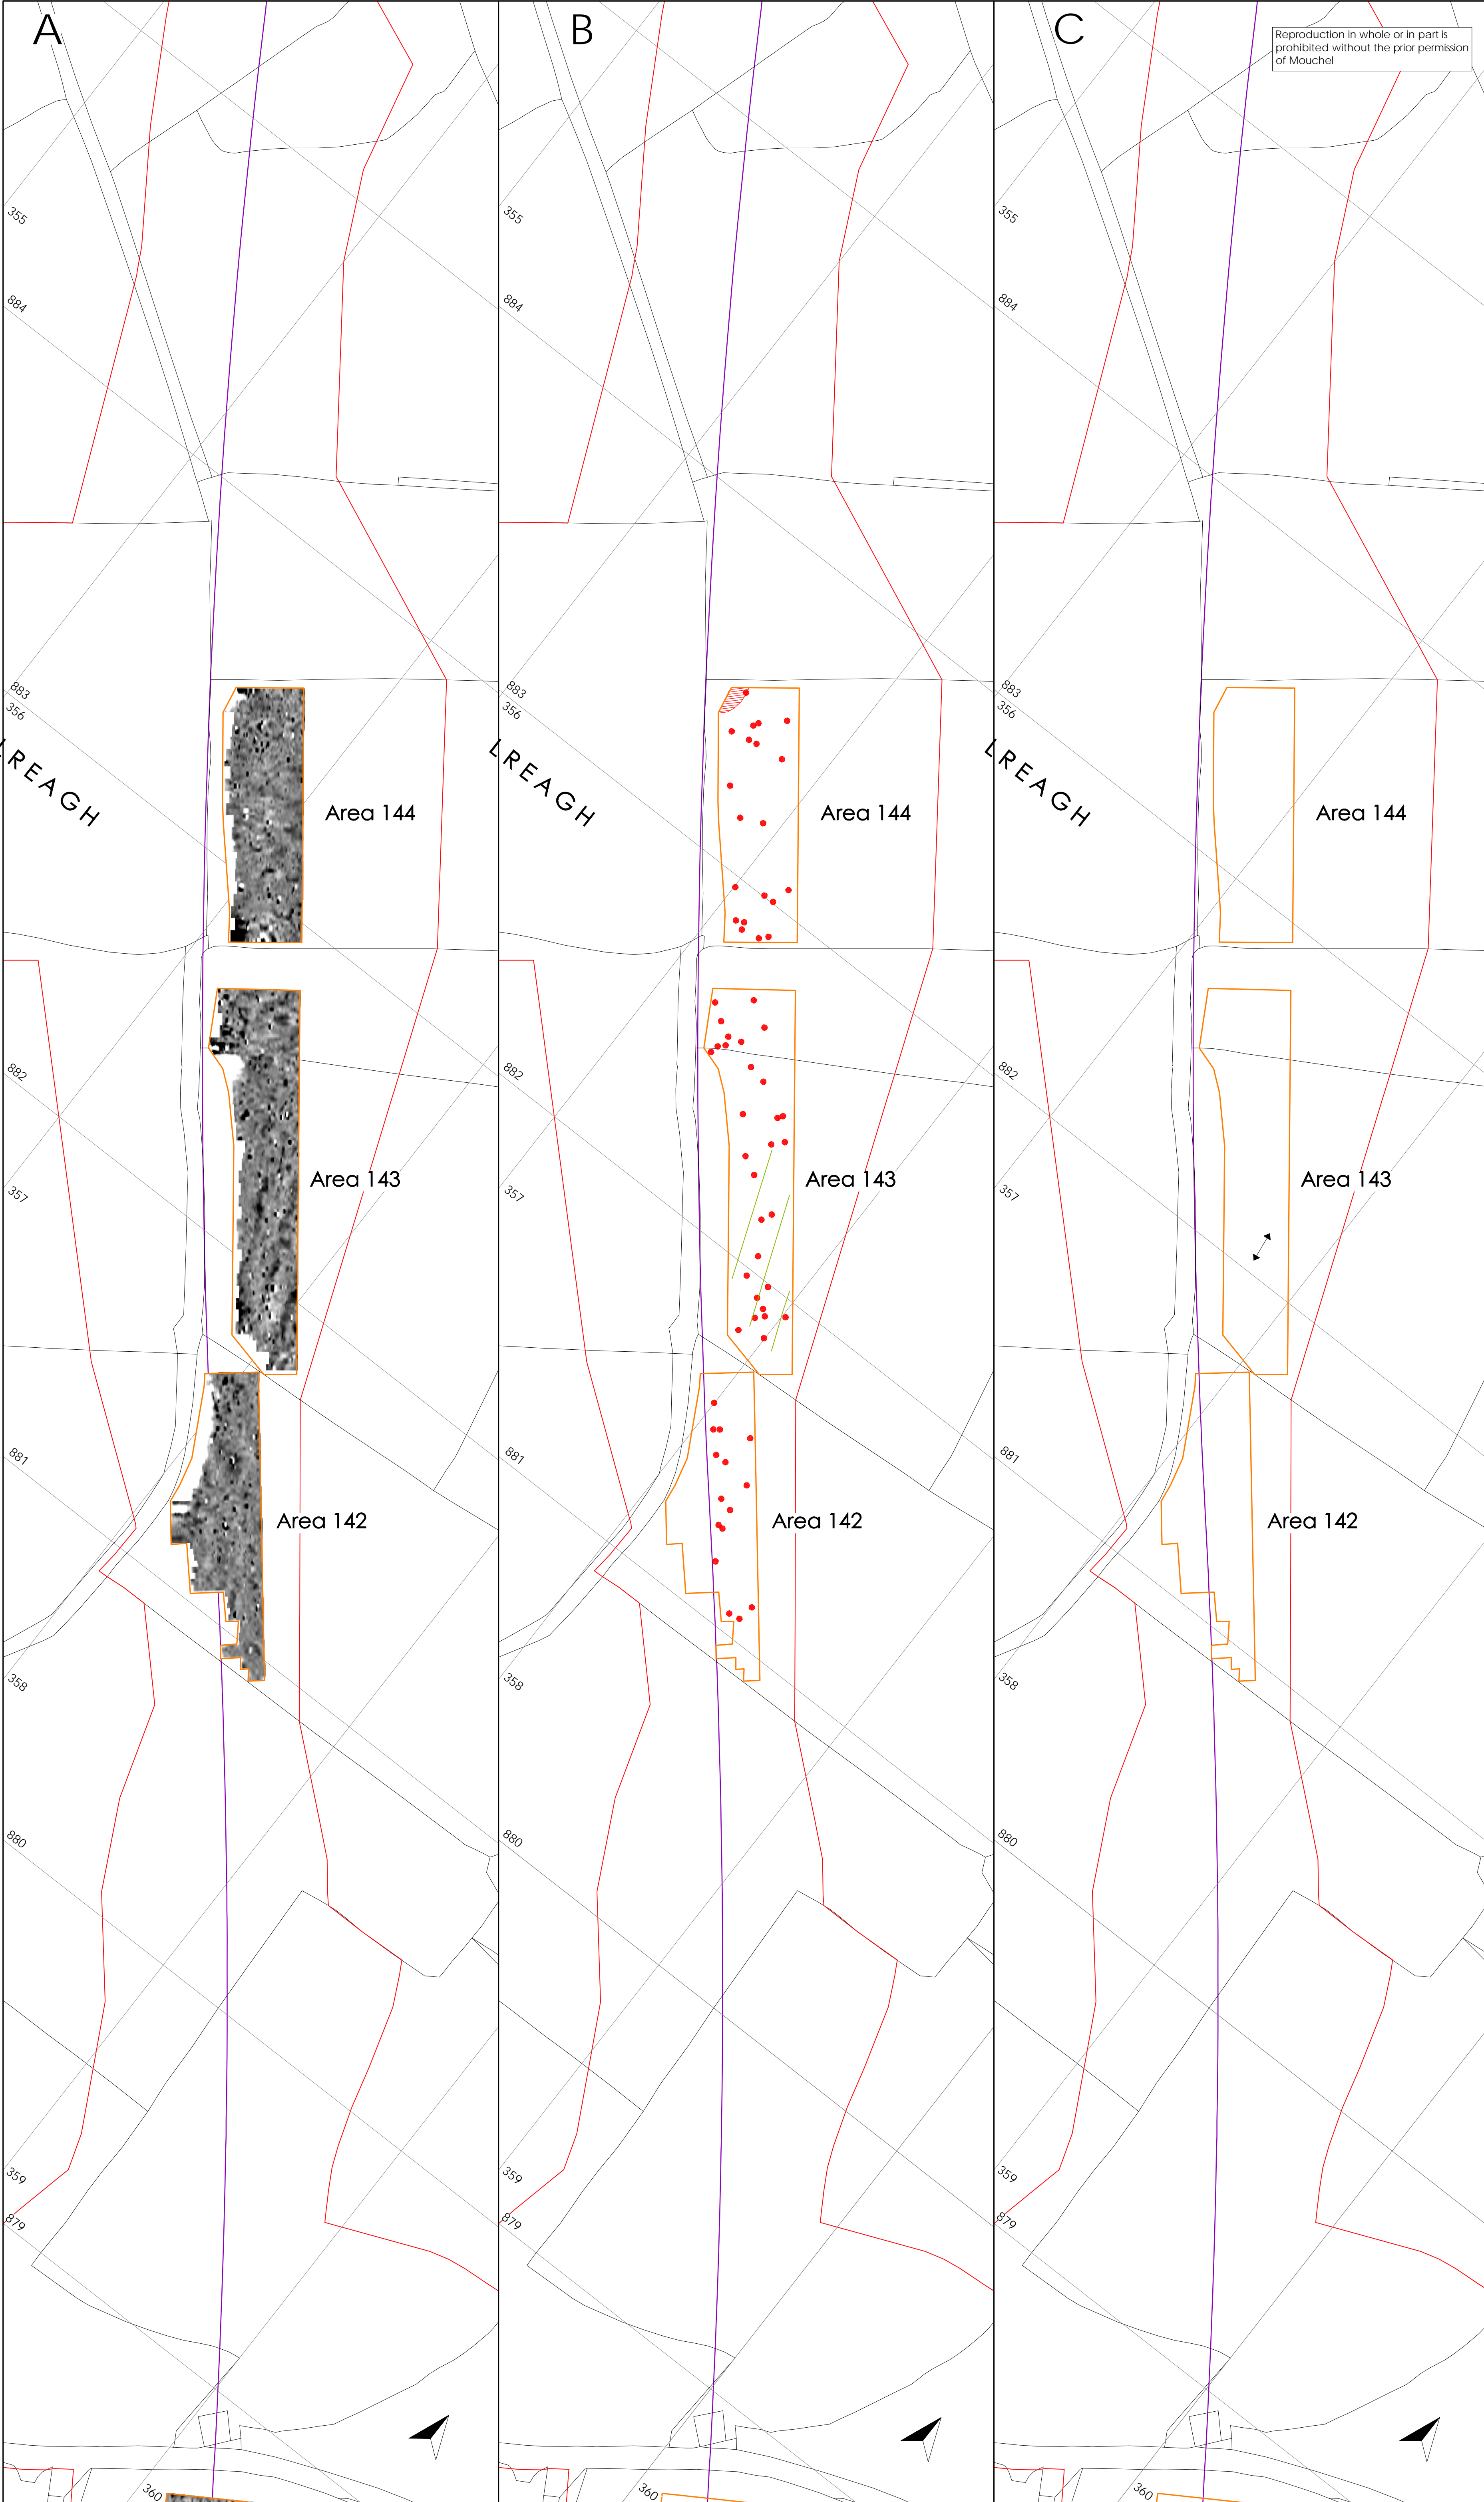
geophysical survey - section 2
report 2746
Figure 33: Areas 46 and 132 geophysical
survey and interpretations

- A - geophysical survey
 - magnetic survey
- B - geophysical interpretation
 - dipolar magnetic anomaly
- C - archaeological interpretation
 - former plough

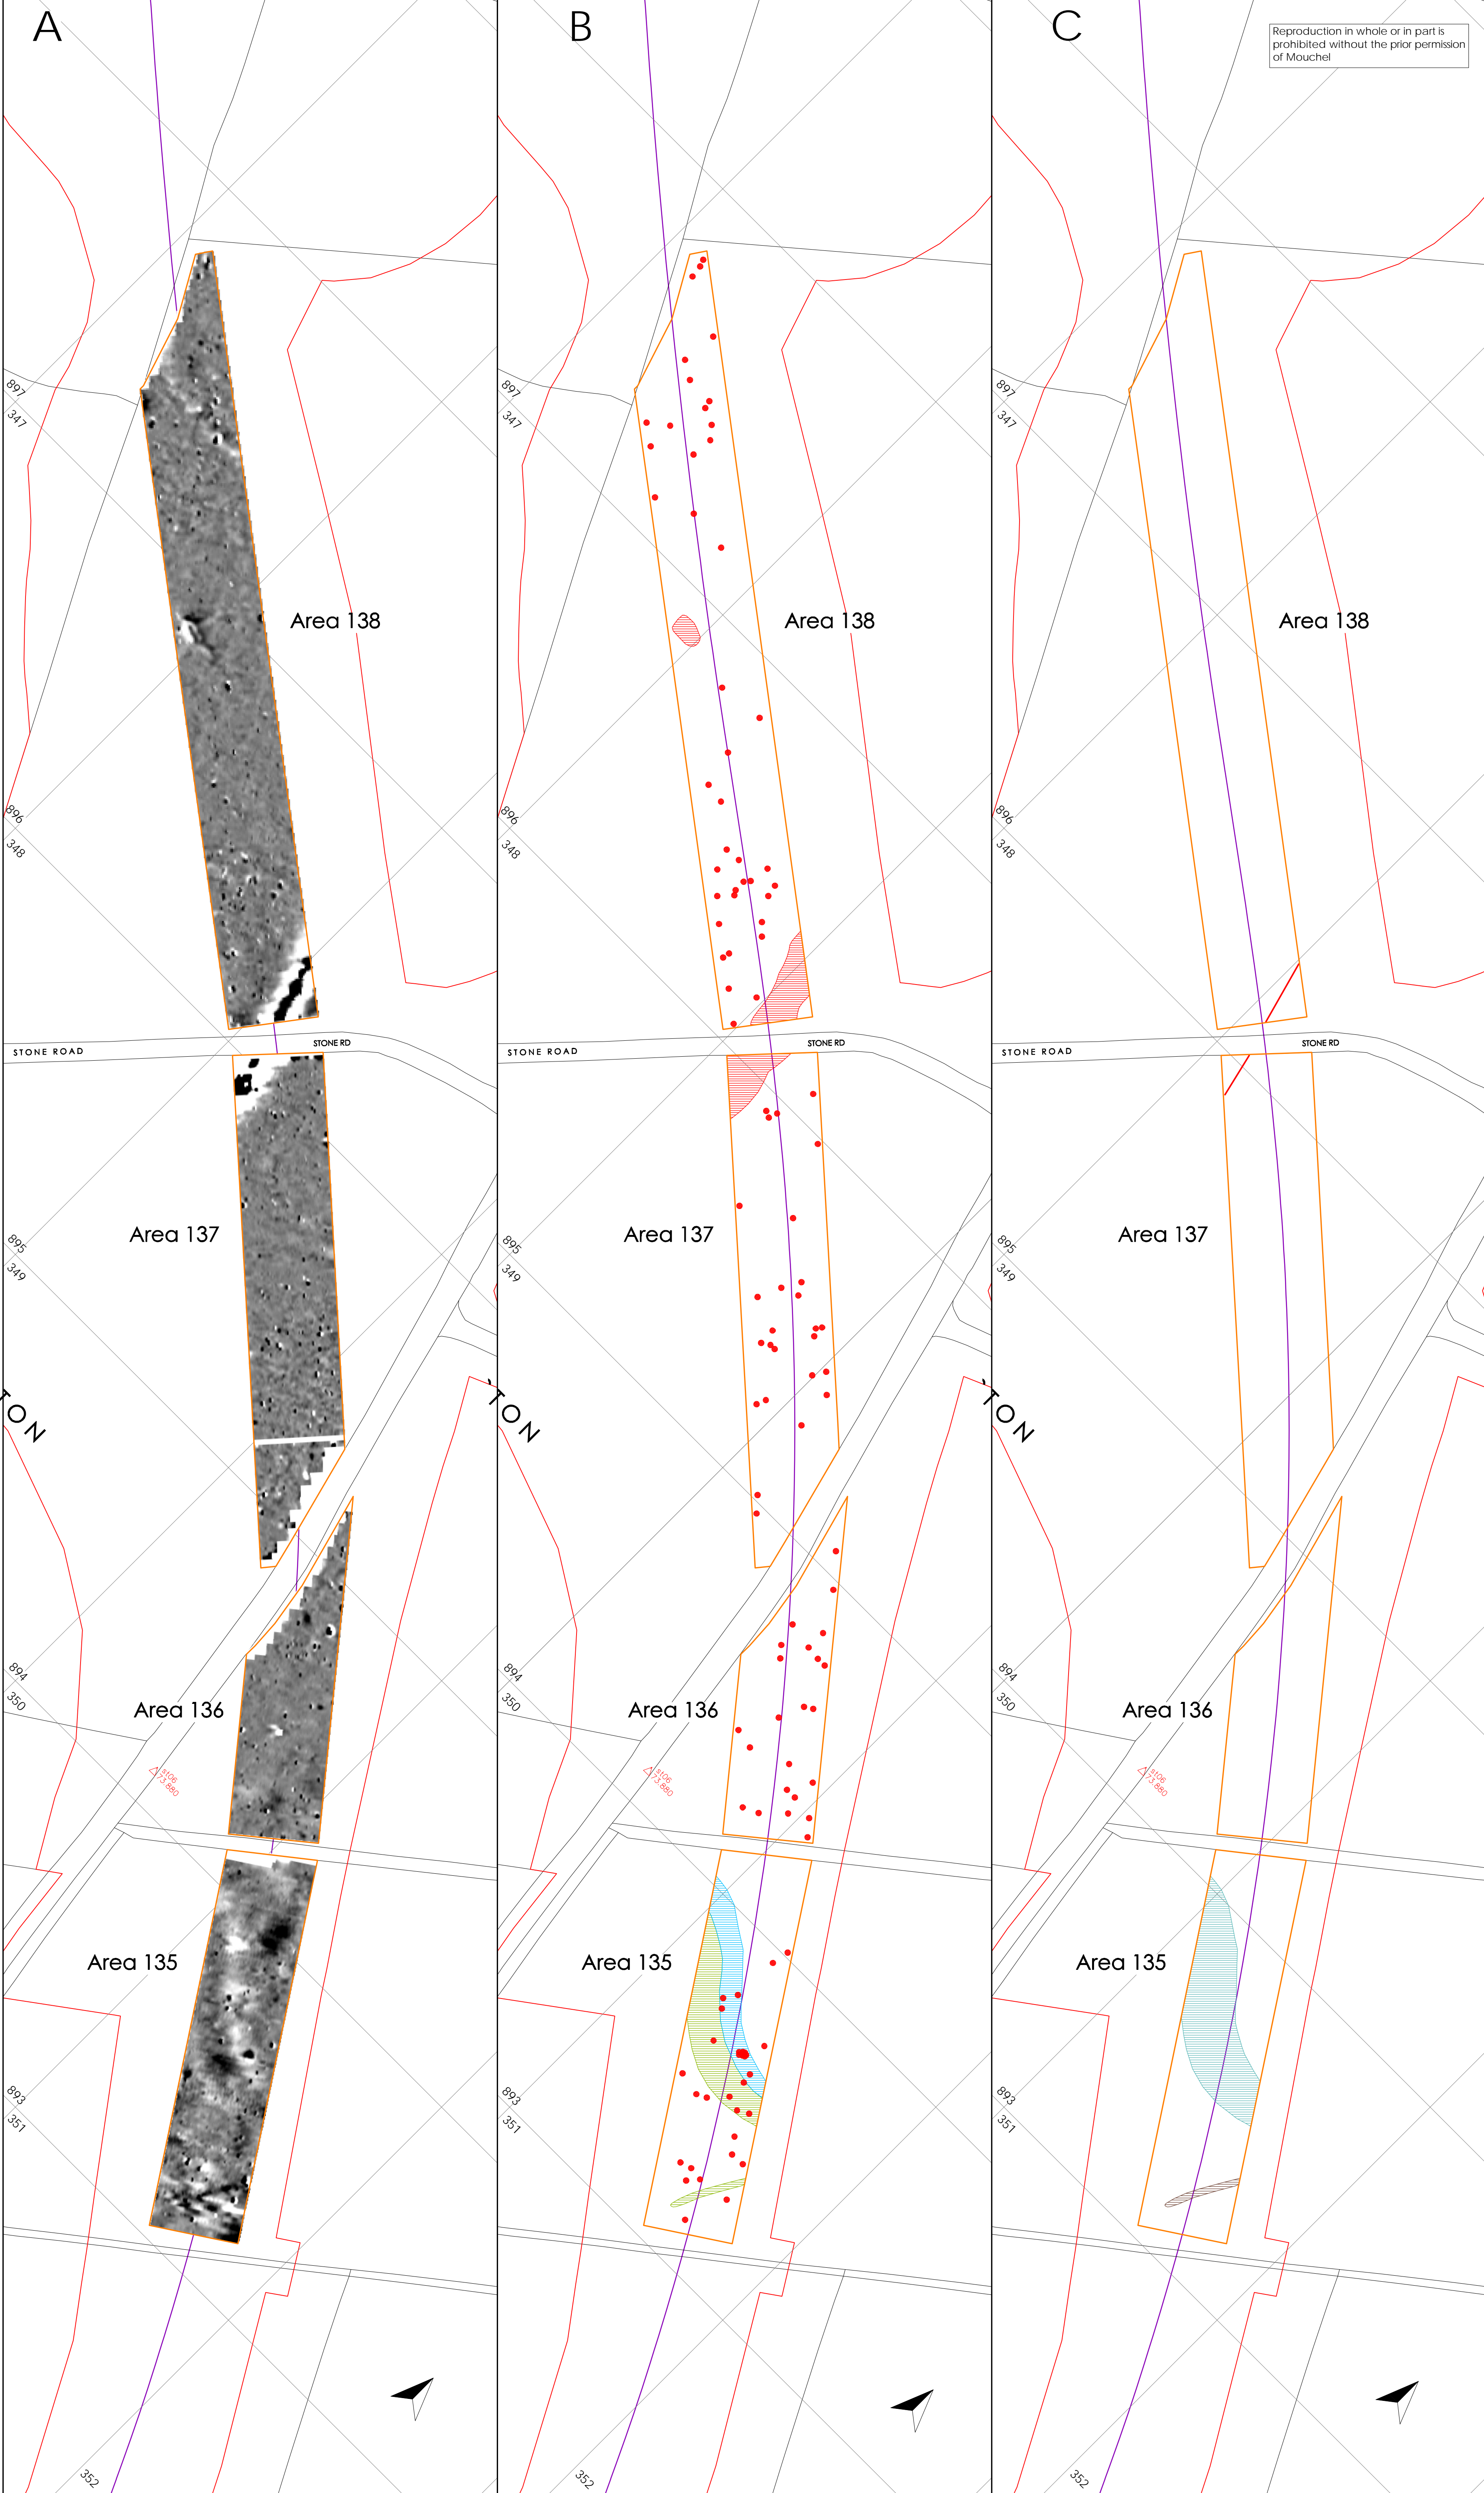
- A - geophysical survey
 - magnetic survey
 - road centreline
 - vesting line
- B - geophysical interpretation
 - dipolar magnetic anomaly
 - positive magnetic anomaly
 - negative magnetic anomaly
- C - archaeological interpretation
 - soil-filled feature
 - geological feature
 - service pipe
