A5 WTC
Western Transport Corridor

Section 2
A5 Western Transport Corridor
Northern Ireland

geophysical survey

report 2746, volume II
January 2012

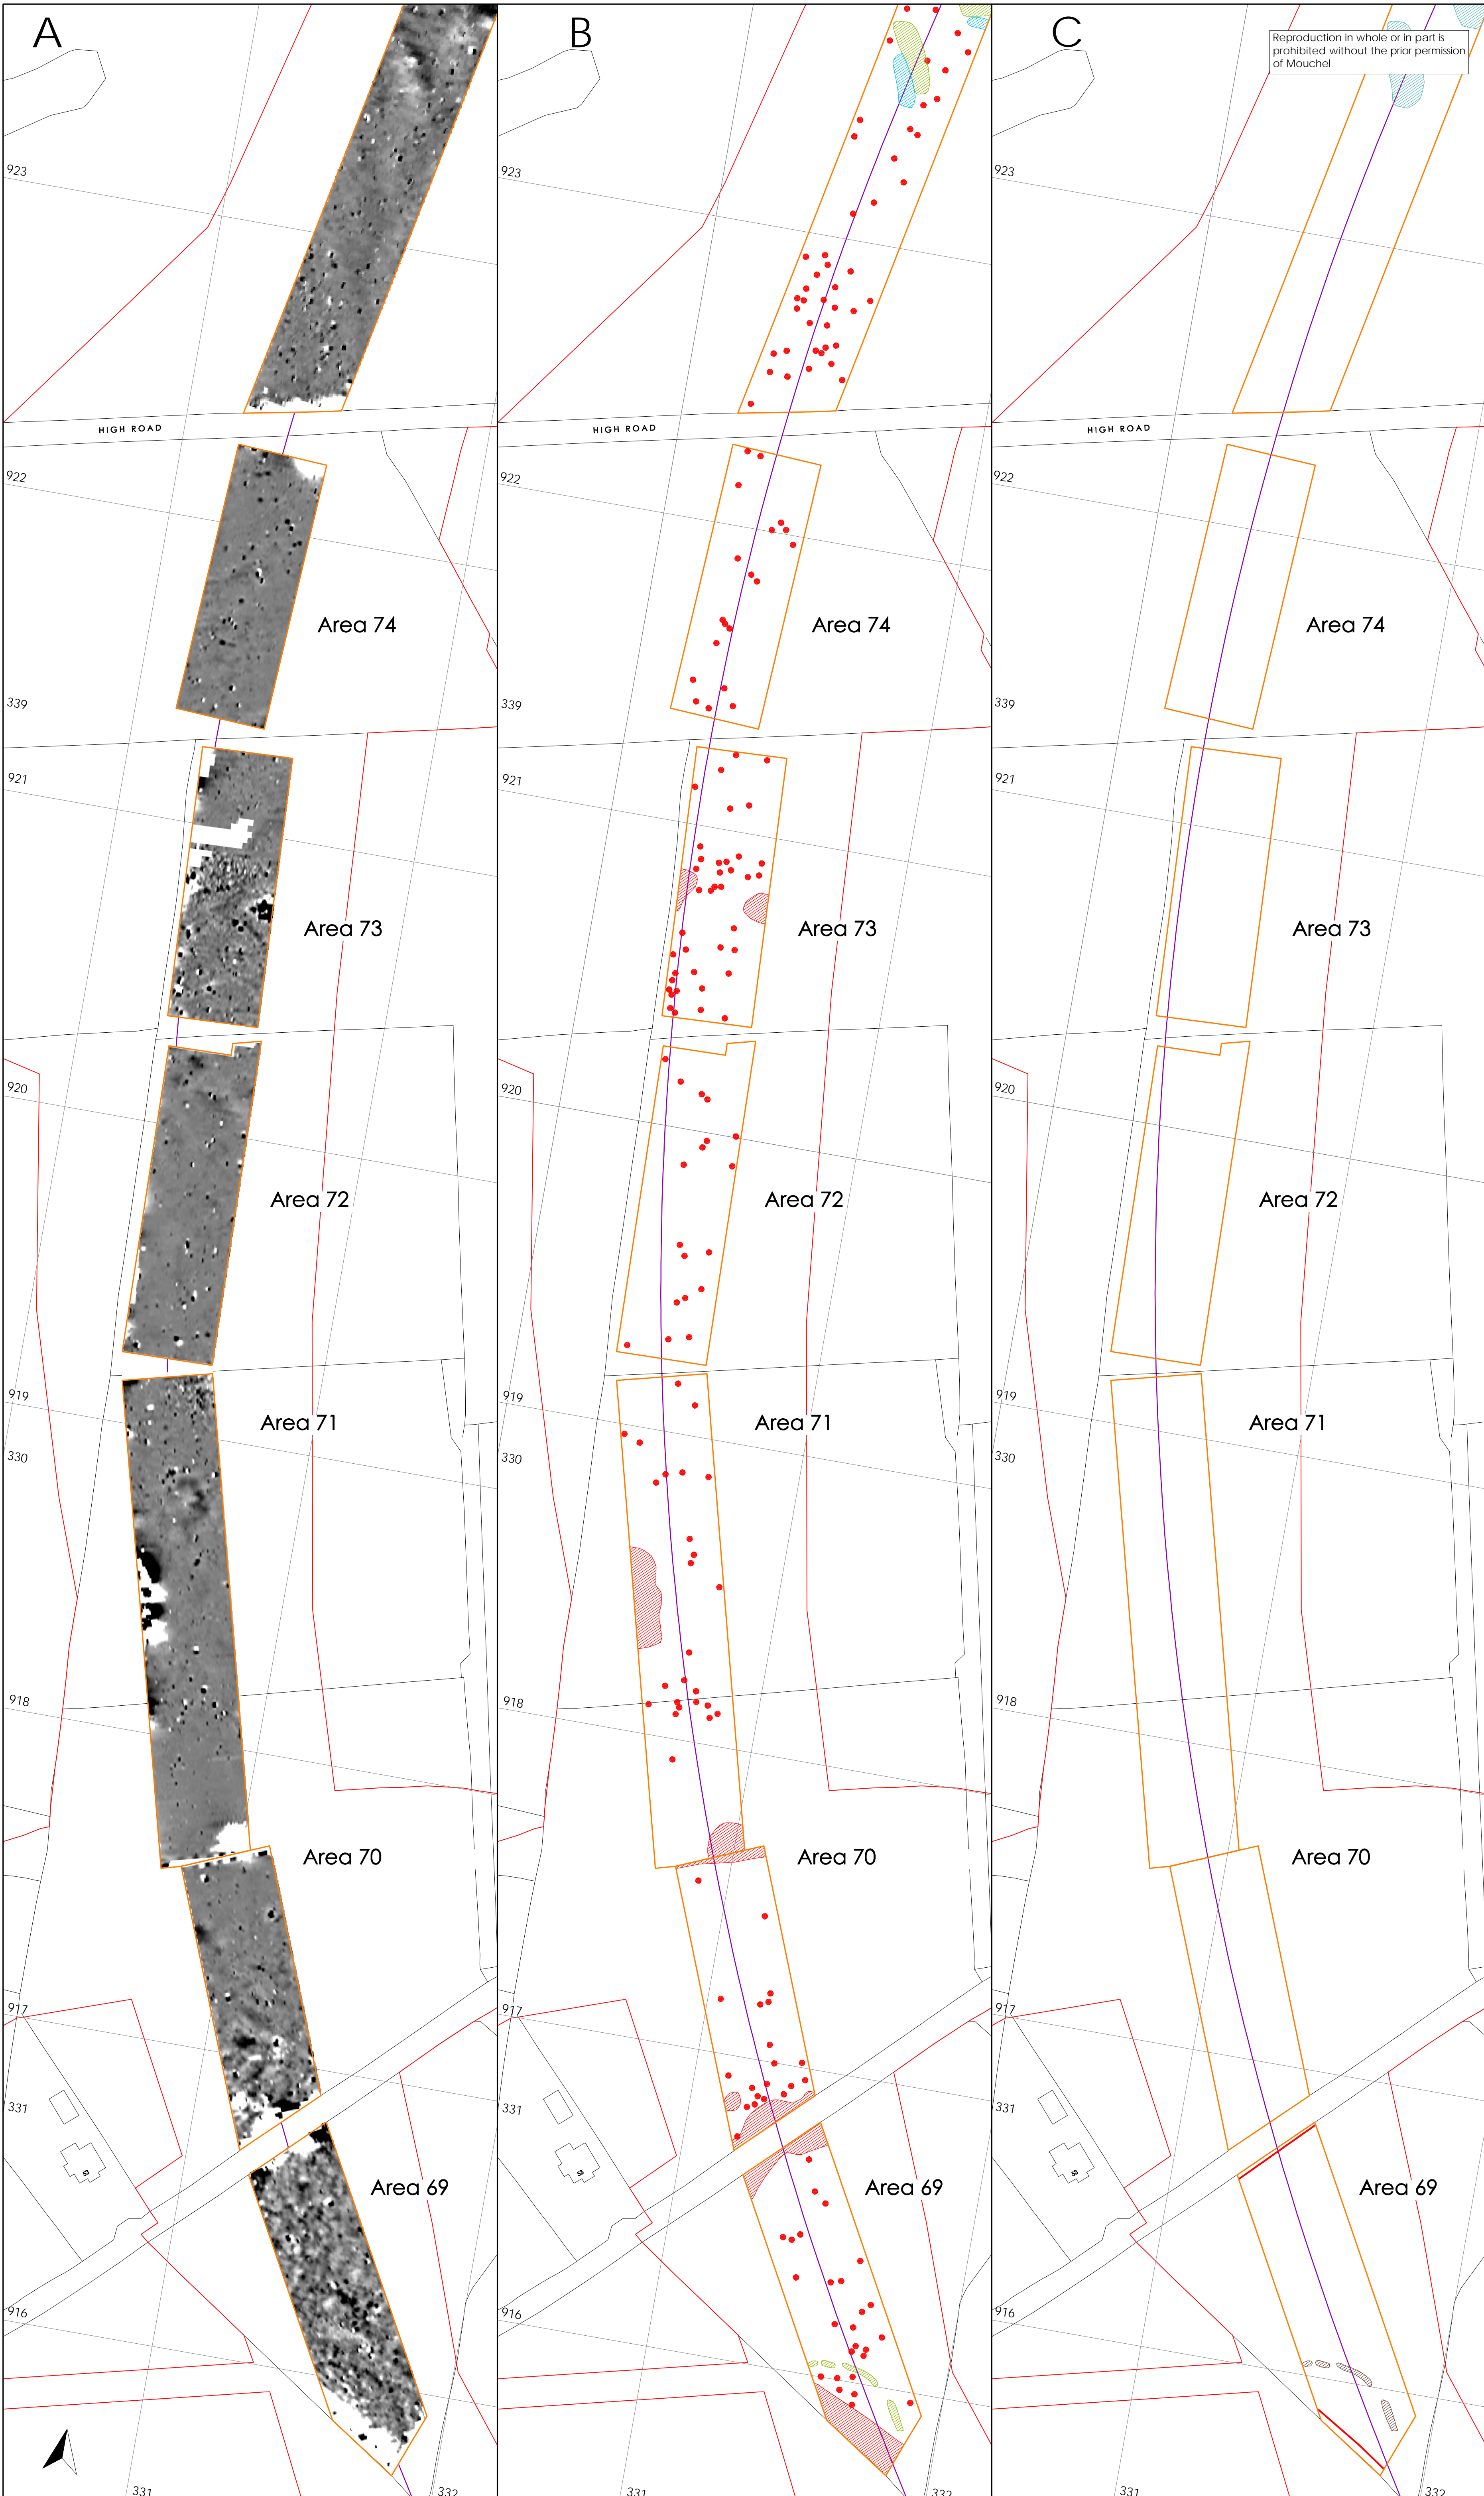
A5 Western Transport Corridor
 Northern Ireland
 geophysical survey - section 2
 report 2746
 Figure 39: Area 139 geophysical survey
 and interpretations

- A - geophysical survey
- magnetic survey
 - road centreline
 - vesting line
- B - geophysical interpretation
- dipolar magnetic anomaly
 - positive magnetic anomaly
 - negative magnetic anomaly
- C - archaeological interpretation
- soil-filled feature
 - service pipe

- 6.17 One survey in this section was extended by the survey team (Area 139; Figure 39). A mound in the southern part of this field occupied slightly higher ground within a bend of a small tributary of the Mourne River. Since the mound was considered to be of potential archaeological interest, possibly even a rath, the survey area was extended to encompass the mound. An anomalous oval area has been identified in the survey, comprising a concentration of many small, strong anomalies. These anomalies could reflect a deliberate concentration of stone here, as opposed to the broad underlying geological variation. Small positive magnetic anomalies here could possibly reflect additional features within the mound.

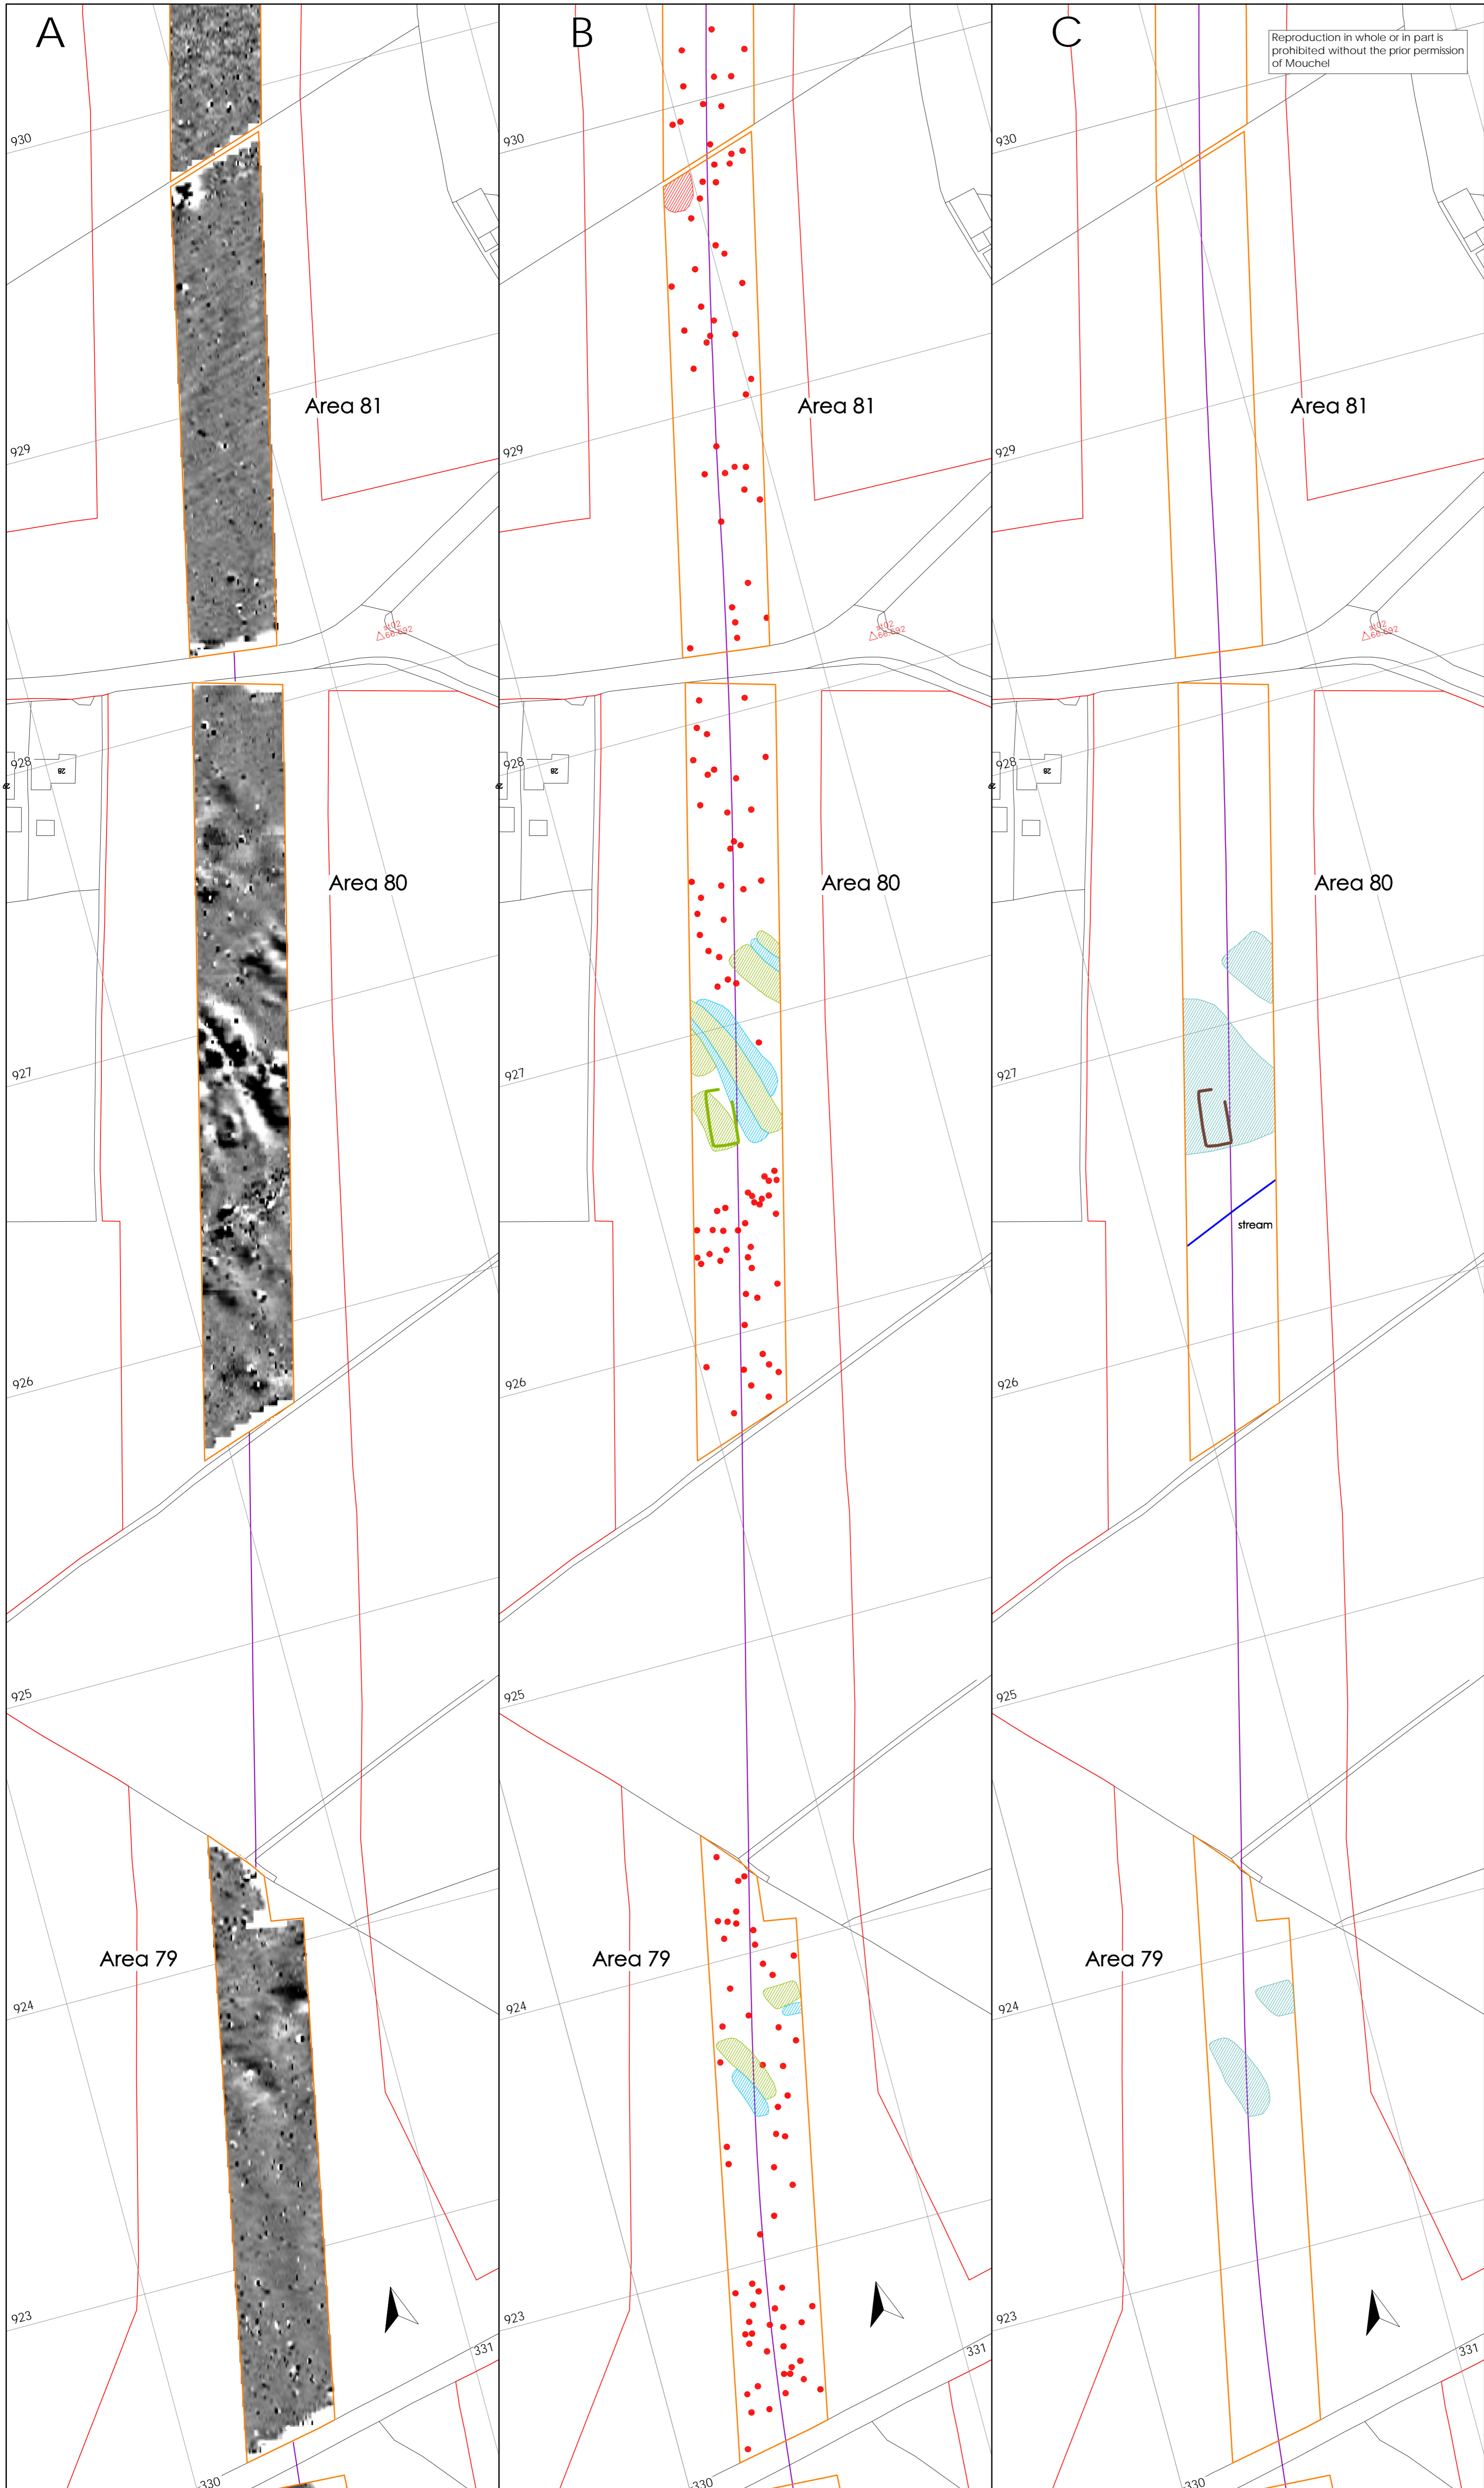
Figure 40: Areas 69, 70, 71, 72, 73 and 74
geophysical survey and interpretations

- A - geophysical survey
- magnetic survey
 - nT
 - road centreline
 - vesting line
- B - geophysical interpretation
- dipolar magnetic anomaly
 - positive magnetic anomaly
 - negative magnetic anomaly
- C - archaeological interpretation
- geological feature
 - soil-filled feature
 - former plough
