Victorian Murray Floodplain Restoration Project

Flora and Fauna Assessment - Hattah Lakes North Floodplain Restoration Project

IS297772-AP-EN-RP-001 | 0

Lower Murray Urban and Rural Water Corporation

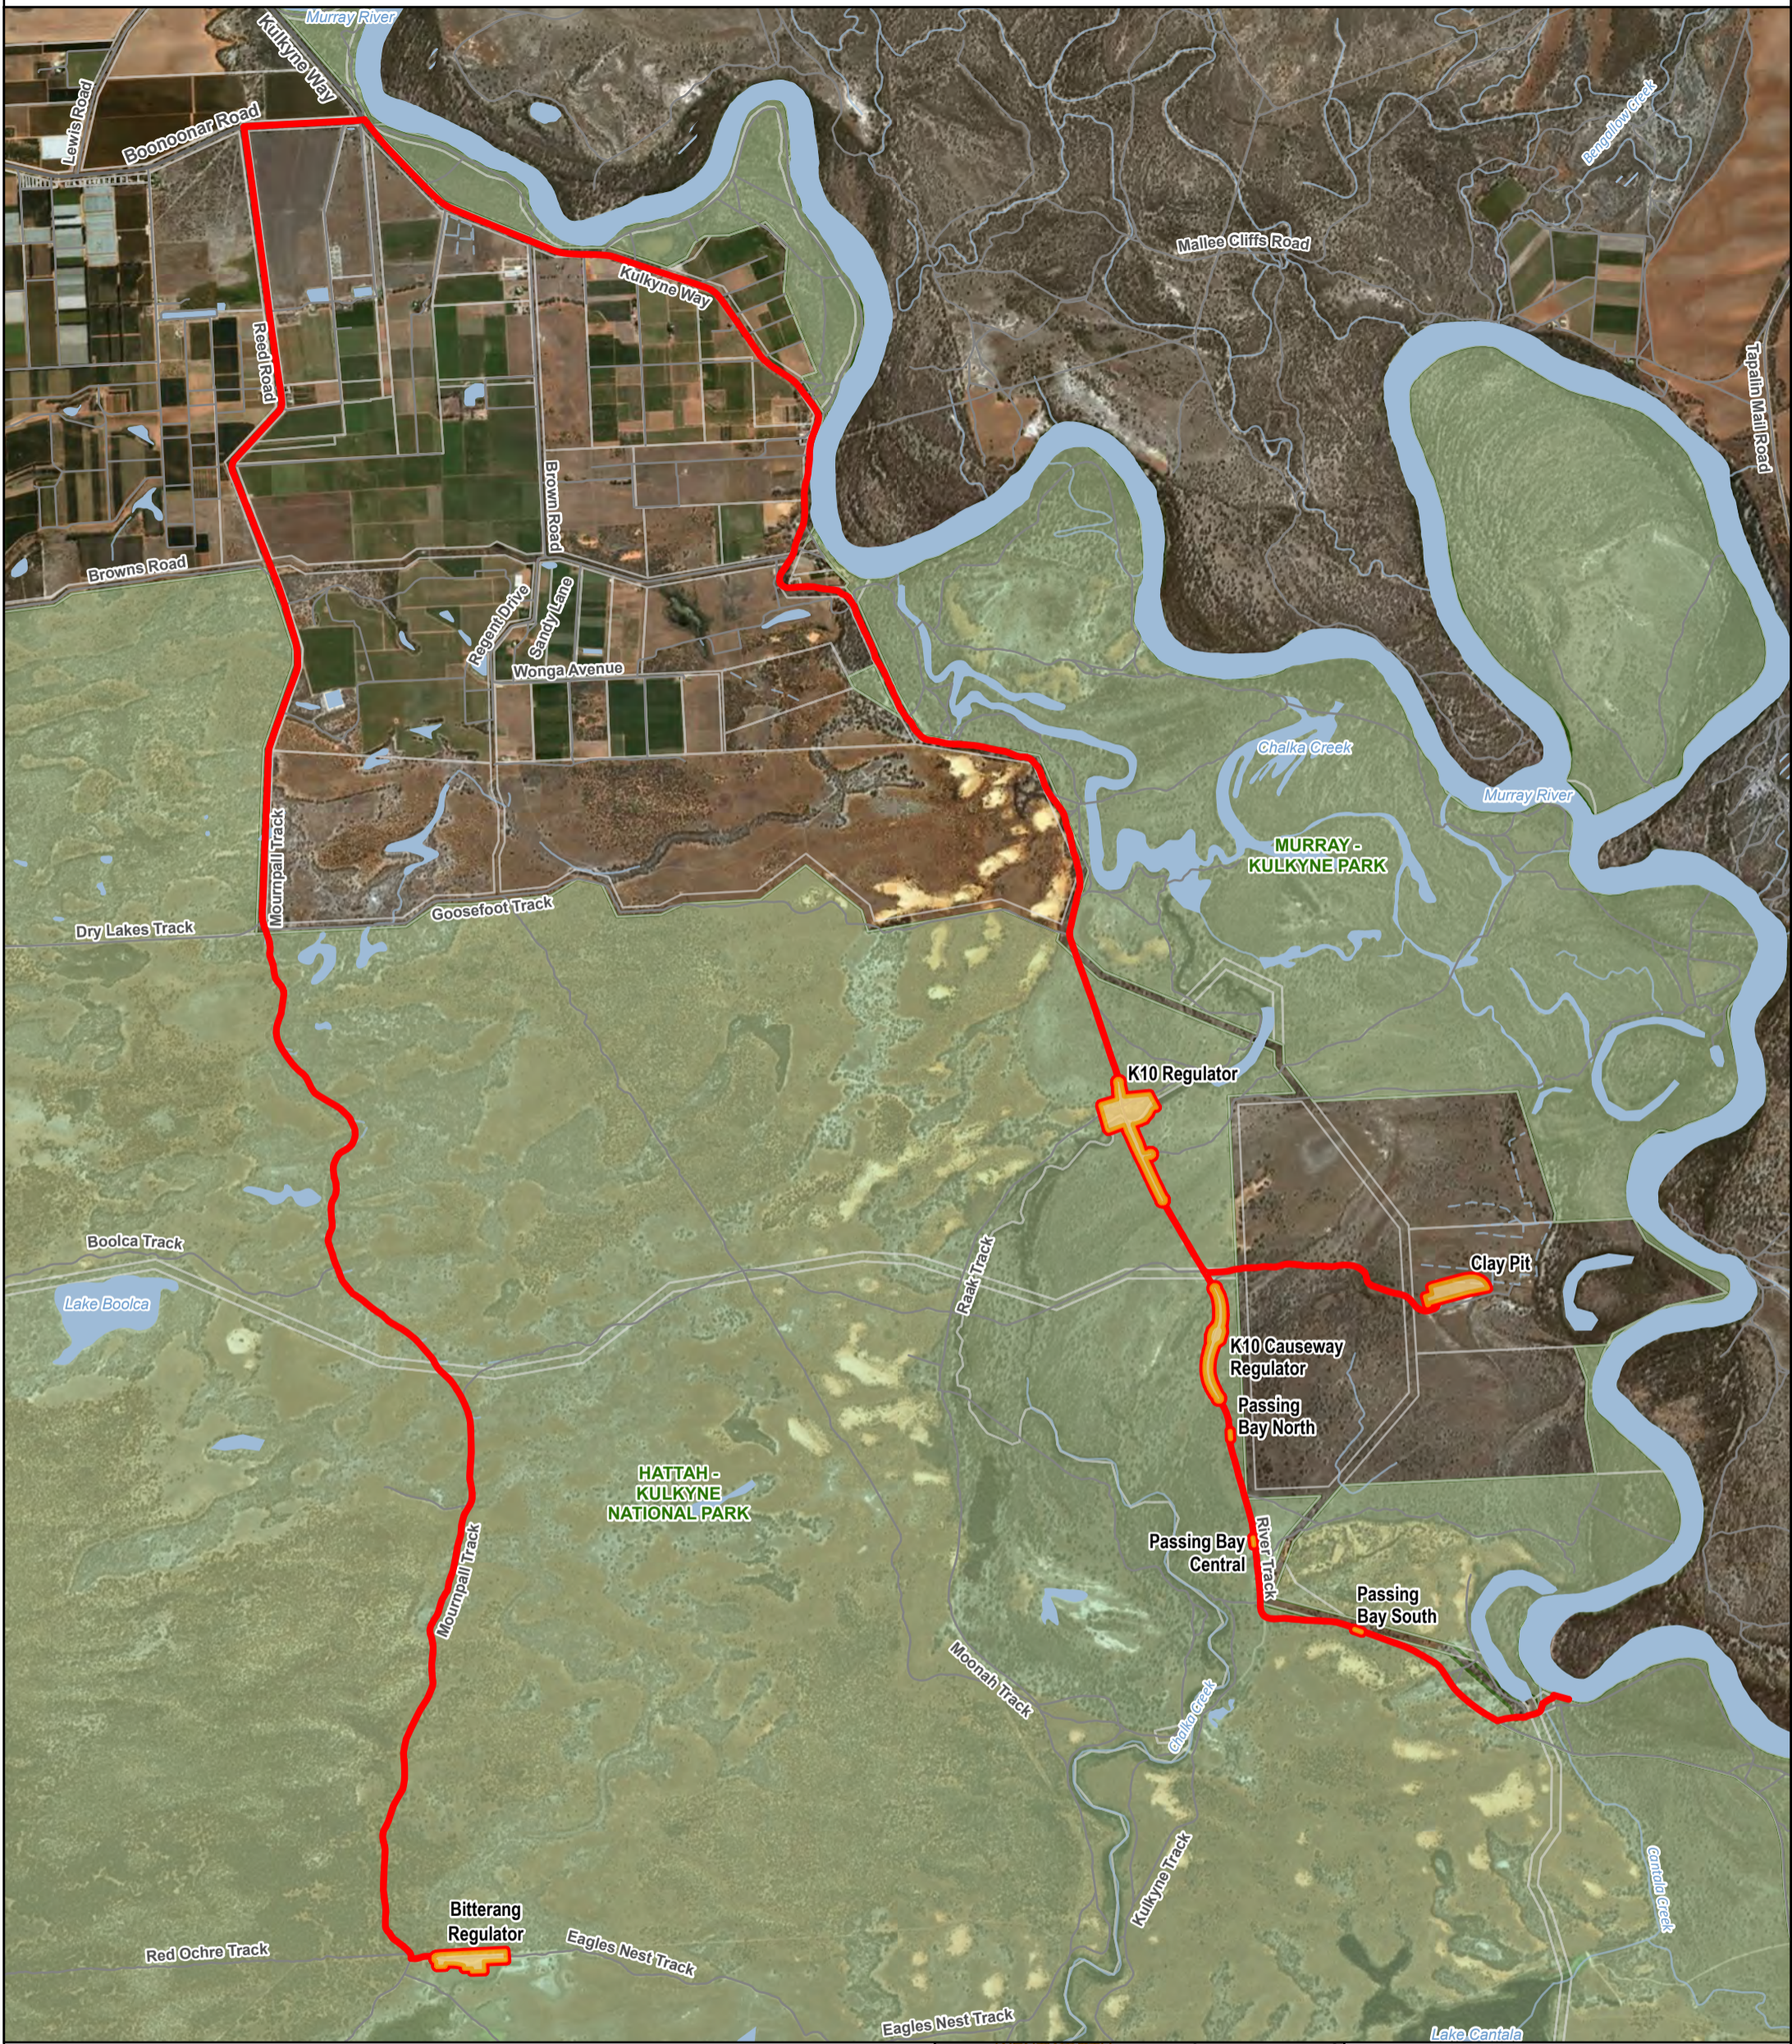
FIGURE 1: Construction footprint at Hattah North

The location of the proposed construction areas (K10 Regulator, K10 Causeway Regulator, Bitterang Regulator, Kulkyne Station Claypit, River Track Passing Bays (North, Central, South) is shown in Figure 1. The location of the proposed inundation area is shown in Figure 2. An overview of the proposed construction areas is provided in Table 1.

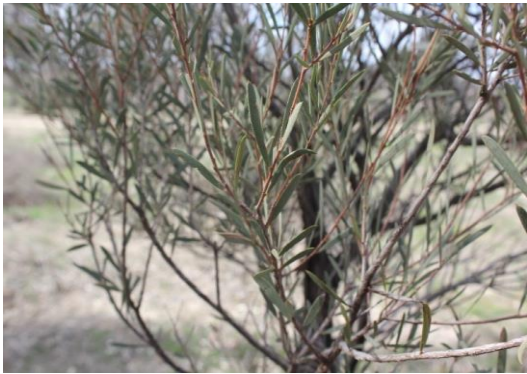
Species Name	Conservation Status	Location(s)	Photo
<i>Acacia oswaldii</i> (Umbrella wattle)	FFG Act – Listed as threatened DELWP Advisory list – vulnerable	K10 regulator x 1 K10 causeway x 1

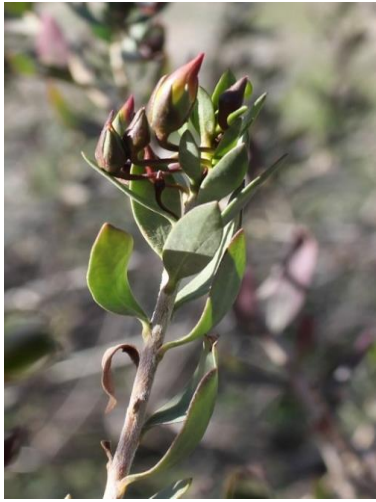
<i>Eremophila maculata</i> subsp. <i>maculata</i> (Spotted Emu-bush)	FFG Act – listed as Threatened DELWP Advisory list – rare	K10 causeway x 1

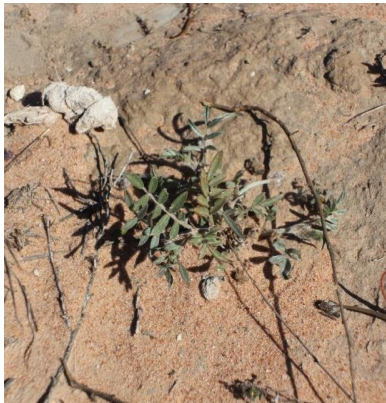
<i>Swainsona phacoides</i> (Dwarf Swainson-pea)	FFG Act – listed as Threatened DELWP Advisory list – endangered	Bitterang regulator and levee x 8
