Victorian Murray Floodplain Restoration Project

Flora and Fauna Assessment - Hattah Lakes North Floodplain Restoration Project

IS297772-AP-EN-RP-001 | 0

Lower Murray Urban and Rural Water Corporation

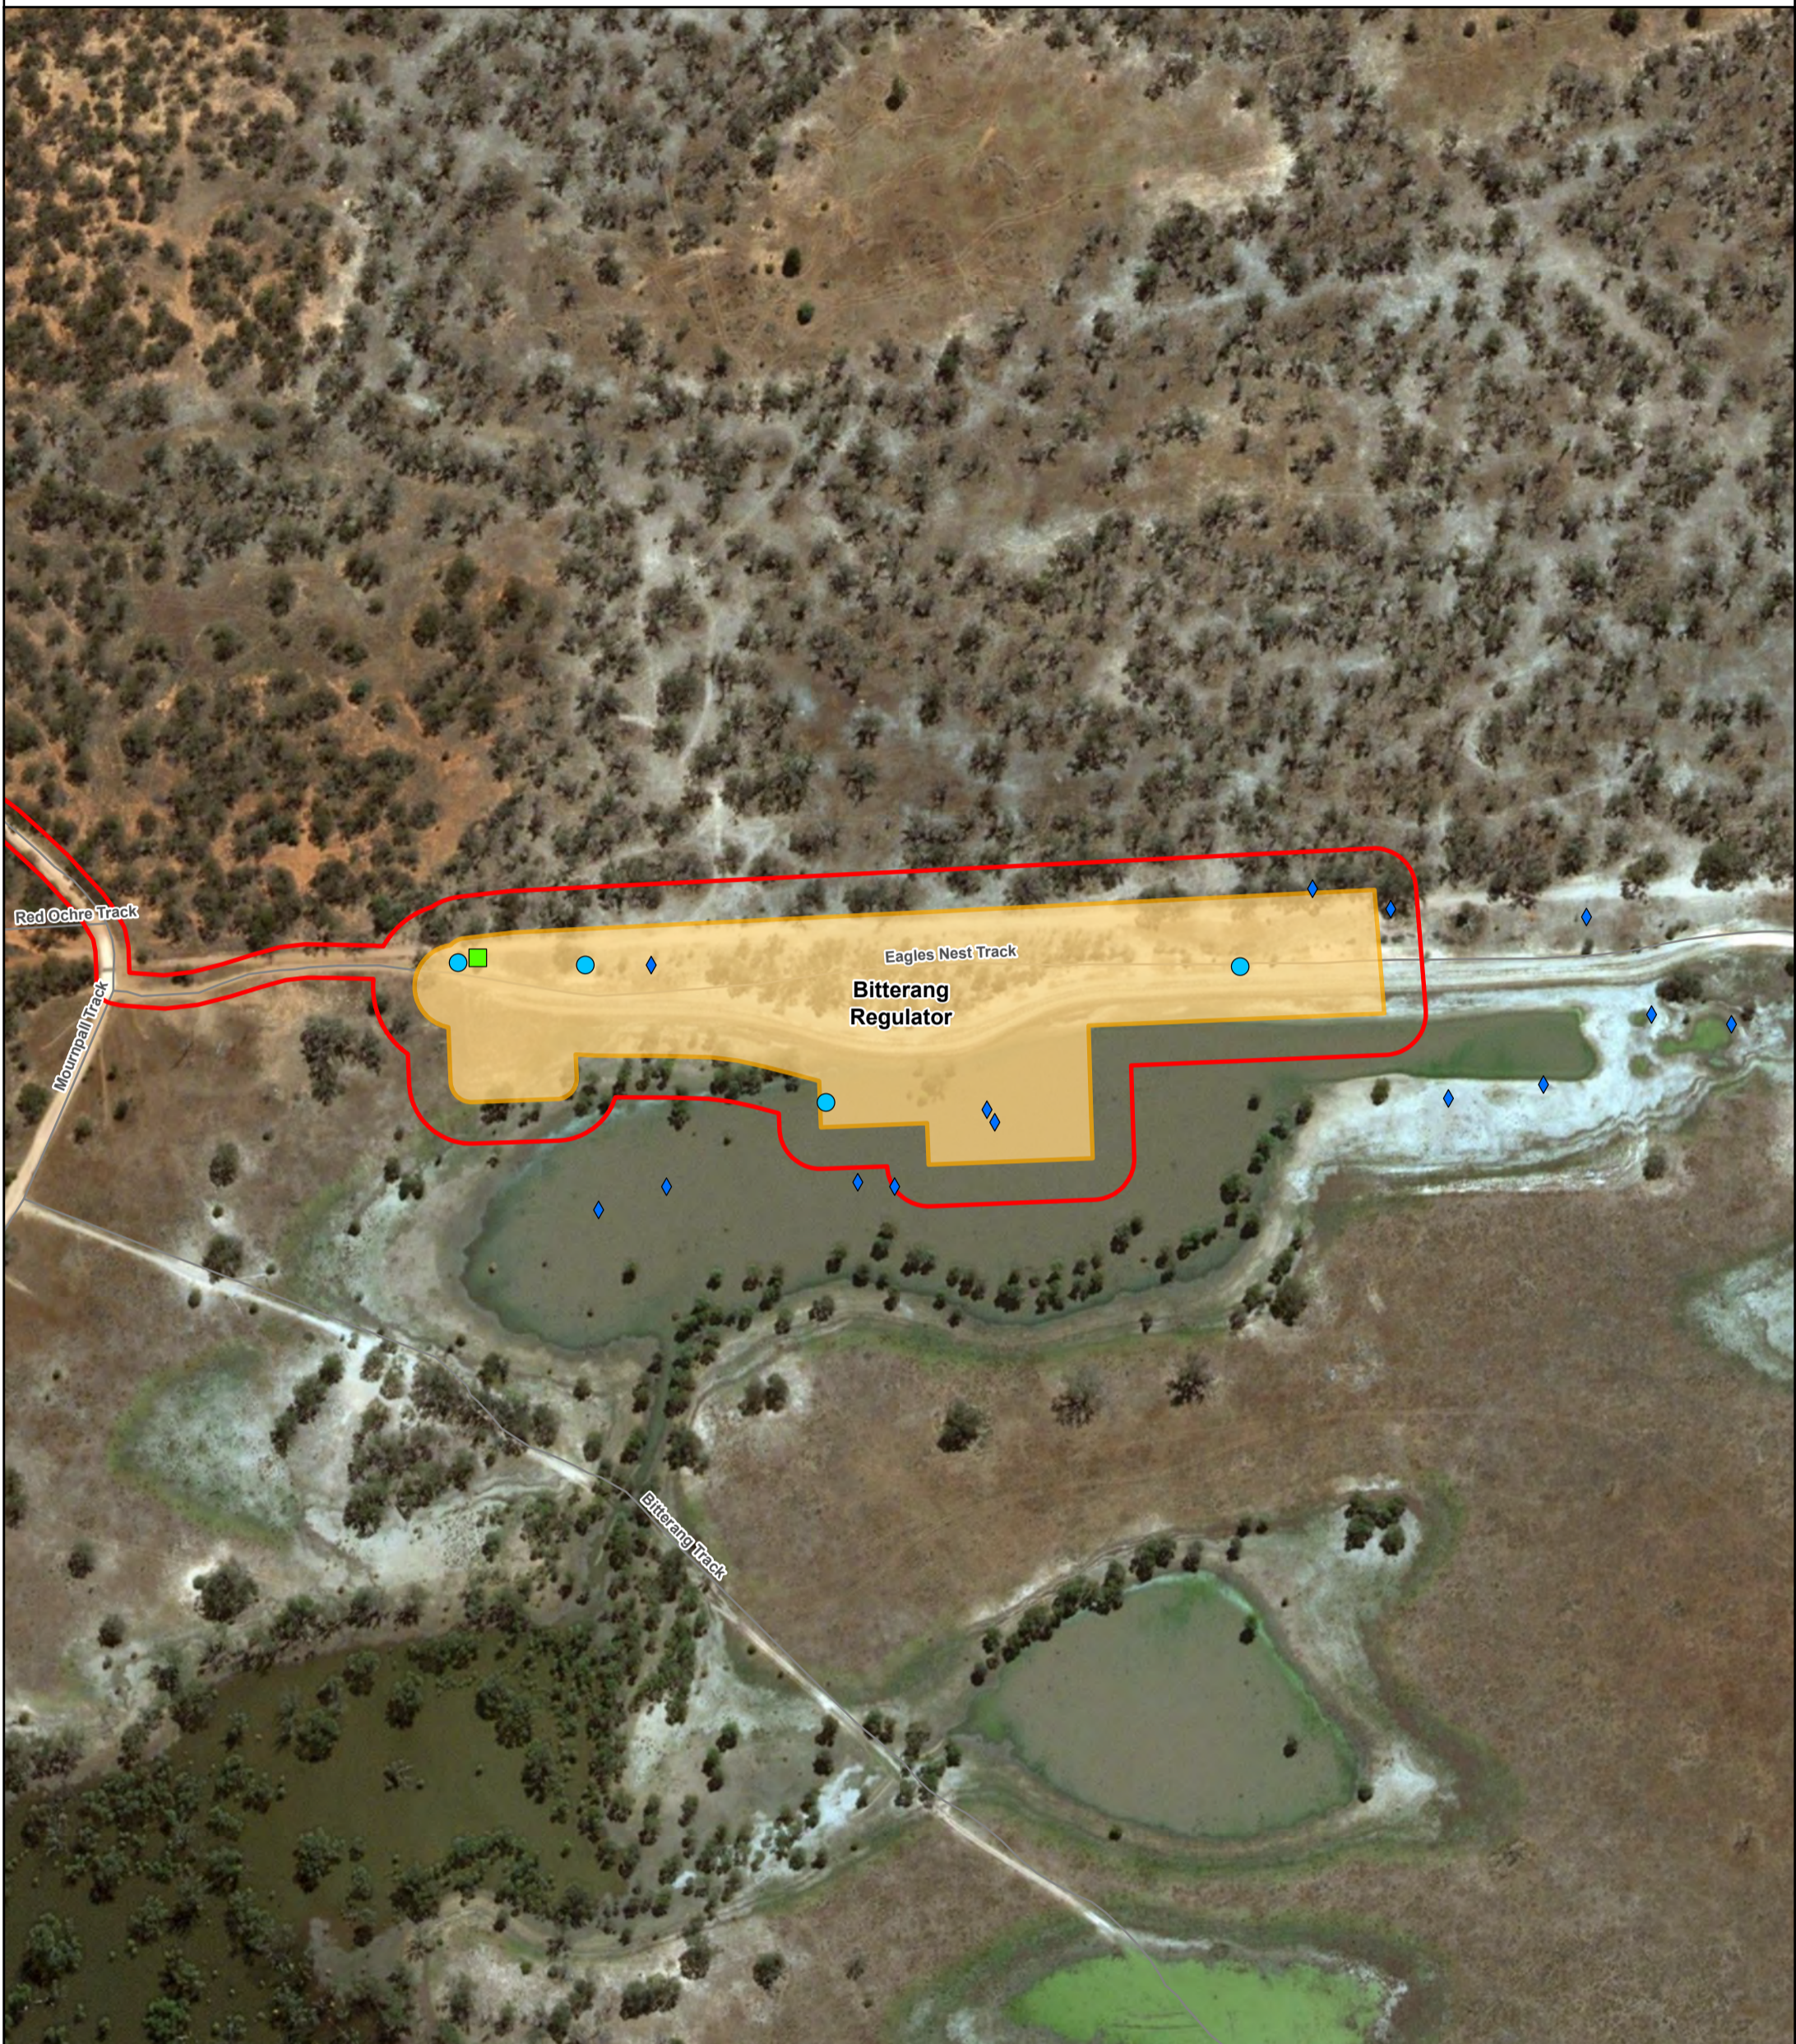
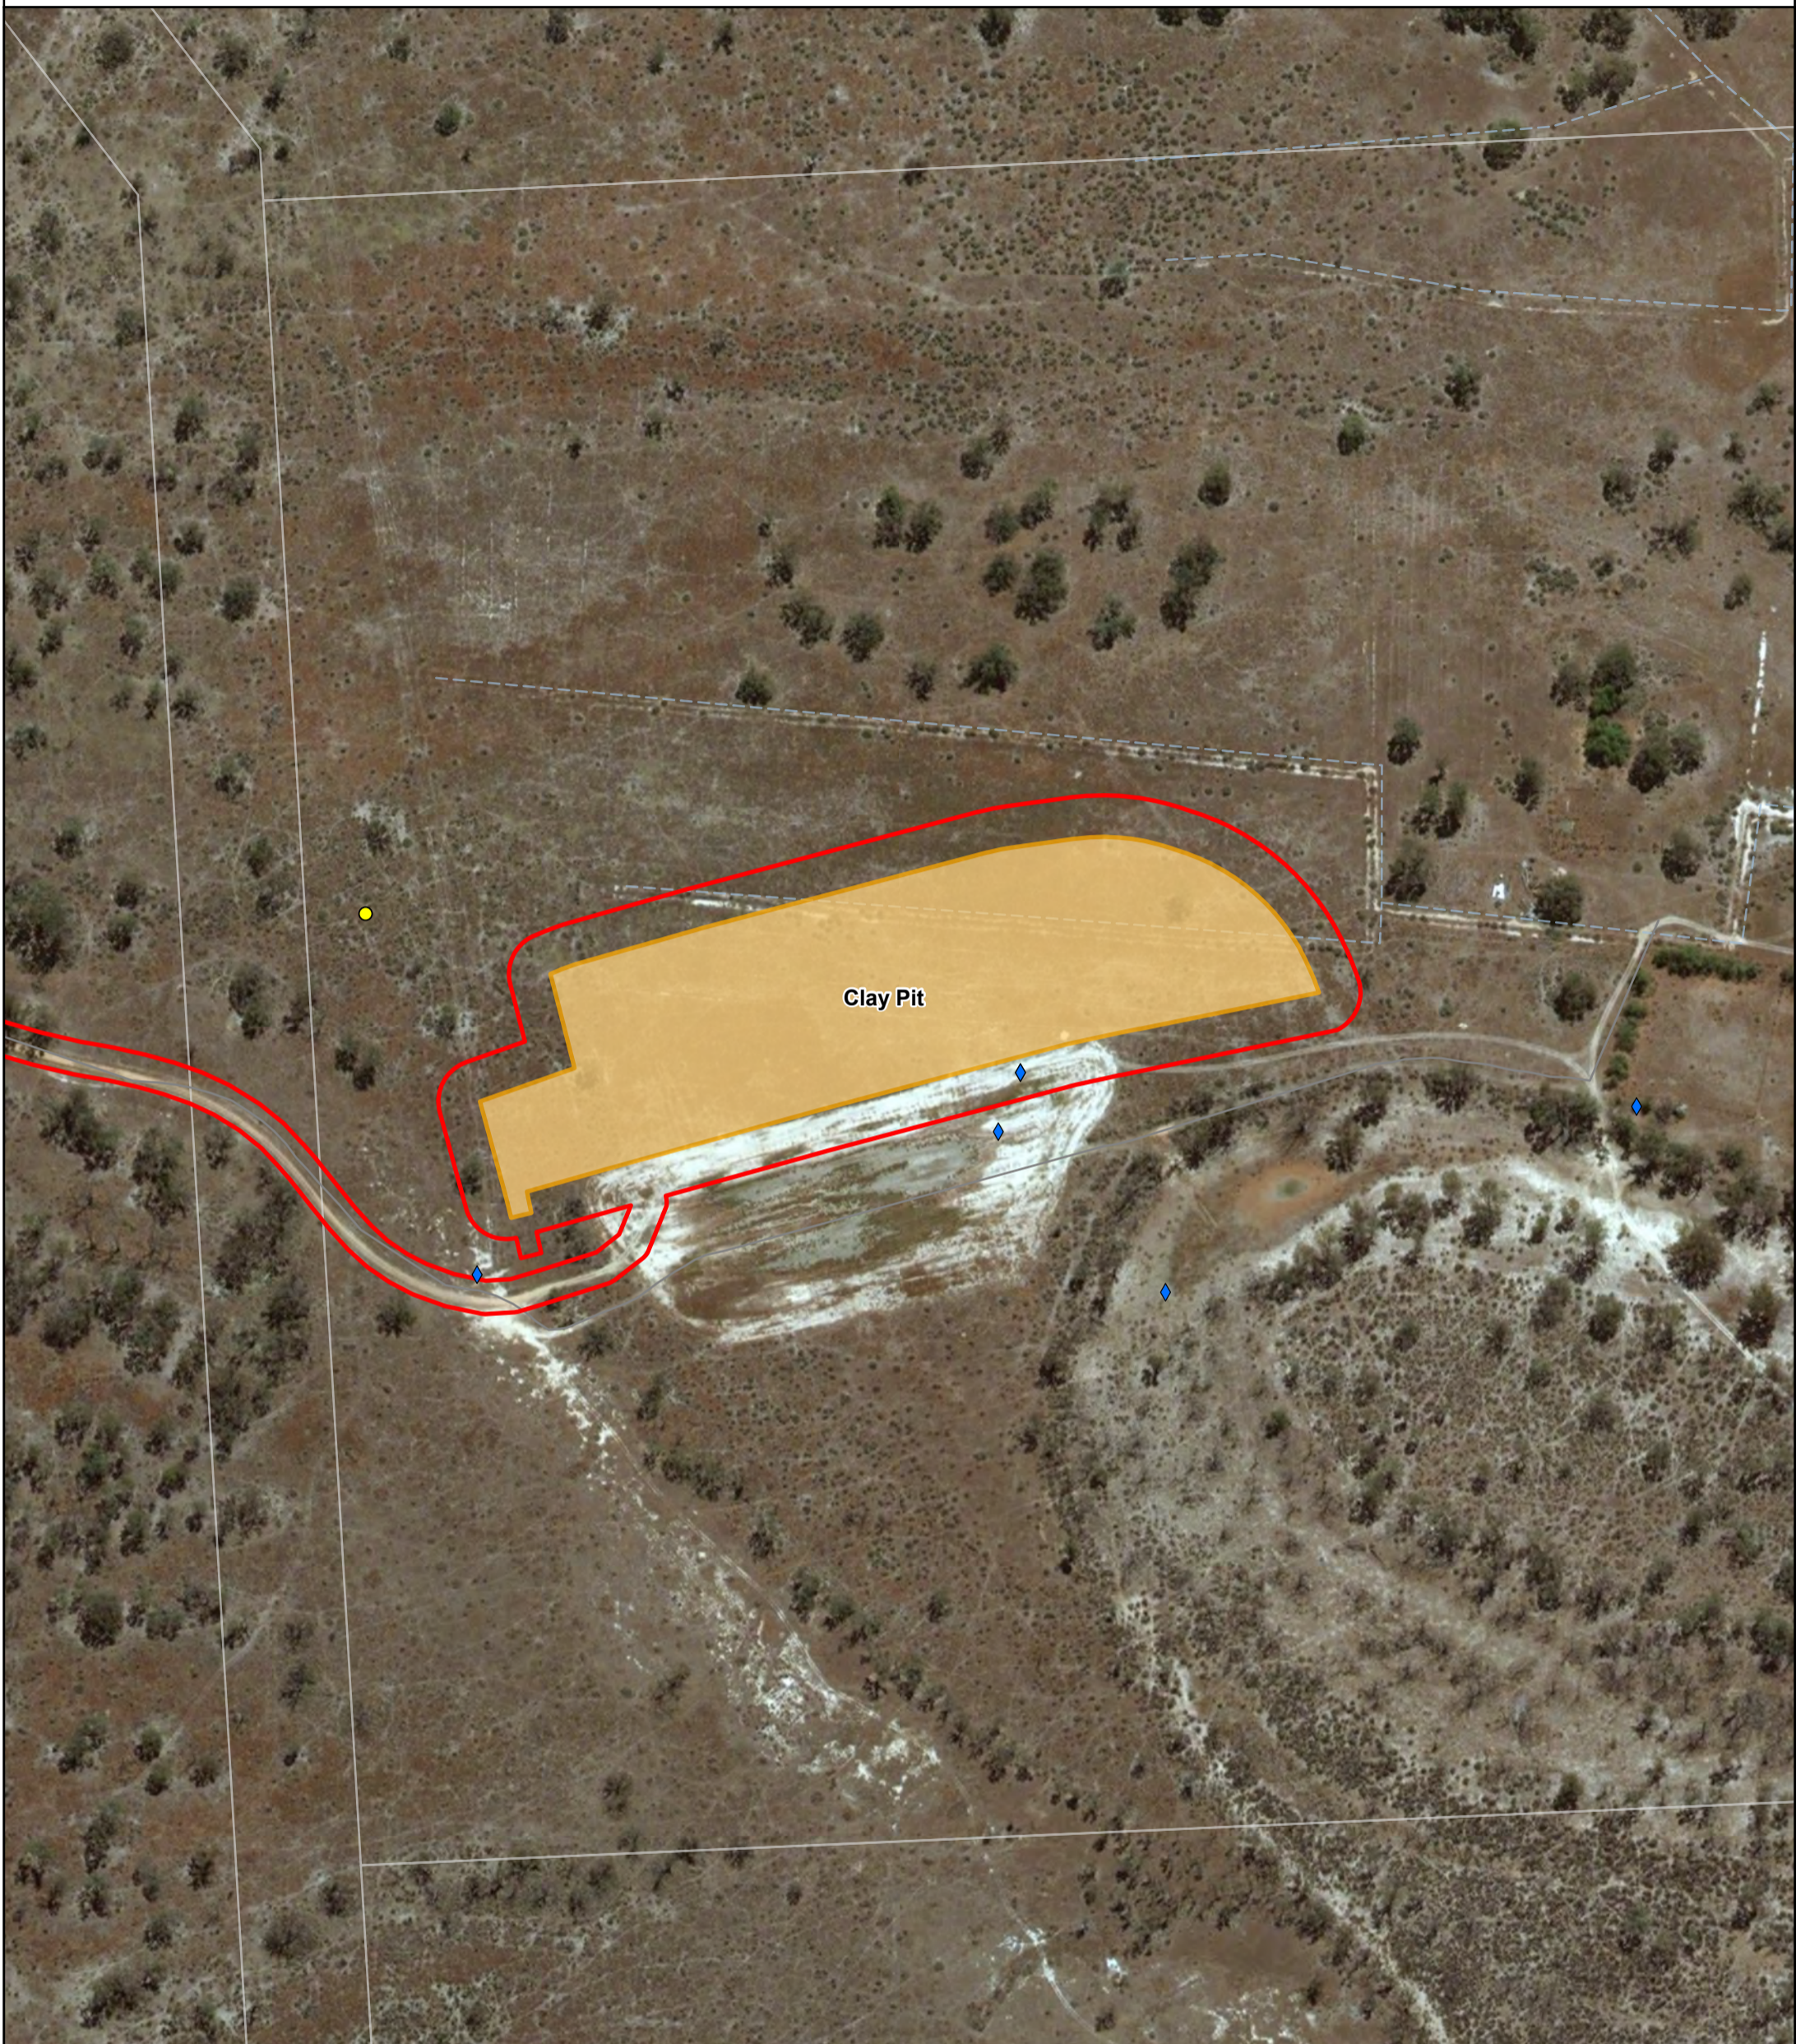
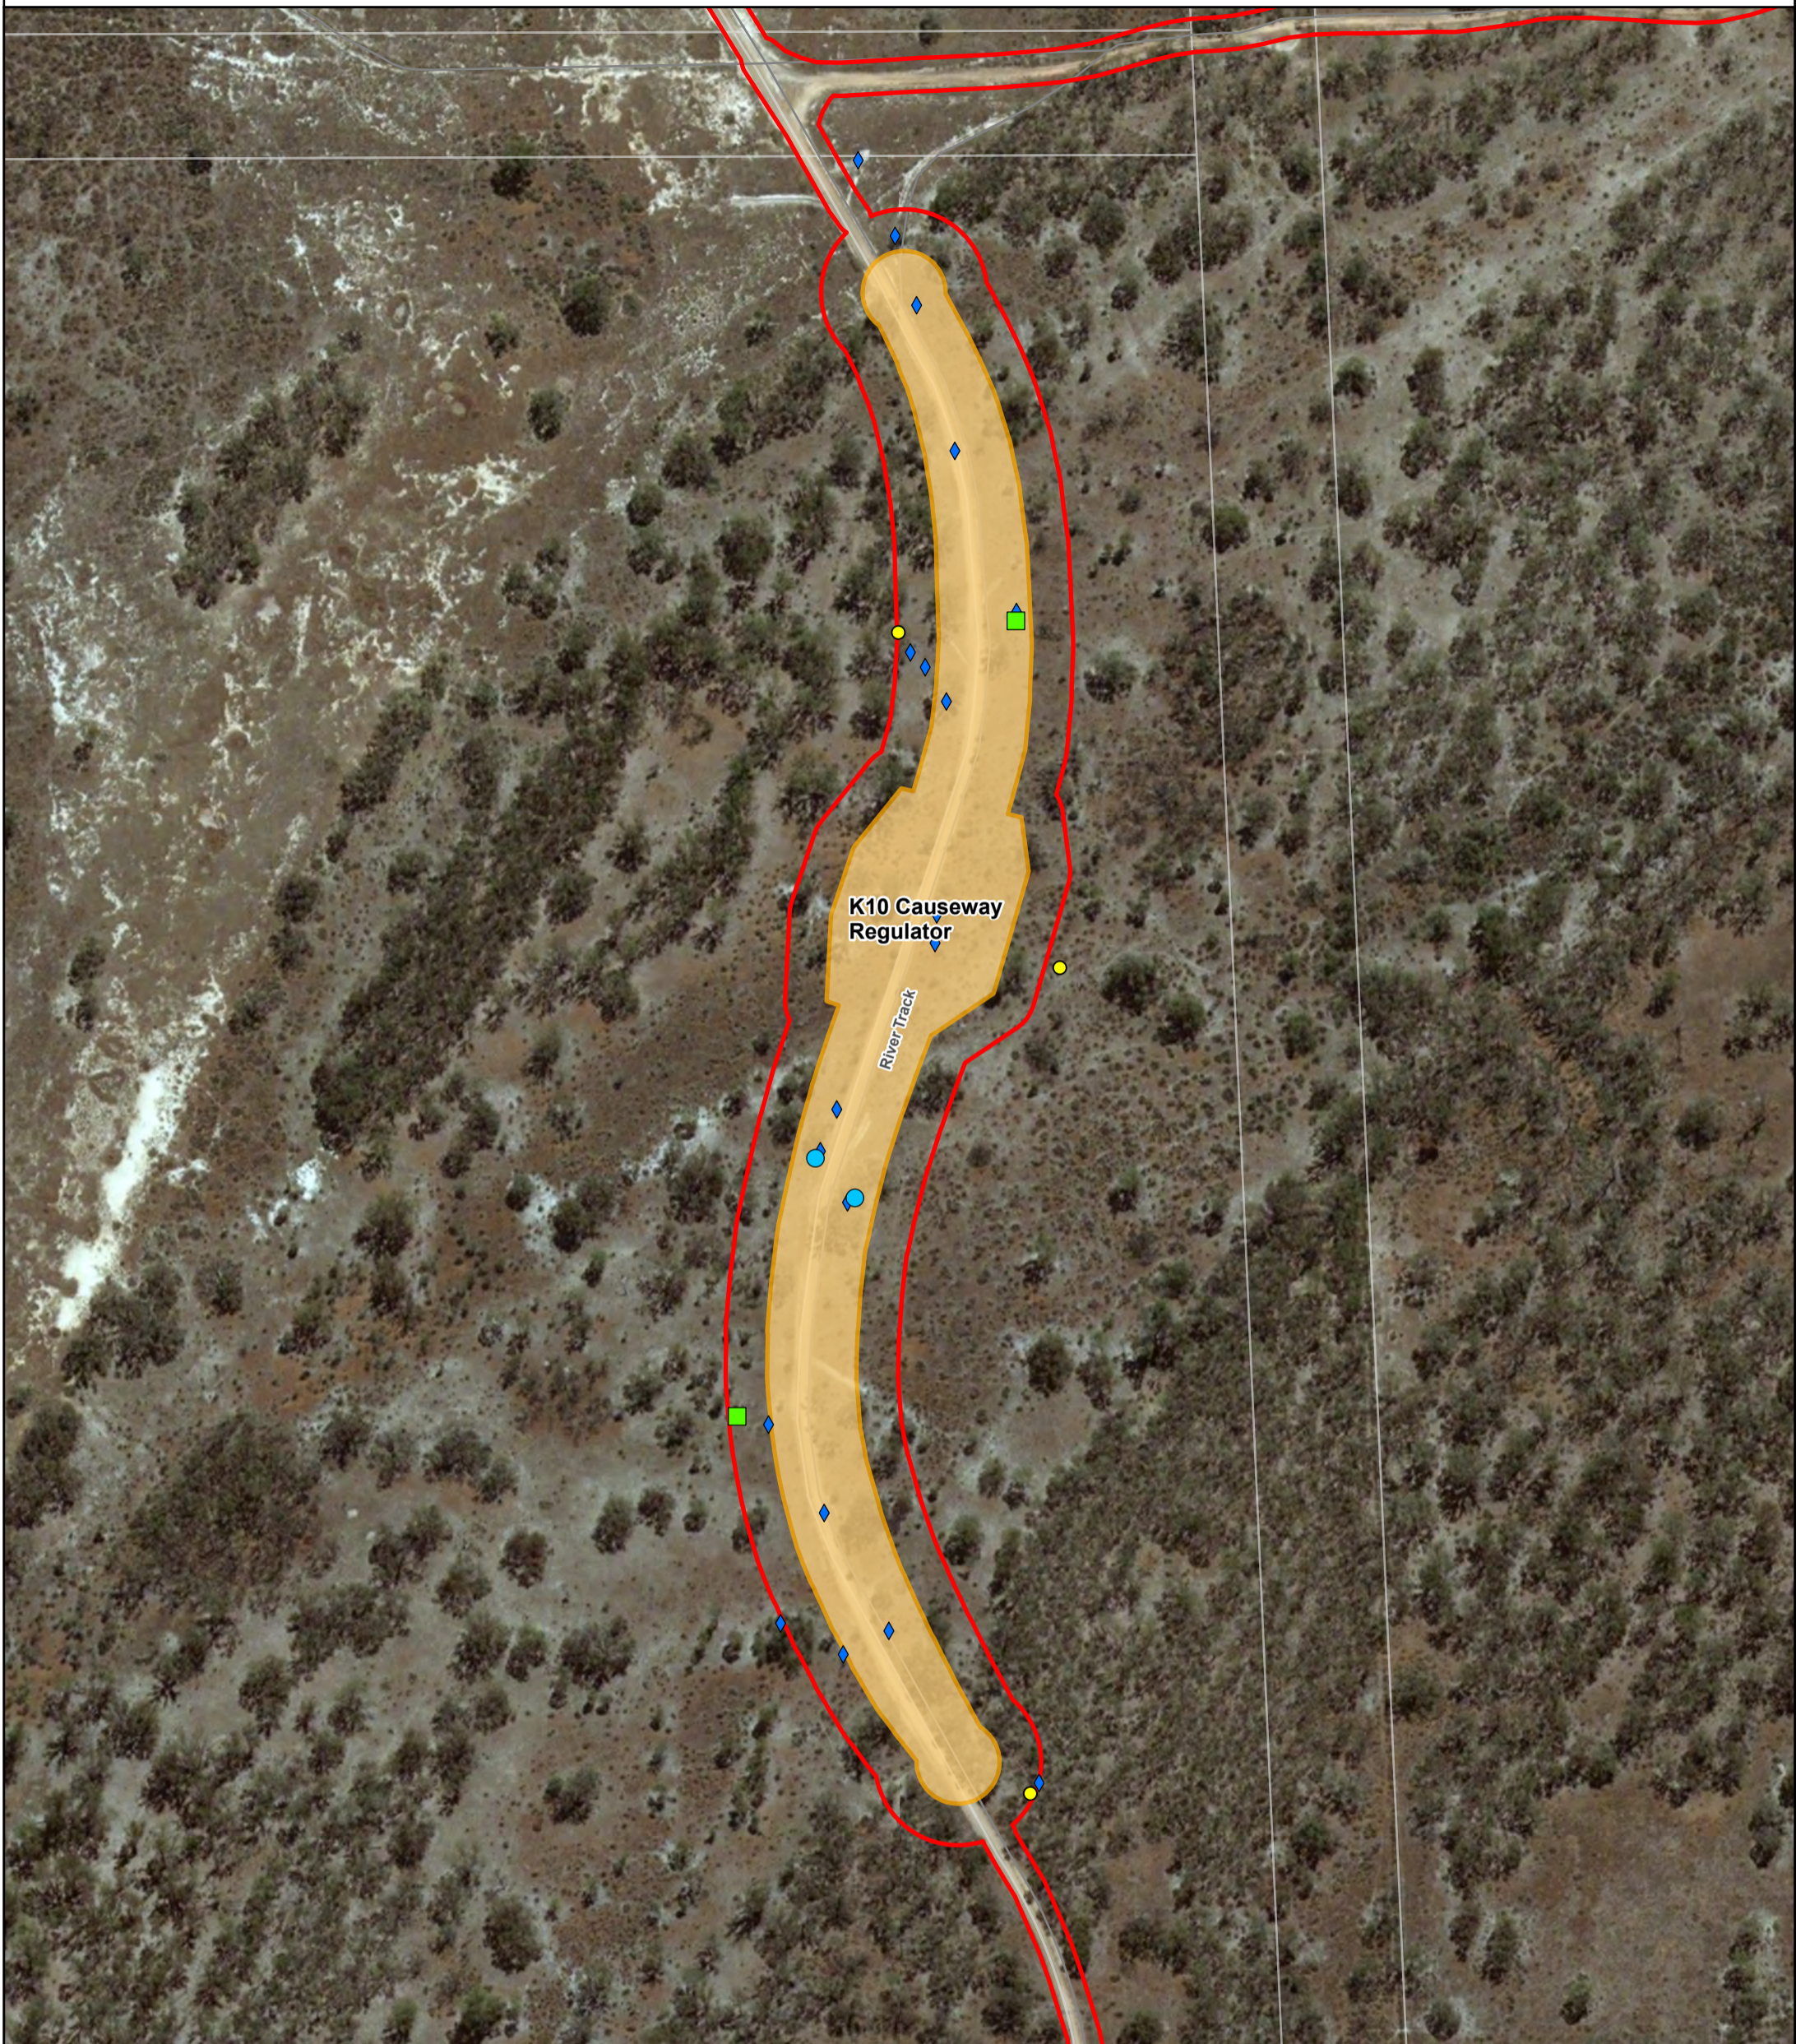
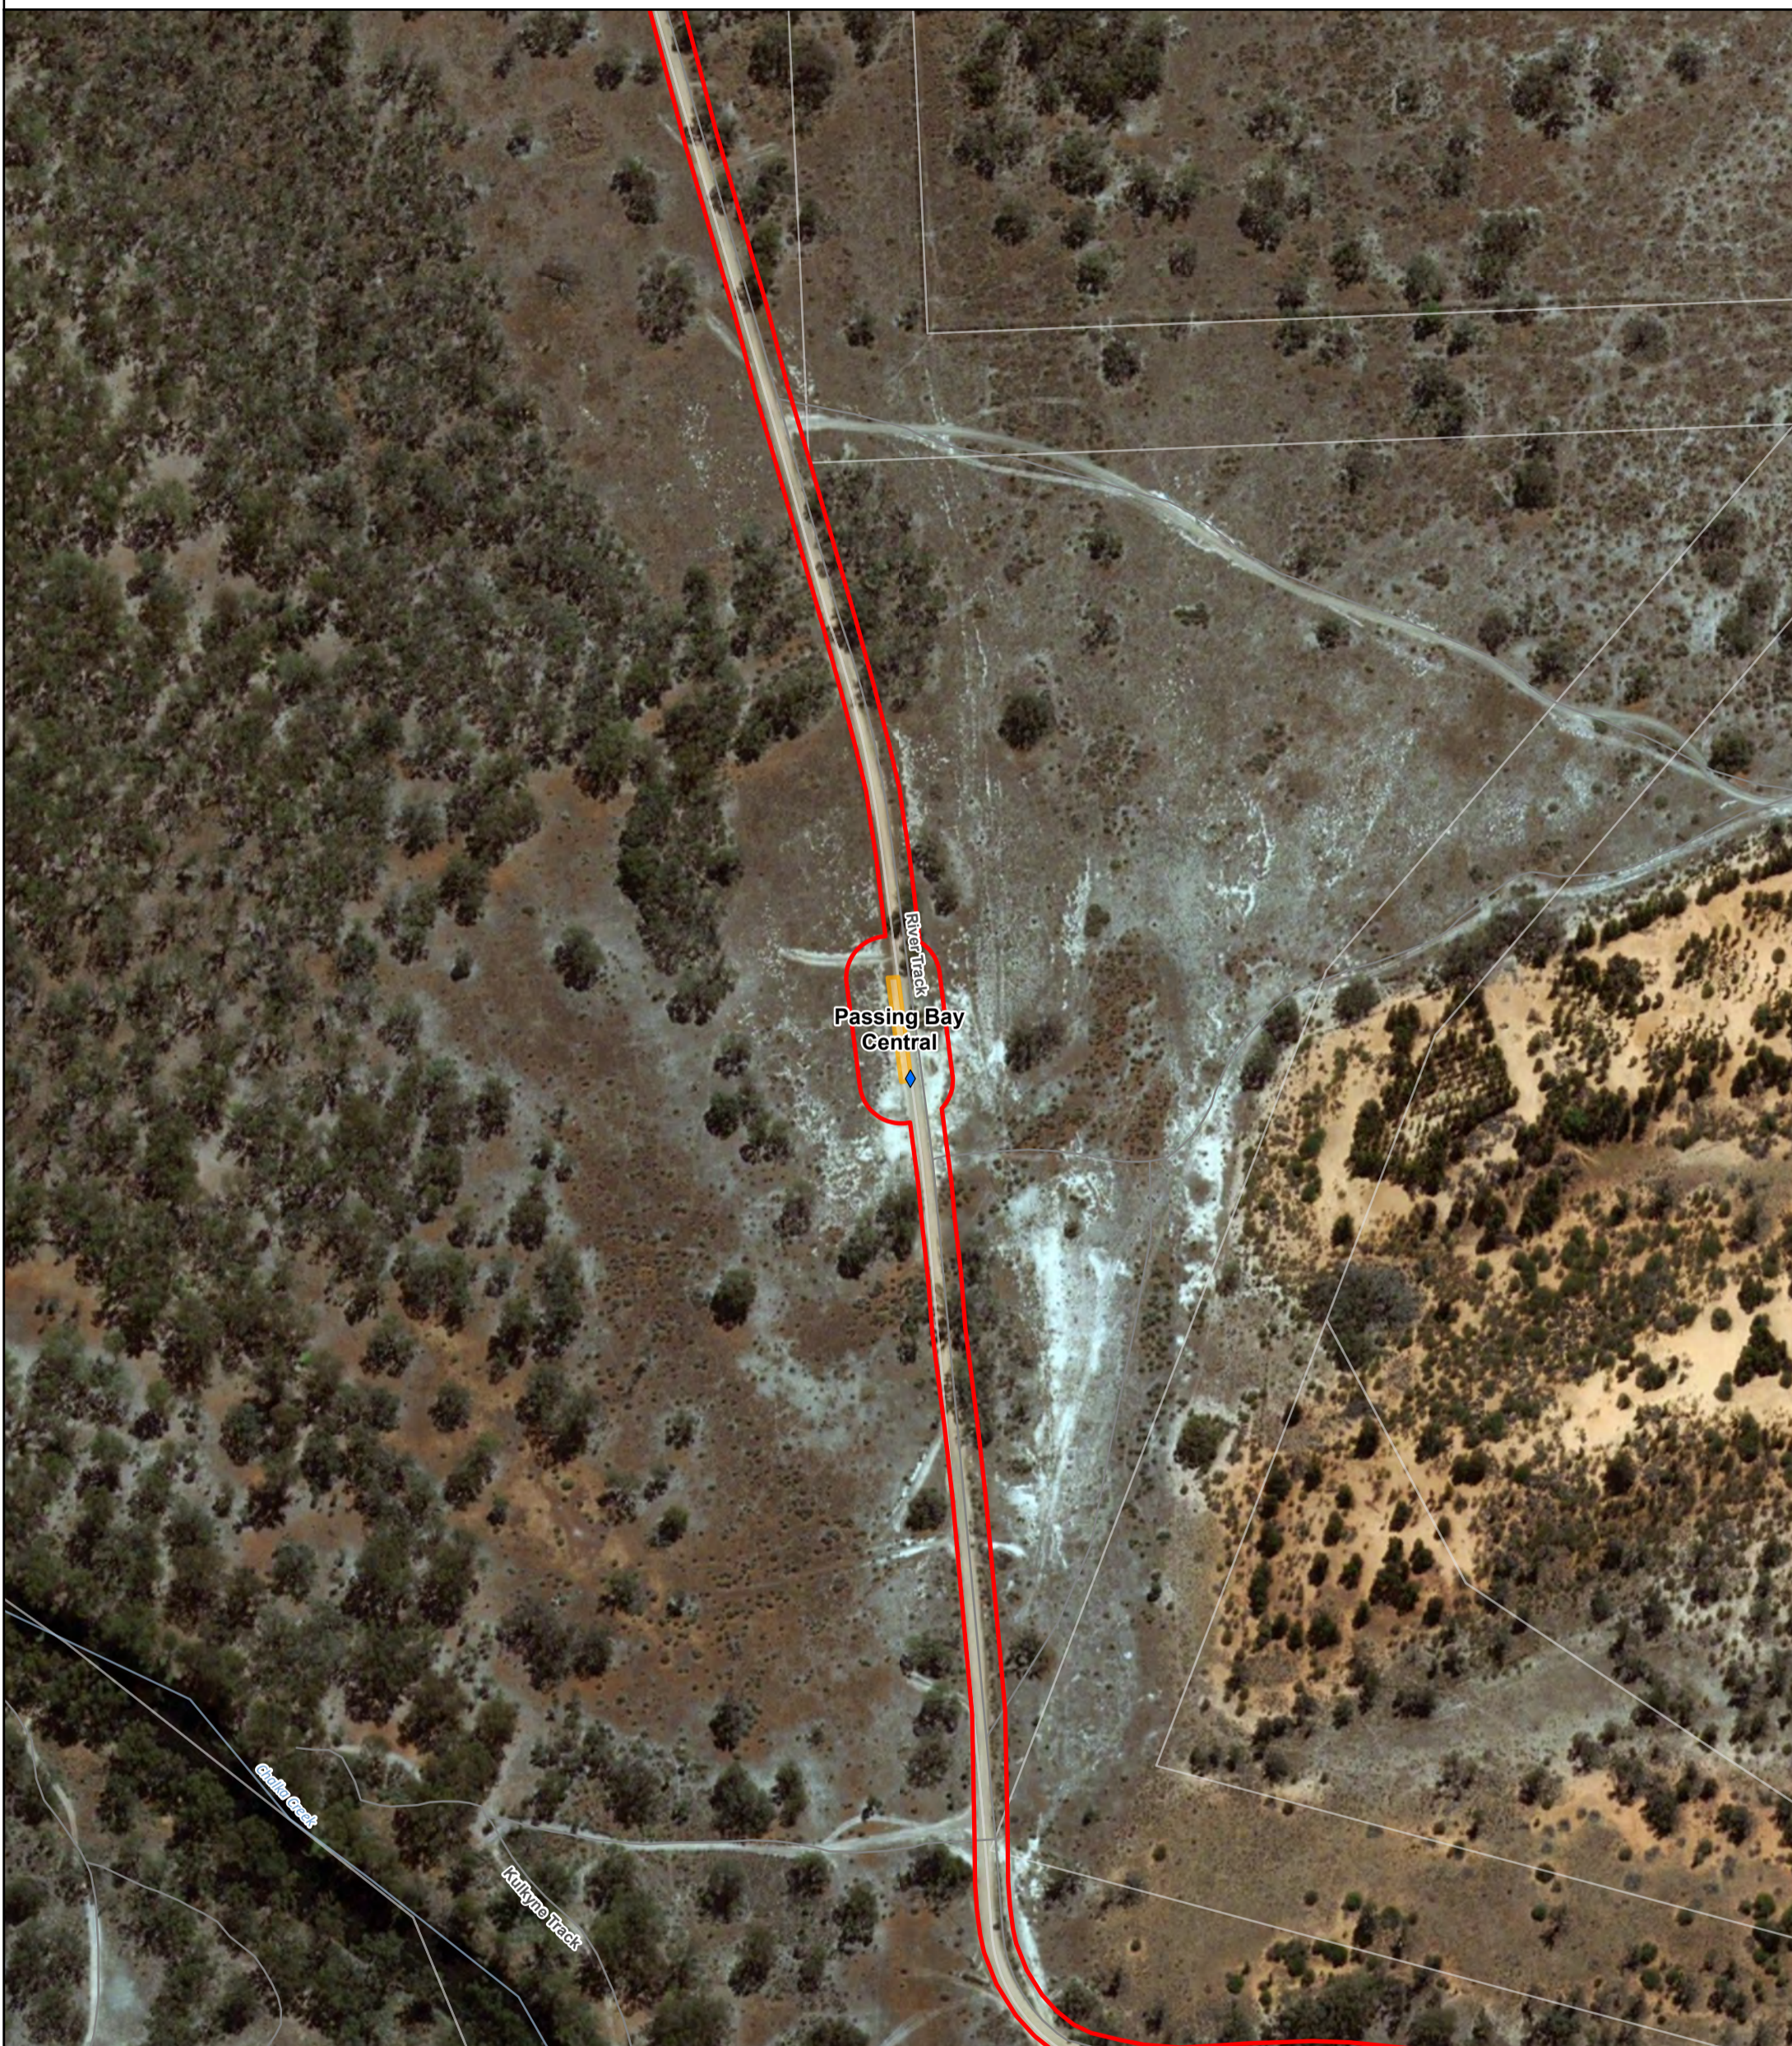
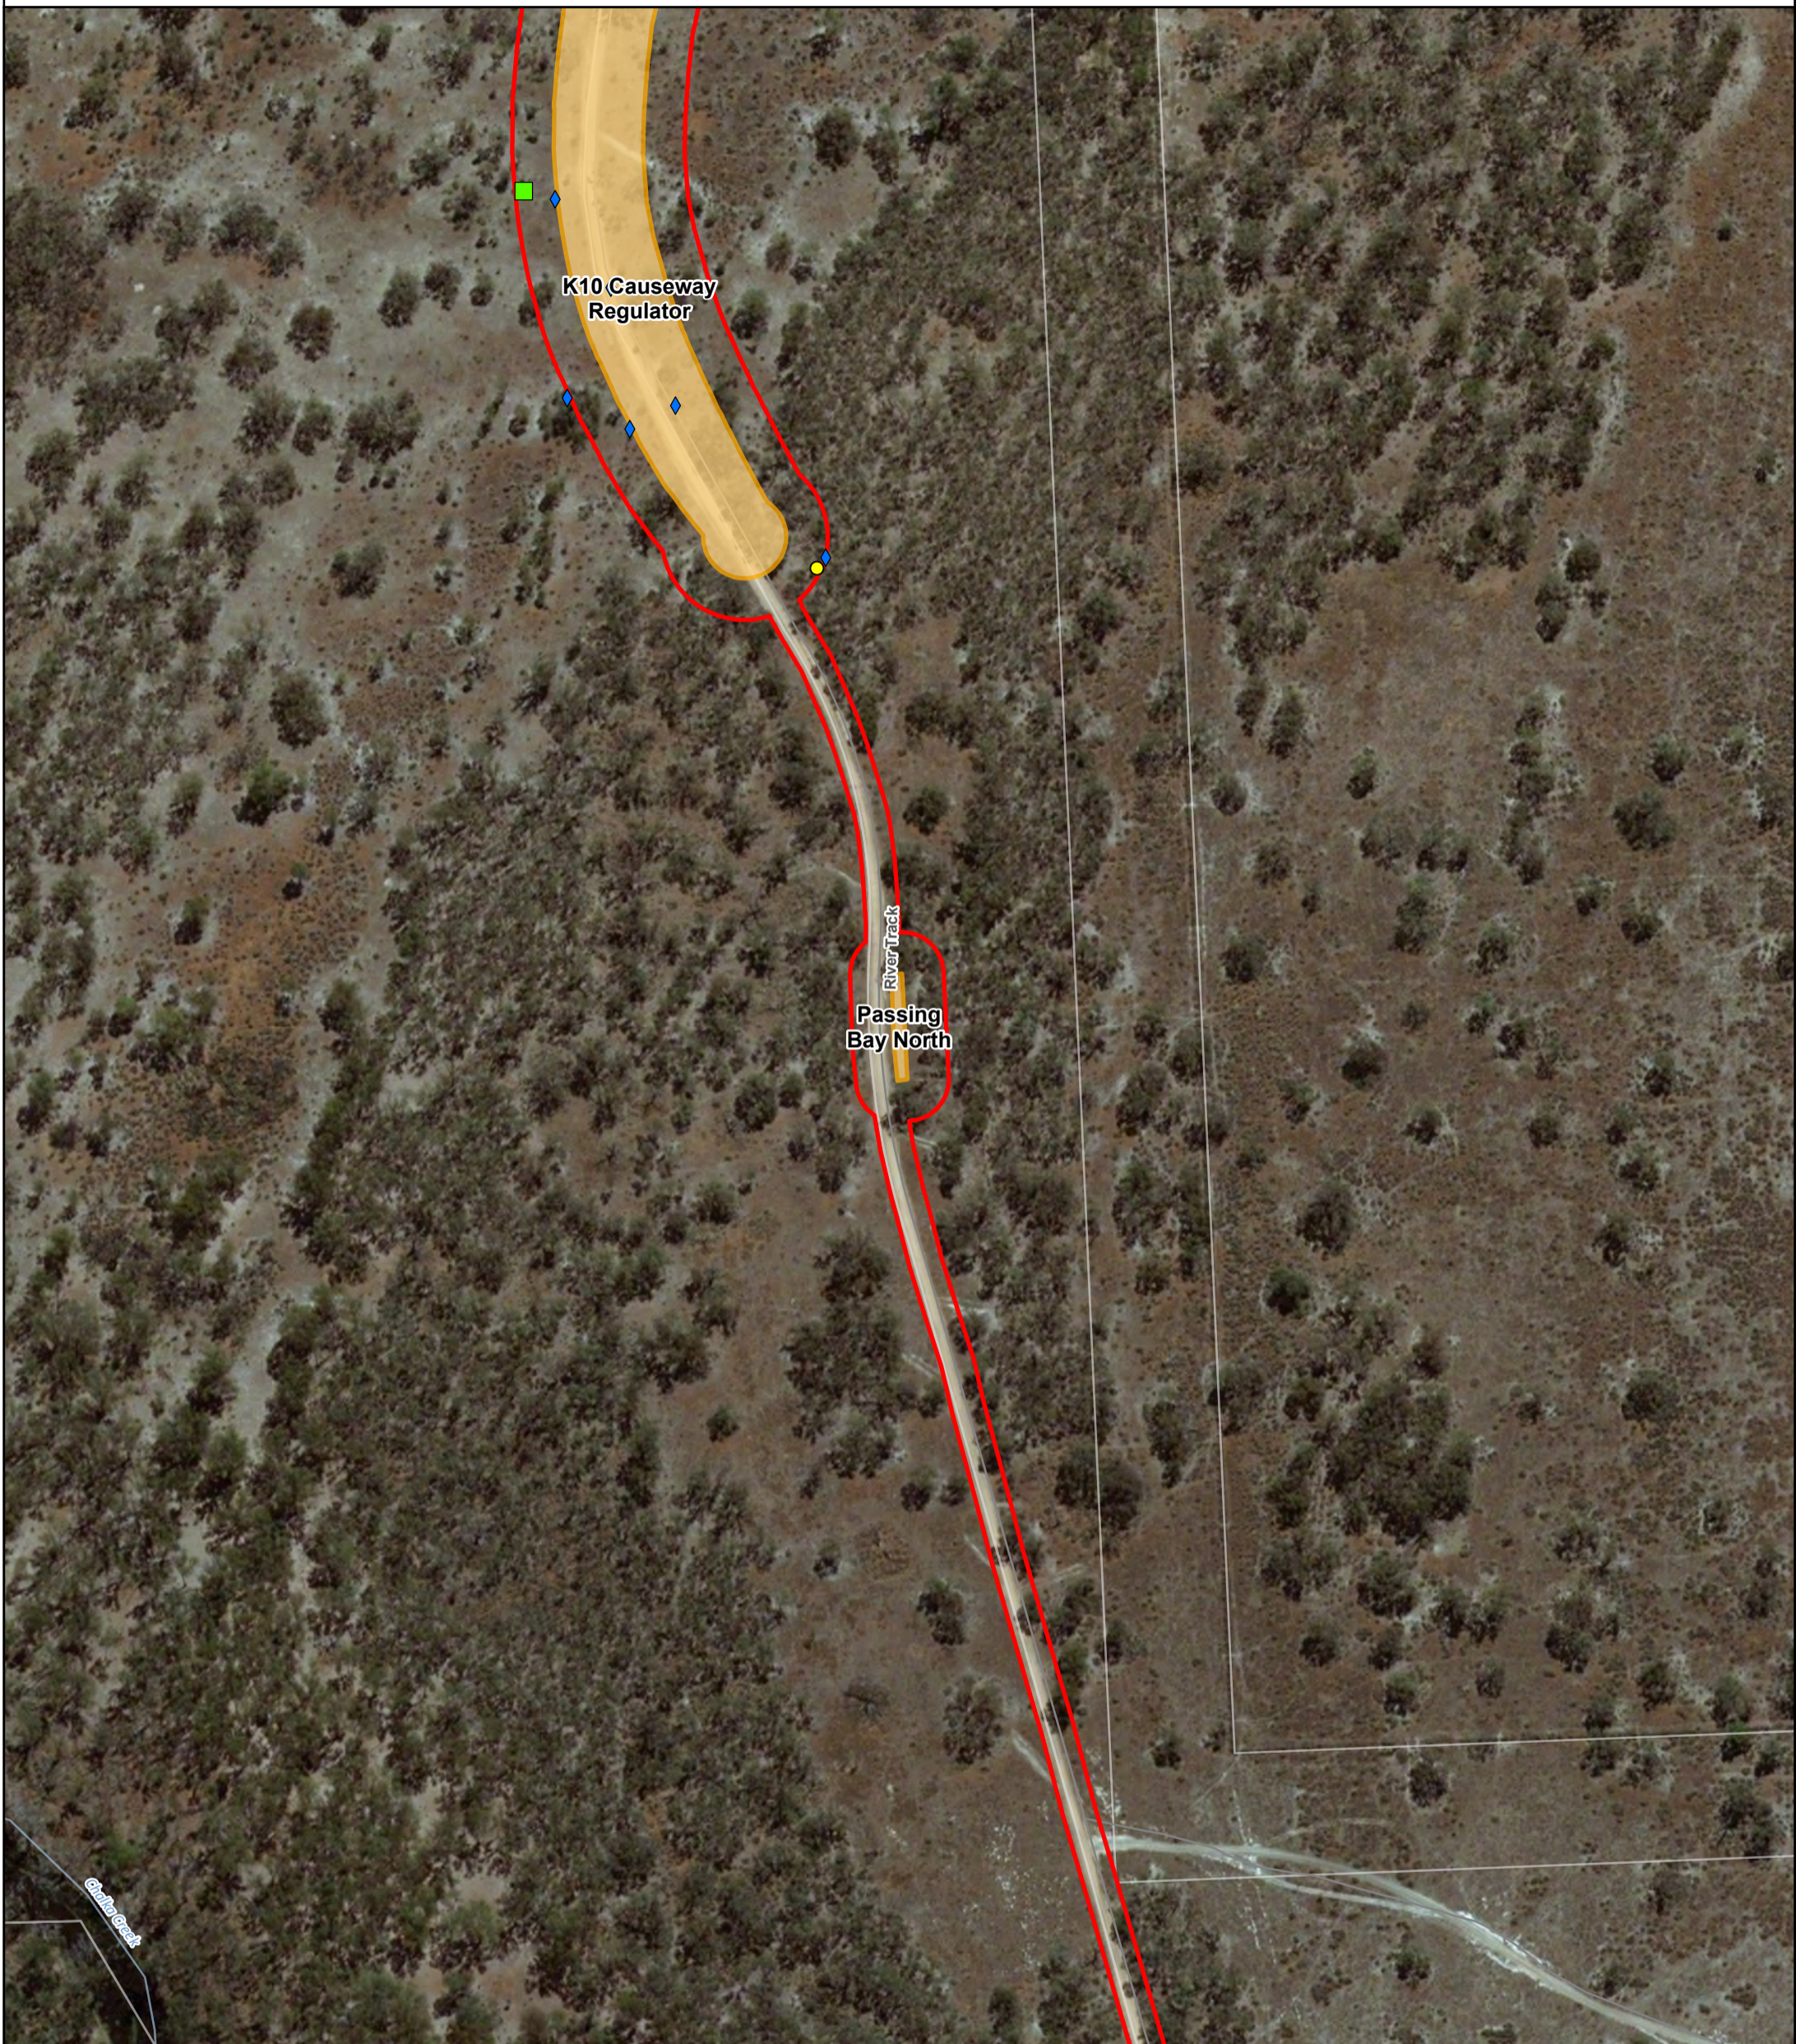
- Indicative Construction Area
- Investigation Area
- Rare and Threatened Flora recorded in 2017
- Rare and Threatened Flora recorded in 2015
- RPNT
- FFG threatened flora species (2019)
- DELWP advisory rare or threatened flora species (2019)
- Minor Road
- Cadastre
- THPS

Surveys were completed on August 22, 26, 29, and September 2 2019, using the Two Hour Point Survey (THPS) technique adapted from GHD (2009), GHD (2011a, b) and Robertson and Hurley (2010). Surveys were undertaken by two ecologists experienced in Regent Parrot survey and behaviour. The survey techniques are specific to the detection of Regent Parrot nesting activity and were developed and refined with the Living Murray Hattah Lakes Floodplain Management Project in recent years. Surveys were completed at 10 permanent observation points established across the survey site [REDACTED] where suitable habitat has been identified for Regent Parrot nesting (Figure 3). At least two THPS were completed at each permanent site during the survey period.

Eight species listed in Victoria under the DELWP advisory list of rare and threatened flora were also recorded incidentally during the 2019 assessments (Table 3 and Figure 3).

A summary of all fauna species recorded during the surveys are provided in Appendix P, with results of the Regent Parrot Two Hour Point Surveys shown in Figure 3.

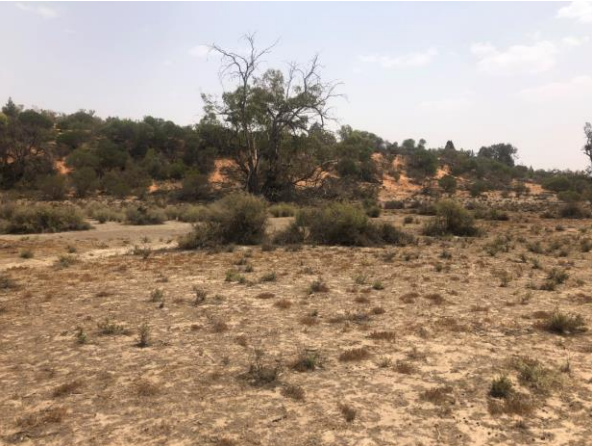
Vegetation type and condition	Flora description	Representative photos
<p>Habitat Zone 1</p> <p>EVC 97: Semi-arid Woodland (treeless)</p> <p>Located at Passing Bay South</p>	<p>Within patches of Habitat Zone 1 this EVC was modified and treeless, and persisting in areas that have been disturbed historically.</p> <p>The midstorey was sparse, containing scattered <i>Nitraria billardierei</i> (Nitre-bush).</p> <p>The understorey was dominated by a range of chenopods including <i>Atriplex stipitata</i> (Kidney Saltbush), <i>Enchylaena tomentosa</i> var. <i>tomentosa</i> (Ruby Saltbush), <i>Osteocarpum acropterum</i> var. <i>deminutum</i> (Babbagia), and <i>Rhagodia spinescens</i> (Hedge Saltbush).</p> <p>The cover of weeds was low, with <5% cover throughout.</p>

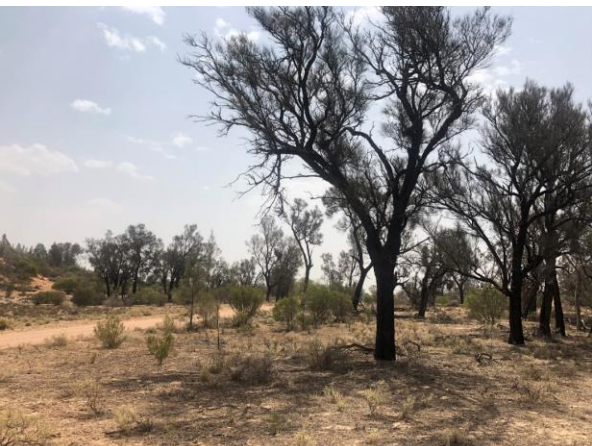
<p>Habitat Zone 2</p> <p>EVC 97: Semi-arid Woodland</p> <p>Located at Passing Bay South</p>	<p>Within patches of Habitat Zone 2 this EVC had maintained a moderate species richness, and a tree canopy dominated by <i>Allocasuarina luehmannii</i> (Buloke).</p> <p>The midstorey included <i>Dodonaea viscosa</i> (Sticky Hop-bush) and regenerating Buloke.</p> <p>The understorey was dominated by a range of chenopods and forbs including <i>Atriplex pumilio</i> (Mat Saltbush), <i>Brachyscome lineariloba</i> (Hard-head Daisy), <i>Enchylaena tomentosa</i> var. <i>tomentosa</i> (Ruby Saltbush), <i>Osteocarpum acropterum</i> var. <i>deminutum</i> (Babbagia), <i>Rhagodia spinescens</i> (Hedge Saltbush) and <i>Roepera apiculata</i> (Pointed Twin-leaf).</p> <p>The cover of weeds was low, with <5% cover throughout.</p>

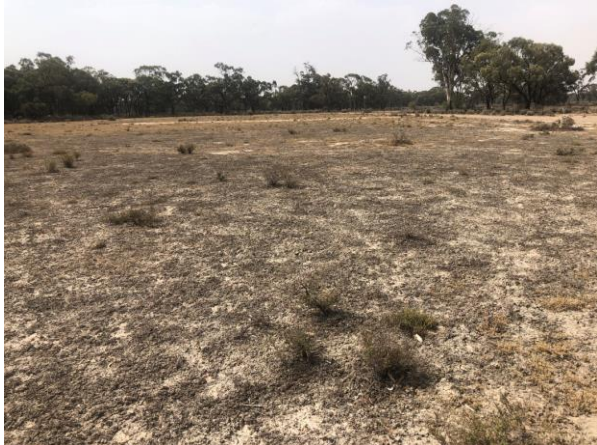
Vegetation type and condition	Flora description	Representative photos
<p>Habitat Zone 3</p> <p>EVC 102: Low Chenopod Shrubland</p> <p>Located at Passing Bay Central</p>	<p>Within patches of Habitat Zone 3 this EVC was highly modified and entirely devoid of an overstorey or midstorey layer. This habitat zone persisted in areas that have been disturbed historically, but still contained >25% cover of perennial native vegetation.</p> <p>The understorey was low in diversity and contained graminoids and chenopods including <i>Atriplex lindleyi</i> (Flat-top Saltbush), <i>Osteocarpum acropterum</i> var. <i>deminutum</i> (Babbagia), <i>Sclerochlamys brachyptera</i> (Short-wing Saltbush) and <i>Tecticornia pergranulata</i> (Blackseed Glasswort).</p> <p>The cover of weeds was low, with <5% cover throughout.</p>

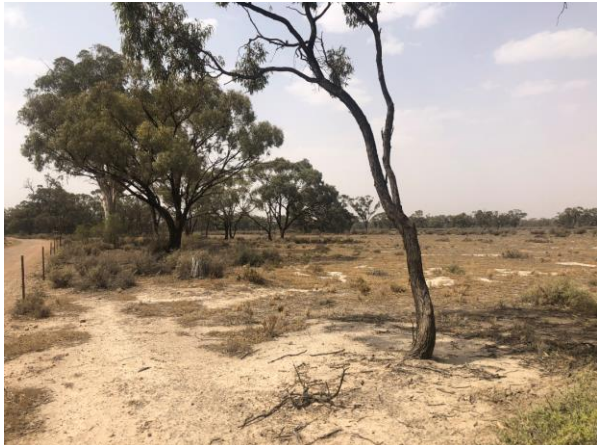
<p>Habitat Zone 4</p> <p>EVC 103: Riverine Chenopod Woodland</p> <p>Located at Passing Bay North</p>	<p>Within patches of Habitat Zone 4 this EVC was modified with a sparse overstorey dominated by <i>Eucalyptus largiflorens</i> (Black Box), but was devoid of a midstorey layer.</p> <p>The understorey was low in diversity and contained graminoids and chenopods including <i>Atriplex lindleyi</i> (Flat-top Saltbush), <i>Enchylaena tomentosa</i> var. <i>tomentosa</i> (Ruby Saltbush) and <i>Maireana pyramidata</i> (Sago Bush).</p> <p>The cover of weeds was low, with <5% cover throughout.</p>
