Victorian Murray Floodplain Restoration Project

Flora and Fauna Assessment - Hattah Lakes North Floodplain Restoration Project

IS297772-AP-EN-RP-001 | 0

Lower Murray Urban and Rural Water Corporation

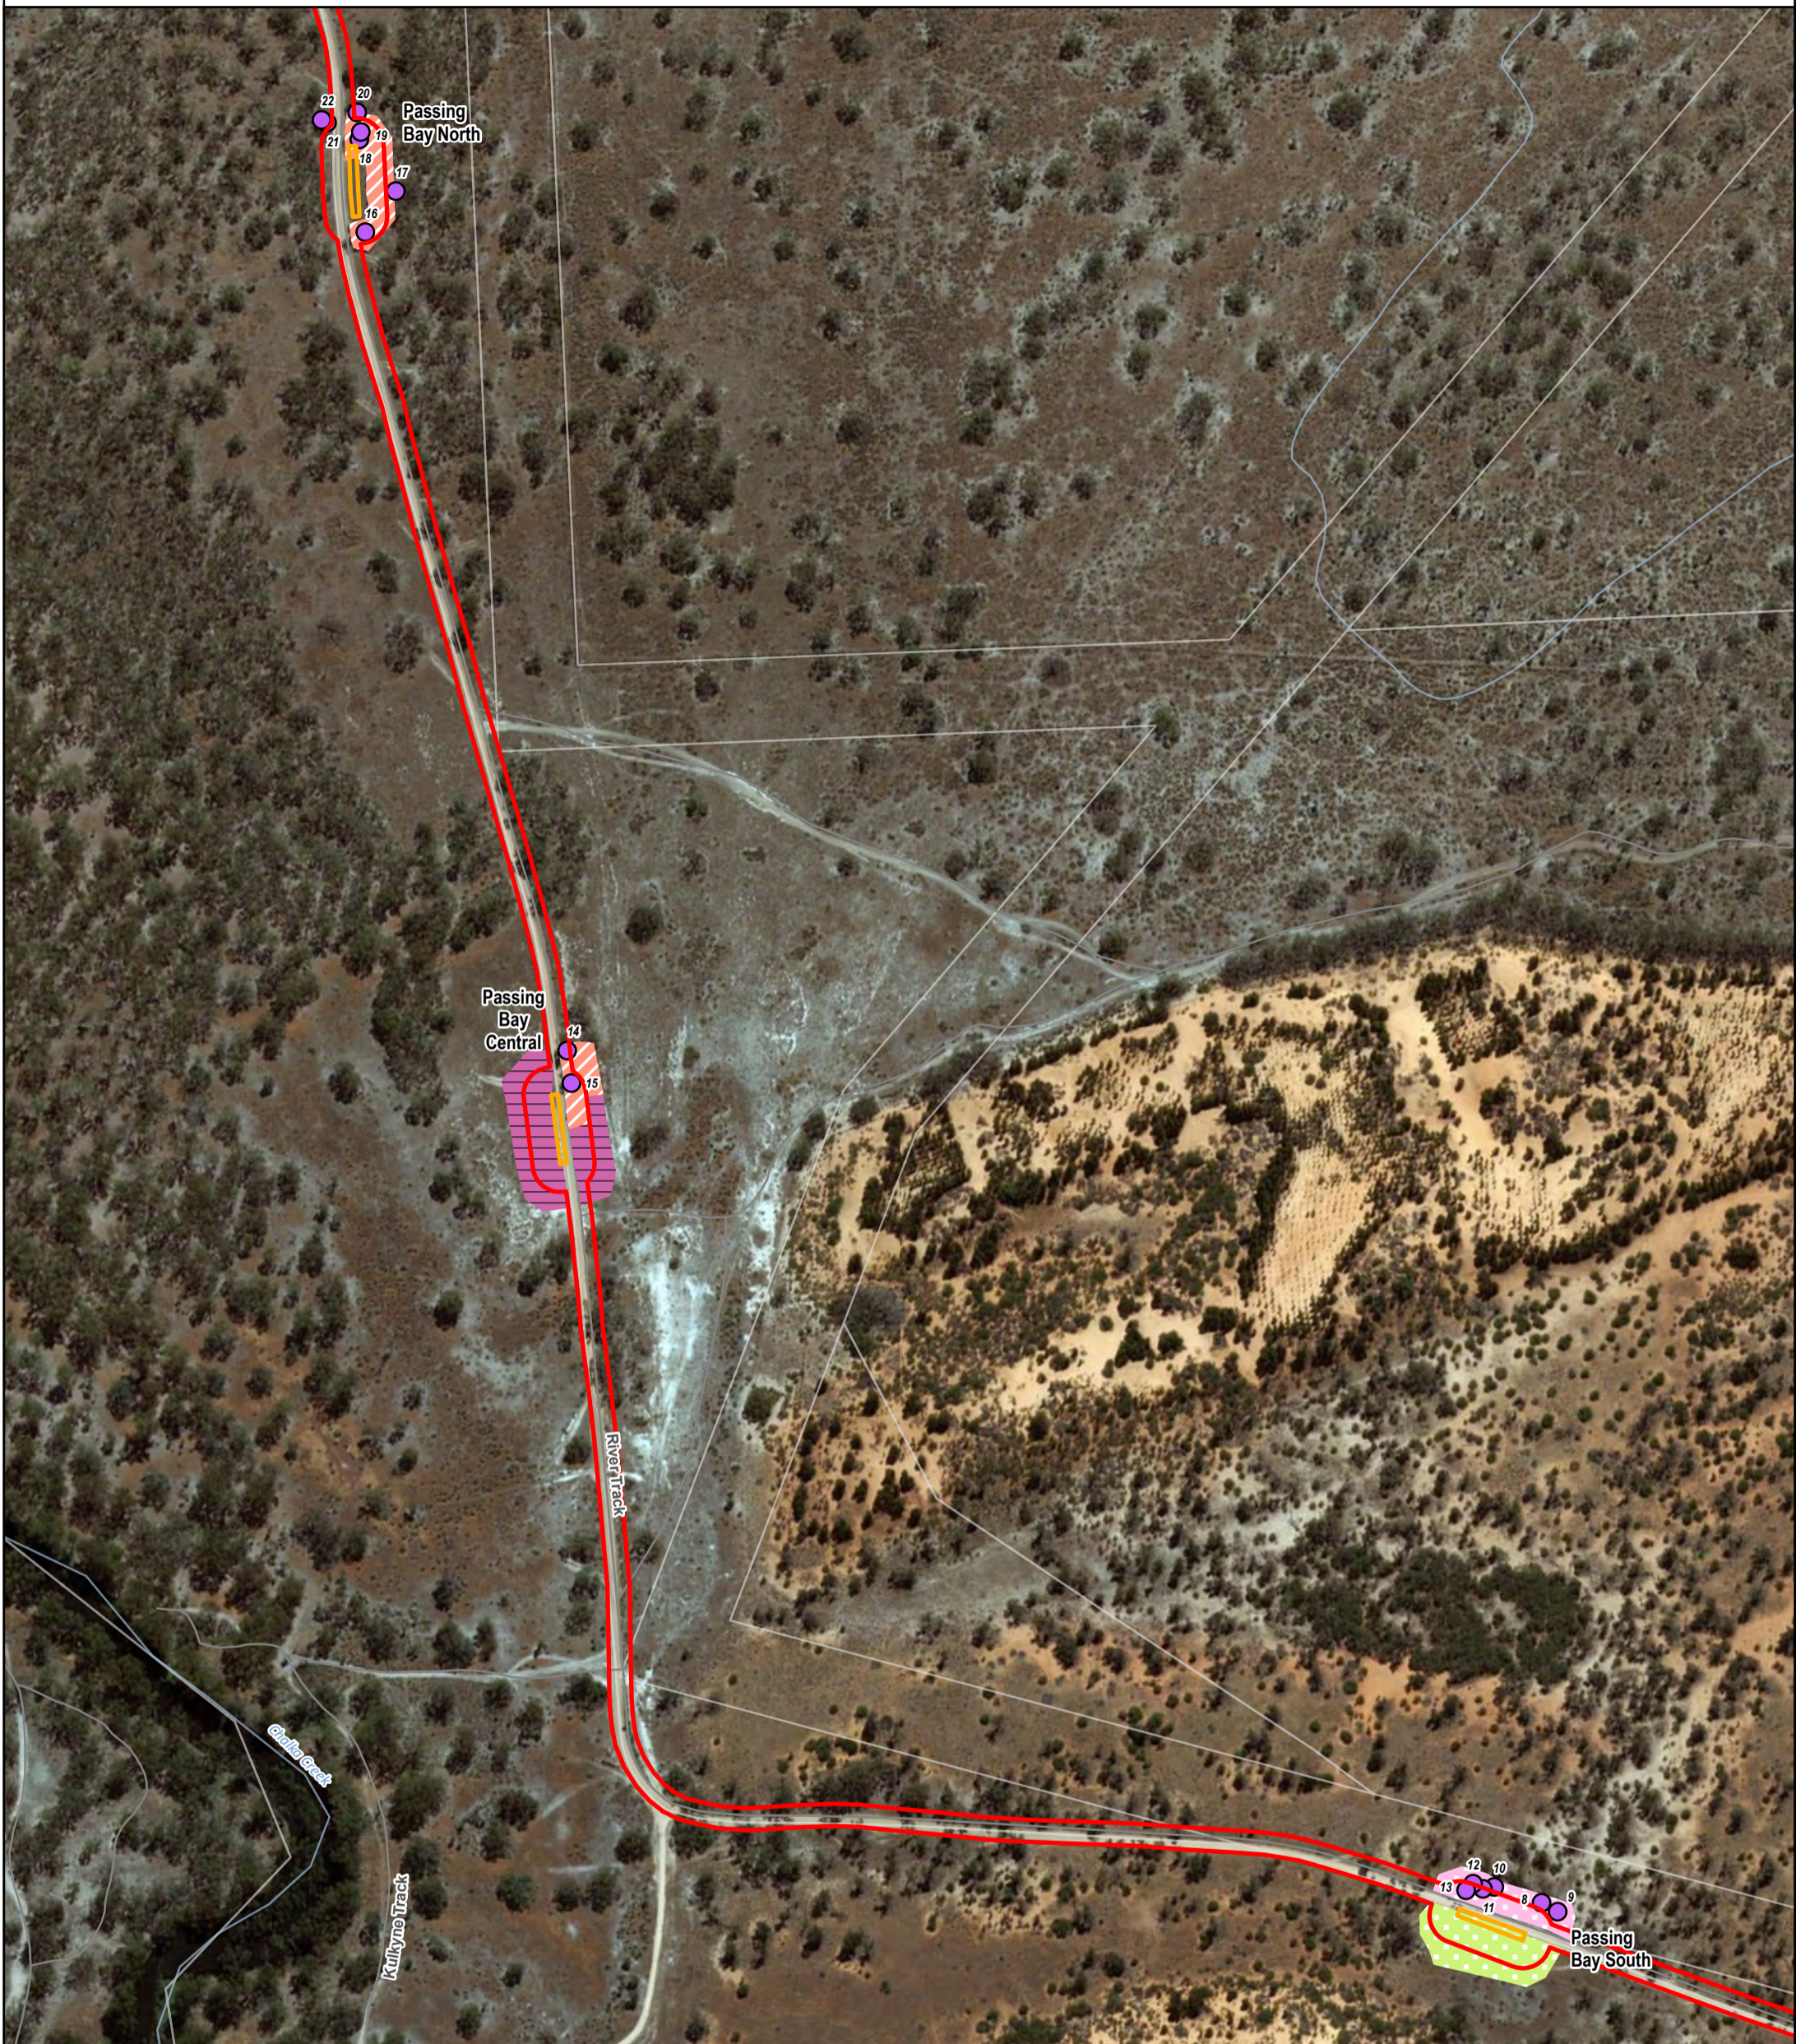
- Indicative Construction Area
- Investigation Area
- Ecology point data recorded in 2019
- Canopy Tree
- HZ 1: EVC 97 Semi-arid Woodland
- HZ 2: EVC 97 Semi-arid Woodland
- HZ 3: EVC 102 Low Chenopod Shrubland
- HZ 4: EVC 103 Riverine Chenopod Woodland
- Minor Road
- Watercourse Stream
- Cadastre

During the field assessment four Habitat Zones (HZs) were identified, a description of the condition of each of the HZs is outlined below in Table 6 and the results of the Habitat Hectares assessment is provided in Appendix D.
