Non-Time-Critical Removal Action
at the Municipality of Culebra, Puerto Rico

Environmental and Cultural Resources Surveys for Isla Culebrita

November 2006

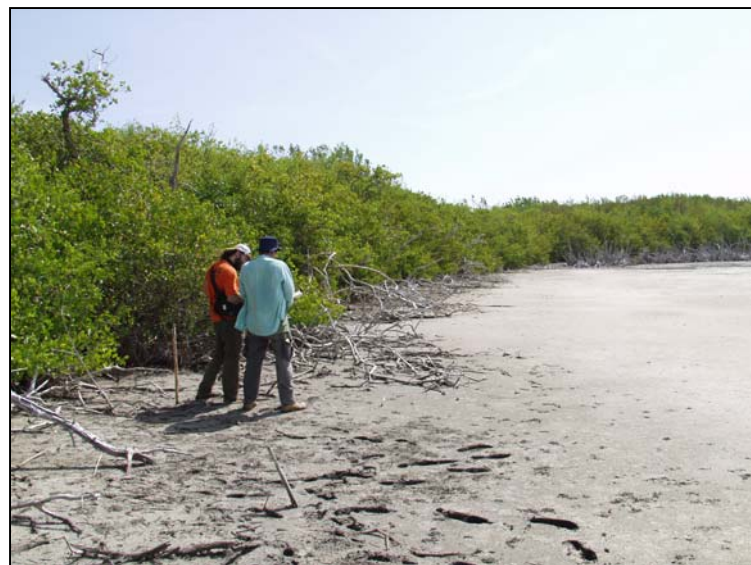
Figure 6. Tidal flat in northwestern tip of Culebrita.

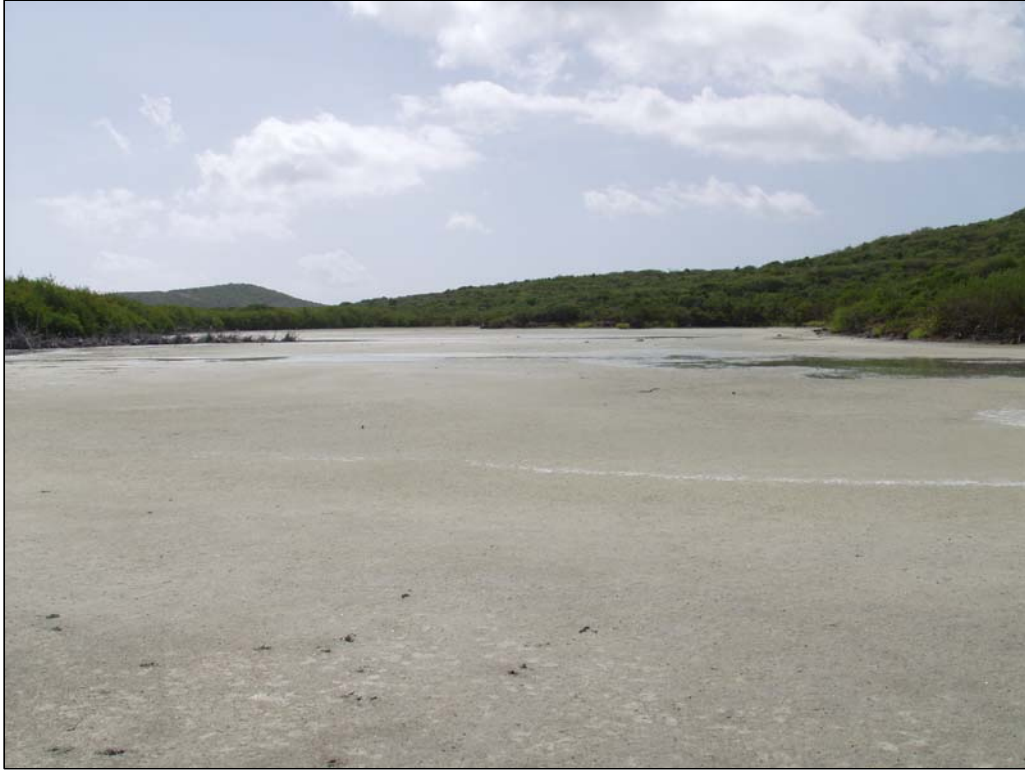
Figure 4. Laguna de Molino (western tidal flat) on July 26, 2006.

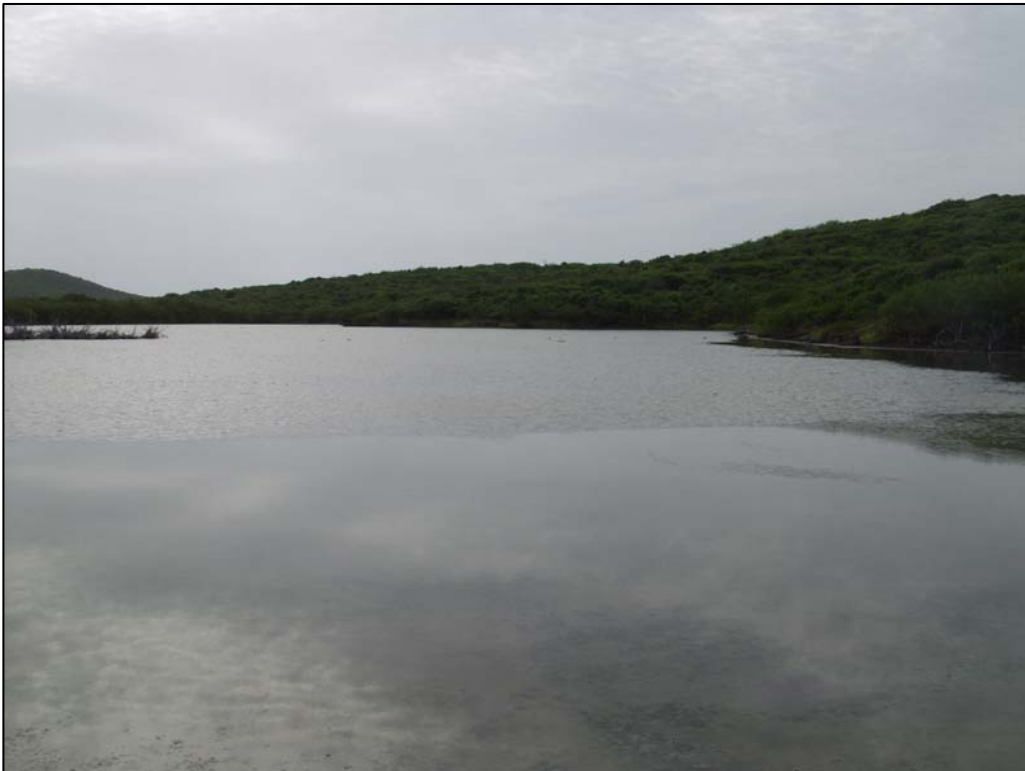
Figure 5. Laguna de Molino on August 11, 2006.

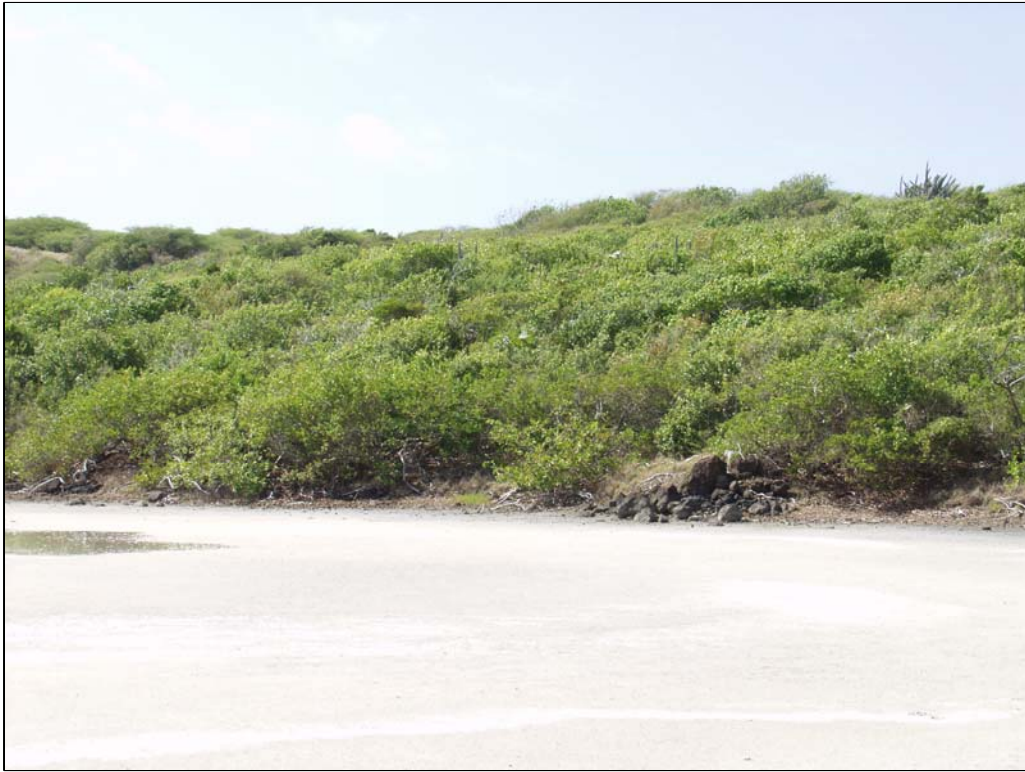
Figure 6. Northern limit of wetland at Laguna de Molino.
